## Segment Analysis of Oneida Creek: The Location of Sources of Pollution

# SEGMENT ANALYSIS OF ONEIDA CREEK

## The Location of Sources of Pollution

September 2004

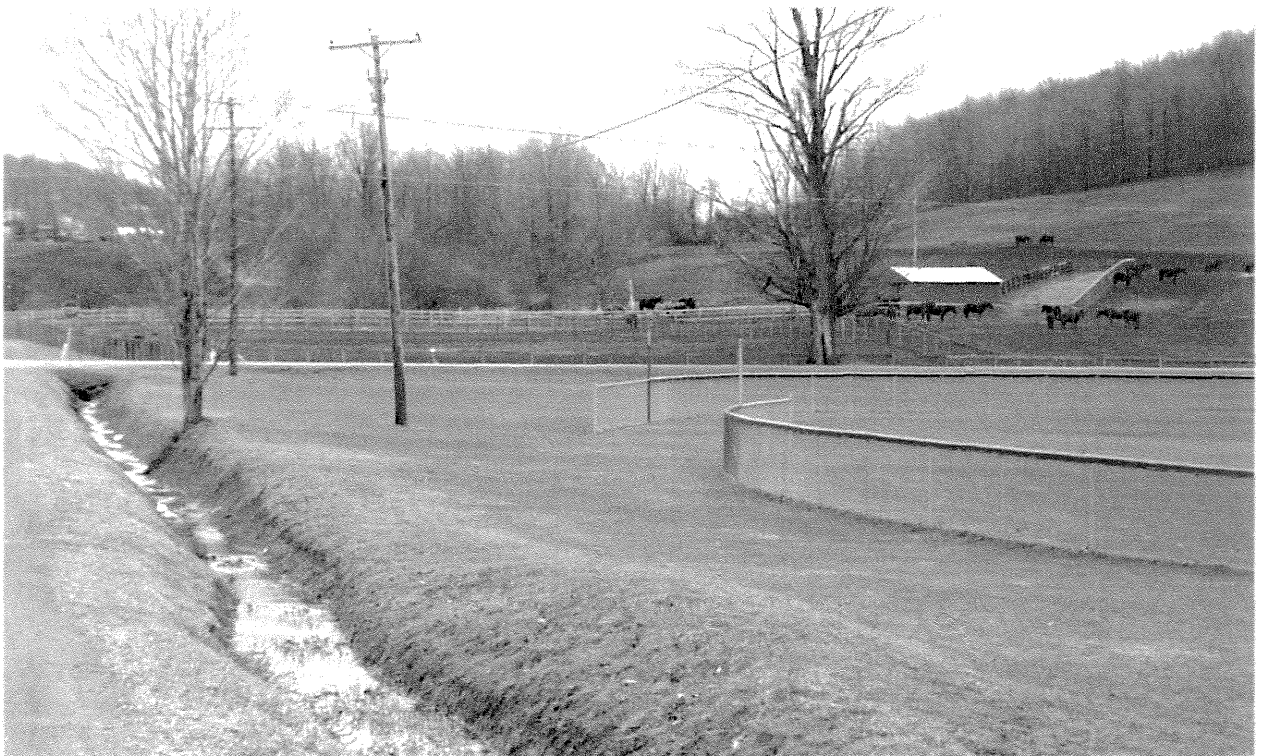
**Figure 7. Ditch that runs into a culvert at site 16. Note extensive area of exposed soil in pasture of grazing horses.**

site 16d by 526% and 482%, respectively. The horse farm was the most likely cause in the observed increase in April while construction practices were the major source in October.

3. Identified point and non-point sources of nutrients and solids can be remediated using Best Management Plans (BMPs). For example at site 16d, buffer strips near the culvert and rotational grazing pens are examples of how these effects can be minimized (See page 10 for some other examples). Also, it was quite clear that construction at the Morrisville Eaton Central School and at site 10b was not properly contained as large losses of soil were observed during one event. Better education of members of the community on construction practices is warranted.

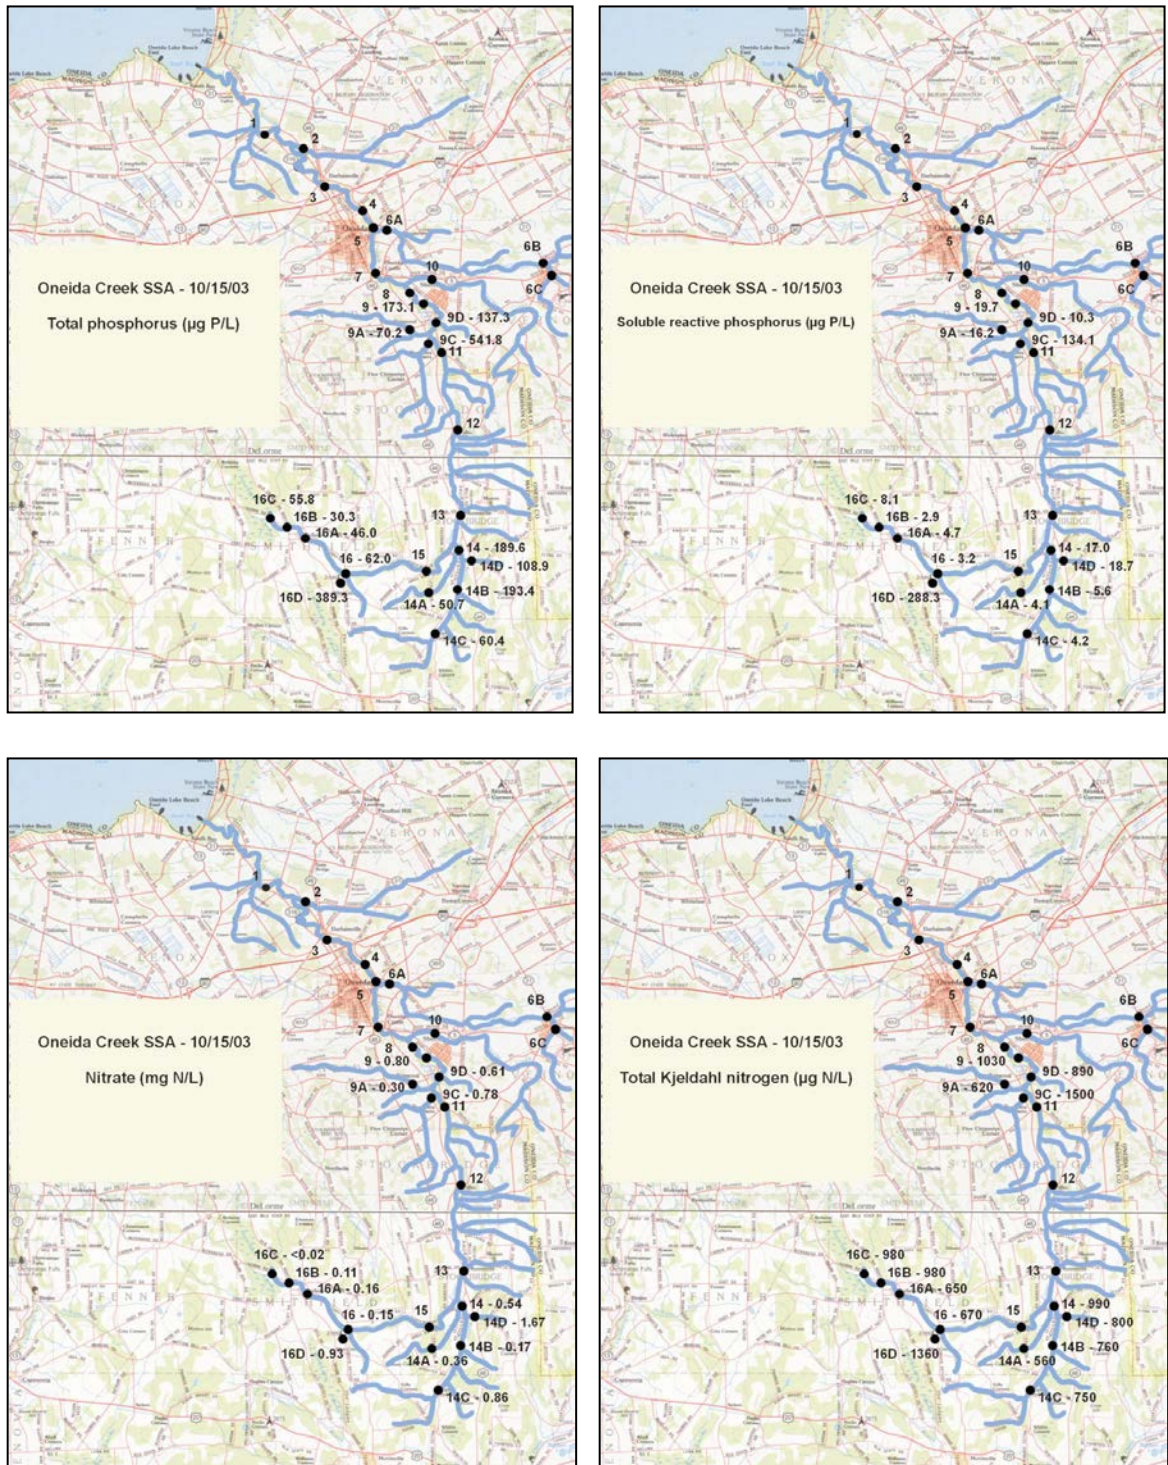
Figure 5. Segment analysis of Oneida Creek, 15 October 2003.

- a. Between sites 16 and 16d, significant increases in soluble reactive phosphorus (8,909%), total phosphorus (528%), nitrate (520%), total Kjeldahl nitrogen, (103%) and total suspended solids (143%) were observed. This site, just south of site 16, received storm water runoff from the nearby Morrisville Eaton Central School and the horse farms.
- b. Between sites 16a (Glass Factory Road) and 16 on South Butler Road, there was an increase in total phosphorus (46 to 62  $\mu\text{g/L}$ ) and total suspended solids (6.4 to 14.1  $\text{mg/L}$ ). This small increase in particulate fractions and not dissolved fractions suggested that soil was being lost through erosion.
- c. Upstream of site 16c on Pleasant Valley Road south of Oxbow Road, a source of total phosphorus, SRP and TSS existed. More sampling is required upstream of this site.

**Site 14 Segment:** Five sites were sampled within this segment. Elevated levels of particulate fractions (TSS and TP) were observed on Blue Creek from sites 14a and 14c downstream to site 14. Total phosphorus increased from 50.7 (site 14a) and 60.4 (site 14c) to 189.6  $\mu\text{g P/L}$  at site 14, while total suspended solids increased from 18.6 (site 14a) and 22.0 (site 14c) to 101.3  $\text{mg/L}$  at site 14. The elevated levels of TSS and TP observed downstream at site 14 were caused by losses, probably soil, within the segment between sites 14c and 14b and perhaps from site 14d to site 14. Further segmenting of the stream is required on the next sampling day.

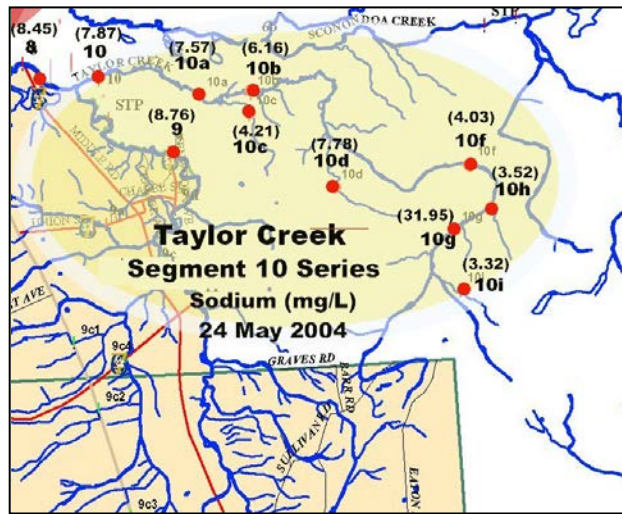
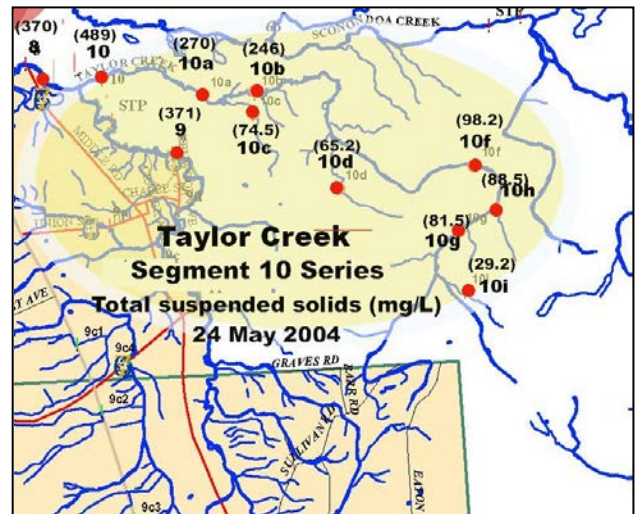
Figure 10. Segment analysis of Oneida Creek, 24 May 2004.

Samples were limited to segment analysis on Taylor Creek. As a result of heavy rains (2.55 inches) during the previous evening, flow rates in Oneida Creek reached 1250 cubic feet per second at the U.S.G.S. Oneida gauging station. Several areas within this segment were identified as having problems. A 100+% increase in total phosphorus (411 to 1,076  $\mu\text{g P/L}$ ) and total suspended solids (270 to 489 mg/L) was observed from site 10a downstream to site 10. Similarly, at site 10b, elevated levels of total phosphorus, total suspended solids and total

Levels of total suspended solids (81.5 mg/L), total Kjeldahl nitrogen (1,330  $\mu\text{g N/L}$ ), total phosphorus (167  $\mu\text{g P/L}$ ) and sodium (37.95 mg/L) were elevated upstream of site 10g. A source was not noted by field technicians, but the high values were indicative of soil loss from fields in agriculture.

Site 10d had high levels of dissolved nutrients including soluble reactive phosphorus (52.8  $\mu\text{g P/L}$ ) and nitrate (7.27 mg N/L). No obvious source was observed as the area was forested. More investigation is needed upstream to determine the potential sources of these nutrients.

At site 10f, bright blue-green water was observed entering the creek from a drainage ditch. A private pond existed in a nearby yard that also had a similar color. Analysis of the water indicated that levels of sulfate were high (199 mg/L). This result suggested that the pond was treated with copper sulfate to reduce weed growth and improve the aesthetic value of the location.
