# Two New Techniques for Evaluating Connectivity of Septic Fields to Great Lake Watersheds and Embayments

## FINAL REPORT

**GENESEE and ORLEANS COUNTY DEPARTMENTS OF HEALTH**

*February 2, 2016*

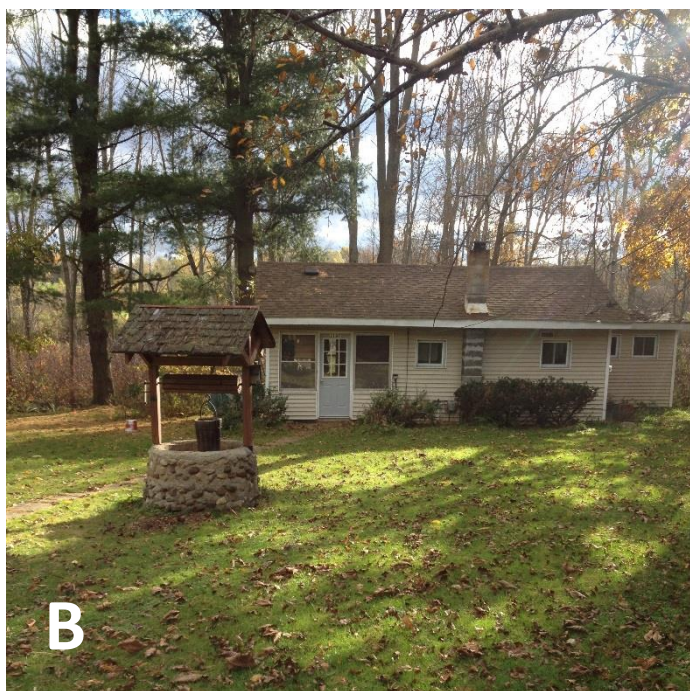
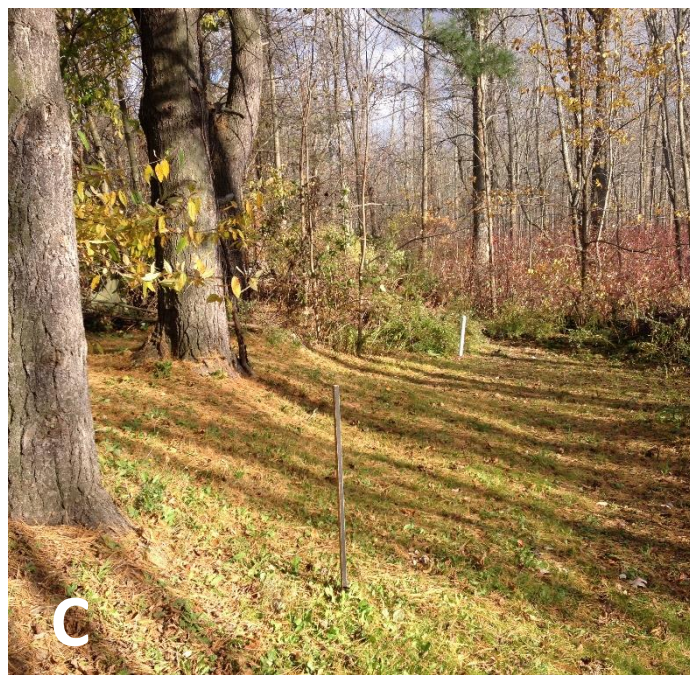
**FIGURE 2** Rush DNA Tracer Experiment site. A) Pictometry Image of site showing sampling wells and suspected location of leachfield. The wetland to the south is the large instream wetland associated with Honeoye Creek. B) Photo of one-bedroom house that was the subject of the experiment. The “wishing well” in the foreground is the well 8 that was used to identify EC of groundwater upgradient (and not impacted) by the septic system. This, and wells 4, 5, and 7 were used as controls. C) Photo of high slope just downgradient of the leachfield. High slope, short distance to a standing body of water, thick clay layer within two feet of the surface, and evidence of an eroded gully originating from where the leachfield is, makes this site a prime candidate for the situation where septic leachate will make it to the stream.

This site is a single bedroom home with a small septic field that was installed in 1993 (**Figure 2**). The area near where the septic field is contains a small erosional gully which may be evidence for a breach in the system. The soil also contains a thick clay layer 0.8m below the surface of the ground. This layer is almost pure-clay. The area where the leach field is believed to be located is only 10 meters from the shore of a wetland associated with Honeoye Creek and the surface gradient is high. This site seems to be a worst case scenario for the success of a septic field. The shallow clay layer probably acts as an aquitard in the early spring –and in fact was the top of the water table when the site was instrumented (early Fall). Shallow water table combined with the short distance and high slope, make it likely that some septic leachate will make it into the water body.

As the wetland contained still water, and the location of individual leach lines were not precisely determined, a suite of three shallow wells (wells 1, 2, and 3) were constructed to sample the plume coming from the system (see **Figure 2**). The wells are 1.5 meters deep and are screened from the bottom of the well to 0.3 m above the clay layer. The upper 0.3 meters of each well was sealed with bentonite clay to prevent contamination from surface water from above. The wells were located downgradient from the leach field site and within 3 meters of the wetland surrounding the creek. Two additional wells (wells 4 and 5) were constructed a large distance away from the house to act as a control. A preexisting groundwater well upgradient of the leach field was also sampled as a control (well 6). A well was also constructed downslope of the septic tank (well 7). Lastly, one 3 meter deep well was constructed within the leach field itself to sample leachate (well 8).

At the Rush site, T3 DNA Tracer was introduced on October 21, 2015 at 12:30 PM to the toilet. A saturated solution of sodium bromide was also added to the system so that EC could be used to identify the presence of the tracer. After the solution was mixed with the bathroom water, the EC of the toilet water was 123 mS. Assuming a gallon of water was present in the toilet, this injection should have caused the septic tank water to increase in EC anywhere from 0.25 to 0.12 mS (depending if it is a 500 gallon to 1000 gallon tank). The wells were all sampled the week previous to act as a control and to assess the average EC of the groundwater. Well number 6 which is located upslope of the leach field has an average EC of 0.69 mS. Well number 7, which is located downslope of the septic tank and presumably away from the effects of the leachfield, was 0.67 mS. Natural ambient groundwater EC is therefore interpreted to be 0.68 mS. Prior to the injection of the tracer, the average EC of the wells downslope of the leachfield (Wells 1, 2, 3) were slightly elevated over the EC of the groundwater, 0.73, 0.76 and 0.73 respectively. Multiple measurements taken within the wells vary considerably in EC and Temperature (as much as 0.1 mS and 2 degrees respectively). The highest temperature and EC is always located at the top of the water column. We believe this is because the warmer septic leachate water moves on top of the groundwater. As a consequences field measurements and samples were always taken near the top of the water column. Within 6 hours, well 1 increased in EC from 0.74 to 0.88, but no tracer was found. Well 3 increased from 0.72 to 0.96 26.5 hours

later. Well 2 did not change in EC at all, and in fact dropped slightly from its 0.76 pre-tracer level. The delay between well 1 and well 3 is probably because well 3 is located farthest away from the tank and distribution box. We cannot explain the lack of change in well 2, unless perhaps its screened interval was not located in a position to receive leachate (unlikely as its screened interval includes area above the clay layer). Another possibility is that the septic line associated with it was clogged. After this initial increase in EC, well 1 progressively decrease in EC with time until its pre tracer injection level 48 hours later. Well 3 decreased to its pre-injection level after only an hour. We believe this is an artifact of the sampling approach for this well as it was sampled with an ISCO sampler utilizing a rinse procedure. EC in all the samples within the sampler were lower than the pre-tracer experiment average and were fairly close to the average groundwater EC observed in wells 6 and 7. The sampler pumps a considerable amount of water when it samples with a rinse procedure, as a consequence we interpret the lower EC value in the ISCO samples to be caused by dilution from surrounding groundwater that was brought up by the pump. This is supported by the EC measurement of 0.738 taken by the YSI meter on 10/24/2015 (in a manner consistent with how the other wells are measured by hand). EC measurements of samples taken by the ISCO sampler are therefore not comparable to measurements taken by hand using the YSI meter and were excluded from our analysis. After the wells returned to their pre-injection EC, the wells progressively drop in EC to below their pre injection average at the end of the experiment. We interpret this to be due to recharge from several rain events that occurred the week after the tracer was injected as well as the 30 gallons of low EC tap water that was used to augment the system on October 29th.

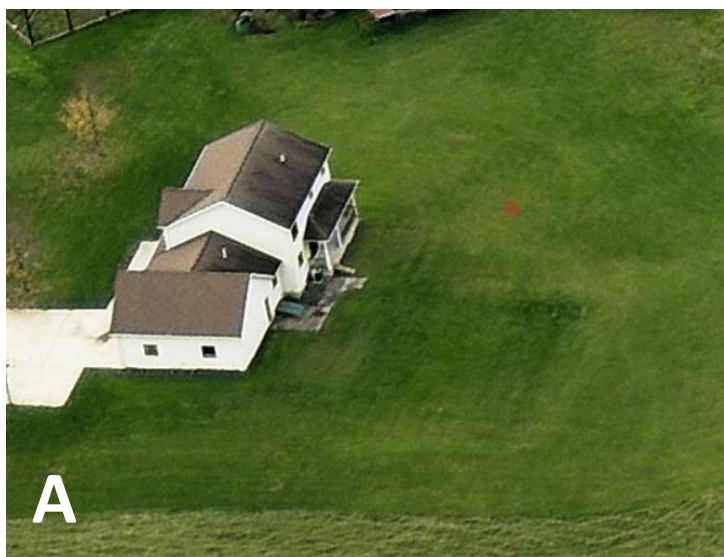
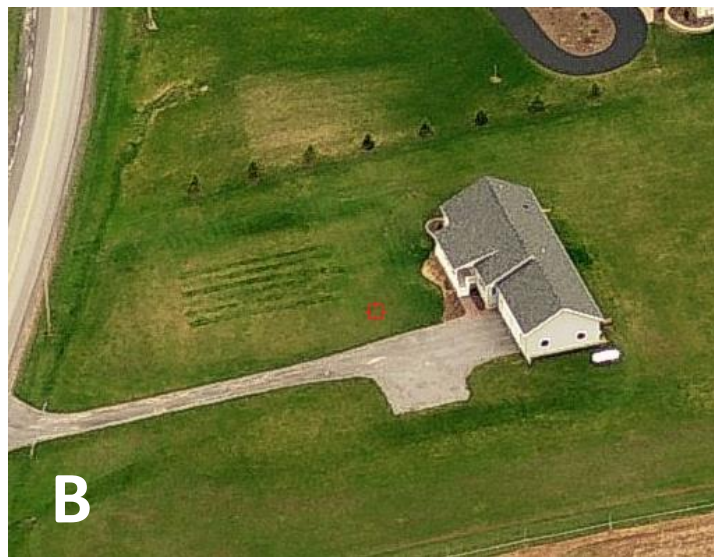
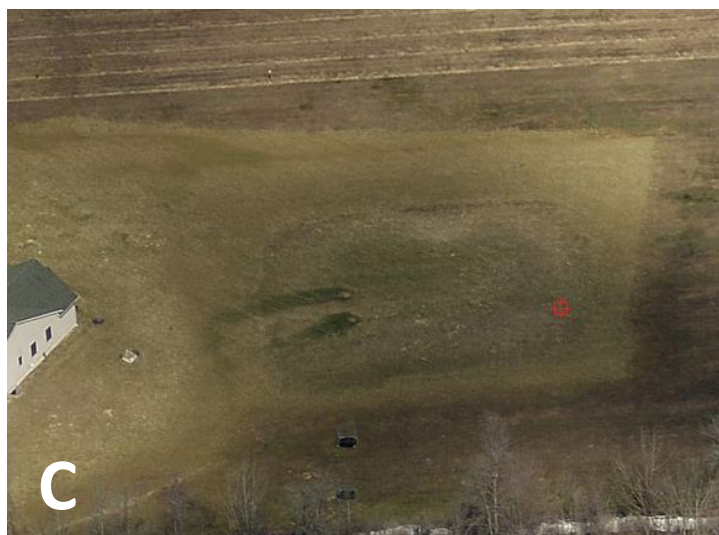
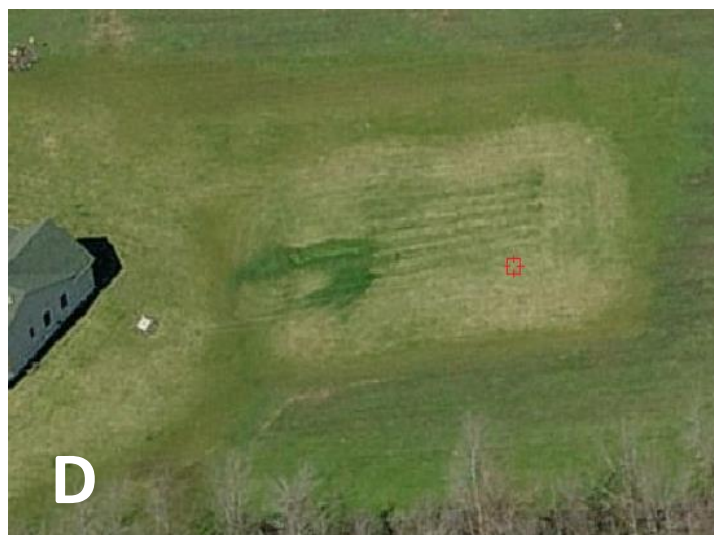
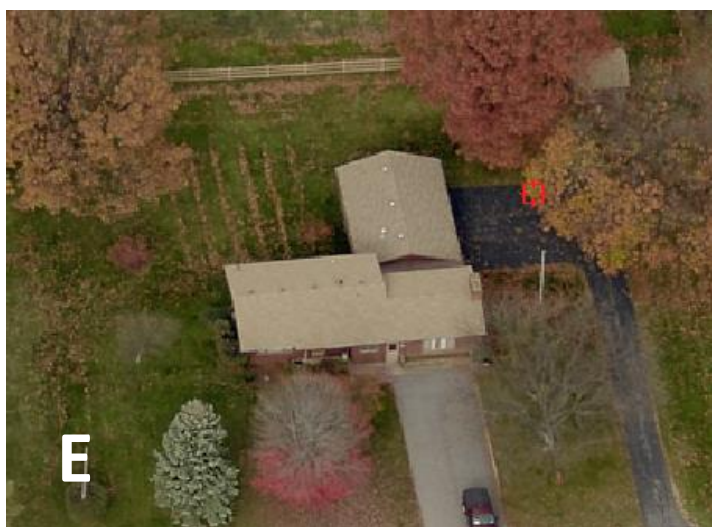
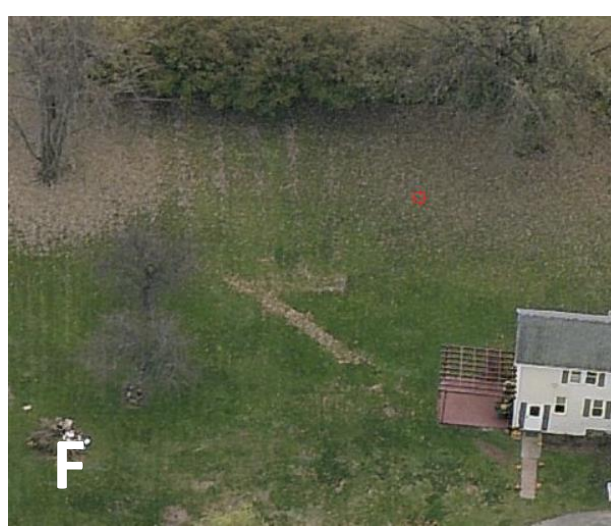
**FIGURE 4** Views of septic leachfields in Oblique imagery. A) Example where individual leachlines are darker than surrounding areas. B) Example where the leachfield appears darker than surrounding grass. C) and D) same leachfield taken in March, and April. Note the difference in shading after the growing season kicks in. E) and F) leaves accumulating in microrelief associated with leach field.

Examples of what septic field look like in the imagery are presented in **Figure 4**. There are generally two patterns of darker grass above septic fields: A rectangular area of darker grass, where the wastewater has spread homogeneously in the surrounding soil (**Figure 4 a**), and sets of parallel dark lines separated by a uniform distance (**Figure 4 b**) The lines of darker grass are located from 5 to 150 feet away from the house. The dimensions vary from 30 to 60 feet for the length of one line, 5 to 6 feet for the width. There can be from 3 to 15 lines, 6 lines being very common. This pattern is the most common in the counties of Orleans and Genesee. These lines are presumably caused by extra nutrient rich water from the leach lines. We have also noticed some darker areas that are not septic fields. These areas seem to be irrigated yards, which can be confused with septic fields when their shape and size are similar. We know that there must be space for the tank and the distribution box between the house and the septic field, which implies that darker areas are usually not directly next to the house. This fact enables us to tell the difference, because owners generally try to irrigate uniformly from their house. The appearance of septic fields does change depending on whether the imagery was taken just before or just after the start of the growing season (**Figure 4 c-d**). In Fall imagery, leaves sometimes accumulate in the microrelief of the leach field. The linear, parallel characteristic of the accumulations (which scale with the dimensions discussed above) help distinguish it from random occurrences of leaves (**Figures 4 e-f**). Generally speaking, large vegetation or shrubbery does not occur in septic fields, this is against code because the roots may sometimes disrupt the piping. Rarely, broken systems can be observed by their plume (**Figure 4 g**). One meter resolution hill shades created from LIDAR data proved useful for locating raised septic fields and occasionally septic tanks and distribution boxes. **Figure 4 h** shows an example of what this looks like.

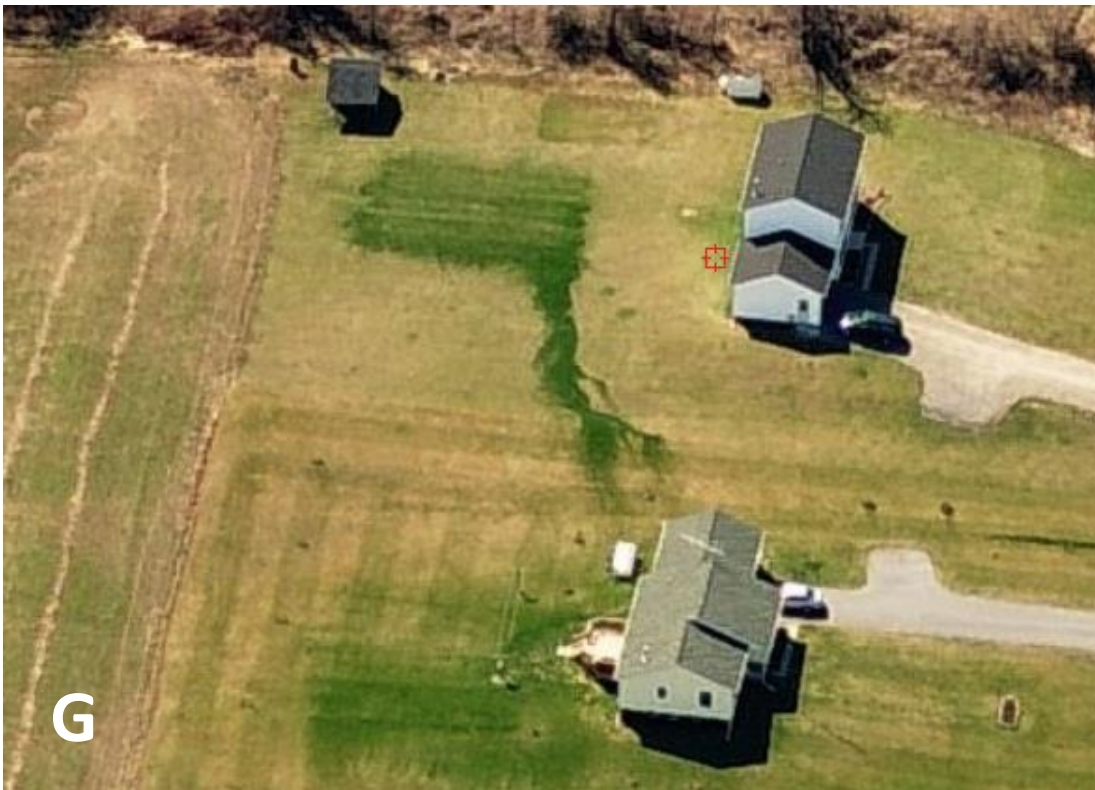
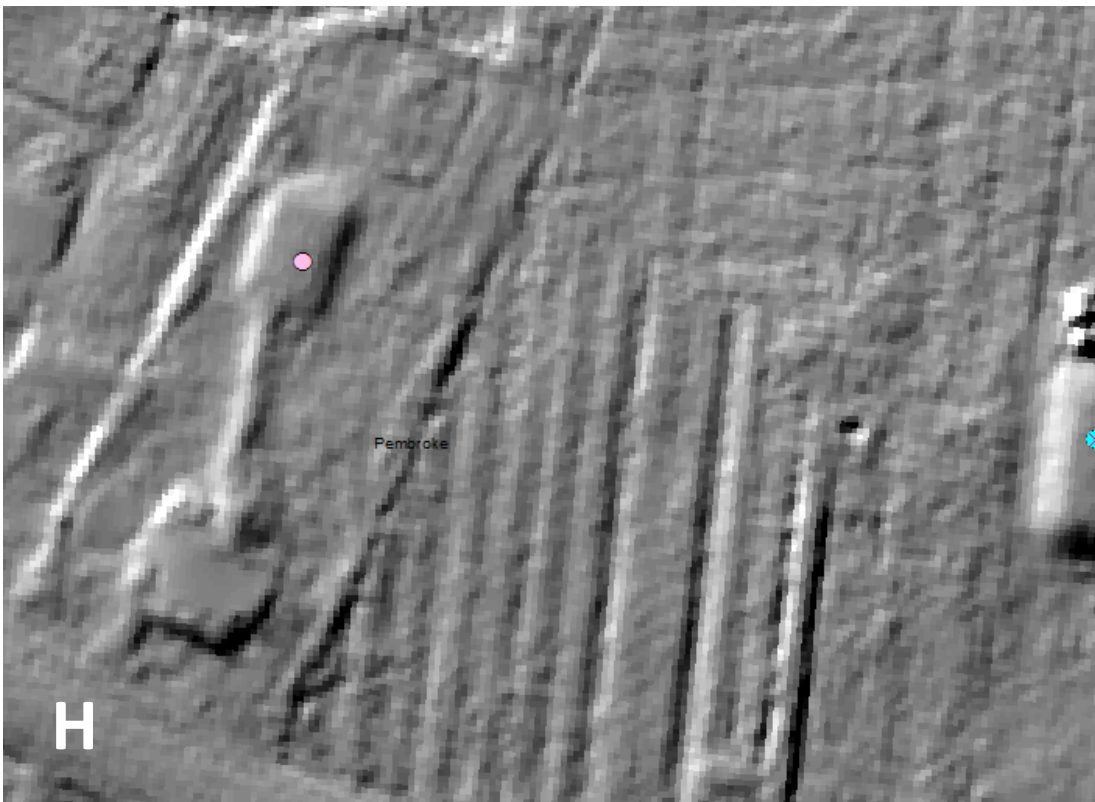
**FIGURE 4 (continued)** Views of septic leachfields in Oblique imagery. G) Failed Septic system that appears to be short circuiting. H) Hillshade from LIDAR derived topography showing a raised septic system connected to a house.

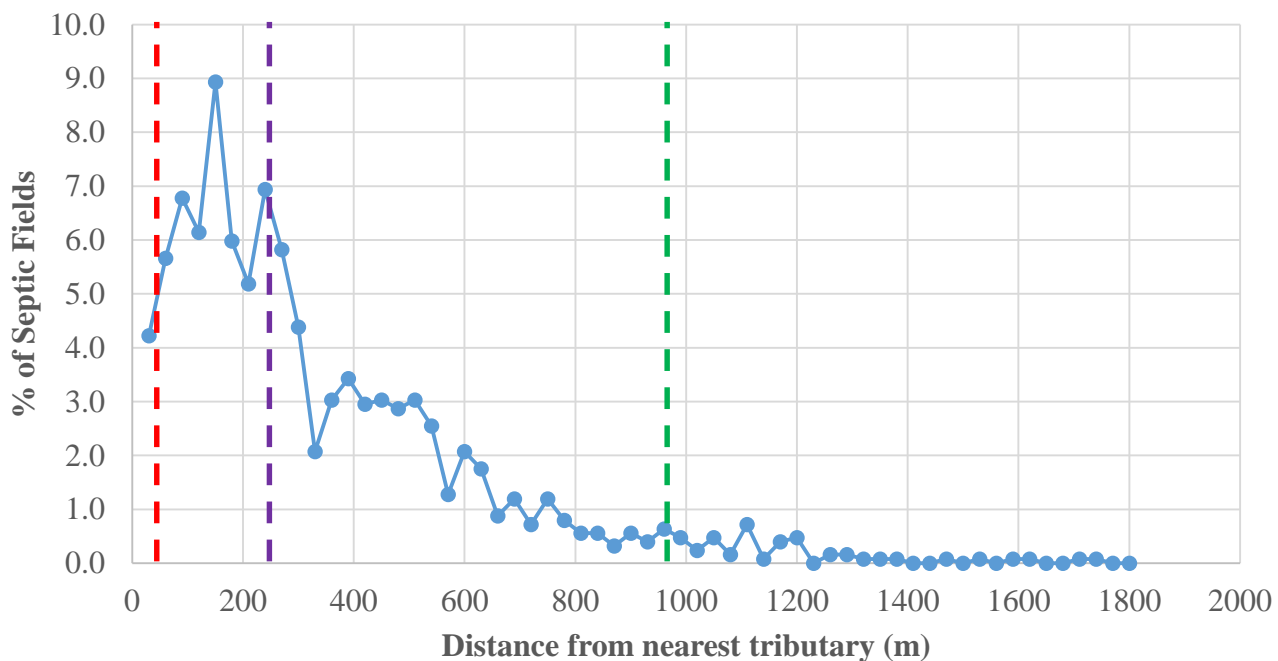
**FIGURE 7** Probability density function of the % of total septic fields located within a distance from the nearest stream. 4.2 % of the septic fields were located within 100 ft of the closest stream (red line). This is below the minimum setback distance required by Department of Health guidelines. Fifty and ninety percent of the septic fields were located within 240 and 960 meters of the nearest stream (purple and green lines).

A total of 3207 septic fields were mapped in the two county study area (**Figure 5**) of which 1277 were located within Oak Orchard Watershed (**Figure 6**). **Figure 7** is a probability density function that presents the average number of septic fields as a function of distance to the nearest tributary. Approximately 4.2% of the leach fields were located less than 100 feet of a tributary. This is below the minimum separation distance of a leach field to a waterbody that is required by the NYS Department of Health guidelines. The average distance of a leach field to a tributary is 327 meters with 50% and 90% of the leach fields occurring within 240 and 960 meters of mapped tributaries, respectively. Septic field density was calculated for subbasin catchments previously defined by an earlier study of nonpoint source pollution study in Oak Orchard Watershed (see Richards et al, 2011). Catchments ranged from 0.13 to 13.2 septic fields per square kilometer of watershed area. This analysis was repeated for a 200 meter buffer surrounding each stream to map out hotspots where septic sites are densely concentrated around streams (**Figure 8**). This size buffer assessed approximately 40% of the mapped septic systems and comprises the largest peak of the probability distribution graph. It was chosen because it is small enough to produce some precision in where dense areas of septic fields are clustered close to the stream, yet large enough to assess a sizable portion of the probability distribution function.

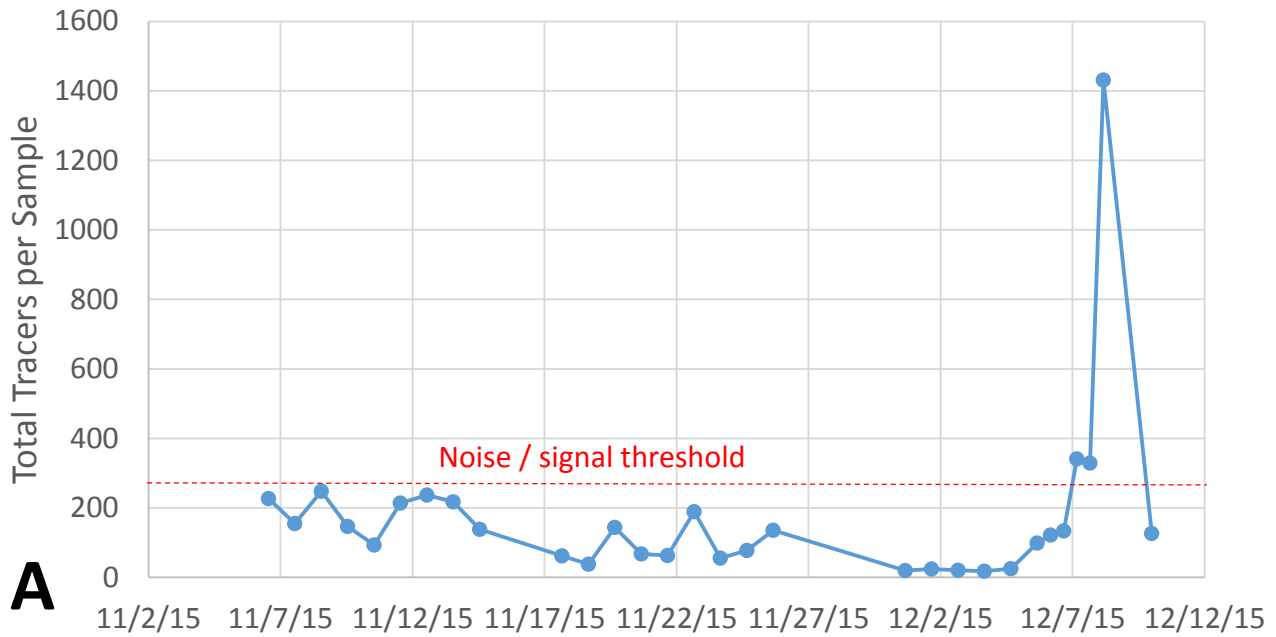
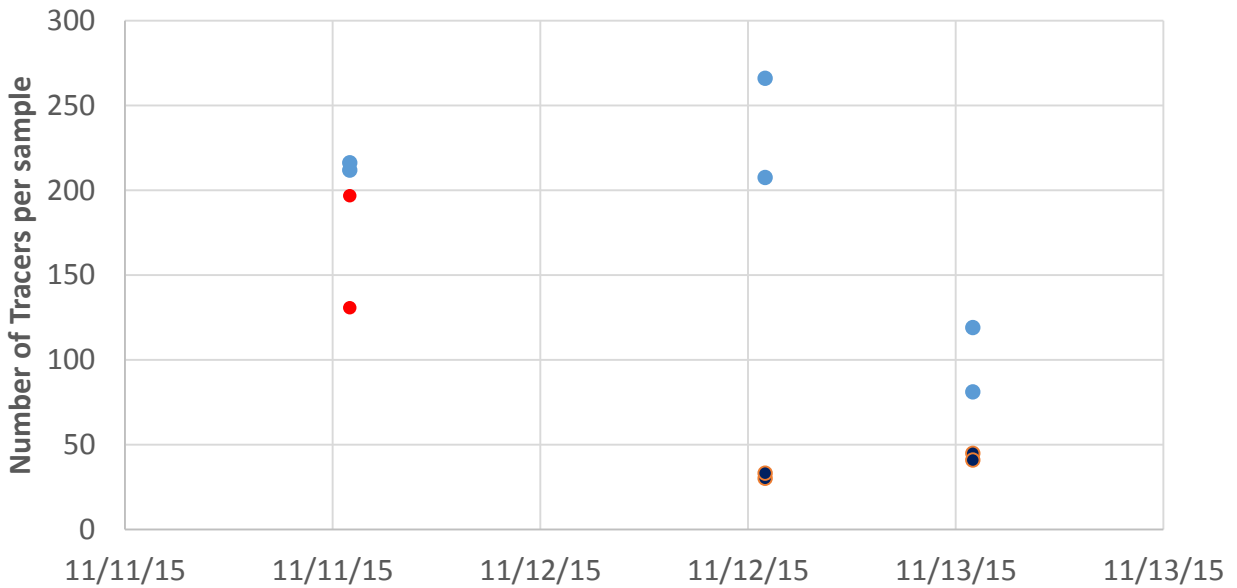
**FIGURE 9** A) Total number of tracers determined per sample for the Webster DNA Tracer experiment. Counts above 250 are considered above the noise/signal threshold for the analysis procedure and represent the actual presence of the tracer. Above the 250 count threshold, the method is quantitative. The breakthrough curve arrived on 12/7/2015, 32 days after the tracer was introduced to the site. B) Comparison of runs for the same samples within the noise threshold. These samples were taken sequentially, note that the trends are inconsistent for each run.

At the Webster site, T3 DNA tracer was introduced on November 6, 2015 at 1:13PM to the first floor bathroom of the Baldwin Residence. The 45 ml solution contained a total of  $7.48E8$  individual DNA tracer particles. Based on the shape of the plot of the number of DNA tracers detected (per sample), a break though curve occurred between 12/7/2015 and 12/8/2015 (**Figure 9a**). Tracers numbering 250 per sample or below are considered instrument noise. Thus

The experiments demonstrated there are several problems that need to be overcome in order for DNA tracers to be practically used in this application. These are, false positive outliers (individual samples that contain an inordinate number of tracers in samples where we believe should not contain tracers), identification of the threshold between noise and actual presence of tracers, and comparability between analysis runs. These issues are interrelated and could be improved by adopting a more systematic approach of identifying the precise threshold of what number of tracers (“copies”) in a sample actually constitutes the presence of the tracer. **Figure 9 b** shows the number of tracers identified for the same samples on two different runs. They are not only different in absolute value, but are also different in the direction of temporal trends. This is a problem, because increasing and decreasing trends in a time series are what we use to identify the location of the breakthrough curve. The samples in Figure were taken early in the experiment when it is unlikely that the tracer made it all the way through the groundwater flow path, and are interpreted to be “noise” from the analysis procedure. Our most successful set of experiment were the analysis runs for the Webster site, where samples taken near the end of the experiment contain numbers of tracers that are almost an order of magnitude greater than the samples shown in Figure. These samples are interpreted to be the first presence of the tracer in the stream and the location of the actual breakthrough curve. When all three runs of the Webster samples are combined, it appears that anything more than 250 tracers constitutes the actual presence of the tracer.
