# Analysis Image-Based Automated 3D Crack Detection for Post-disaster Bridge Assessment in Flyover Mall Boemi Kedaton

Muhammad Abi Berkah Nadi<sup>1</sup>, Sayed Ahmad Fauzan<sup>1</sup>

<sup>1</sup> Civil Engineering Department, Institut Teknologi Sumatera, South Lampung, Lampung Province, Indonesia.

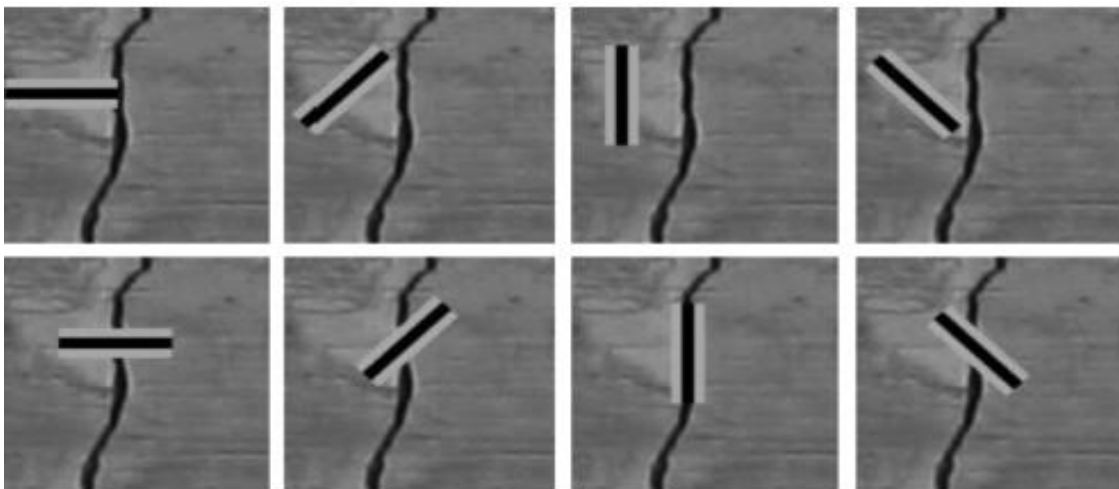
**Figure 4.** An example of template matching for crack detection

These methods benefit from various image processing techniques such as edge and corner detection, point-based feature detection and extraction, and template matching techniques to conduct identification of the surface anomalies. Some of these techniques such as Sinha et al. (2003) are also accompanied with machine learning techniques such as neuro-fuzzy networks for precise classification purposes. An example of a template matching approach by Ehrig et al. (2011) is presented in Fig. 2. This involves passing a much smaller template image over the larger detection image at various angles and subtracting the two. If that result at a given position is a small enough value the target feature from the template (i.e., a crack) has been located.

In Fig. 4, the crack would be detected in the 8<sup>th</sup> image in the series, where the template is aligned with the crack. Despite their benefits, template matching and majority of the other 2D approaches discussed previously do not provide 3D depth information directly from the content of the images and as a result do not enable measurement of severity of these cracks. More comprehensive review of the 2D condition assessment and in particular crack detection methods can be found in “Adaptive vision-based crack detection using 3D scene reconstruction for condition assessment of structures” (Jahanshahi et al. 2009; Brilakis et al. 2011; Jahanshahi and Masri 2013).
