## Geomorphic Effects of Engineered Log Structures and Response to a Catastrophic Flood Event in a Missouri Ozarks River

Joseph S. Nash

A Master's Thesis

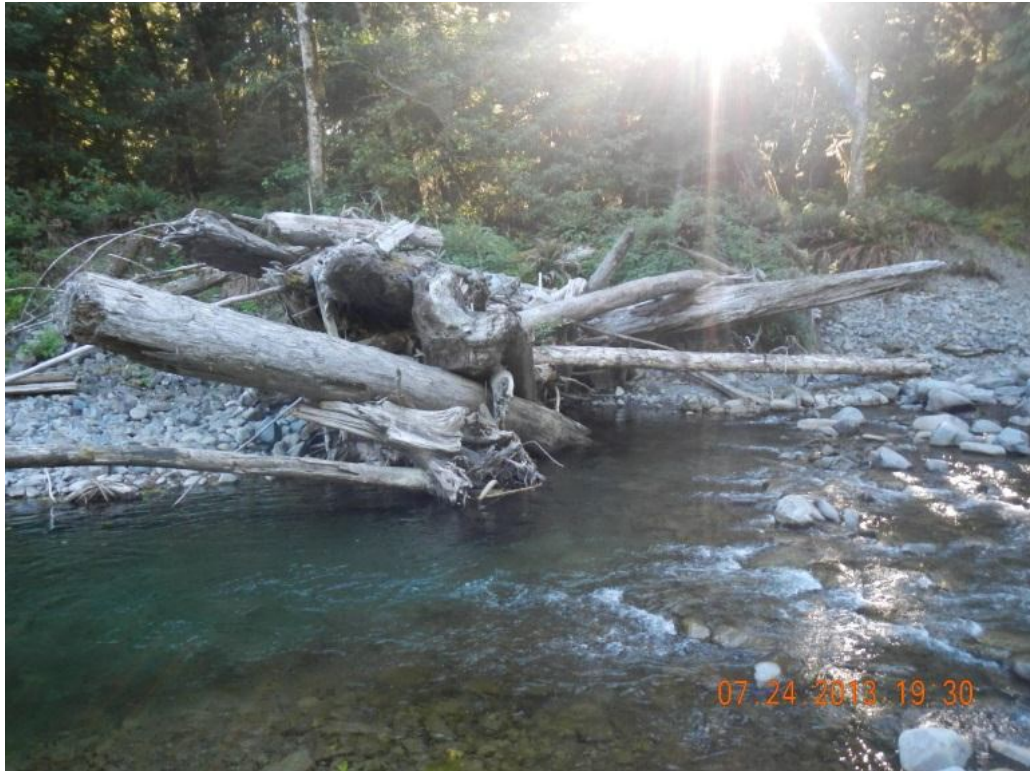
Figure 1. Example of an ELJ in the Pacific Northwest, (Kimbrel, 2014).

The initial function of adding LWD to streams was to increase aquatic habitat (Kimbrel et al., 2014) (Figure 1). However, the knowledge and literature base evolved into applications to mitigate flood damage by using LWD as bank protection and thalweg control (Abbe et al., 1997; Gerhard and Reich, 2000; Hall and Moler, 2006; Stewart et al., 2009; Pess et al., 2012; Baird et al., 2015; Kramer and Wohl, 2017). Early attempts of using LWD were developed as log weirs, dams, and flow deflectors (Roni et al., 2015). Since the early implementation of ELSs, design factors have developed to meet individual needs based on specific river systems or regions (Roni et al., 2015). Since the 1990s, design of wood structures moved from placement of riprap and cut wood to installing whole trees with root structures (NRCS, 1996; Roni et al., 2015) (Figure 2). Design factors have also changed due to widely accepted methods of using a natural channel design published by Rosgen (1996). These methods, although not universally applicable, describe a baseline approach to engineering and design of restoration projects (Lave, 2012; Yochum, 2018). River management manuals and protocols have been developed to standardize the use of in-stream wood as a management tool (Rosgen, 1996; Roni et al., 2015; Yochum, 2018). Geomorphically related design goals include irrigation diversions, grade control, bridge protection, and streambank stabilization (NRCS, 2007). Government agencies began to routinely include LWD applications in channel protection, For example, NRCS (2007) describes design applications based on Rosgen (2001) including cross-vanes, W-weirs, and J-hook vanes. Bank and bar stabilization ELS designs used by the U.S. Bureau of Reclamation (USBR) include step jams and valley jams (Abbe et al., 1997; Baird et al., 2015).

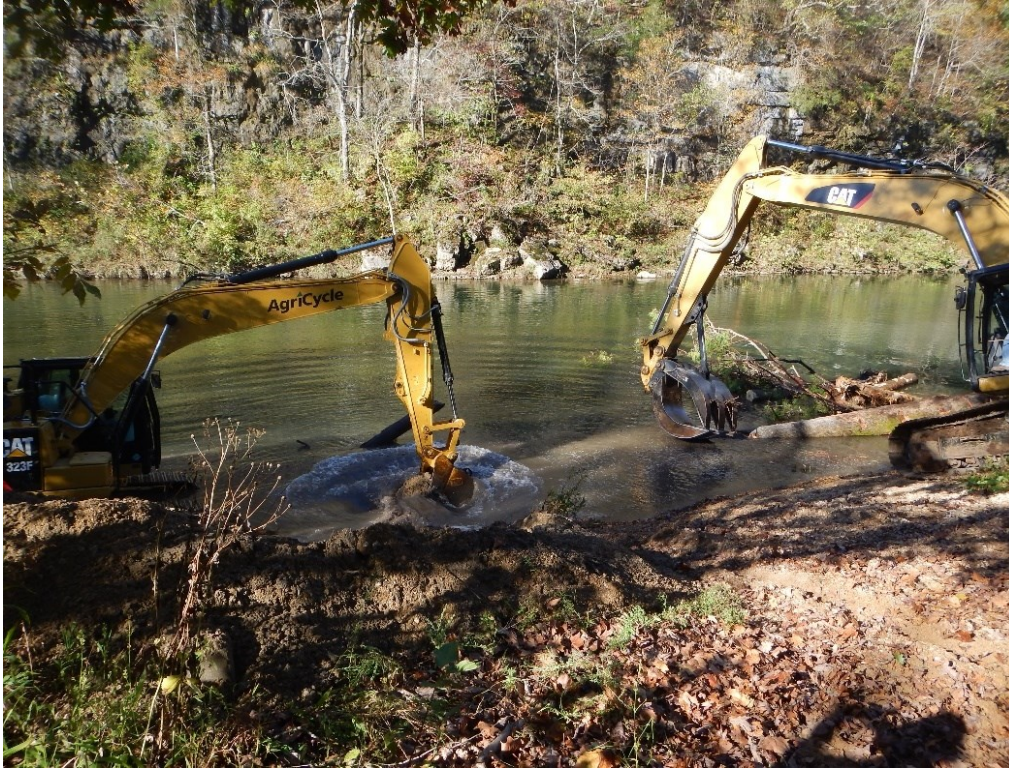
Figure 5. Construction of ELS 1. Excavator digging a trench in the bed for key piece placement.

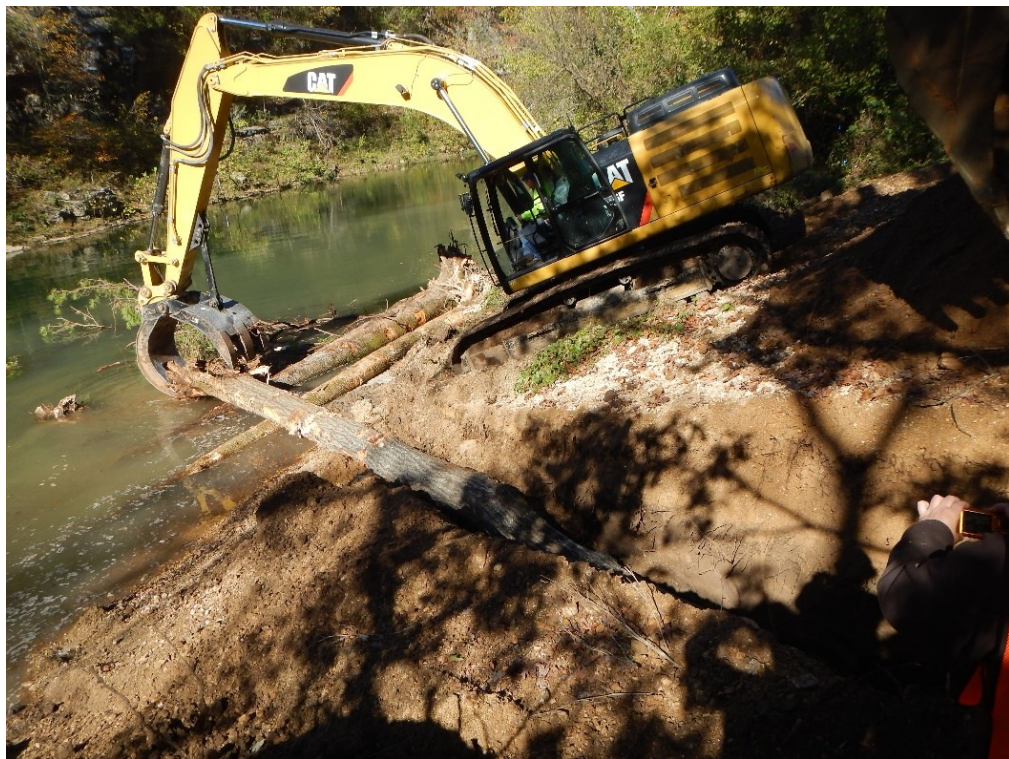
Figure 6. Excavator placing logs in a trench perpendicular to flow positioned over key pieces.

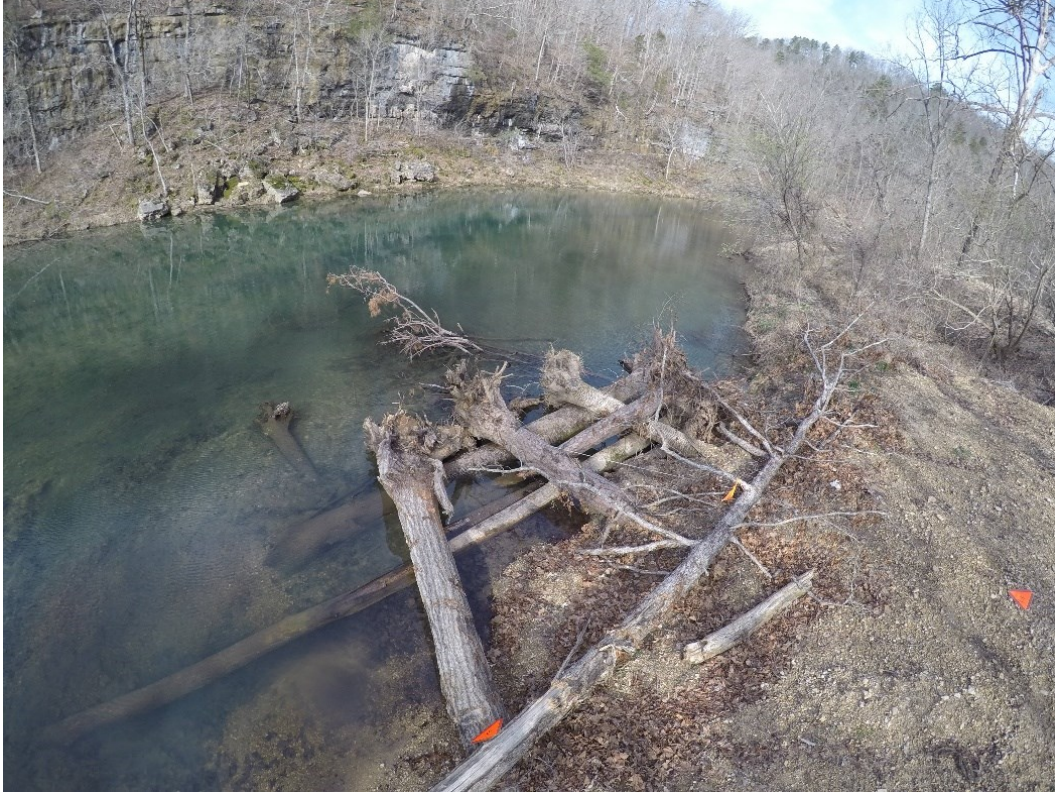
Figure 7. ELS 1. Flow direction from picture right to picture left.

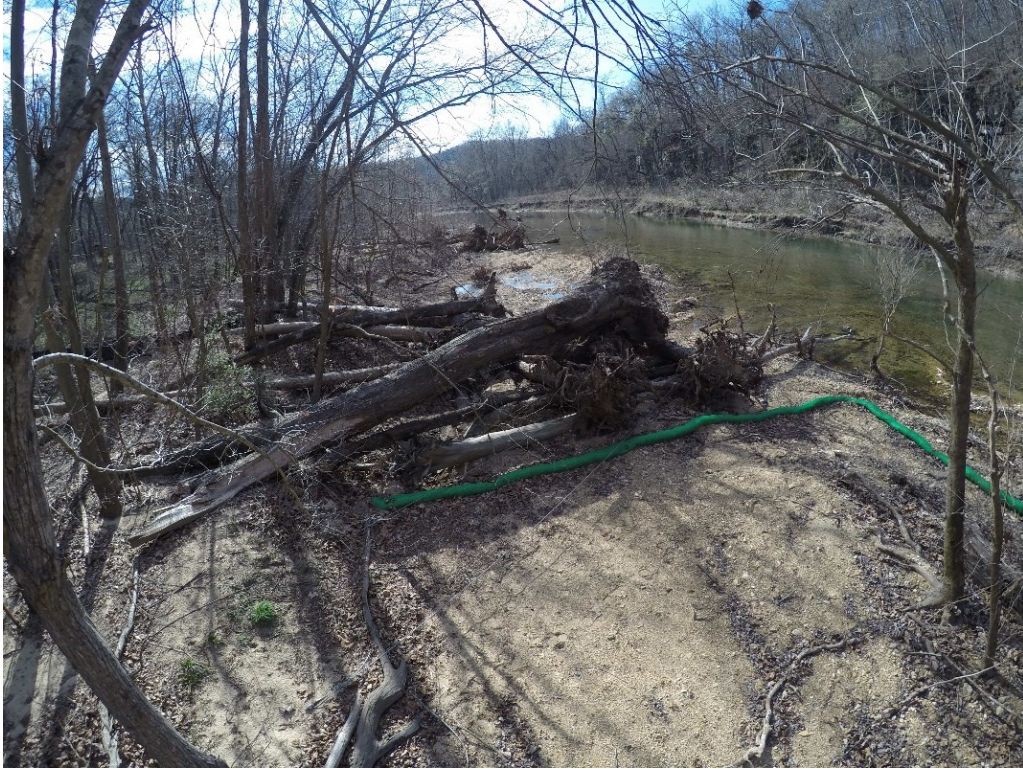
Figure 9. ELS 3. Location on lateral bar and flow direction from right to left.

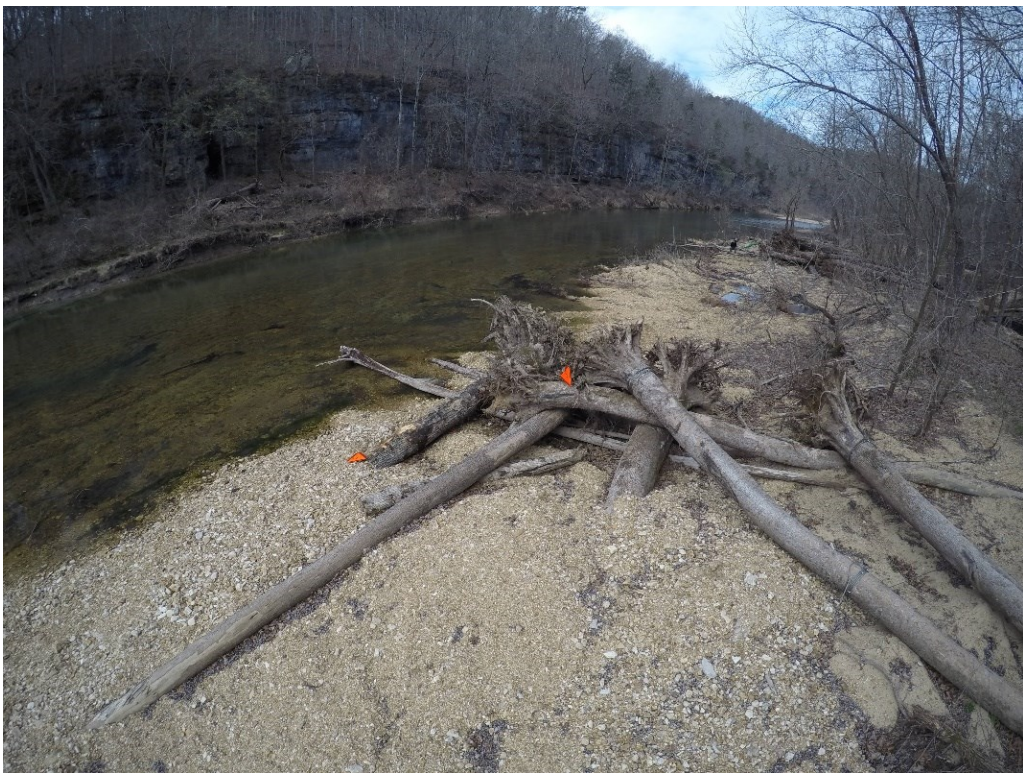
Figure 10. ELS 4 in foreground and ELS 3 in background. Flow direction from right to left and burial of key pieces with root fans oriented upstream.

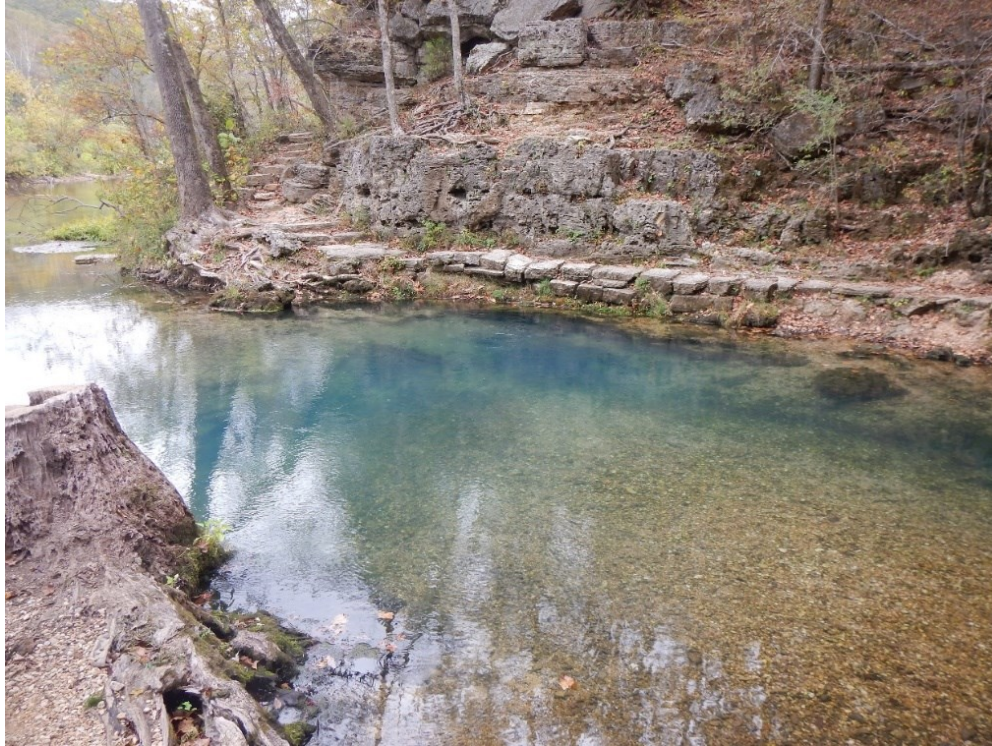
Figure 17. Blue Spring located at the downstream limit of the NFRA.

**Hydrology.** Hydrology for the North Fork River is dependent on baseflow from groundwater input from springs. There are over 200 springs in the North Fork Watershed (Miller and Wilkerson, 2001). Blue Spring has one of the highest flow rates in the watershed and is located at the downstream boundary of the study site at North Fork Recreation Area (Figure 17). Other large spring inputs come from Althea, Big, North Fork, Rainbow, and Topaz Springs (Vineyard and Feder, 1974) (Table 1). The U.S. Geological Survey (USGS) operates a hydrological gaging station near the mouth of the North Fork River at Tecumseh, MO. Discharge has been recording at this station since October 1, 1944. Peak streamflow for the North Fork River has been increasing over the gage record (Figure 18).

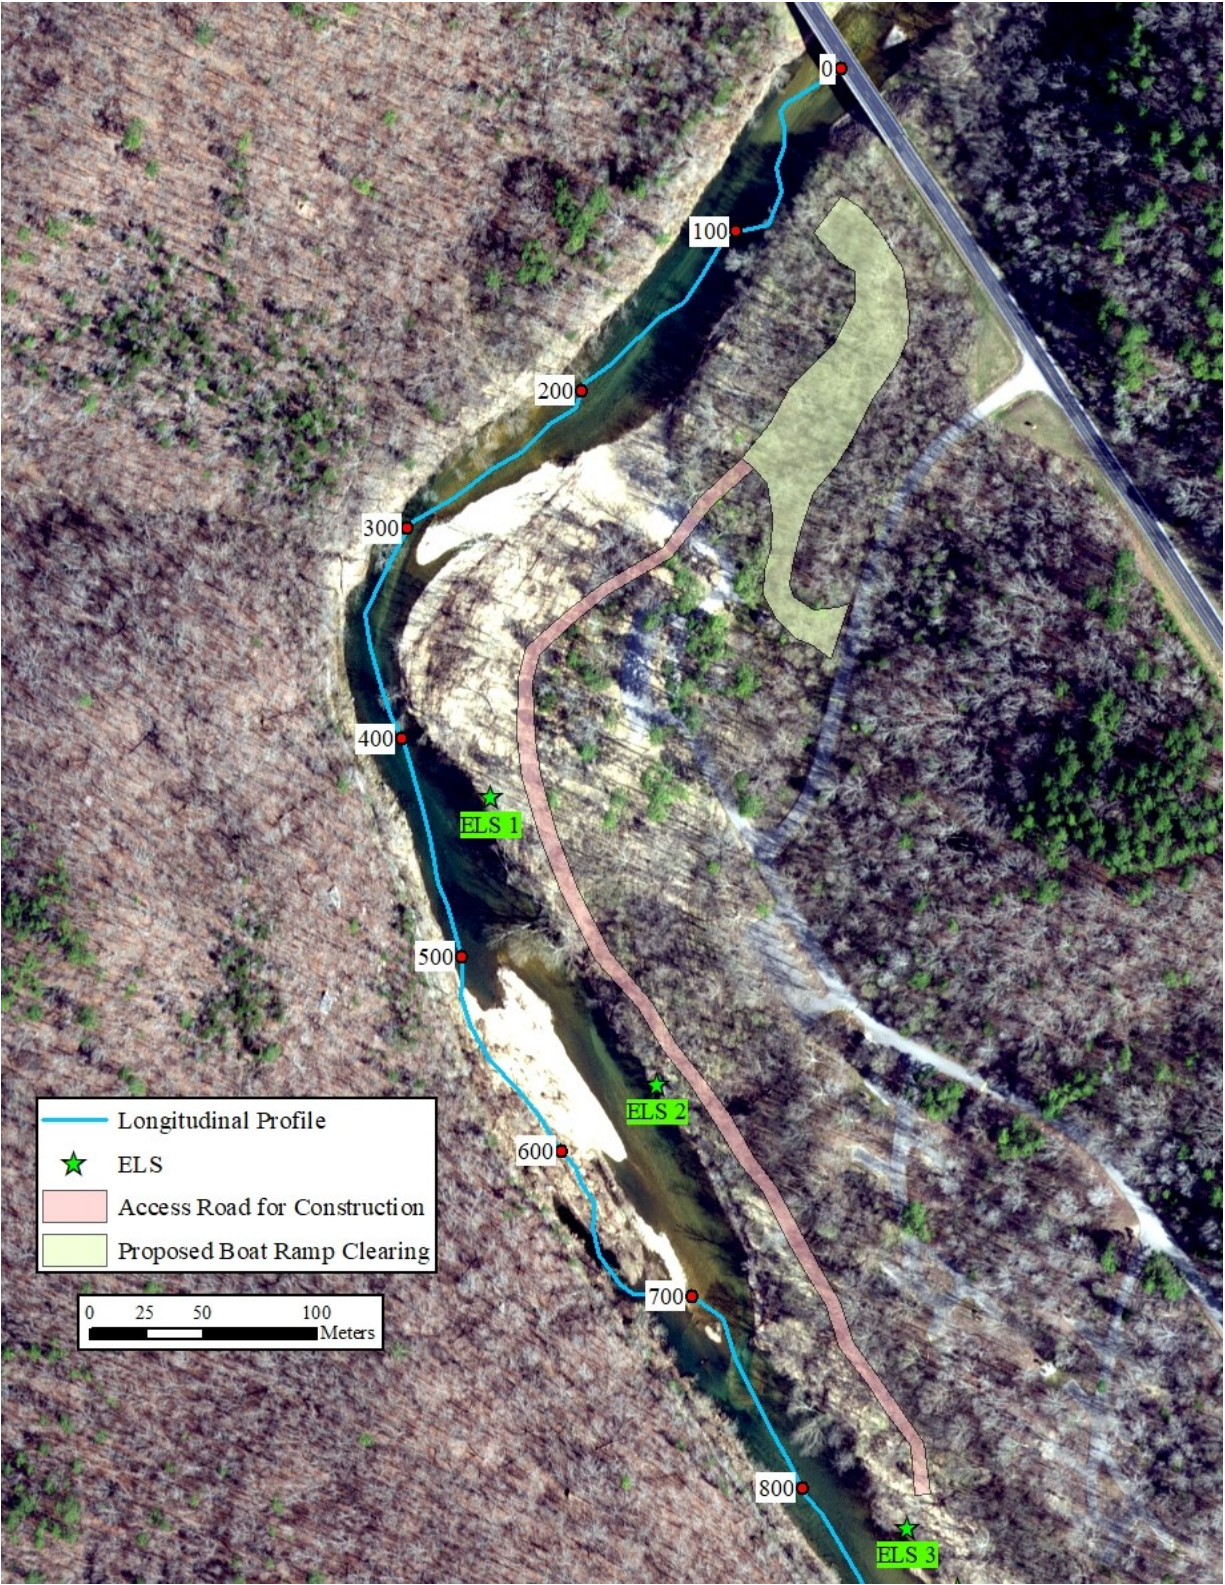
Figure 20. Construction disturbance to the North Fork Recreation Area including clearing for proposed boat ramp and construction access road (MDNR, 2015).

During construction of the ELSs there were no measurable changes to channel form, capacity or substrate composition. Changes only occurred at the proposed boat ramp where trees were cleared from river distance 0 m to 166 m, and on the floodplain from 350 m to 830 m where an access road was cleared for equipment to transport logs to ELS sites (Figure 20). After the construction of ELSs was completed, trees were placed over the construction road to mimic downed trees typically seen on a forest floor. Design specifications of the ELSs outlined that bed and banks be replaced to pre-construction condition (Gubernick, 2015). Due to the embedding of logs into the bed and banks, substrate was unconsolidated but local topography remained the same. Erosion control barriers were placed around the ELSs to prevent sediment from entering the river. After the ELS construction cables were wrapped around ELS logs and secured to the banks using anchors driven into the sediment.

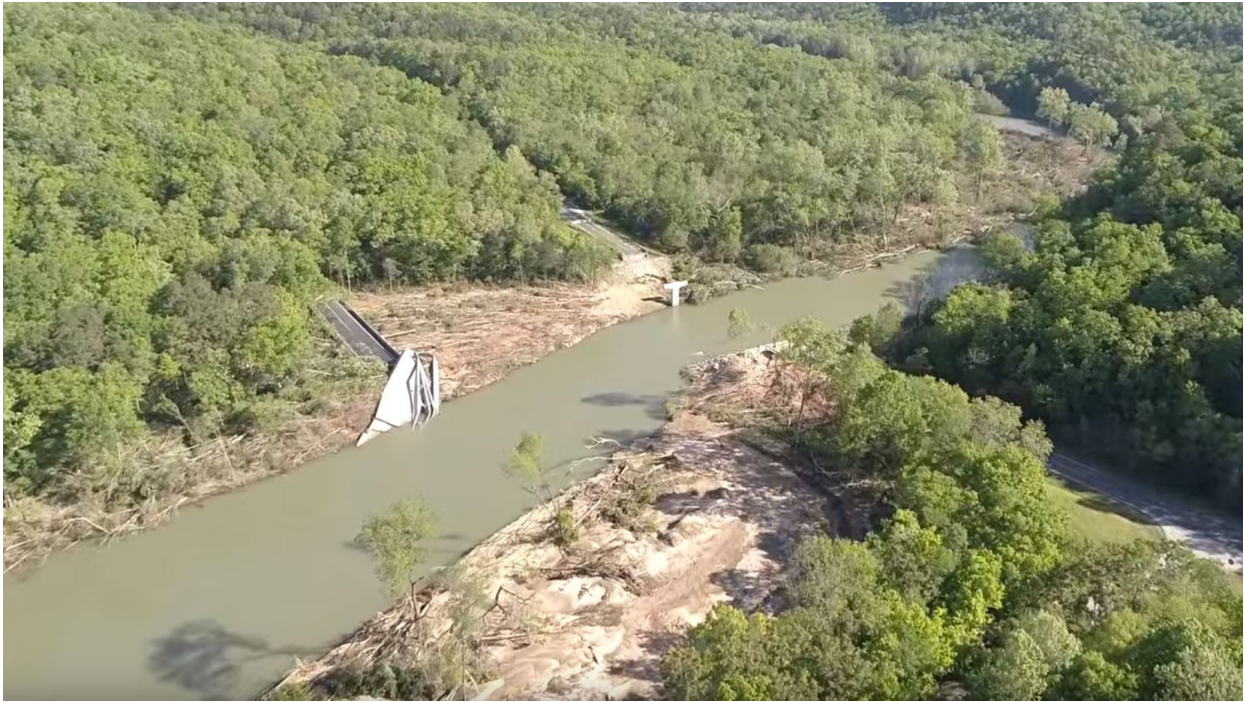
Figure 23. Highway CC bridge at NFRA. Deck of bridge washed downstream of road. (Aerial Ozarks, 2017).

Infrastructure damage was caused by the April flood at the NFRA included road and parking lot asphalt being entrained, and Highway CC Bridge was washed out (Figures 55 and 56). It is likely that the Highway CC bridge failure was induced by LWD transportation and damming during the rising limb of the hydrograph. Relatively high recruitment of LWD in a forested watershed can be associated with local infrastructure damage since flood waters transport LWD until there is an obstacle where it accumulates (Ruiz-Villanueva et al., 2014). Transported LWD can also accumulate where cross-sections are constrained such as Highway CC Bridge where fill was used to shorten the span of the bridge, constraining the valley (Ruiz-Villanueva et al., 2014; Wu et al., 2014). Rafted LWD cause a damming effect where local stage increases put pressure on bridge piers (Wu et al., 2014). Kochel et al., 2016 cite similar flood damage which included 9 bridges being washed out in heavily wooded watersheds.

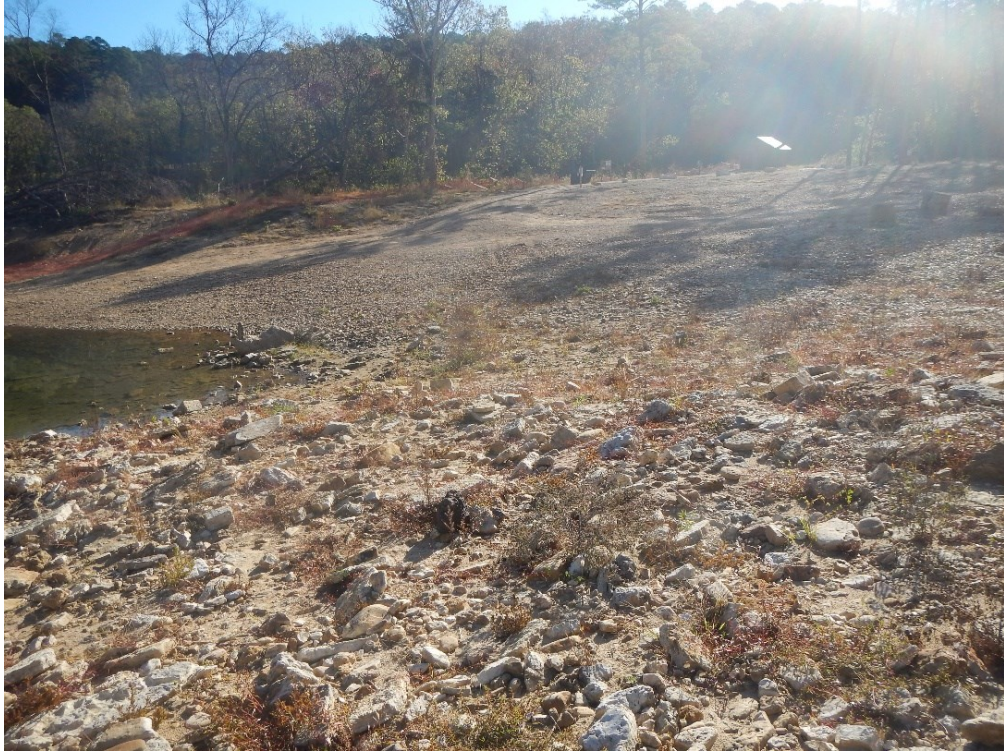
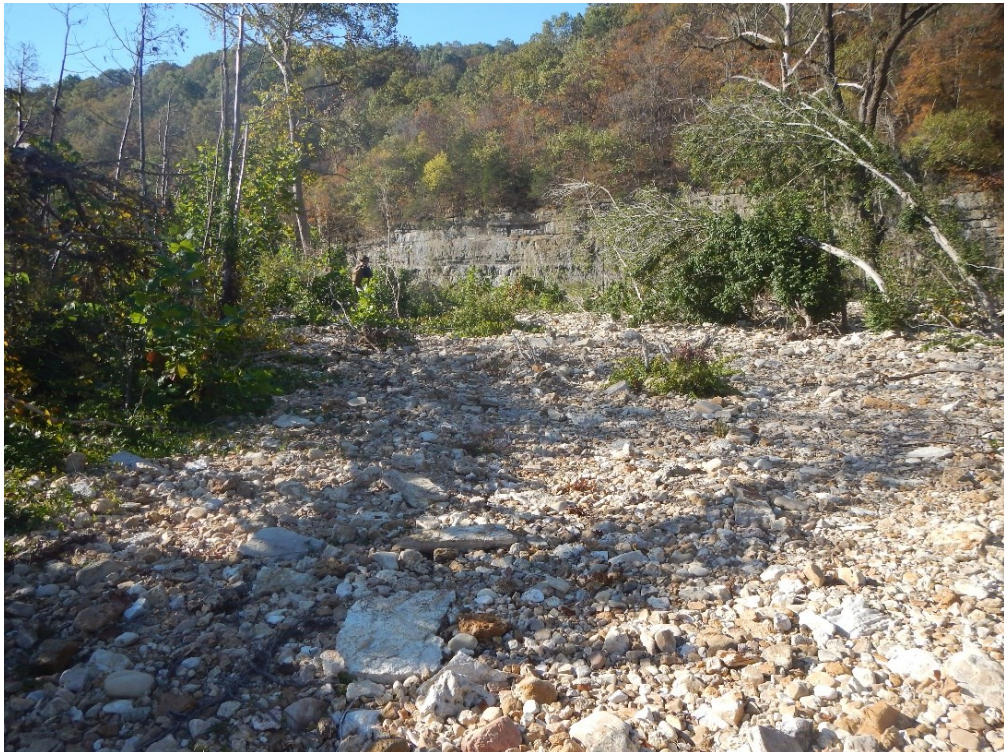
Figure 37. Existing boat ramp after extreme flood event. Bar head acting as a ramp with coarse sediment (top) and looking downstream at the head of the high-flow chute (bottom).

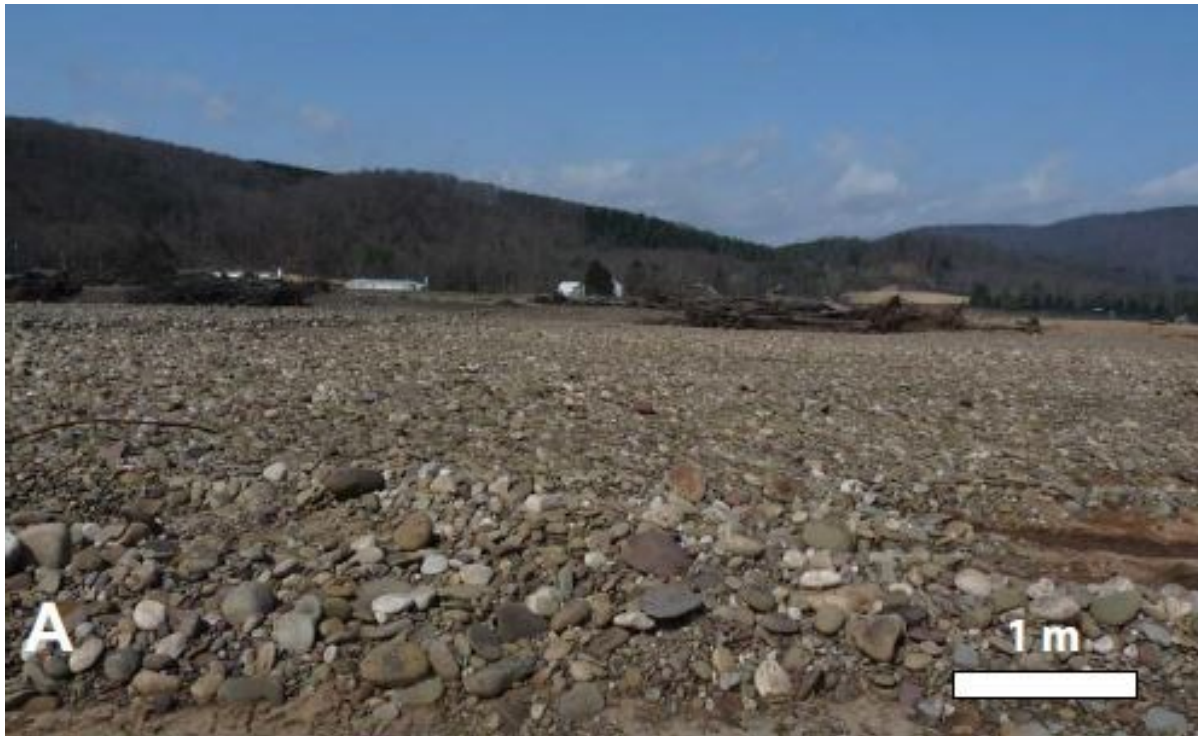
Figure 38. High-flow chute development and floodplain sedimentation (top) (Kochel et al., 2016). Dashed red line is the chute and A (bottom) shows similar coarsening of ramp at NFRA.

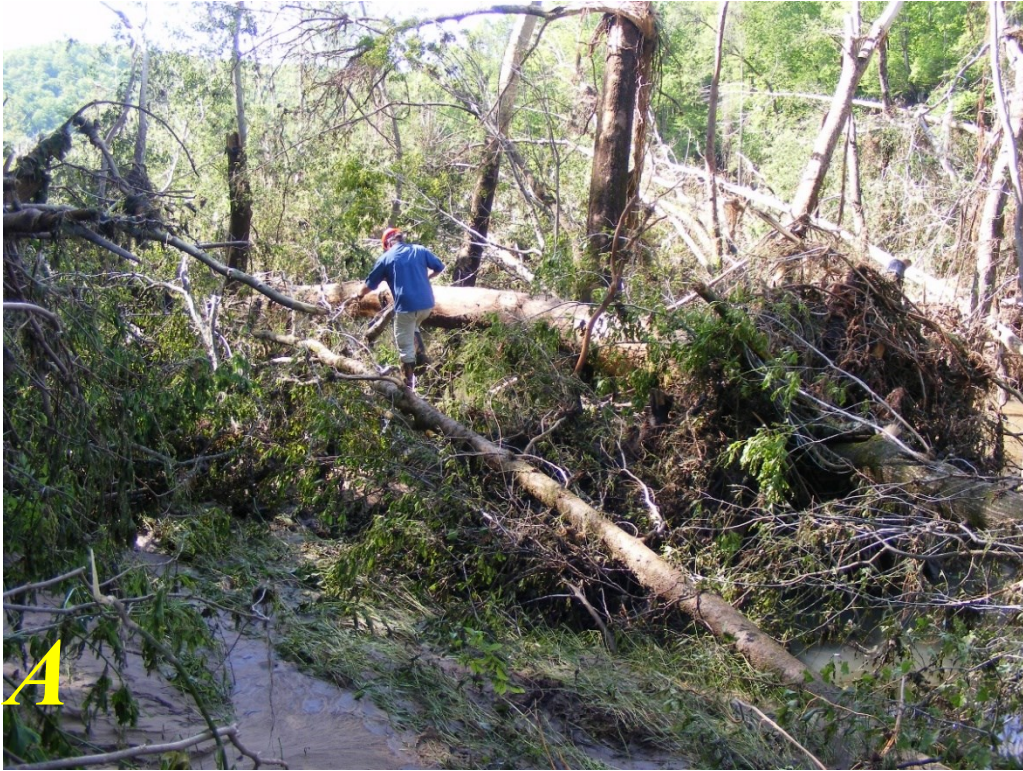
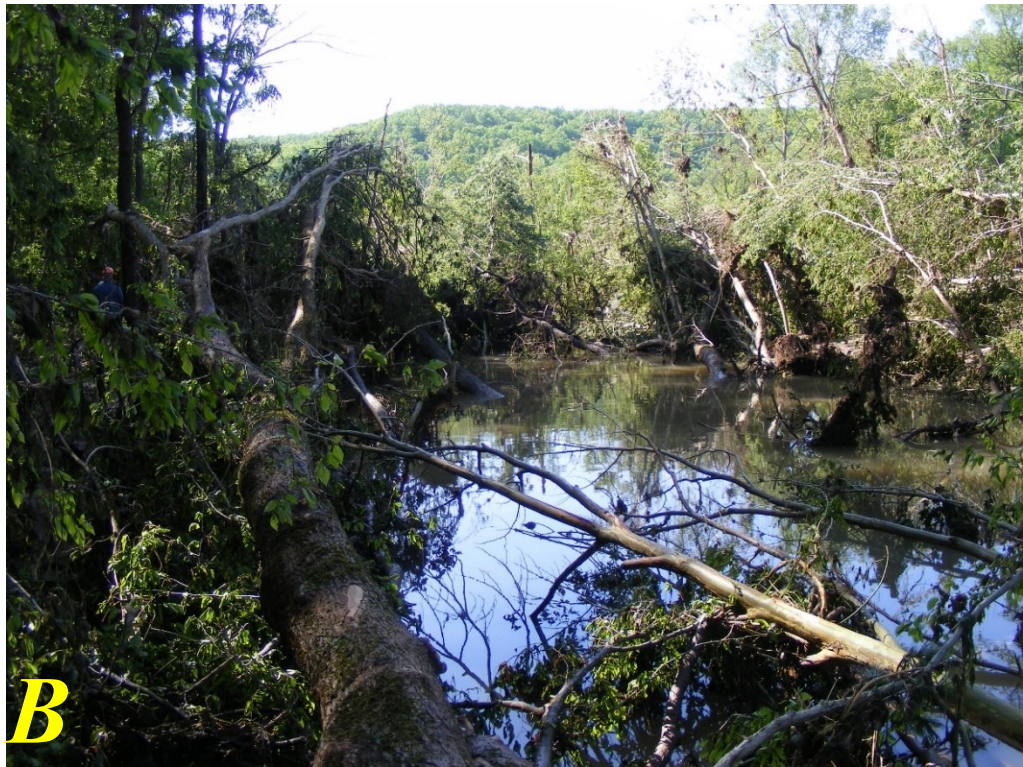
Figure 40. Post-flood LWD and toppled riparian forest on lower floodplain surface at ELS 3 (A), and backwater flooded chute near ELS 4 (B).

At ELS 3 the flood caused sand deposition on the left bank to the level of the floodplain (Figure 39). Structure ELS 3 is located on the head of the lateral bar where flow separates into a chute channel on the left and main channel to the right. The flood deposited a bar downstream of ELS 3 which is typically seen on the downstream side of a log jam obstruction (Keller and Swanson, 1979; Gurnell et al., 2002). This bar deposition was between ELS 3 and ELS 4 and it increased the bar elevation by 1.84 m (Figure 39). A scour pool 0.57 m deep formed on the instream side of ELS 3 behind a large tree and rootwad that was lodged against ELS 3. Chute channel deposition of sand and LWD made it impossible to resurvey the pre-flood ELS 4 cross-section line (Figure 40).

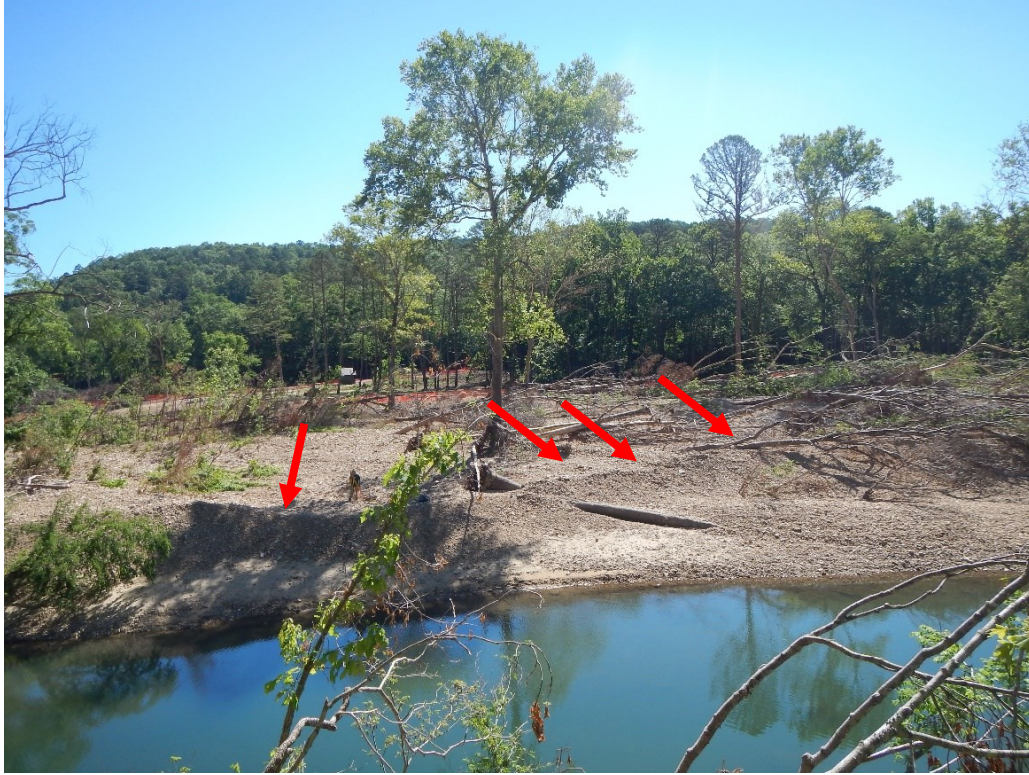
Figure 42. Slip face deposition caused by April Flood at ELS 1. Arrows show new bank line.

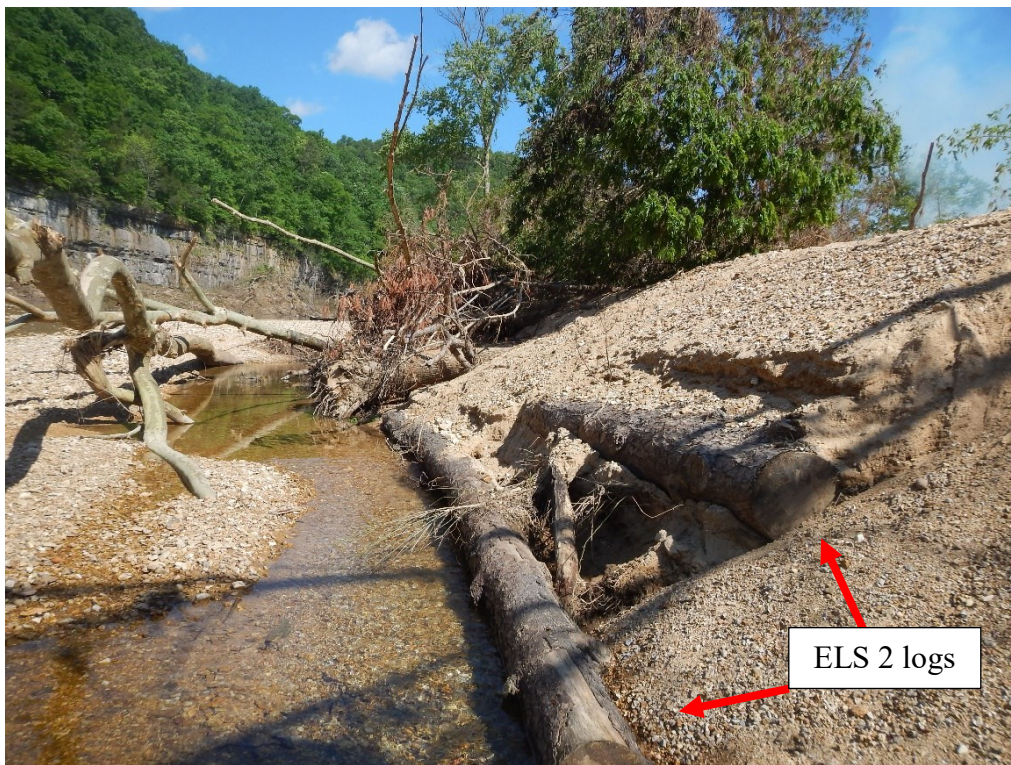
Figure 43. Deposition caused by April Flood at ELS 2 where bank angle lowered. Arrows show cut ends of logs in ELS 2.

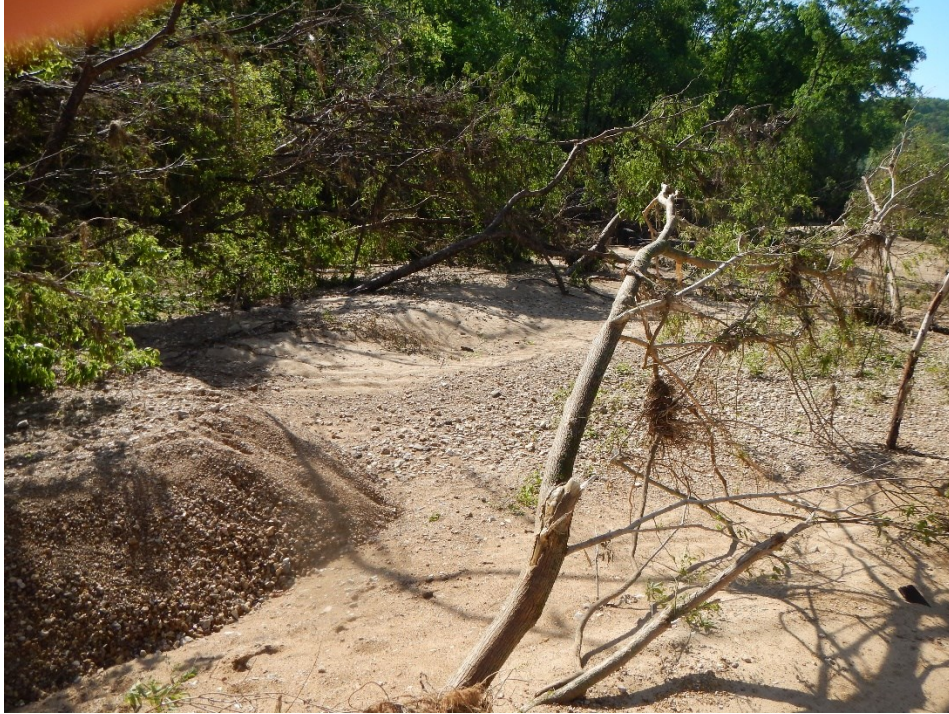
Figure 49. Floodplain splay lobe between ELS 1 and ELS 2 looking downstream.

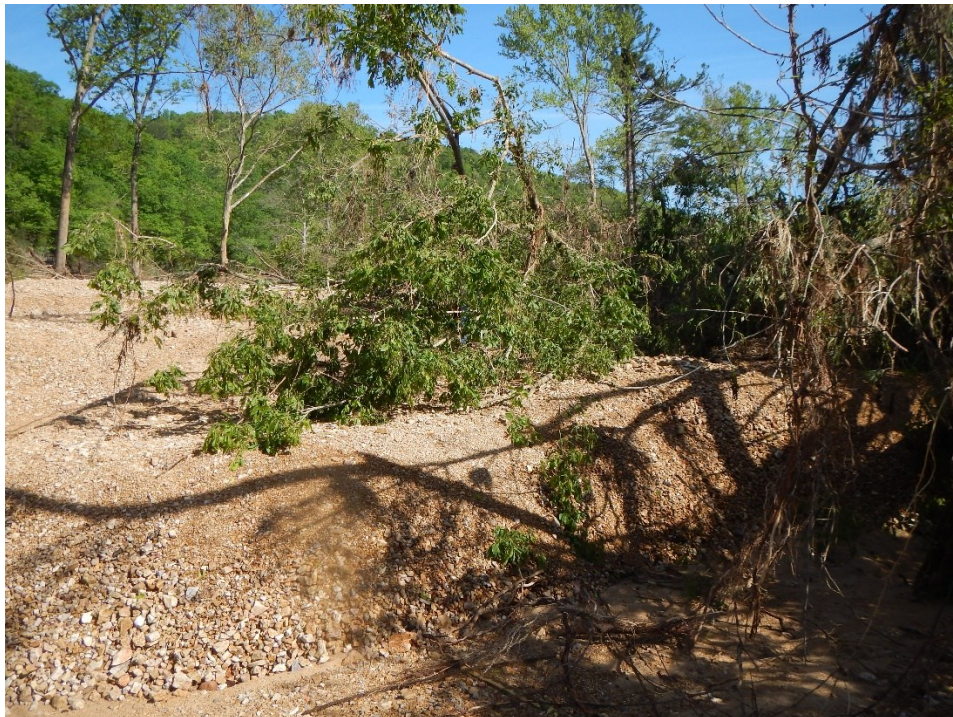
Figure 50. Floodplain splay lobe between ELS 1 and ELS 2 looking upstream.

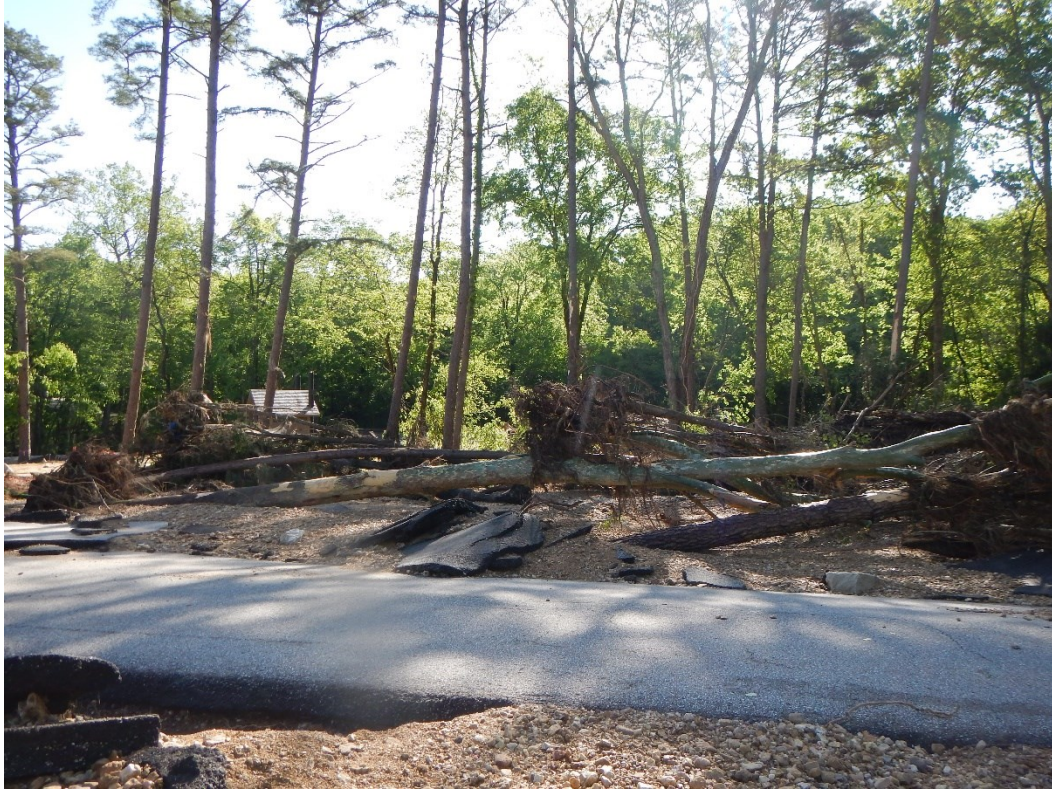
Figure 55. Imbricated asphalt pieces and toppled riparian trees caused by the April Flood.

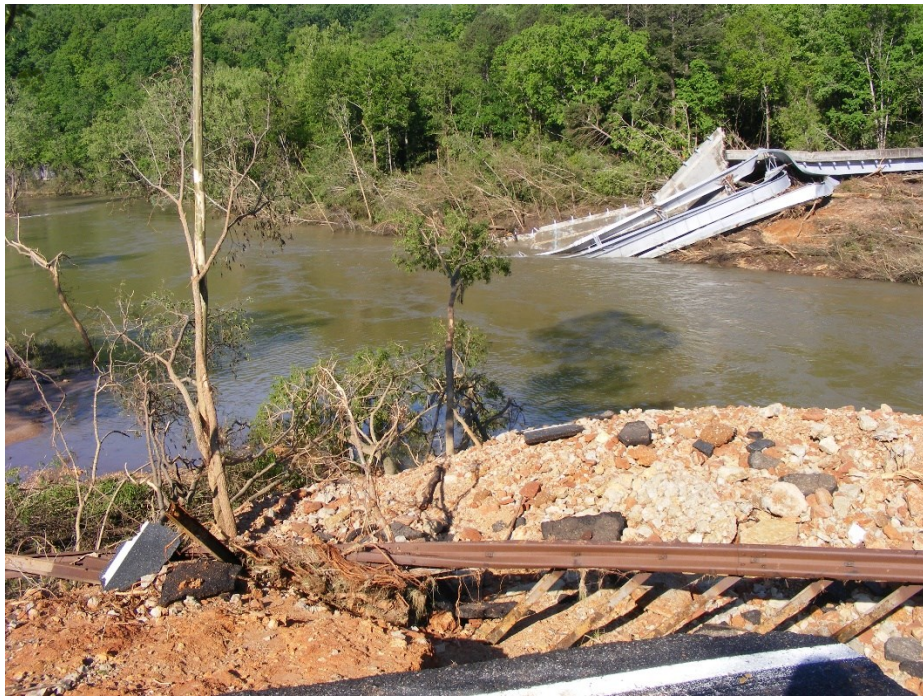
Figure 56. Deck of the Highway CC Bridge that was destroyed during the April Flood.
