**National Water Quality Initiative (NWQI)  
Pilot Watershed Assessment for:**

**Lamar Lake-North Fork Spring River  
Watershed (HUC- 110702070206)**

Deliverable # 1 – Inventory of the Watershed  
Deliverable # 2 – Resource Analysis of the Watershed  
**Deliverable # 3 – Final Report: Identification of  
Conservation Needs on Vulnerable Acres**

**OEWRI EDR-18-003**

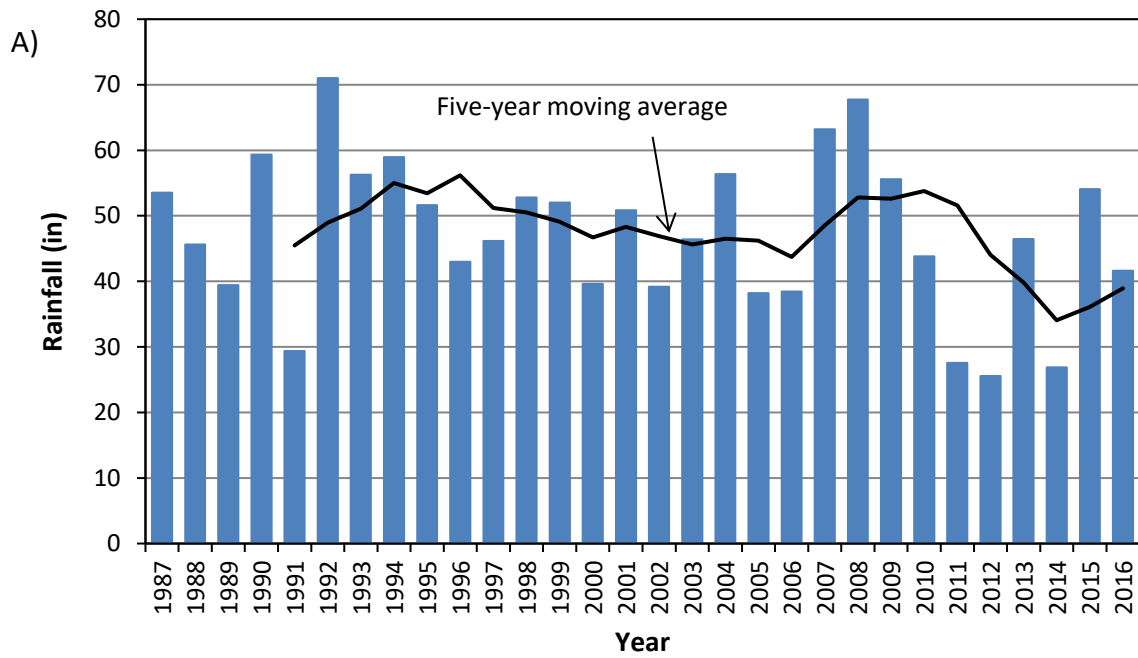
Figure 4. A) Annual total rainfall and B) average annual temperature from 1987-2016 for Lamar, Missouri.

Southwest Missouri has a temperate continental climate with hot summers and moderate winters (Davis and Schumacher 1992). Over the 30 year period from 1987-2016, the average annual rainfall at Lamar, Missouri ranged from 25.6-71.0 inches with an average of 47.4 inches per year (Table 1). The highest monthly rainfall totals (>5 inches) occur in the late spring and early summer during the months of May and June, with generally less precipitation (<3 inches) during the winter months (Figure 3). Between 1987-2016, average annual temperature ranged from 53.5-60.3 °F with an average of 56.5 °F (Table 1). Over that period, average monthly temperatures range from 33.2 °F in January to 78.4 °F in July (Figure 3). Over the last 30 years, the overall precipitation and temperature trends show increasing temperatures and decreased overall rainfall since 1987 (Figure 4).

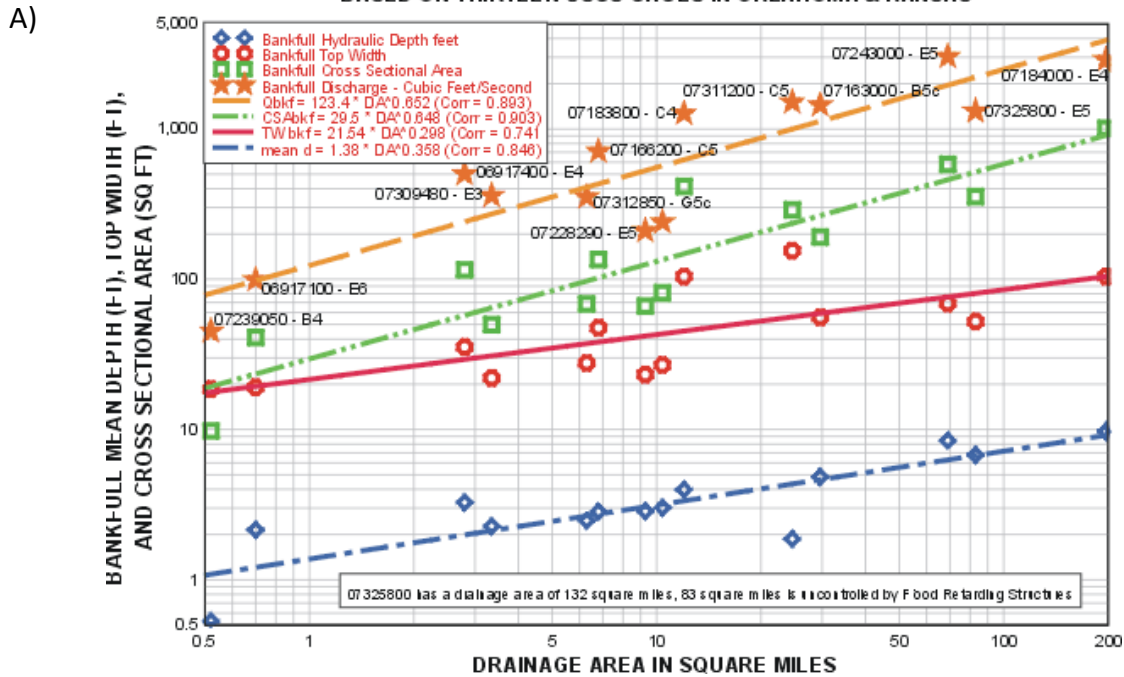
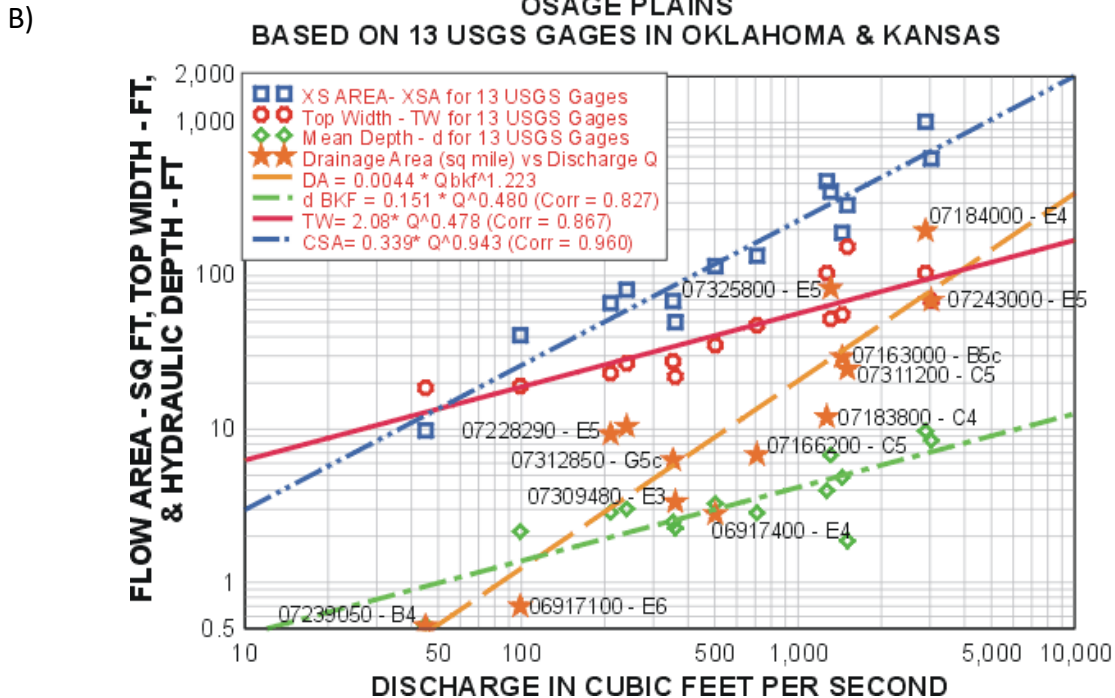
PRELIMINARY CENTRAL LOWLAND PHYSIOGRAPHIC REGIONAL CURVE  
OSAGE PLAINS  
BASED ON THIRTEEN USGS GAGES IN OKLAHOMA & KANSAS

PRELIMINARY CENTRAL LOWLAND PHYSIOGRAPHIC REGIME CURVES  
OSAGE PLAINS  
BASED ON 13 USGS GAGES IN OKLAHOMA & KANSAS

Figure 6. Preliminary A) regional and B) regime curves for the Osage Plain physiographic region. Source: NRCS-National Water Management Center

The Lamar Lake-North Spring River watershed is located in the Osage Plains section of the Central Lowland Province of the Interior Plains (USDA, 2006). This region is characterized by rolling plains where local relief is typically between 50-150 ft (MDNR 1986). The underlying bedrock consists of Pennsylvanian age interbedded limestone, sandstone, shale and coal beds of the Cherokee Group that generally southeast to the northwest (Hughes 1974, Kleeschulte et al. 1985). Streams in this region are low gradient featuring low velocities, few riffles, with mixed bed sediments ranging from silt to bedrock (Davis and Schumacher 1992, Kiner et al. 1997). Published regional curves and regime equations available on the NRCS website have been developed for analysis of typical channel morphology for streams in the Osage Plains with drainage areas between 0.5-200 square miles (Figure 6, USDA 2017a).

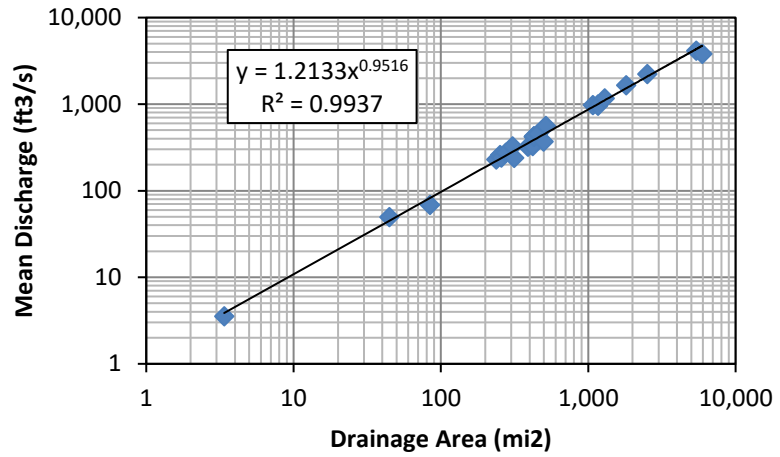
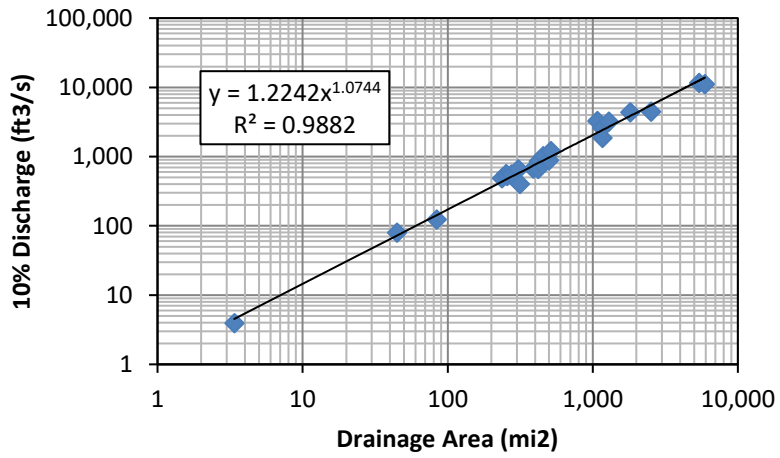
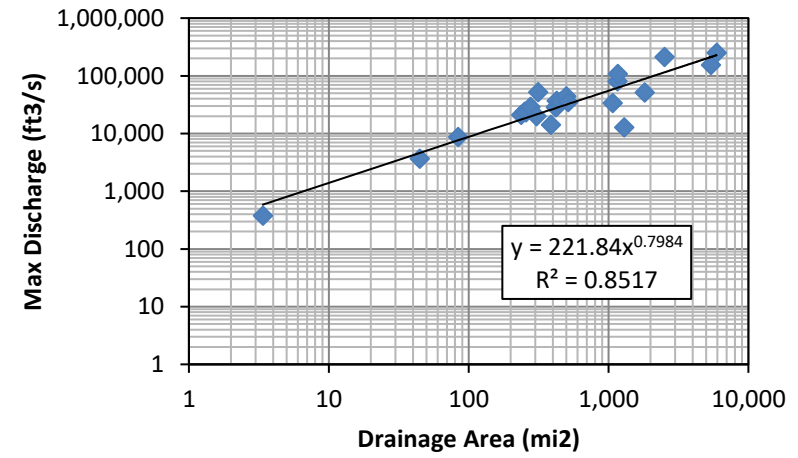
Figure 14. Drainage area and discharge relationships for 25 USGS gaging stations near the study watershed.

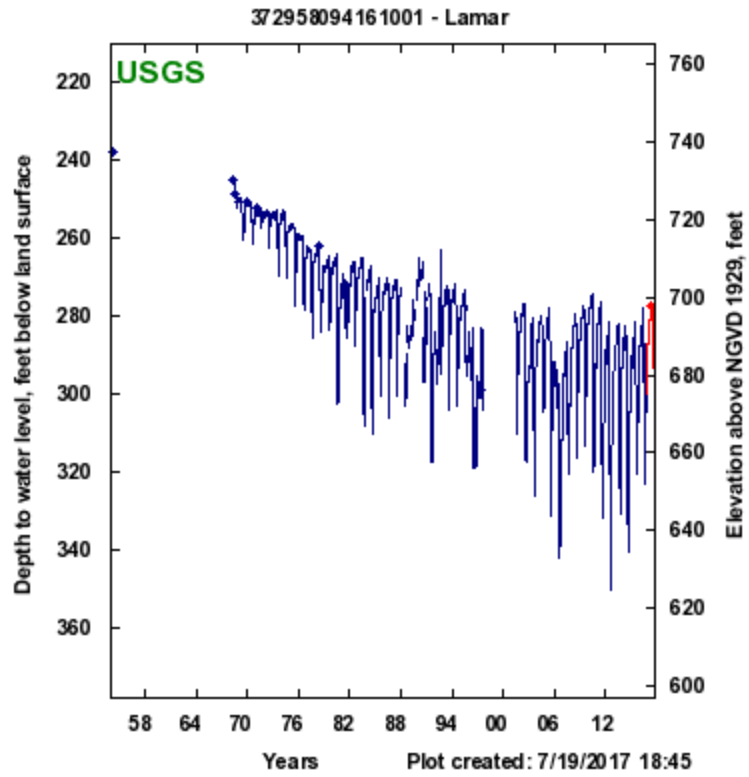
Figure 15. Ground water level change for Lamar (1968-2017).

372958094161001) that has been operating since 1968 and data from this station shows not only a steady decline in ground water levels in this area but ground water levels have become increasing more variable over time (Figure 15).

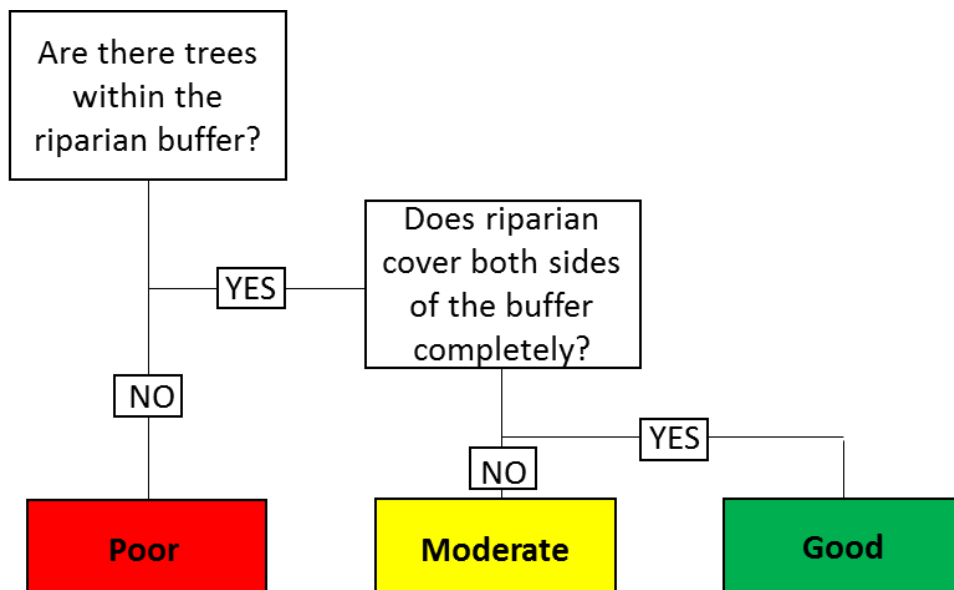
Figure 21. Flow chart showing decision tree for riparian corridor assessment from aerial photo analysis.

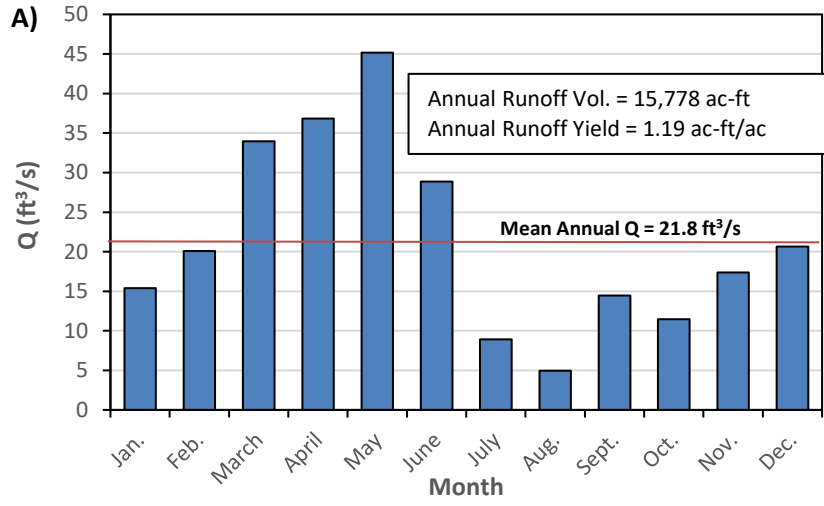
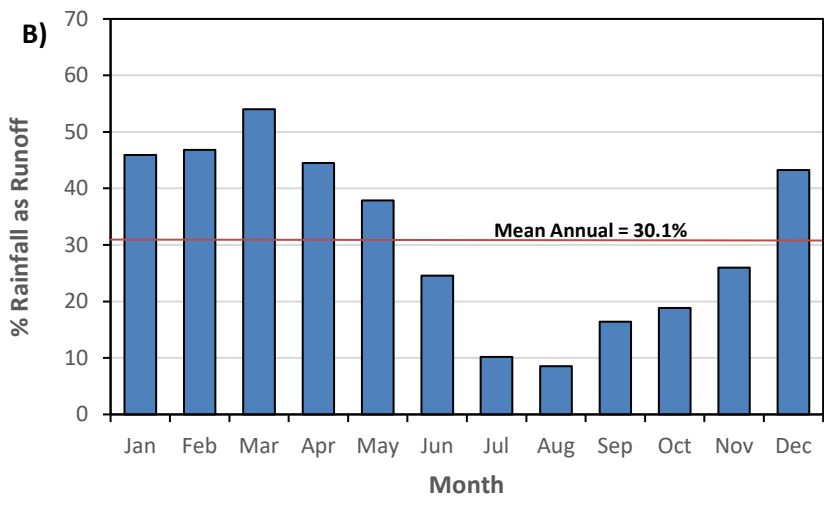
Figure 25. Mean monthly discharge and runoff percentage for the A), B) HUC-12 watershed and the C), D) Lamar Lake watershed.

Annual and monthly runoff rates for the HUC-12 watershed and the Lamar Lake watershed were estimated using equations developed from USGS gaging stations in the region. Monthly runoff rates are important for understanding the seasonal variability and how rainfall-runoff relationships correspond to land management and annual runoff rates will be used to help validate the STEPL model hydrology results. A list of the equations used for this analysis of monthly mean discharge values can be found in Appendix E. Mean annual discharge for the HUC-12 watershed is 21.9 ft<sup>3</sup>/s and 5.3 ft<sup>3</sup>/s for the Lamar Lake watershed (Figure 25). Total runoff volume for the HUC-12 watershed was 15,778 ac-ft and 3,884 ac-ft for the Lamar Lake watershed. For both watersheds, average discharge peaks in the month May and is the lowest in August. Average runoff as a percentage of rainfall for the HUC-12 watershed was 30.1% and 32.4% for Lamar Lake. The remainder of the rainfall is either lost to evapotranspiration or moves through the soil into groundwater storage through infiltration (USDA 2009). These estimates compare well with the literature where evapotranspiration rates for Missouri range from 60-70% and infiltration rates average around 3.8% of rainfall totals in the area (Czarnecki et al. 2009, Sanford and Selnick 2013). Monthly mean runoff as a percentage of rainfall is highest in the late winter and early spring and lowest in the late summer and early fall ranging from less than 10% in August to 50-60% in March.
