Research Article

Monitored structural behavior of a long span cable-stayed bridge under environmental effects

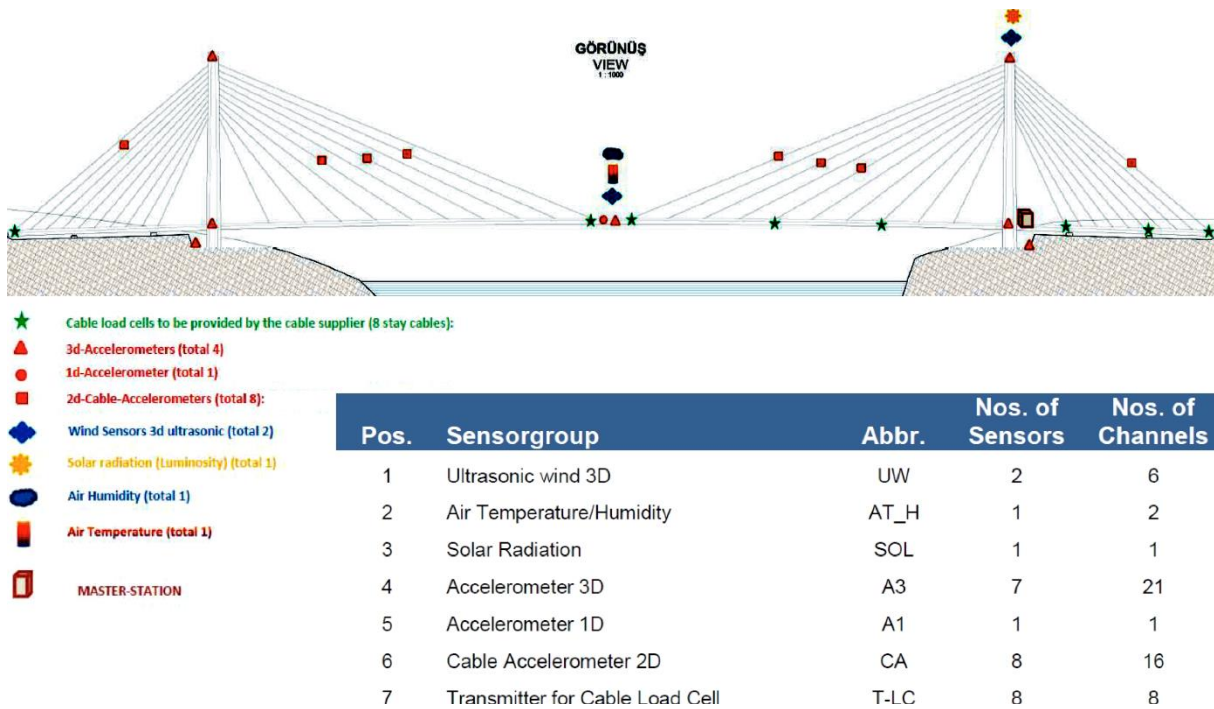
Fig. 2. The sensor types and locations in Nissibi Bridge (VCE, 2012).

The monitoring system of the bridge consists of 28 sensors located on the foundations, deck, pylons and cables including load cell, accelerometers, wind, temperature and humidity sensors. Bridge structural monitoring system and some views of the sensors are shown in Figs. 2 and 3.

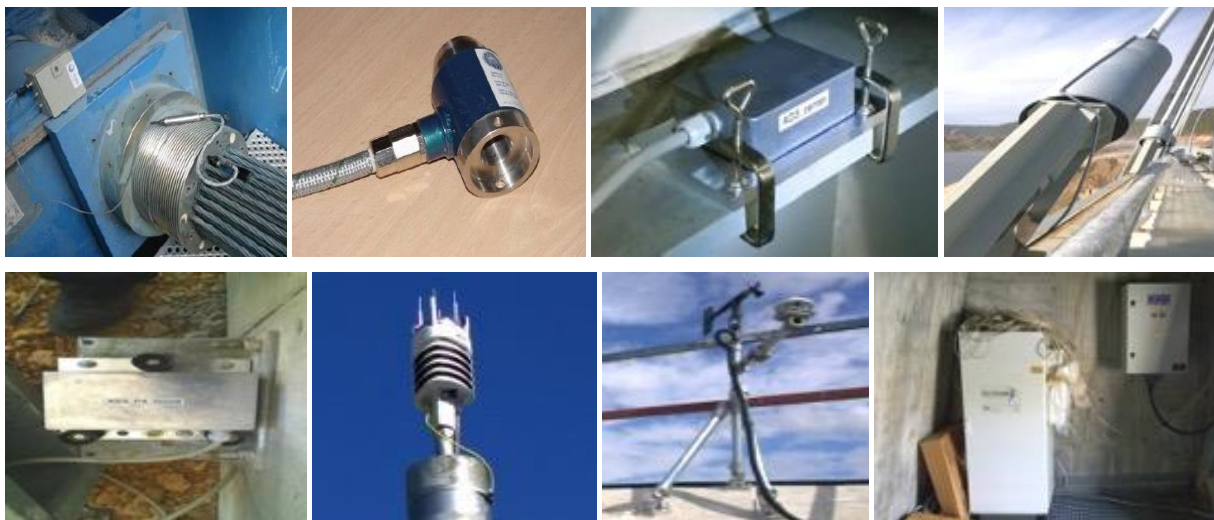
Fig. 3. Some views from sensors located in Nissibi Bridge (NBR, 2015).

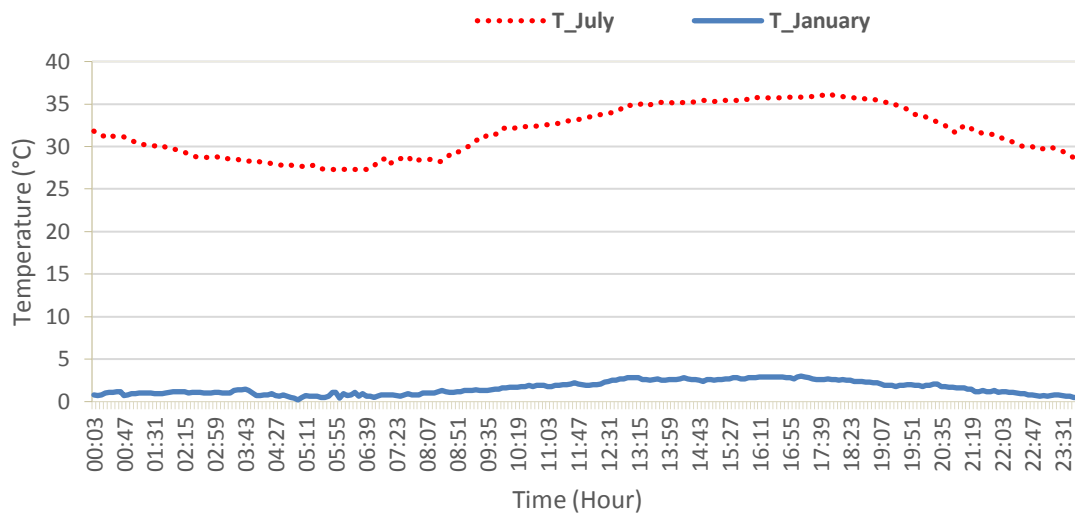
(a) Daily temperature

(b) Daily humidity

(c) Daily wind speed

Fig. 4. Variations of air temperature, humidity and wind speed on July 31, 2015 and January 1, 2016.

The cables, pylons and deck behaviors under environmental effects such as air temperature, humidity and wind speed are investigated in this section. The forces and acceleration responses of bridge elements measured from the bridge monitoring system are compared for various environmental meteorology. The data recorded in the hottest summer (July 31, 2015) and the coldest winter (January 1, 2016) days are chosen for the comparisons. The daily variations of air temperature, humidity and wind speed with time are shown in Fig. 4. It can be seen from Fig. 4a that air temperature is above 30°C

on July 31 and below 3°C on January 1. The temperature slightly decreases and reaches the minimum in the early morning in both day. The temperature then increases to the maximum in the early afternoon and decreases in the evening and at midnight. The temperature reaches a minimum of approximately 0°C at around 05:00 hrs on January 1 and a maximum of approximately 36°C at around 16:00 hrs on July 31. The relative humidity ratio on January 1 is higher than the ratio on July 31. The humidity decreases and reaches minimum in the evening in both days. Maximum wind speed is observed over 12 m/s on January 1, whereas the maximum wind speeds occur in the afternoon on July 1 and at midnight on January 31. In general, the change in temperature between

The variations of temperature and humidity in January 1 and July 31 are shown in Figs. 4a and 4b. The variation of cable forces with air temperature on July 31 and January 1 are depicted for cables 160, 260, 360 and 451 in Figs. 6 and 7. It can be seen from Figs. 6 and 7 that the values of cable forces slightly change in July 31 and January 1 throughout the day. The cable forces increase and reaches the maximum values in the early morning on January 1, in which temperature has smallest values. Besides cable 160, cables forces recorded in July 31 have maximum values in the afternoon, in which temperature has maximum values.

The design wind speed was taken into account as 33.6m/s (120km/h) at the design stage of the bridge. Variations of wind speed on July 31 and January 1 are shown in Fig. 4c. Maximum wind speed recorded was slightly over 12m/s in January 1. The variation of forces for Cable 160,

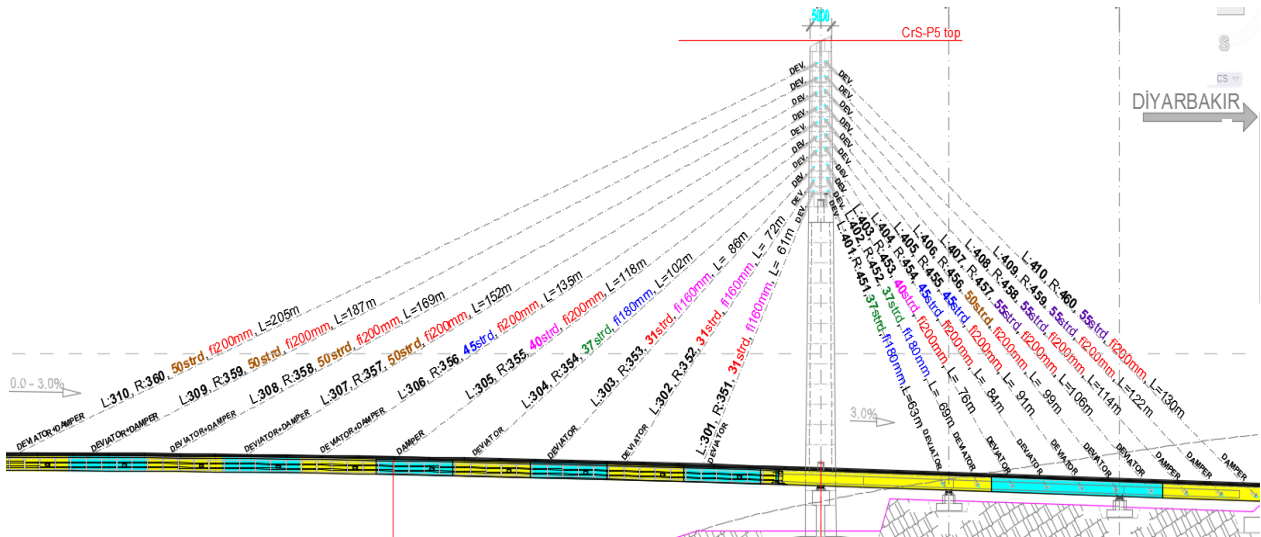
(a) Pylon P4

(b) Pylon P5

Fig. 5. Cable properties on the pylons P4 and P5 (NBP, 2012; NBR, 2015).

The properties of cables on the pylons P4 and P5 are shown in Fig. 5. The prestressed concrete and steel deck are carried by 20 double cables (80 cables in total) in the left and right of pylons P4 and P5. Cables 160, 260, 360 and 451 are selected for the investigation of the response of the cable forces under temperature and wind effects.

It can be seen from Fig. 5 that Cables 160 is with

length of 130m, 55 strands and 200mm diameter; and Cable 260 and 360 is with length of 205m and 50 strands and 200mm diameter. Both cables have dampers and are in the right side of the deck. Cable 160 is in the Adiyaman side of pylon P4. Cable 260 at pylon P4 and Cable 360 at pylon P5 are in the middle of the deck span. Cable 451 is with length of 63m, 37 strands and 180mm diameter and is in the Adiyaman side of pylon P5. The environmental effects on cable forces are investigated for an individual strand force in each cable.
