An experimental study on influence of shear failure type partial wall on reinforced concrete frame

Hisato Hotta*, Takeshi Nakajima

Department of Architecture and Building Engineering, Tokyo Institute of Technology, 152-8550 Tokyo, Japan

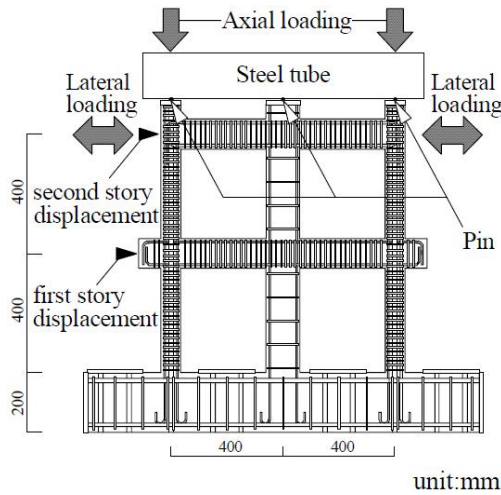
Fig. 1. Specimen (MW12-S) and outline of static loading.

The outline of the loading is illustrated in Fig. 1 above mentioned. In order to restrict the wall's axial elongation

caused by their bending yield, a steel tube with sufficient stiffness is attached to the top of the specimens with pin support. Due to this treatment, the specimens show almost the same behavior as that on the lower part of middle-rise buildings. A constant axial force equivalent to 0.15 bDFc (25.1 kN) was loaded by vertically pulling PC bars running through the center of the columns. The both ends of the second story beam of the specimen was horizontally pulled and pushed with the same force.

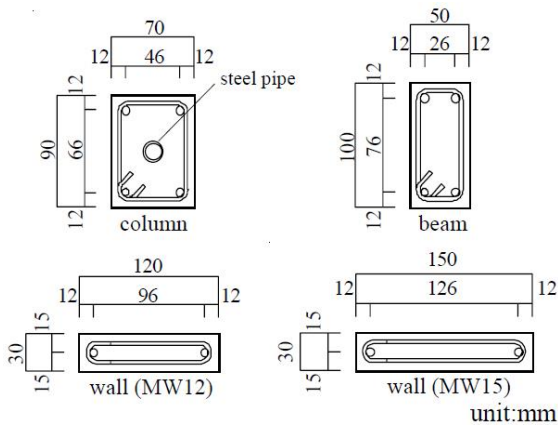
Fig. 2. Section of members.

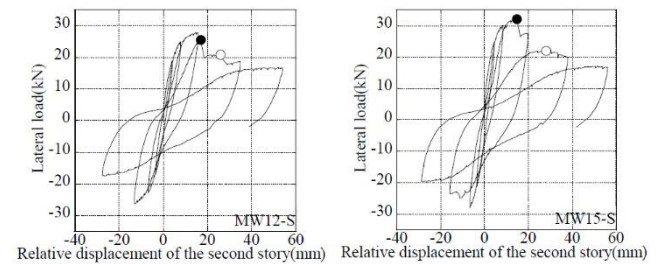
Relationships between the lateral load and the displacement of the second story are indicated in Fig. 3. MW12-S recorded the maximum lateral load (27.2 kN) in the third loading loop, and the second story wall and the first story wall fell in shear failure in turn in the fourth loading loop. MW15-S recorded the maximum lateral load (32.0 kN) in the third loading loop, and soon, the wall of the second story fell in shear failure. And the wall of the first story fell in bond failure in the fourth loading loop.

Fig. 3. The relationships between the lateral force and the displacement.

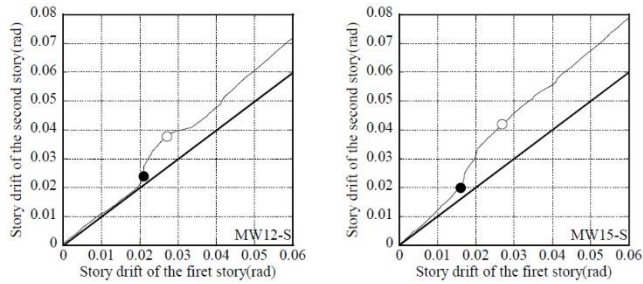
Relationships between the story drift angle of the first story and that of the second story are shown in Fig. 4. Dots ◦ and • indicate the point the first and the second story walls failed. It is recognized the story drift of the second story increased compared with that of the first story after the second story wall failed. It shows progress of flexural deformation at the second story column-base. This tendency is outstanding in MW15-S. That means, the walls of MW15-S are stiffer than those of MW12-S,

therefore the difference of story stiffness between the first story and the second story appears more clearly after one of the partial walls fails.

Fig. 4. Relationship between story drift of the second story and the first story.

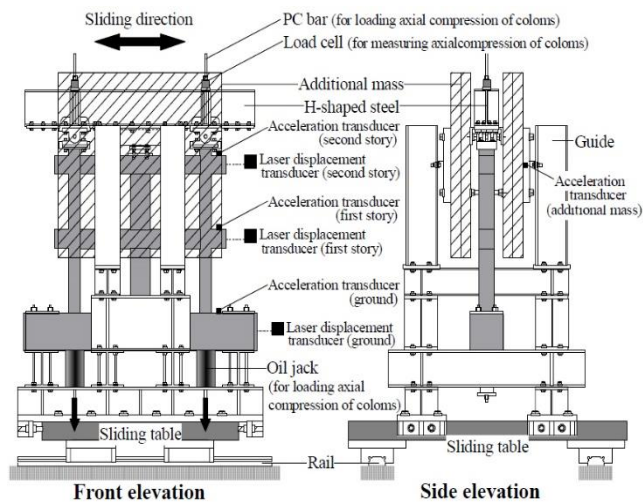
The outline of the setup is illustrated in Fig. 5. How the mass is connected to the specimen is detailed in Fig. 6. A H-shaped steel is connected at the top of the column of the specimen by pin connections. The total mass of the additional mass is 1.97 tons. Its center of gravity is almost coincident with the central point of the second story beam, therefore it can be said that the loading is similar to that of the static loading test. The H-shaped steel also plays the role of restricting the walls' axial elongation. As the axial force of the columns due to the mass is shorter than design axial compression of 0.15 bDFc (28.4 kN), the lack is filled up by pulling PC bars running through the columns. Input ground motion is NS component of JMA KOBE wave. As the size of the specimen is 1/8 times as large as a practical frame, amplitude of the wave is reduced to 1/8. The compression ratio of time axis is 3/10. The wave is named briefly "Kobe" in this paper. The natural period of the specimen including the additional mass is about 0.10 sec., therefore the specimen corresponds to a building with natural period of 0.33 sec., namely, a 5-6 story middle-rise building in actual size. A typical input ground motion is shown in Fig. 7. Run table is shown in Table 3.

Fig. 5. Outline of loading setup and measuring.

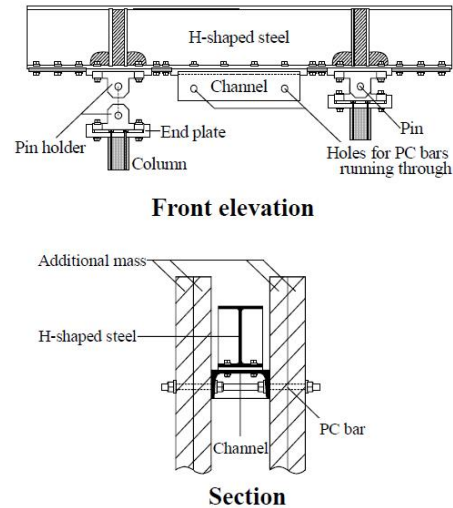
Fig. 6. Detailed drawing of connection to specimens of additional mass.

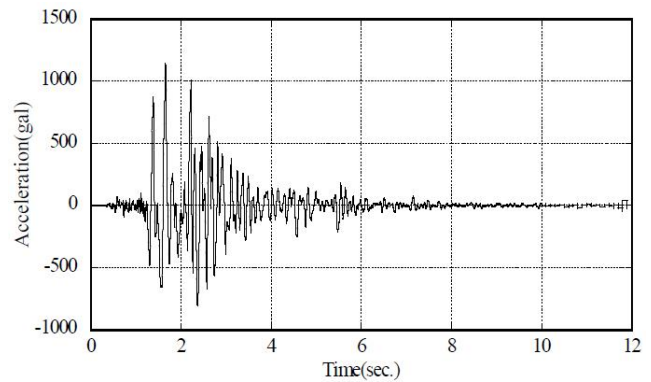
Fig. 7. Input ground motion (Kobe-1.0).

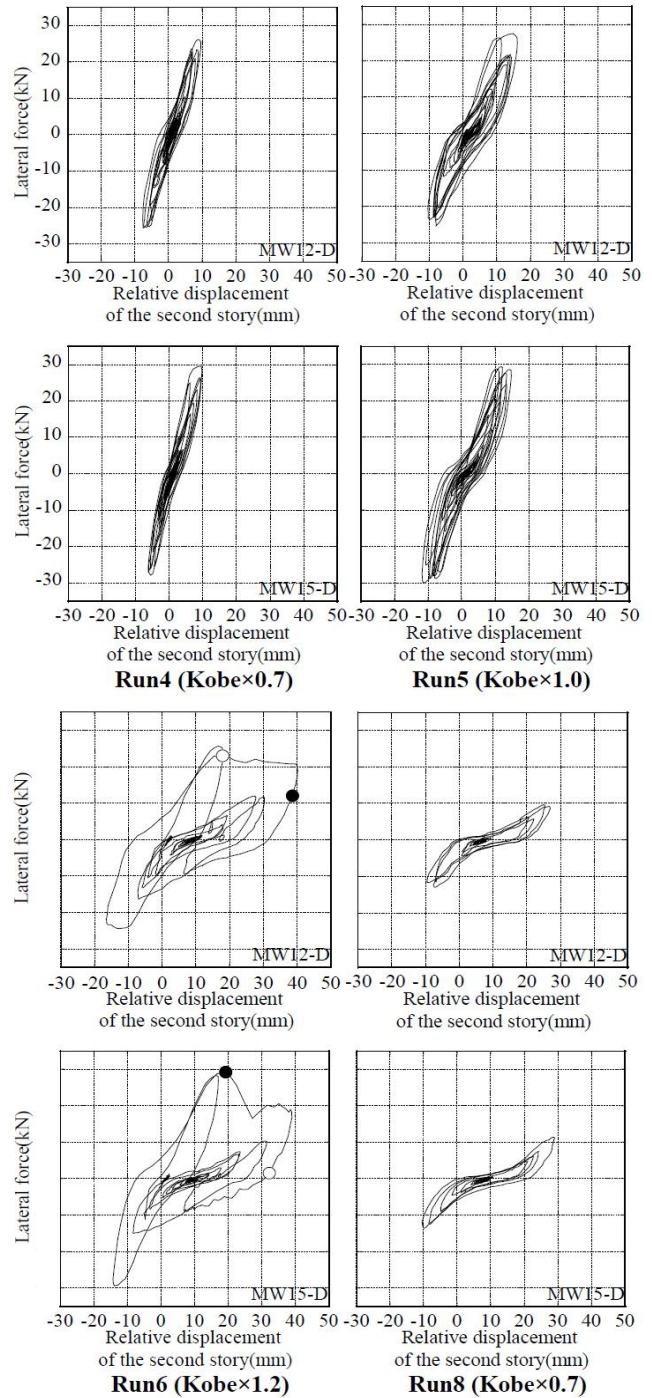
The relationships between the lateral force and the displacement are shown in Fig. 8 for several input level, Run-4, -5, -6 and -8. In the figure, the lateral force means the one obtained by multiplying the recorded absolute acceleration of the additional mass by the mass of 1.97 tons, which is equivalent to the sum of restoring force and damping force, and the displacement is the relative displacement between the stub and the second floor. Until Run-3, both specimens showed almost elastic behavior. During Run-4, the both specimens went into inelastic

region and hysteresis loop gradually shifted to slip type. As for Run-5, a number of shear cracks are observed in the walls after shaking for both the specimens, however, they had not yet experienced the strength degradation due to shear failure of the walls. During Run-6, the walls at both the stories were failed due to shear in both the specimens. As shown in Fig. 9, it can be recognized that the elongation of the walls rapidly decreased after the time indicated by dots ◦ and ●, and it is considered that the walls were failed at the time indicated by the dots, respectively. According to the above consideration, as for the specimen MW12-D, the wall at the lower story failed at first (1.53 sec) and then the upper story wall failed (1.61 sec), and as for MW15-D, the upper wall failed at first (1.53 sec) and then the lower one (1.63 sec.) As for Run-8, both specimens exhibited considerable slip behavior, and the restoring force did not reach the residual lateral strength of the specimens.

Fig. 8. The relationships between the lateral force and the displacement.

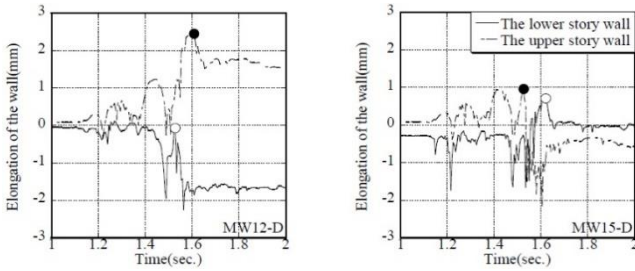
Fig. 9. Time history of the elongation of the walls (Run-6).

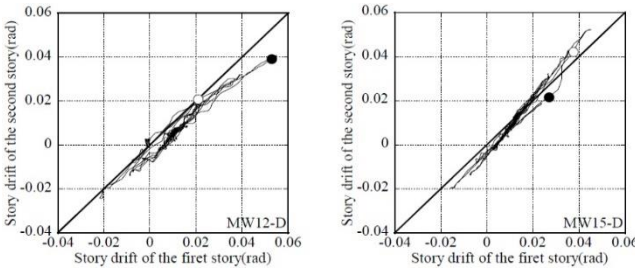
Story drift angle of the first story is compared with that of the second story in Fig. 10. It is recognized that the story-drift at the story where the wall failed former rapidly increased compared with the other during two times of the shear failure of the walls. It is the same results as provided in the static loading test, though the wall failed earlier was different according to the specimens. In the specimens for the shaking table test, two failure occurred in a very short period of 0.1 sec and the columns were designed still little stronger than the beams, therefore, the influence of the brittle behavior of the wall is limited small. The reason they occurs in a short period can be considered that shear failing of one wall releases the restriction of the elongation for the other wall, and that weaken the shear strength of the wall, however, if less stronger columns are used, the attention should be continuously paid on this problem, because there is still some fears the brittle failure of the wall eventually cause story collapse.

Fig. 10. Relationship between story drift of the second story and the first story (Run-6).

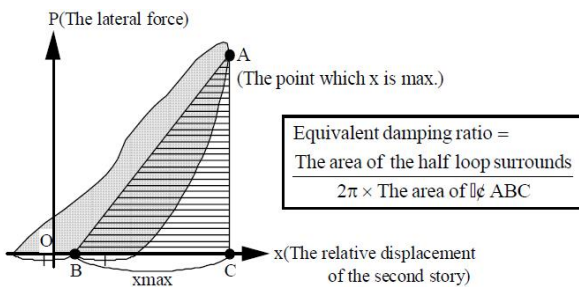
Fig. 11. Evaluation of equivalent damping.

Equivalent damping ratio evaluated each half loop as shown in Fig. 11 is plotted in Fig. 12 for both the specimens. This includes the ordinary viscous damping ratio because the lateral force is the sum of restoring force and damping force in the hysteresis previously described. The horizontal axis of Fig. 12, x_{max} corresponds to that in Fig. 11 and it is almost equivalent to the lateral displacement of the story when x_{max} is smaller than about 10mm, therefore the plots in Fig. 12 are the equivalent damping ratios before the wall fails. In spite that the walls do not fail, they exhibited 0.1 and more. The damping ratios for MW12-D are totally higher than those for MW15-D.

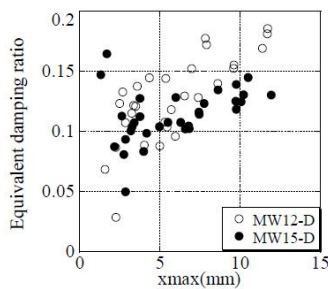
Fig. 12. Relationship between equivalent damping ratio and x_{max} (Run-3, -4, -5).

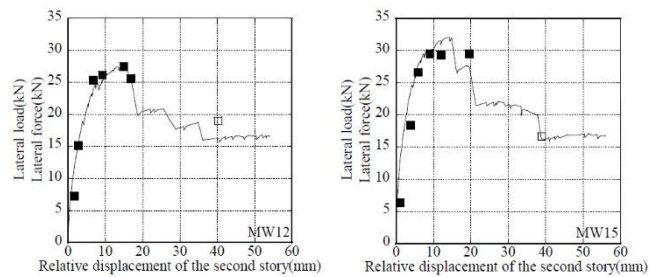
The relationships between the lateral load and the displacement under the static loading test (solid line) and the relationships between the lateral force and the displacement under the shaking table test (■ and □) are shown in Fig.13. Dot ■ means the time when the specimens recorded the maximum lateral load during each Run from -1 to -6, and dot □ means the time when the specimens recoded the maximum displacement of the second story during Run-6. Though the lateral force is the sum of restoring force and damping force, the velocity of deformation is almost 0 when the dots ■ and □ are recorded, therefore damping force included in the lateral force at the dots ■ and □ is almost 0.

Fig. 13. Outline of loading setup and measuring.

The specimens' mechanical properties for the both loading tests are similar. By the above consideration, the lateral force recorded through the shaking table test can be simply compared with the lateral load recorded through the static loading test. Generally the results under the both loading tests are coincident with each other in MW12 and MW15. The displacement when the specimens show the peak restoring force in the both loading tests are also coincident with each other. In other words, the deformation limit of the walls does not depend on a method of the loading. Under the shaking table test the displacement increases rapidly after the walls failed than under static loading test.
