An Investigation into Road Pavement Failure Susceptibility Indices of Osogbo-Iwo Road

O.S. ADERINOLA S.A. OLA A.O. OWOLABI

Civil Engineering Department, The Federal University of Technology, P.M.B 704, Akure, Nigeria

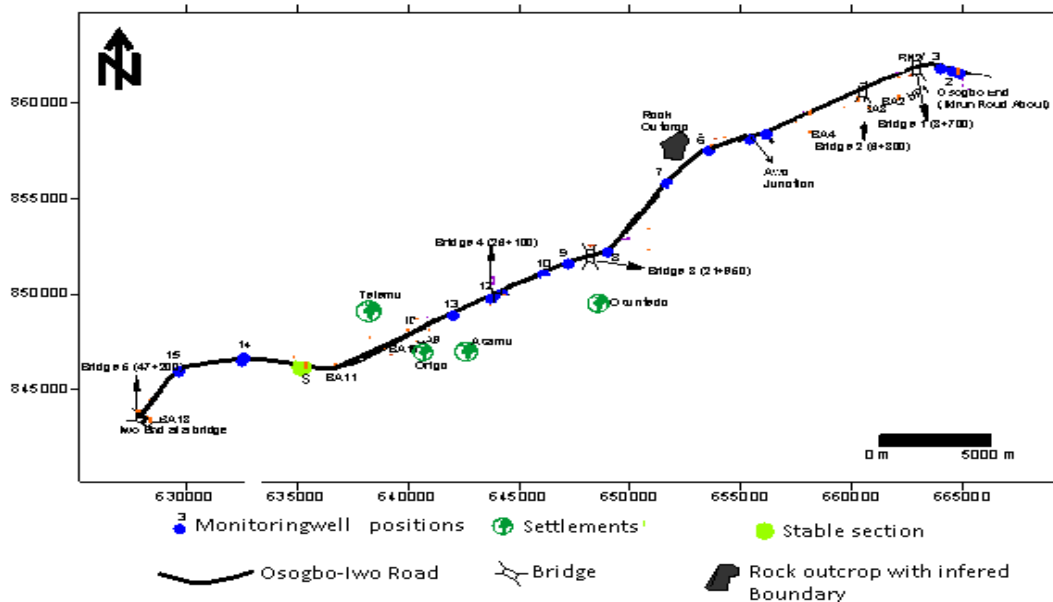
Fig.1b: Osogbo-Iwo Road showing positions of Monitoringwell and other features along the Road

The field investigation undertaken consisted of fifteen (15) monitoring wells (3.0 m [10 feet] deep). Monitoring wells (Piezometers) were installed at each of the fifteen identified major failed segments(Ola et al, 2009). The borings were put down by rotary auger rig to advance the holes. 12.7cm (5 inches) diameter holes were drilled and samples were continuously taken. Jar samples were taken between intervals and at interval of 0.3m (1foot), 1.52m (5 feet) and 3.05m (10 feet). Standard penetration test (SPT) in conjunction with split spoon samples (and U2 samples where appropriate) were taken. The standard penetration test involves driving a 5.08cm (2.0 inches) O.D. split spoon sampler 60.9cm (24 inches) long through a depth of 45.7cm (18 inches) with a 63.6 kg (140 lb) hammer dropping 76.2cm (30 inches) for each blow. The standard penetration resistance N is the number of blows required to drive the sampler through the last 30.5cm (12 inches) of penetration. Similar procedures were followed for the U2 except that the tube was for undisturbed samples of 5.08cm (2 inches) diameter. The U2 is 5.5 cm (2.17 inches) I.D and 5.7 cm (2.24 inches) O.D. The record of casing blow counts was also kept.
