Application of Electrical Resistivity Tomography (ERT) and Aerial Photographs Techniques in Geo Hazard Assessment of Karst Features in Constructing Sites in Perak, Peninsular Malaysia

Riyadh R. Yassin*, Ros Fatimah Muhammad, Samsudin Hj Taib

Department of Geology, Faculty of Science, University of Malaya, 50603 Kuala Lumpur, Malaysia. *Email: riyadh.geophsea@gmail.com

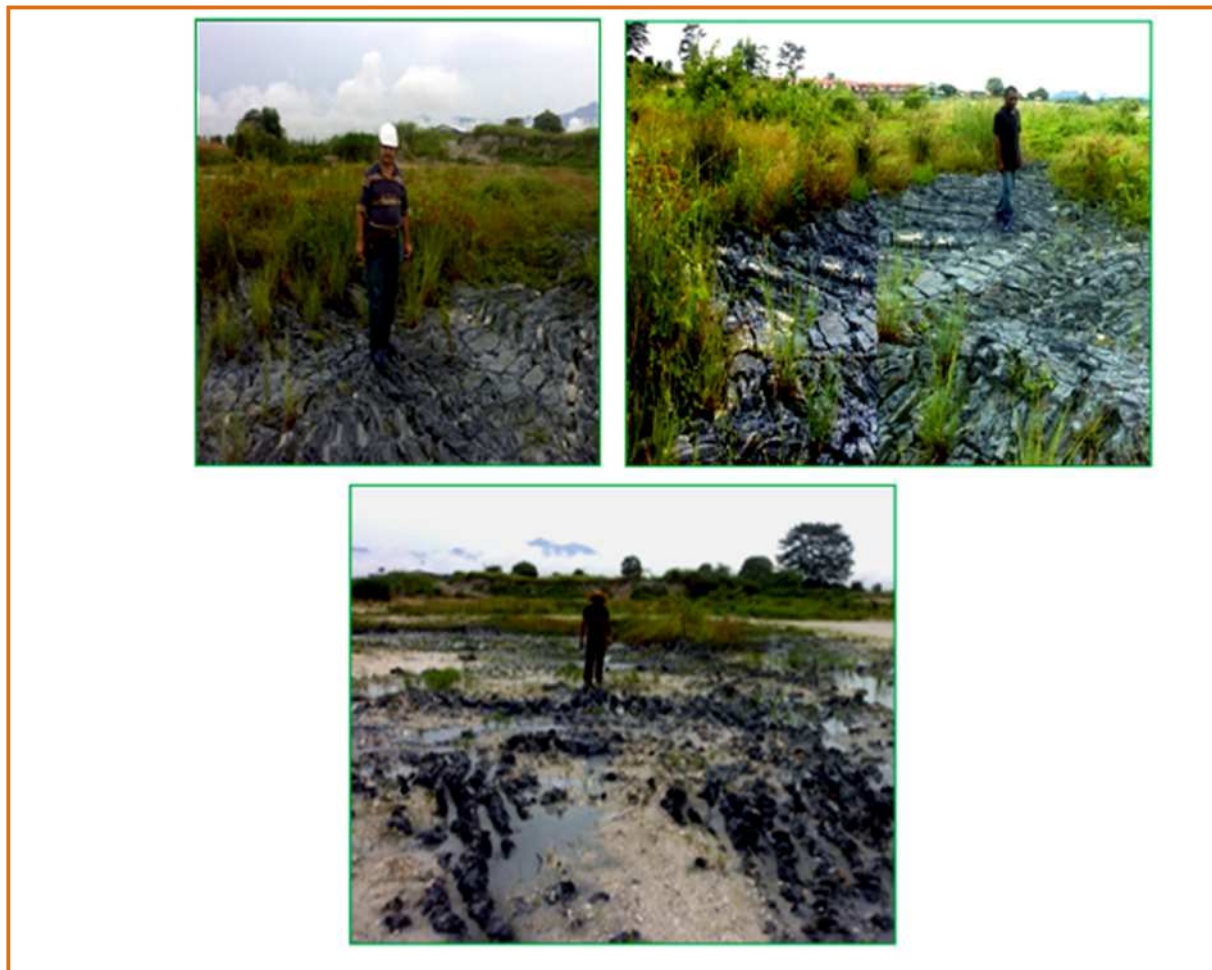
Figure 4: land Photographs viewing several positions that recognized in aerial photographs in construction site #1, which identified as the depositional of gry swamps clay

Direct ground inspections in the two construction sites resulted in the discovery of sinkholes that were not visible in aerial photographs and satellite images due to many factors. For example, the area may be enclosed by vegetation, sinkholes definite size, or their depth is too small to be detected. The recorded model is used for the explanation of each sinkhole, including a diagram of the sinkhole and its access geometry, the covering features with the district and the coordinates, orientation, dimensions, age, continuation degree, vegetation and symbols of volatility as cracks, scarps or pipes. These features supply information on the activity and the periods of the sinkholes, and act as indicators of plausible location of future sinkholes in proximity to human structures and other observations. The existence of features such as muddy areas, or the expansion of vegetation and holes crammed with materials may help detect shallow subsidence depressions. Generally, the application of geophysical surveys is desired to determine whether these irregular characteristics are interrelated to sinkholes. Ground inspection at site#1 reveals no sinkhole. On the other hand, aerial photographs of the area imply that it is made up of old swamps, which might contain sinkholes on its subsurface. More than four big black spots were recognized in aerial photographs, three of them circular to semi circular in shapes, while the others possess an extended shape. However, due to human activity and excavating work being done there as an ex-mining area, most of these features were packed with sand and other material, and among them, three areas with deposits of grey swamp clay in circular shapes were acknowledged. The clay seems to sink down due to numerous factors, which will be explained shortly. Figure 6 shows land photographs and the positions of three big black spots in the aerial photographs, which might include sinkholes under the depositional of gray swampy clay construction site #1

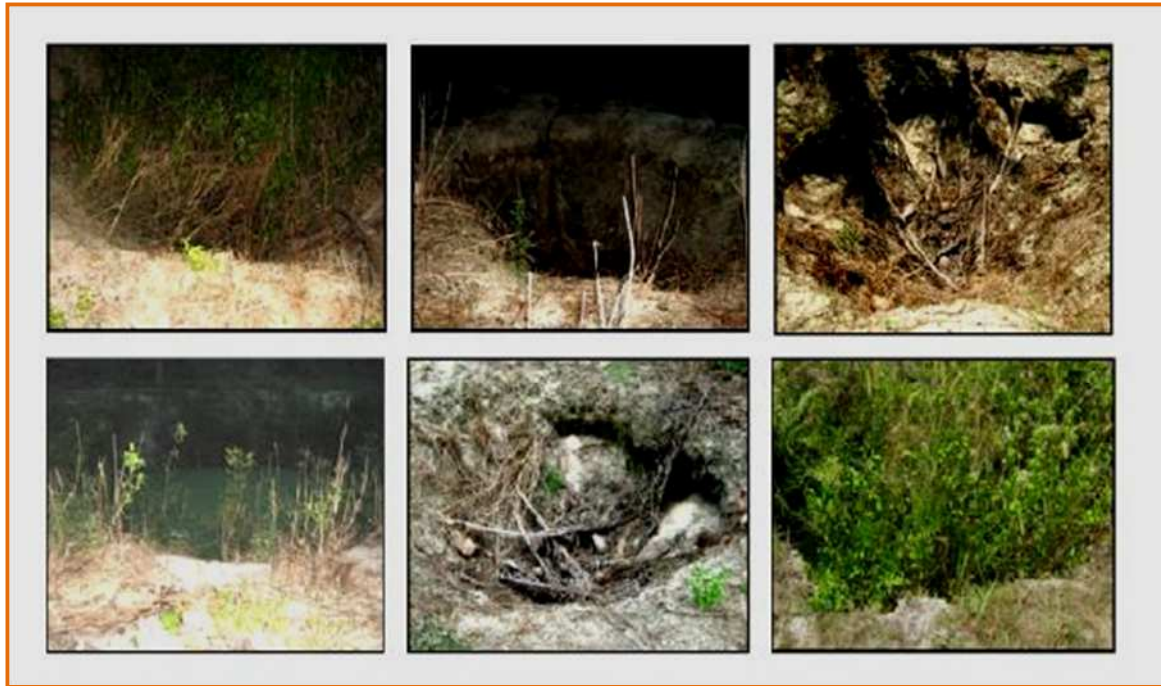
Figure 5 : Land Photographs viewing a number of sinkholes that identified as water in-fill, empty and covered with vegetation was determined as small and narrow in construction site #2 and site#3

During the ground inspection at site #2, two sinkholes was discovered, but not recognized in aerial photographs and satellite images, as adjacent small plants enclose it. One of these sinkholes has a diameter of ~7m-10m., water in-filled, of visually undetermined depth, are recognized and proven as a sinkhole with a narrow showing throat, positioned in the south west flank of this site. The other sinkhole has a diameter of ~35m- 40m, positioned in the north east side of this site, was in-filled with wet clay and other material of sediments due to karst activity, raised a question that this sinkhole might be linked in the subsurface to one or more of the large tabular conduits or channels, and the presence of cavities or voids of undetermined depth. Clay, or air in-filled karstic sinkhole or cavities were present, which could compromise the veracity of this site. The south section of this site is littered with soil cover collapses.

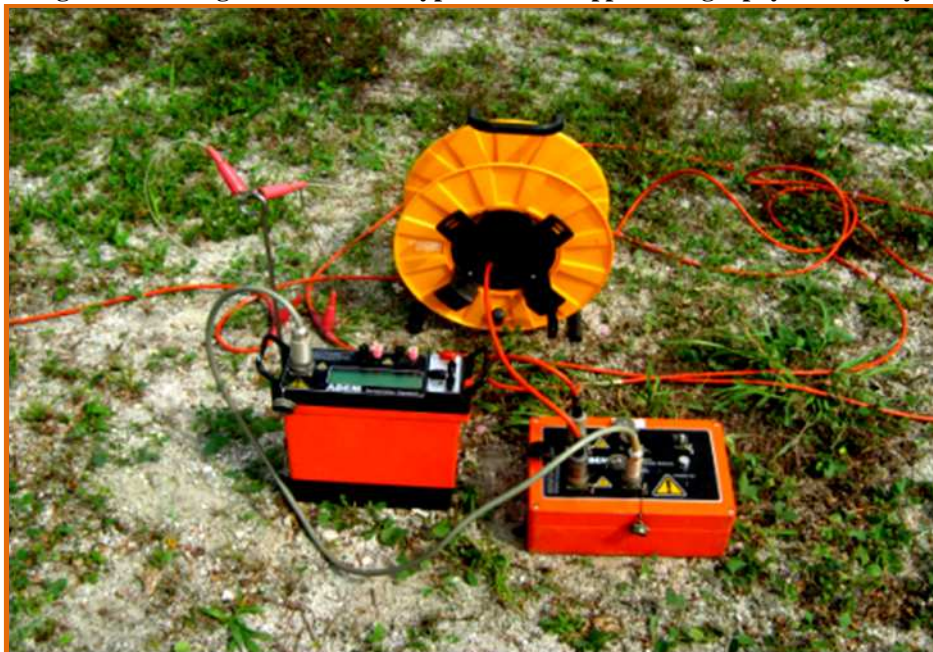
Figure 9: viewing the instrument type SAS1000 applied on geophysical survey

In a distinctive survey, most of the fieldwork involves laying out the cables and electrodes. After doing that, the measurements are taken automatically and stocked into the computer. This resistivity procedure usually gives a better grouping of spatial resolution and depth of study in karst terrain than any other geophysical technique.

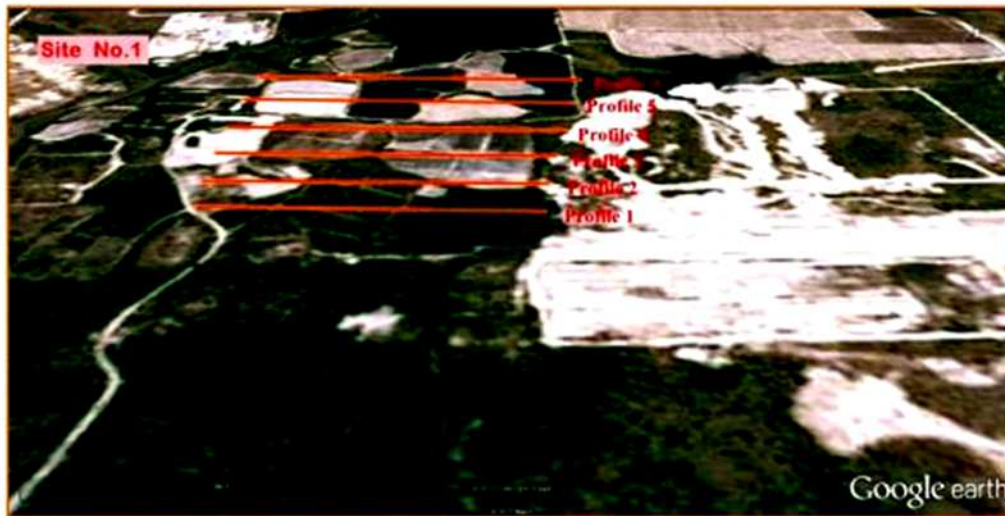
Figure 10: Google earth satellite images viewing the location of resistivity profiles in construction site #1

Six electrical resistivity traverses or profiles, Profile-1 to Profile-6, were controlled over and along the survey area in site #1. The direction of these profiles in (N90°W), and the level of those lines are shown in the location map, illustrated in Figure 10. The electrical resistivity data accumulated along the two dimensional (2-D) electrical resistivity profiles were determined to be in excess of, or beneath the sinkhole, using a 41-channel array in the Wenner configuration. The length of each profile was 200 m, with an electrode spacing of 5m, on average, spaced at 25m between each profile. The total length of all profiles in this site was 1200 m, covering an area of 30000 m²; 190 data points were composed for each (41-electrode) in one profile, and on average, about 1140 data were composed for a total six profiles in this site.

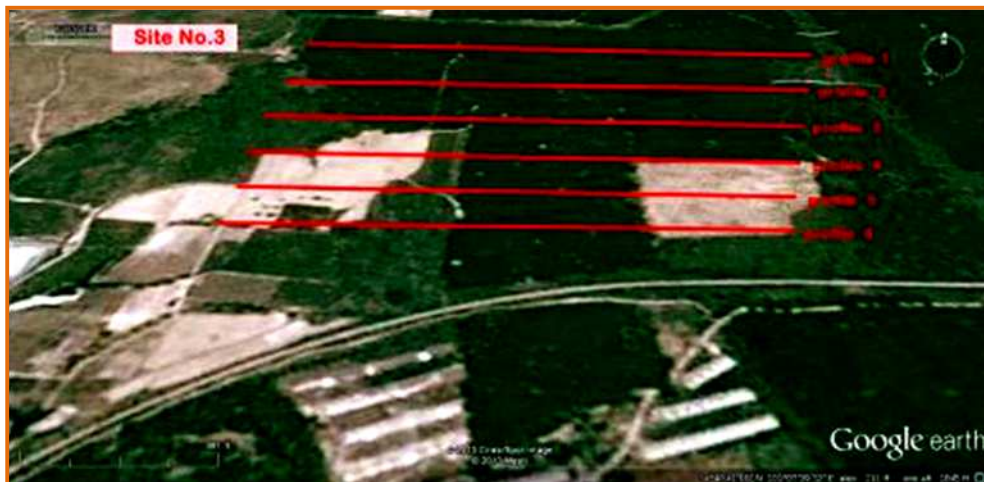
Figure 12: Google earth satellite images viewing the location of resistivity profiles in construction site #3

Six electrical resistivity traverses, named Traverses-1 to Traverses-6, were controlled over and along the survey area at site #3. The directions of these profiles are in (N90°W), and the levels of those lines are shown in the satellite image, illustrated in Figure 12. Electrical resistivity data were acquired and accumulated for the purpose of mapping this site along the two dimensional (2-D) electrical resistivity profiles, using an 81-channel array in Wenner design. The measurement length of each profile was 400 m, with an electrode spacing of 5m, on average, spaced at 25 m intervals between each profile. The total length of all profiles at this site was 2400 m, covering an area of 60000 m², with 340 data points composed for each (81-electrode) in one profile. On average, about 2040 data were collected from a total six profiles at this site.
