# The Role of Surveying and Mapping in Erosion Management and Control: Case of Omagba Erosion Site, Onitsha Anambra State, Nigeria

Ndukwe Chiemelu\*, Francis Okeke, Kelechi Nwosu, Chiamaka Ibe, Raphael Ndukwu & Amos Ugwuoti.  
Dept. of Geoinformatics & Surveying University of Nigeria Enugu Campus

*The paper was written from a project on erosion sponsored by World Bank/Federal Ministry of Environment (Nigeria Government) under NEWMAP project*

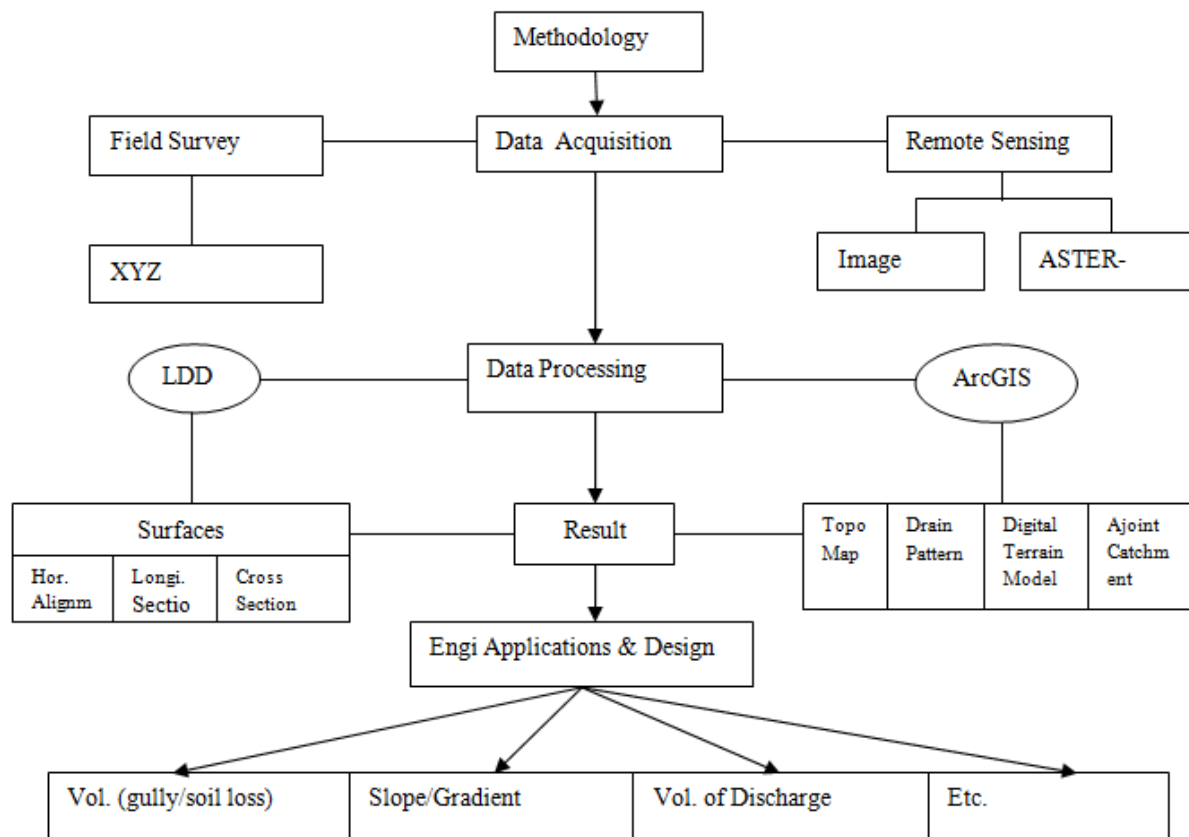
The project was accomplished from three basic approaches, which are: the field survey data acquisition method, data acquisition through internet and remote sensing, and finally data processing for the final results. Fig 4 is the methods schema

**Fig 1. Methodology Schema**

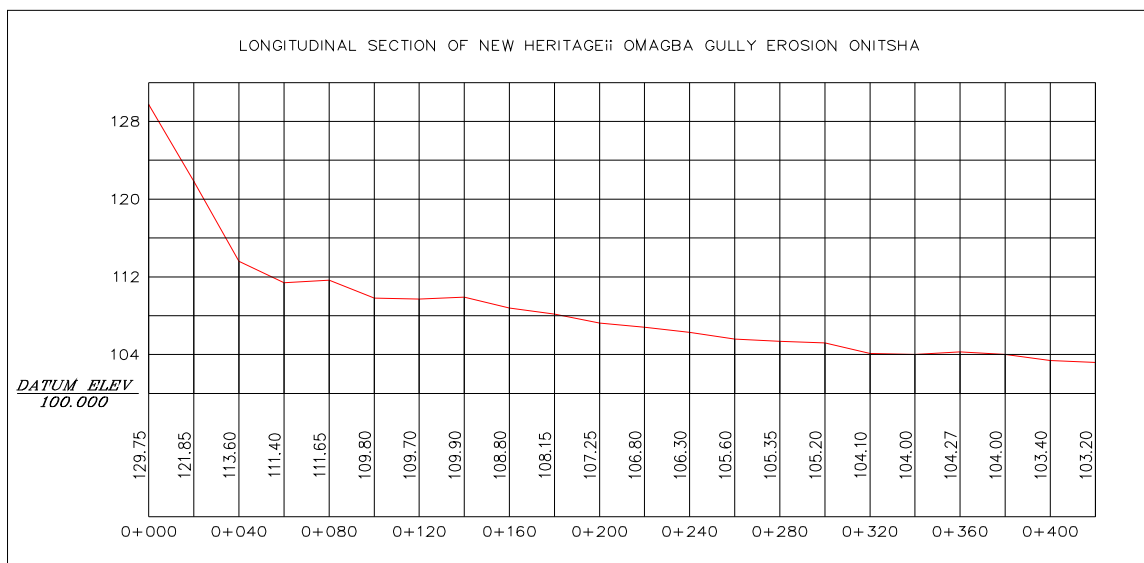
Figure 2 Longitudinal section of the gully bed of New Heritage II erosion site

The field survey data was processed using the Land development desktop (LDD) by Autodesk. Surface was created using the software from which the longitudinal and cross sectional plans were produced. (See figures 2 & 3). Further processing was carried out on the r/s data using ArcGIS software. The hydrological functions of the spatial analyst tools were used to create TIN for the production of various topographic details and the watershed of the catchment area for analysis.

1. Calculation of the volume of the gullies in order to determine the quantity of soil being eroded. This was done using the cross sectional data and the field survey measurements. An agreement exists between the gully depth and the width (Torri and Borselli, 2003).
2. The topographic map of the catchment was used for the calculation of the volume of water flowing into the canal.
3. The flow speed along the canal was obtained by determining the gradient of the flow line. This was done using the longitudinal profile of the gully bed.

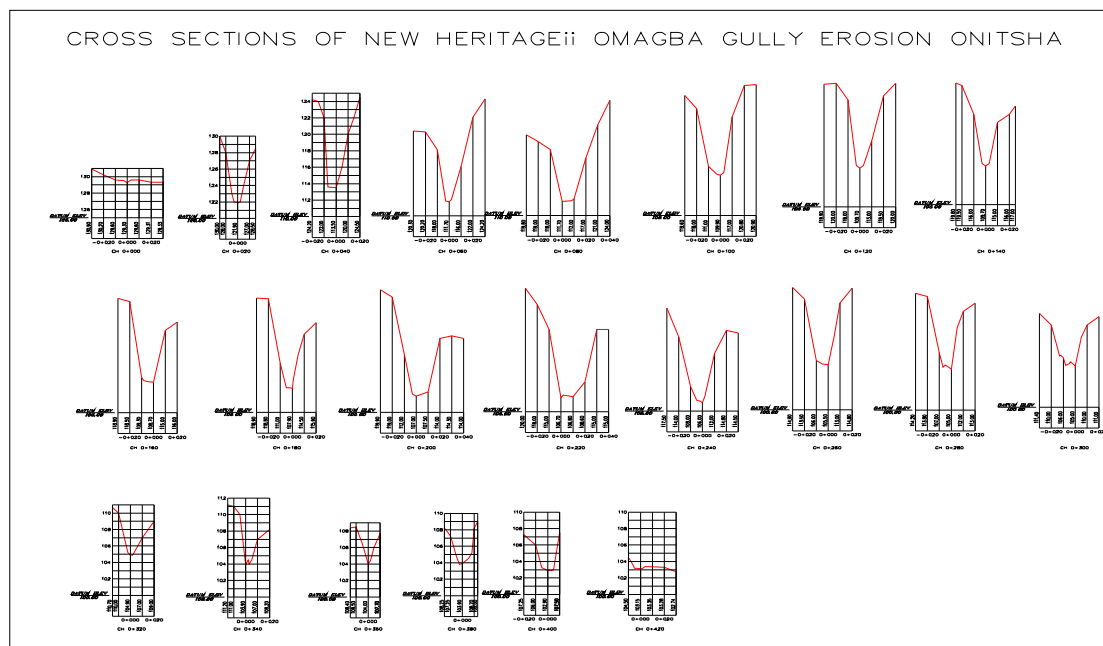
Figure 3 Cross-Sections of New Heritage II Omagba Gully Erosion Site

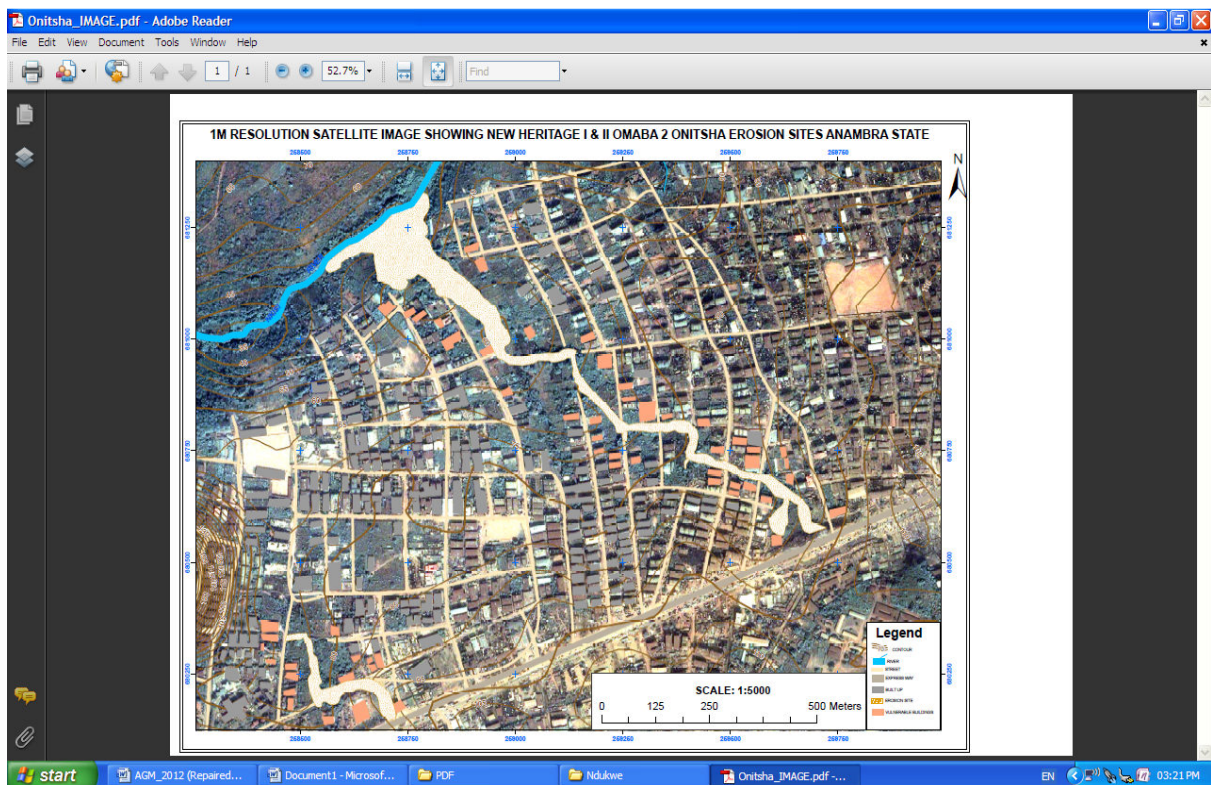
Fig.4 Image map showing in 1m resolution

The result of the processing are these maps showing the topographic details of the catchment areas of the two erosion sites (New Heritage I and II), at Omagba 2 Onitsha, for watershed analysis and engineering design. Figure 4 shows the image map with highlight on the two erosion sites and some details surrounding them. Figure 5 show the DTM of the erosion catchment formulated from TIN of ASTER-Dem values. It also shows the drainage pattern. Figure 6 shows the ajoint catchment map, while figure 7 is the topographic map of the study area showing the contours and the details including the two erosion sites.

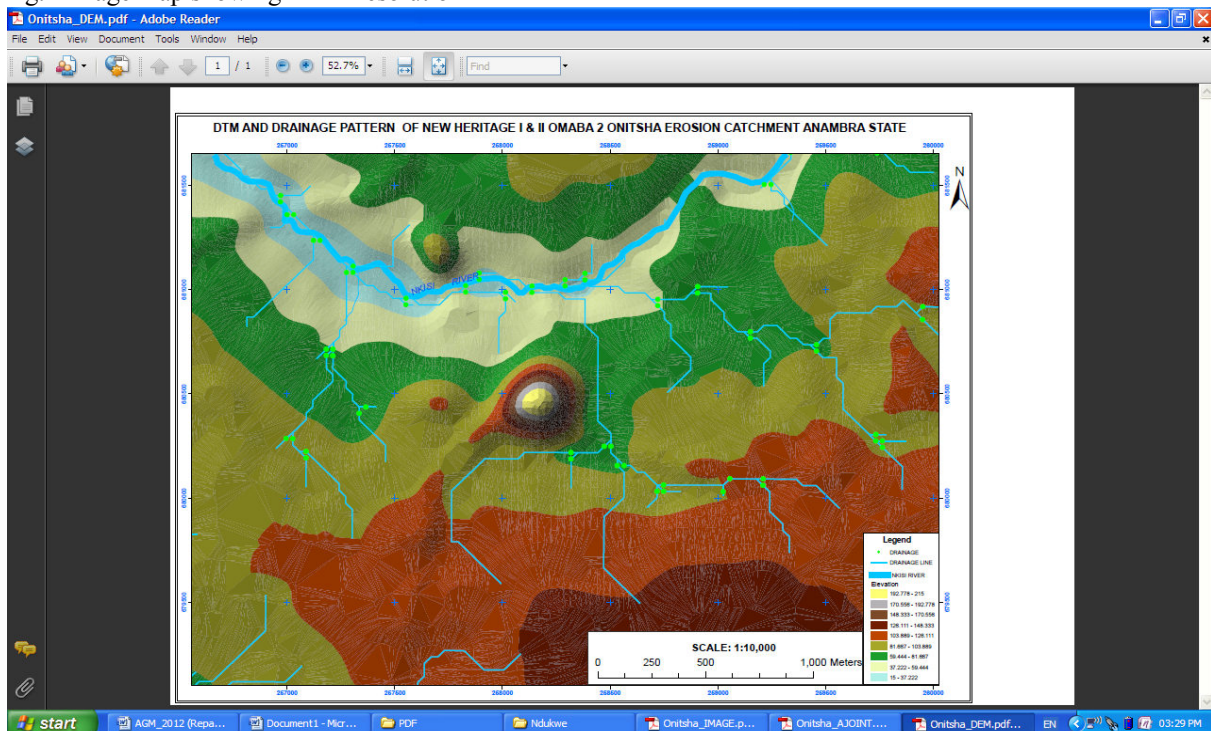
Figure 5. DTM and Drainage Pattern of the sites using TIN

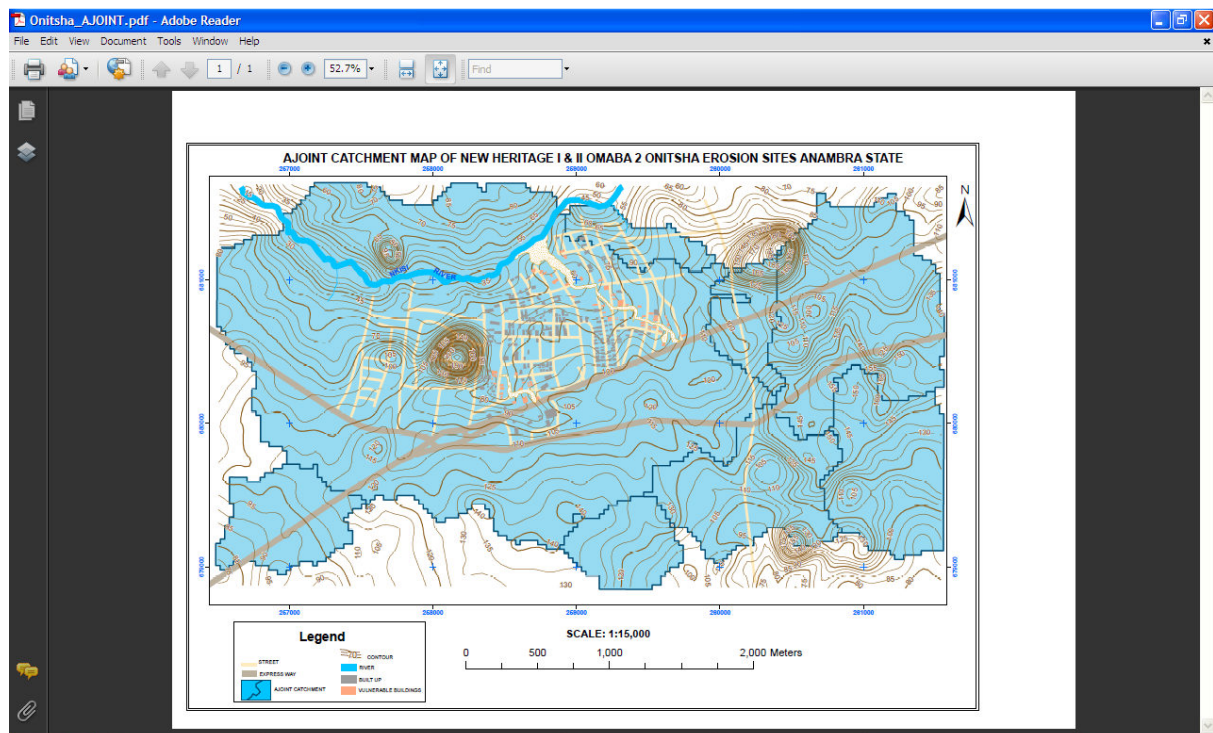
Figure 6 Ajoint Catchment map

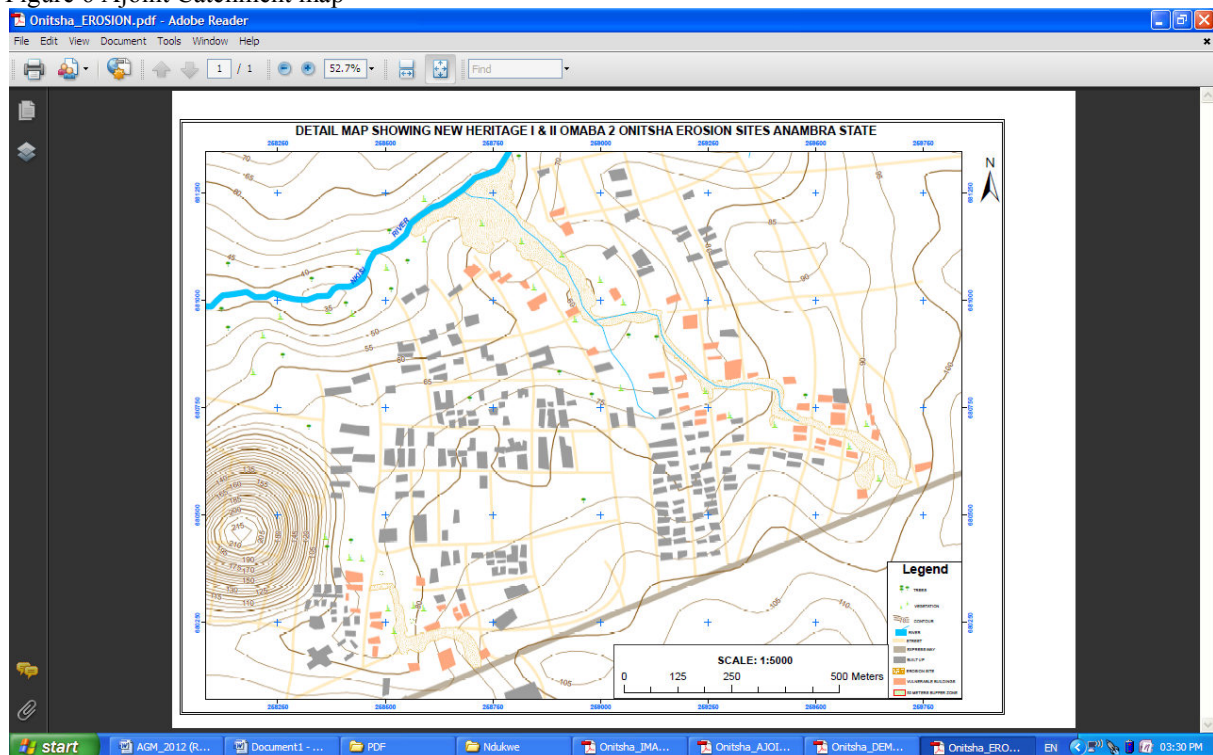
Figure 7 Topographical Map showing details

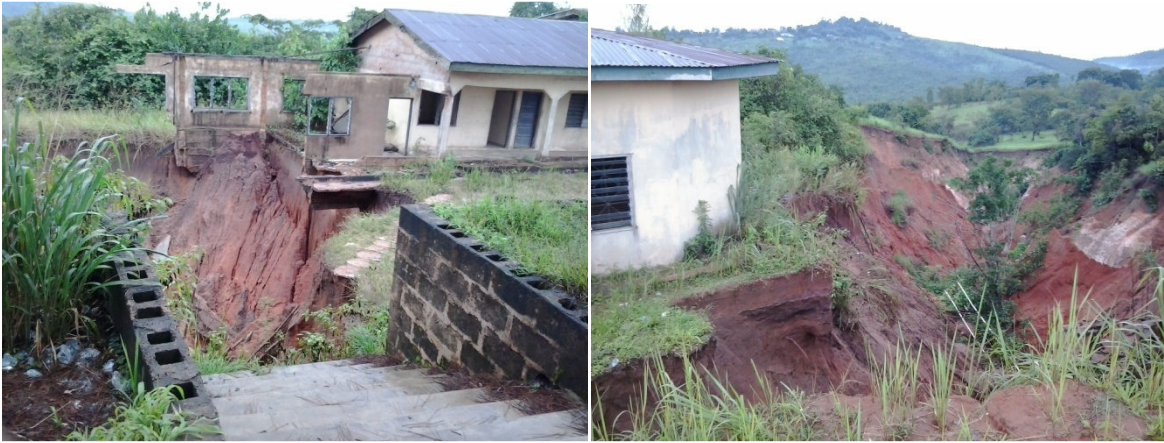
Figure 8. Omagba Gully site.
