An Appraisal of Gully Erosion along River Ngaddabul Floodplain, Maiduguri, Borno State, Nigeria

Abstract

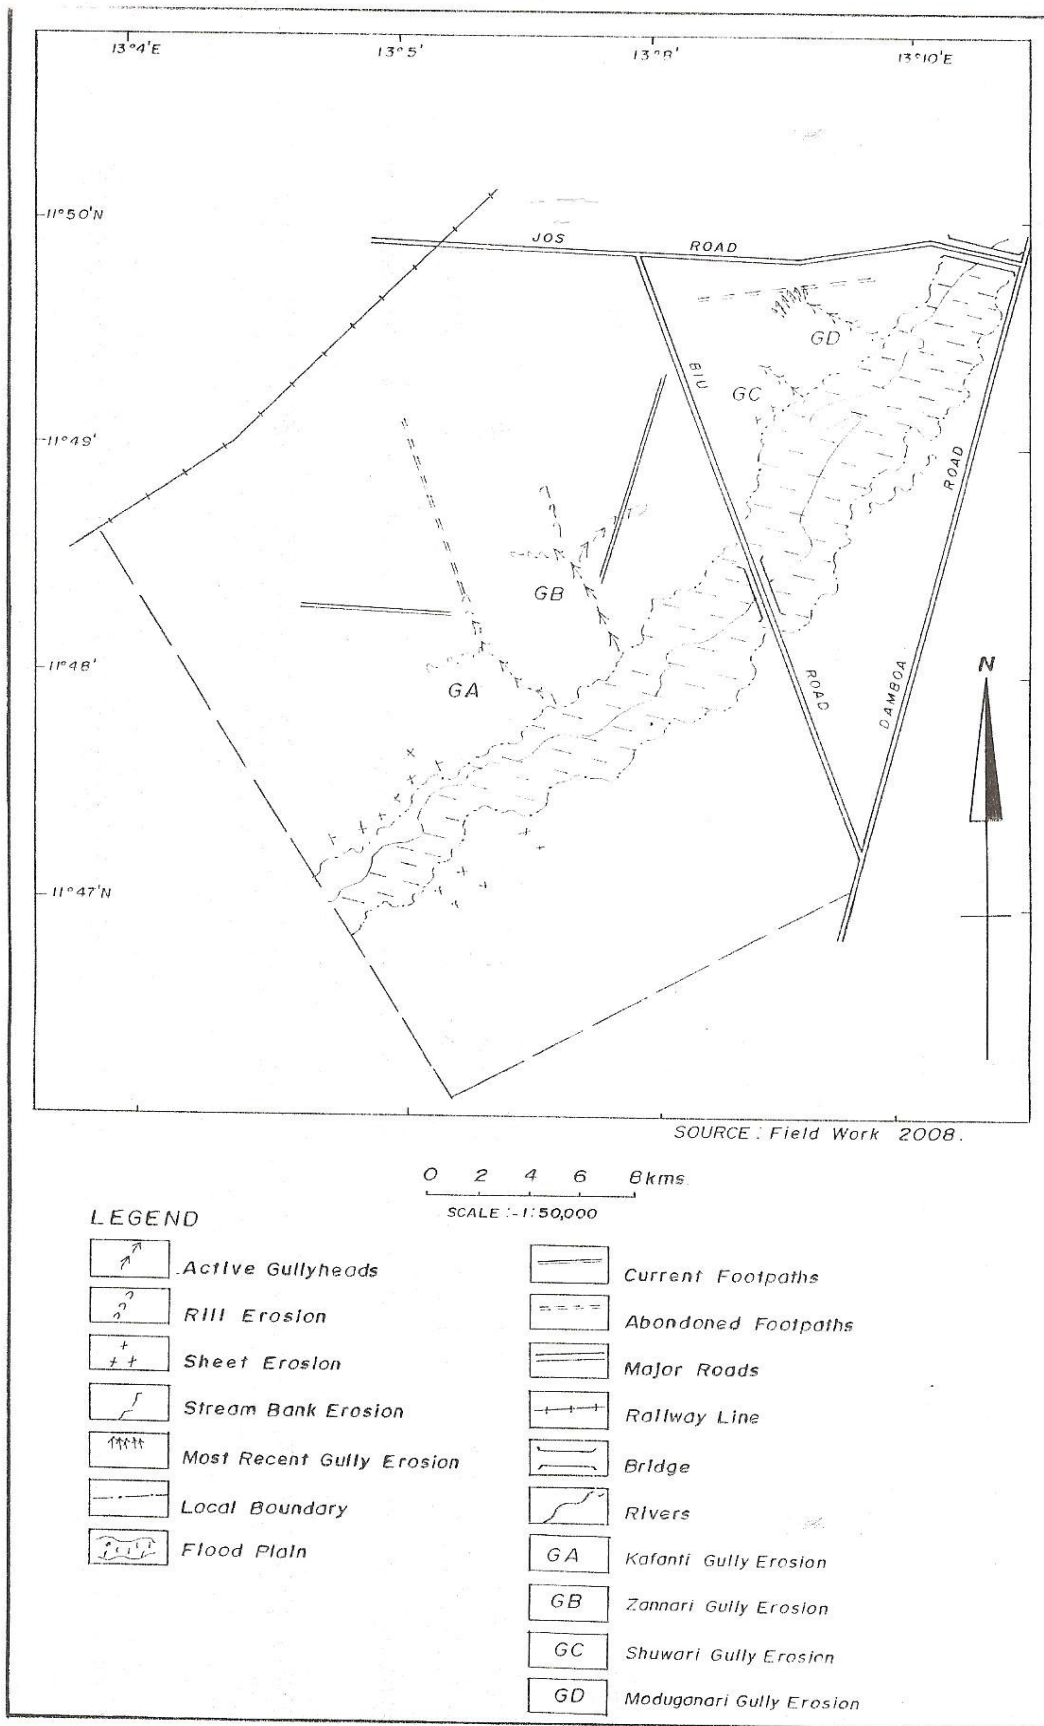
The gully above shows the main gully channel which served as the subsequent basin at Kafanti and Zannari areas, while the two other minor gullies connected to the main gully channel at the western side are the consequent basins which made the morphometric of the 2nd order gully.

Fig. 4.1 : GULLY STRUCTURE ALONG NGADDABUL RIVER FLOOD PLAIN.

The gullies were measured at two different periods. First they were measured and mapped before the onset of the rain in March and later another measurement was also taken after the peak rain in August. Four prominent gullies were identified. These are Kafanti, Zannari, Shuwari and Moduganari gullies respectively. From the results obtained by physical assessment of the prominent gully catchments, two types of the gully forms were identified. These are 1st order gullies as in Shuwari and Moduganari gullies and 2nd order gullies at Kafanti and Zannari gullies. The gullies at Kafanti and Zannari exhibited 2nd order gullies. The gullies here are incising in a gently sloping valley (Plate 4.1), with generally well – defined, somewhat irregular margins due to the existence of numerous small lateral head cuts. While, Shuwari and Moduganari gullies displayed remarkably 1st order gullies (Fig 4.1)

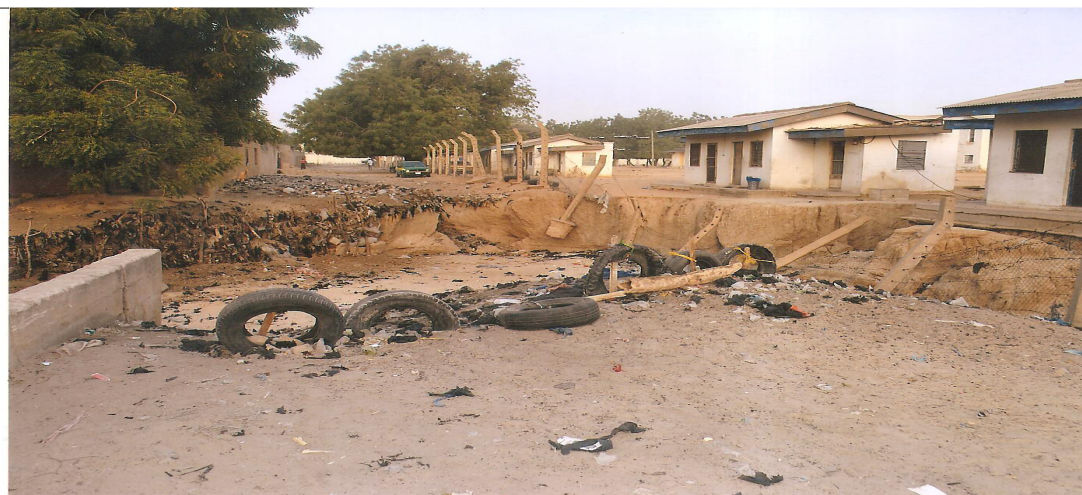
Plate 4.2: Cut off Road by Gully Erosion behind Mobile Police Barrack

The total annual rainfall for Maiduguri from 2003 – 2008 measures between 533 – 897mm. Greater percentage of the stated amount falls between May to September and at the onset of the rainy season, the scanty vegetal cover offer less protection to the soil. Rainstorm induces flash runoff leading to erosion. Cocheme and Fran quip (1967) opined that wherever mean annual rainfall exceeded 500mm, even in the Sahel zone where annual rainfall is low, considerable runoff can occur. When the runoff occurs in an area cleared of vegetation and exposed surfaces, as in most of the locations in the gully sites. Such intense storms can affect near surface mechanical eluviations, leading to the blocking of pores spaces, and reduction in infiltration rate. Hence, the gullies are formed by surface runoff from localized rainfall events of high intensity in the fine to coarse grained particles. The new extension of the gully channel has cuts off the footpath linking mobile police barracks and the police headquarters (plate 4.2).

Moreover, the rainfall intensity at the period of fieldwork (2008) also posed serious threat to buildings at the mobile police barracks and even some outside the barracks fence. The gullying processes had force some boy’s quarters to be abandoned. And many buildings outside the barracks fence were at the verge of collapsing into the channels.

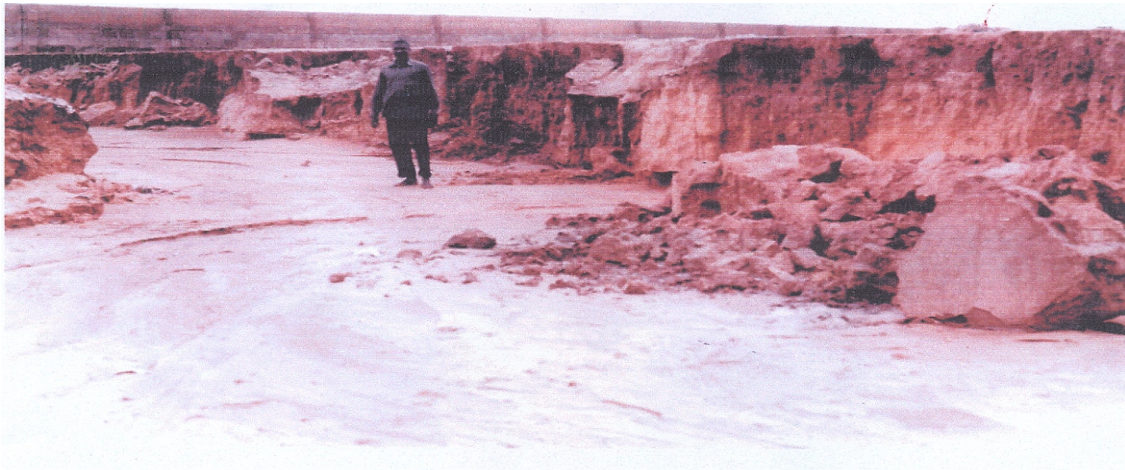
Plate 4.3: Gullying Process due to Sliding and Caving in Shuwari
