Impact of Erosion on Street Roads: A Case Study Of Sijuwade Area Akure Ondo State Nigeria

This research evaluates the impact of erosion and runoff on street roads. Reconnaissance survey was carried out to assist in the identification and accurate delimitation of the study area, out of which thirteen streets were selected. Factors responsible for erosion in the study area were observed to ranges from natural cause including topography, rainfall and soil nature. Human factor responsible for erosion in the area studied include land use pattern and waste disposal method, poor construction and maintenance activity. Effect of erosion on the studied area includes Rendering of road way non motorable through creation of gullies, Carving in (slope instability) on drains ditches that were not lined, Flooding of road ways during rain due to blockage of drains, Pollution of water bodies in the environment as a result of sediment deposition, Destruction of Pavement infrastructure i.e. pavement, culverts and drainages. It is therefore concludes that Erosion also have various effects on street roads not all factors assumed to be responsible for erosion form agricultural perspective is responsible

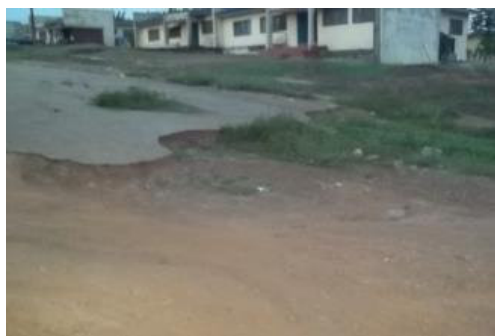
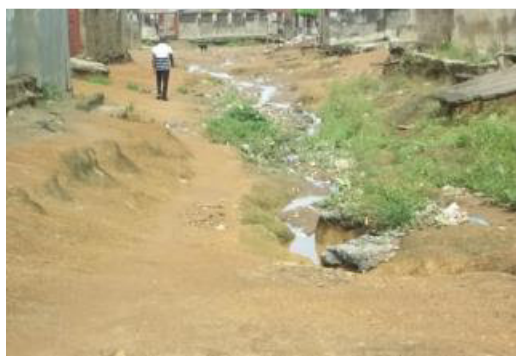
To an extent when rainfall water infiltrates into the existing soils that serve as the foundation for these unpaved street roads and when water input exceed the soil's capacity to absorb water runoff occur. Runoff when improperly channeled lead to erosion. On most of the unpaved roads studied there exist underlying impervious rock layers leading to formation of gully when the loose soil particles that overly these road has been remove. Such a scenario was observed on Yaba Street Idi-AgbaTitun as shown on plate 2.

Particularly, Erosion impact was found to be severe on Yaba Street at Idi AgbaTitun. Also, terrain where underlying impervious layers does not exist, craters were created making such road non motor able. A typical example of such was found at Ifelodun Streets as shown in Plate 3.

Plate 2a: An Eroded Surface of a Paved Road and Gully Erosion at Yaba Streets

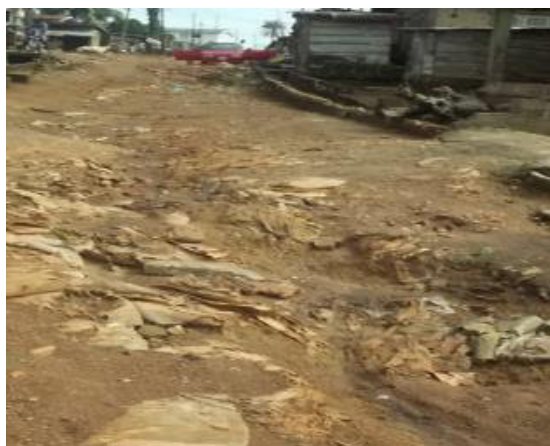
Plate 3: Erosion Problem at Ifelodun Street

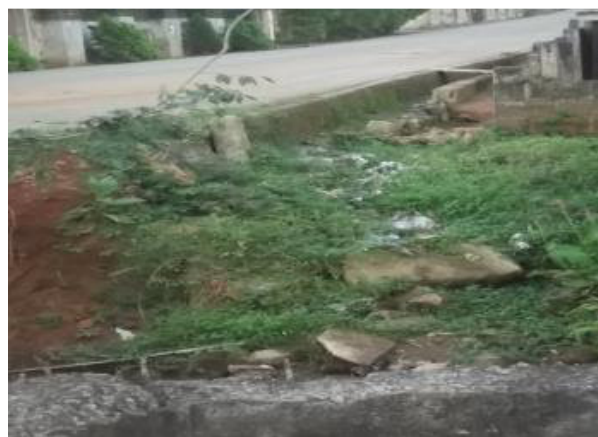
Land use pattern in the areas studied were observed to be terrible. Some of the buildings were observed to be constructed on waterway. Also the way refuses were dumped in the existing drainage limited the way in which drainage performs and when drainages which are expected to be conveying runoff from the road surfaces are obstructed it causes erosion. This often aids in the development of gully on roadway and sometimes flooding which affect both homes and pavement infrastructures as capture in plate 4.

Plate 4: A Typical Example of a Block Drain

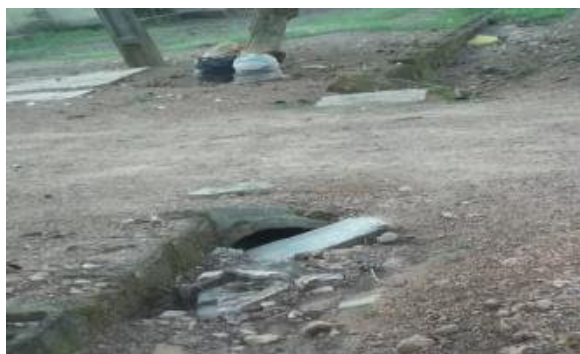
causes roadway flooding. Typical example of this can be found on New Sijuwade Street. In this case, uncontrolled run off and incessant disposal of wastes into the drainage channel often causes flooding when rainfall and this has also lead to carving in of the cross culvert that provide access to other parts of the streets. Typical example of poor maintenance practice was also found on Ala quarter where a damaged drainage was not repaired as shown in plate 5 and 6.

Plate 5: An Improperly Maintained Drainage at Ala Quarters

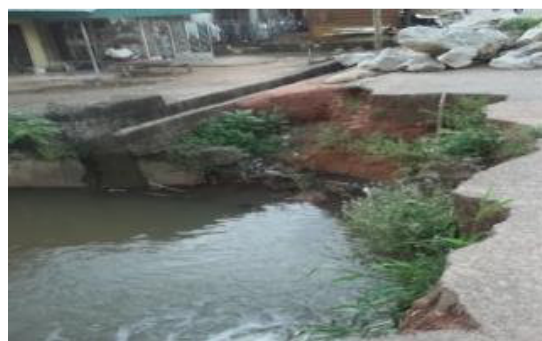
Plate 6: A Caved in Section of Sijuwade Street

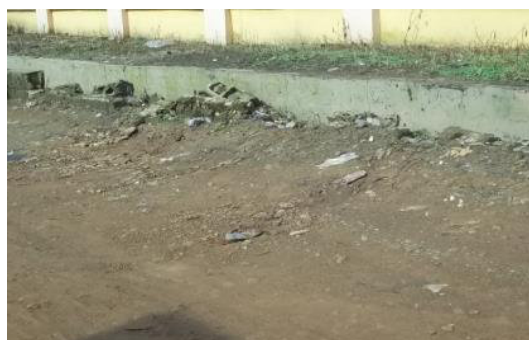
Also improper construction of drainages and culvert were also found to cause road erosion. Drain that was supposed to be constructed using concrete retaining wall at one side and block wall on the other were observed to be constructed using double block wall. Alternate drying and shrinkage of these block wall by rain lead to drying shrinkage and whenever these occur they tend to give way to erosion thereby causing runoff to flow on road surfaces. Typical example can be seen on Plate 7, in this case a double block wall.

Plate 7: A Badly damaged Drain at Dele Johnson Street Due to Improper Construction
