## Study on behaviour of corroded RC beams repaired in shear with NSM CFRP rods

**Abstract.** The near surface mounted reinforcement technique (NSM) is one of the promising techniques used nowadays. In the NSM technique, the Carbon Fibre Reinforced Polymer (CFRP) rods are placed inside pre-cut grooves and are bonded to the concrete with epoxy adhesive. Experimental results obtained on concrete short beams taken from one beam exposed to a natural corrosion for 25 years then repaired only in flexion or in flexion and shear are reported. Results were compared to control beams. One 6-mm-diameter NSM CFRP rod is used to repair the beams. The beams were tested statically in three-point bending up to failure. Results showed that the failure mode of all repaired RC beams in flexion was by shear failure after CFRP rods slip. But the failure mode of the corroded RC beams repaired in both flexion and shear occurred due to concrete crushing. An increase was noticed in the ultimate shear capacity of those repaired beams.

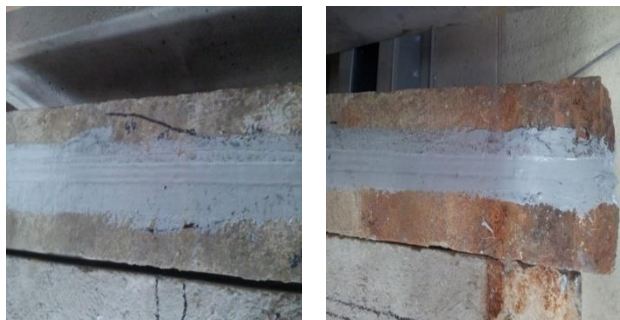
a. A1T Control.Beam                      b. A1CL3 Corroded. Beam

Fig. 3. Concrete surface after installing the CFRP rod.

between the concrete surface and the epoxy resin material. Figure 3 shows the final shape of the repaired beams after levelling the surface. After the two full span length for both beams A1CL3 and A1T were loaded up to failure, the four edges (A1CL3-SB, A1CL3-B, A1T-SB and A1T-B) in figure 4 were cut out of the full span for both beam A1CL3 and A1T.

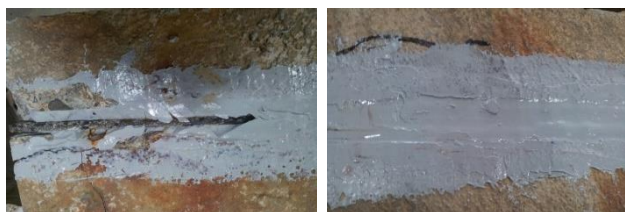
a. Before Re-repairing.                      b. After Re-Repairing.

Fig. 5. Re-repairing with NSM in bending.

The two edges (A1CL3-B and A1T-B) were re-repaired in bending only by removing the cracked areas of the epoxy resin material and install new material instead as shown in figure 5.

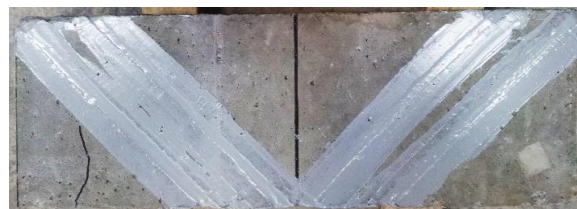
Fig. 6.a A1T-SB after repairing in shear.

The two edges (A1CL3-SB and A1T-SB) were re-repaired in bending and in shear using the configuration shown in figure 2. Four rods were installed on each side of each edge spaced with 10cm. The same procedure and technique followed for installing the rods shown in figure 4. Figures 6a, 6b present the two edges (A1T-SB and A1CL3-SB) after the repairing in shear.

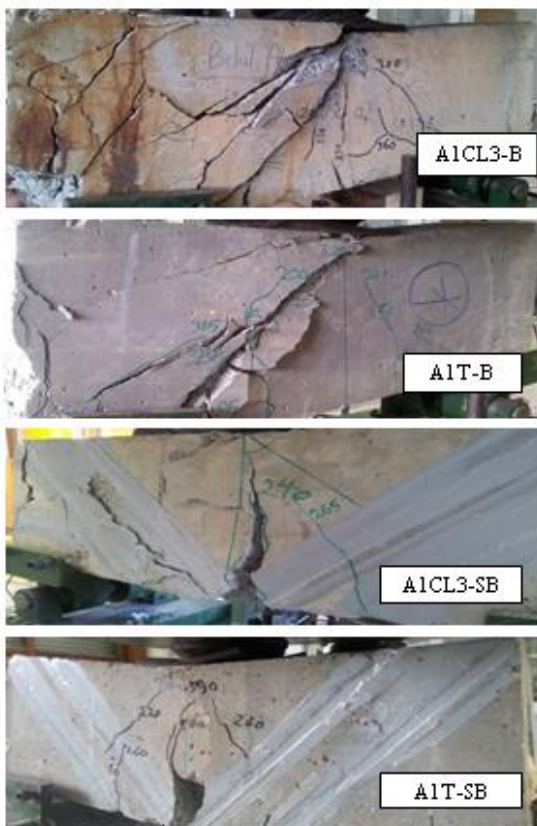
Fig. 12 Failure modes for four beams.

Non shear repaired beams A1T-B and A1CL3-B failed by diagonal tension failure. The shear repaired control and corroded beams A1T-SB and A1CL3-SB respectively failed by crushing of compressed concrete (figures 12, 13). The shear repaired control beam A1T-SB failed at 414.6 kN which was higher than the ultimate load capacity of non shear repaired control beam A1T-B which failed at 337.4 kN. The ultimate load capacities of shear repaired corroded beam A1CL3-SB and the non-repaired one A1CL3-B were close to each other (367.8 kN and 373.3 kN respectively) and higher than the ultimate load for of non shear repaired control beam A1T-B (337.4 kN). Figure 11 shows that the shear repaired beams A1T-SB and A1CL3-SB showed a higher rigidity than the non shear repaired beams A1T-B and A1CL3-B.
