# A round-robin project in Japan for the evaluation of nondestructive responses of natural flaws

This paper introduces the current status of a round-robin project aiming at gathering non-destructive data of natural flaws. The project, which was launched in 2009, prepared specimens containing artificial stress corrosion cracks and thermal fatigue cracks, and served the specimens to a round-robin test to gather non-destructive data. A total of 12 universities and research institutes have participated to the round-robin test. Some of the specimens are already destroyed to confirm the true profiles of the cracks, whereas others remain undestroyed. All the data are presented at a dedicated webpage, together with the results of the destructive tests, so that they are freely available for anybody.

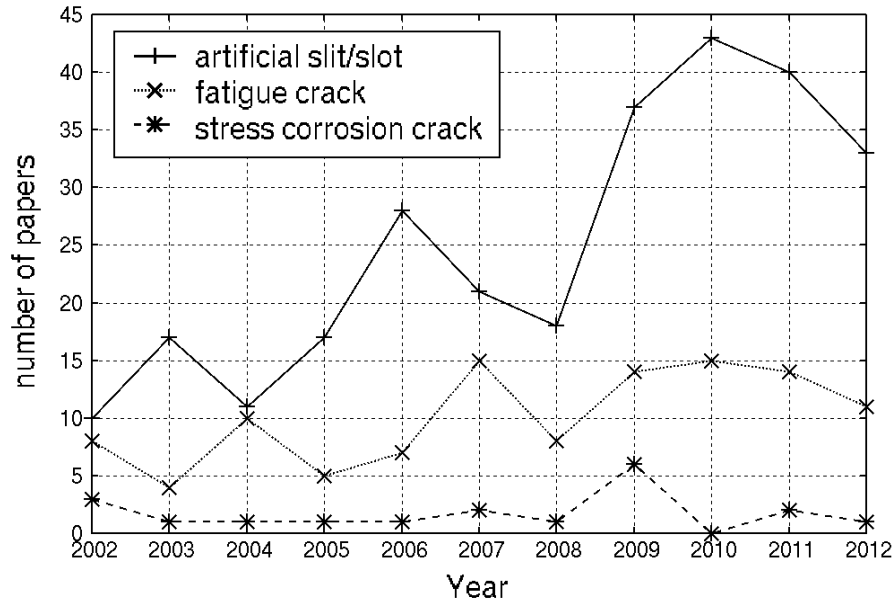
Figure 1. The number of papers dealing with artificial slit, fatigue cracks, or stress corrosion cracks. The increase in the number of papers stems mainly from the increase in the number of papers published in one of the journals.

Maintaining the safety of structures is one of the most important issues for the energy, environment and sustainable economy. The Periodic nondestructive testing and evaluation (NDT&E) is indispensable for assuring the safety of structures. Defects in important structures have to be detected in their early stage, and their effects on the integrity of the structures are needed to be evaluated in order to discuss the suitable maintenance activities. A large number of studies have been carried out for the R&D of techniques for the NDT&E of flaws and degradations appearing in nuclear power plants. One of important targets of the techniques is a crack such as fatigue and stress corrosion cracks because of its serious effect on structural integrity. However, most studies have a common problem. That is, they often use artificial slits for their validations, although the responses of an artificial slit to non-destructive testing are not always similar to that of an actual crack. Figure 1 presents the results of a survey counting the number of studies dealing with artificial slits, fatigue cracks, or stress corrosion cracks for the development of nondestructive testing and evaluation methods. The survey targeted studies published in three international journals whose scope is nondestructive testing and evaluation, that is, NDT&E International, Journal of Nondestructive Evaluation, and Nondestructive Testing and Evaluation. A glance at the figure confirms that most studies use artificial slits for evaluating or demonstrating their methods.

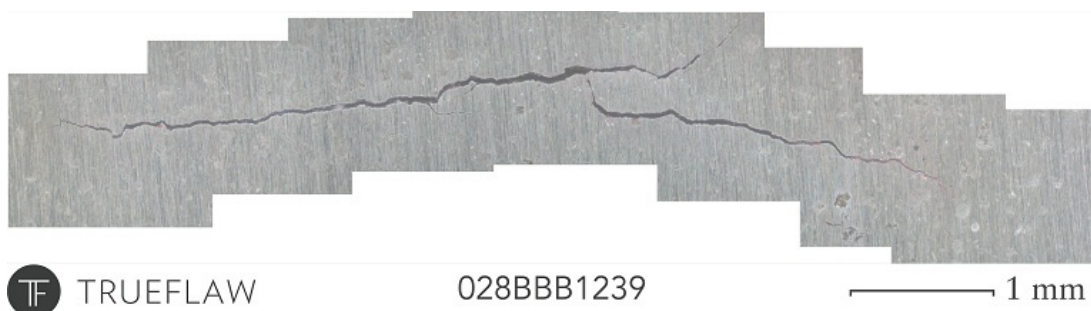
Figure 2. Microscopic photograph of the surface opening of one of the thermal fatigues offered to the project. Pictures with a higher resolution are available at the webpage

Three type 304 austenitic stainless steel specimens containing total of nine thermal fatigue cracks, which are listed in Table 2, were offered to the project in 2011. The thermal fatigue cracks were artificially introduced by cyclic thermal loading due to induction heating and water cooling. No initial crack was used to introduce the thermal fatigue cracks. All the specimens have been destroyed and the profiles of the thermal fatigue cracks
