Experimental Studies on Reinforced Hollow-Block Concrete Sections

Falah M. Wegian¹⁾ and Falah A. Almottiri²⁾

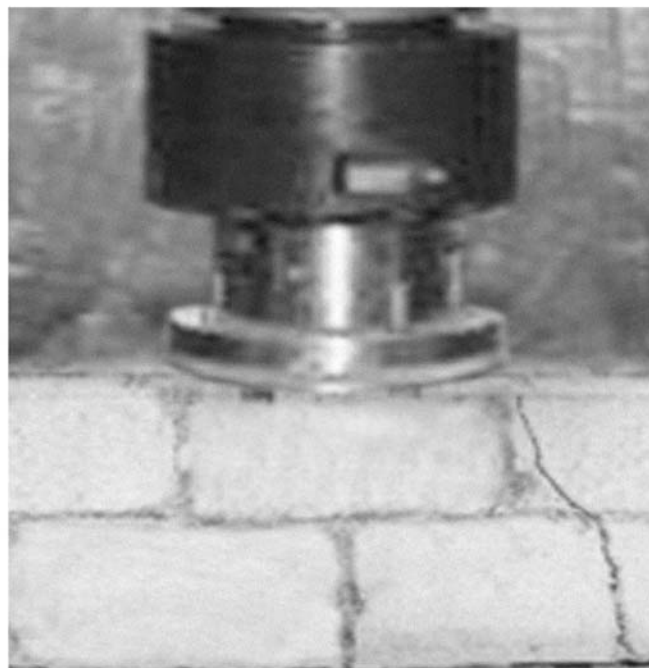
Figure (3): Shear Failure for Beam Tests.

After the initial fracture, the cracks for both groups (small and long beams) opened relatively rapidly. In all cases of the beams failing in shear, the complete collapse of the specimens was prevented due to the dowel action of the reinforcing bars, as shown in Fig. (3).
