Flexural Ductility Behavior of Strengthened Reinforced Concrete Beams Using Steel and CFRP Plates

ABSTRACT

Test Program

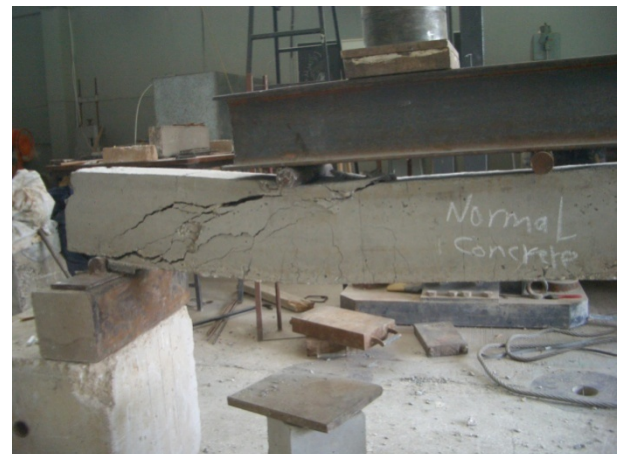
Control Beam: The behavior of the control beam under loading was typical of a beam subjected to flexural stresses, failure load was at 145 kN. Crack pattern showed that uniformly spaced cracks were formed in the bending region which formed concrete blocks connected by the dowel action of the bottom

steel, at the point of maximum diagonal shear cracks the mid-span strain at the compression side was 0.00121 and at the tension side it was 0.0148. Maximum deflection at mid-span was 10.9 mm.

**Figure 3: Failure of the control beam**

Strain values of the control beam are shown in Table 2, the failure mode is shown in Fig.3 and the strain distribution over the cross-section is plotted for the 50kN, 100kN and failure loads as shown in Fig.4. The ductility value for the control beam is 7.35.

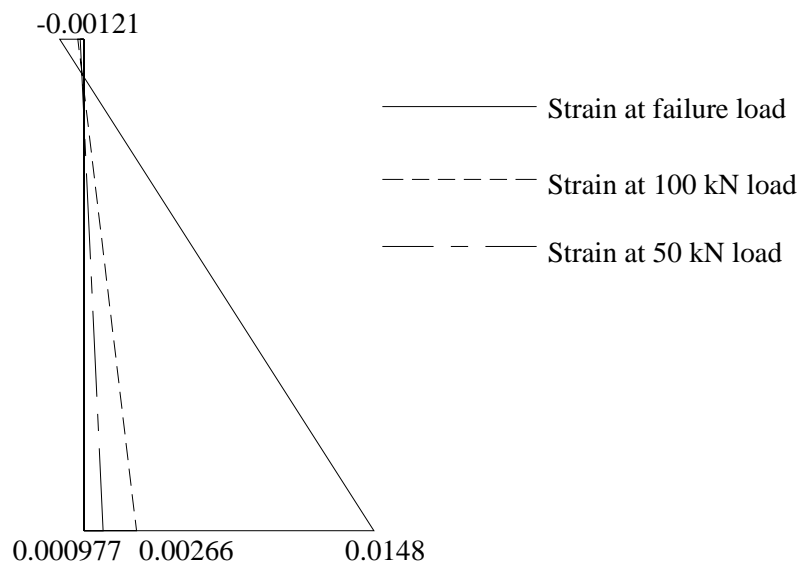
Figure 4: Strain distribution for the control beam

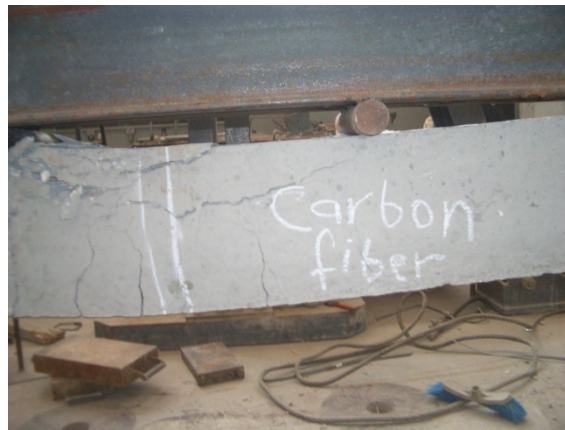
Beams Retrofitted with CFRP Plates: Failure was typical of a brittle compression failure, debonding at the cracked region followed by crushing of the concrete at the top. The maximum load reached at failure was 190 kN, the mid-span strain at the compression side was 0.0028, while the strain at the tension side at failure load was 0.0064. Maximum deflection at mid-span was 13mm. Average of the beams' experimental data for this group is shown in Table 3, failure mode is

Figure 5: Failure mode of beam retrofitted with CFRP plates

shown in Fig. 5, and the strain distribution over the cross-section is plotted for the 50kN, 100kN and failure loads as shown in Fig.6. The ductility value for this group of beams is 3.2, where we notice a drop in ductility for this group of beams.

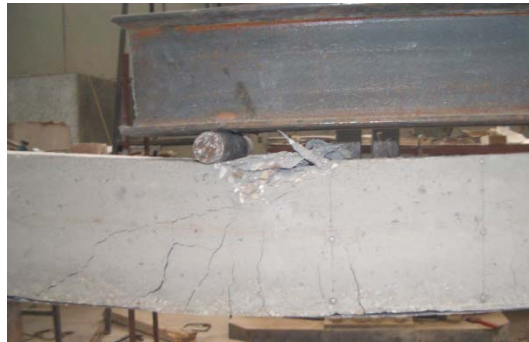
Beams Retrofitted with HSGS Plates: Failure was an excellent example of balanced failure. The maximum load reached at failure was 192kN, the mid-

span strain at the compression side was 0.0022, while the strain at the tension side at failure load was 0.0257 and maximum deflection at mid-span was 10.82 mm (Table 4). Failure mode is shown in Fig. 7, and the strain distribution over the cross-section is plotted for the 50kN, 100kN and failure loads as shown in Fig.8. The ductility value for this group of beams is 12.85, where we notice an increase in ductility for this group.

Figure 7: Failure mode of beam retrofitted with HSGS plates

Ductility of a member is defined as its ability to sustain inelastic deformations prior to failure without substantial loss of strength. A ductile system displays sufficient warning before catastrophic failure. Looking at Fig. 7, it is obvious that the beams retrofitted with HSGS plates showed the highest deformation before collapse, the second would be the beams retrofitted with NSS plates, the un-retrofitted beam comes third
