Key aspects in 2D and 3D modeling for stability assessment of a high rock slope / Giovanni Barla; Francesco Antolini; Marco Barla; Andrea Perino. - STAMPA. - (2013), pp. 15-18. ((Intervento presentato al convegno Workshops 2013 - Failure predictions in geotechnics tenutosi a Salzburg, Austria nel 9/10/2013.

Workshop "Failure Prediction in Geotechnics"

Key Aspects in 2D and 3D Modeling for the Stability Assessment of a High Rock Slope

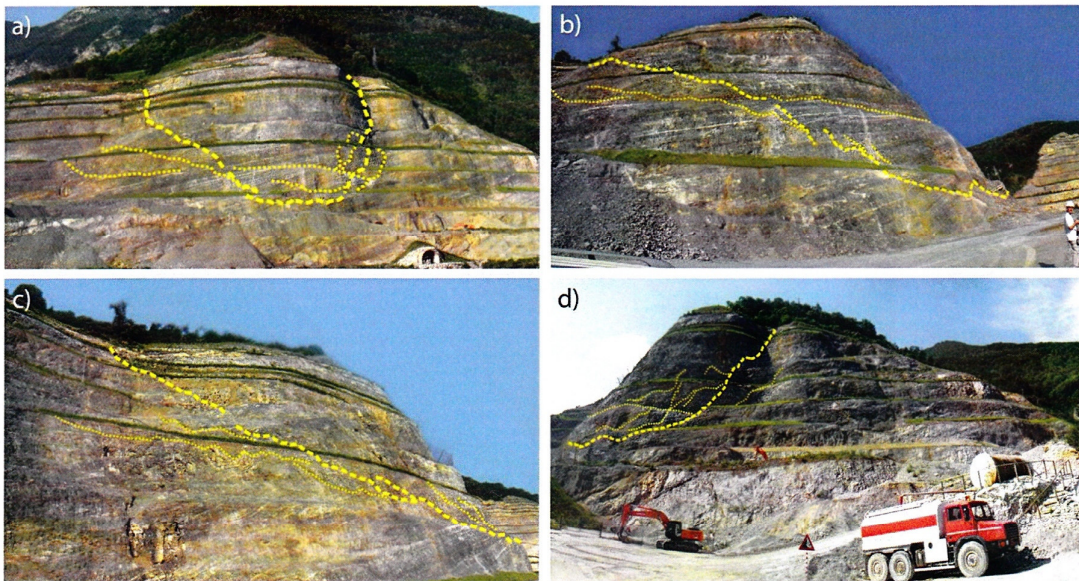
Figure 1: A view of the rock slope with the rock volume in limit equilibrium conditions as observed in the front a) and laterally b), c), d).

This presentation is intended to describe the rock mechanics and rock engineering studies carried out for the stability assessment of a 120 m high rock slope in a limestone quarry in the Piedmont Region (Italy). The rock slope is characterised by the presence of a 340,000 m³ estimated rock volume (Figure 1), standing in limit equilibrium conditions, which impairs quarrying activities below the berm elevation reached. Following an outline of the case study, the in situ investigations carried out, including detailed geological mapping, 3D imaging with a laser scanning equipment and infrared thermo-graphic methods will be described. Then, the results of real-time monitoring of the rock face by using a Ground-Based Synthetic Aperture Radar (GBInSAR) will be presented. Three dimensional continuum and discontinuum modeling involving a back analysis of a plane sliding instability at the toe of the slope and detailed slope stability studies of the rock volume, aimed at the definition of the likely instability scenarios, will be described. Finally, the actions envisaged in order to continue with the quarrying activities at the site will be discussed.

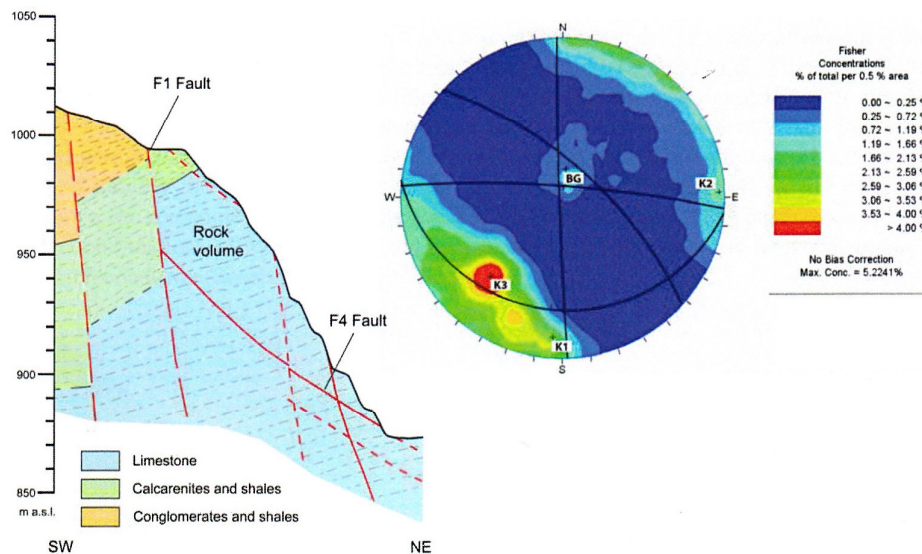
Figure 3: Schematic SW-NE cross section of the slope with a stereographic plot showing the bedding (BG) and joint sets (K1, K2, K3) in limestone.

A SW-NE cross section taken nearly orthogonal to the slope face is shown in Figure 3. The limestone rock mass is of fair quality with the Geological Strength Index (GSI) estimated to be in the range 50-60. The intact rock uniaxial compressive strength is equal to 50-60 MPa for limestone and 15-20 MPa for brecciated limestone which is present along the main fault F4, which nearly isolates the rock volume of interest. The bedding (BG) and three joint sets (K1, K2, K3) characterise the limestone rock mass.

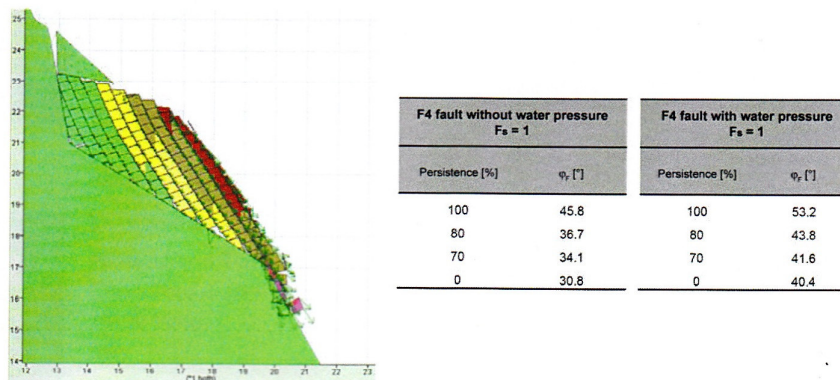
Figure 5: 2D discontinuum modelling of the toe instability (Zone B in Figure 4) and combination of friction angle and persistence values along the fault leading to a limit equilibrium condition.

With the above in mind, 2D and 3D continuum and discontinuum modeling were carried out with the dual purpose to assess the stability conditions of the rock volume of interest and to develop possible instability scenarios in view of the future quarrying activities. A special attention was devoted first to the assessment of the strength and deformability characteristics along the sliding surface (typically fault F4), including its continuity and possible existence of rock bridges along it. This was possible through a back analysis of the plane sliding instability occurred at the toe of the slope (Zone B in Figure 4). A 2D discrete element simulation with a friction angle along the joints equal to 35.7° associated to 80% persistence is illustrated in Figure 5. The combinations of friction angle and persistence values along the F4 fault which may lead to a limit equilibrium condition (instability) are also shown.
