LIDAR DATA ANALYSES FOR ASSESSING THE CONSERVATION STATUS OF THE SO-CALLED BATHS-CHURCH IN HIERAPOLIS OF PHRYGIA (TR)

C. Marson¹, G. Sammartano², A. Spanò^{2*}, M.R. Valluzzi³

KEY WORDS: LiDAR Data, 3D models, feature detection, structural assessment, damages, decay, cracks detection

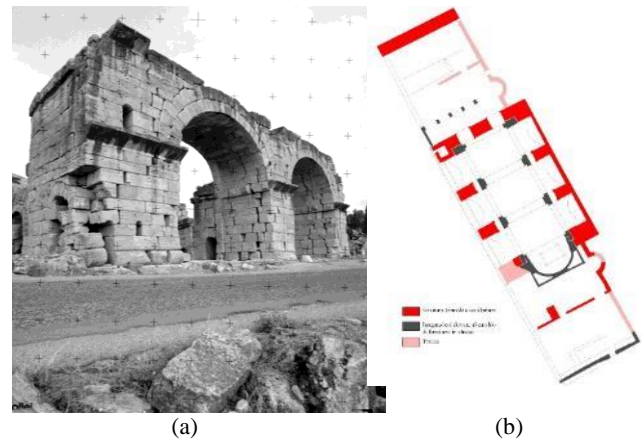
Figure 1. (a) An archive photograph of the west front (acquired in 1997 – Politecnico di Torino) b) Schematic representation of roman public building (red) turning into the Byzantine church (added structures in grey).

The so-called Baths-Church in Hierapolis of Phrygia (figure 1a) are the results of many construction phases, starting from the

- the system of the western two arcades, supported by first phase pillars, second phase pillars, and the first level (5 metres high) of the northern façade (Figure 1a);
- the eastern structural system composed by one-barrel double rings vault, first and second phase pillars and the perimeter eastern wall (that includes part of the main vault);
- the northern freestanding wall.

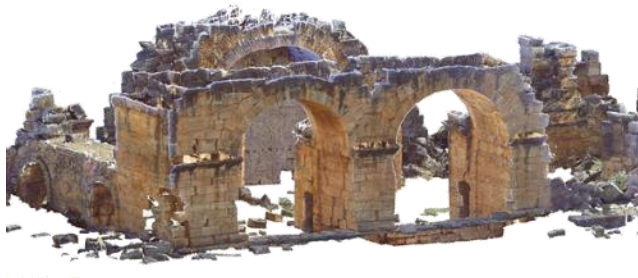
Figure 2. (a) Two general view of the overall LIDAR points cloud (b) the eastern structural system including one-barrel double rings vault, and first and second-phase pillars in some points cloud views; (c) the dimensioned architectural plan of the building. (Invernizzi, Spanò, Alferi, 2014)

Today, compared to the original configuration of the complex, the building is subdivided by three main structural parts, quite well conserved (Figure 2a):

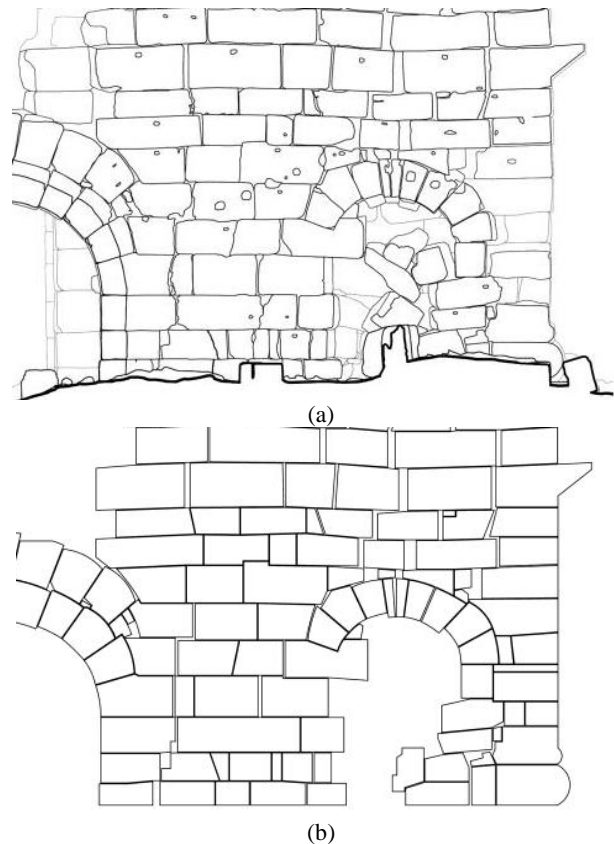
Figure 6. Different level of detail in (a) vectorialization of masonry blocks and in (b) discretized geometry for the structural analyses.

been based on FEM method and the metric survey drawings realized using LiDAR technology were the starting point for the definition of the discretized geometry necessary for the execution of the structural analyses.

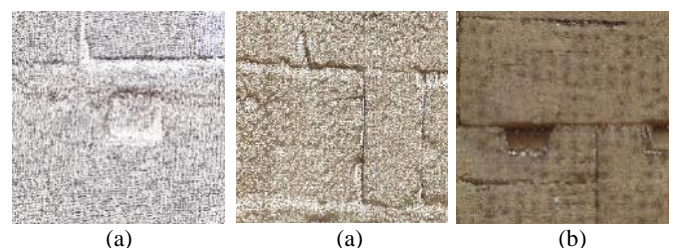
Figure 7. Digitalization of the LiDAR point cloud orthoprojection, with different rasterization resolution (*PointCab* interface): 1 mm/px 970Mb; 5mm/px, 1.3Mb; 1cm/px, 2.29Mb

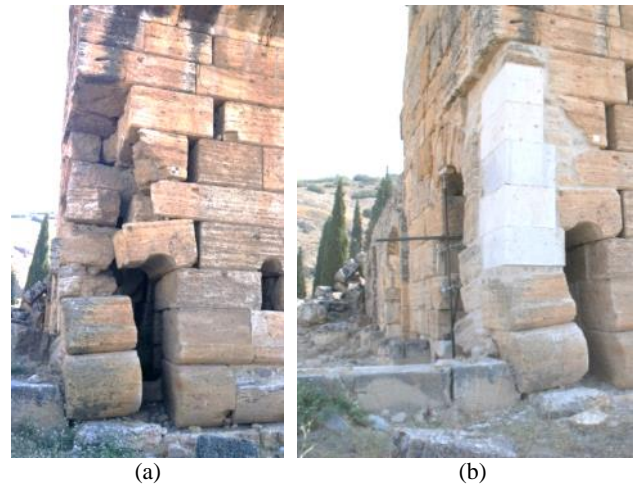
Figure 12. (a) lacks of blocks at the north-western corner and (b) more recent integration of blocks.

The interpretation of the causes that led to the current configuration cannot disregard the analysis of the construction techniques applied. The Baths-Church are composed by a system of interlocked travertine blocks. The extended overlapping, possible thanks to the great dimensions of blocks, allows the structure maintaining equilibrium also in critical condition, such as widespread lacks (Figure 12) or considerable sliding between blocks. Obviously, when a block does not have a continuous supporting surface and the force exceeds its strength, a crack develops and the system could become unstable. Figure 12 (a) represents first condition, not evolved in collapse thanks to the integration of corner blocks Figure 12 (b).

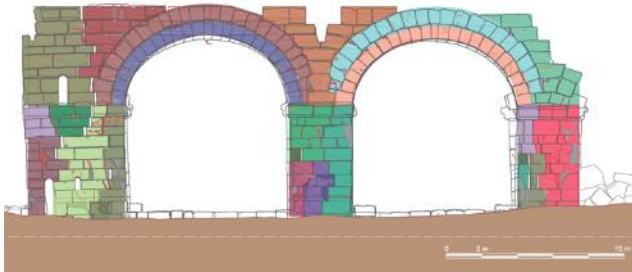
Figure 14. Identification of kinematic portion.

The integration of the evaluation of the conservation state, the crack pattern and the failure mechanisms allow for identifying kinematic portions for structural assessments of seismic vulnerability to be implemented in the calculation codes. For the façade in question, they are plotted in Figure 14. The portions are composed by elements involved in the same structural behaviour.
