# Remediation of Hydrocarbon Contamination in Downtown Mandan, North Dakota

Characterization, Assessment, Planning, and Design

University of North Dakota Geological Engineering

3 May, 2012

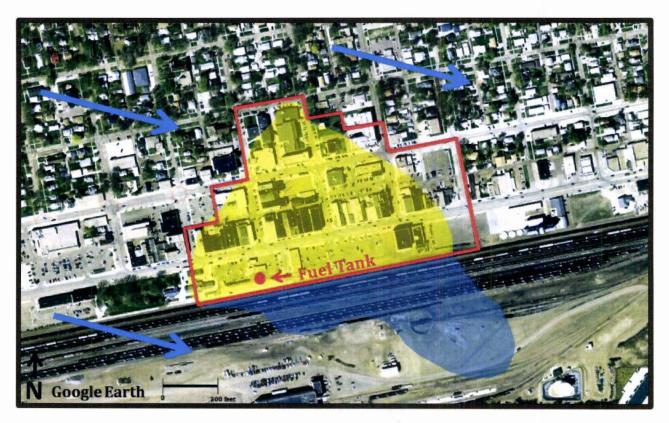
Figure 2 - Delineated Plume in Downtown Mandan

Yellow denotes the contaminated area that BNSF is responsible for remediating Dark Blue denotes the contaminated area under the BNSF property that is not required to be remediated Light Blue denotes general groundwater flow direction
