University of Minnesota Morris Historic Preservation Plan: A Plan for Landscape & Buildings

Historic Preservation Plan

A plan for landscape & buildings

Prepared by the
University of Minnesota Morris
Historic Preservation Planning Team
May 2005

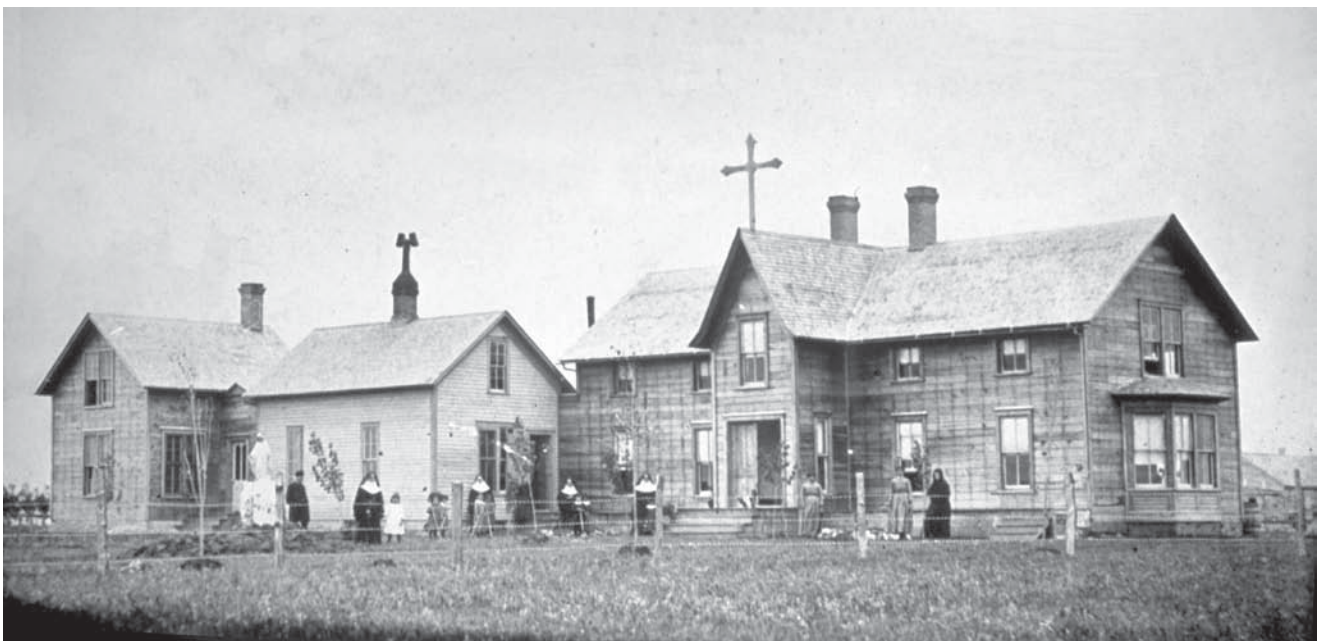
ca. 1888, MHS

The earliest known photo of the campus and staff, circa 1888. Note the unpainted buildings, barbed-wire livestock fencing, religious statue, and newly-planted trees. Judging by the size of their large leaves relative to the very thin branches, the trees are probably native cottonwoods.

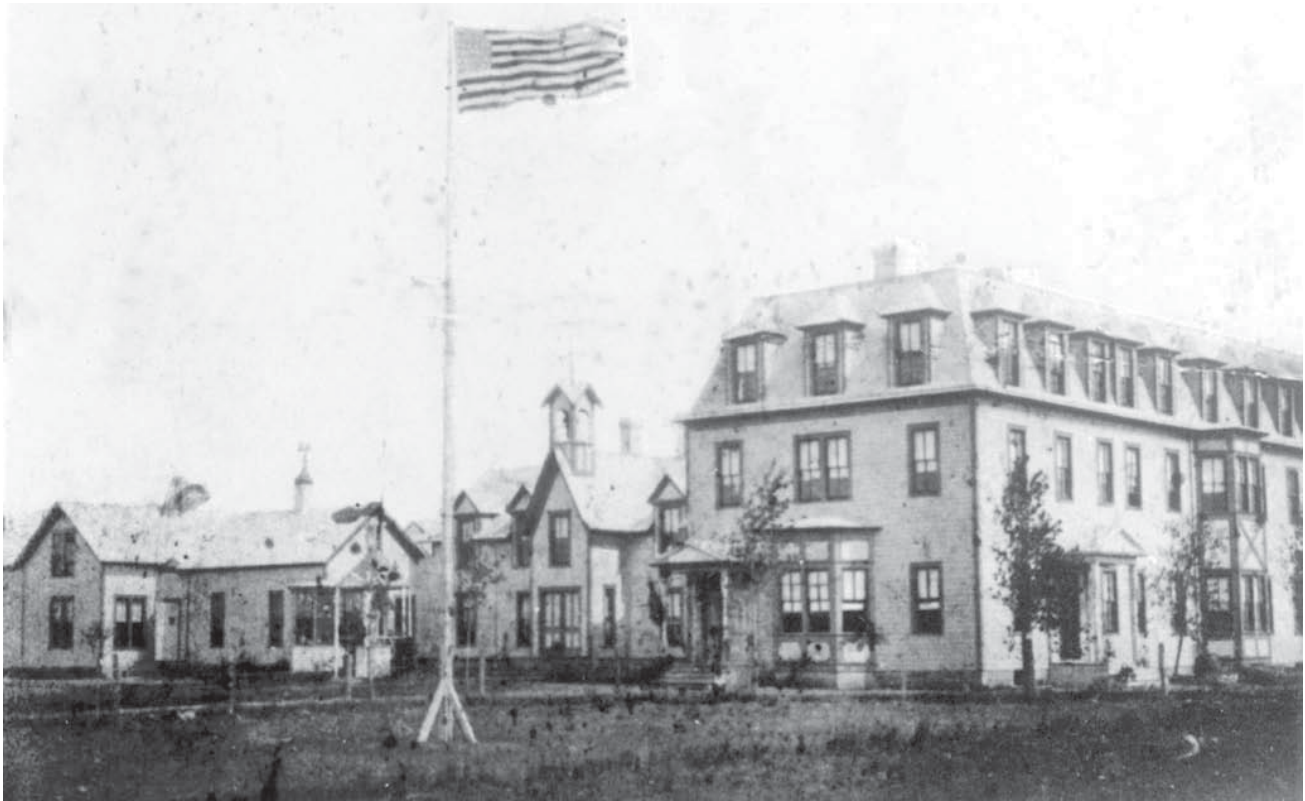
1896, SCHS

The campus in 1896. The largest building, the Mansard-roofed dining hall and dormitory, was used by the WCSA for the same purpose and razed in 1918.

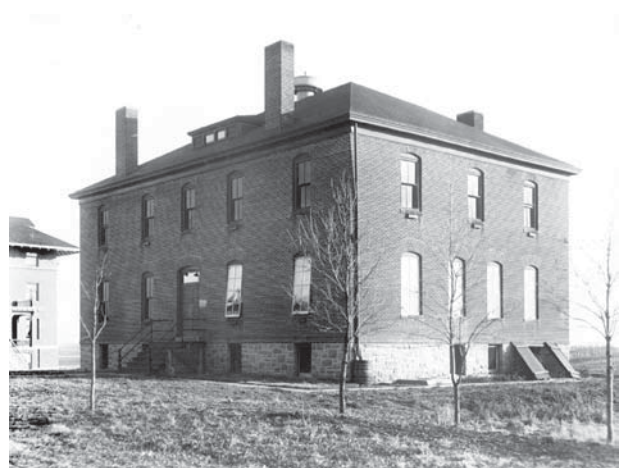
ca. 1914, University Archives, U of M

The present-day Multi-Ethnic Resource Center was built in 1899 as the Morris Indian School boys’ dormitory. The front porch was added by the WCSA in 1921, several years after this photo was taken.

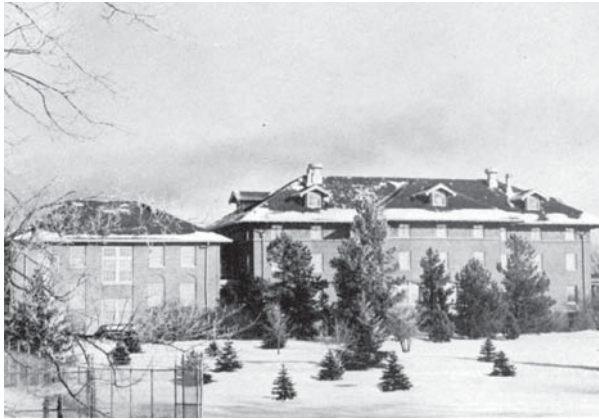
ca. 1955, WCMHRC

Spruce grouping behind Spooner Hall, mid-1950s. Note larger trees nearer the building and newer plantings on the hillside in the foreground spaced for future growth.

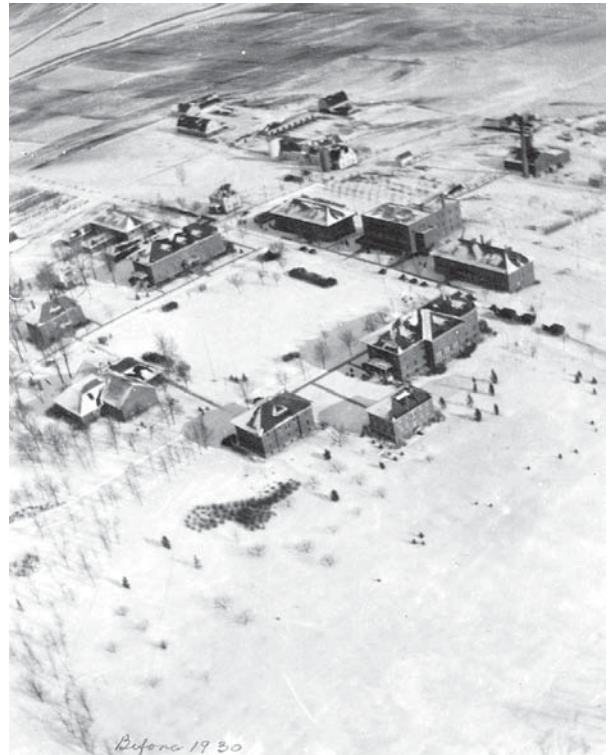
ca. 1925, UMM

The earliest known campus aerial view.

The importance of windbreaks for the campus is most evident when two winter aerial views, at right, from circa 1925 and 1957 are compared. In the first view, although most of the 1911 campus plan is built-out, the south hillside by Miller Field and the open area to the north of Community Services are largely bereft of trees.

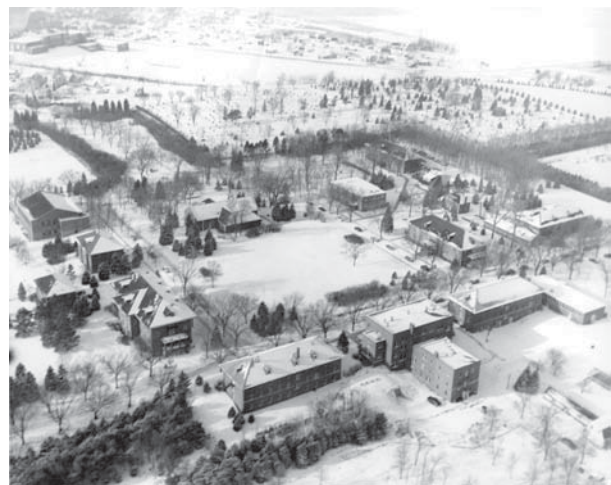
1957, SCHS

Winter view from the 1950s looking northwest.

By the mid-fifties, as the North Windbreak reached maturity, there was a remarkable enclosure and continuity to the campus edge. Windbreaks were both dense and thick in solidly framing the campus to the north and west. To the southeast near the present dorm area (lower left in 1957 photo), a large grove anchors the hillside.

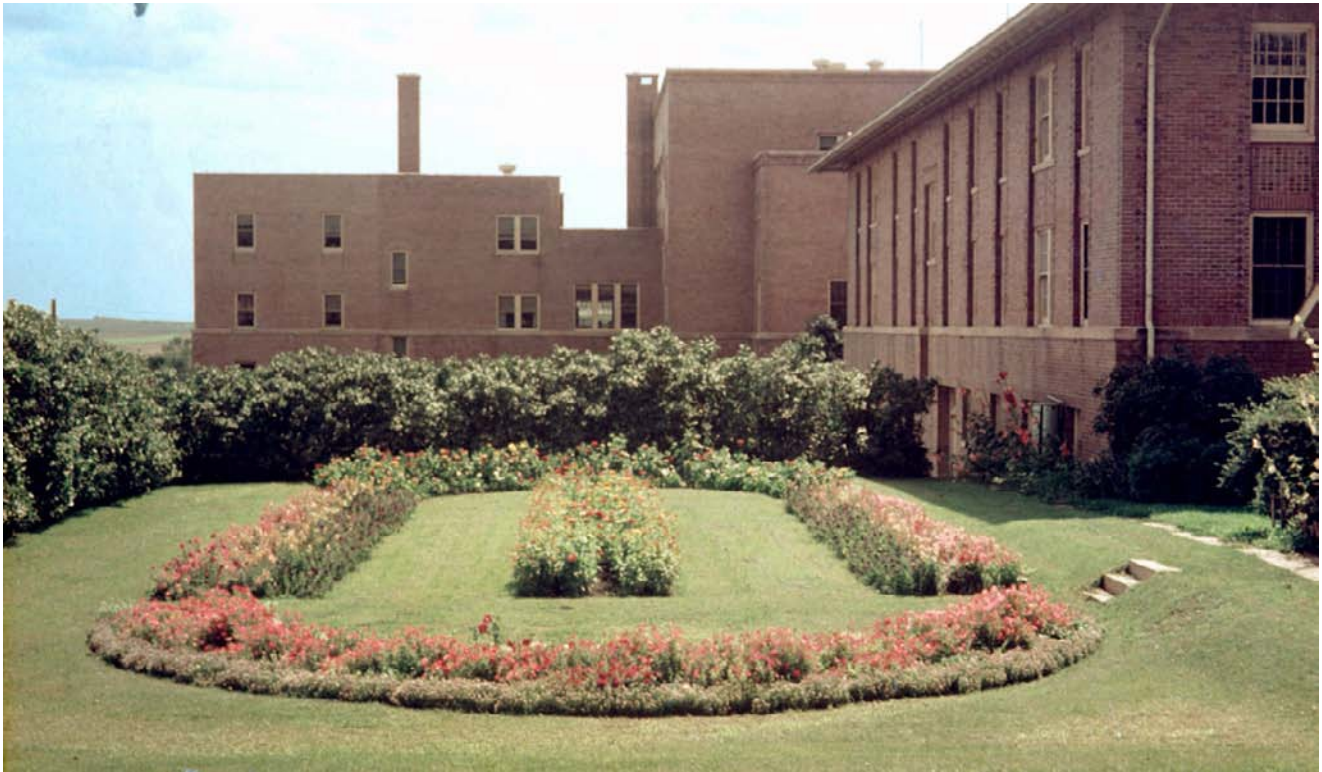
ca. 1948, WCMHRC

Garden terrace behind present-day Social Science created by the WCSA. The annual parterre blends linearity with symmetrically curving end beds. Enclosed and protected from the winds, this lost garden is a microcosm of the larger windbreak structure of the campus. One of the most significant expressions of Morell & Nichols' design is their use of grading. As in their work at Morgan Park in Duluth and in several estates, the firm often employed 3:1 slopes to accommodate grade changes ranging from three to fifteen feet. At the relatively level Morris site, only small slopes were necessary. At both this former garden and the Pine Hall Glen, the grading created consistent and linear slopes in lieu of retaining walls. Where possible, future grade changes should be accommodated in this manner.

The design principles of terracing and enclosure continue inside the campus at the garden scale. Though most likely not envisioned by Morell & Nichols, the ornamental garden behind present-day Social Science (shown above) extends their vision for the enclosure of windbreaks and the introduction of symmetrical curves in roads to complement perpendicular lanes. Here, the curving garden beds themselves contrast with the enclosing linearity of the lilac hedge and building walls. Curving yet symmetrical patterns on the flat ground plane accentuate the garden's smoothness as a quiet room into which one descends on a 3:1 slope carved with three concrete steps.

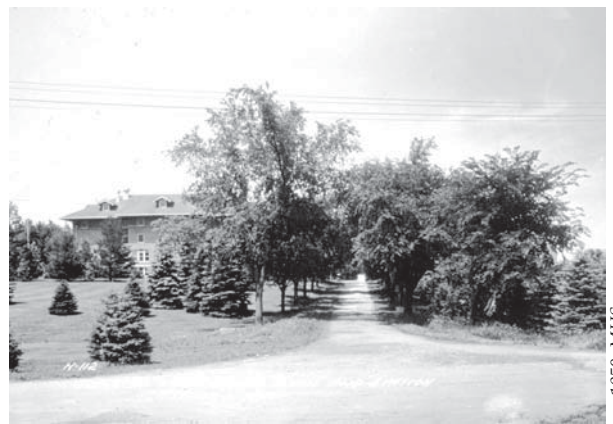
ca. 1950, MHS

The entrance from Second Street once offered a clear view through campus focused by an arcade of elms. This entry and its trees were removed for the construction of Gay Hall in the 1960s. Future planning should consider reopening (at least visually) this critical circulation element in the original Morell & Nichols campus plans.

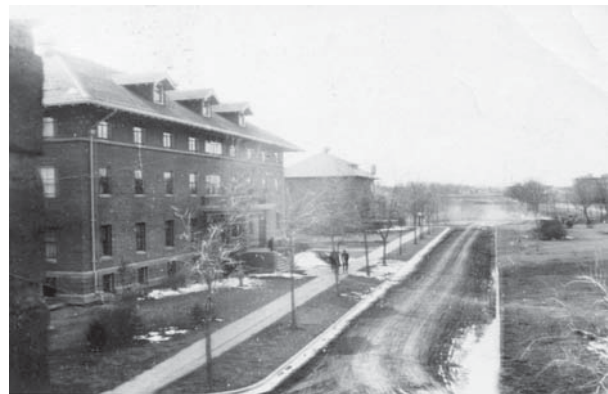
ca. 1924, SCHS

The parallel structure of street, curb, trees, sidewalk and façades.

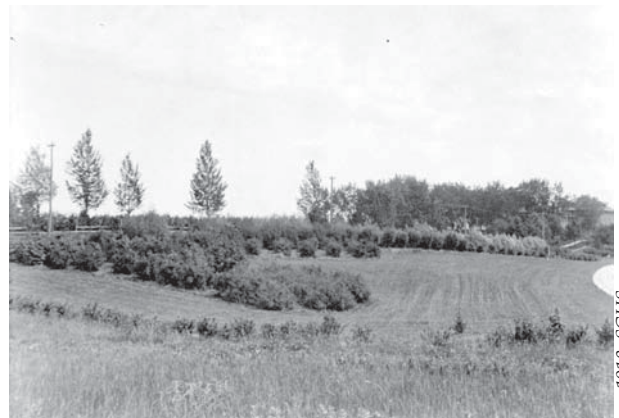
The windbreak along the Fourth Street Entry Drive shortly after planting. Note how the land gently slopes from the city cemetery to the street.

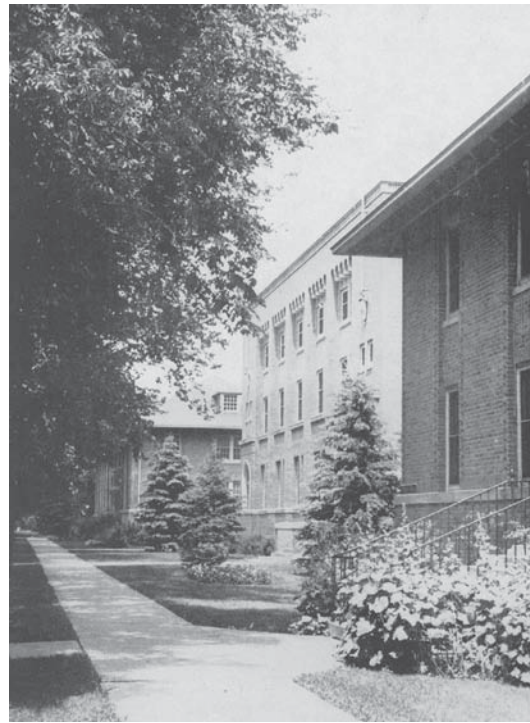
ca. 1944, WCMHRC

The central campus was designed as a flat plane. The horizontal lines were expressed in level sidewalks, streets, Kasota stone watertables, string courses, and the consistently-elevated first stories of the buildings.

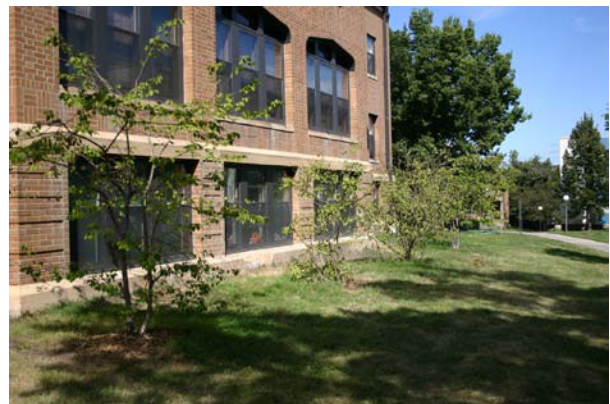
This row of Japanese Lilacs (recently moved to the south side of Spooner Hall) is an excellent model for planting of historically-used understory trees of appropriate scale and canopy density for the district. These plantings will also allow light into the building as they mature.

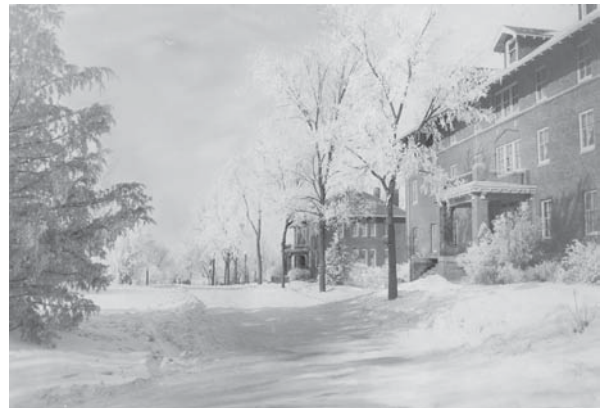
Evenly-spaced American elms line most streets in the historic district. New disease-resistant hybrids are now being planted to replace those lost to Dutch Elm Disease.

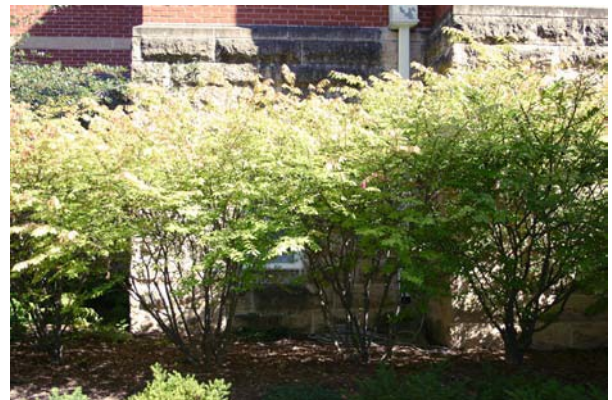
This row of winged euonymus (burning bush) helps to soften the foundation of an historic building at Macalester College. Such foundation plantings were also used at the WCSA and are still appropriate near many buildings.

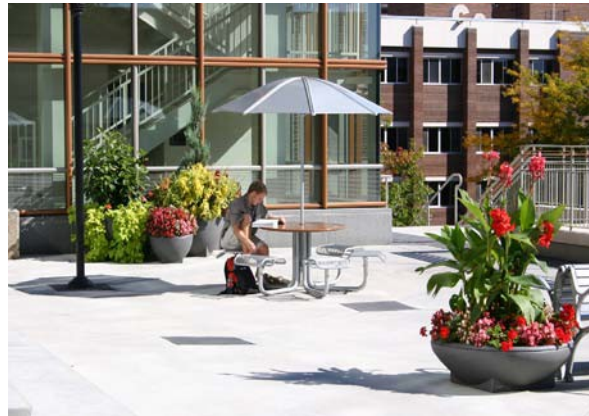
Campus Case Study: Planter Gardens

During the WCSA era, the UMM campus, especially the Mall, demonstrated annuals that were also being tested for hardiness. At the recently renovated Coffman Union terrace at the University's Twin Cities campus, shown above, many of these historic species are gathered in round planters. They help to break down the massiveness of surrounding buildings and paving while also adding color. At UMM, such planters, interpreted with historic species identifiers, may be one way of interpreting the Garden Campus for the Student Center terraces, the terrace east of Briggs Library, and in front of the Science Auditorium. They should not be placed in lawn areas.

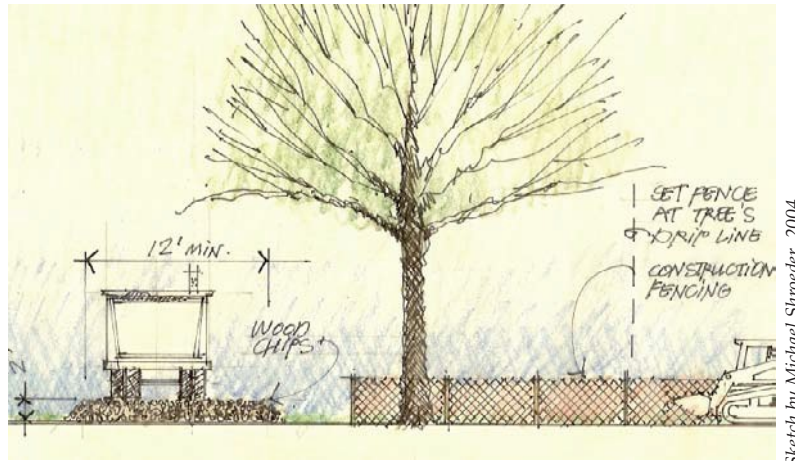
Protection of drip lines and minimal soil compaction are essential for tree preservation during construction. Install fencing to the drip line and place a thick layer of wood chip mulch for equipment to drive on.

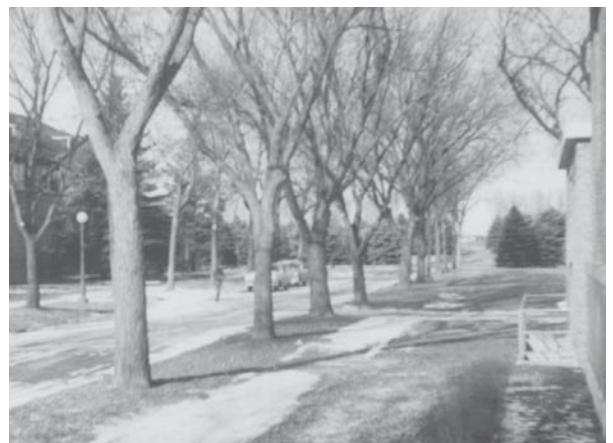
ca. 1955, SCHS

The street between Social Science and Camden Hall. Note the strong visual lines created by road, curb, trees, and sidewalk.

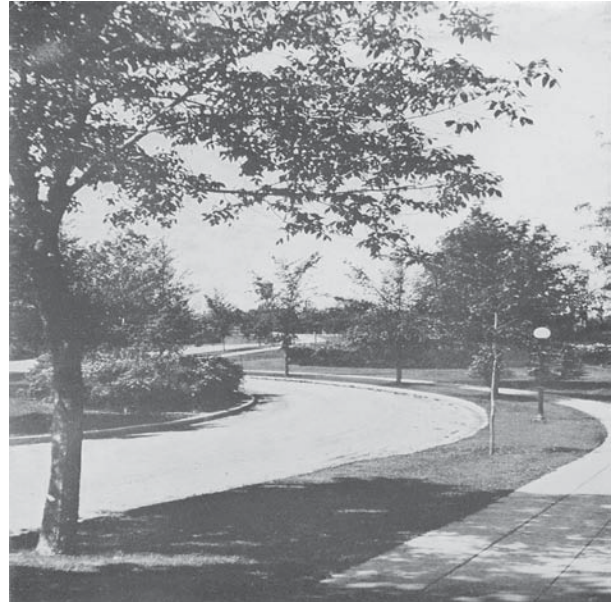
ca. 1927, WCMHRC

Near the Pine Hall Glen, the campus entry created an elegant banding of sidewalk, curb and drive.

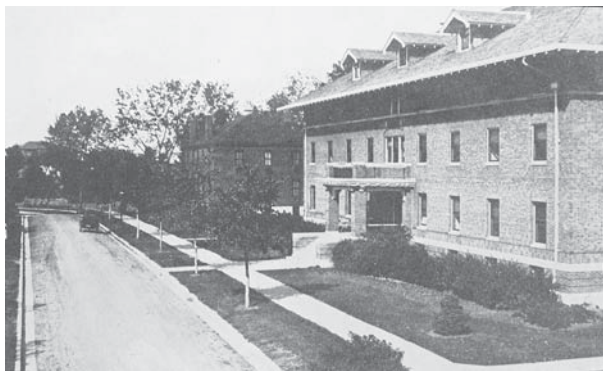
ca. 1923, WCMHRC

Linearity in sidewalk and curb design in front of Camden Hall.

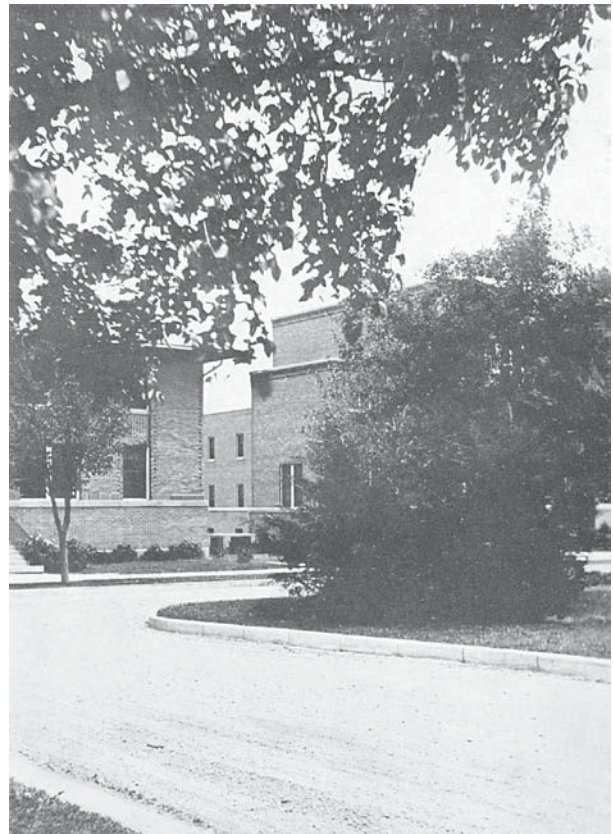
ca. 1927, WCMHRC

On the Mall, the curbs were sharply defined.

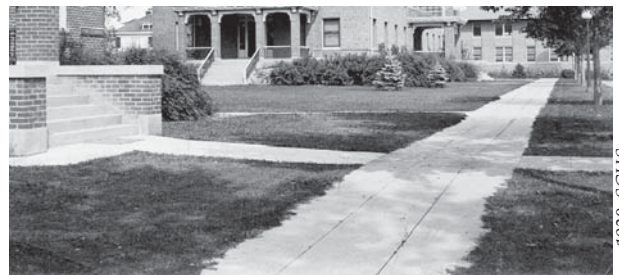
cir. 1930, SCHS

This image illustrates the orthogonal and gridded sidewalks dating from the early WCSA era. As the ornamental campus grew to maturity, the progression from curbs to sidewalks to building steps provided an elegant transition from the outdoors to the academic realm of Mall buildings.

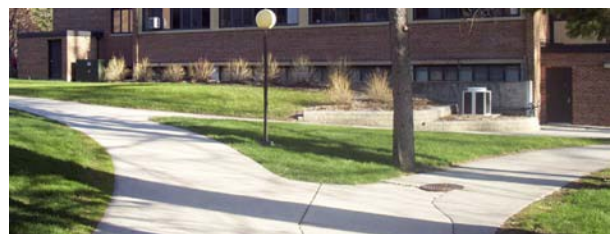
2004

This image illustrates the curvilinear pedestrian sidewalks of the Liberal Arts era that, while effective in the residential quadrant, are not appropriate within the historic area or near the entries to most historic buildings on campus (except in the 1968 Mall design).

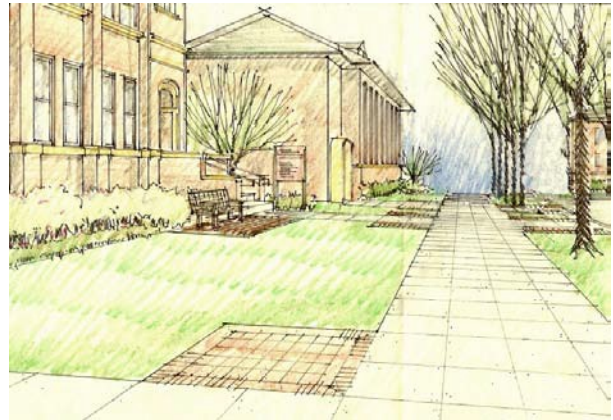
Recommended paver pad to address desire line grass wear. Pads should be used sparingly, only where the volume of traffic is heavy. Brick should be of the color and type specified herein. Note the bench pad near the building entry in the background.

[A] In cases of turf wear or other damage at corner shortcuts where sidewalks and/or other circulation routes come together, using this recommended paver; or using a paver such as Borgert Product's Uni-decor

pattern with Holland stone border and in Autumn Blend color. These wear areas should be no larger than needed and orthogonal in shape.

- [15] Using rectangular pads with paver products specified in 14A above for areas under bike racks, benches, interpretive signs, and similar situations (rather than concrete), to retain visual linearity and reduce the expanse of concrete.

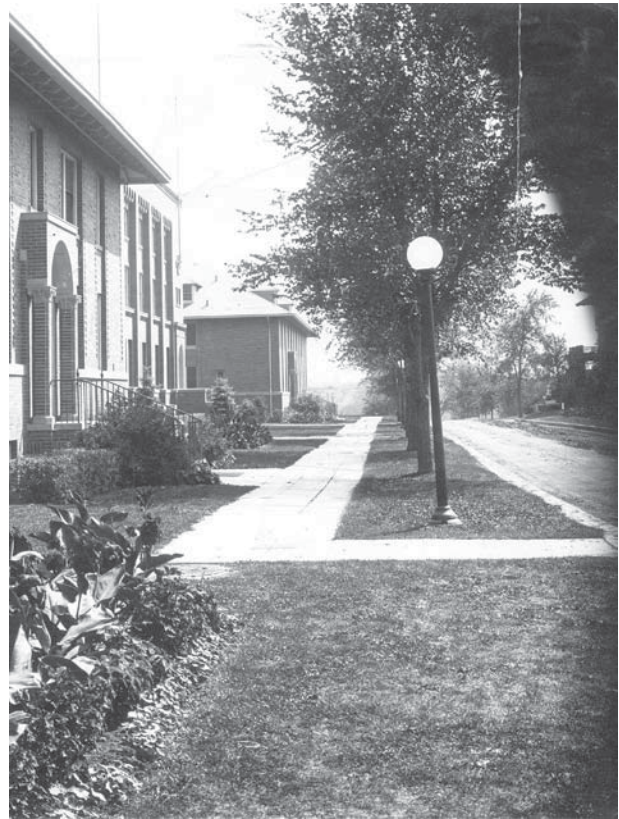
ca. 1925, University Archives, U of M

The original Mall globe lights were placed in the boulevard at about 60-foot spacing. It is recommended that they be replaced with a Dark Sky compliant or sensitive fixture and located in roughly the original locations but not elsewhere in the historic district.

In the 1960s shortly after UMM was founded, a pedestrian-scaled, simple metal pole with a globe luminaire was introduced. These were the first lights that were placed on the Mall and along walkways between and behind buildings. There are now approximately 200 on campus, both inside and outside the historic district.

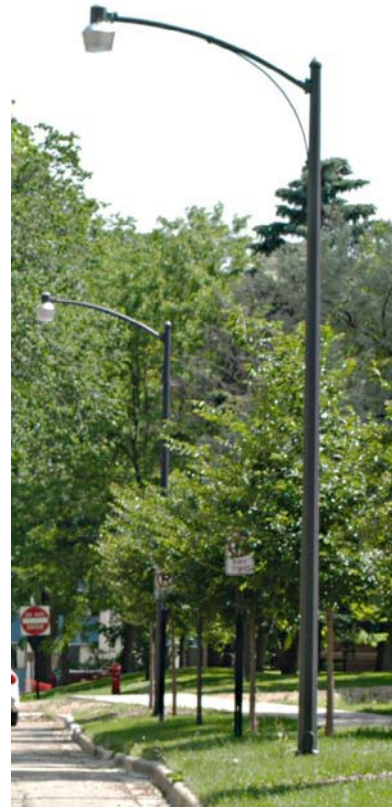
The “University Standard” streetlight was first used on campus circa 1955. It is recommended that these poles be retained.

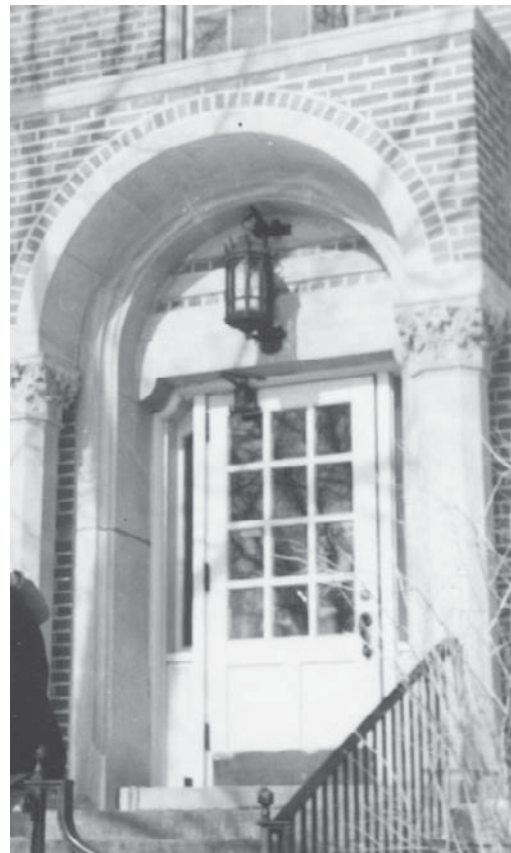
1949, Wes Gray private collection

The original entrance light on Blakely Hall, shown here, matched the light still hanging on Pine Hall's east façade.

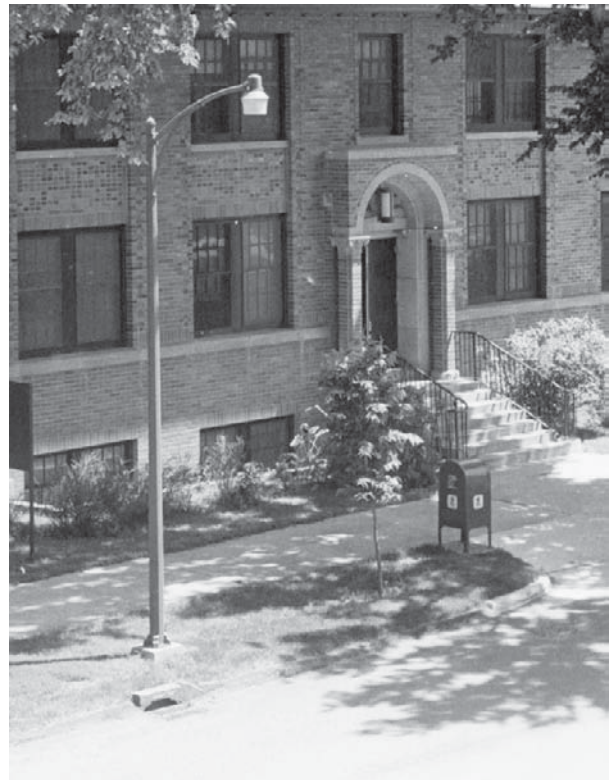
ca. 1980, UMM

A University Standard lamp pole in front of the Social Science Building. These poles are still manufactured and fit well in the historic district. It is recommended that the luminaires be replaced with unobtrusive fixtures that cast light downward.

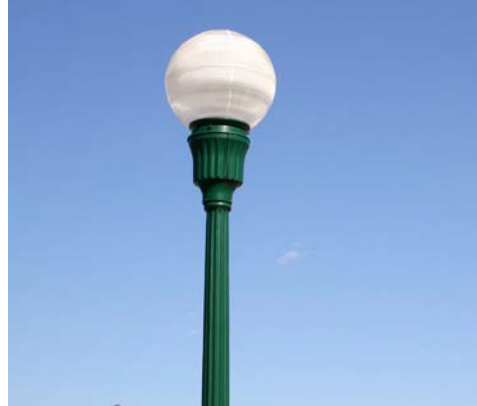
This light at the University's Twin Cities campus evokes the original fluting, shape and scale of the WCSA-era Mall lights. Located near the new Scholars Walk, this light is one of many products available. At UMM such lights should be used only where historic precedent exists.

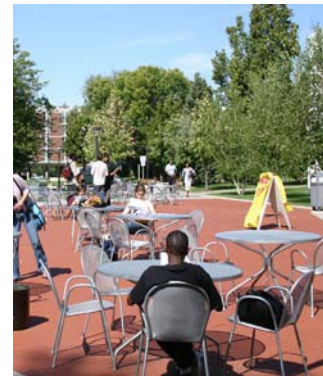
Campus Case Study: Durable and Movable Terrace Furniture

This movable and durable plaza furniture is honestly contemporary and could serve as a fairly neutral element in a traditional campus setting like UMM's. With the option for umbrellas, such movable tables and chairs provide a choice of sun and shade as well as location.

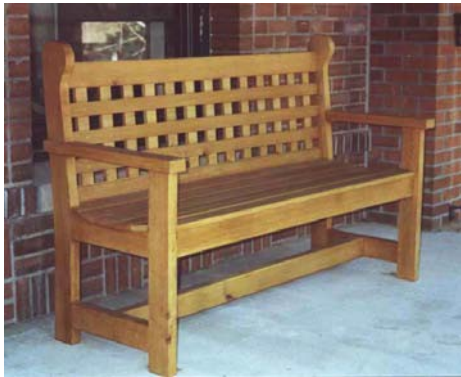
UMM has begun to use a custom-made Craftsman style bench, shown here, that is adapted from the WCSA bench that appears in the photo on page 1 of this report. It is recommended that no more than 12 of these benches be built. Rather than being sited in open areas, they should be placed in sheltered sites close to buildings where brickwork will serve as a backdrop. They should be stained a neutral color rather than painted. The sole exception could be a painted bench placed at a rehabilitated WCSA water garden behind Community Services as per the photo on page 1. (See recommendations for paver bases in the Circulation guidelines.)

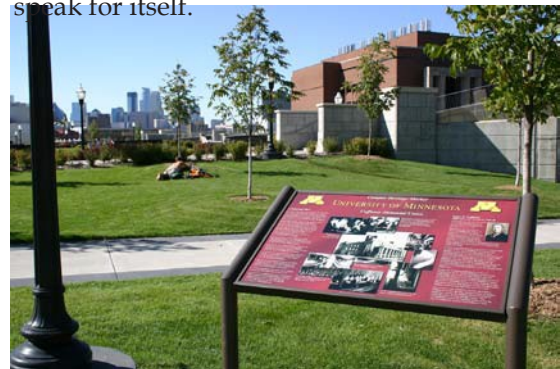
2004

Interpretive panels help to tie the contemporary campus to the people and activities of the past. The style of panel in the photo below, used on the University's Twin Cities campus and also at UMM, is modern yet restrained in its design. However, for the UMM historic district, the heavy metal structure and its maroon tinting is too conspicuous. UMM might consider designing custom interpretive panels that evoke the wrought iron color and scale of historic railings on campus. In color, scale, and detail, interpretive graphics should be as unobtrusive as possible to allow the campus to speak for itself.

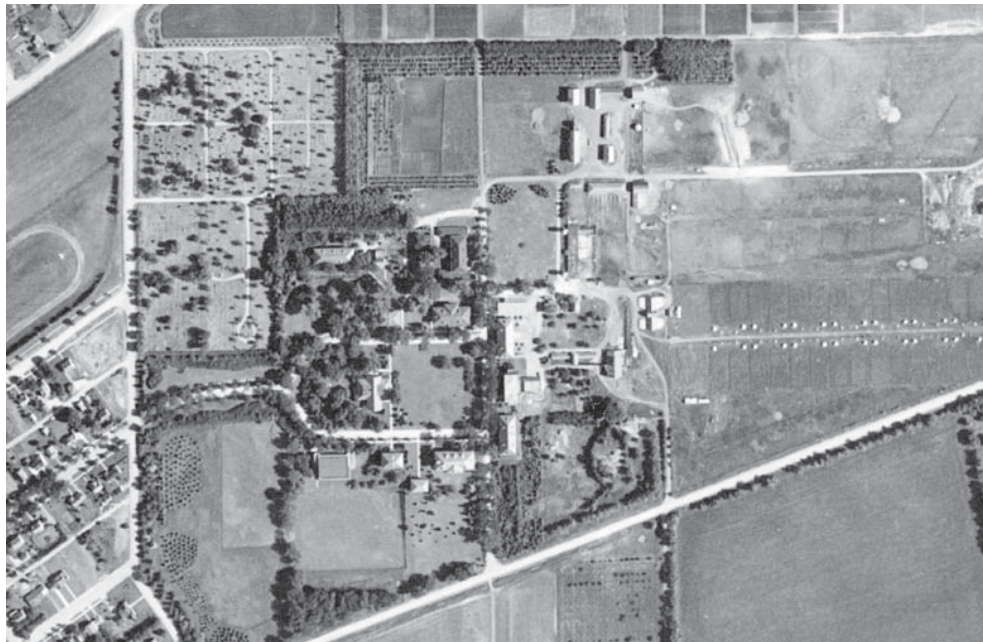
1951, Borchert Map Library, U of M

This 1951 air photo of the WCSA campus provides one of the clearest definitions of the emerging windbreaks, groves, recreational fields and orchards of the designed landscape. In the discussion of the treatment zones to follow, this air photo will be used as reference and comparison to discuss the more mature and at times deteriorated planting, spatial, and circulation features encountered on campus today.

Vegetation. Twelve American elms, planted 30 feet on center, remain from the original set of about 24 that were planted circa 1918 (see 1951 aerial photo). About ten basswood trees follow the curve of the sidewalk on its north side. They were planted in the 1970s anticipating the loss of the elms to Dutch elm disease. The windbreak along the cemetery was comprised of deciduous and evergreen trees, lilacs, and other large shrubs. The windbreak was originally balanced by a similar line of trees and lilacs on the south side of the road (now removed). The cemetery windbreak has recently been replaced with a row of about 50 arborvitae and several new lilac shrubs, although some original lilacs remain. Narrow flower gardens were added along the cemetery windbreak and the Southwest Grove circa 1980.

As evident in the 1951 aerial photo, likely taken within 15 years after planting, the spruce grove was bounded on the west by cedar and a line of Scotch pine, several of which are still visible.

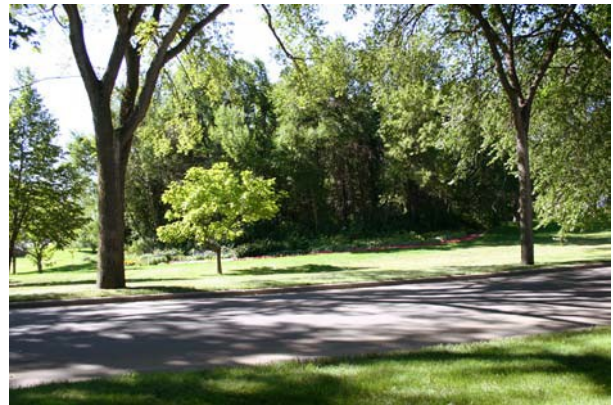
View to the south from the drive into the Southwest Grove, originally planted as a circle of spruce. The Entry Drive was historically framed on the north and south by windbreaks. The open boulevard space between them should be understood not only as the historic connection between Morris and the campus, but also as the site of outward visual connections between the drive and the first football field site, just to the left of this photo, along with vistas to the fields and orchards further south.

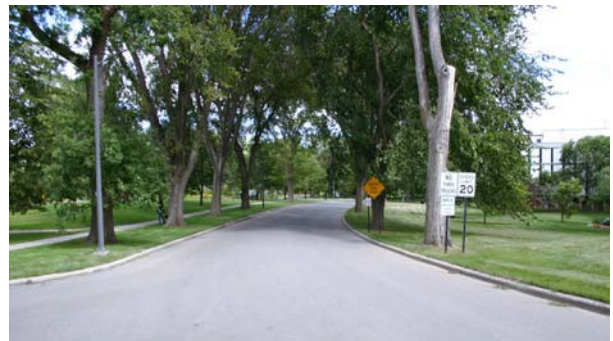
Surviving elms create an entry effect that recalls the parkways of Minneapolis, Duluth, and other cities where Morell & Nichols practiced.

- [3] Continue to treat all surviving mature elms for Dutch elm disease.
- [4] Interplant a single variety of new hybrid elms between the existing boulevard elms and where they are missing. They should be chosen for a cathedral structure branching effect. 'Discovery' and 'Accolade' are recommended.

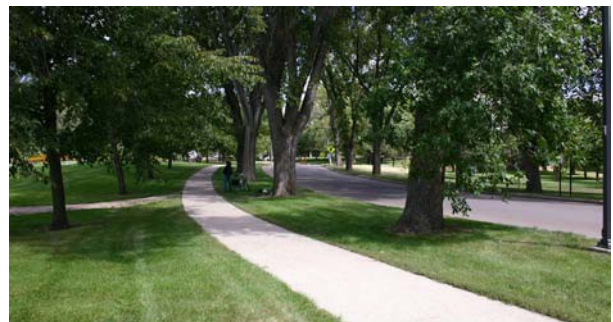
View along the sidewalk into campus. Note the clean edges of the road, grass boulevard, and parallel sidewalk.

Circulation Corridors. Roughly paralleling the entry road, the current sidewalk alignment is six feet wide. The sidewalk was originally scored in squares and has probably been replaced once. There is a 14-foot boulevard between the sidewalk and the road.

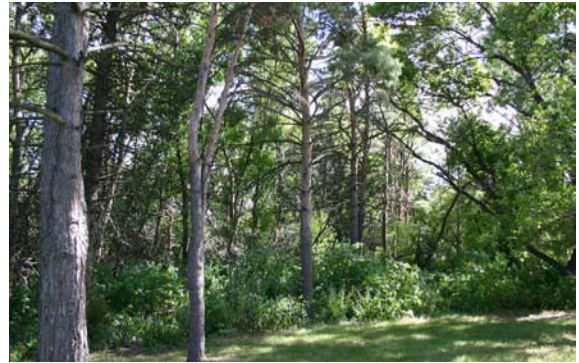
2004

Remnant line of Scotch pines on the west edge of the north spruce grove.

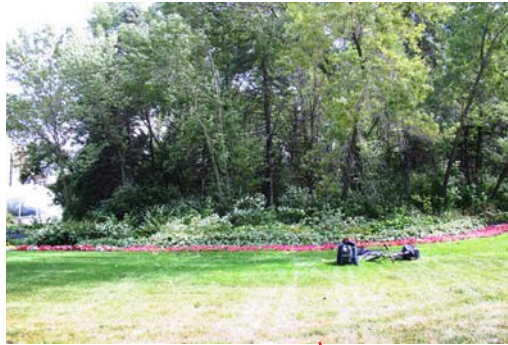
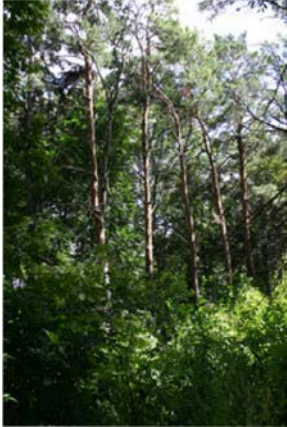
At its northern tip, the curve of the old spruce grove, now immersed in deciduous growth, is still visible. New shade gardens accent the edge where it meets the Fourth Street entry lawn.

The walk to LaFave House was constructed in 2000 and slices through a cross-section of the spruce grove, revealing its core, decayed from years of light deprivation. New border plantings and lighting were added. This path offers opportunities for further interpretation of the grove and windbreak's history and potential rehabilitation with new plantings, pruning and thinning.

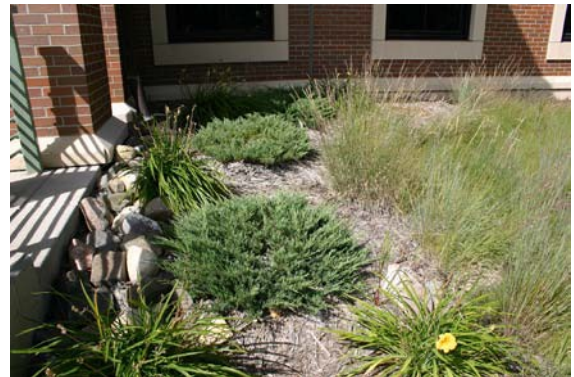
This photo illustrates the current planting condition at the edge of the Science Building. Neither true to native ecology nor the campus planting history, this bed is a confusing mix of non-native and native species. For teaching purposes, native plant communities should be maintained in clearly defined areas with all exotics removed.

Interpretive signage could help to explain the native landscape of the Morris area and the rarity of undisturbed prairies. Nearby, hackberry and other cathedral shaped trees should be planted near the Science Building entry and in West Lot islands to minimize the scale of the parking lot and the new Science wing.

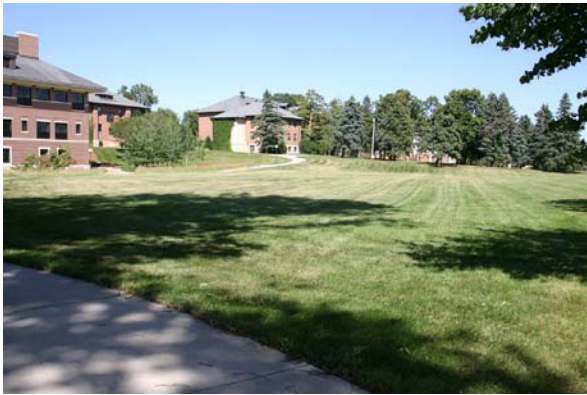
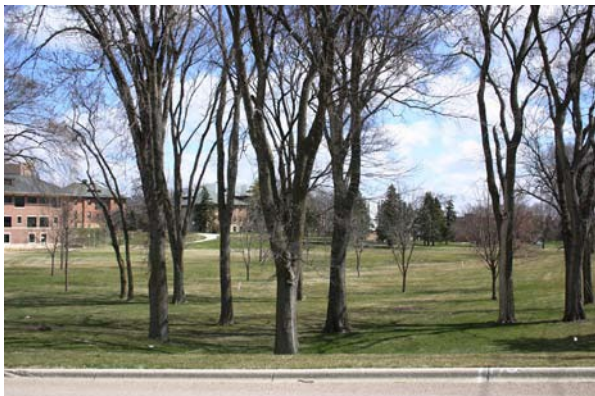
Note the spatial enclosure defining Miller Field created by the straight and perpendicular edges of tree plantings to the south and west of the site. Such a north-south line of trees can be replanted to separate the former Field area from the West Parking lot and to recall its former shape as a level and oblong outdoor space.

Taken from a low angle, this photo shows the level plinth of the field still remaining. In plan view, though compromised by the curving walks of the new Science project, Miller Field retains much of its character-defining three-dimensional expression of grading and site manipulation. Note surviving field bank to the east.

With about 12 remaining elms, the Elm Grove is one of the most graceful collections of canopy trees remaining. Beyond, new ash and basswood extend the Grove into the former field footprint. This view from the West Parking Lot reveals the gentle grading leading down to the level field and the Spooner Hillside framing the northeast end.

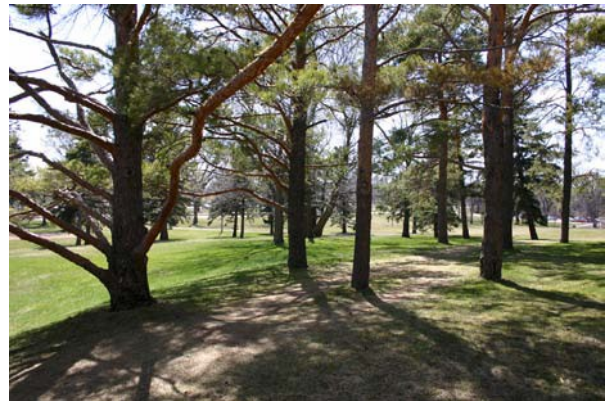
2004

A blend of Scotch Pine and spruce, the Spooner Grove is one of the most intact evergreen groupings remaining from the WCSA era.

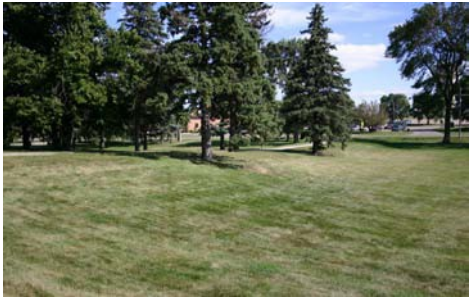
2004

Framing the east end of Miller Field, this spruce grove was likely planted circa 1920. Today about 18 spruce, 3 large multi-trunked basswood, and newer honeylocust exist in this area. Note how the grading frames the corner of the former field.

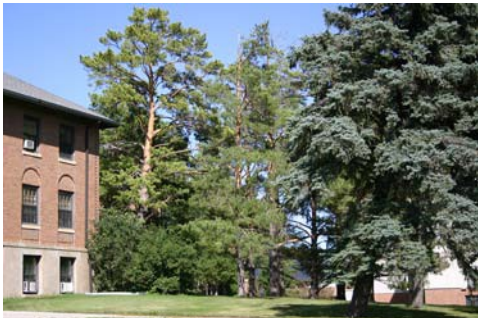
2004

Just to the east of Education, this grove of 9 Scotch pines catches the west afternoon light to create a golden hue that contrasts with the tone of the blue spruce just to the south. These trees serve not only to create a spatial edge to the hillside, they also shelter a grassy and human-scaled environment beneath their lower branches.

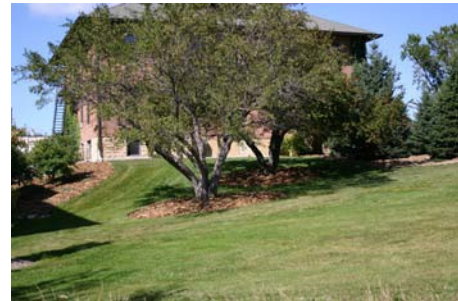
2004

With nearly 12-inch trunks, these crabapple trees to the south of MRC are among the finest historic ornamental trees on campus.

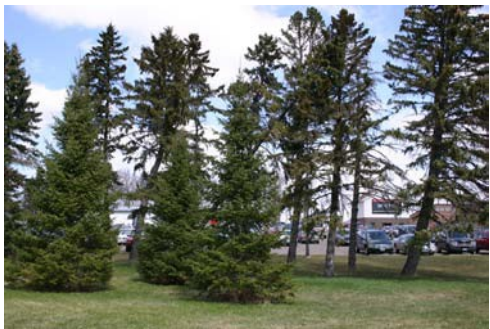
Begun as two groves, a spruce windbreak dating from the 1930s frames the north end of the Quad. The trees are aging, yet provide important spatial closure and screening.

- [2] Retain existing healthy spruce and prune dead limbs.
- [3] In several phases, remove deteriorated spruce and replace with Norway or Black Hills spruce. Also interplant new spruce near the corners of the barn, along the north end of the Quad, and near Community Services.

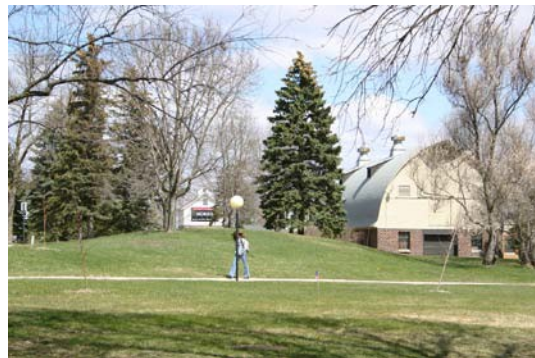
As an important campus open space, the Engineering Quad affects areas around it. In this view from behind Social Science, the healthy spruce near the Cattle Barn frame a subtle yet distinctive vista to the Seed House.

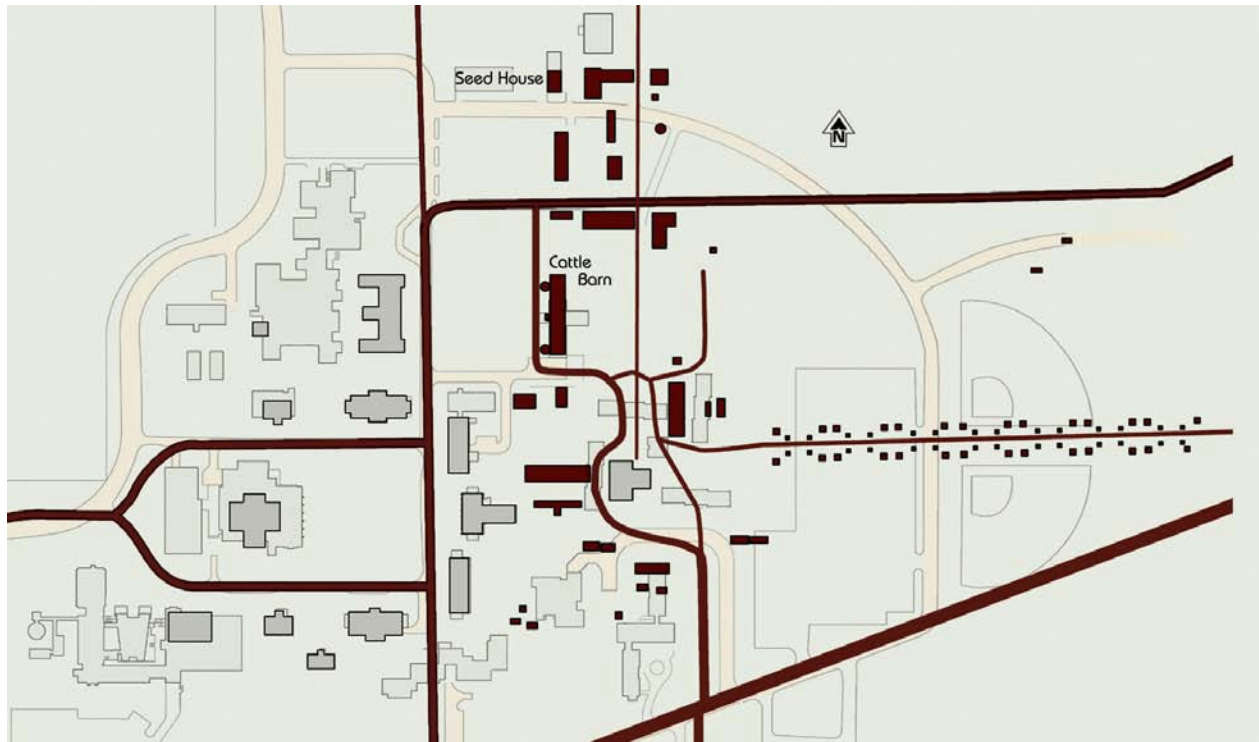
2005, Gemini Research

This image shows the 1941 farm buildings of the West Central School of Agriculture (red) against the backdrop of the current campus. The Cattle Barn and the Seed House are still standing. North and northeast of the Cattle Barn were barns for horses and sheep, and a corncrib, machine shed, and other structures. South and southeast of the Cattle Barn were the herdsmen's houses, greenhouse, poultry barn, hog barn, and brooder houses. Arrayed in an east-west line was an experimental pig feeding facility. Shown in dark gray are non-farm WCSA buildings that were standing in 1941.

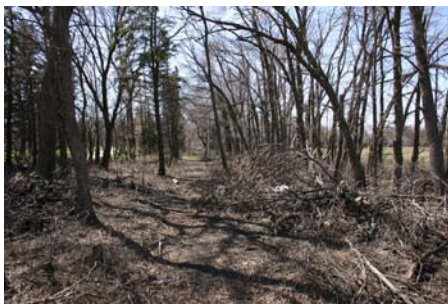
2004

Early spring view showing ground debris and deteriorated spatial structure as inside trees suffer from lack of sunlight.

Most of the windbreak area does not appear to have been maintained other than intermittent thinning and removal of downed trees. The condition of the trees is variable, with inner rows suffering from light deprivation and the exterior rows showing the healthiest foliage. Buckthorn has established itself throughout the windbreaks. Both Common Buckthorn and Glossy Buckthorn are invasive species capable of rapidly spreading and displacing native or desired plant species. Both are listed by the Minnesota Department of Agriculture as restricted noxious weeds. UMM made one cutting of buckthorn about four years ago, but much buckthorn deadwood remains and new seedlings are now vigorous.

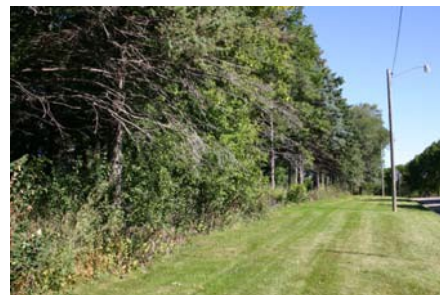
2004

View along the east side of the Northwest Windbreak just to the north and west of HFA. Note the relatively dense condition of foliage on the sunny edge. Also, note the spruce row that forms the eastern edge.

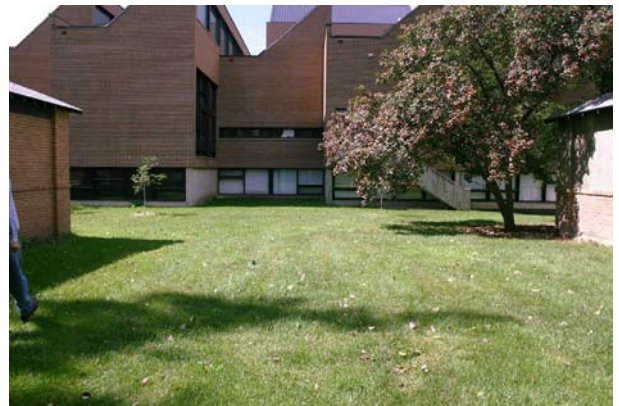
South Court view toward HFA in summer. Note the mature viburnum specimen tree to the right. The rooflines and brick massing of HFA provide a contrasting and rich backdrop for this scene. The footprint of the former oblong water pool is in the immediate foreground.

Water Features. The rectangular pond of the south court's water garden is visible in footprint, but is beneath the sod.

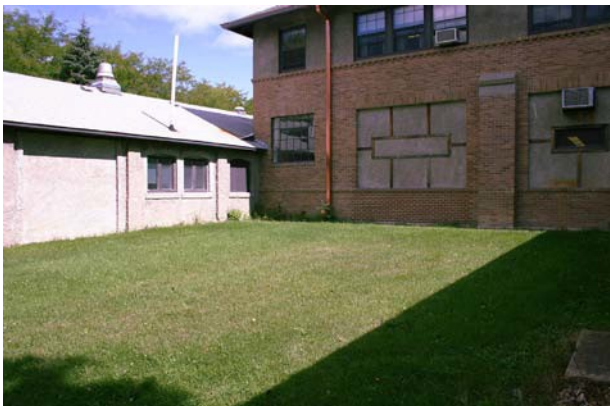
The clear open lawn of the north court. Note the new copper gutters and downspout along with the other intricate brick and window details of Community Services. With the contrast to the older Blacksmith wing to the left, these details could provide a rich backdrop for temporary sculpture exhibits or special events.

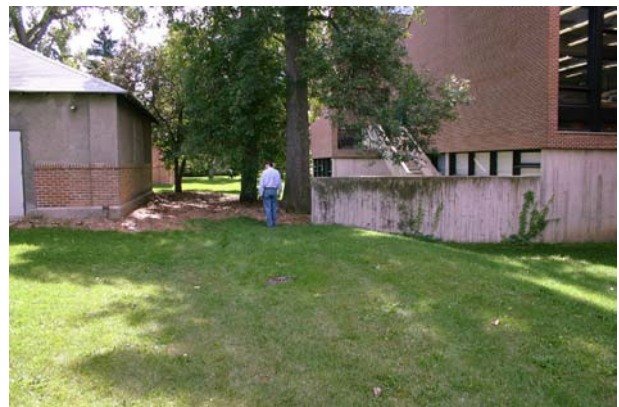
Narrow linear space between HFA and the two courts. Note the cast-in-place concrete retaining wall that serves to draw HFA's modern-era materials into the space.

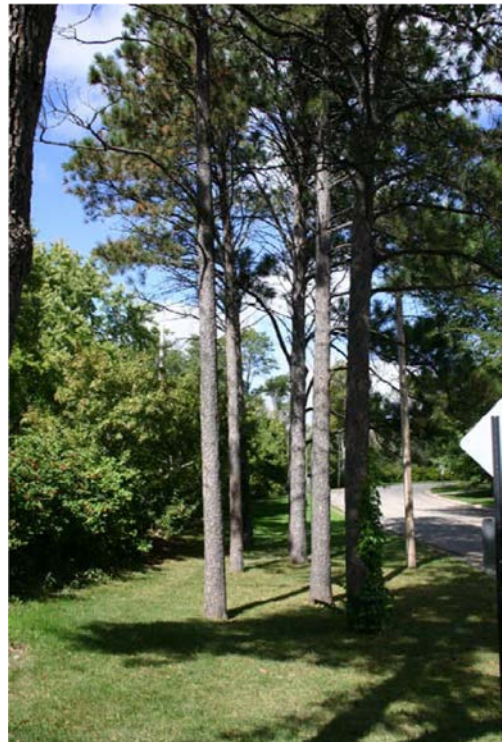
2004

Across Martin Luther King Drive, this stand of Ponderosa pine is one of the most intact on campus. Early annual reports indicated that this species fared well when many red pines failed. Such plantations help to screen the Glen from the cemetery and add to its bucolic quality.

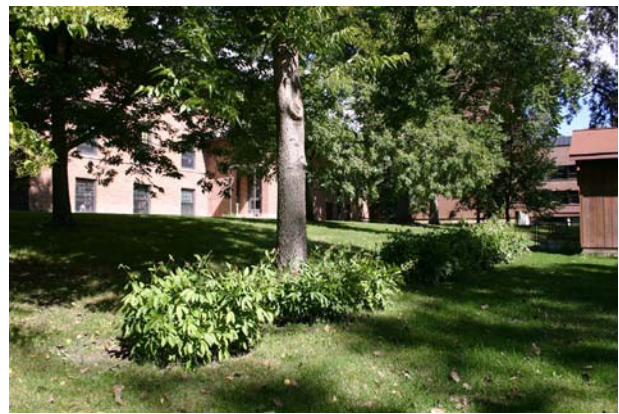
2004

This line of peonies is one of the most significant herbaceous reminders of the ornamental heritage of the campus during the WCSA area. Through much of this period, the Glen was the site of picnics, lectures and Station Day events.
