University of Minnesota Morris Historic Preservation Plan: A Plan for Landscape & Buildings

Historic Preservation Plan

A plan for landscape & buildings

Prepared by the
University of Minnesota Morris
Historic Preservation Planning Team
May 2005

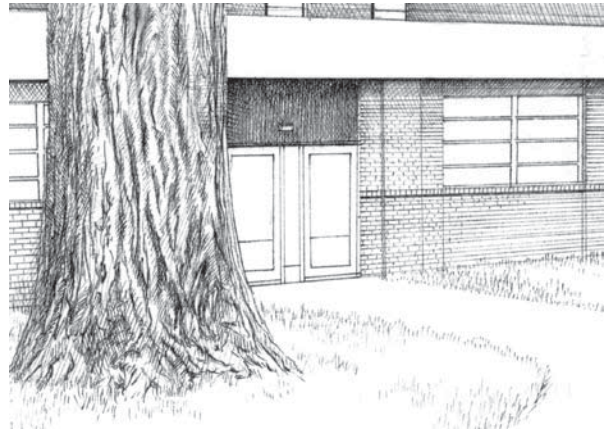
Sketch by Kyung-eun Han, 2004

In the Cottonwood Corridor, several cottonwoods have diameters of nearly four feet.

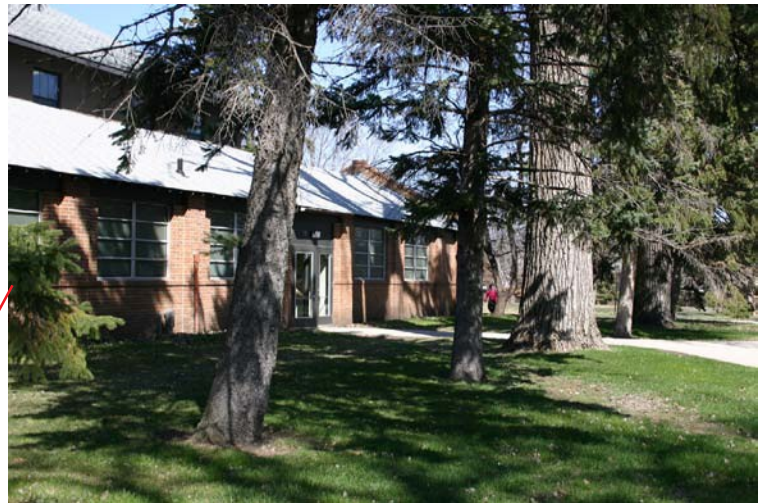
2004

To the south of Community Services, remnant cottonwoods intermingle with spruce trees likely planted in the 1920s and 1930s. The effect of soaring cottonwoods and the winter texture and colors of the spruce is unique to this area of campus.

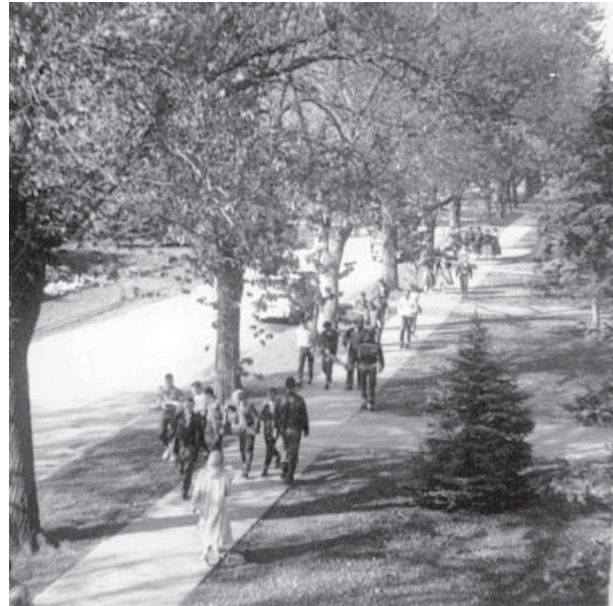
ca. 1945, SCHS

1940s era view of the Mall terraces showing the open plane of lawn separating the sidewalk from building foundation plantings.

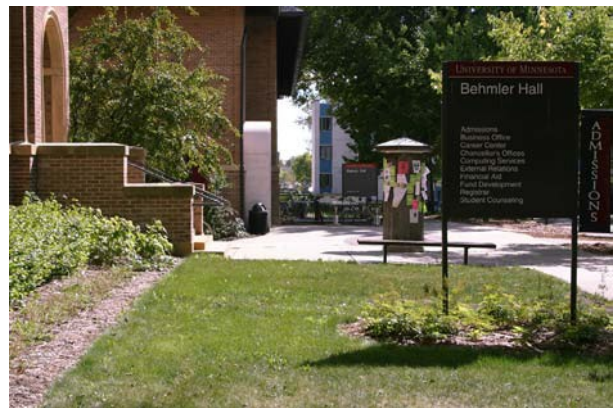
2004

This contemporary view at the front of Behmler illustrates the manner in which paving, kiosks, benches, shrub beds and other masses have intruded on the once smooth lawn between sidewalk and buildings. Historically, shrubs such as spirea along with spruce or yew were planted only at steps and buildings corners.

- [10] Along building foundations, use a monoculture line of hedge plantings with higher flourishes of other varieties at the steps, using historic photos as a guide. Don’t allow hedges to grow taller than the level of the water table and or first story sills. Hedges in front of Behmler, Blakely, and Social Science could be formally clipped, if possible.

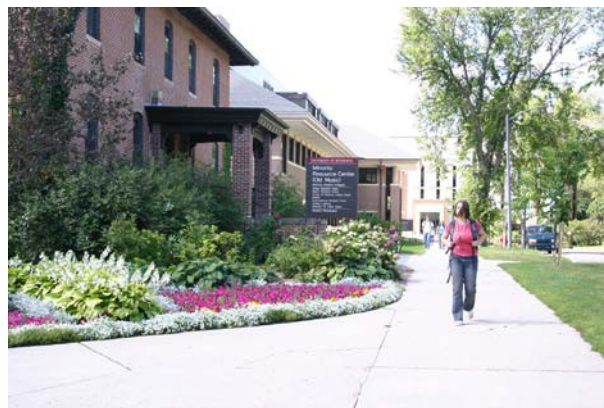
2004

Although a great source of color for the Mall Terraces, the Alumni Garden neither reflects historic orthogonal spatial patterns nor the terrace setbacks. In this view looking west, the garden beds become a visual interruption of the flow of space that is further blocked by signs. Returning terrace areas to grass with gardens concentrated in islands and as strips would be more compatible with planting patterns during the WCSA era.

- [12] If desired, install a few flower beds of regular shape (oval, etc.) within the terrace area, using historic photos as a guide.
- [13] Redesign the Alumni Garden to make it more compatible with the historic landscape. Recommendations include:

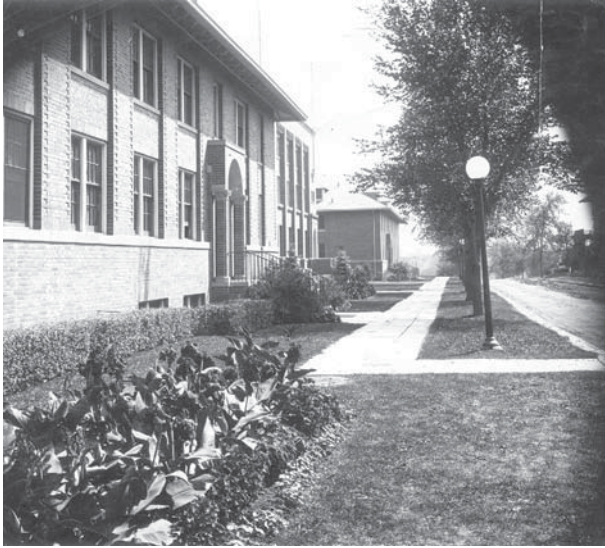
ca. 1925, University Archives, U of M

The Mall Terraces should be returned to their original open appearance during the period 1910-1963.

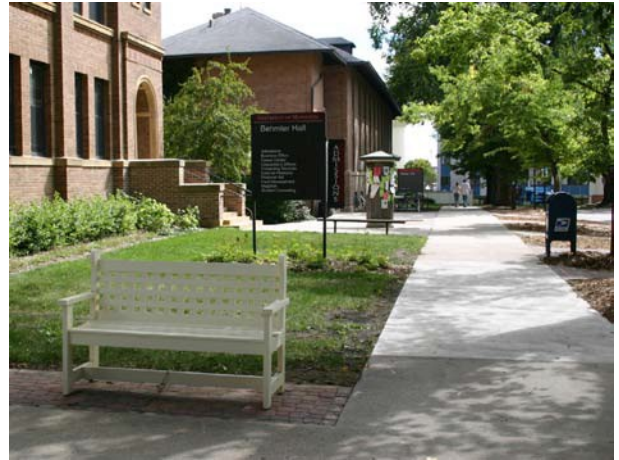
2004

Today, unlike the circa 1925 image, the terraces are filled with numerous objects. Benches should not be placed in open space on the Mall Terraces.

A limited number of re-created Craftsman benches should be placed flat against buildings as their predecessor was in the Engineering water garden. If there is turf wear at corners, dry-laid pavers should be used sparingly, only when traffic is heavy, and placed in a square pattern as shown in the foreground. Two-foot sidewalk scoring can help to restore the linear and small scale character that once existed between street and buildings.

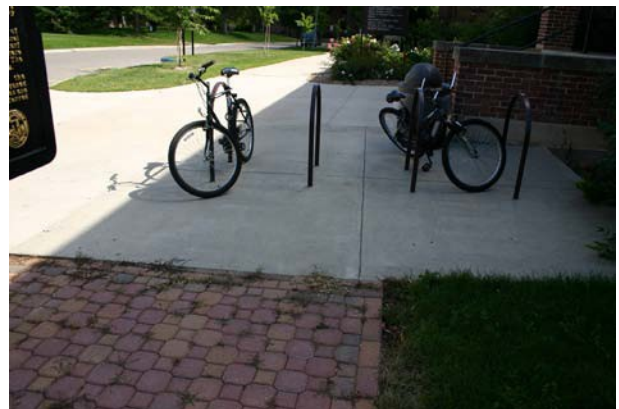
It is recommended that bike racks be placed close to building facades, rather than cluttering the formerly open terrace area. Pavers, rather than concrete, should be used under bike racks, benches, and other objects to mitigate the visual effect of large expanses of concrete. (See Circulation Guidelines for more information.)

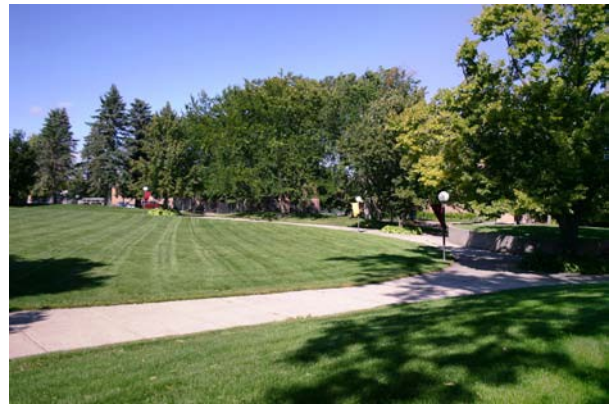
The grading, planting, circulation, and site layout of the 1968 Mall were designed to create an integral whole that offers the flexibility for recreation, formal events, and screening from surrounding traffic.

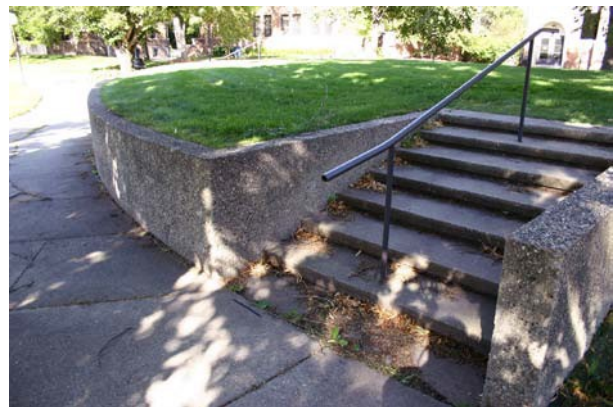
The stage is integral to the 1968 Roger Martin design. The texture of the aggregate concrete, the scale of the shallow, recessed steps and the gentle angle of the metal rail create an elegant minimalist expression of late 1960s American landscape architecture.

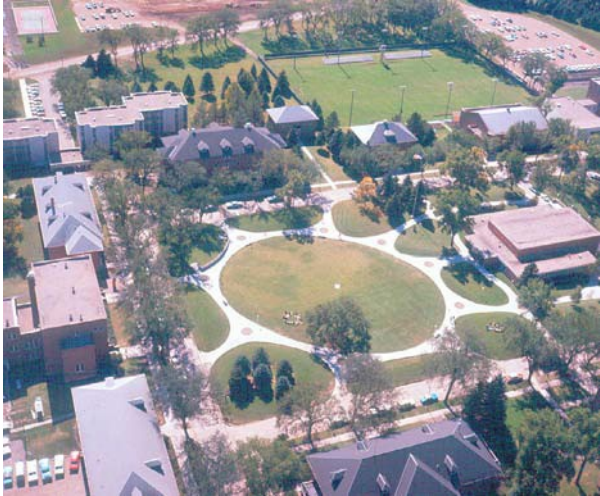
1969, SCHS

The Mall circular paths and lawn areas created by the Roger Martin design (shown here in an aerial view just after completion) have been somewhat compromised at the west edge by the Student Center expansion of Edson Hall, but the overall design remains powerful and effective.

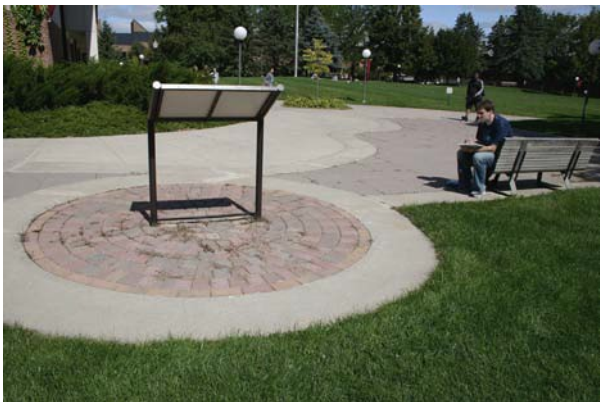
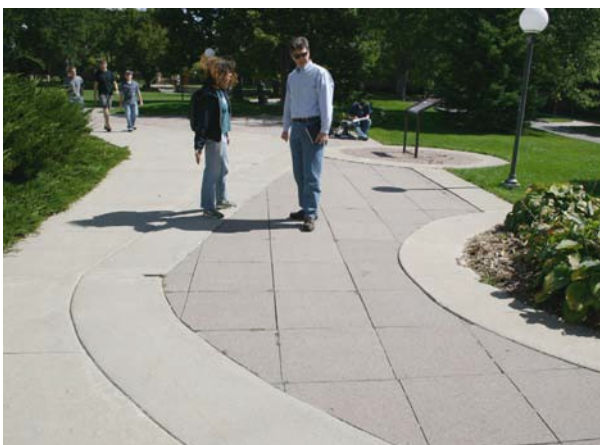
2004

These two photos show a poorly-designed mix of masonry pavers and arbitrary concrete patterns creates a confusing and largely unusable space near the south entry of the Student Center.

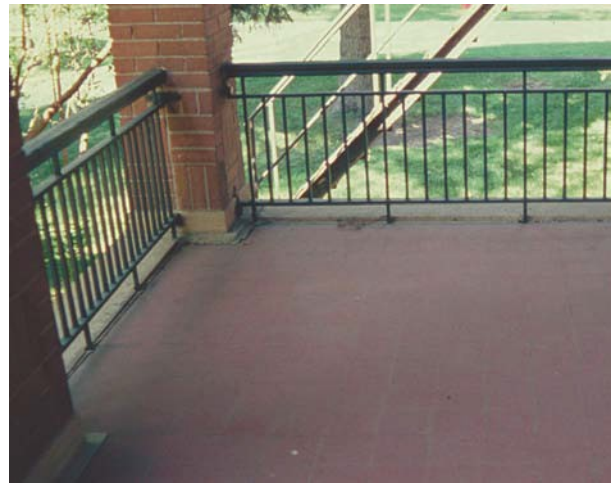
The masonry details of window edges, floor planes and insets contribute to the texture, color and symmetry of UMM's historic buildings. This image shows the tile floor of Camden Hall's west porch.

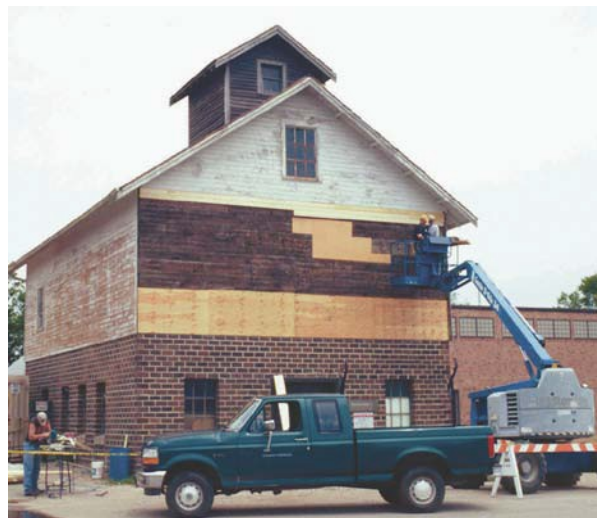
Repairing distinctive wood elements is one of the most cost-effective investments UMM can make in retaining the historic character of dormers, window muntins, and surviving WCSA buildings. Shown here: the shiplap on the Seed House is replaced with the same material and dimension in the 2003 rehabilitation.

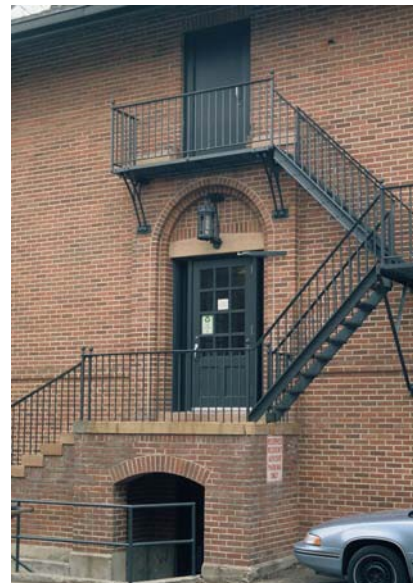
2004

Railings on Pine Hall and many Mall buildings engage visitors with a tactile and visual experience.

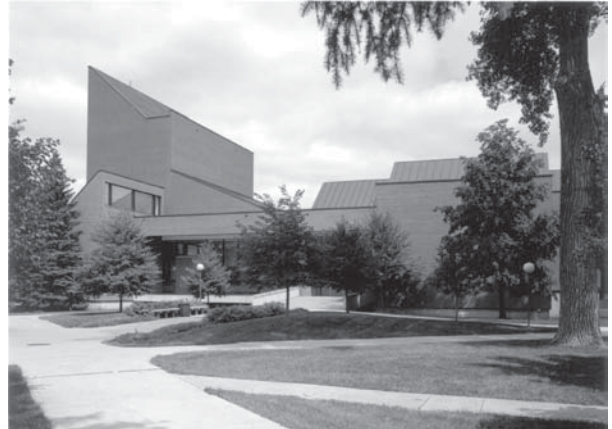
2002

HFA's towers are roofed with standing-seam coated metal. The building was designed by Ralph Rapson and completed in 1973.

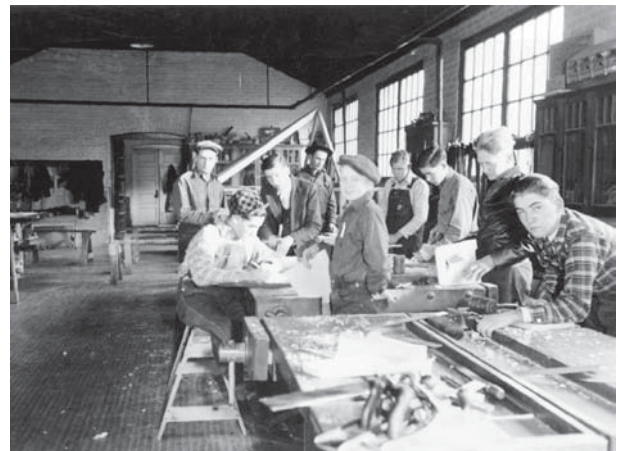
Large industrial sash windows in present-day Community Services

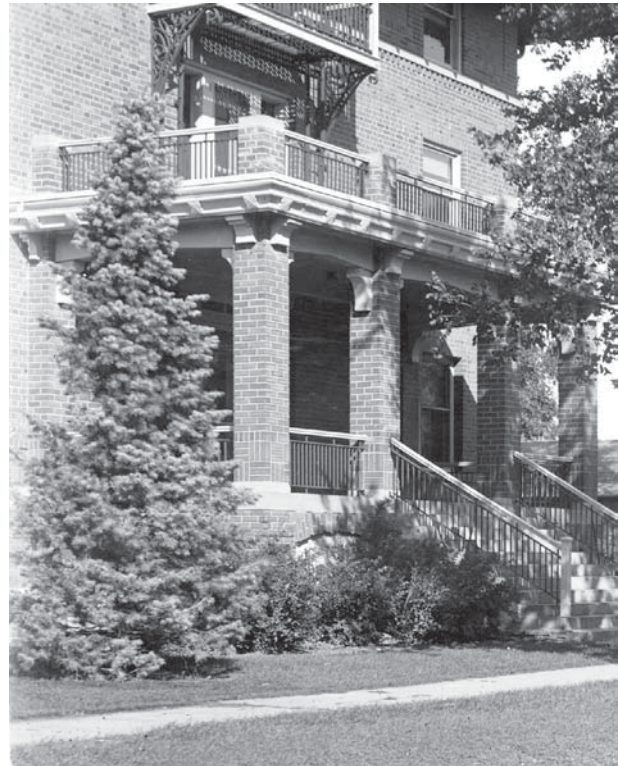
Camden Hall’s east porch. Note also a third-level balcony.

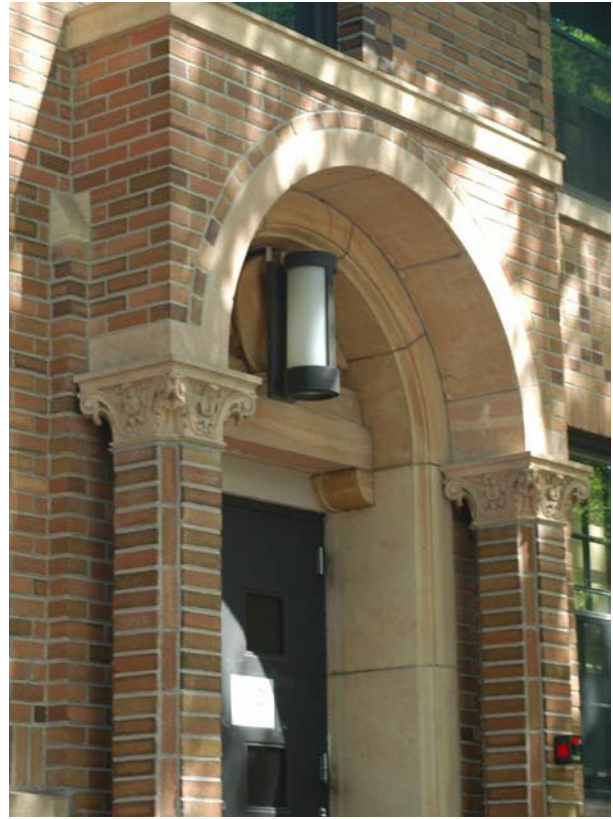
Brick columns and Kasota stone mark the main entrance to Social Science.

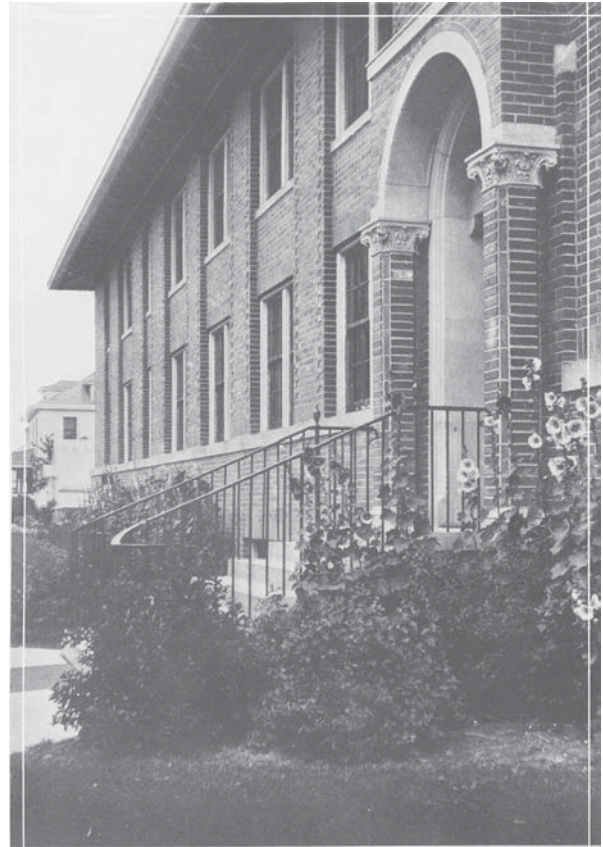
ca. 1925, WCMHRC

The entrance to Social Science, adorned with hollyhocks. This entrance is still well preserved, but similar entrances on Blakely and Pine Halls have been lost.

“supported” by columns made of brick (on Blakely Hall and Social Science) and limestone (on Pine). Social Science’s entrance is well preserved today. Blakely Hall and Pine Hall’s staircases and entrances were removed in 1966 and 1968, respectively. Behmler Hall has two identical, intact, limestone staircases and stone and brick entrances. They are located in the outer bays.

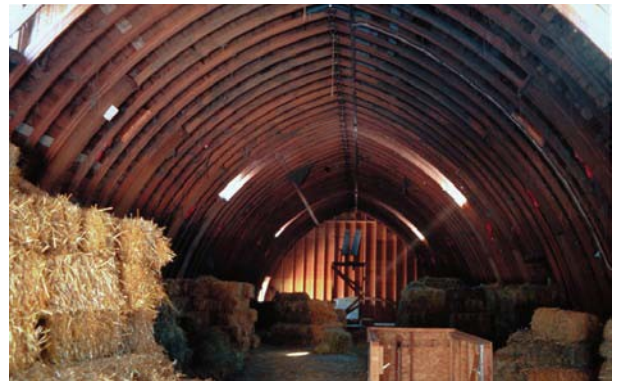
Exposed laminated wood rafters in the Saddle Club Barn.

The two remaining farm buildings have structural systems that were designed to be seen. The Saddle Club Barn has tile walls and laminated rafters (which are described above under “Roofs”) and the Seed House has tile walls and reinforced concrete interior walls and binpartitions.

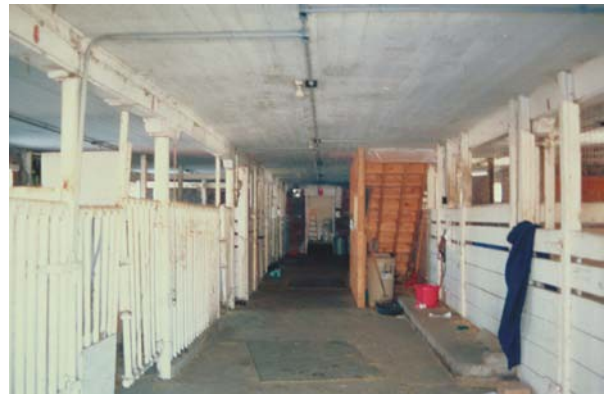
The wood ceiling patterns, stalls and posts of the barn interior are a unique legacy of the WCSA era.

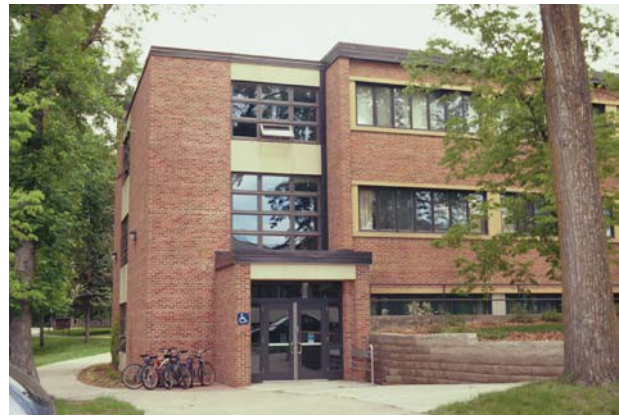
This successful 1997 stair and elevator addition on Humanities is placed on a side wall away from the historic main entrance, is well-scaled, and has compatible materials and detailing.

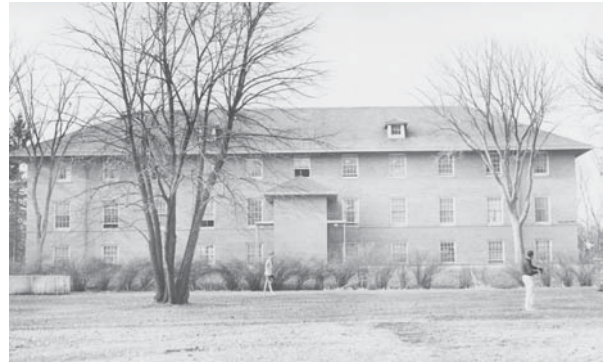
Pine Hall's 1968 stair tower addition was insensitively placed in the center of the main façade, replacing the historic main entrance.

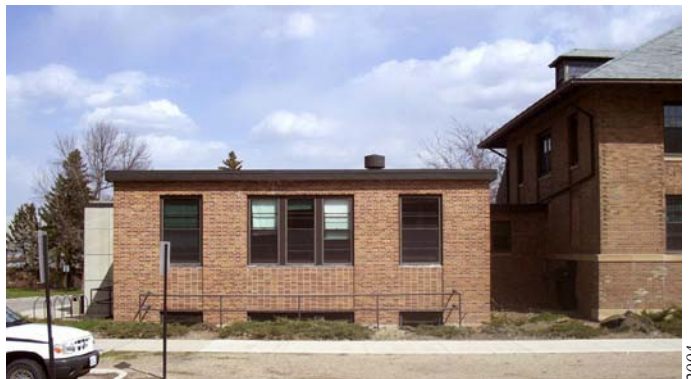
The 1950 north addition to Social Science was set apart from the original building in a way that allowed the 1920 massing and design to continue to be conveyed. (This addition is being altered in the Social Science rehabilitation project.)

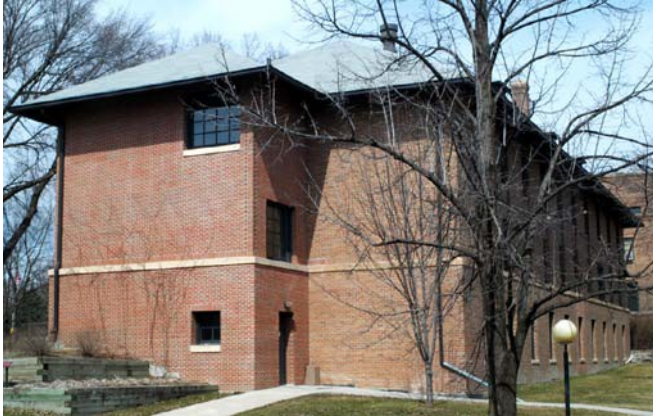
The designer of this 1988 addition to Blakely Hall used a hipped roof, red-brown brick, and Kasota or cast stone trim compatible with the original building. The addition is set back from both east and west façades so that the original corners of the building are unobstructed. Windows are included, and are multi-paned.

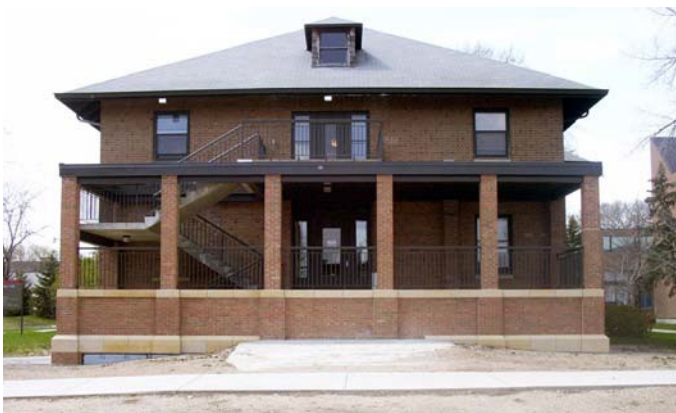
Camden Hall's 2001 east porch addition is out-of-scale with other porches in the district, spans the entire façade rather than being set in from the corners, and does not have a central entrance – an important character-defining feature of the historic porches.

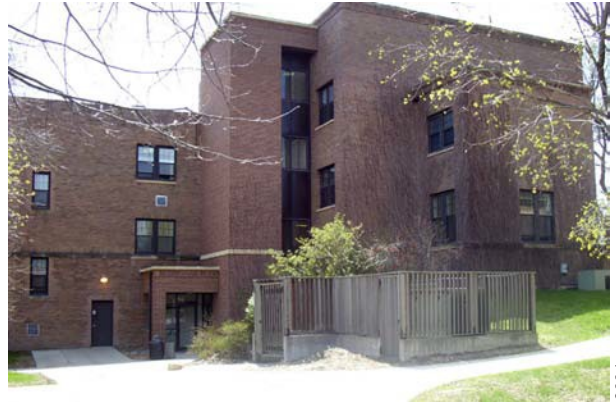
Behmler Hall's 1980s elevator tower addition is tucked into a rear corner. The addition's footprint is minimal and its materials and detailing are compatible.

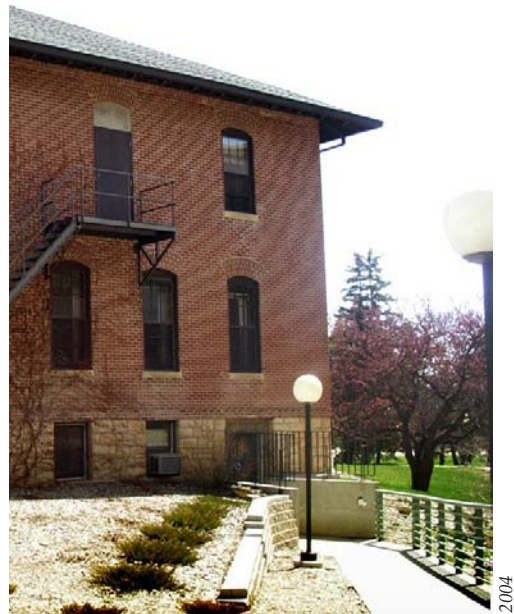
A basement-level door and access ramp were added to the west façade of MRC in 1996.

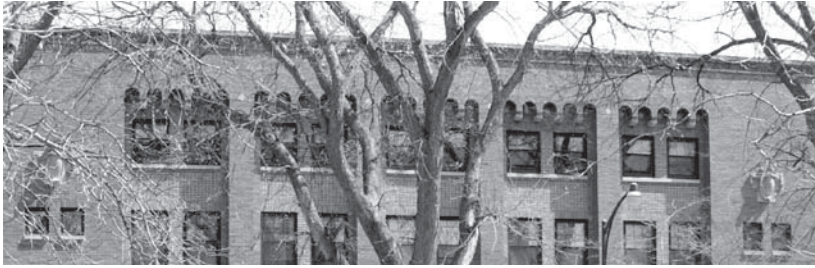
University Bldg 721

Both the 1926 and 1930 projects were designed by the University. A metal exterior stair and concrete loading dock have been added to the rear (east) end. In circa 1960, the main (west) entrances were changed: multi-paned wood doors were replaced with metal doors, the transoms were filled with brick, and cylindrical black entrance lamps were installed. In the early 1980s, a brick elevator tower was added to the north façade.

The building's foundation was stabilized in 1954. Today the building shows signs of settlement with masonry cracking. Ivy is growing on the walls. The

windows and doors appear to be in good condition. The front steps had been deteriorating and were recently replaced with Kasota salvaged from the WCSA Gym.

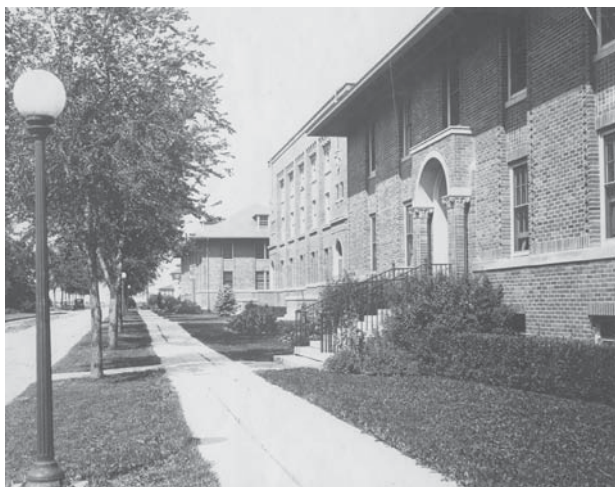
Blakely Hall's main entrance originally matched the entrance of Social Science. Note the clipped hedges and orderly placement of landscape elements.

The original slate tile roof is now asphalt. In 1966, the main entrance was removed from the third bay, and a window (and dorm room) replaced it. The interior central stairwell was removed and replaced with dorm rooms with east windows smaller than those of the stairwell. At the same time, a brick stair tower was added to the north end, becoming the main entrance. The removal of the front entrance had the effect of erasing one of Blakely Hall's most dominant features, and obscuring its mirror-image design relationship to Social Science.

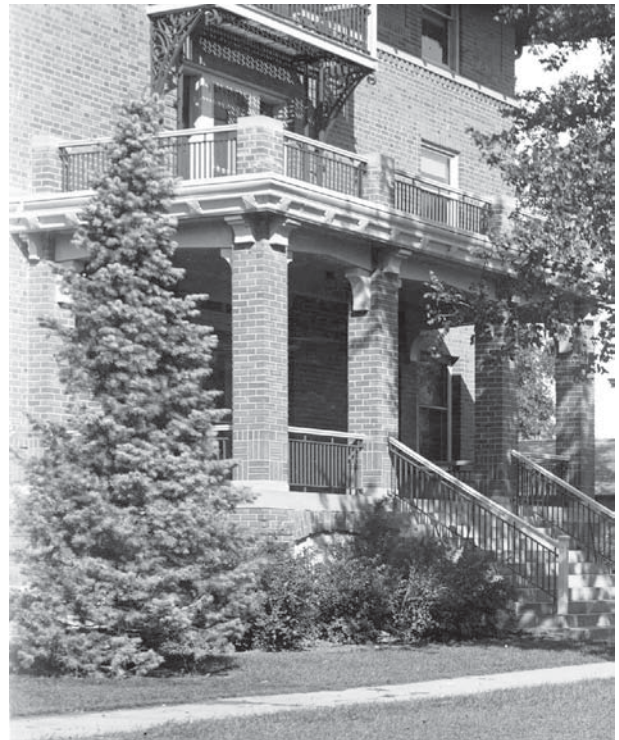
Assimilation

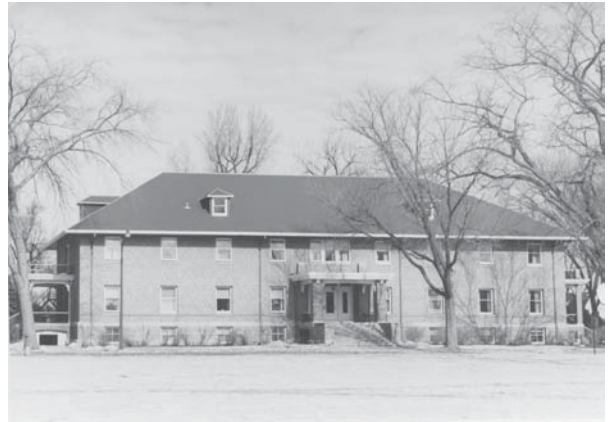
education of high school students was the focus from October to March, much of the rest of the year was devoted to research, summer outreach programs, and farm visits.

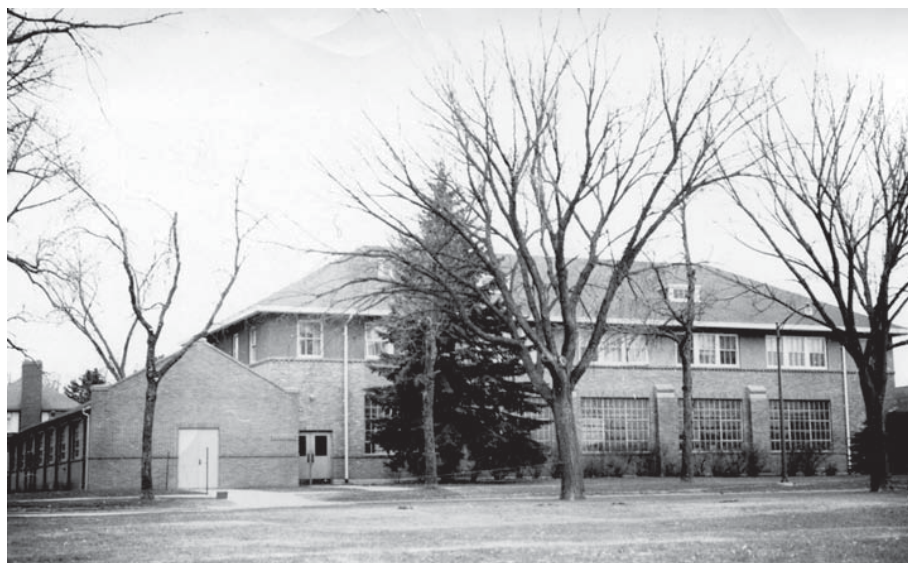
improvements in this advancement, and about the value of farming as a lifestyle that was viable in the modern world.³

- [4] All windows should be inspected and repaired or, if required, replaced to match historic original. Return openings to original size where they have been reduced, and retain existing segmental-arched openings. The original first-floor industrial-style metal windows should be recreated with appropriate energy efficient windows.

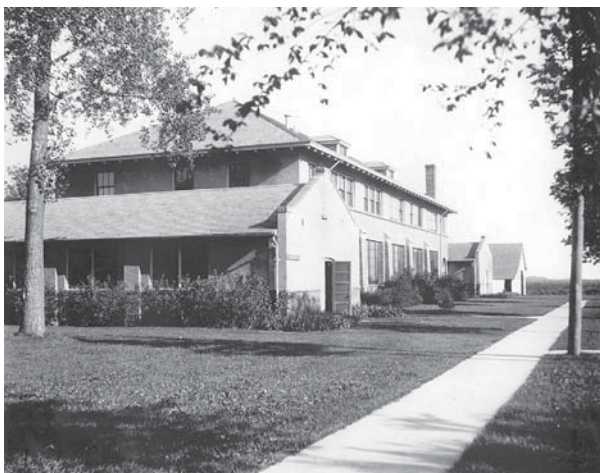
The experiment station at Morris was the third of five regional branches of the Minnesota Agricultural Experiment Station headquartered at the University’s “St. Paul” campus. Agricultural experiment stations grew from two important federal laws: the Hatch Act of 1887, which established federal funding for experiment stations and attached them to land-grant colleges, and the Smith-Lever Act of 1914, which established a system of federally-funded county agricultural outreach agents. (The experiment station at Morris, originally operated in conjunction with the agricultural high school, outlived the high school and still operates. Its fields abut the eastern side of the current UMM campus and its headquarters are located about one mile east of UMM. The station is now called the West Central Research and Outreach Center or WCROC.)

- [8] Retain the original ceilings on the north and south wings. Retain original second-story interior features if possible.
- [9] Replace the steel entrance doors on the main façade with a more historically compatible alternative. (Available historic photos do not clearly show the original doors; look for additional historic photos to help guide the choice.)

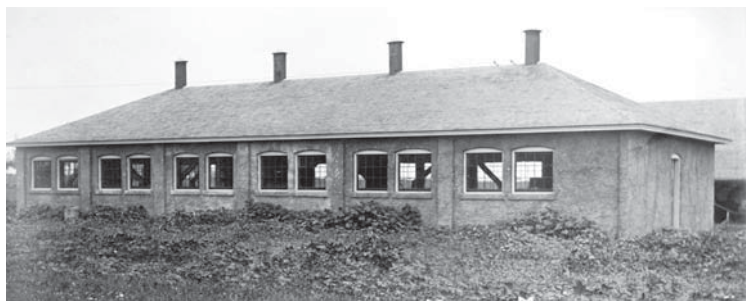
The WCSA Blacksmith Shop, built in 1911, was incorporated as the north wing of Community Services (Engineering) when the larger building was constructed in 1915. This wing housed about ten forges at which WCSA students learned metalwork.

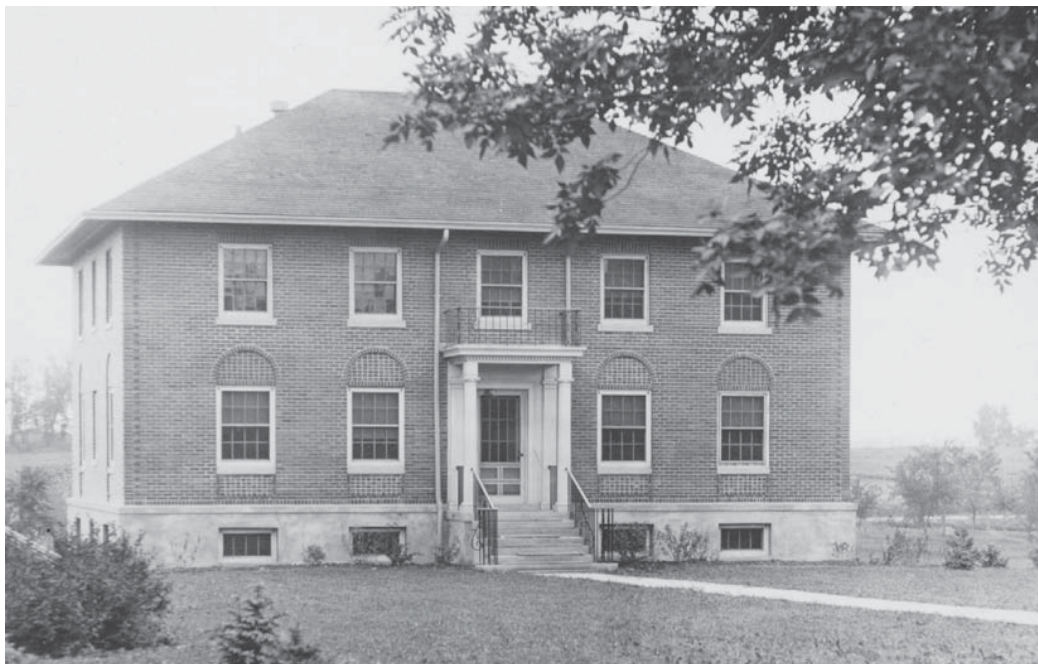
Serving beef at a Station Day picnic.

The Infirmary (now Education) shortly after completion. The building's detailing, windows, and front porch are well preserved.

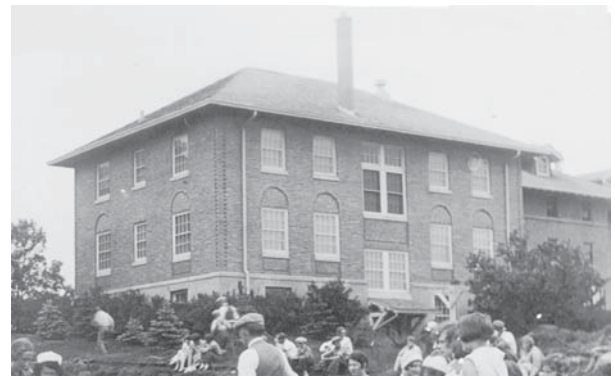
Education's foundation was stabilized in 1954. The building was last reroofed in 1994. In 1995, some of the Kasota steps were replaced in-kind; today several steps show severe flaking and spalling. The stone and tile porch floor has settled and cracked. The porch's wood columns and other detailing need attention to prevent deterioration. All four façades show considerable settlement cracking, especially near the windows. Ivy is growing on most walls.

Education's west and south elevations.

- [5] Remove ivy from the exterior.
- [6] Because Education shows evidence of settling, assess and correct soil conditions before any exterior repointing. When soil is stabilized, correct drainage problems and repair masonry using best preservation practices.

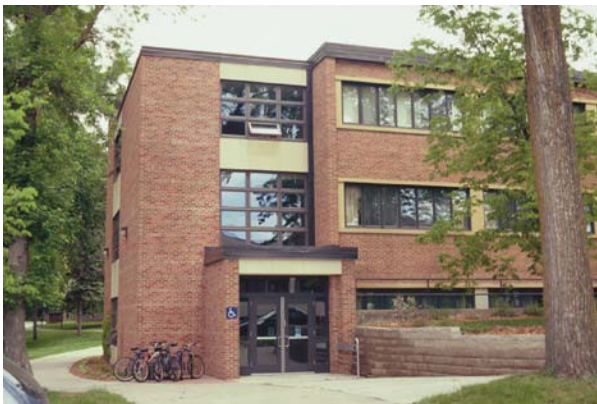
2004

This recent stair tower addition to the Humanities Building respects its brick, stone color, fenestration and massing. Humanities is a modern-era building whose durable materials and siting complement the Mall area.

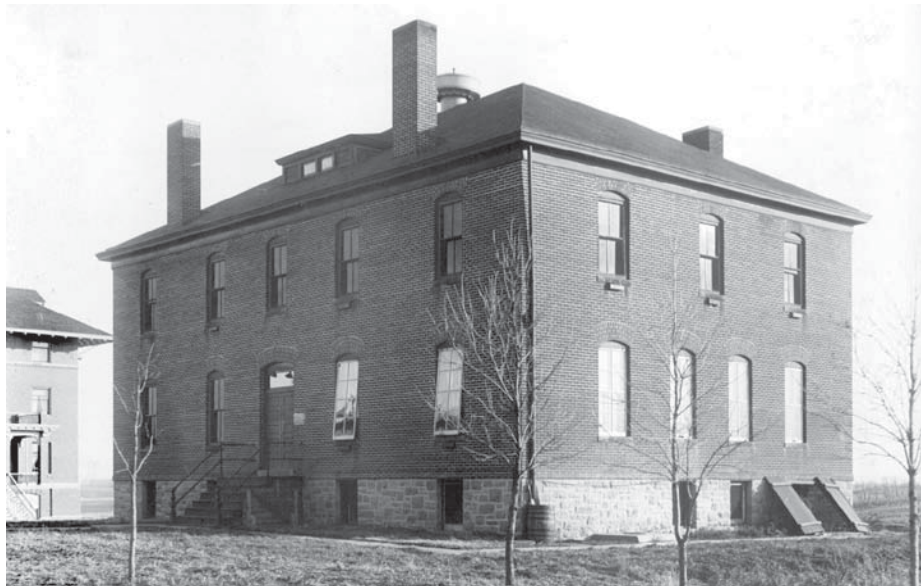
ca. 1914, University Archives, U of M

The building before Clarence H. Johnston, Sr., designed 1921 alterations to make it match Camden and Spooner Halls. Spooner Hall is at left.

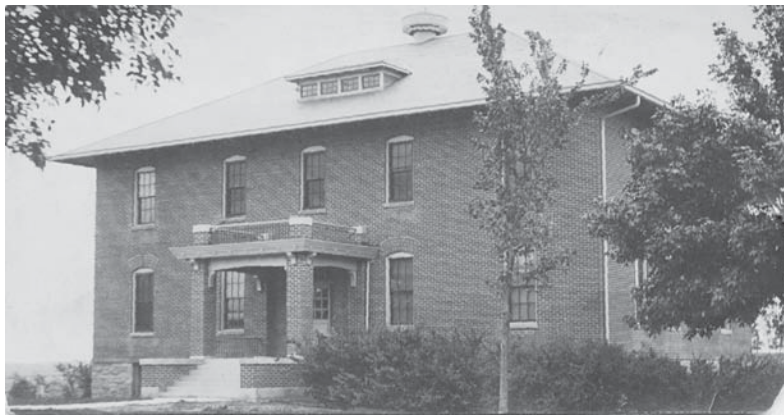
The MRC while it was called Music Hall.

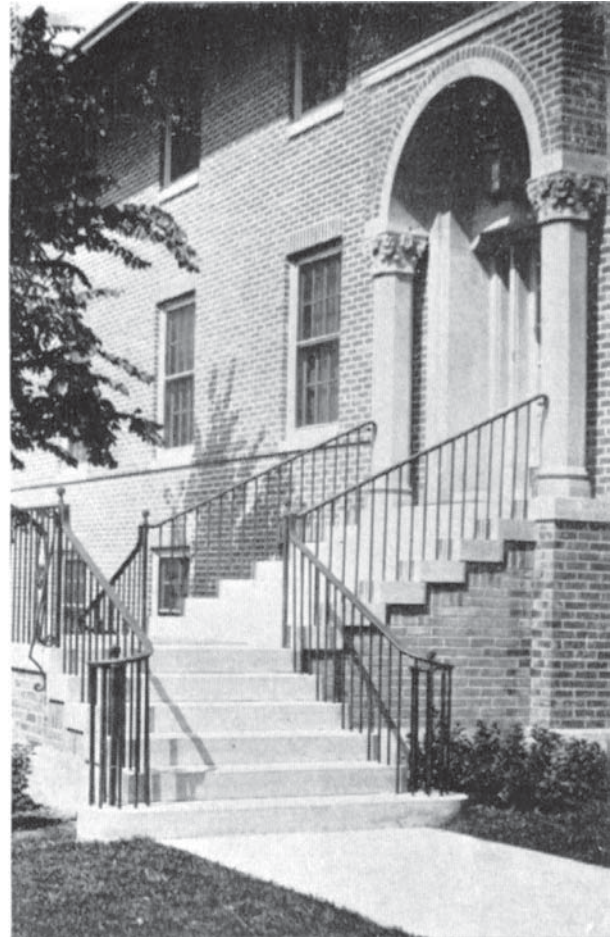
Pine Hall's main entrance with double stairway and stone columns was removed in 1968.

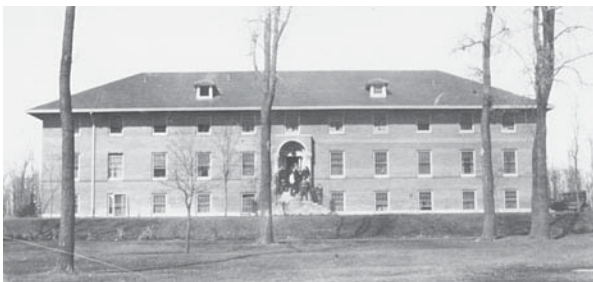
Pine Hall's main facade with its original front entrance.

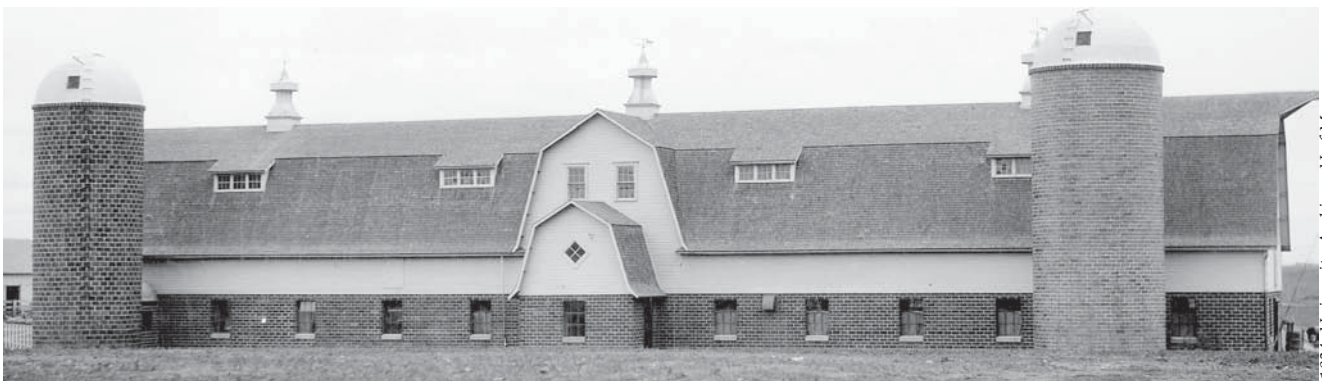
At 175 feet long, the Cattle Barn is an impressive structure. Silos on the west façade (now gone) were built of hollow tile, brick, and later glass-lined steel. The roof was rebuilt after the 1950 hay mow fire.

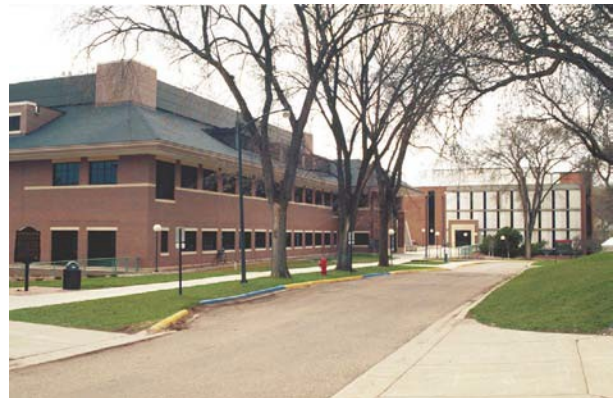
The 2000 wing of the Science Building, at left, was designed to blend with the historic buildings in the district.

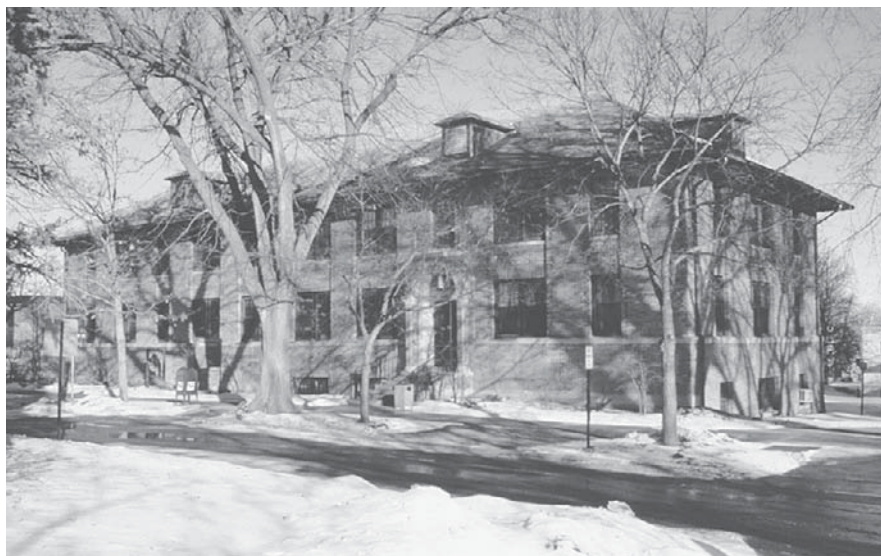
The Social Science Building and Blakely Hall were designed as nearly identical, mirror-image buildings that flank Behmler Hall.

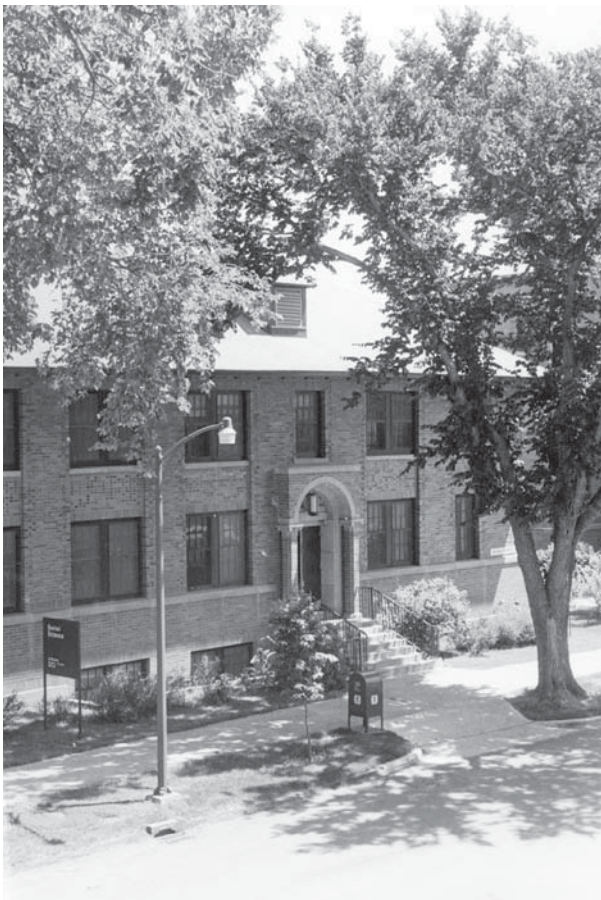
Social Science's main entrance.

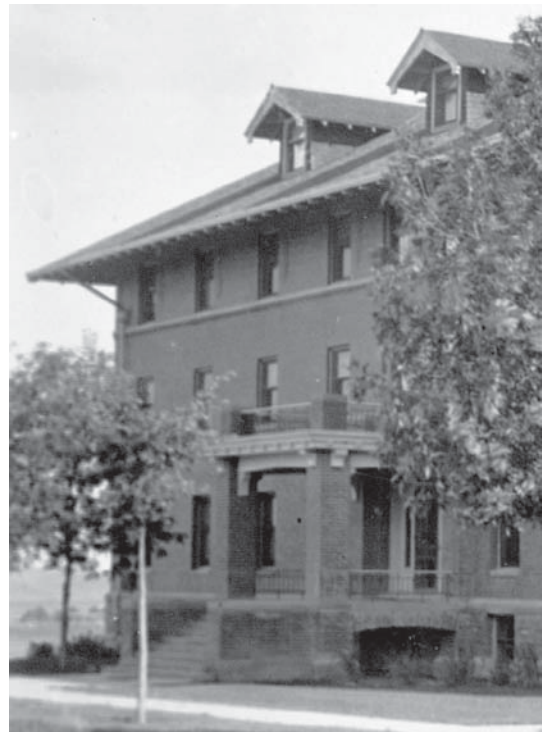
Spooner's front porch.

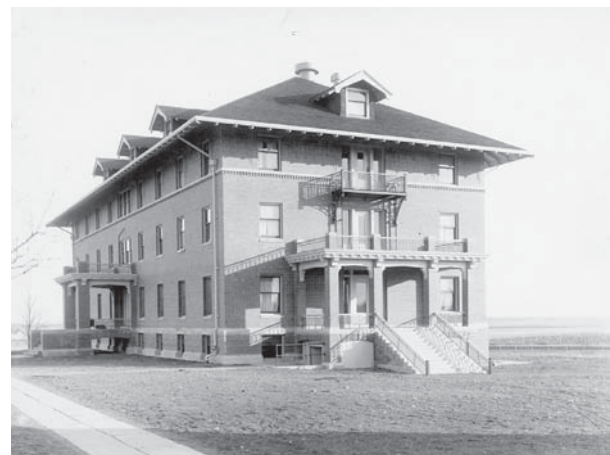
1913, University Archives, U of M

Spoooner Hall and Camden Hall were identical at completion, each with three open porches. Spoooner is shown here.

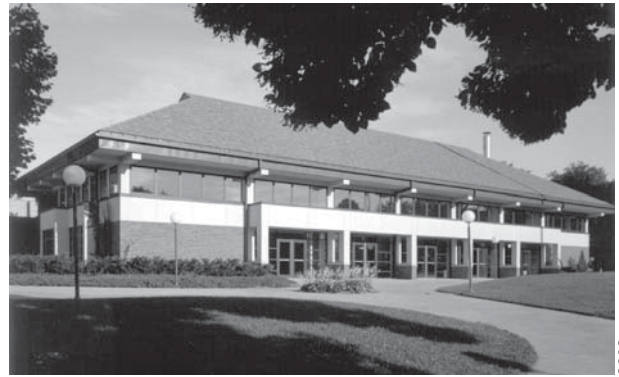
2002

The building's 1992 expansion has a hipped roof to complement the historic buildings around the Mall.

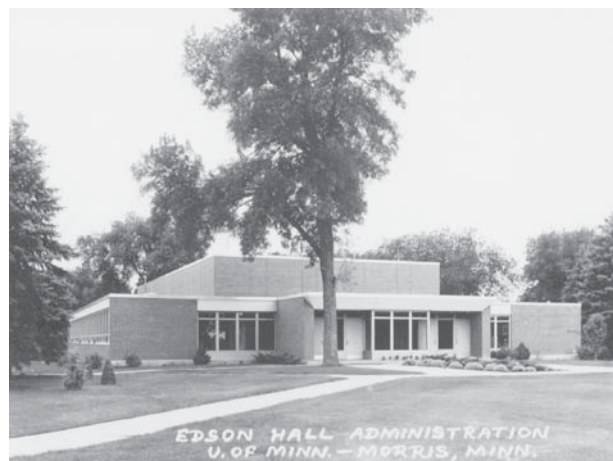
ca. 1960, SCHS

Edson Hall was remodeled in 1992 and renamed the Student Center.

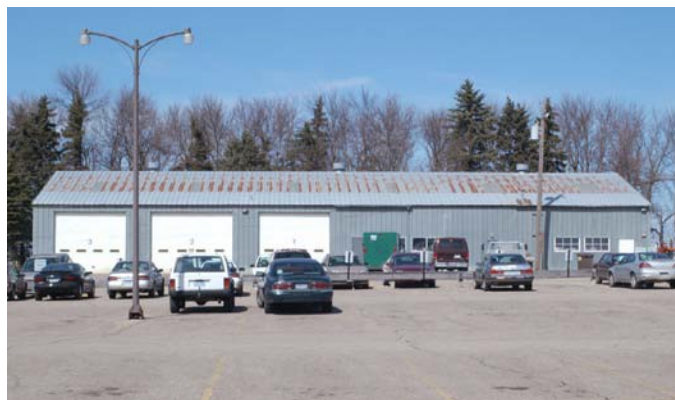
The Transportation Garage was built as the WCSA Machinery Shed. Behind the building is the North Windbreak.

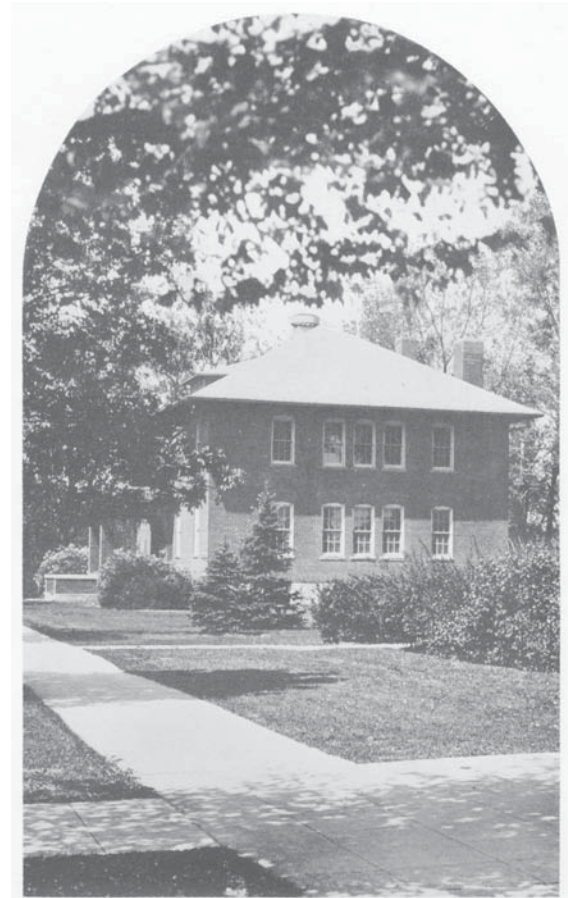
ca. 1930, WCMHRC

The WCSA Home Economics Building was built in 1898 by the federal Indian School as a girls' dormitory. It was razed in 1954 to make way for the present-day Humanities Building.

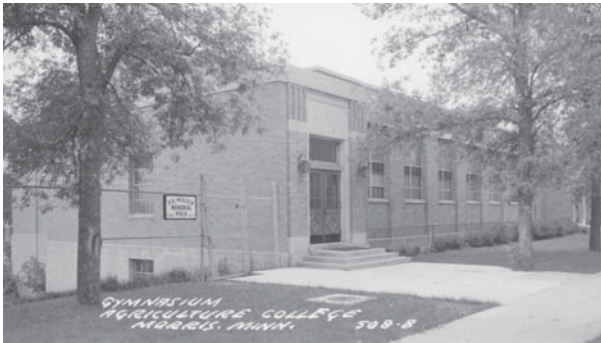
ca. 1940, SCHS

The WCSA Gymnasium was built in 1931 and demolished about 1999. It is one of few major WCSA buildings to have been razed.

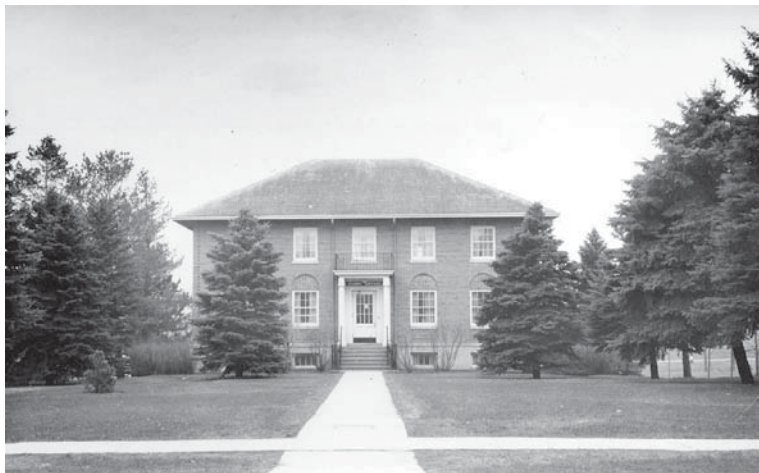
1967, UIMM

Education's front porch and other architectural elements have largely been preserved. The building was constructed in 1923-1924 as the WCSA Infirmary.
