## Shoreline Situation Report Gloucester County, Virginia

# Shoreline Situation Report GLOUCESTER COUNTY, VIRGINIA

Special Report In Applied Marine Science and Ocean Engineering Number 83 of the

VIRGINIA INSTITUTE OF MARINE SCIENCE  
Gloucester Point, Virginia 23062

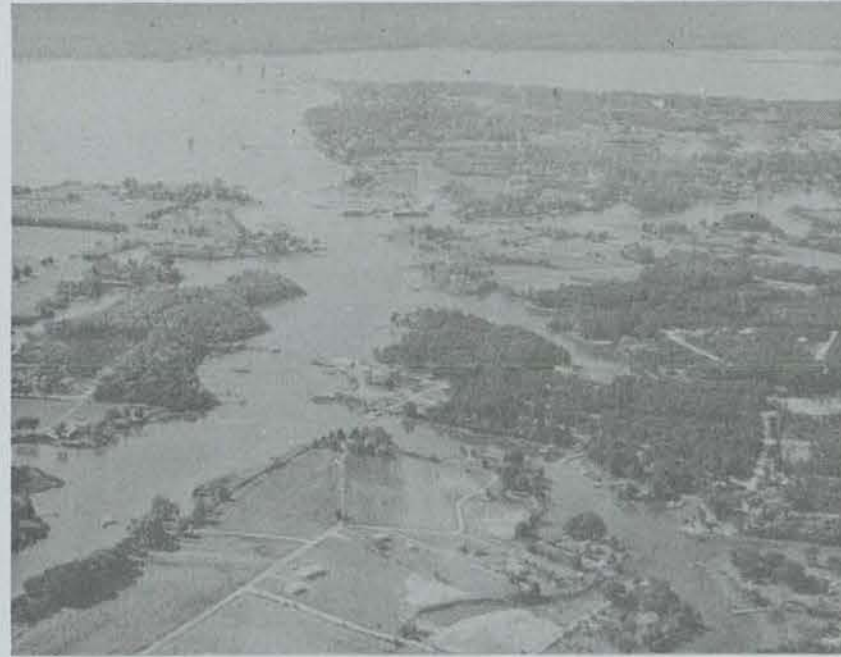
FIGURE 4

Erosion is but one of several problems which face the users of Gloucester County's shoreline. An ever increasing problem is the deterioration of the water quality. Increasing residential and commercial development and the lack of adequate sewage treatment facilities have led to several closures of shellfish grounds (Figure 4, Map 1E). Related actions such as over-fertilization of

FIGURE 4: Commercial and residential pollutants have closed Sarah Creek to shellfishing. Planning should be instituted to prevent the degradation of water quality in this and other creeks.

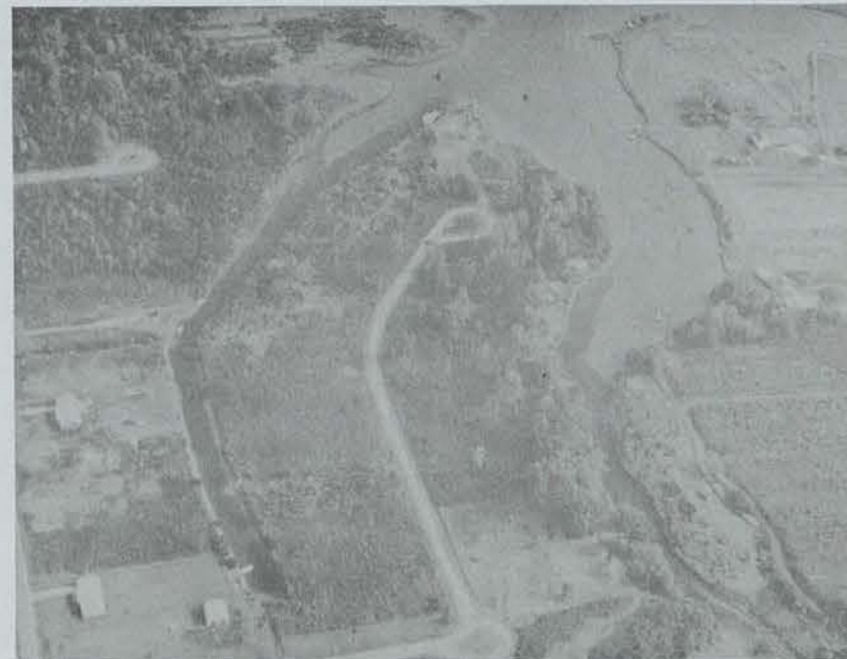
FIGURE 5

lawns and over use of pesticides also contribute to the degradation of the water quality. Localized reduction in water quality is typified by actions such as those illustrated in Figure 5. This type of dredging creates an unproductive bottom due to the lack of circulation within the lower sections of the canal.

FIGURE 5: Dredged dead end canals like these on the Severn River are generally discouraged. The canals have not caused an increase in boat use because extensive flats are located between them and the river channel. Dead end canals can also produce biological deserts on their bottoms. This is a result of lack of circulation in the lower water layers.

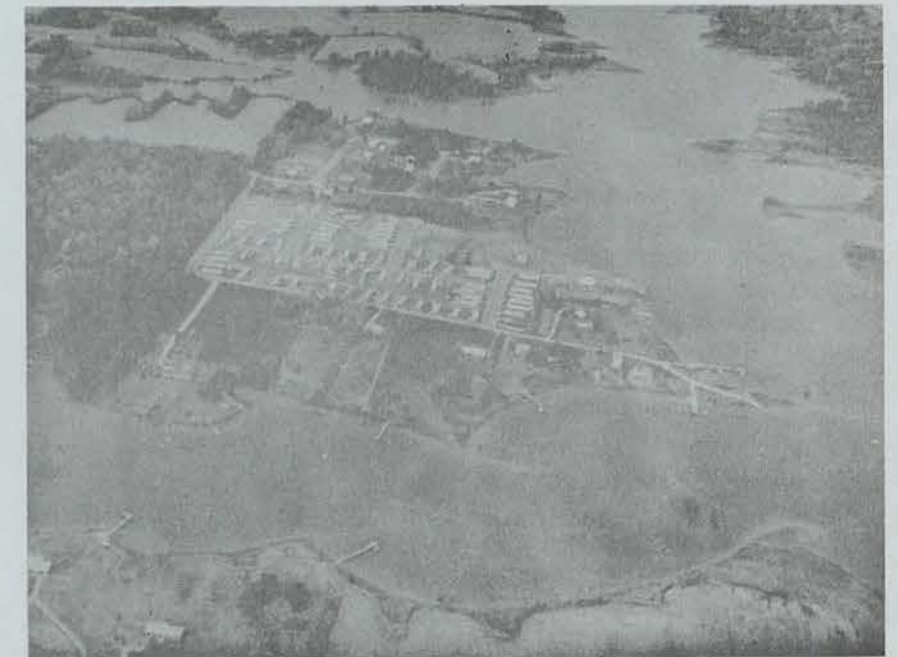
FIGURE 6

FIGURE 6: Intensive developments such as this can lead to a degradation of the water quality. Septic fields are only marginally effective and are easily flooded. The flood hazard is high for most of Gloucester's shoreline.

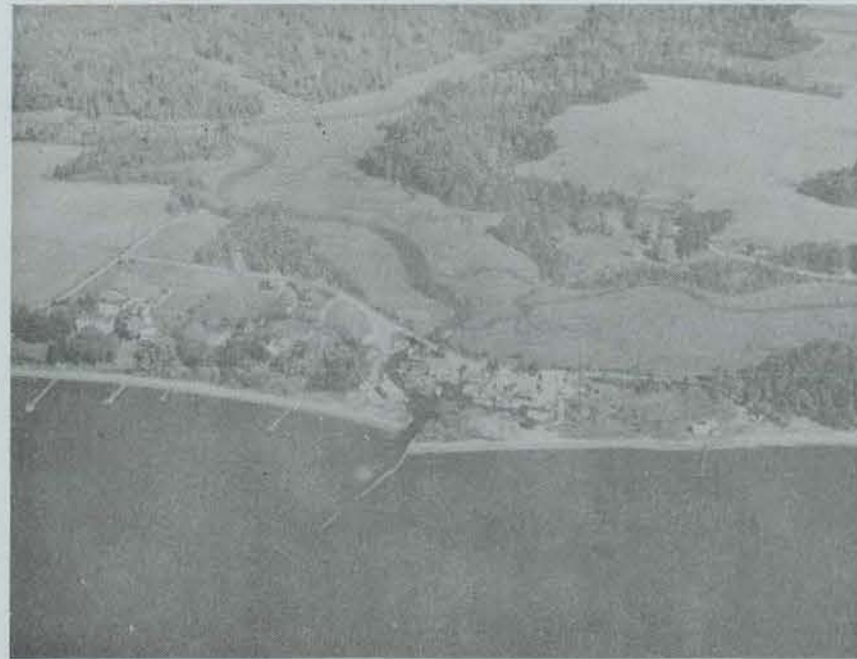
FIGURE 7

FIGURE 7: The Fox Creek area has the potential of being a good shore oriented public recreational facility. An area such as this could be developed publicly or privately to meet the county's growing recreational demand.

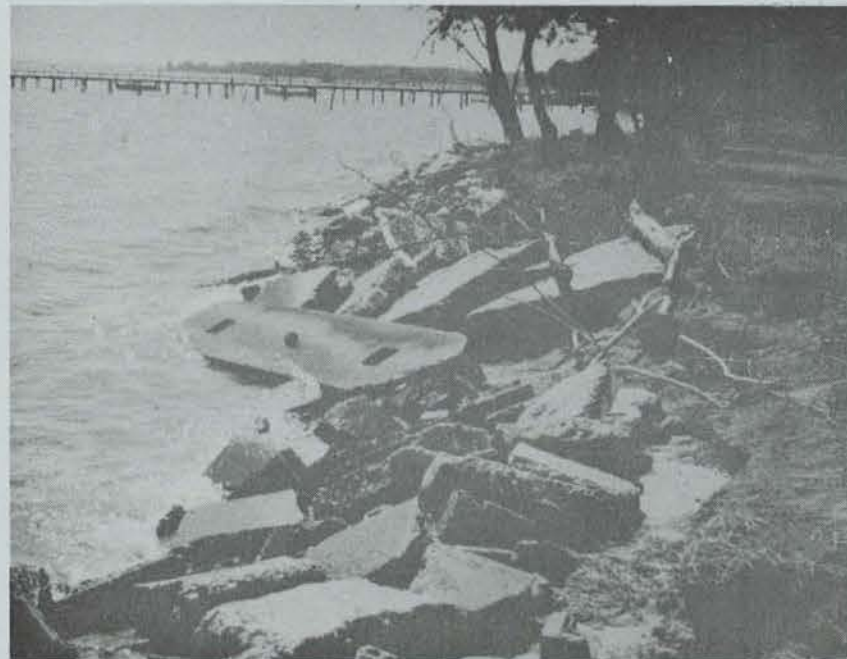
FIGURE 9

FIGURE 9: When used properly, riprap revetments can be very effective at slowing erosion. Proper application includes the use of filter cloth and adequate size stone. The stones should be placed rather than dumped on the shoreline.
