Shoreline Situation Report City of Hampton, Virginia

Shoreline Situation Report
CITY OF HAMPTON, VIRGINIA

Special Report In Applied Marine Science and Ocean Engineering Number 76 of the

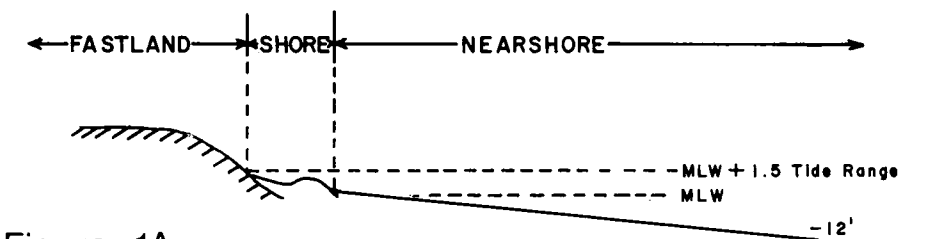
Figure 1A

An illustration of the definition of the three components of the shorelands.

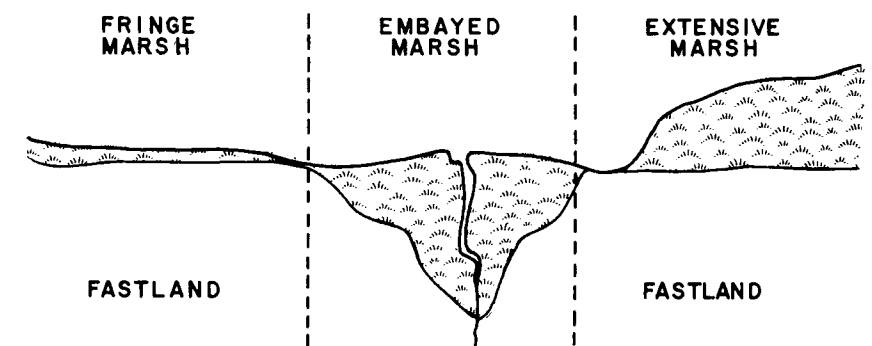
Figure 1B

A generalized illustration of the three different marsh types.

The physiographic character of the marshes has also been separated into three types (see Figure 1B). Fringe marsh is that which is less than 400 feet in width and which runs in a band parallel to the shore. Extensive marsh is that which has extensive acreage projecting into an estuary or river. An embayed marsh is a marsh which occupies a reentrant or drowned creek valley. The purpose in delineating these marsh types is that the effectiveness of the various functions of the marsh will, in part, be determined by type of exposure to the estuarine system. A fringe marsh

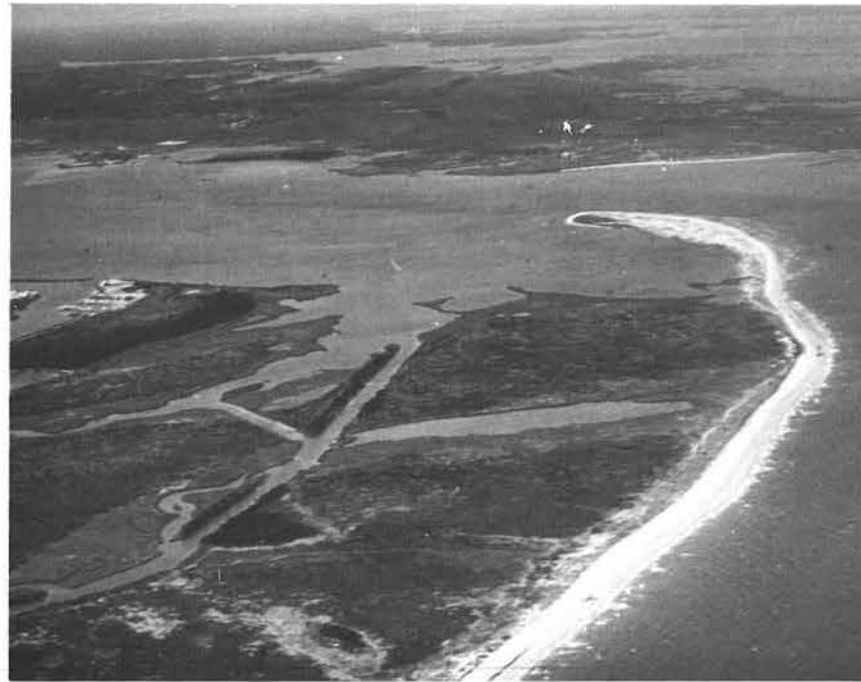
Figure 2

Figure 2: Northend Point and the Back River from near Grand View. The dune area is the site of an experimental grass planting. Most of the marsh is city owned.

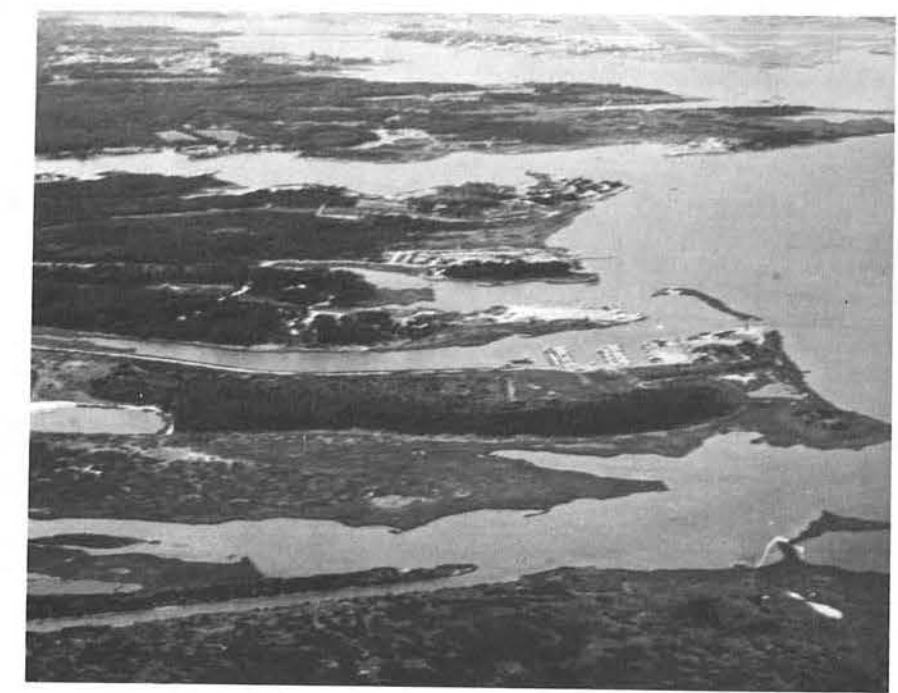
Figure 3

Figure 3: Hampton and Sunset Creeks, the city's sole industrial-commercial shore area.

The bulk of the privately controlled portions of the city's shorelands are classified for residential use. Other than some of the lower portions of the Hampton River and Sunset Creek, (Figure 3) very little of the shoreline is involved with commercial or industrial uses. Some of the lands bordering on the Back or Harris Rivers (Figure 4) are very little used and are classified either as agricultural or unused shorelands.

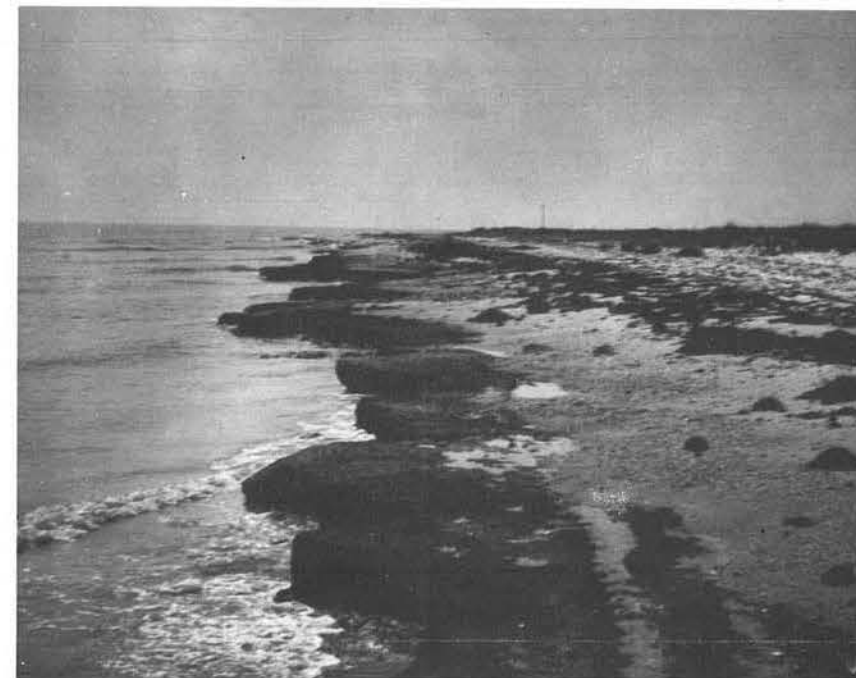
Figure 5

Figure 5: The beach north of Grand View. As the beach retreats over the marsh, peat blocks erode out of the thin beach face.

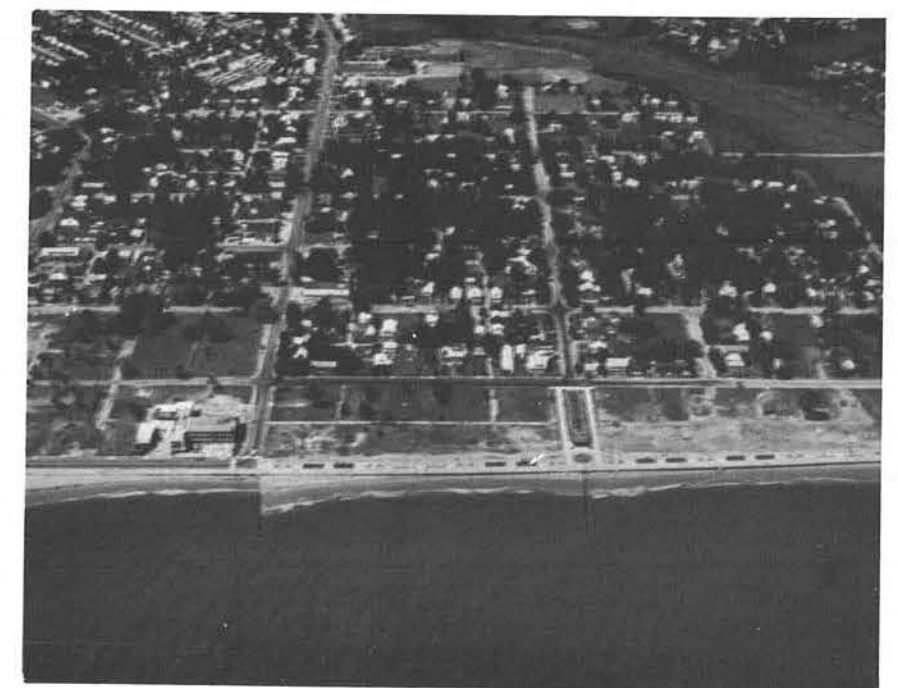
Figure 6

Figure 6: Seawall north of Buckroe. The groins are approximately 200 feet long and 600 feet apart.

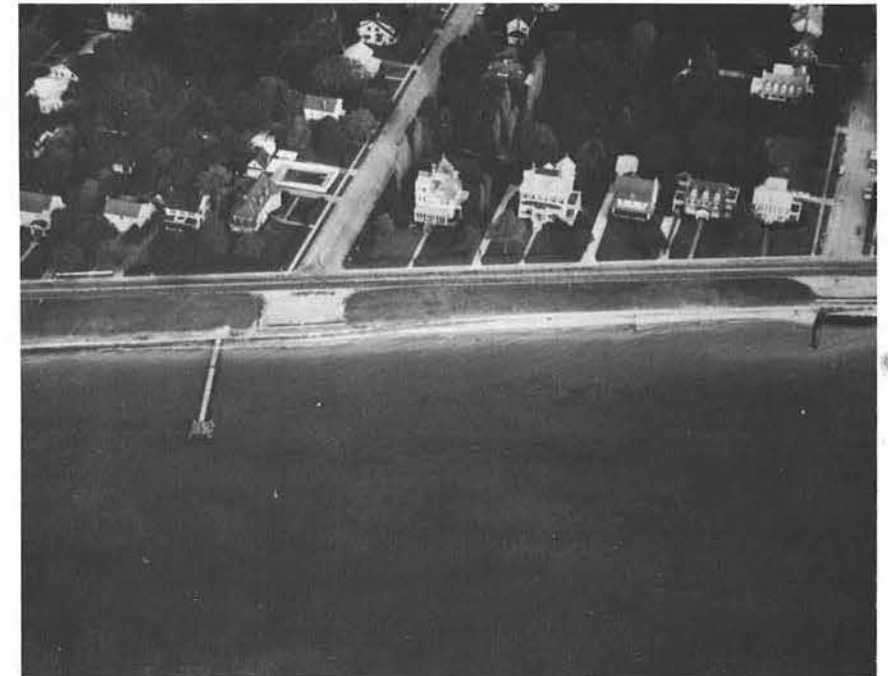
Figure 8

Figure 8: The Wythe area of Hampton on Hampton Roads. Most of the shoreline of this segment has been bulk-headed to the detriment of the beach. A better beach might be established through a program of artificial nourishment.

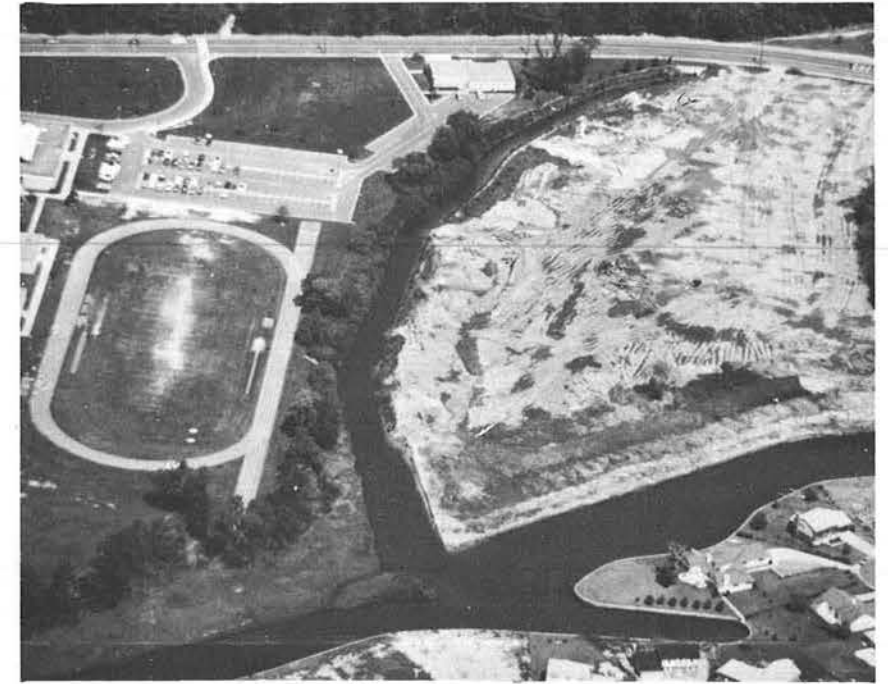
Figure 10

Figure 10: Hampton Creek near Syms Junior High School. The area is an example of dredge and fill canals dug into existing small creeks and upland areas to produce waterfront property.

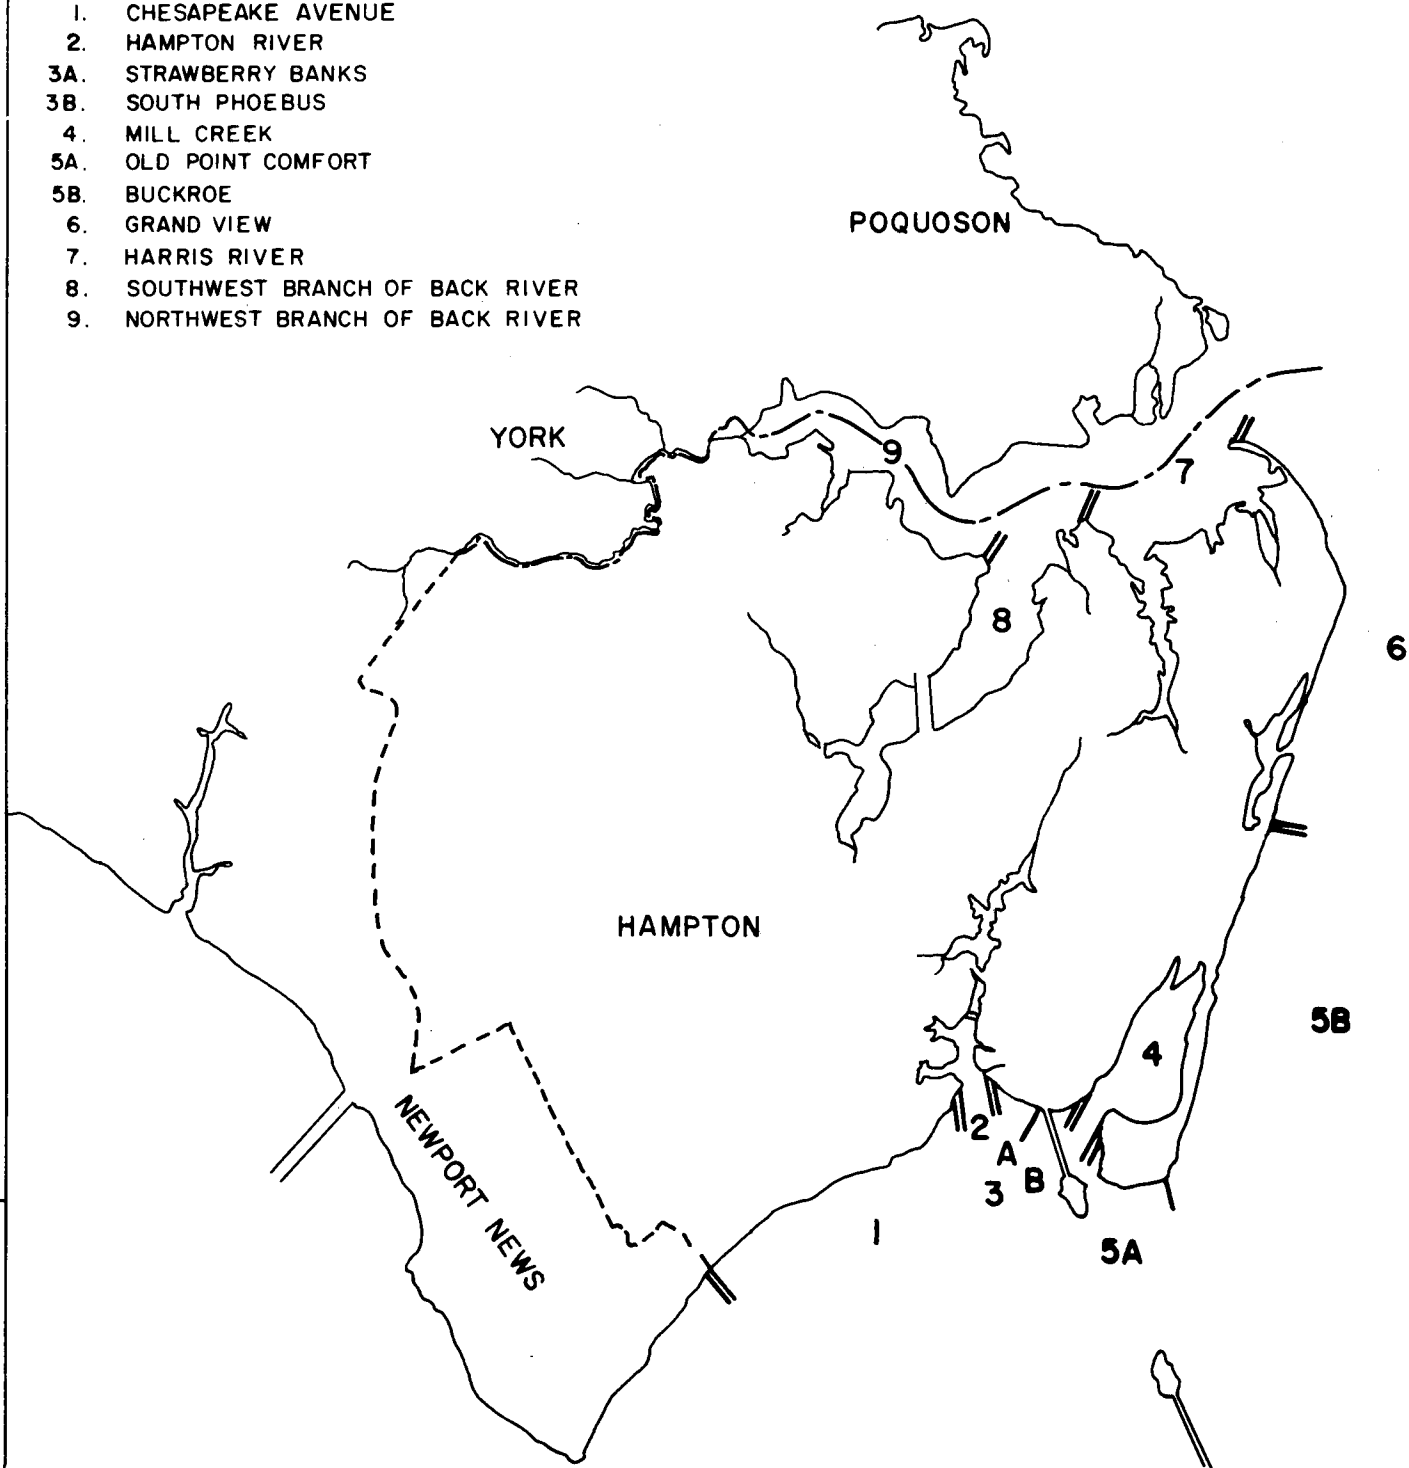
SEGMENT LOCATION MAP

- 1. CHESAPEAKE AVENUE
- 2. HAMPTON RIVER
- 3A. STRAWBERRY BANKS
- 3B. SOUTH PHOEBUS
- 4. MILL CREEK
- 5A. OLD POINT COMFORT
- 5B. BUCKROE
- 6. GRAND VIEW
- 7. HARRIS RIVER
- 8. SOUTHWEST BRANCH OF BACK RIVER
- 9. NORTHWEST BRANCH OF BACK RIVER

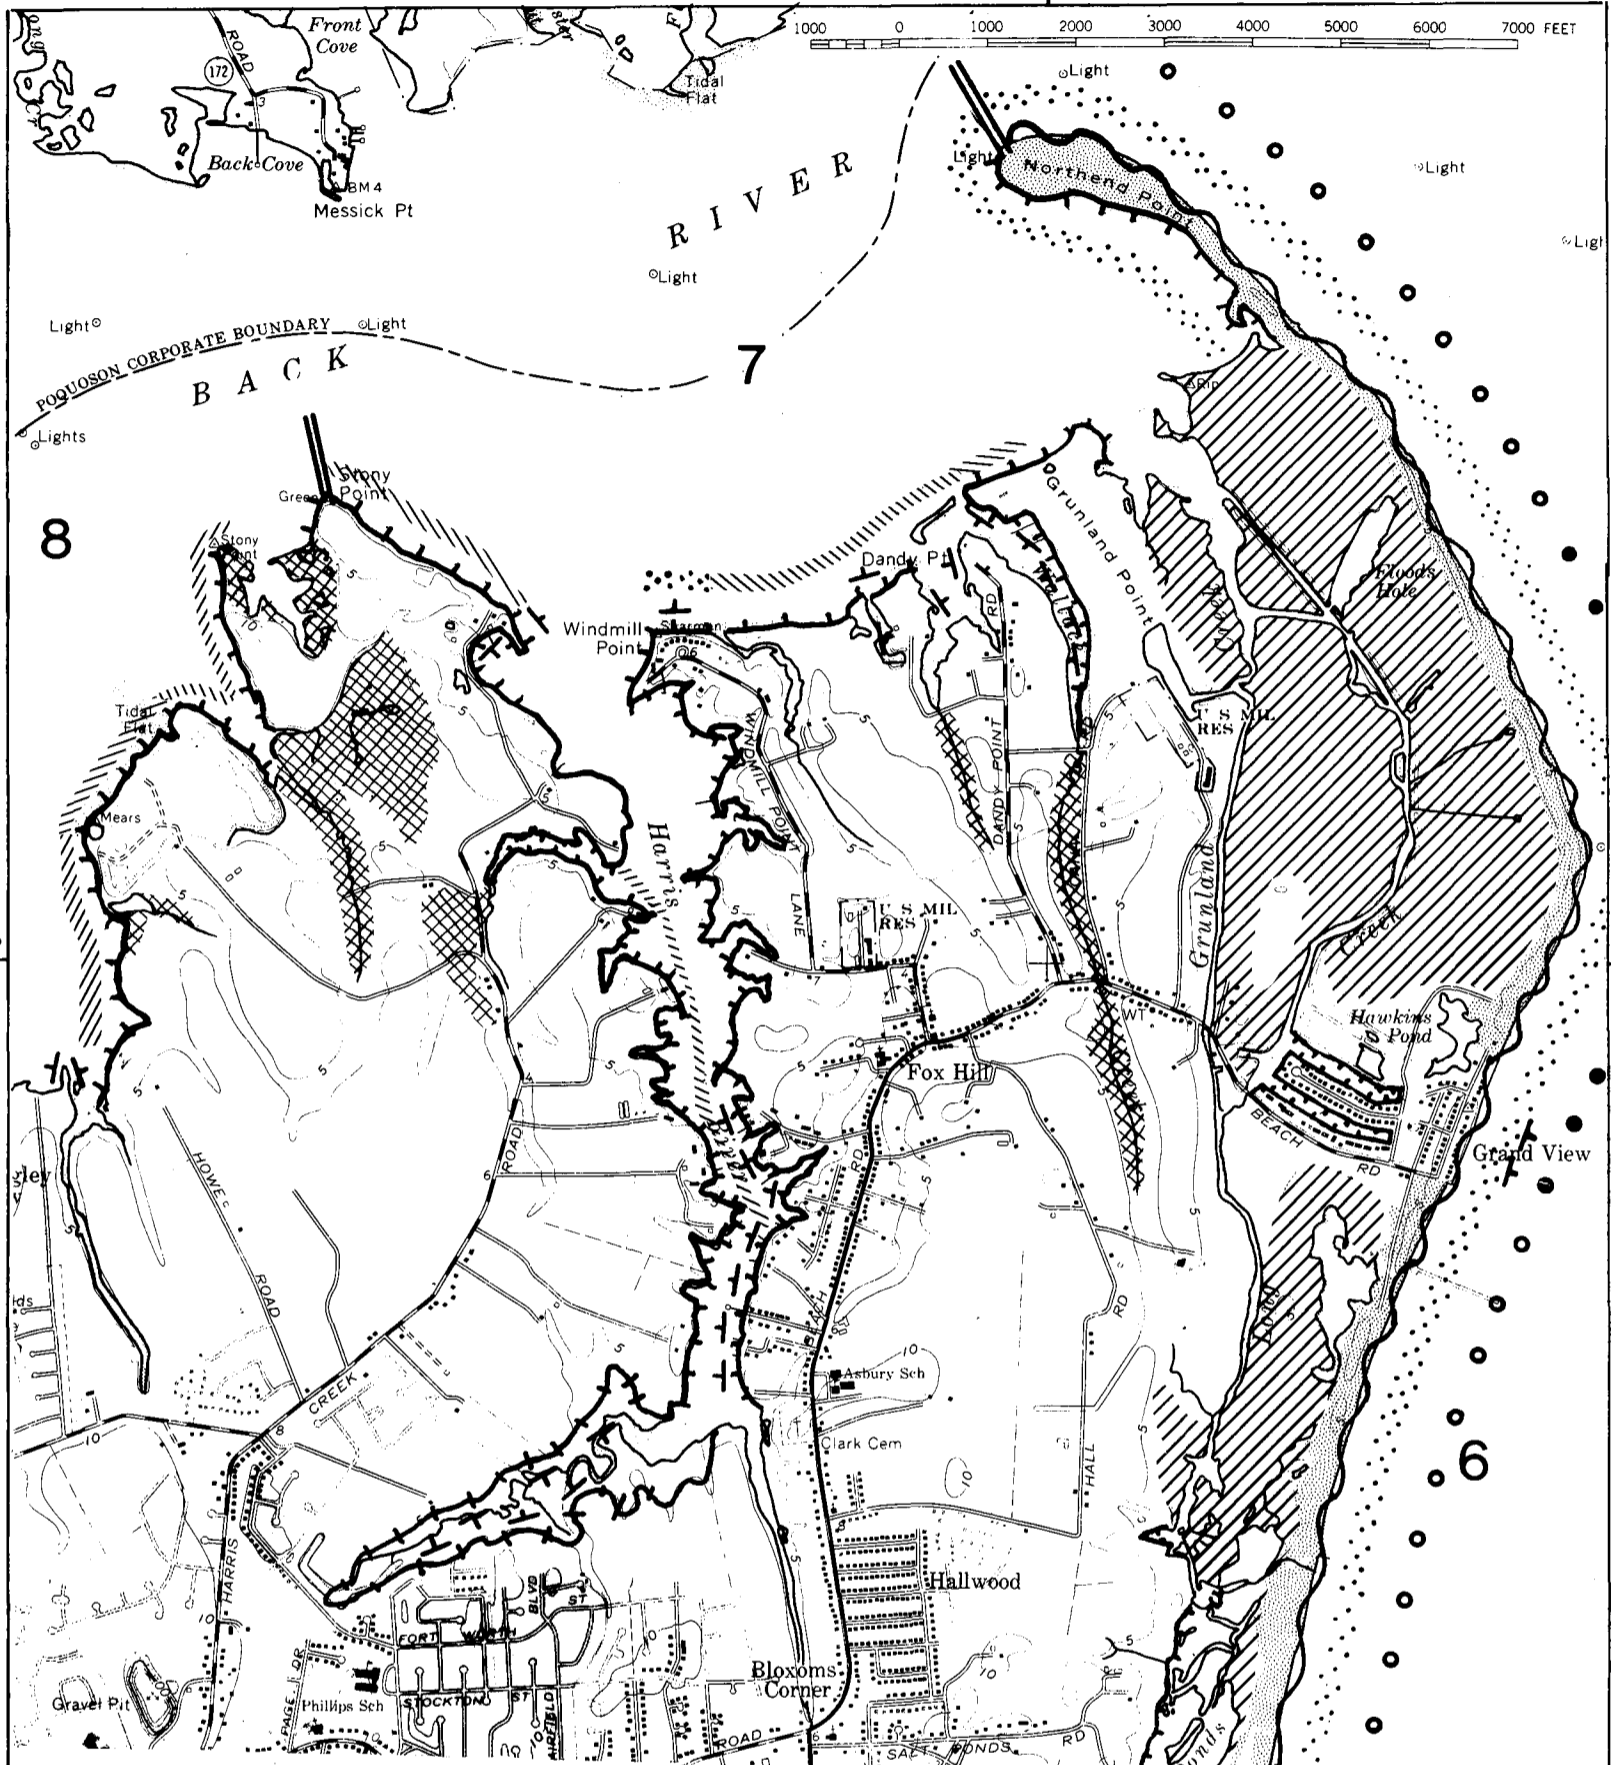
MAP 4B

HAMPTON - GRAND VIEW
SHORELANDS TYPES
 Segments 5B, 6, 7, 8

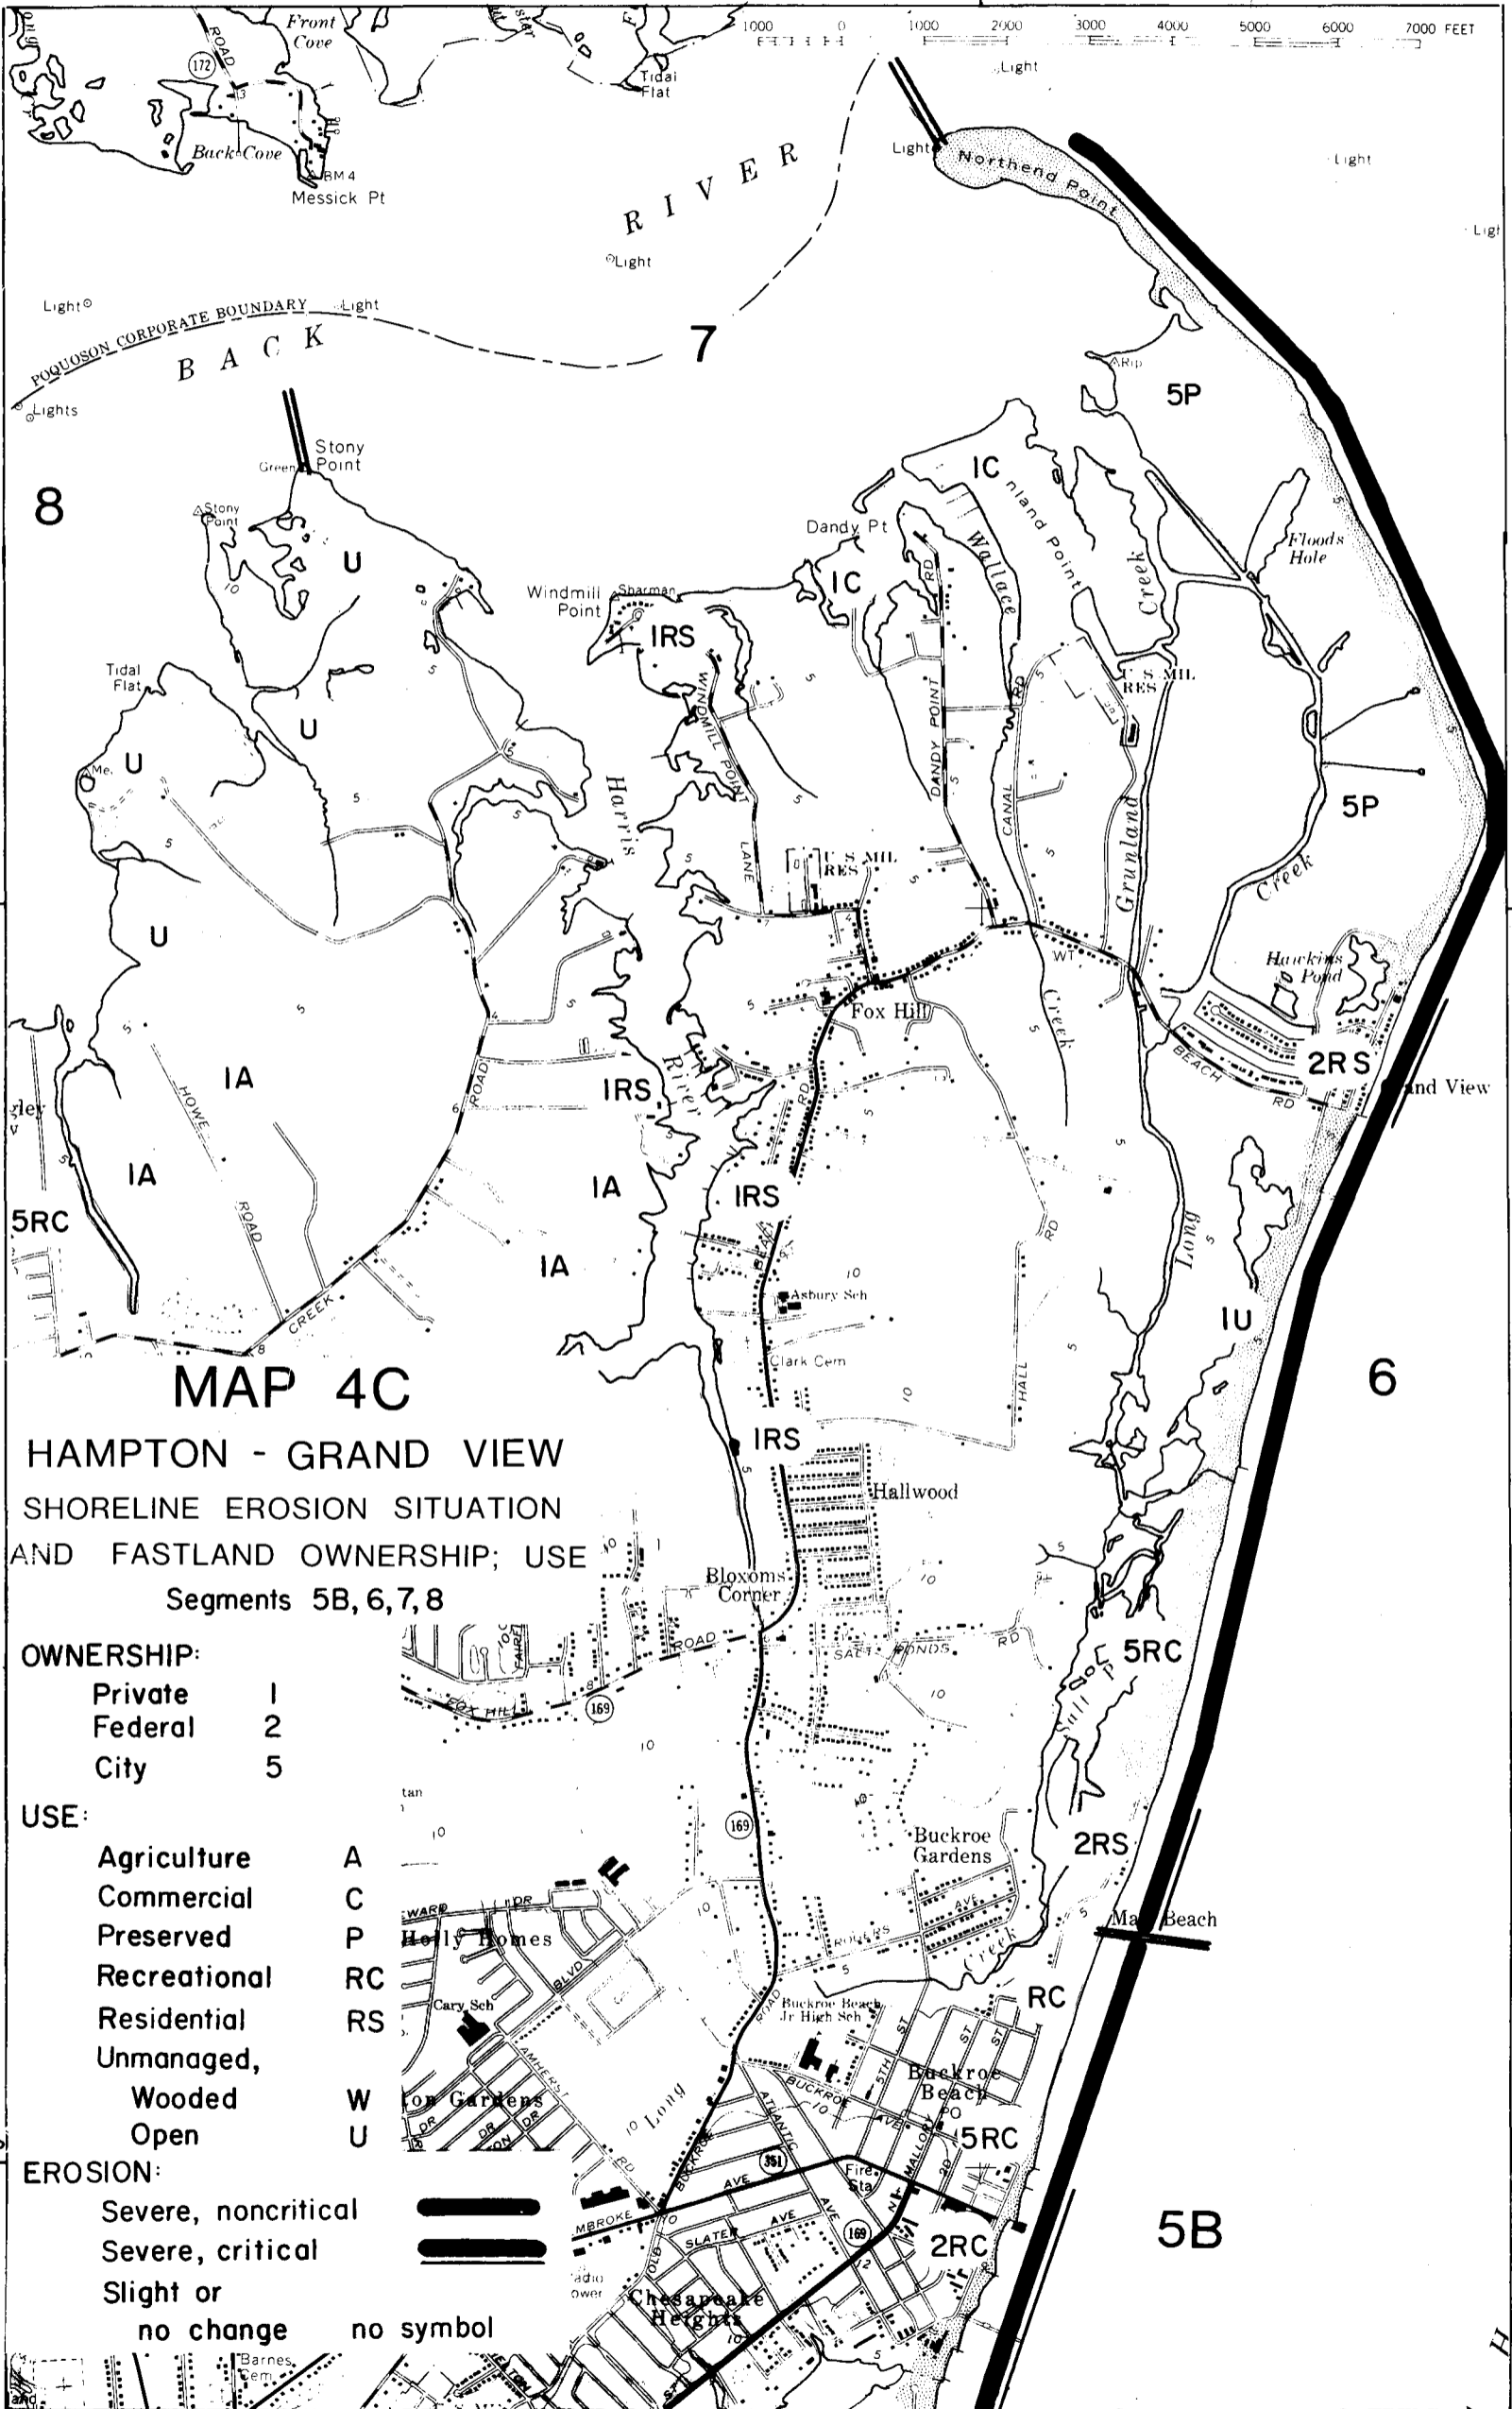
MAP 4C

HAMPTON - GRAND VIEW
 SHORELINE EROSION SITUATION
 AND FASTLAND OWNERSHIP; USE
 Segments 5B, 6, 7, 8

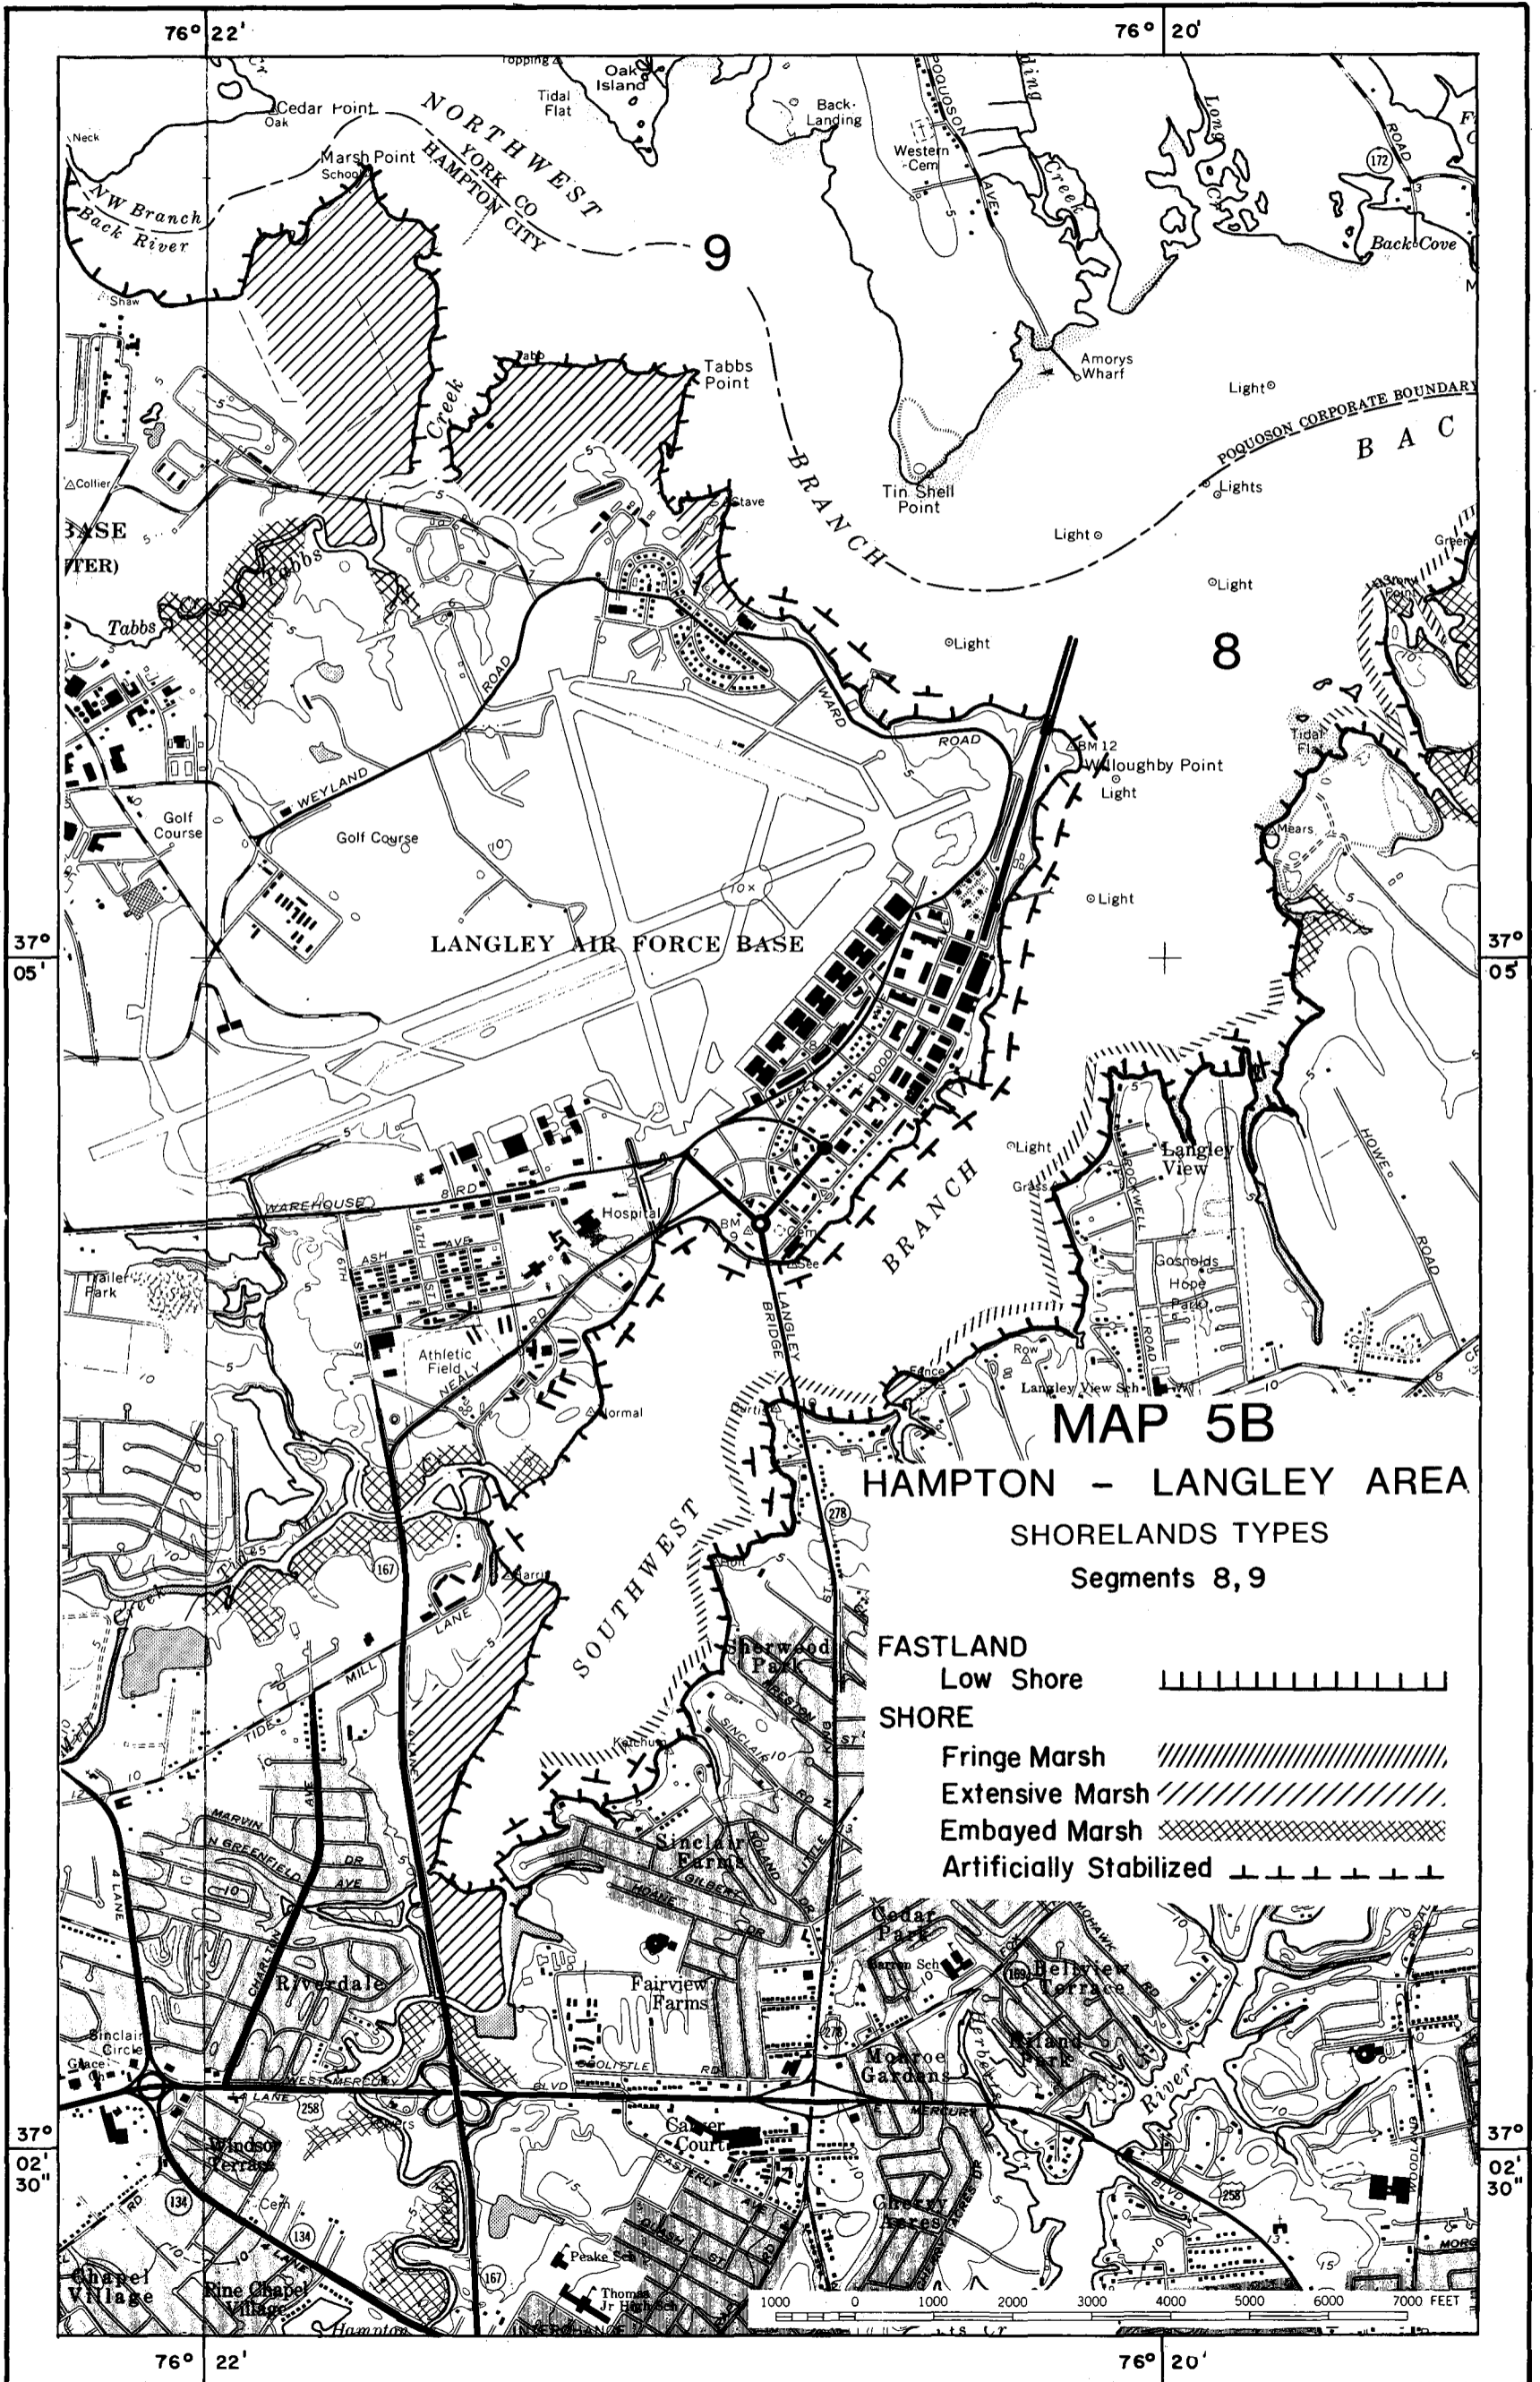
MAP 5B
HAMPTON - LANGLEY AREA
 SHORELANDS TYPES
 Segments 8, 9
