## Shoreline Situation Report New Kent, King William, and King and Queen Counties

Shoreline Situation Report  
NEW KENT, KING WILLIAM, AND KING and QUEEN COUNTIES

Chesapeake Research Consortium Report Number 44  
Special Report In Applied Marine Science and Ocean Engineering Number 99 of the

VIRGINIA INSTITUTE OF MARINE SCIENCE  
Gloucester Point, Virginia 23062

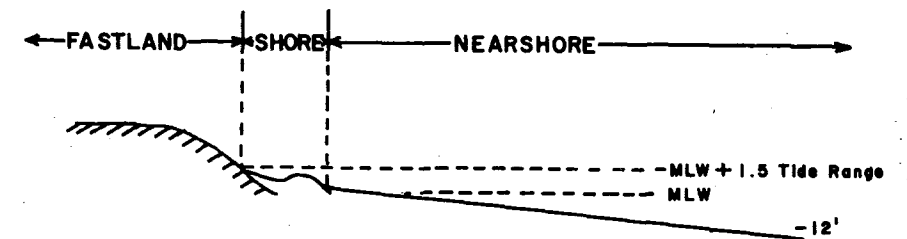
FIGURE 1: An illustration of the definitions of the three components of the shorelands.

be considered as being composed of three interacting physiographic elements: the fastlands, the shore and the nearshore. A graphic classification based on these three elements has been devised so that the types for each of the three elements portrayed side by side on a map may provide the opportunity to examine joint relationships among the elements. As an example, the application of the system permits the user to determine miles of high bluff shoreland interfacing with marsh in the shore zone.

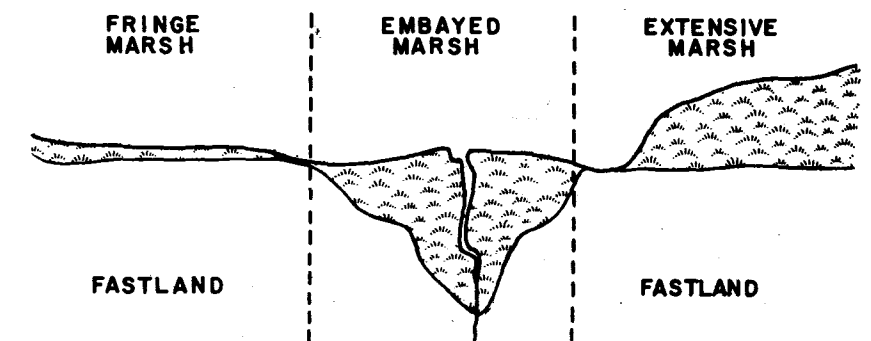
FIGURE 2: A generalized illustration of the three different marsh types.

The physiographic character of the marshes has also been separated into three types (see Figure 2). Fringe marsh is that which is less than 400 feet in width and which runs in a band parallel to the

shore. Extensive marsh is that which has extensive acreage projecting into an estuary or river. An embayed marsh is a marsh which occupies a reentrant or drowned creek valley. The purpose in delineating these marsh types is that the effectiveness of the various functions of the marsh will, in part, be determined by type of exposure to the estuarine system. A fringe marsh may, for example, have maximum value as a buffer to wave erosion of the fastland. An extensive marsh, on the other hand, is likely a more efficient transporter of detritus and other food chain materials due to its greater drainage density than an embayed marsh. The central point is that planners, in the light of ongoing and future research, will desire to weight various functions of marshes and the physiographic delineation aids their decision making by denoting where the various types exist.

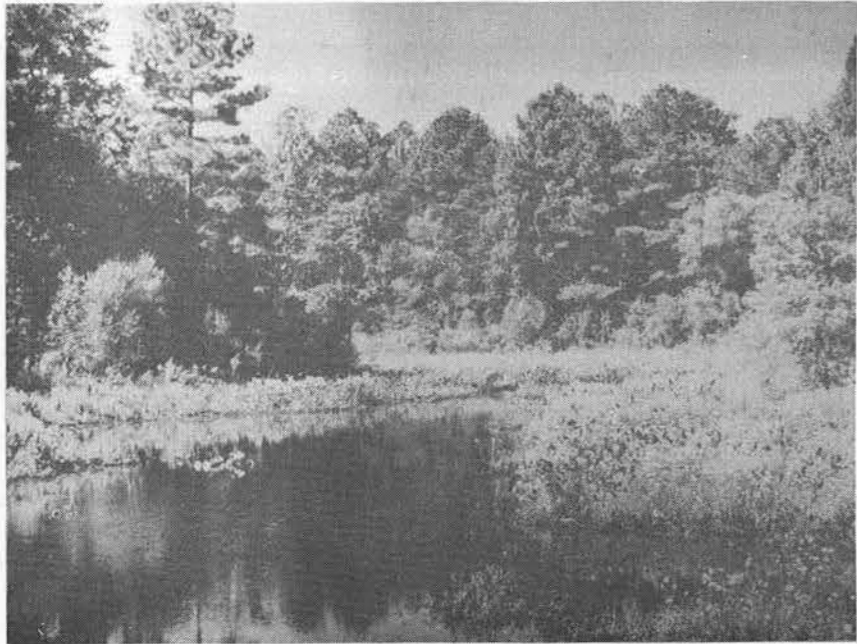
Figure 3

FIGURE 3: A portion of Diascund Creek in New Kent County. This is a very valuable area of fresh water wetlands.

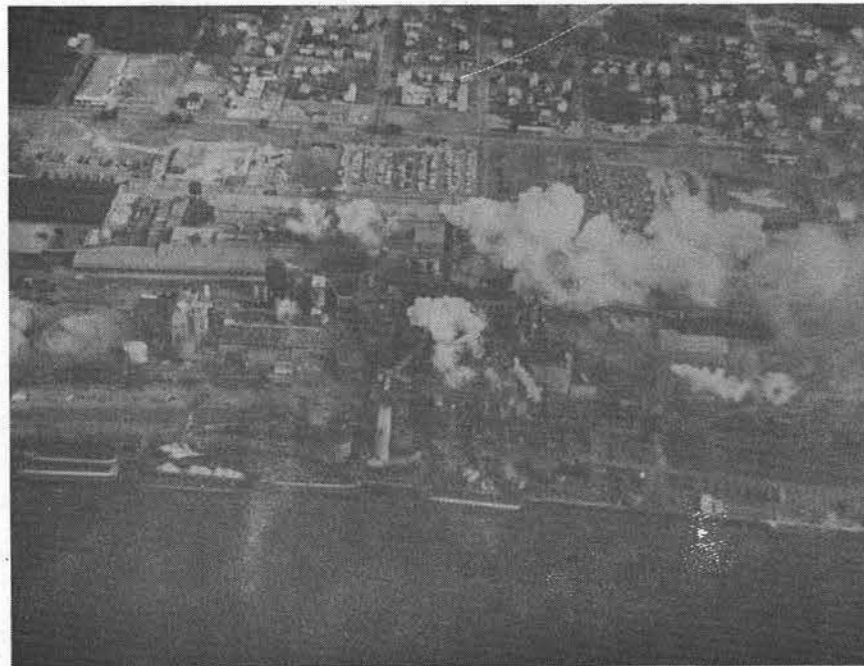
Figure 6

FIGURE 6: The Pamunkey River near its mouth at West Point. This is the only industrial area along the tri-county shore zone.

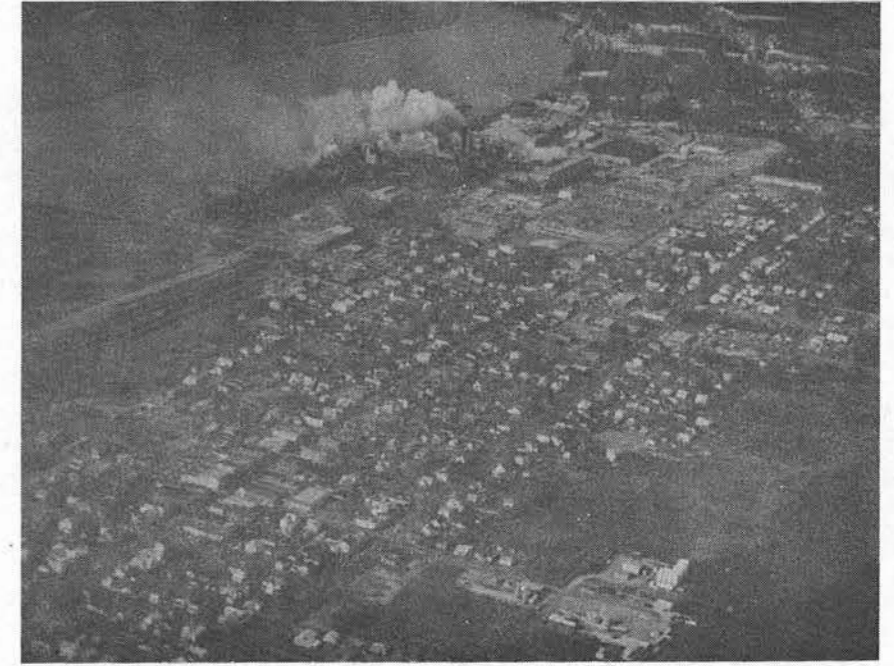
Figure 7

FIGURE 7: An overview of the city of West Point from the Mattaponi River across to the Pamunkey.

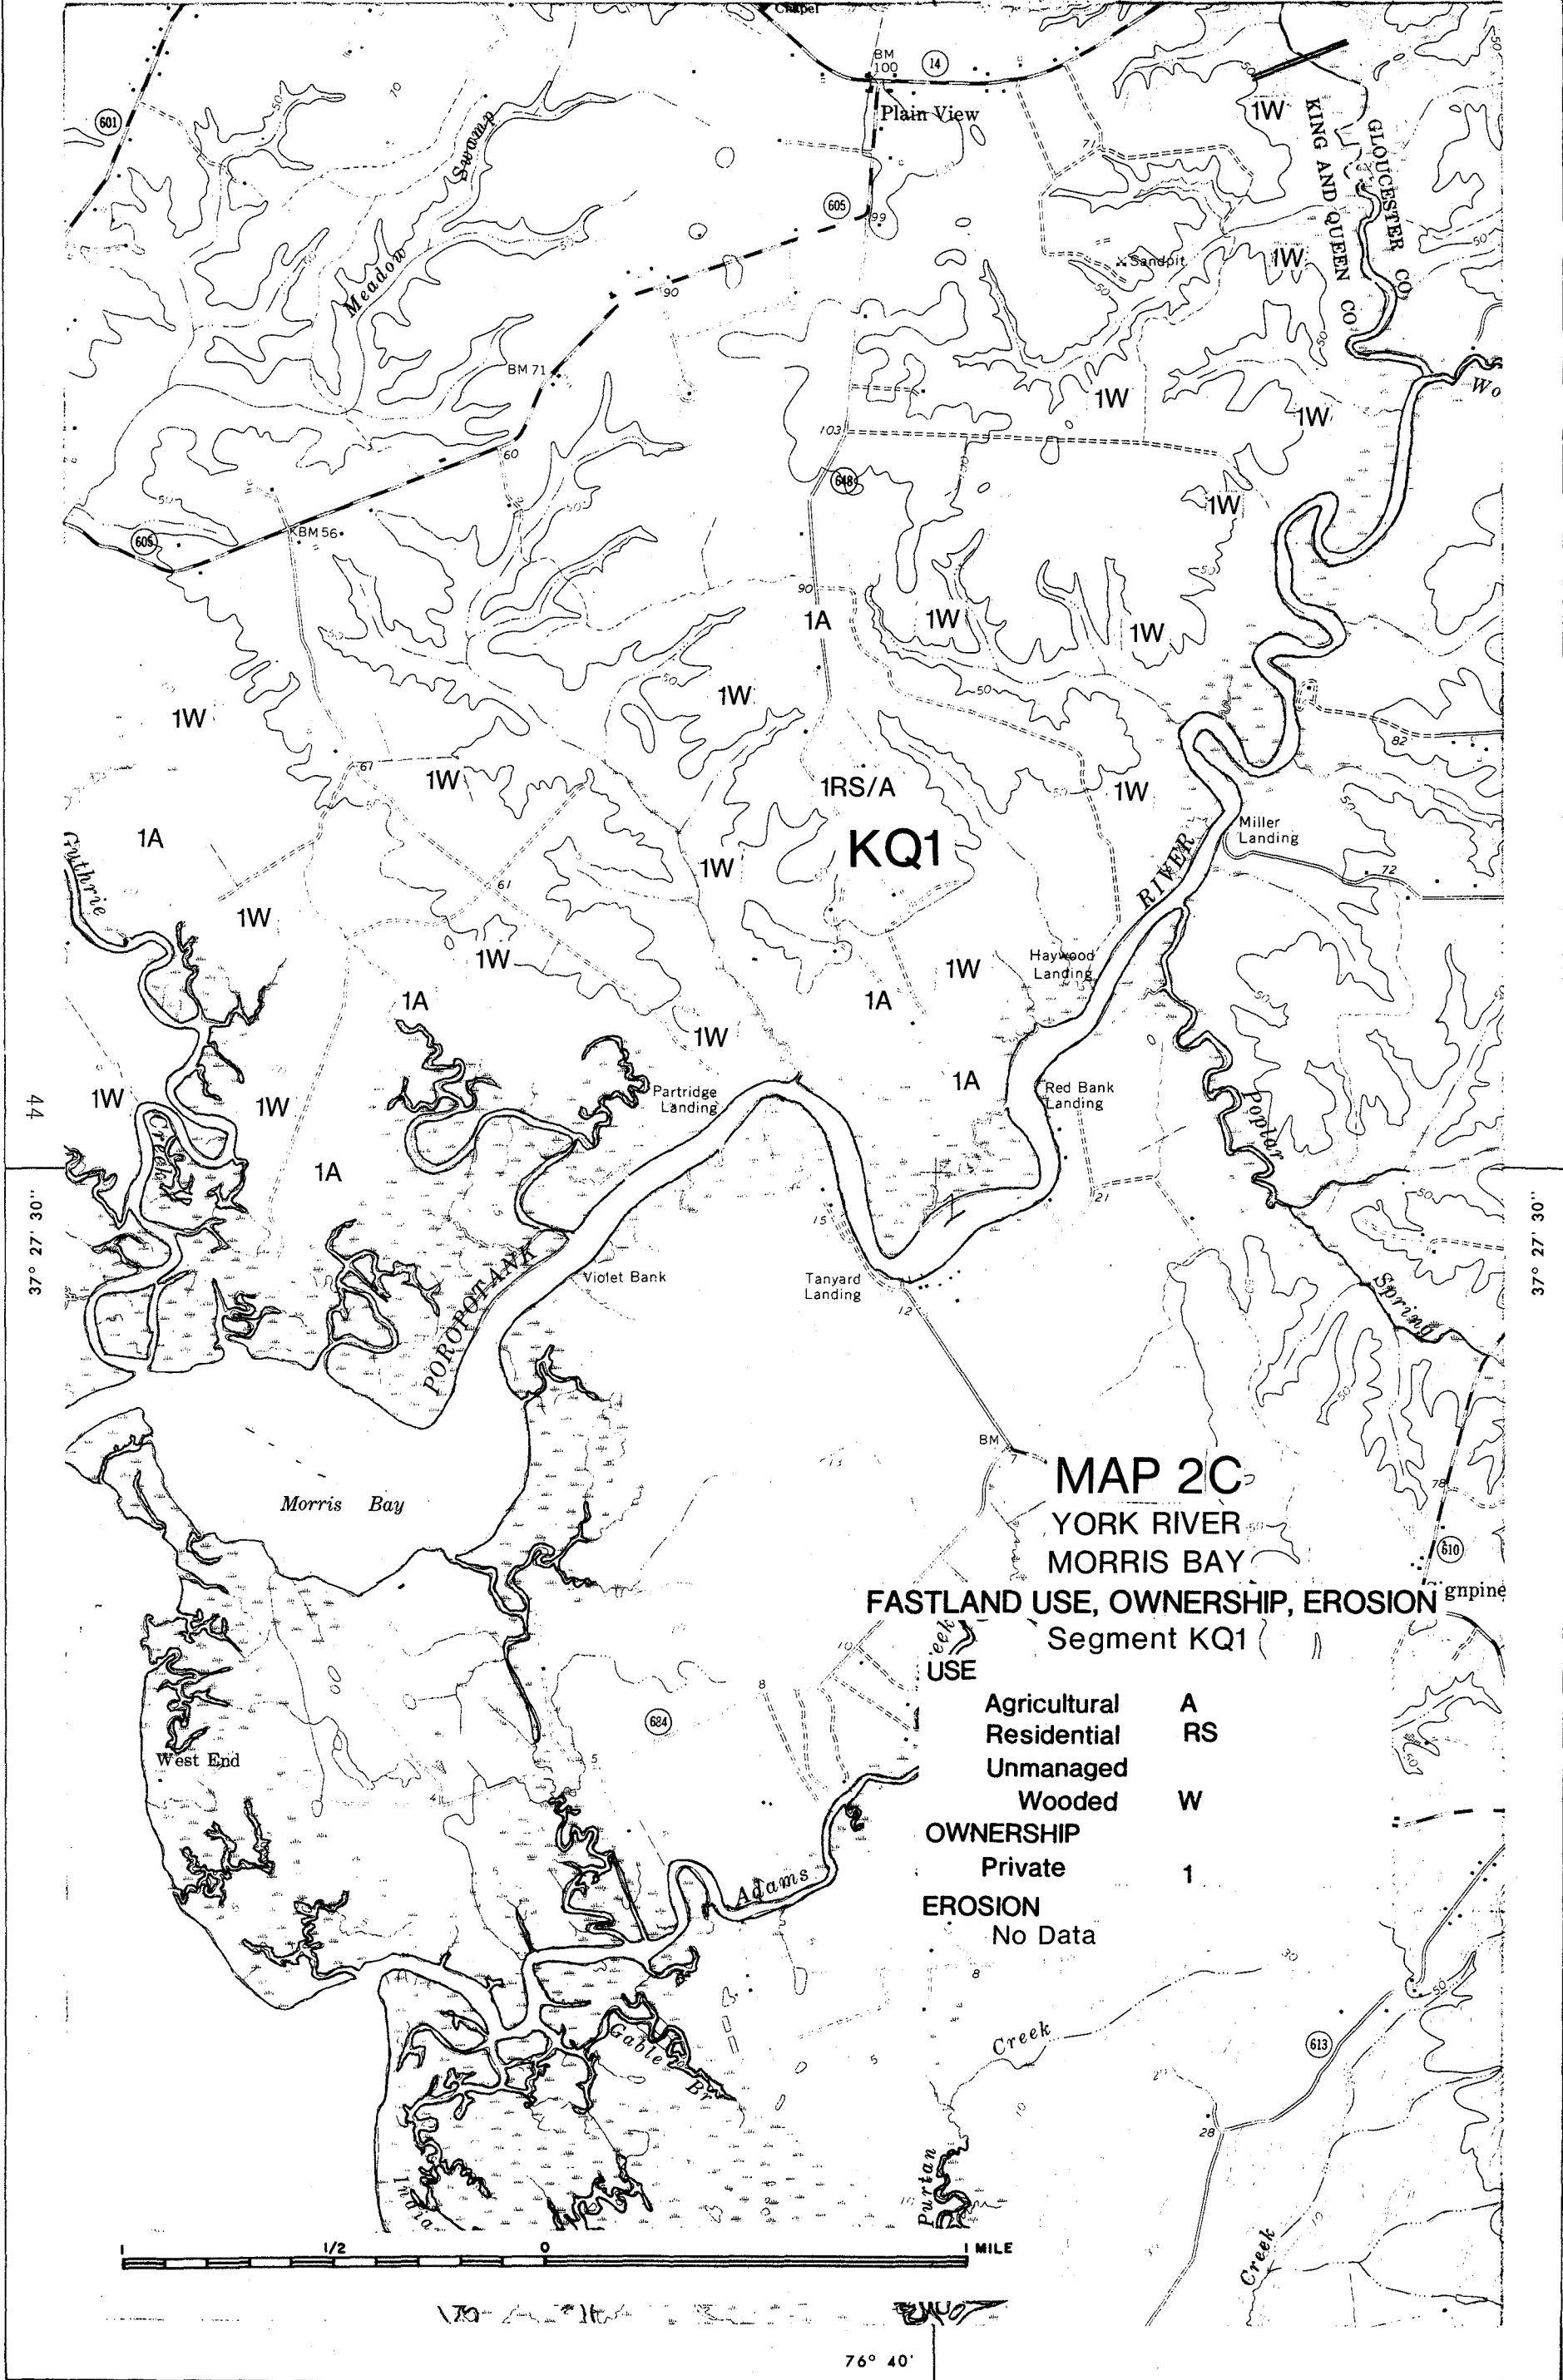
**MAP 2C**  
**YORK RIVER**  
**MORRIS BAY**  
**FASTLAND USE, OWNERSHIP, EROSION**  
 Segment KQ1

<b>USE</b>	
Agricultural	A
Residential	RS
Unmanaged	
Wooded	W
<b>OWNERSHIP</b>	
Private	1
<b>EROSION</b>	
No Data

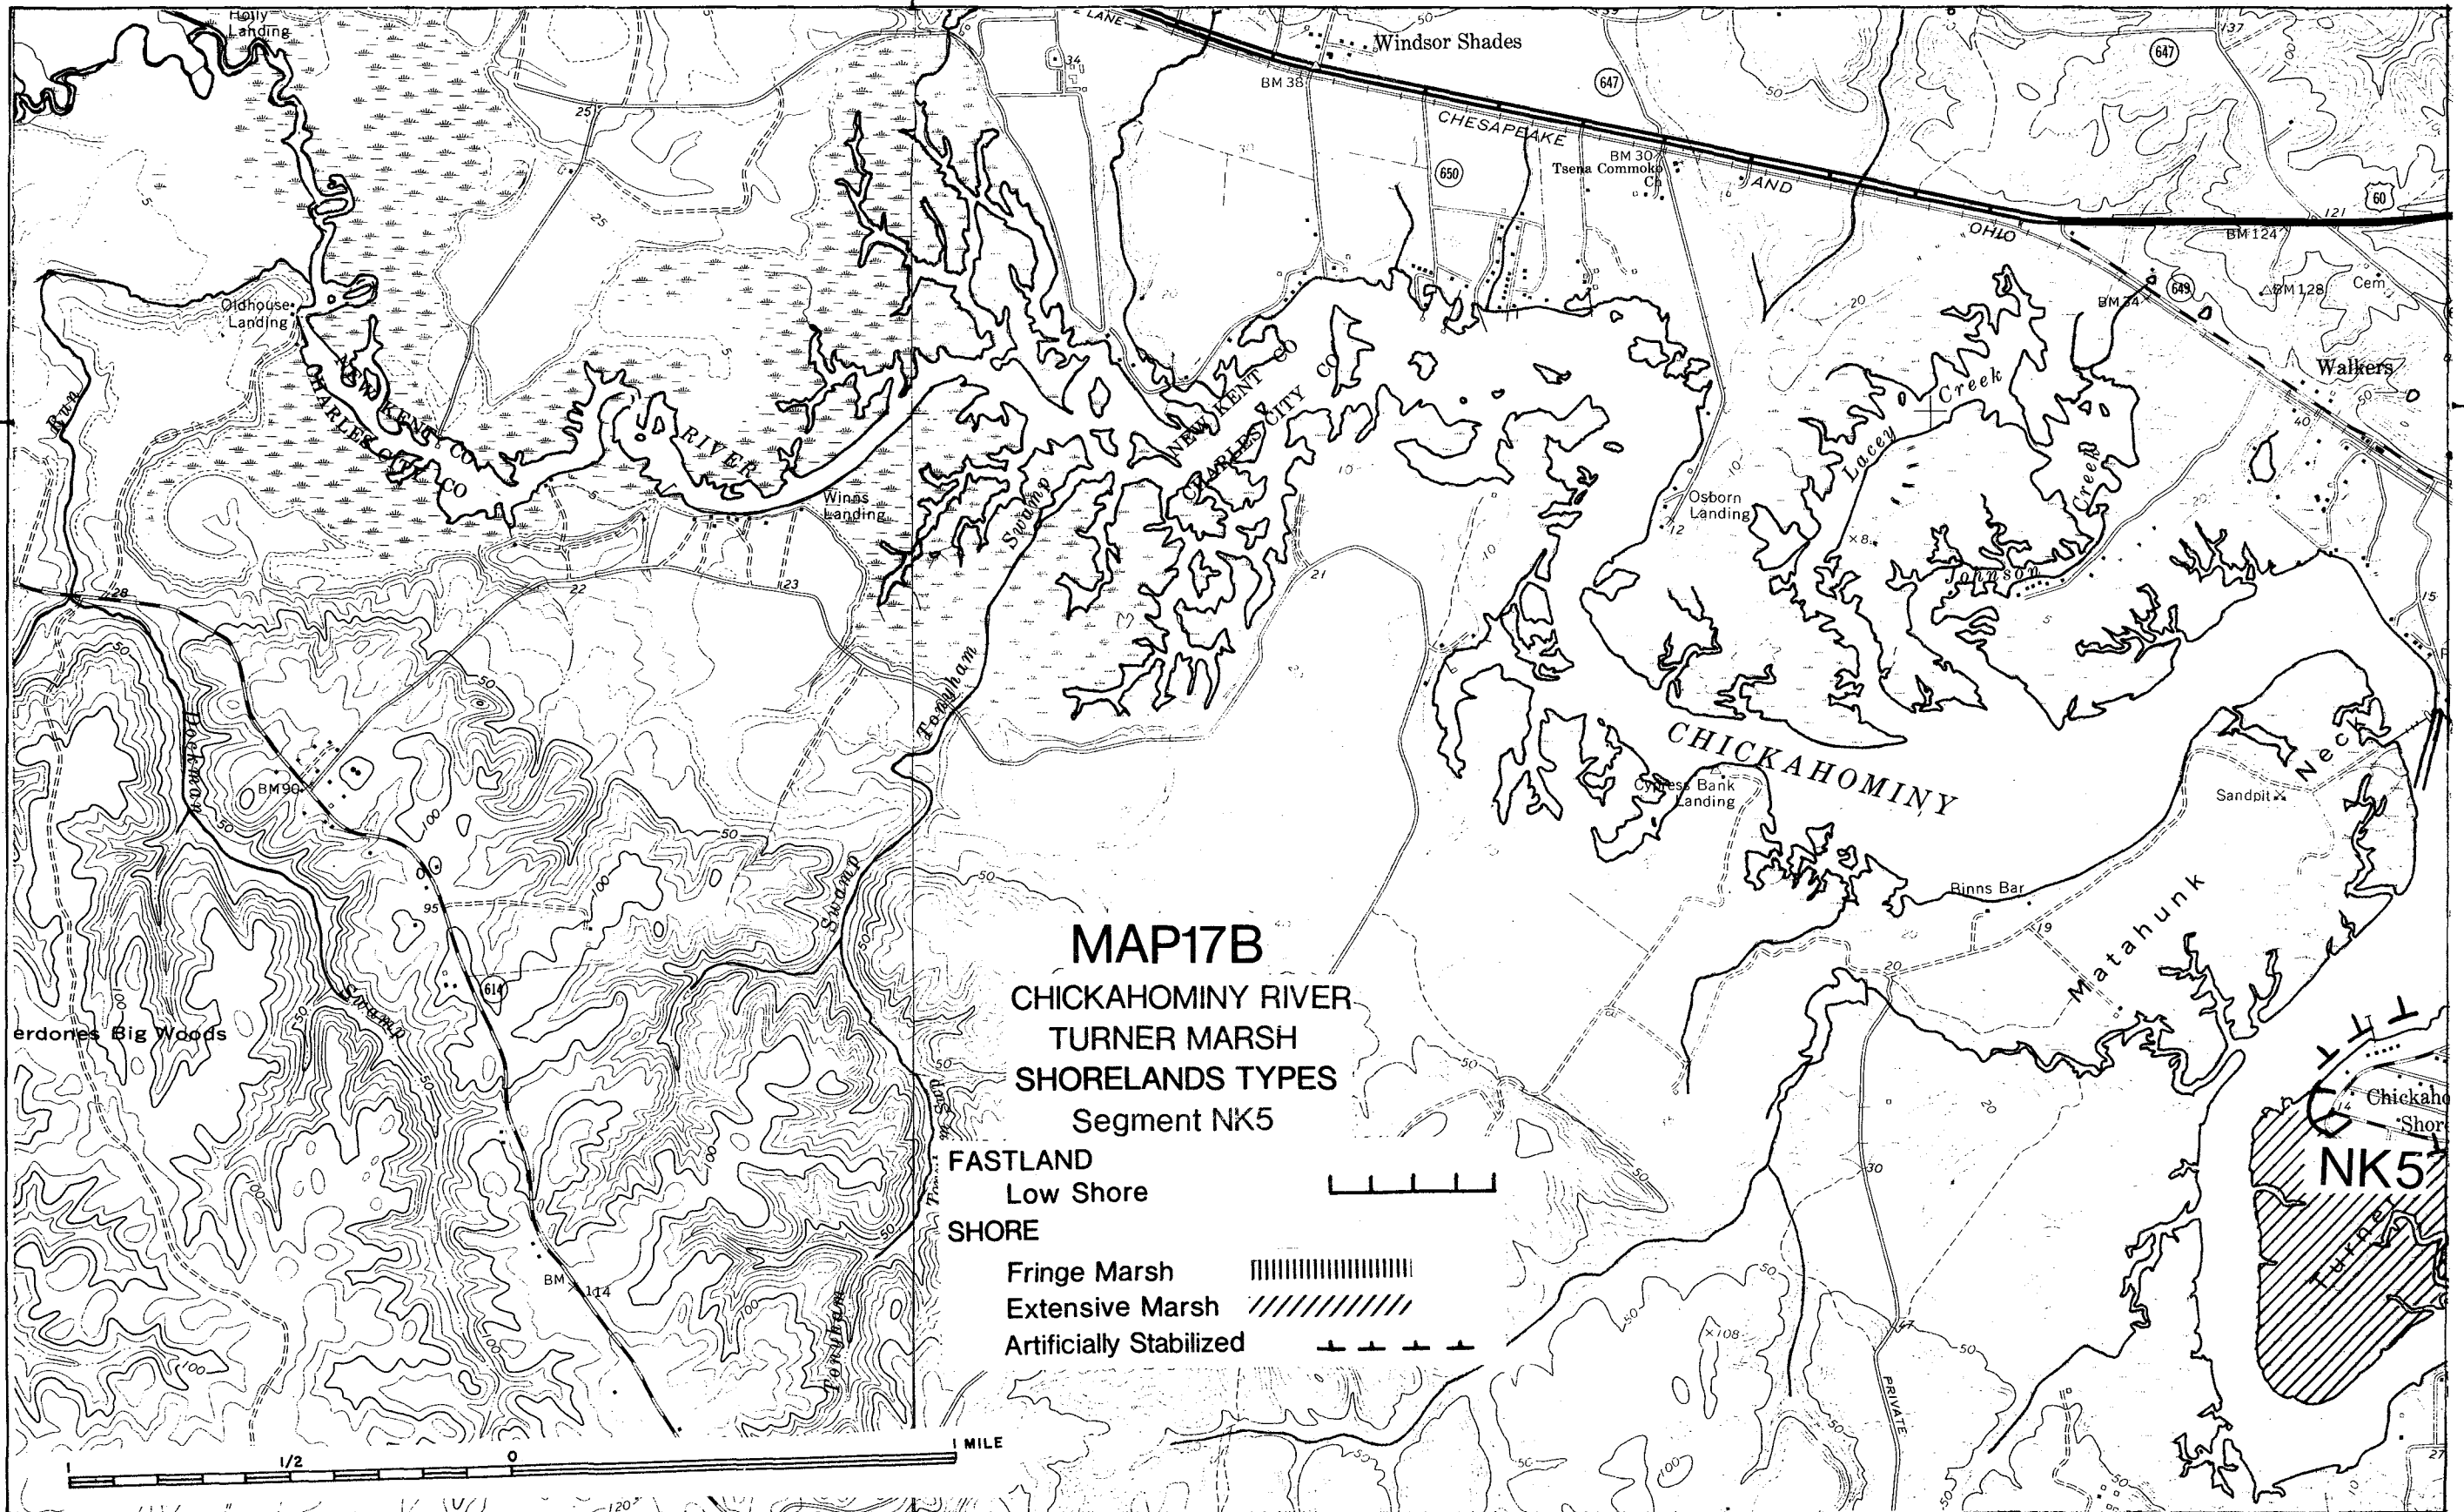
MAPS: USGS, 7.5 Min.Ser. (Topo.), NEW KENT  
Quadr., 1965.  
USGS, 7.5 Min.Ser. (Topo.), WEST POINT  
Quadr., 1965.  
C&GS, #496, 1:40,000 scale, PAMUNKEY AND  
MATTAPONI RIVERS, 1973.  
C&GS, #495, 1:40,000 scale, YORK RIVER,  
Yorktown to West Point, 1973.

- FASTLAND
- Low Shore
- SHORE
- Fringe Marsh
- Extensive Marsh
- Artificially Stabilized

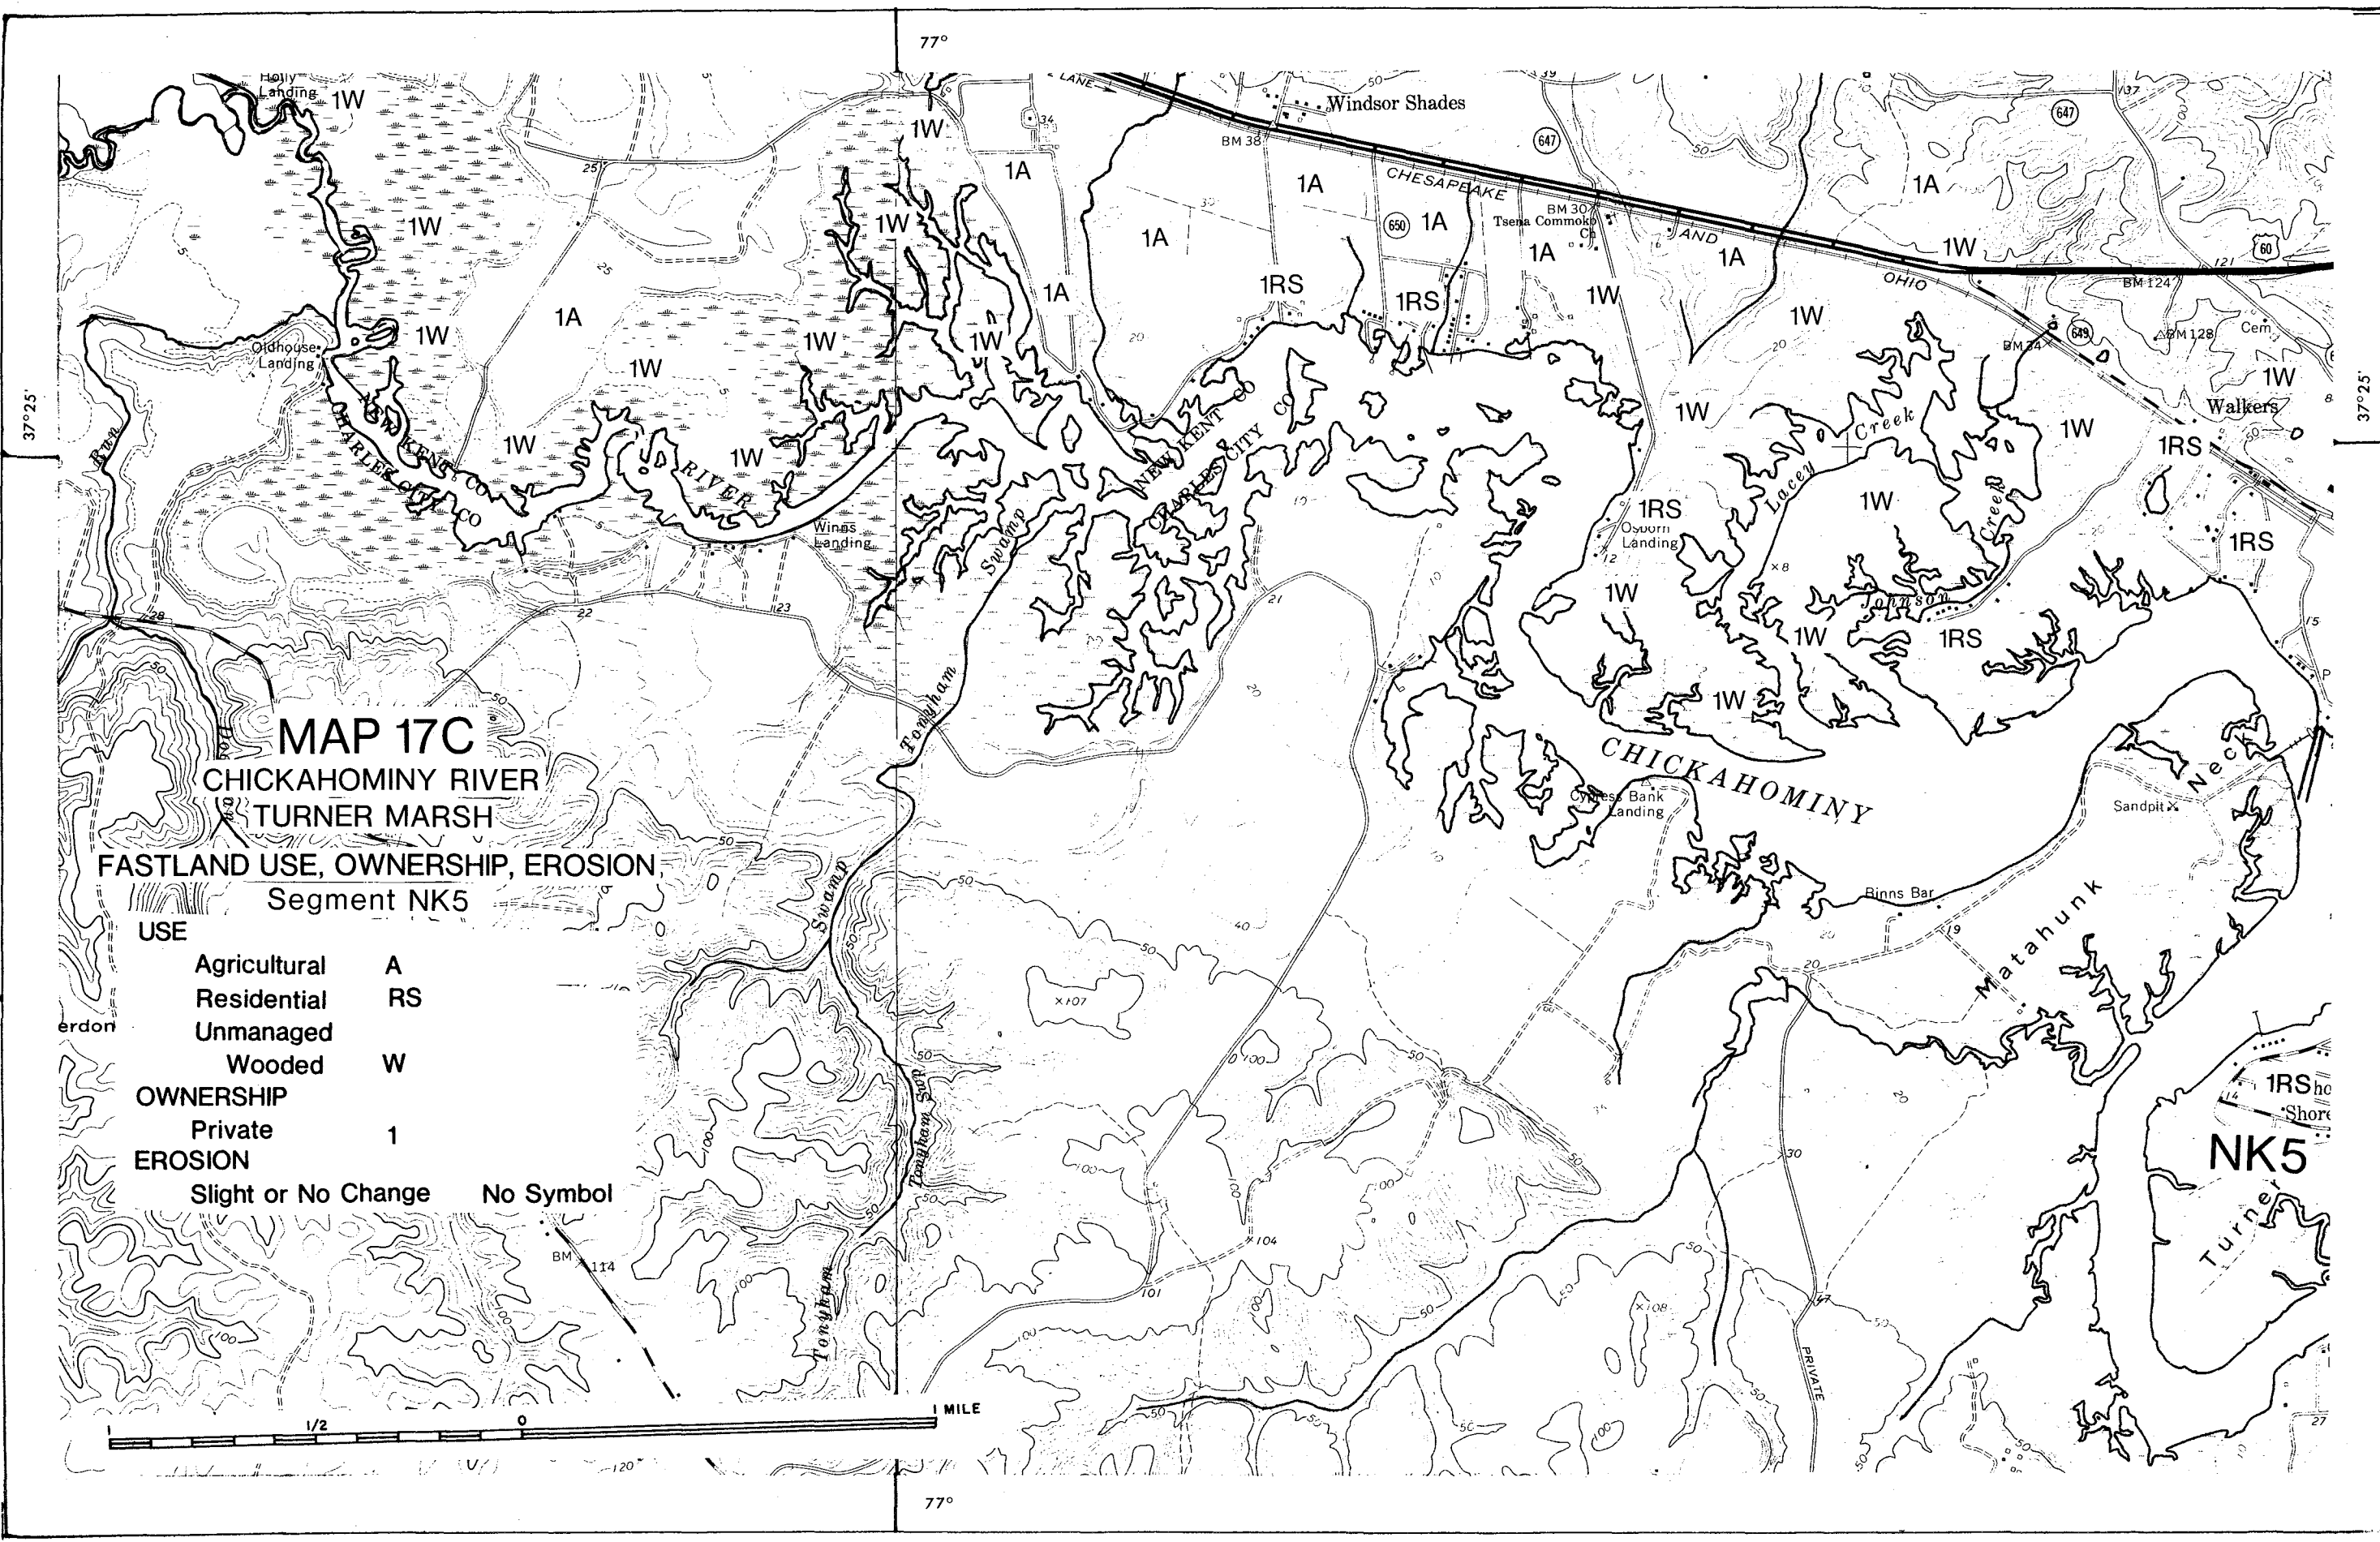
**MAP 17C**  
**CHICKAHOMINY RIVER**  
**TURNER MARSH**  
**FASTLAND USE, OWNERSHIP, EROSION,**  
**Segment NK5**

<b>USE</b>	
Agricultural	A
Residential	RS
Unmanaged	
Wooded	W
<b>OWNERSHIP</b>	
Private	1
<b>EROSION</b>	
Slight or No Change	No Symbol
