## Shoreline Situation Report Prince William County, Virginia

# Shoreline Situation Report PRINCE WILLIAM COUNTY, VIRGINIA

Special Report In Applied Marine Science and Ocean Engineering Number 119 of the

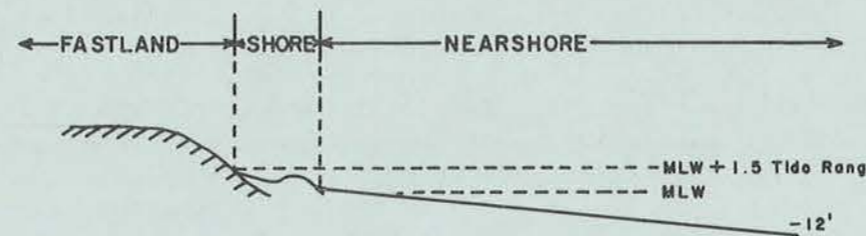
Figure 1

A profile of the three shorelands types.

The shorelands of the Chesapeake Bay System may be considered as being composed of three interacting physiographic elements: the fastlands, the shore and the nearshore. A graphic classification based on these three elements has been devised so that the types for each of the three elements portrayed side by side on a map may provide the opportunity to examine joint relationships among the elements. As an example, the application of the system permits the user to determine miles of high bluff shoreland interfacing with marsh in the shore zone.

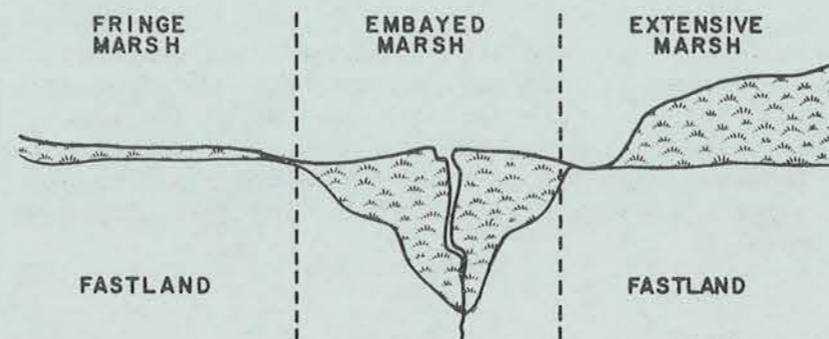
Figure 2

A plan view of the three marsh types.

The physiographic character of the marshes has also been separated into three types (see Figure 2). Fringe marsh is that which is less than 400 feet in width and which runs in a band parallel to the shore. Extensive marsh is that which has extensive acreage projecting into an estuary or river. An embayed marsh is a marsh which occupies a reentrant or drowned creek valley. The purpose in delineating these marsh types is that the effectiveness of the various functions of the marsh will, in part, be determined by type of exposure to the estuarine system. A fringe marsh may, for example, have maximum value as a buffer to wave erosion of the fastland. An extensive marsh, on the other hand, is likely a more efficient transporter of detritus and other food chain materials due to its greater drainage density than an embayed marsh. The central point is that planners, in the light of ongoing and future research, will desire to weight various functions of marshes and the physiographic delineation aids their decision making by denoting where the various types exist. The classification used is:

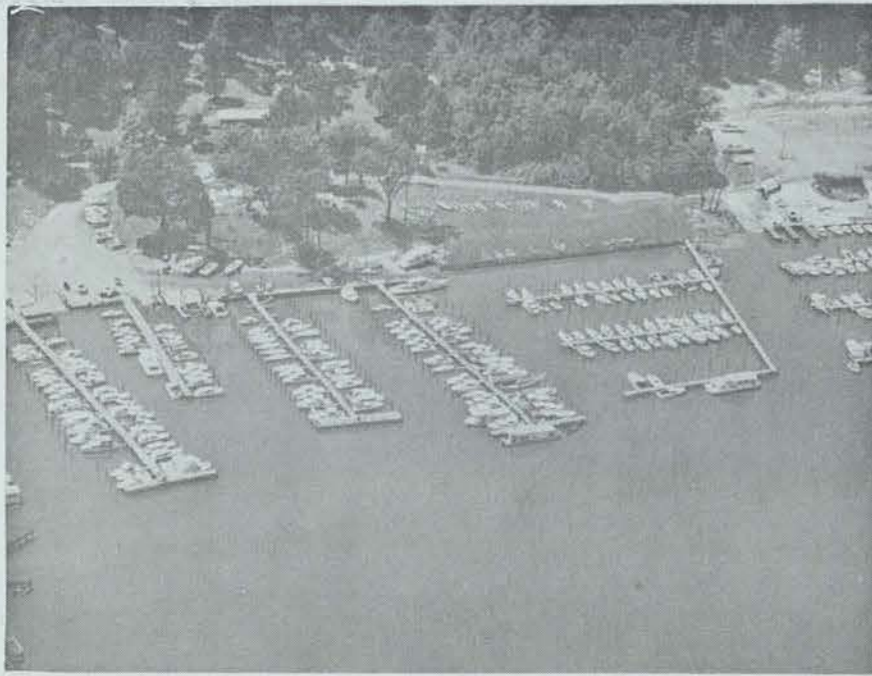
FIGURE 3

FIGURE 3: Marina facilities on Neabsco Creek, north of the railroad bridge (Subsegment 2B).

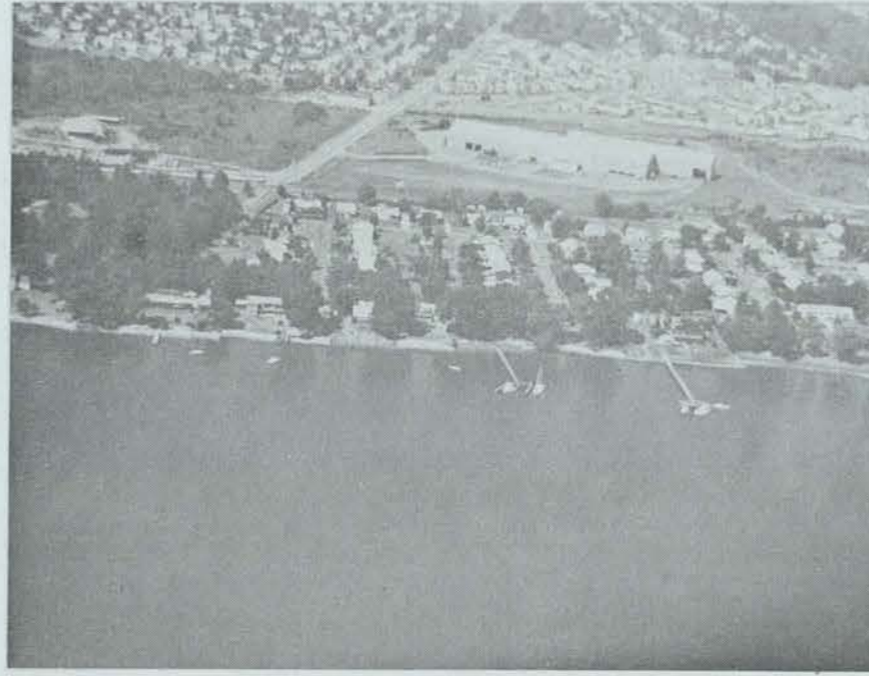
FIGURE 4

FIGURE 4: The Bayside Park shoreline (Subsegment 2A). Many of the structures are below elevations of ten feet and could be susceptible to flooding.

FLOOD HAZARD: Low to moderate, critical. The only area susceptible to flooding, aside from the tidal marshes, is the Bayside Park section. Many structures here are below the 10-foot contour, several of which might be inundated

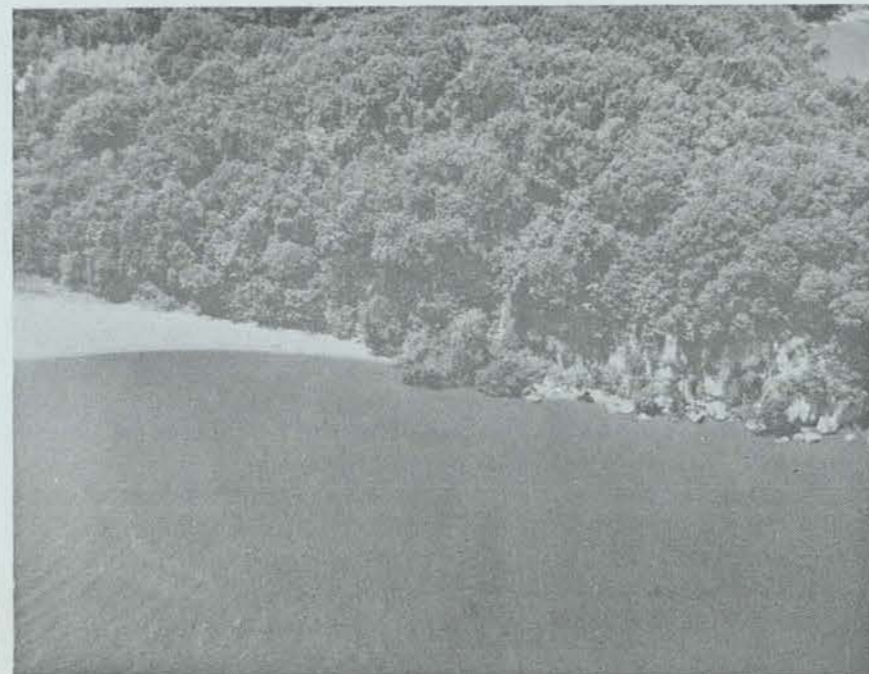
FIGURE 5

FIGURE 5: Bluffs and beach at Freestone Point (Subsegment 2B). The bluffs are composed primarily of rock and can withstand most erosive forces. The beach on the left side of the photo is one of the nicest in the county.

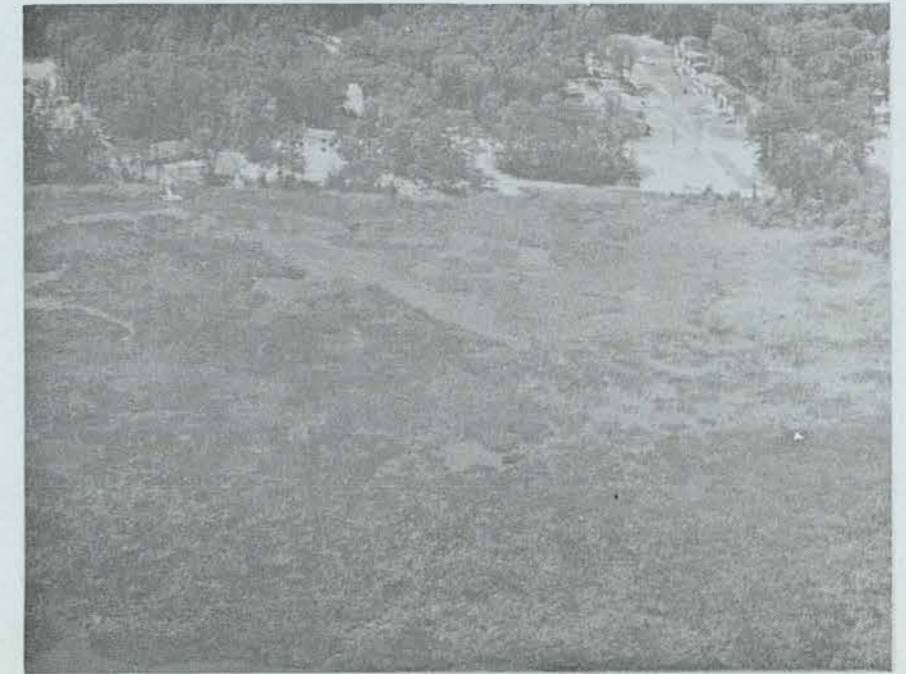
FIGURE 6

FIGURE 6: Embayed marsh fronting new development on Quantico Creek (Segment 4). Residential buildups behind valuable marsh areas are environmentally sound if proper precautions are taken to ensure there are no harmful effects on the marsh system.

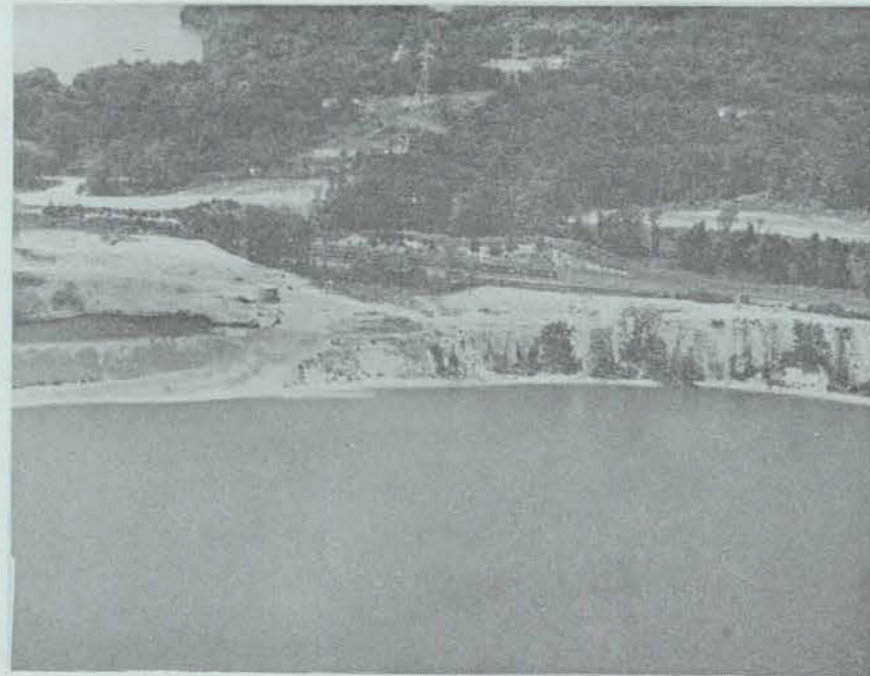
FIGURE 7

FIGURE 7: Vulnerable bluffs north of the VEPCO substation (Subsegment 3B). The bluffs will probably continue to erode at a slight to moderate rate until the area is artificially stabilized.

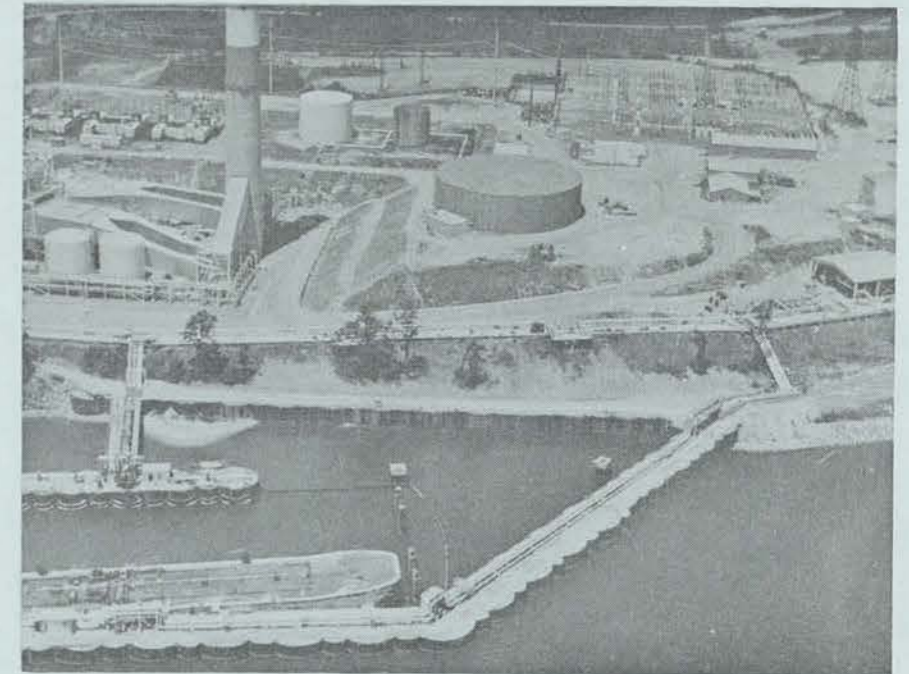
FIGURE 8

FIGURE 8: VEPCO substation on Possum Point (Subsegment 3B). The bulkhead is vertical steel sheet pile back-filled with a stone and sand aggregate.

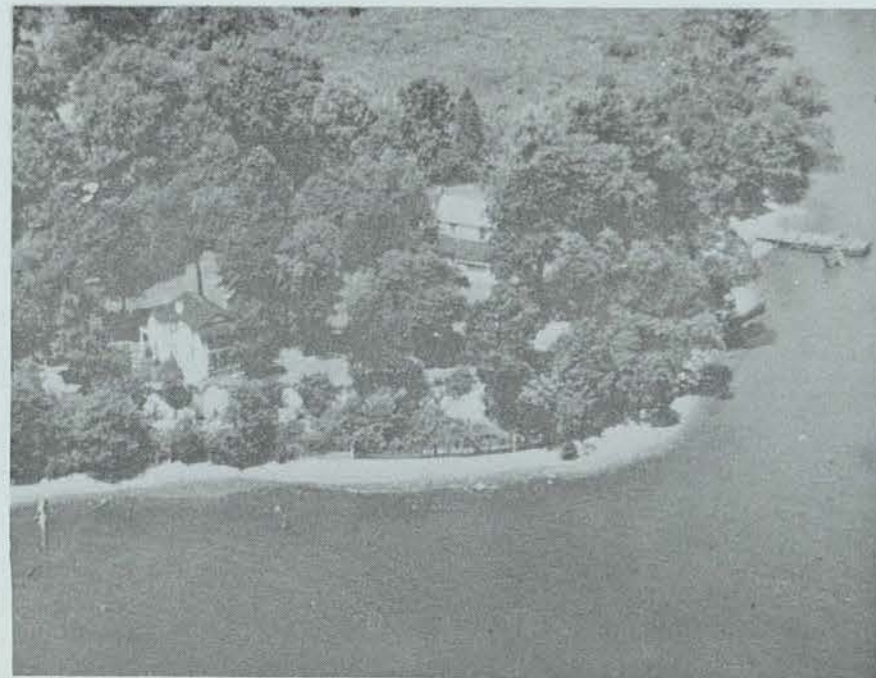
FIGURE 9

FIGURE 9: North end of Chopawamsic Island (Subsegment 5A). The house in the foreground is endangered by continued erosion of the bluff. Two sets of bulkhead seem to be ineffective in combatting the erosion problem. Downhill rain runoff is also a major factor in the erosion of the cliff.

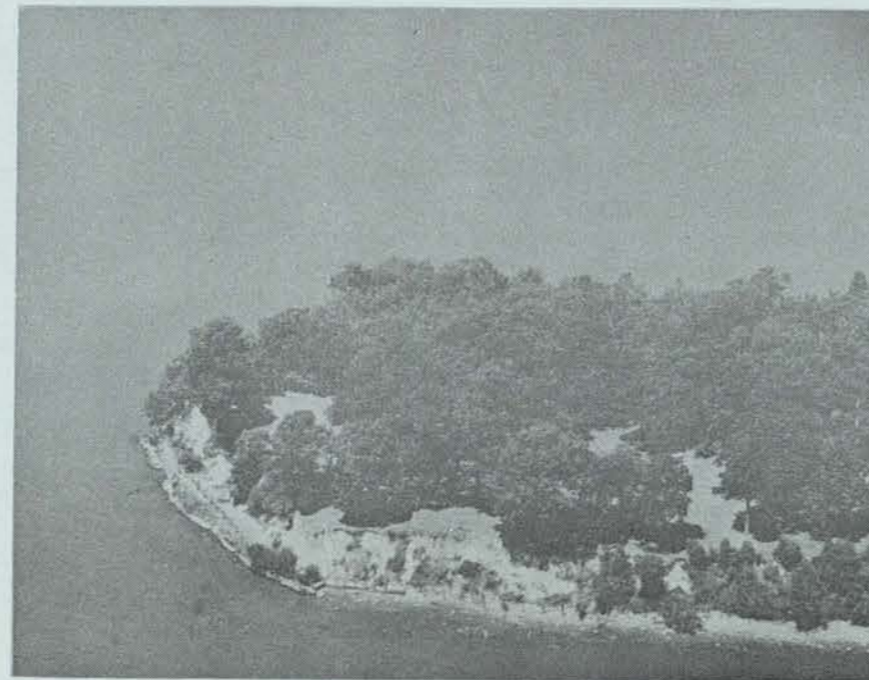
FIGURE 10

FIGURE 10: South end of Chopawamsic Island (Subsegment 5A). The bulkheading of this area has failed, leaving the cliffs exposed to wind generated waves from the southeast.

Several factors influence the location and rate of erosion for any section of shoreline. Along a major river such as the Potomac, a primary cause of erosion is wind generated waves. In bluff areas, waves attack the exposed cliff base. This process eventually undercuts the base of the cliff, causing the upper portion to slump. The height and growth of waves is controlled by four factors: The overwater distance across which the wind blows (the fetch), the velocity of the wind, the duration of time that the wind blows, and the depth of the water. Prince William County is affected by storms out of the northeast and southeast. Fetches during northeasters range from 2.5 to 6.6 nautical miles and during southeasters from 3.5 to 10.0 nautical miles. The southern end of Chopawamsic Island, having a fetch of 10.0 nautical miles from the southeast, has moderate erosion. Only pilings remain from an earlier attempt at bulkheading this section (see Figure 10).
