Shoreline Situation Report Stafford County, Virginia

Carl H. Hobbs III
Virginia Institute of Marine Science

Shoreline Situation Report STAFFORD COUNTY, VIRGINIA

Special Report In Applied Marine Science and Ocean Engineering Number 79
Chesapeake Research Consortium Report Number 13

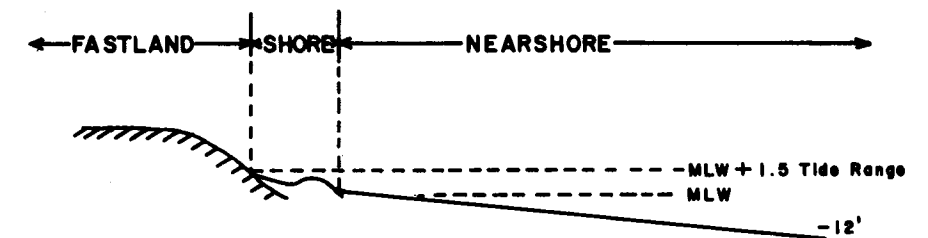
Figure 1

An illustration of the definitions of the three components of the shorelands.

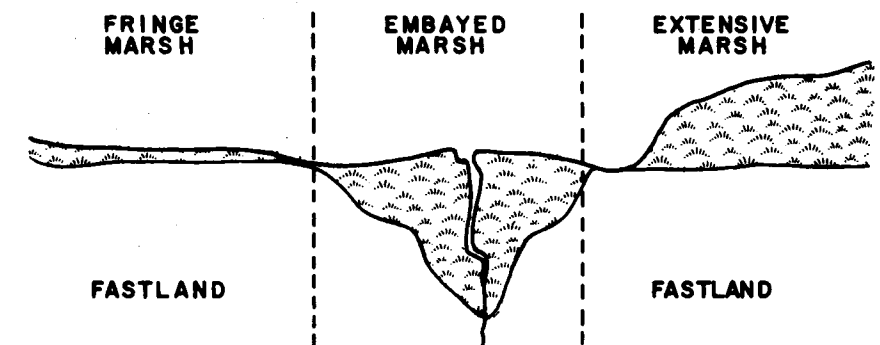
Figure 2

A generalized illustration of the three different marsh types.

The physiographic character of the marshes has also been separated into three types (see Figure 2). Fringe marsh is that which is less than 400 feet in width and which runs in a band parallel to the shore. Extensive marsh is that which has extensive acreage projecting into an estuary or river. An embayed marsh is a marsh which occupies a reentrant or drowned creek valley. The purpose in delineating these marsh types is that the effectiveness of the various functions of the marsh will, in part, be determined by type of exposure to the estuarine system. A fringe marsh may, for example, have maximum value as a buffer to wave erosion of the fastland.

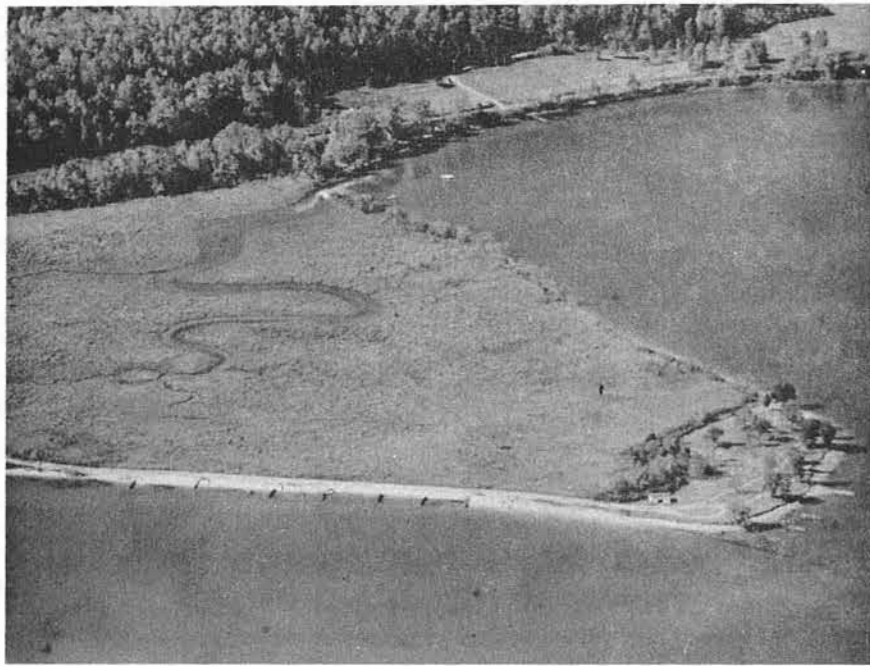
Figure 3

According to local sources, the three groins along the north face were butted into the shore three years ago. This indicates a local shoreline erosion rate on the order of fifteen feet per year. Before facing the problem of stabilizing the shoreline, it is necessary to understand the causes of erosion.

3. Aerial view of Youbedamm Landing at the mouth of Aquia Creek on the Potomac River. The blunt end of the peninsula is experiencing severe erosion, as evidenced by the separation of the groins from the mainland. The large, partially filled groinfield on the Potomac River is trapping some of the eroded material.
4. A ground view at Youbedamm Landing looking out toward the Potomac River. The structure in the foreground is the remains of a groin. In less than ten years the bank has retreated, leaving the groin stranded and useless as a shore defense structure. The large tree in the background has, since the date of this picture, surrendered its hold on the shore and fallen into the river.

The task at this site is twofold, first to stabilize the shoreline then, water quality aside, to enhance the quality of the area as a bathing beach. It should be noted that no shore defense structures or methods are permanent. Some are effective for only a few months or years, while others may work for decades, but none work forever.

If alternatives 4 or 5 are used strict criteria such as might be found in the U.S. Army Corps of Engineers, Coastal Engineering Research Center's Shore Protection Manual or its earlier Technical Report No. 4, Shore Protection, Planning and Design should be used.

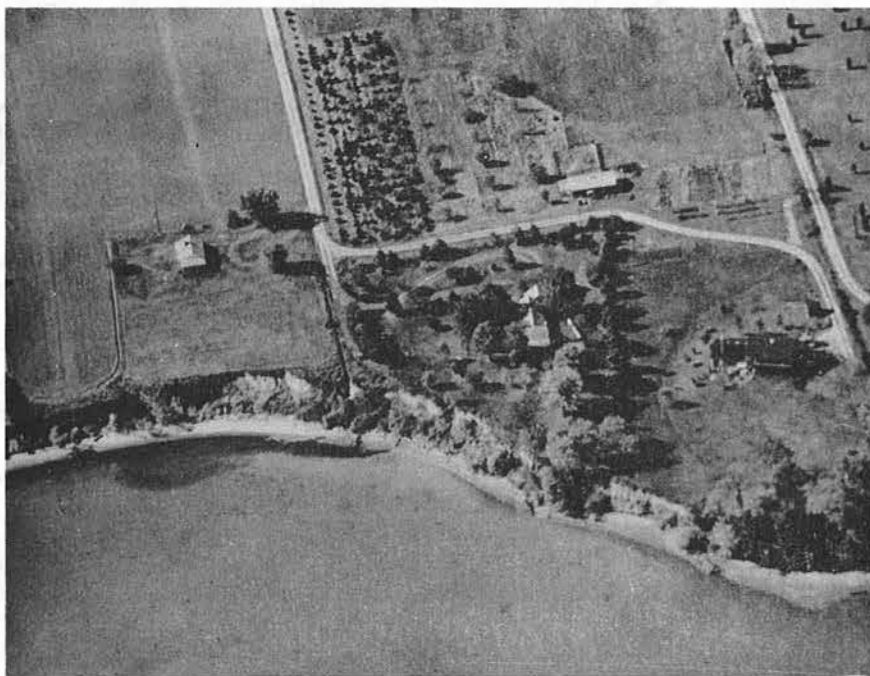
Figure 5

5. An area of very severe erosion just north of Marlboro Point on the Potomac River. The high bluff consists of unconsolidated sediments that are easily eroded by waves. Most attempts at shore protection have met with little or no success as they have not been of sufficient scope to stem the problem.
6. A ground view near Marlboro Point, south of the area shown in the preceding photograph. The great erosion has removed much of the bank, significantly undercutting the house.

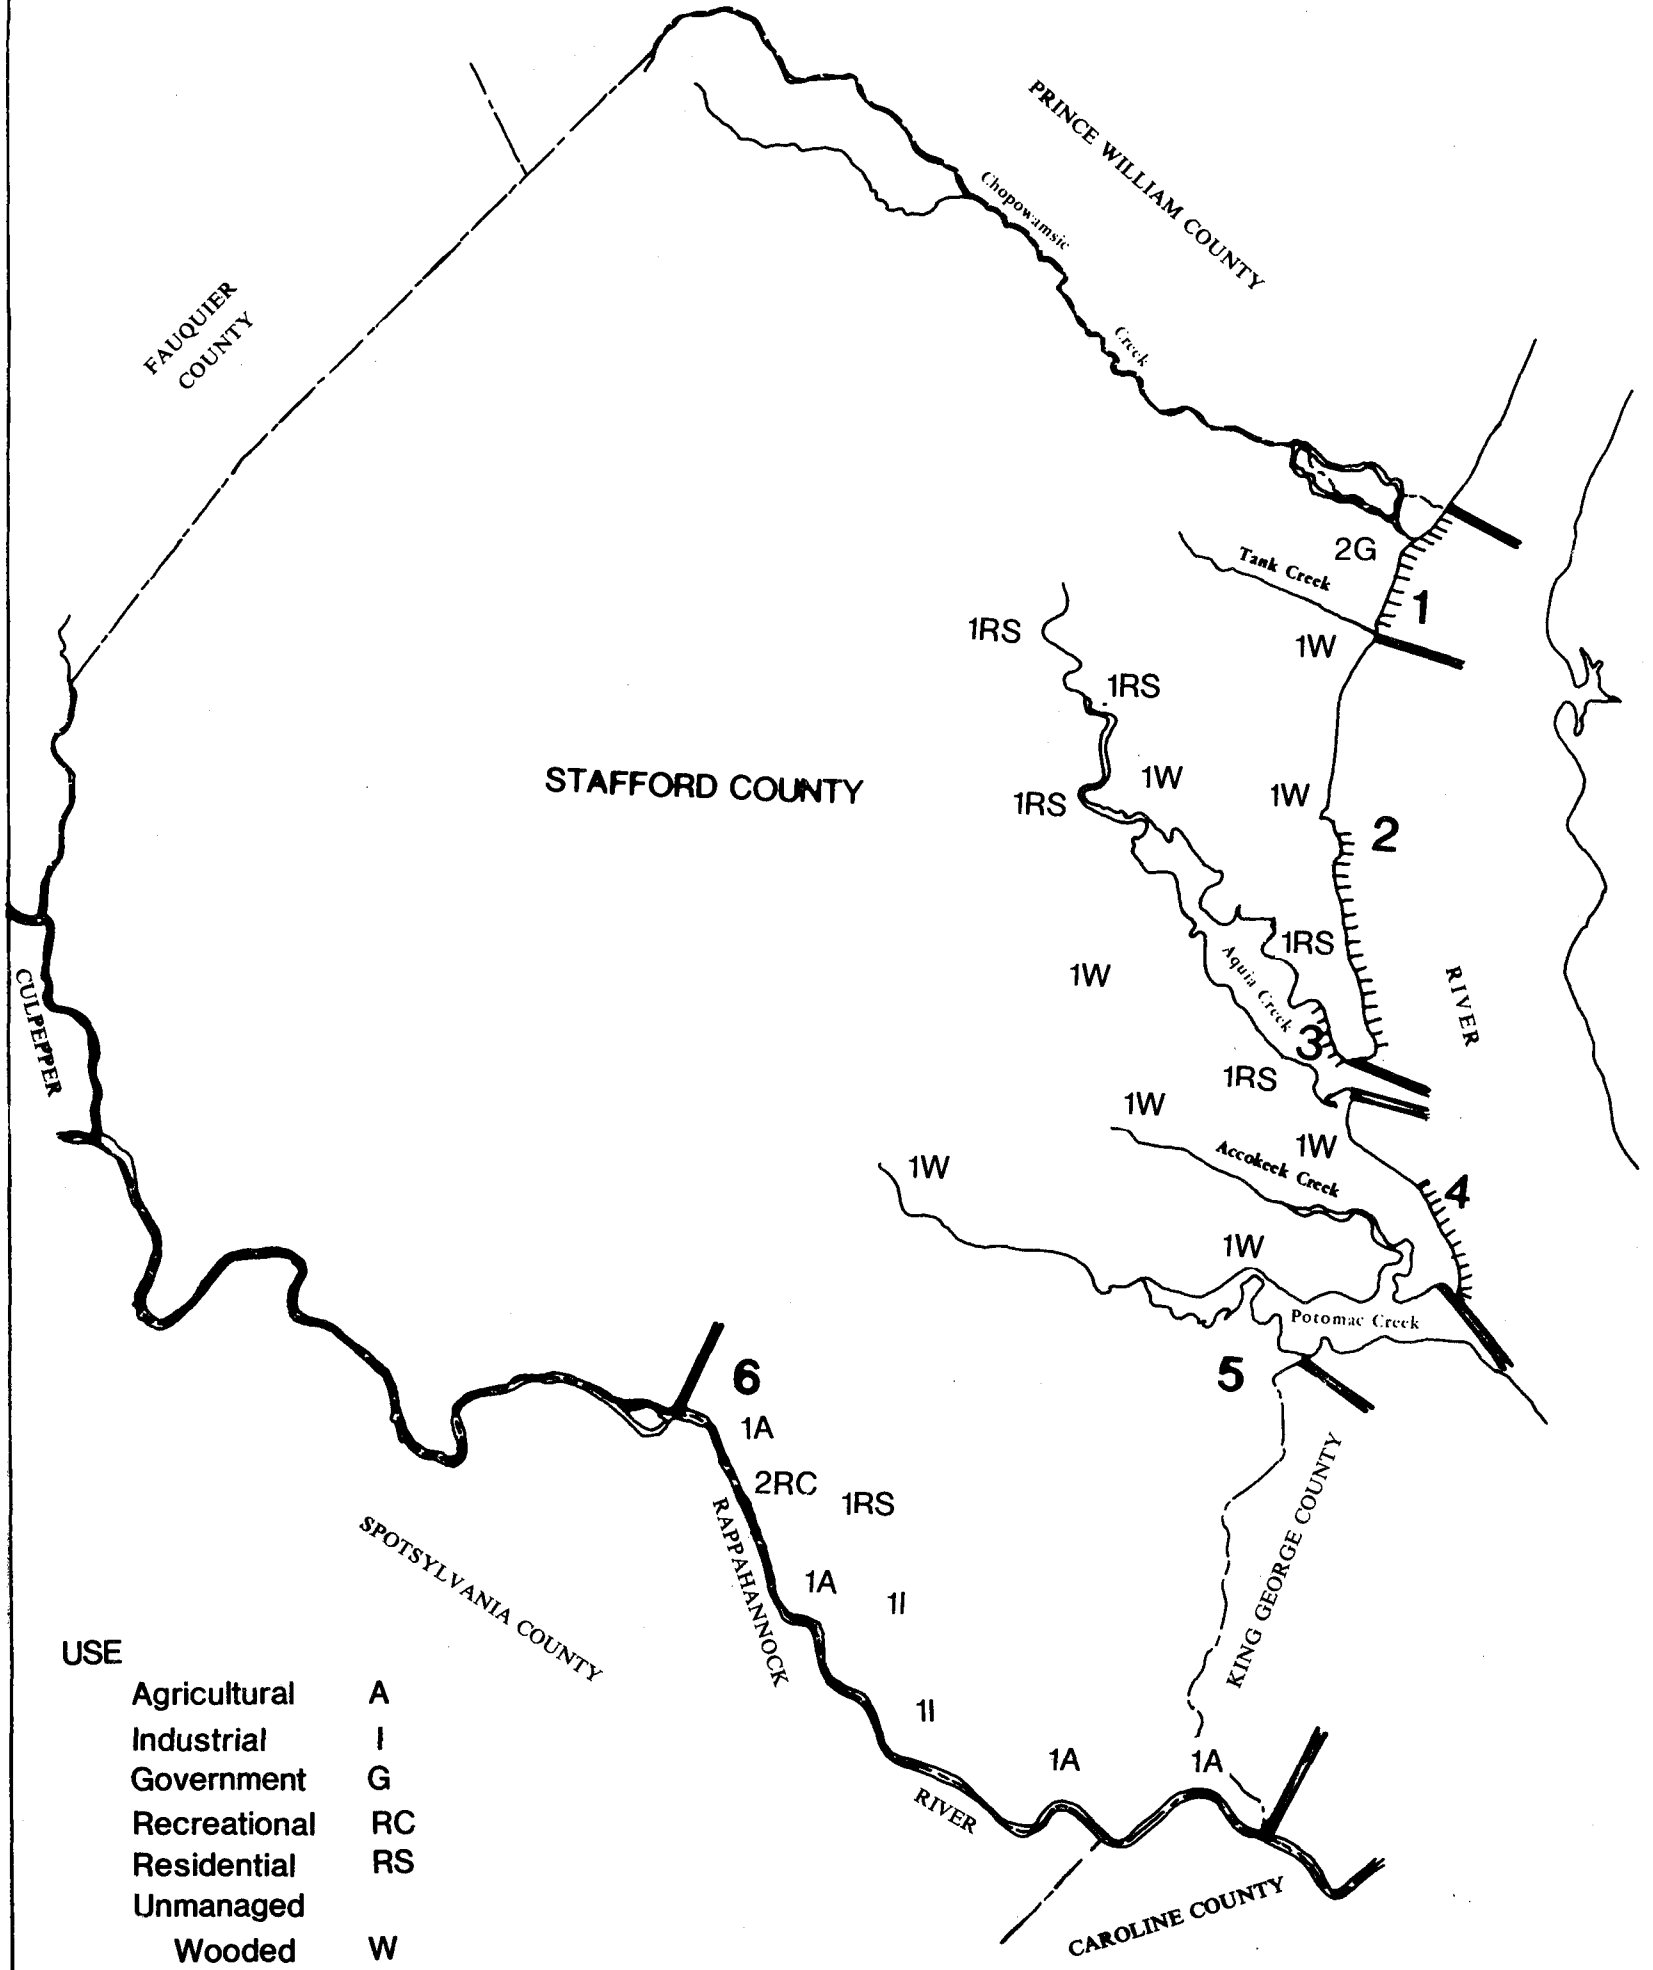
MAP 1C

STAFFORD COUNTY
FASTLAND USE, OWNERSHIP, EROSION
