Shoreline Situation Report York County Virginia

Shoreline Situation Report YORK COUNTY, VIRGINIA

Special Report In Applied Marine Science and Ocean Engineering Number 82 of the

VIRGINIA INSTITUTE OF MARINE SCIENCE

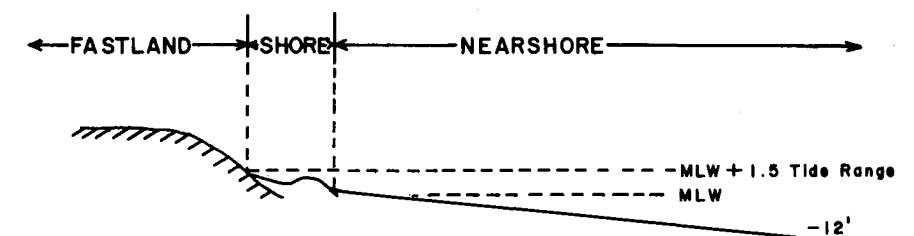
Figure 1A

An illustration of the definition of the three components of the shorelands.

may be considered as being composed of three interacting physiographic elements: the fastlands, the shore and the nearshore. A graphic classification based on these three elements has been devised so that the types for each of the three elements portrayed side by side on a map may provide the opportunity to examine joint relationships among the elements. As an example, the application of the system permits the user to determine miles of high bluff shoreland interfacing with marsh in the shore zone.

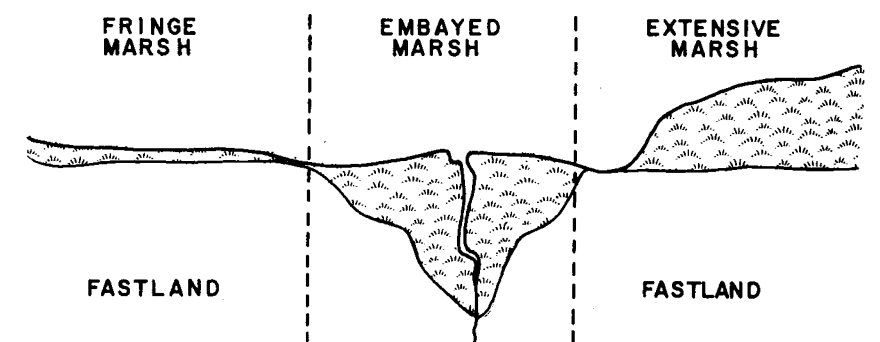
Figure 1B

A generalized illustration of the three different marsh types.

The physiographic character of the marshes has also been separated into three types (see Figure 1B). Fringe marsh is that which is less than 400 feet in width and which runs in a band parallel to the shore. Extensive marsh is that which has extensive acreage projecting into an estuary or river. An embayed marsh is a marsh which occupies a reentrant or drowned creek valley. The purpose in delineating these marsh types is that the effectiveness of the various functions of the marsh will, in part, be determined by type of exposure to the estuarine system. A fringe marsh

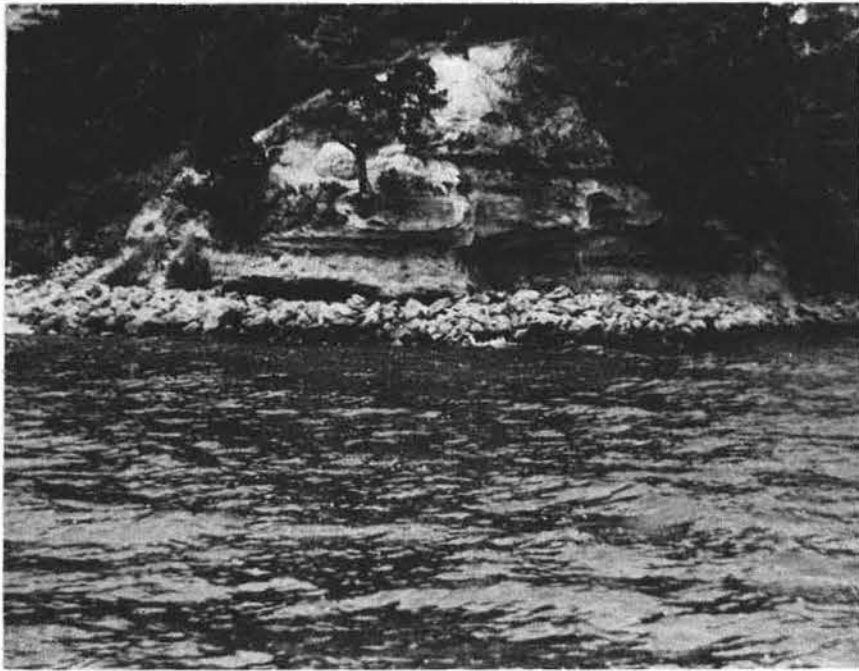
Figure 2

FIGURE 2: Large stone riprap which protects much of the nonmarsh York River shoreline. However, there is no beach along these sections at high tide.

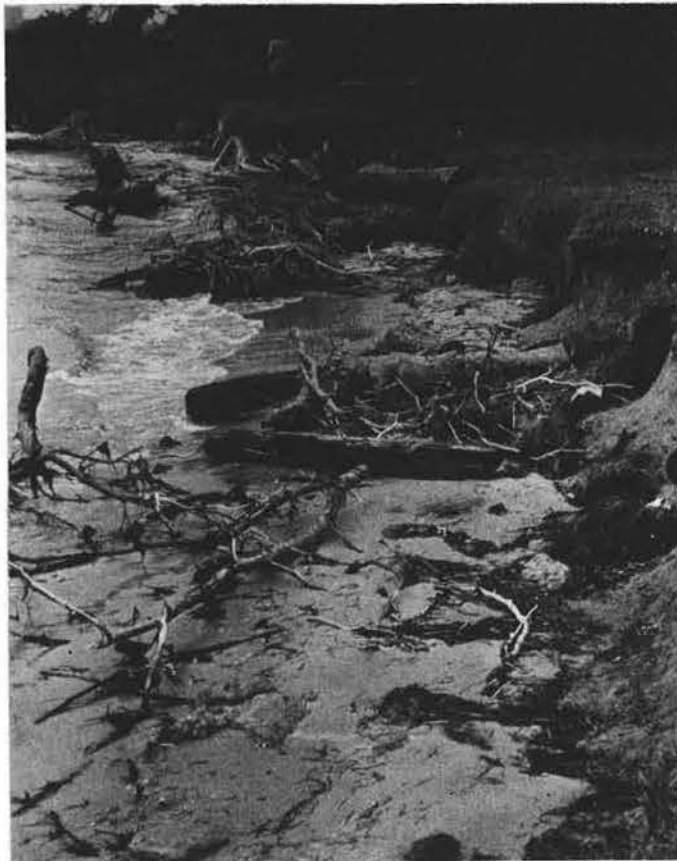
Figure 4

FIGURE 4: Wave erosion at the Park Service picnic grounds in Yorktown.

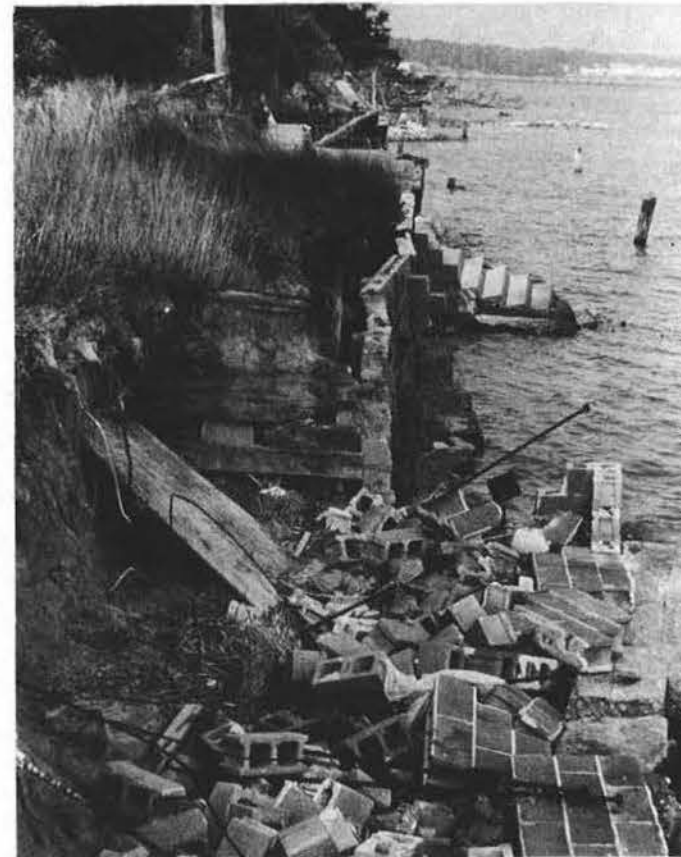
Figure 5

FIGURE 5: One example of the many poorly designed and constructed bulkheads in York County.

Suggested Action: To avert additional damage, the York River bulkheads should be either replaced or repaired. Those individuals whose bulkheads are destroyed or in disrepair might consider the use of properly placed, adequate size riprap, if they are only concerned with stopping erosion. However, the enhancement of a beach in this area would require groins. Due to the extensive amount of shoreline protection in this segment and that a significant amount of the beach sand is supplied by local sources of erosion, only properly designed and constructed groins would be of any value.

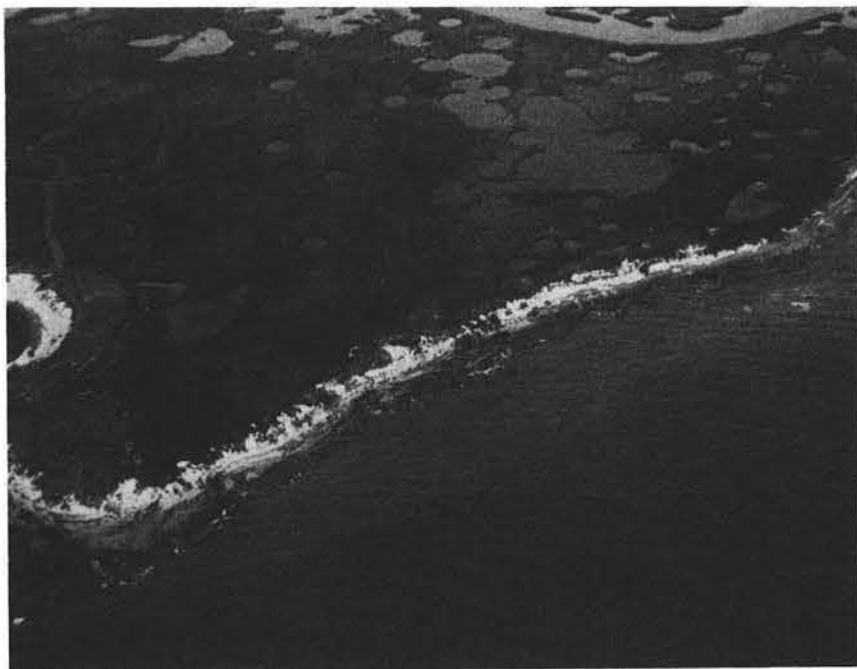
Figure 6

FIGURE 6: The Plumtree Island Wildlife Refuge marsh with its small barrier beach.

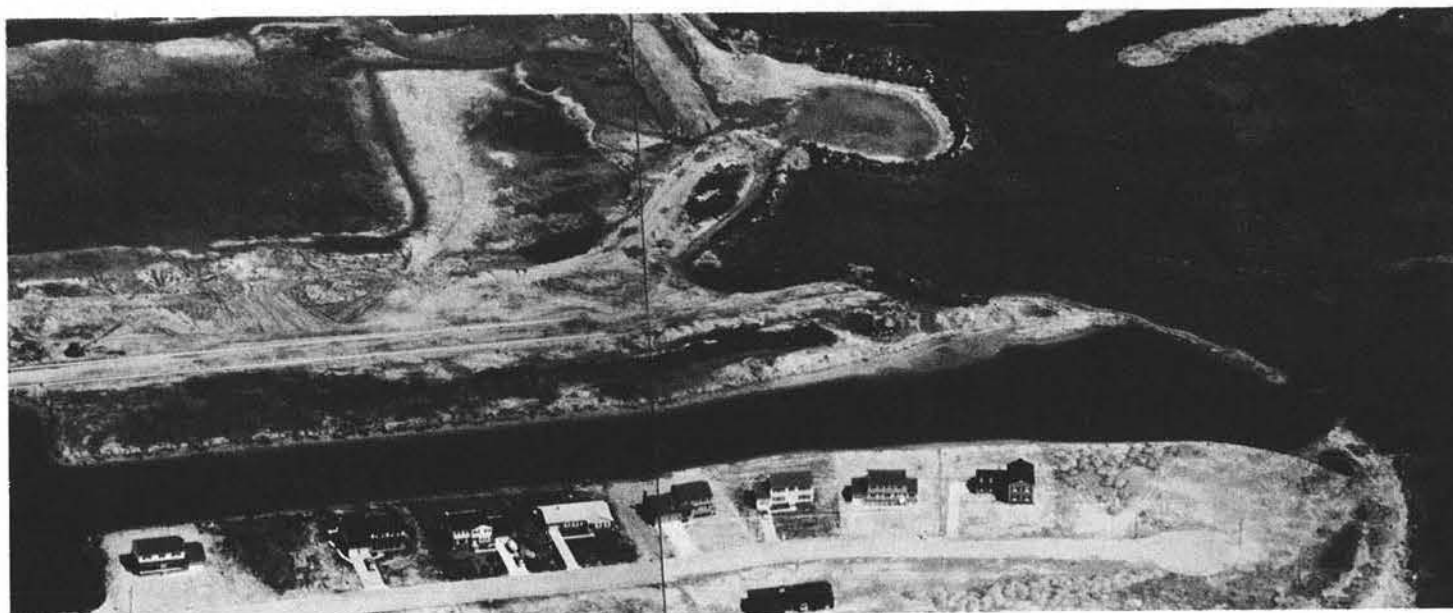
Figure 8

FIGURE 8: Another example of a dead end canal and spoiled marsh. Such practices are environmentally unsound in addition to placing homes in high flood hazard areas.

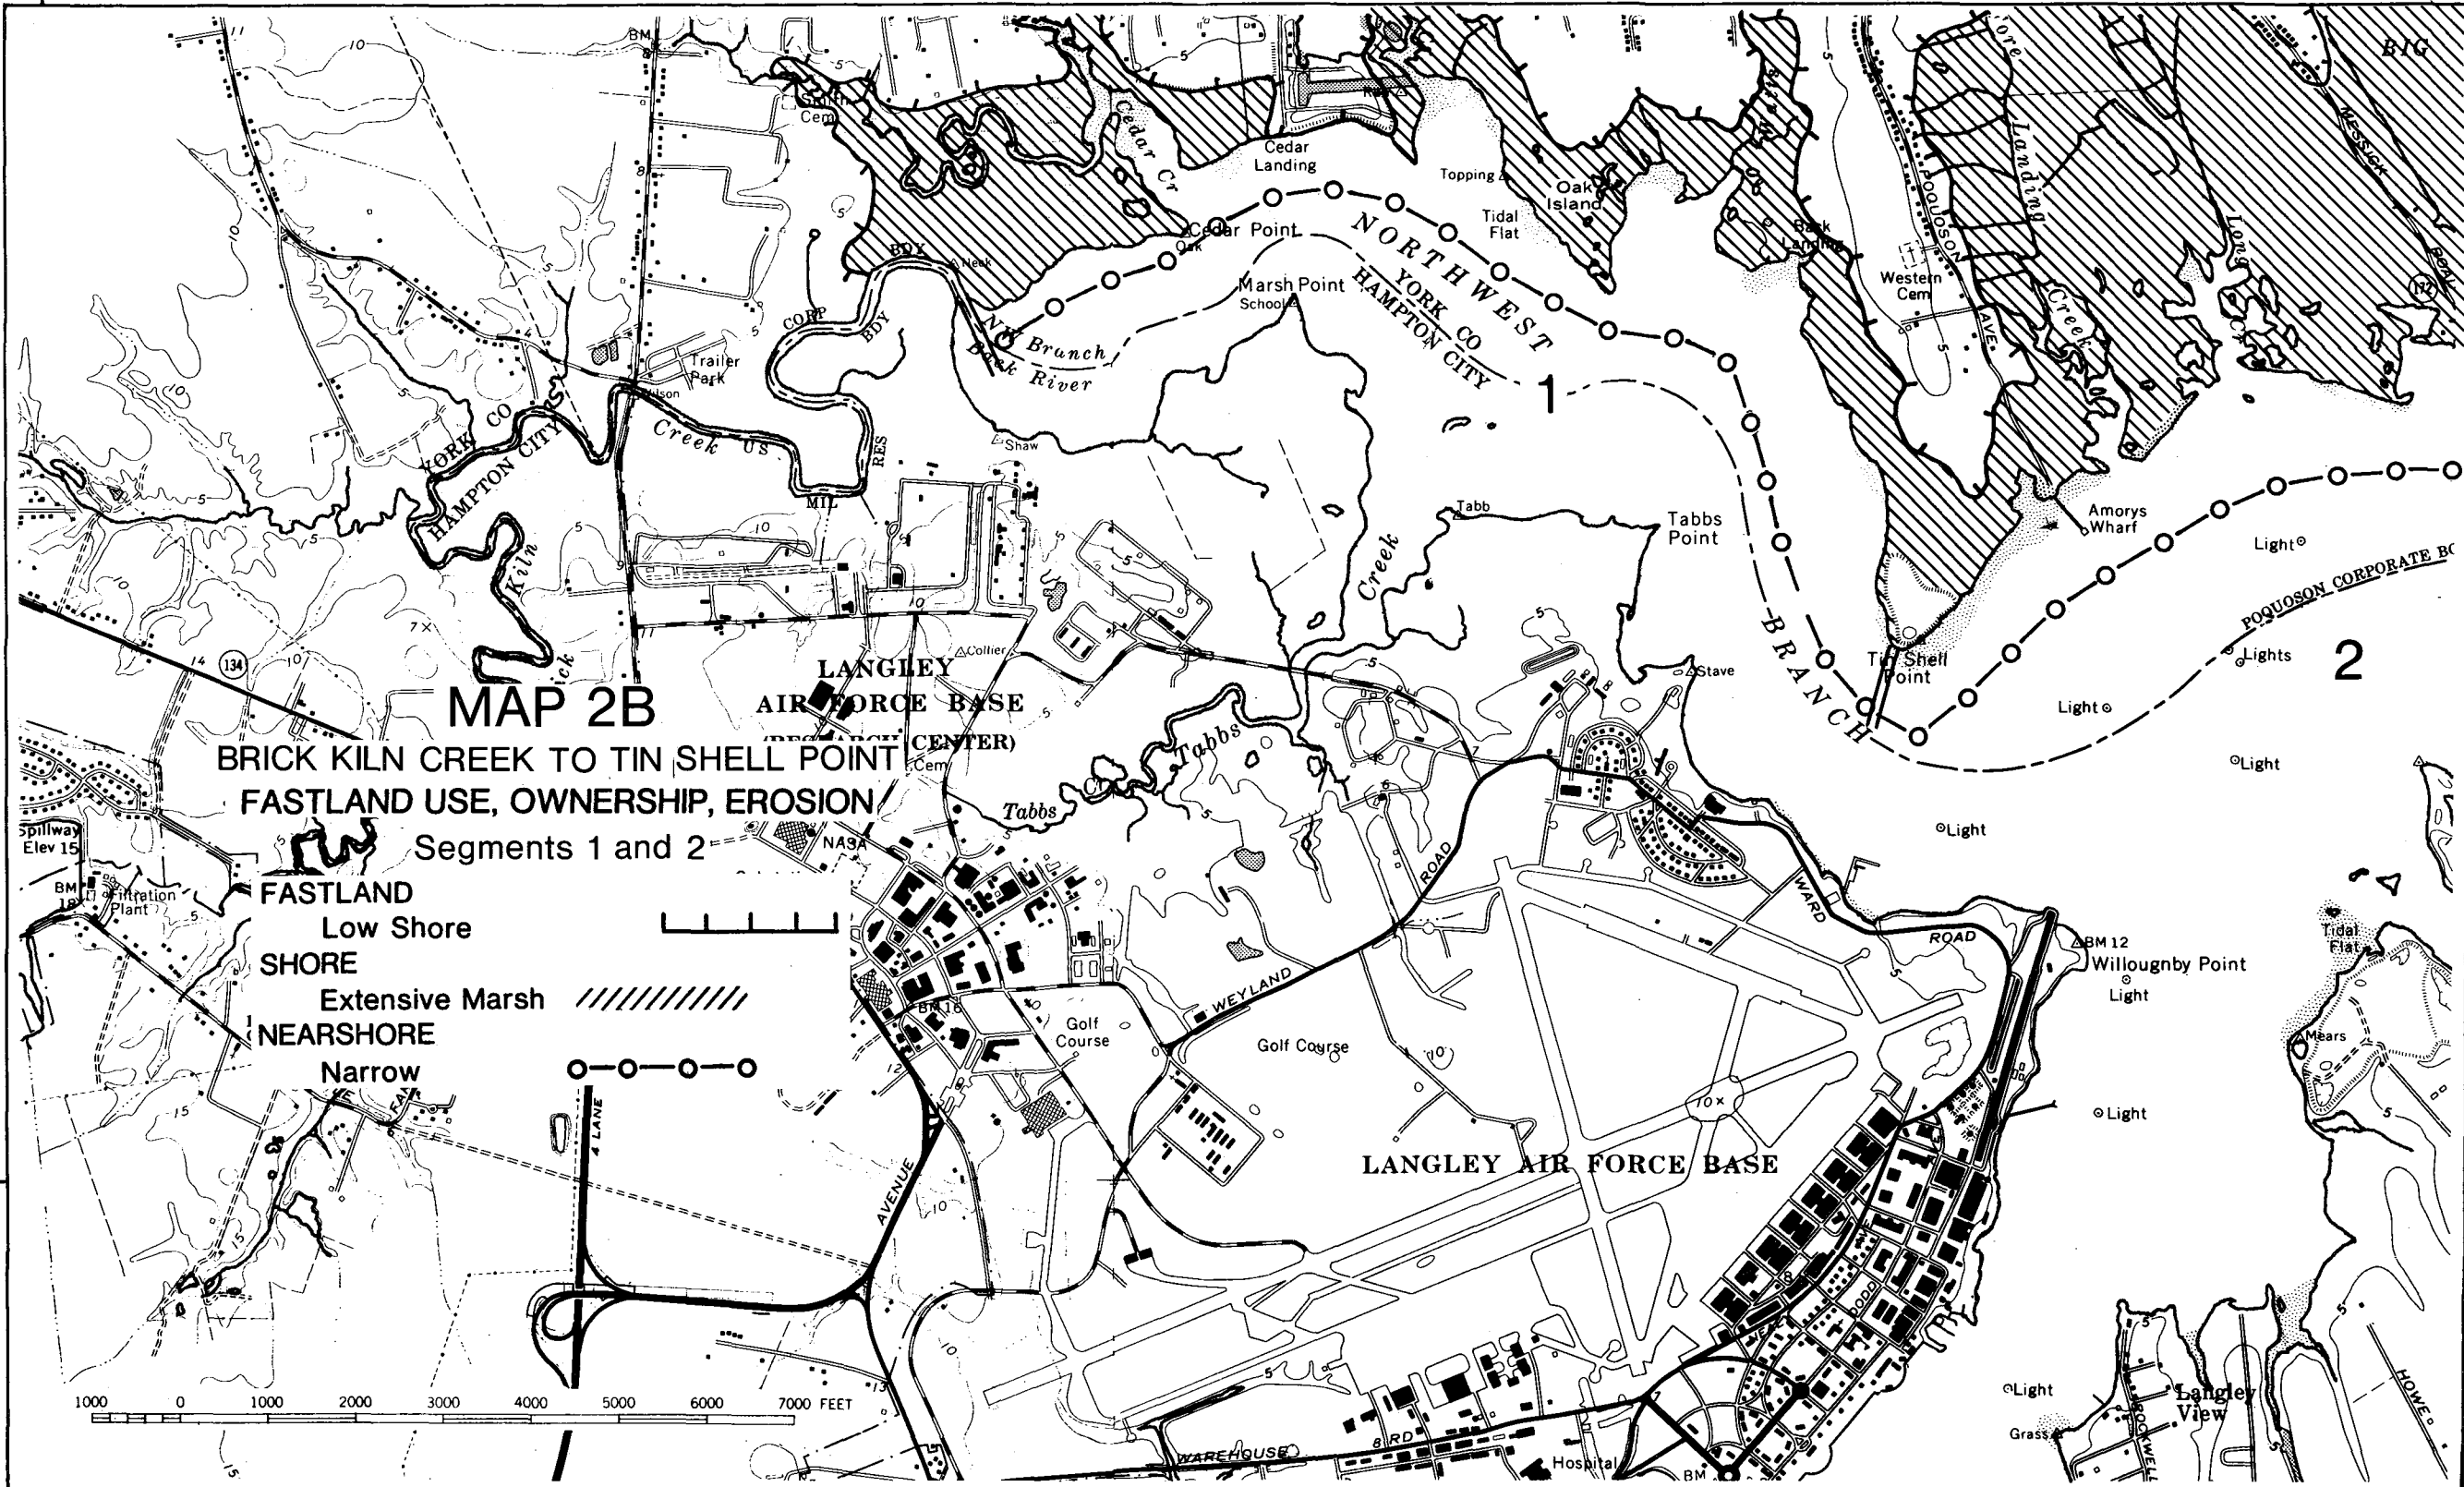
MAP 2B

BRICK KILN CREEK TO TIN SHELL POINT FASTLAND USE, OWNERSHIP, EROSION

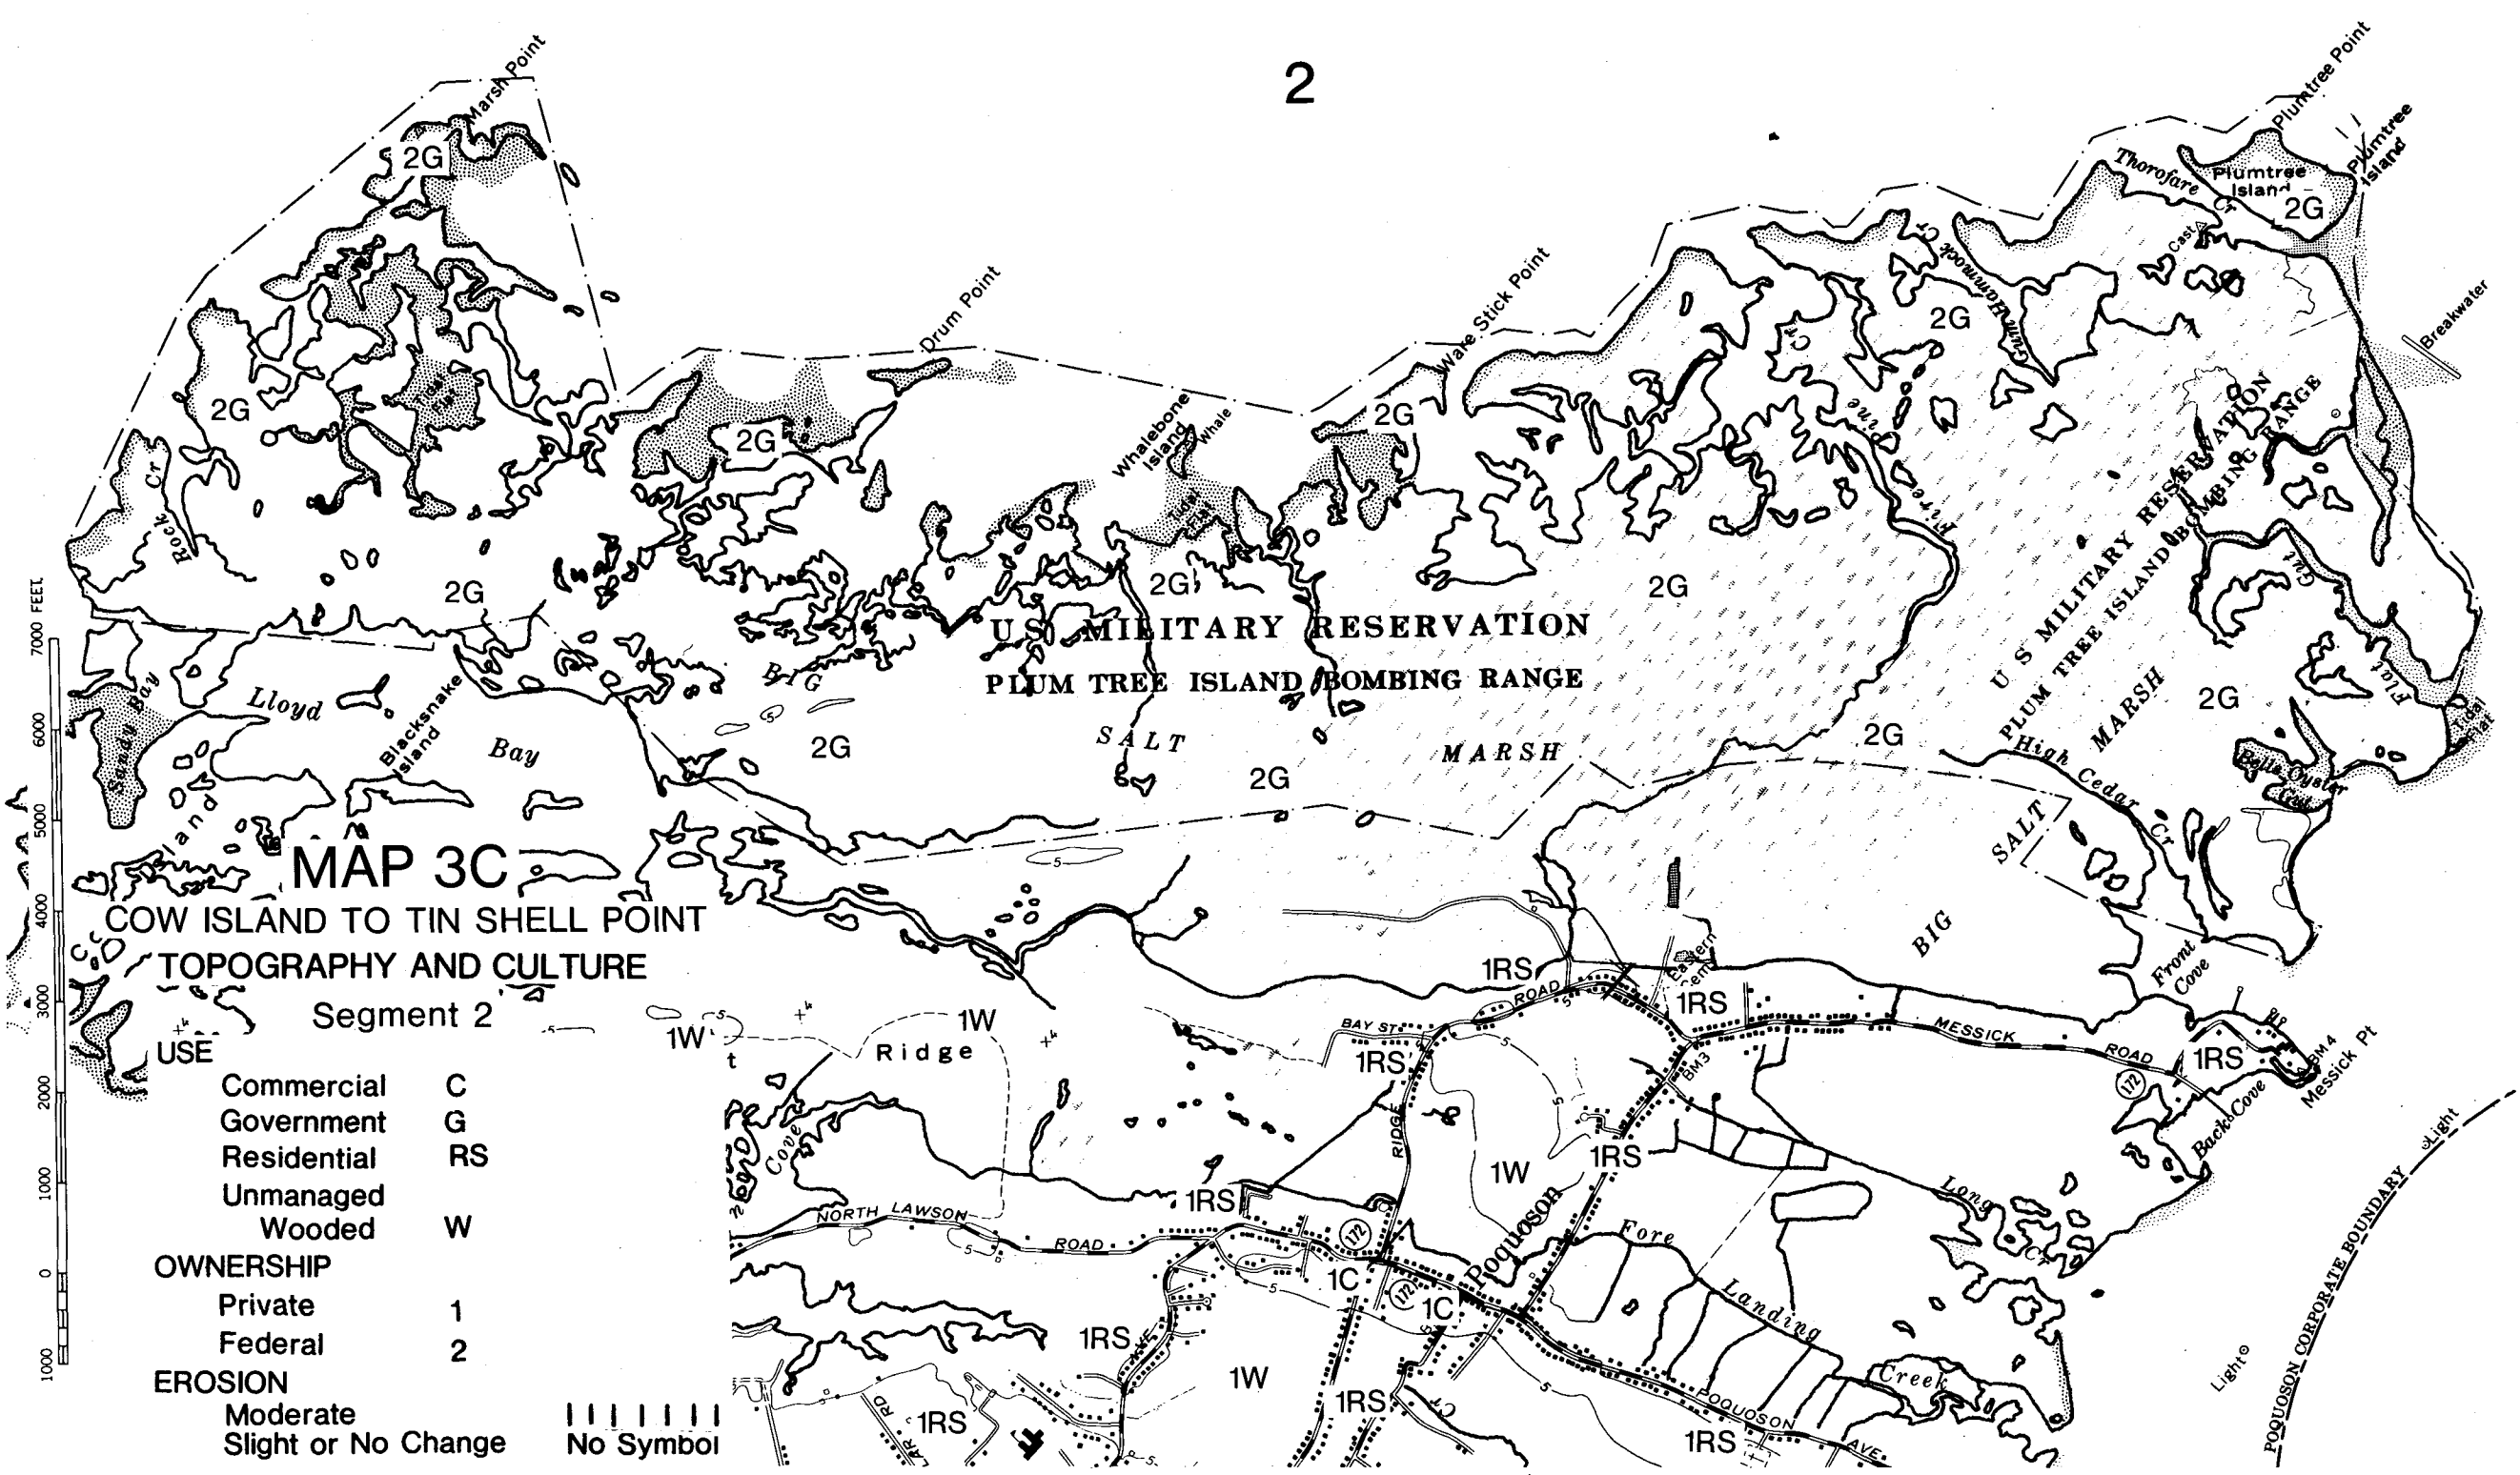
MAP 3C

COW ISLAND TO TIN SHELL POINT
TOPOGRAPHY AND CULTURE

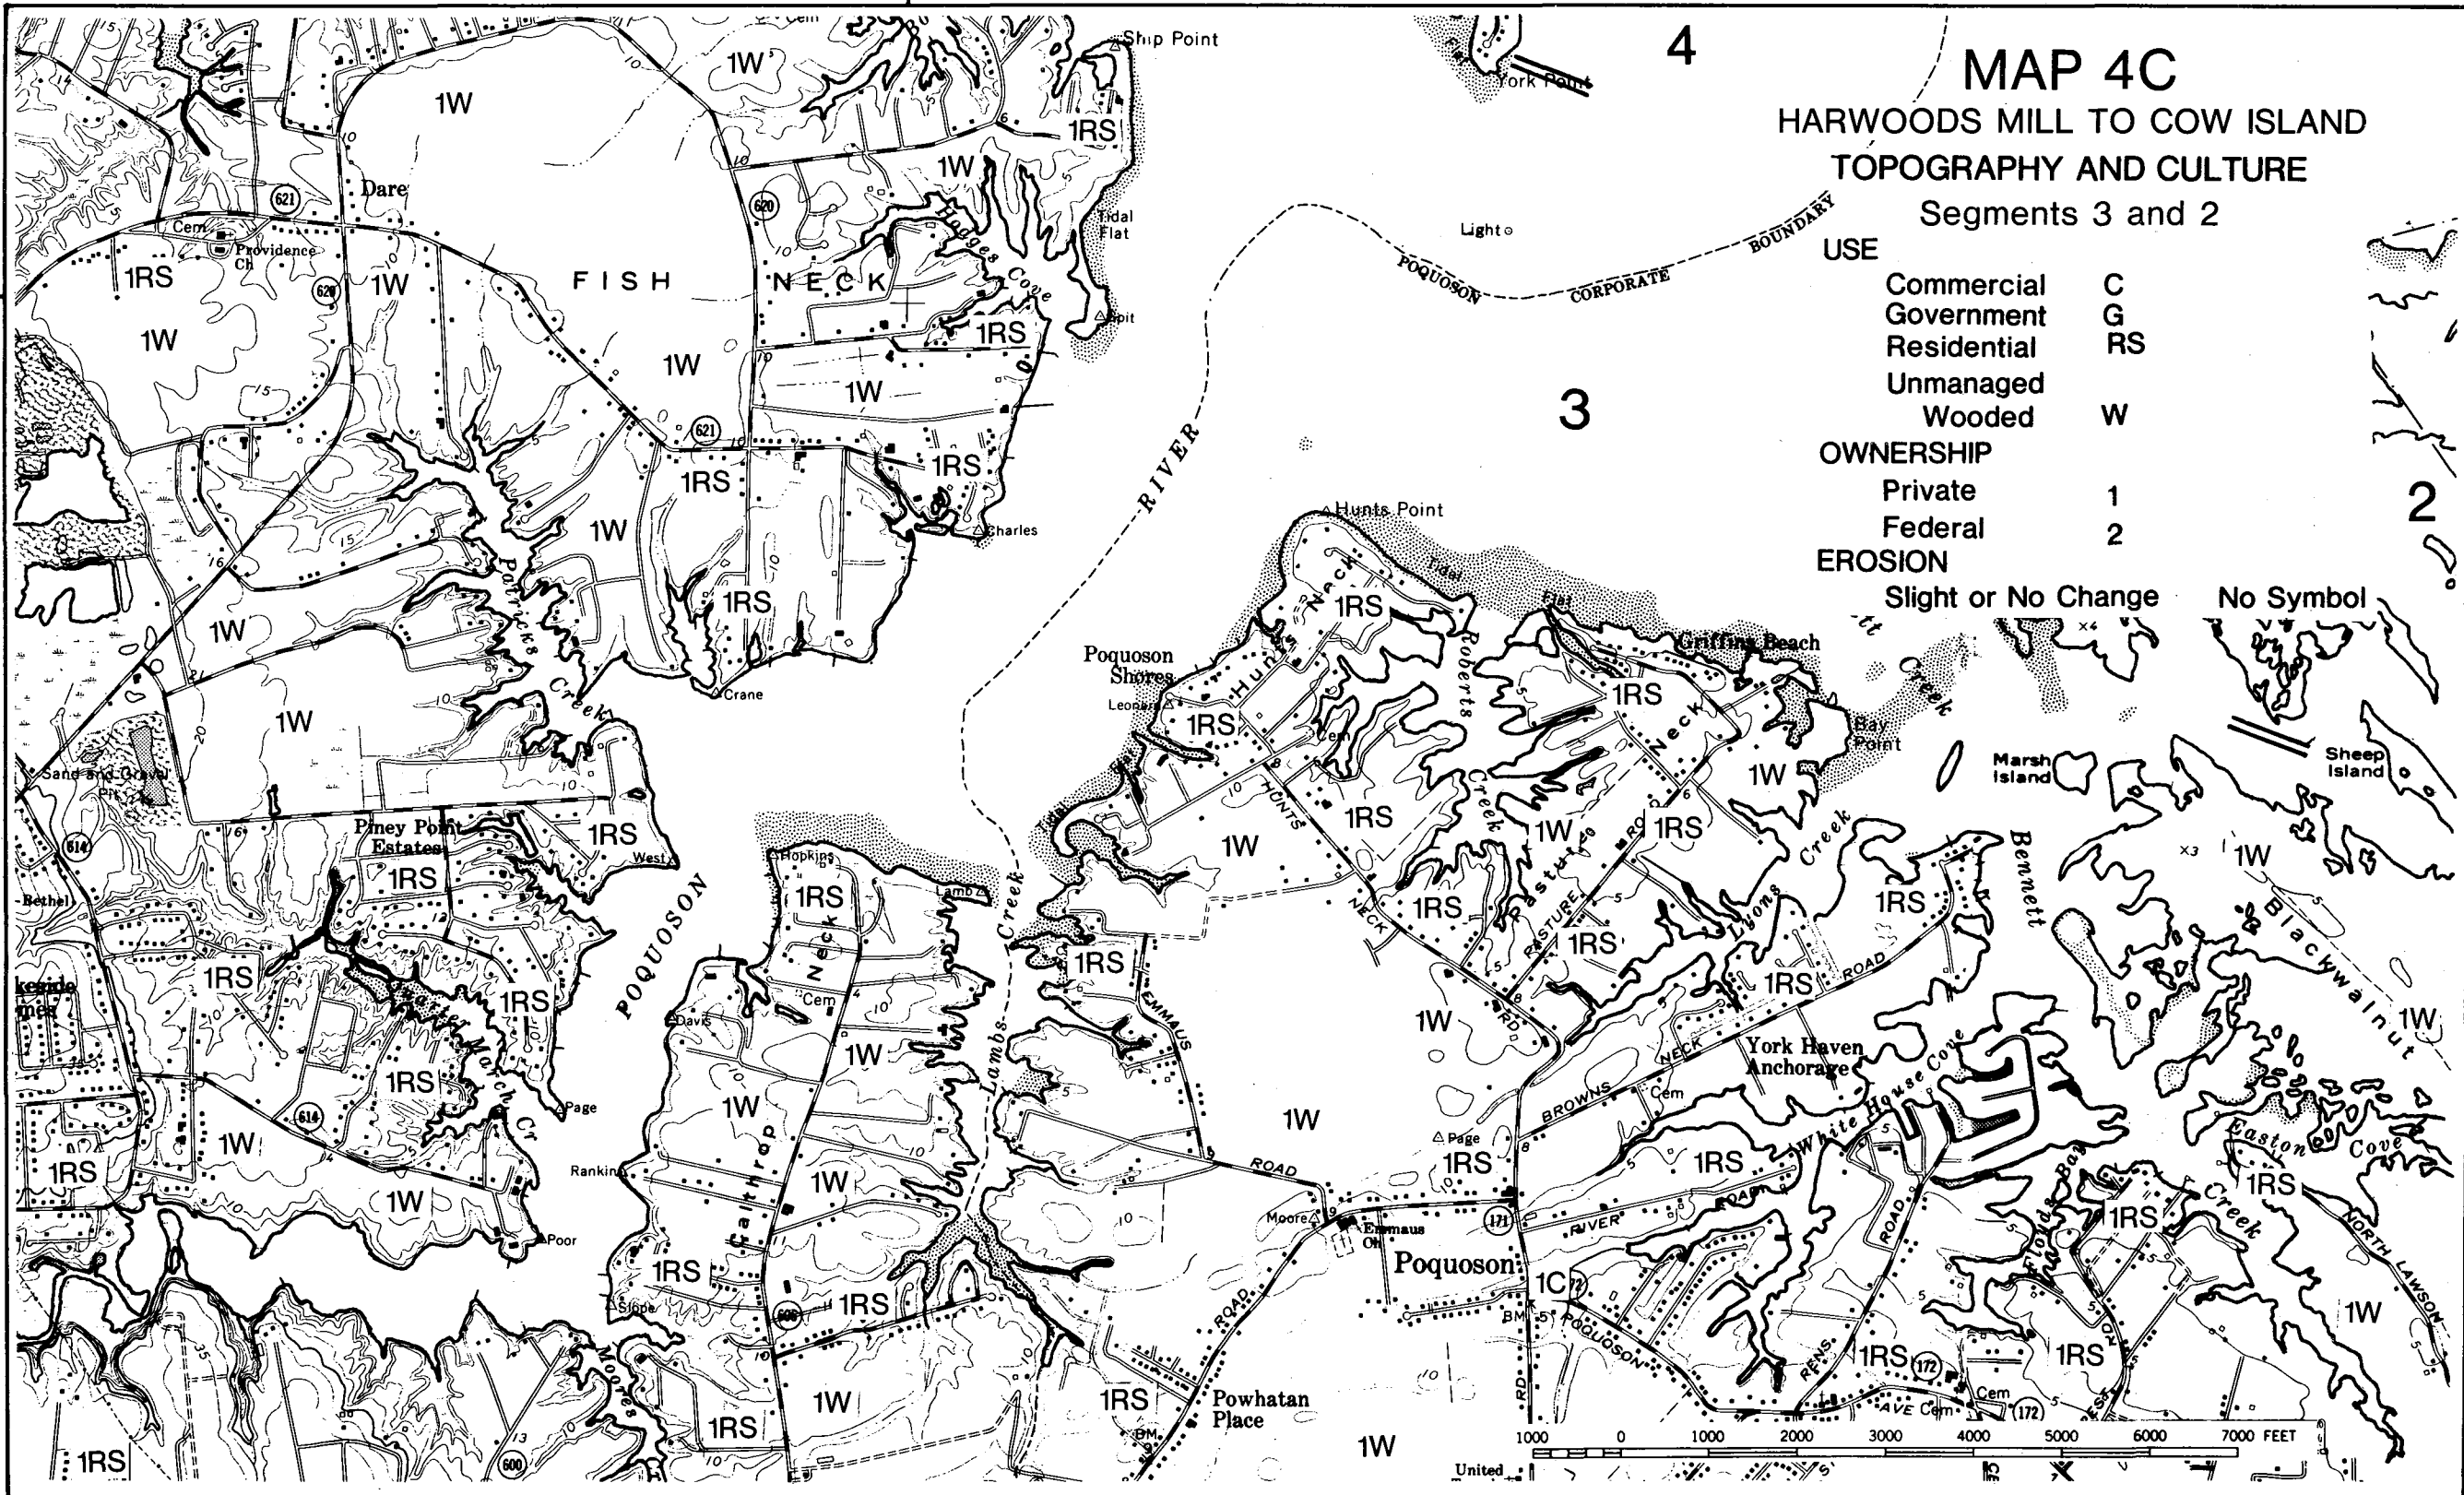
MAP 4C
HARWOODS MILL TO COW ISLAND
TOPOGRAPHY AND CULTURE
 Segments 3 and 2

USE	
Commercial	C
Government	G
Residential	RS
Unmanaged	
Wooded	W
OWNERSHIP	
Private	1
Federal	2
EROSION	
Slight or No Change	
No Symbol

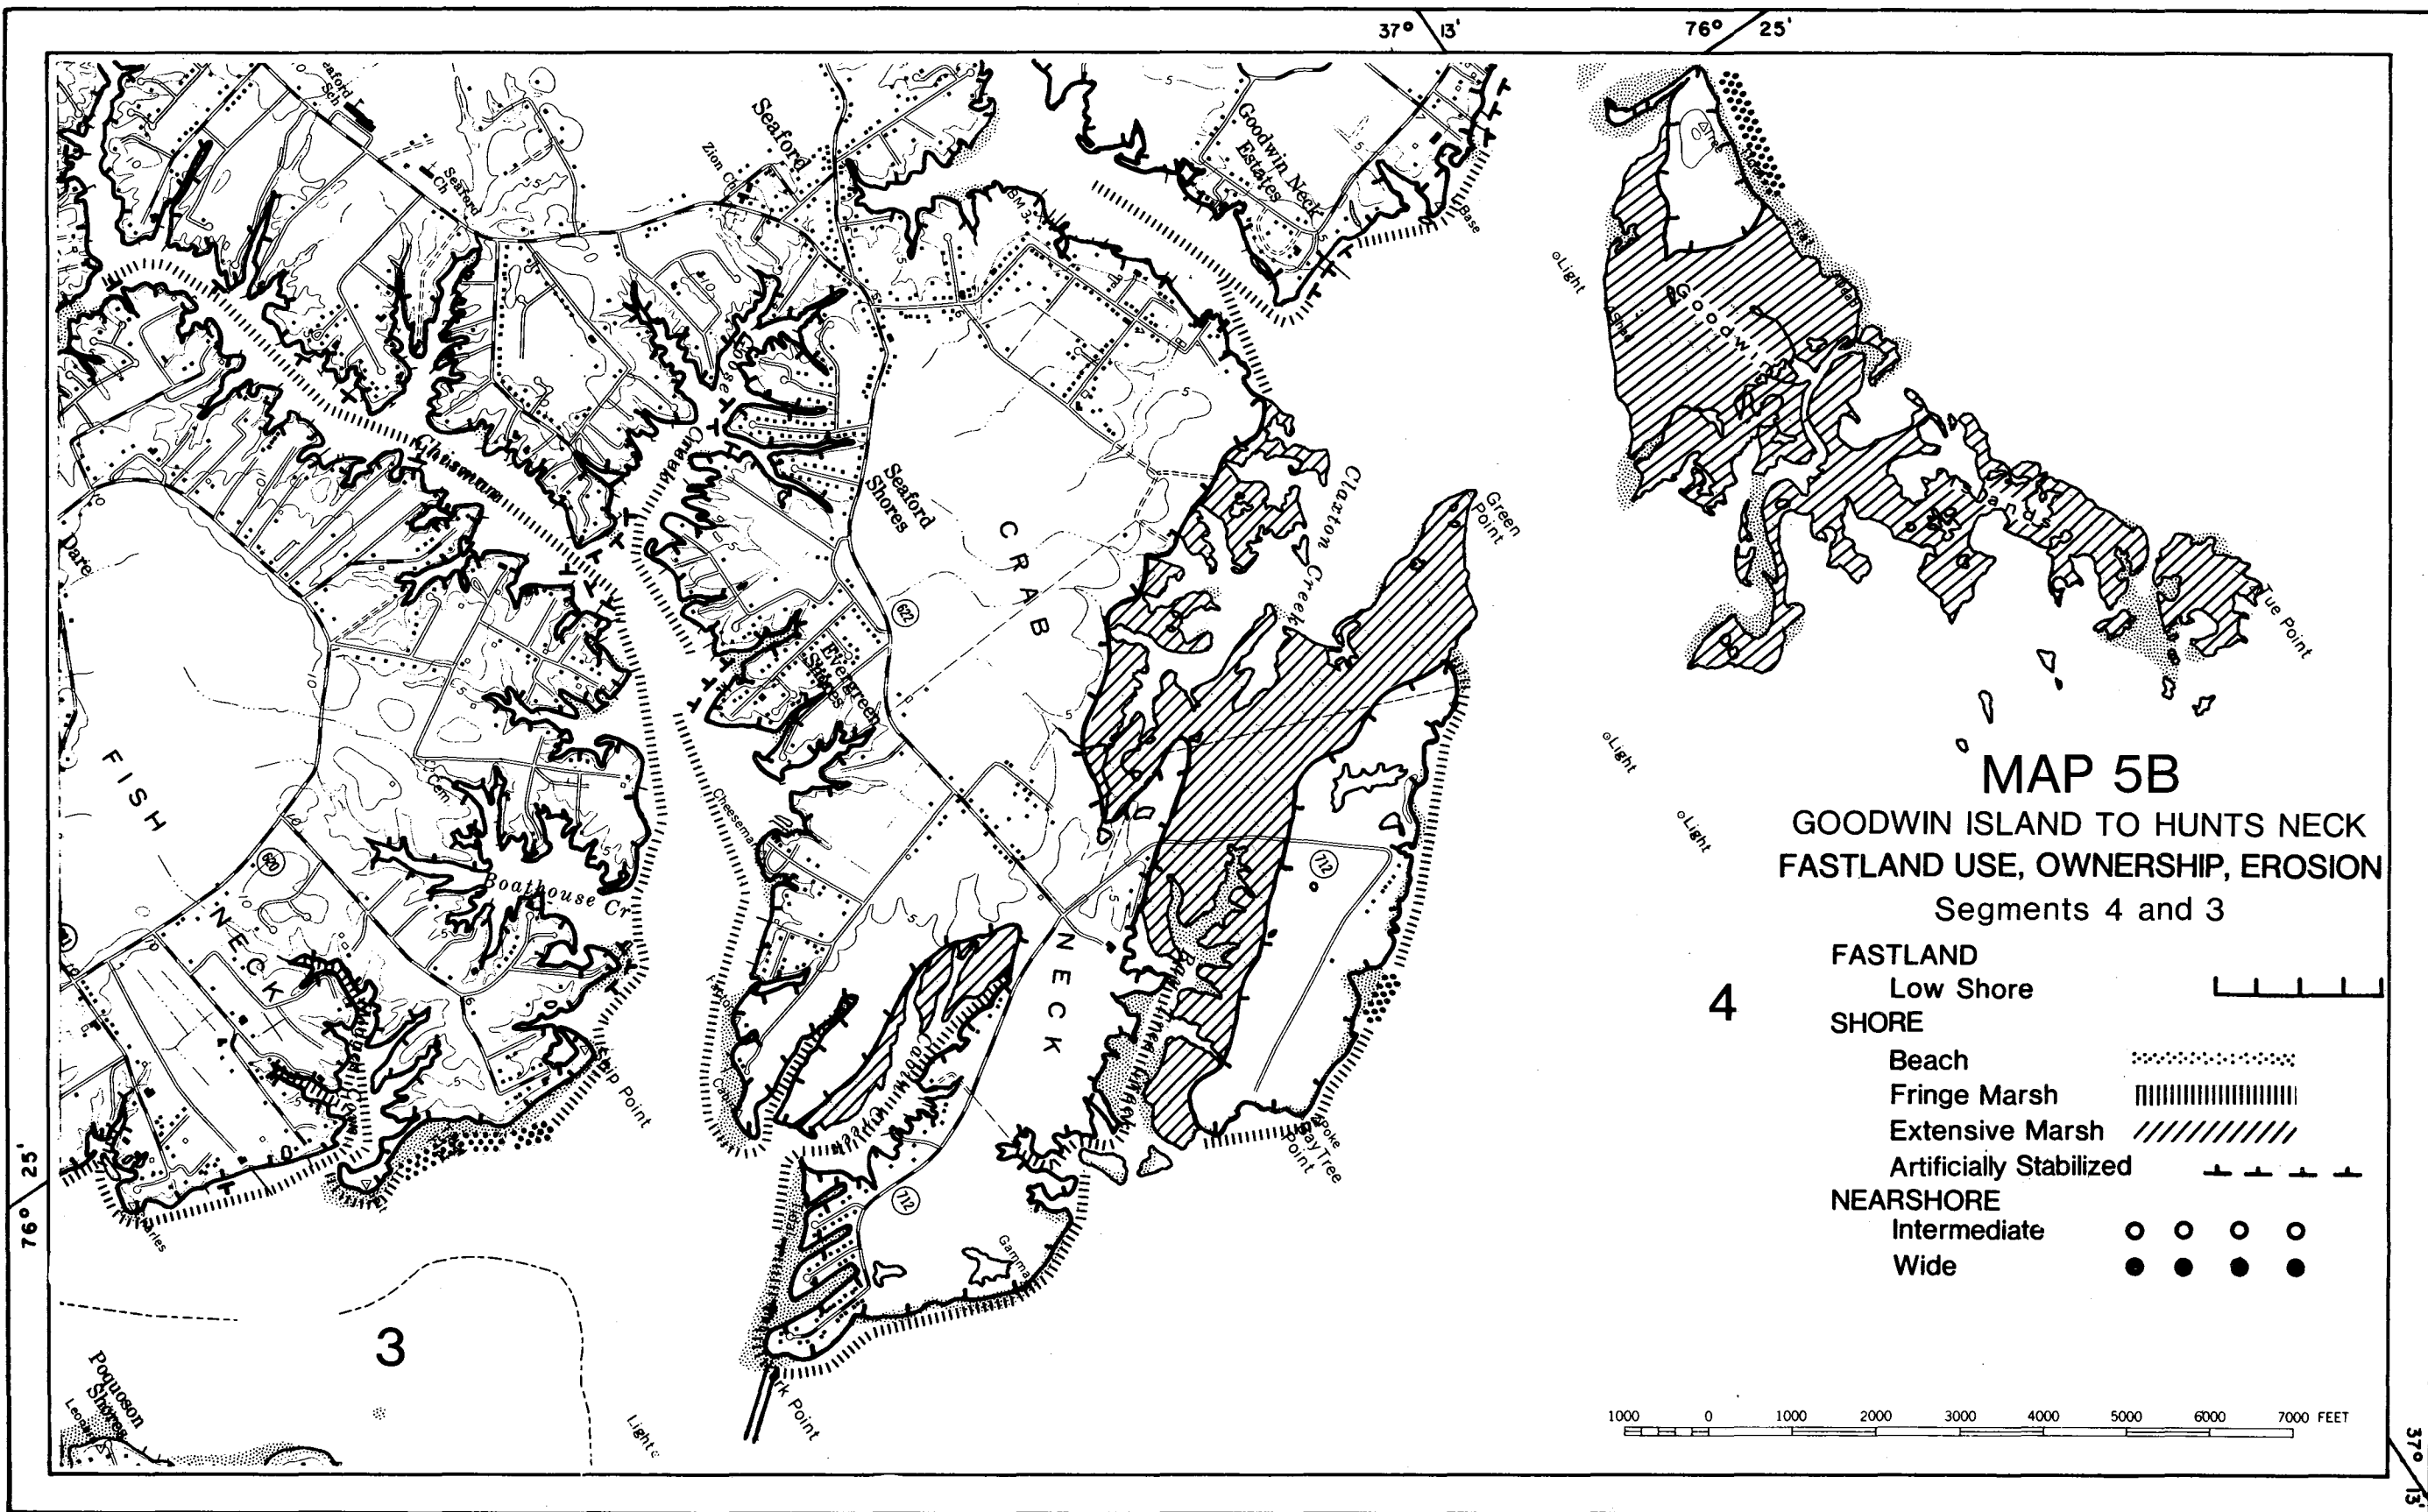
MAP 5B
 GOODWIN ISLAND TO HUNTS NECK
 FASTLAND USE, OWNERSHIP, EROSION
 Segments 4 and 3

- 4**
- FASTLAND**
 Low Shore
- SHORE**
 Beach
 Fringe Marsh
 Extensive Marsh
 Artificially Stabilized
- NEARSHORE**
 Intermediate
 Wide

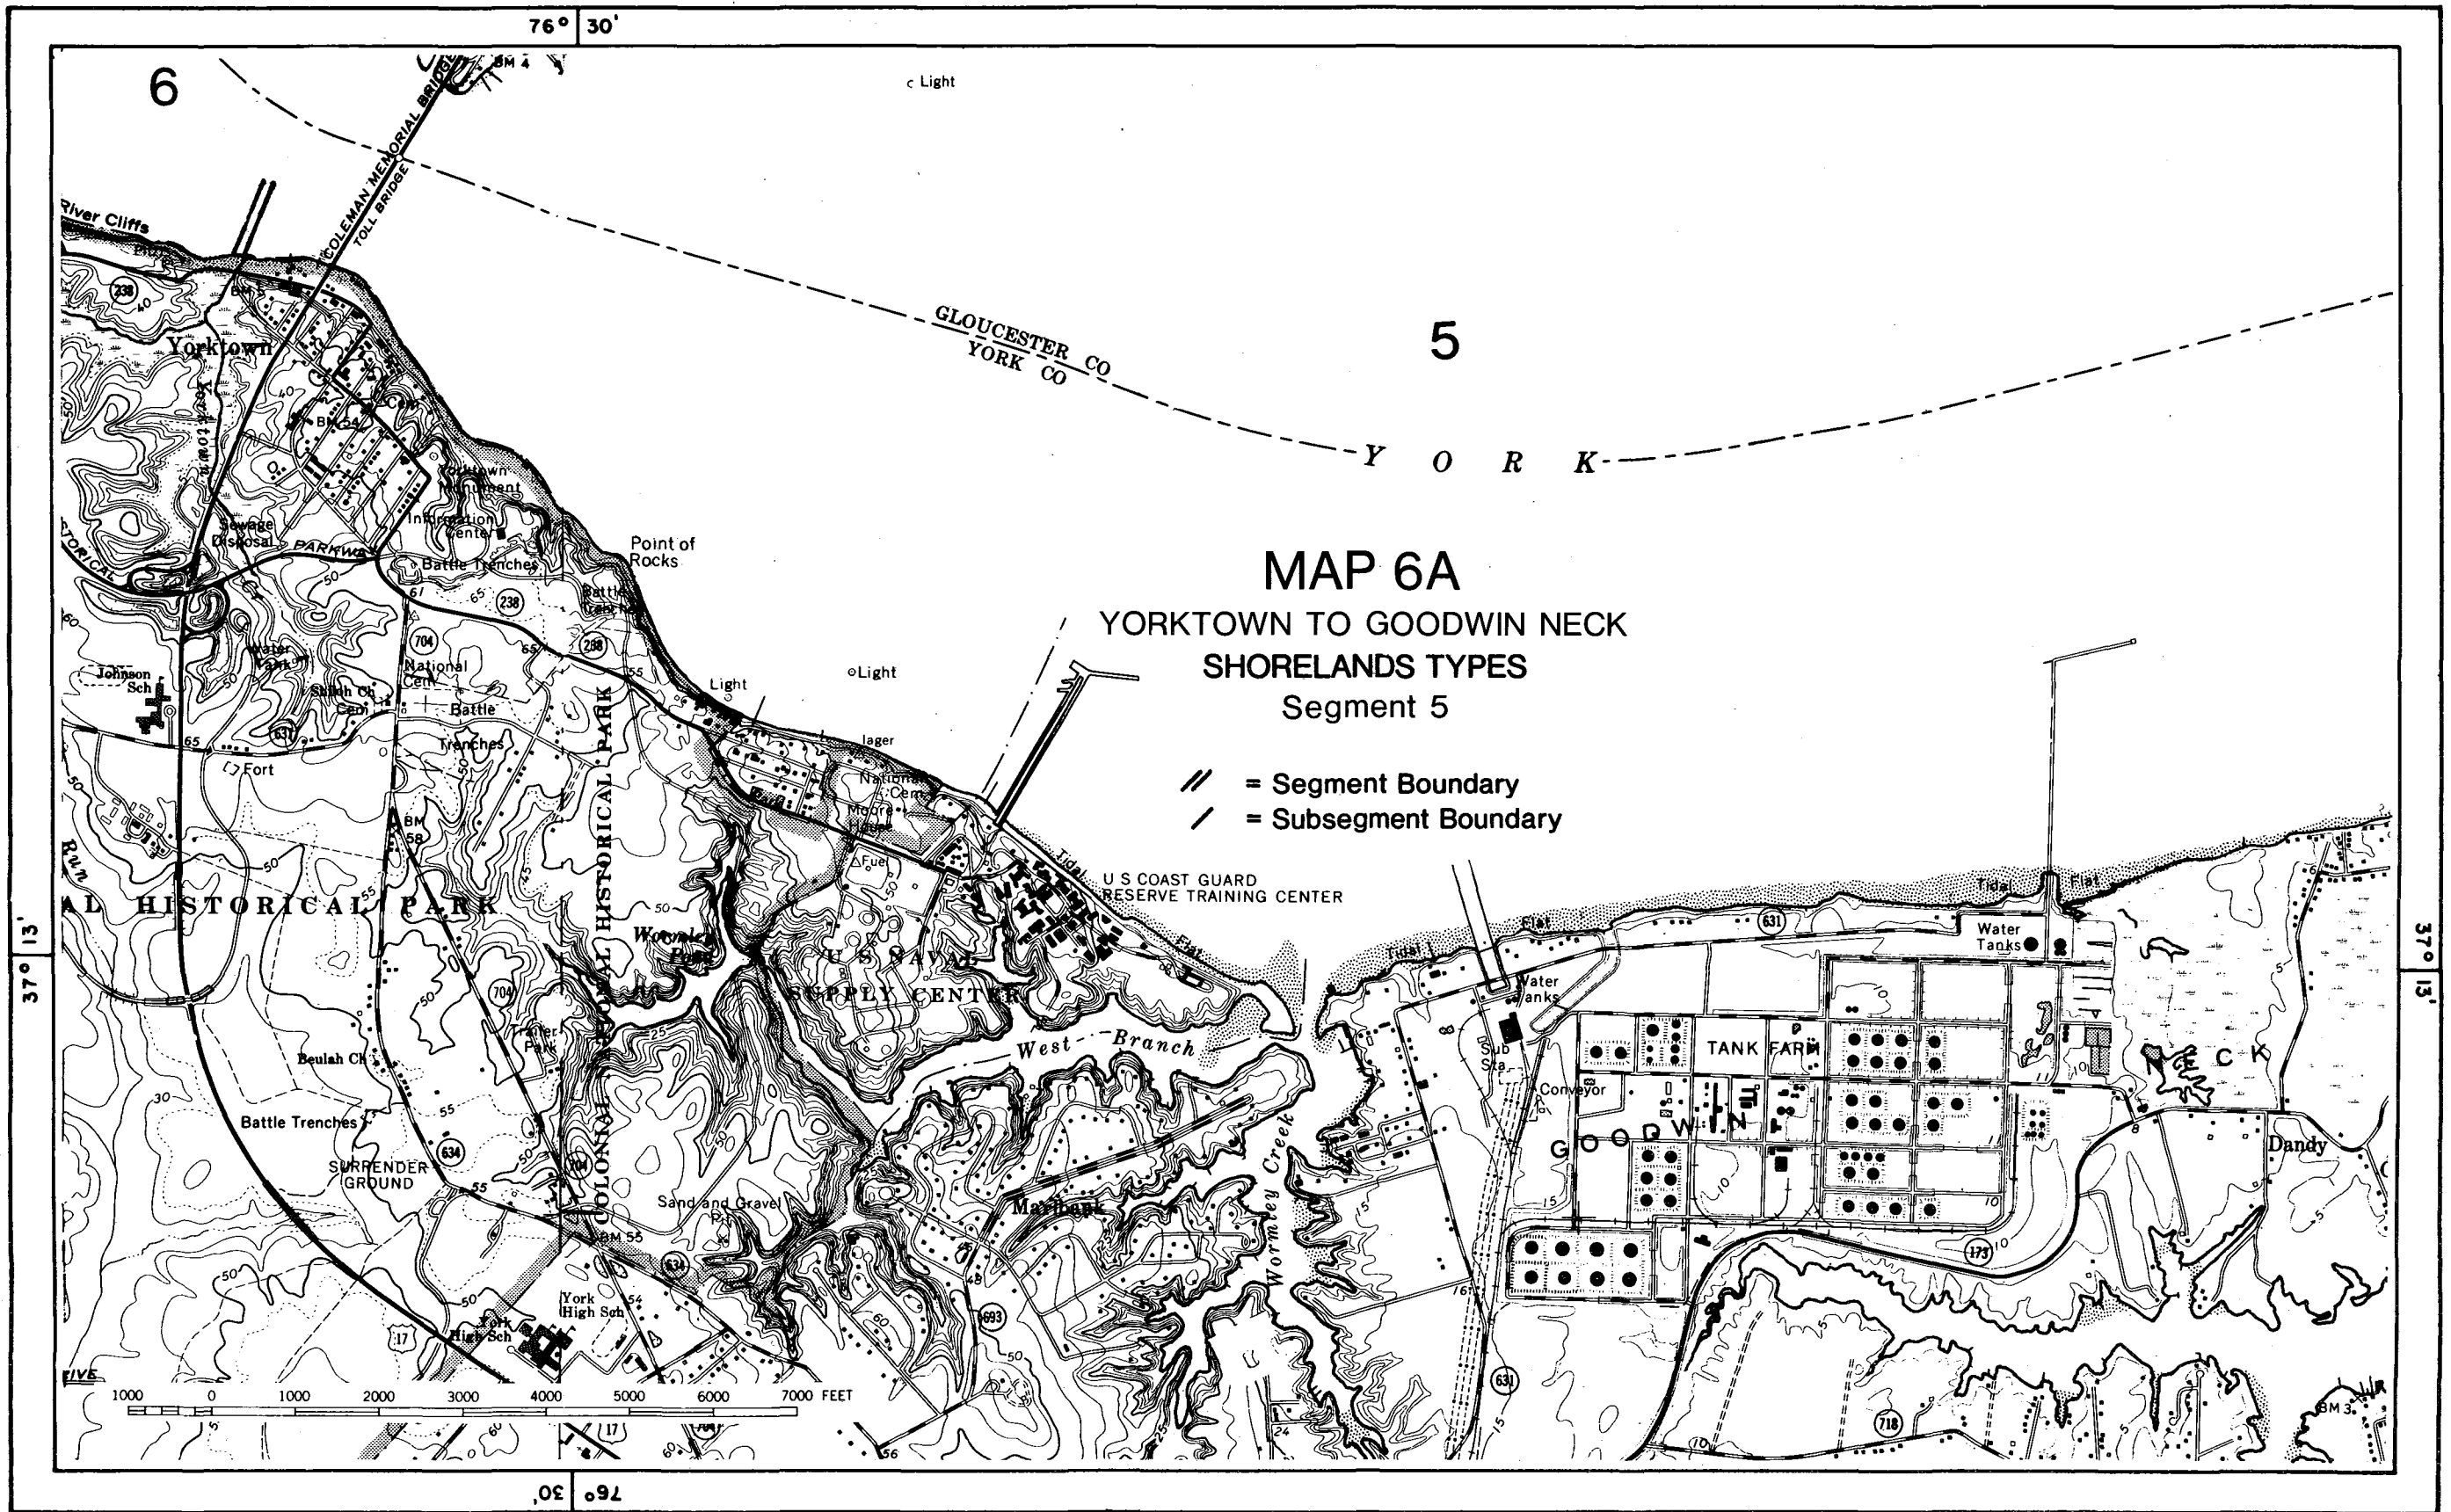
MAP 6A
YORKTOWN TO GOODWIN NECK
SHORELANDS TYPES
Segment 5

- // = Segment Boundary
- / = Subsegment Boundary
