Shoreline Situation Report York County Virginia

Shoreline Situation Report YORK COUNTY, VIRGINIA

Special Report In Applied Marine Science and Ocean Engineering Number 82 of the

VIRGINIA INSTITUTE OF MARINE SCIENCE

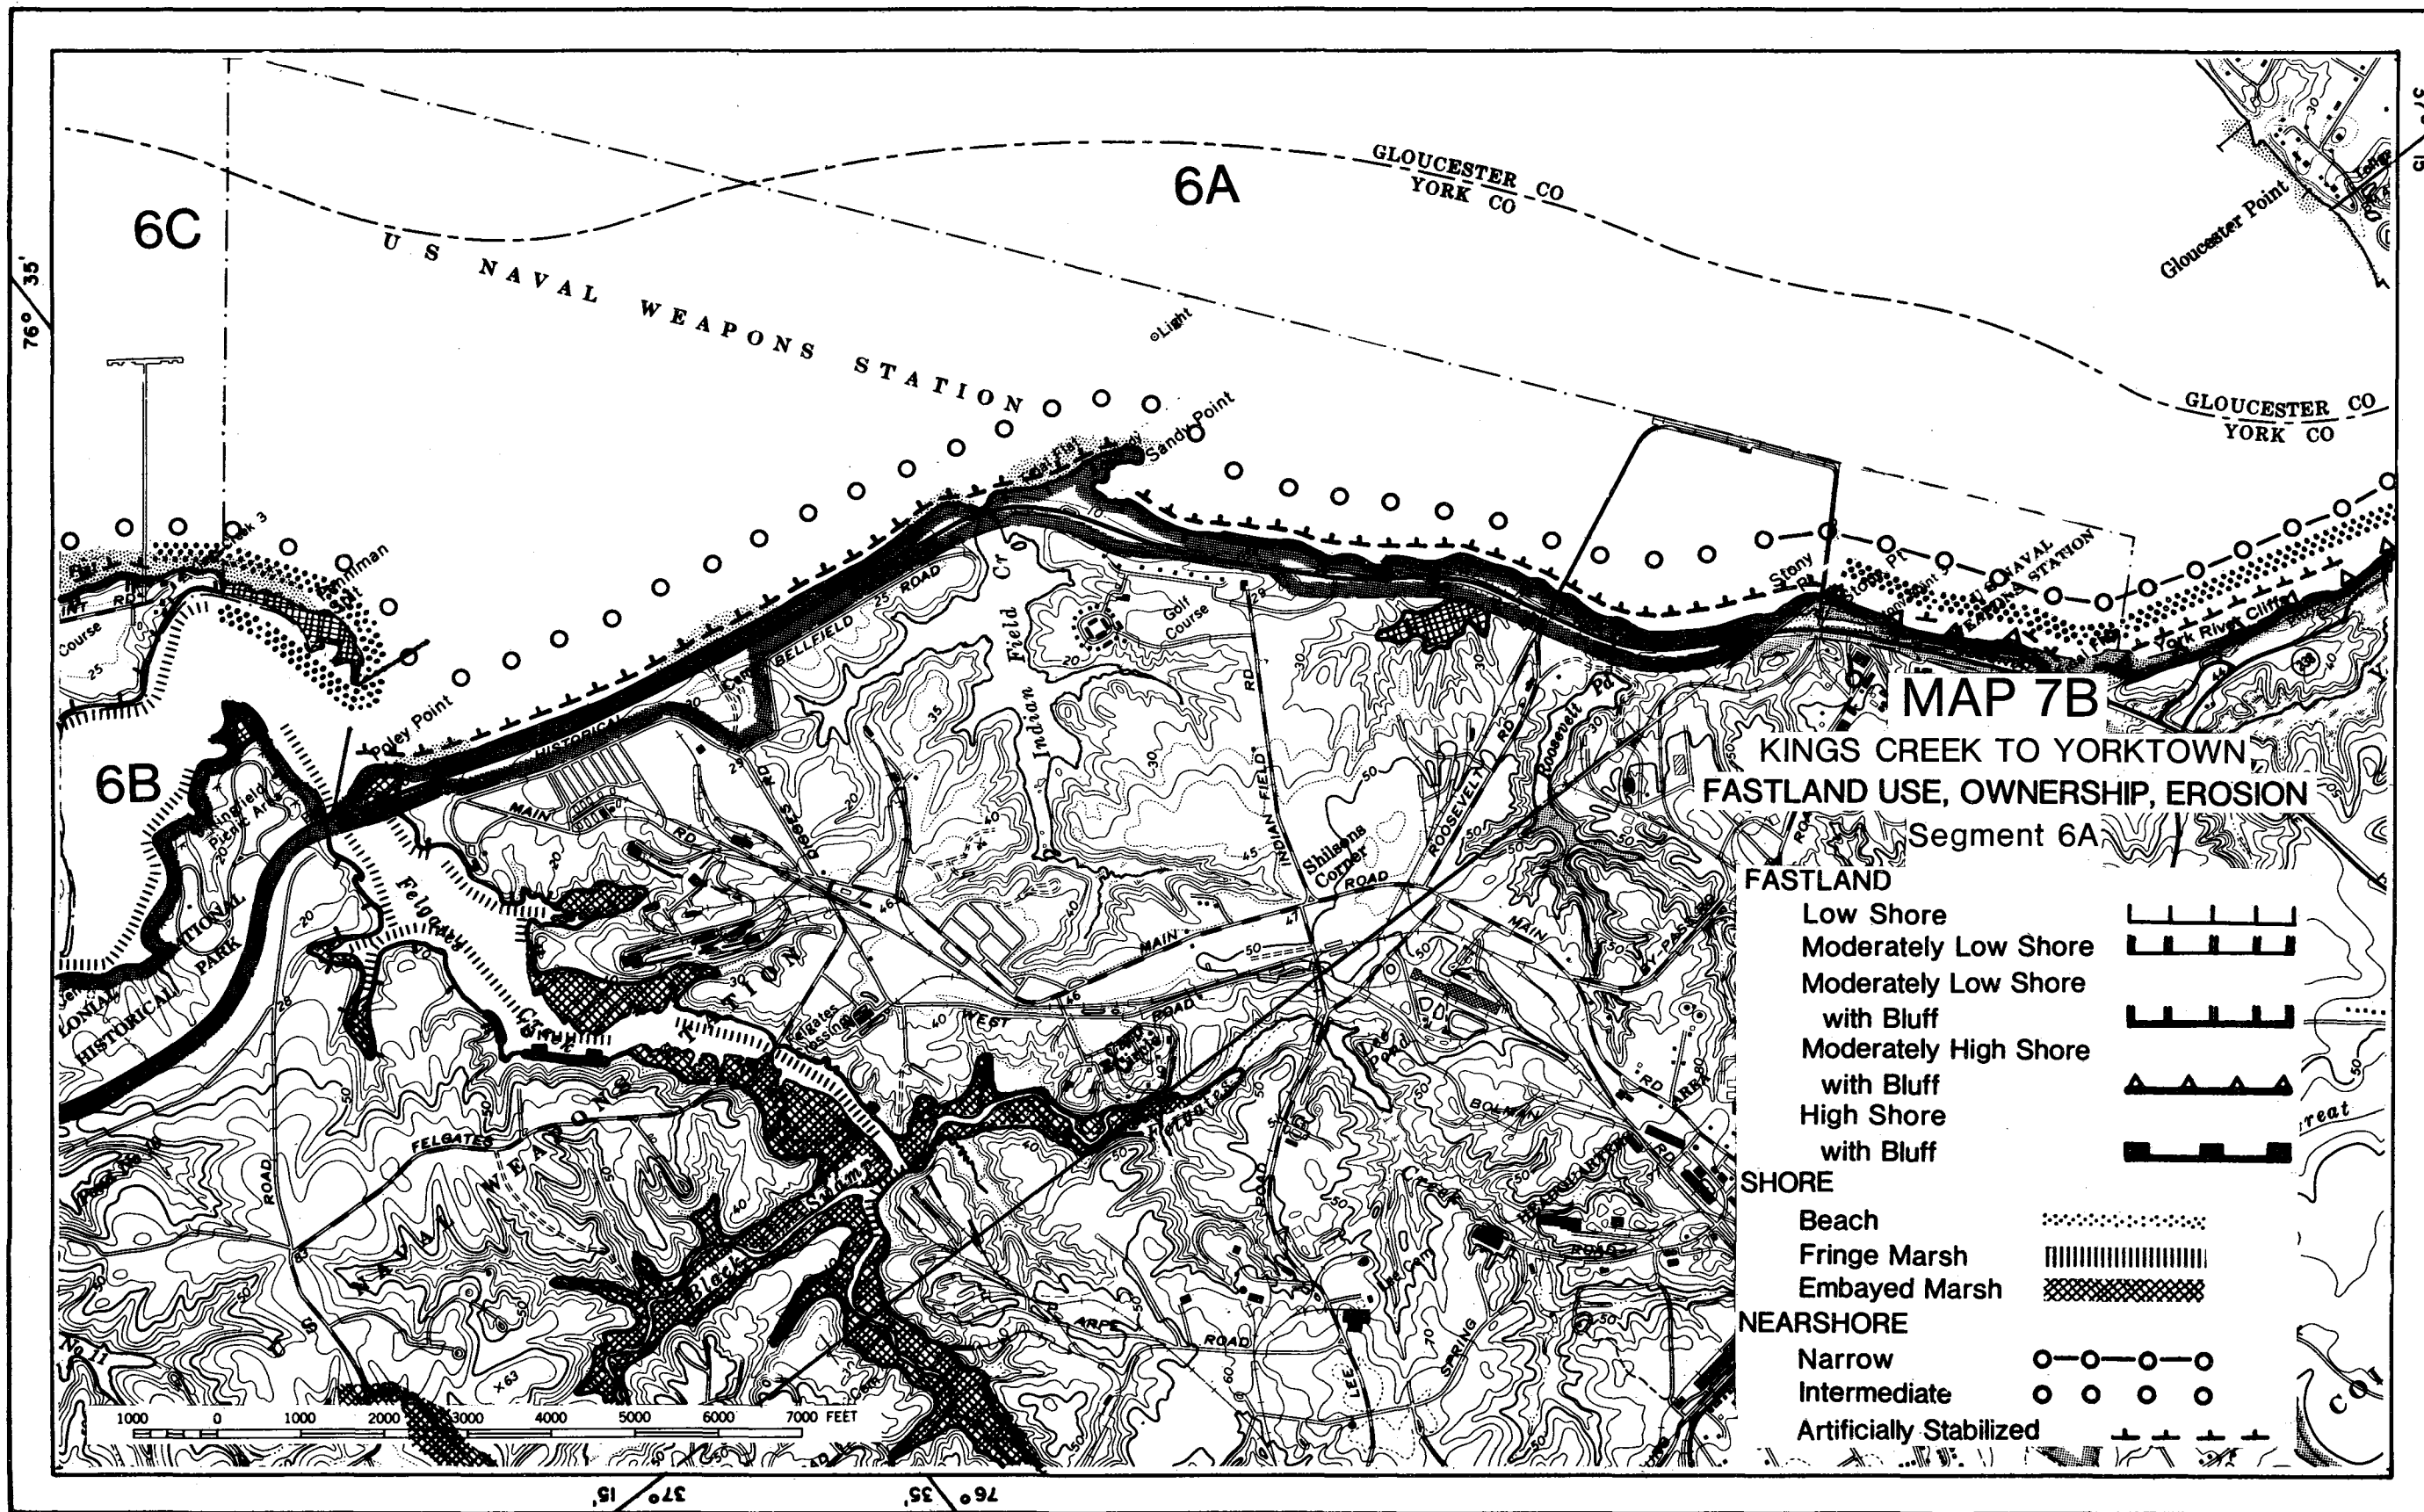
MAP 7B

KINGS CREEK TO YORKTOWN,
 FASTLAND USE, OWNERSHIP, EROSION
 Segment 6A

- FASTLAND**
- Low Shore
 - Moderately Low Shore
 - Moderately Low Shore with Bluff
 - Moderately High Shore with Bluff
 - High Shore with Bluff
- SHORE**
- Beach
 - Fringe Marsh
 - Embayed Marsh
- NEARSHORE**
- Narrow
 - Intermediate
 - Artificially Stabilized

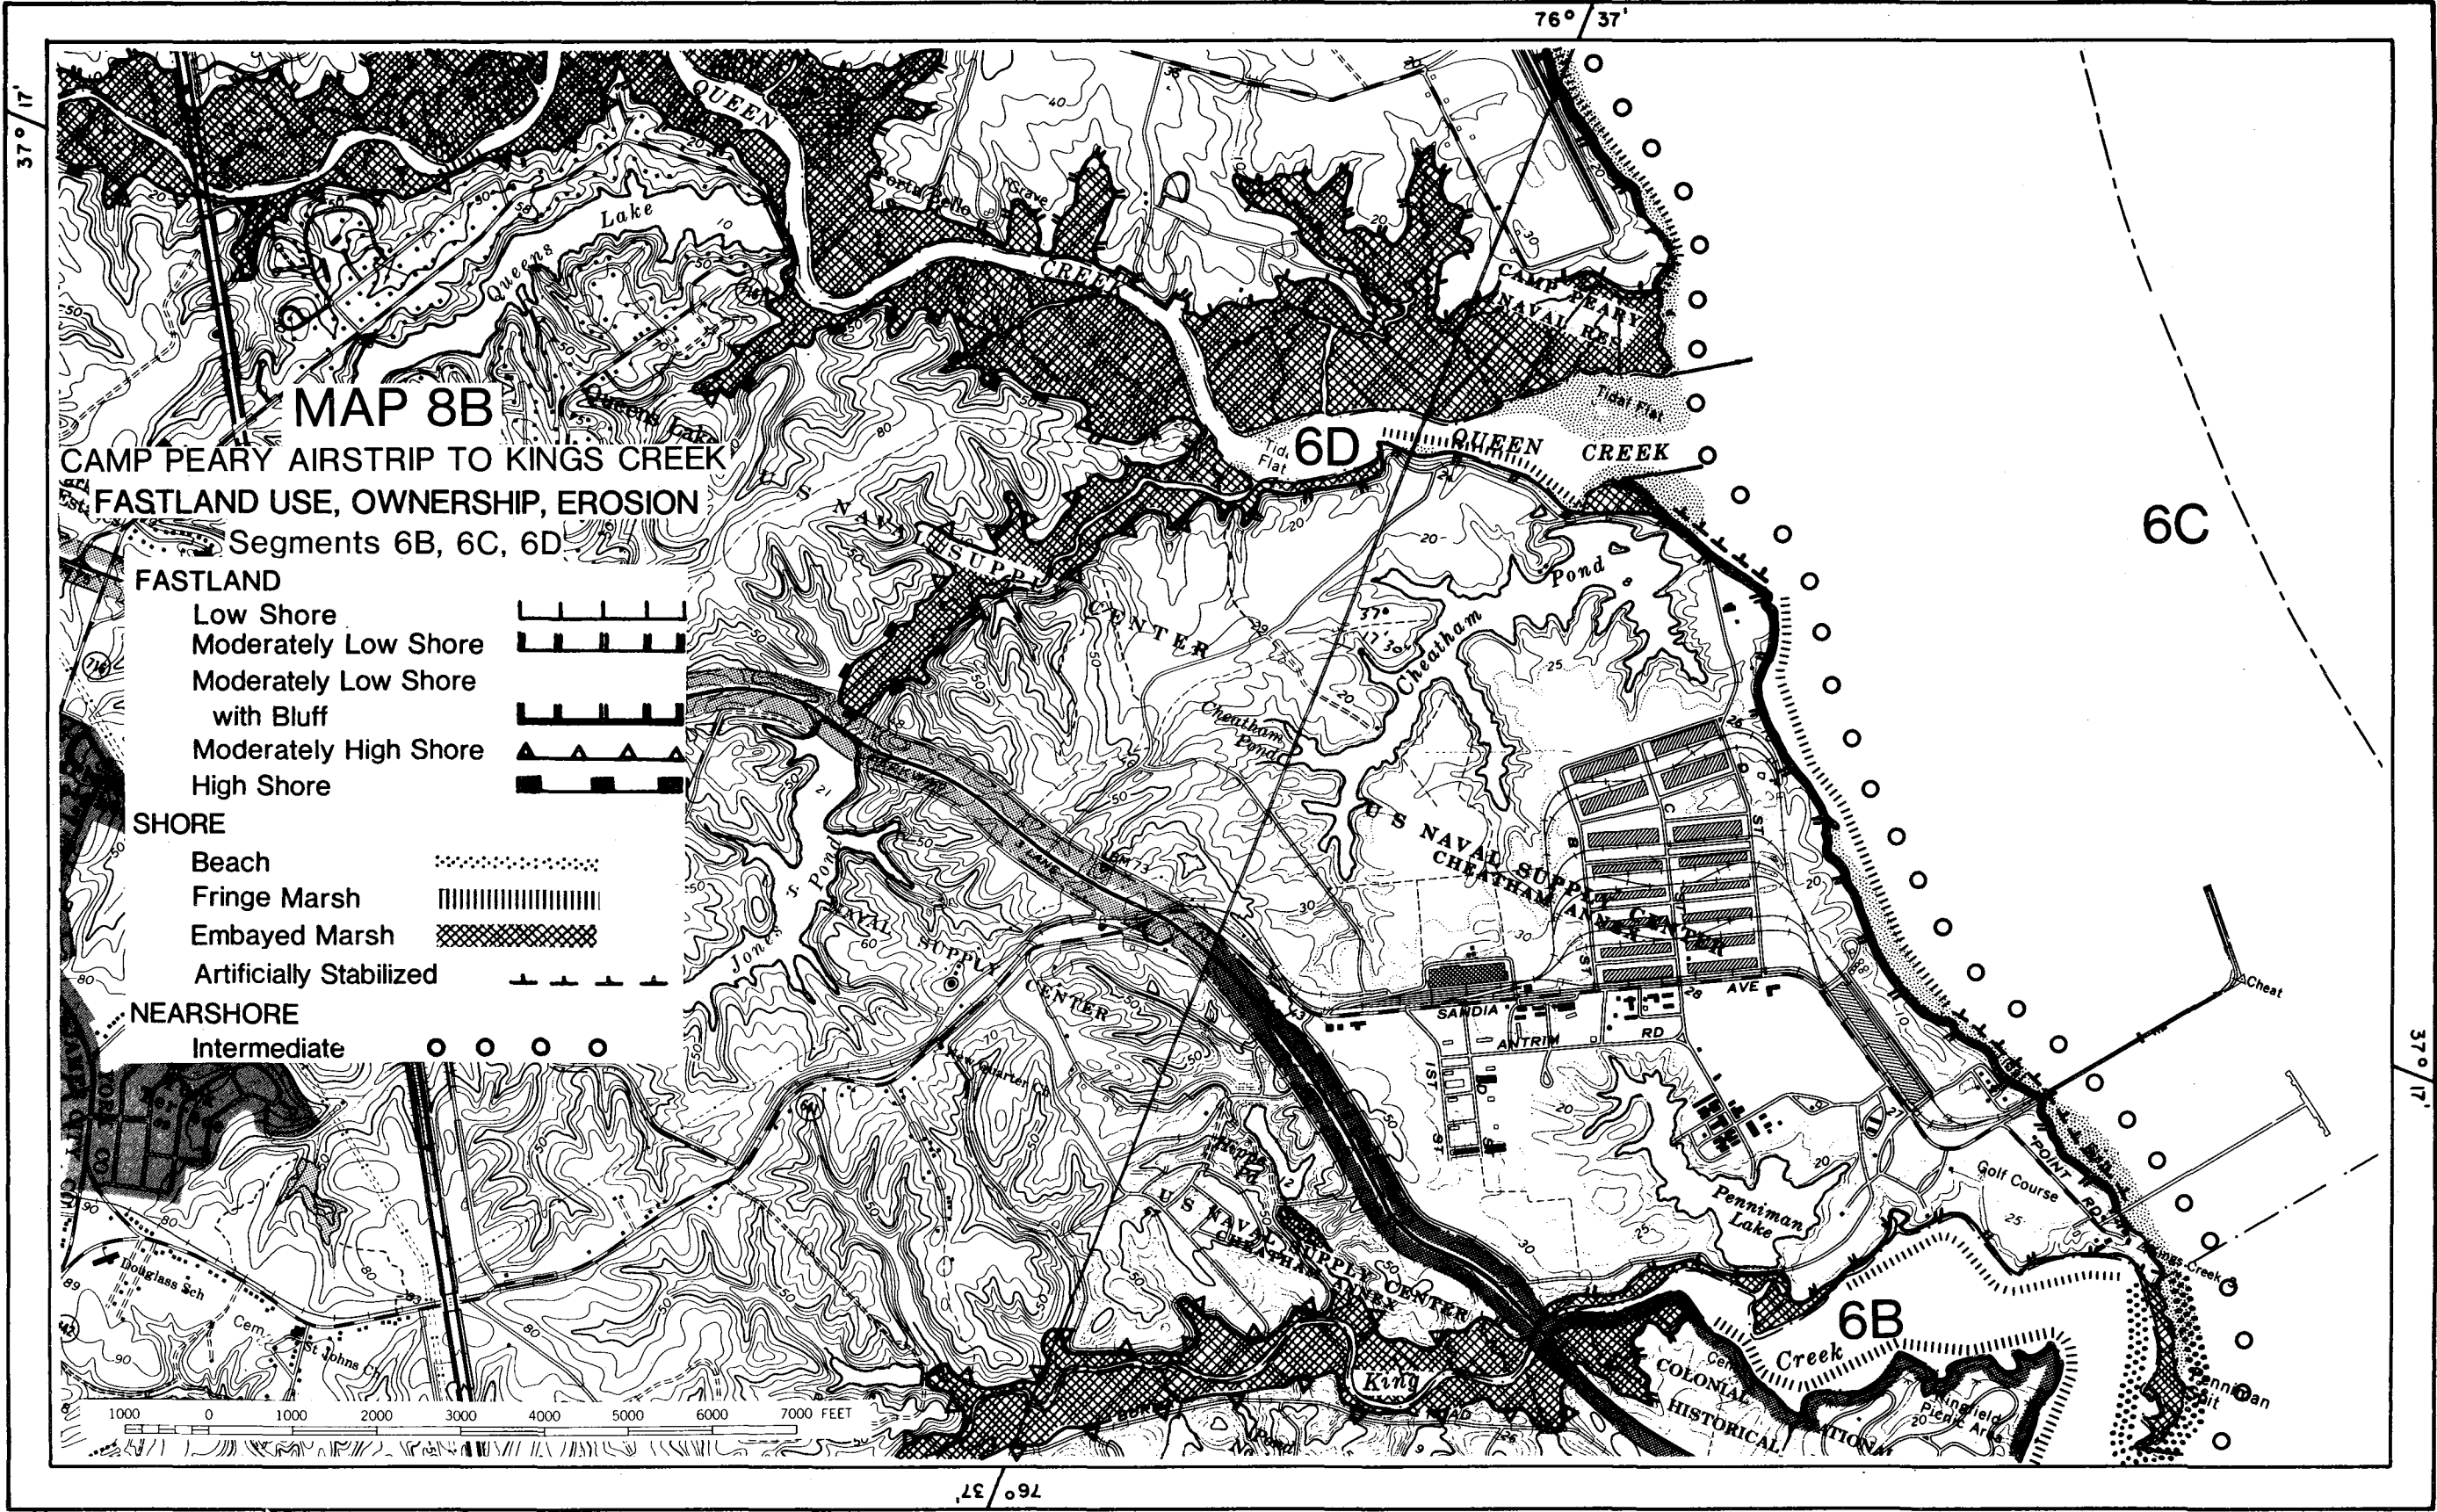
MAP 8B

CAMP PEARY AIRSTRIP TO KINGS CREEK
FASTLAND USE, OWNERSHIP, EROSION
 Segments 6B, 6C, 6D

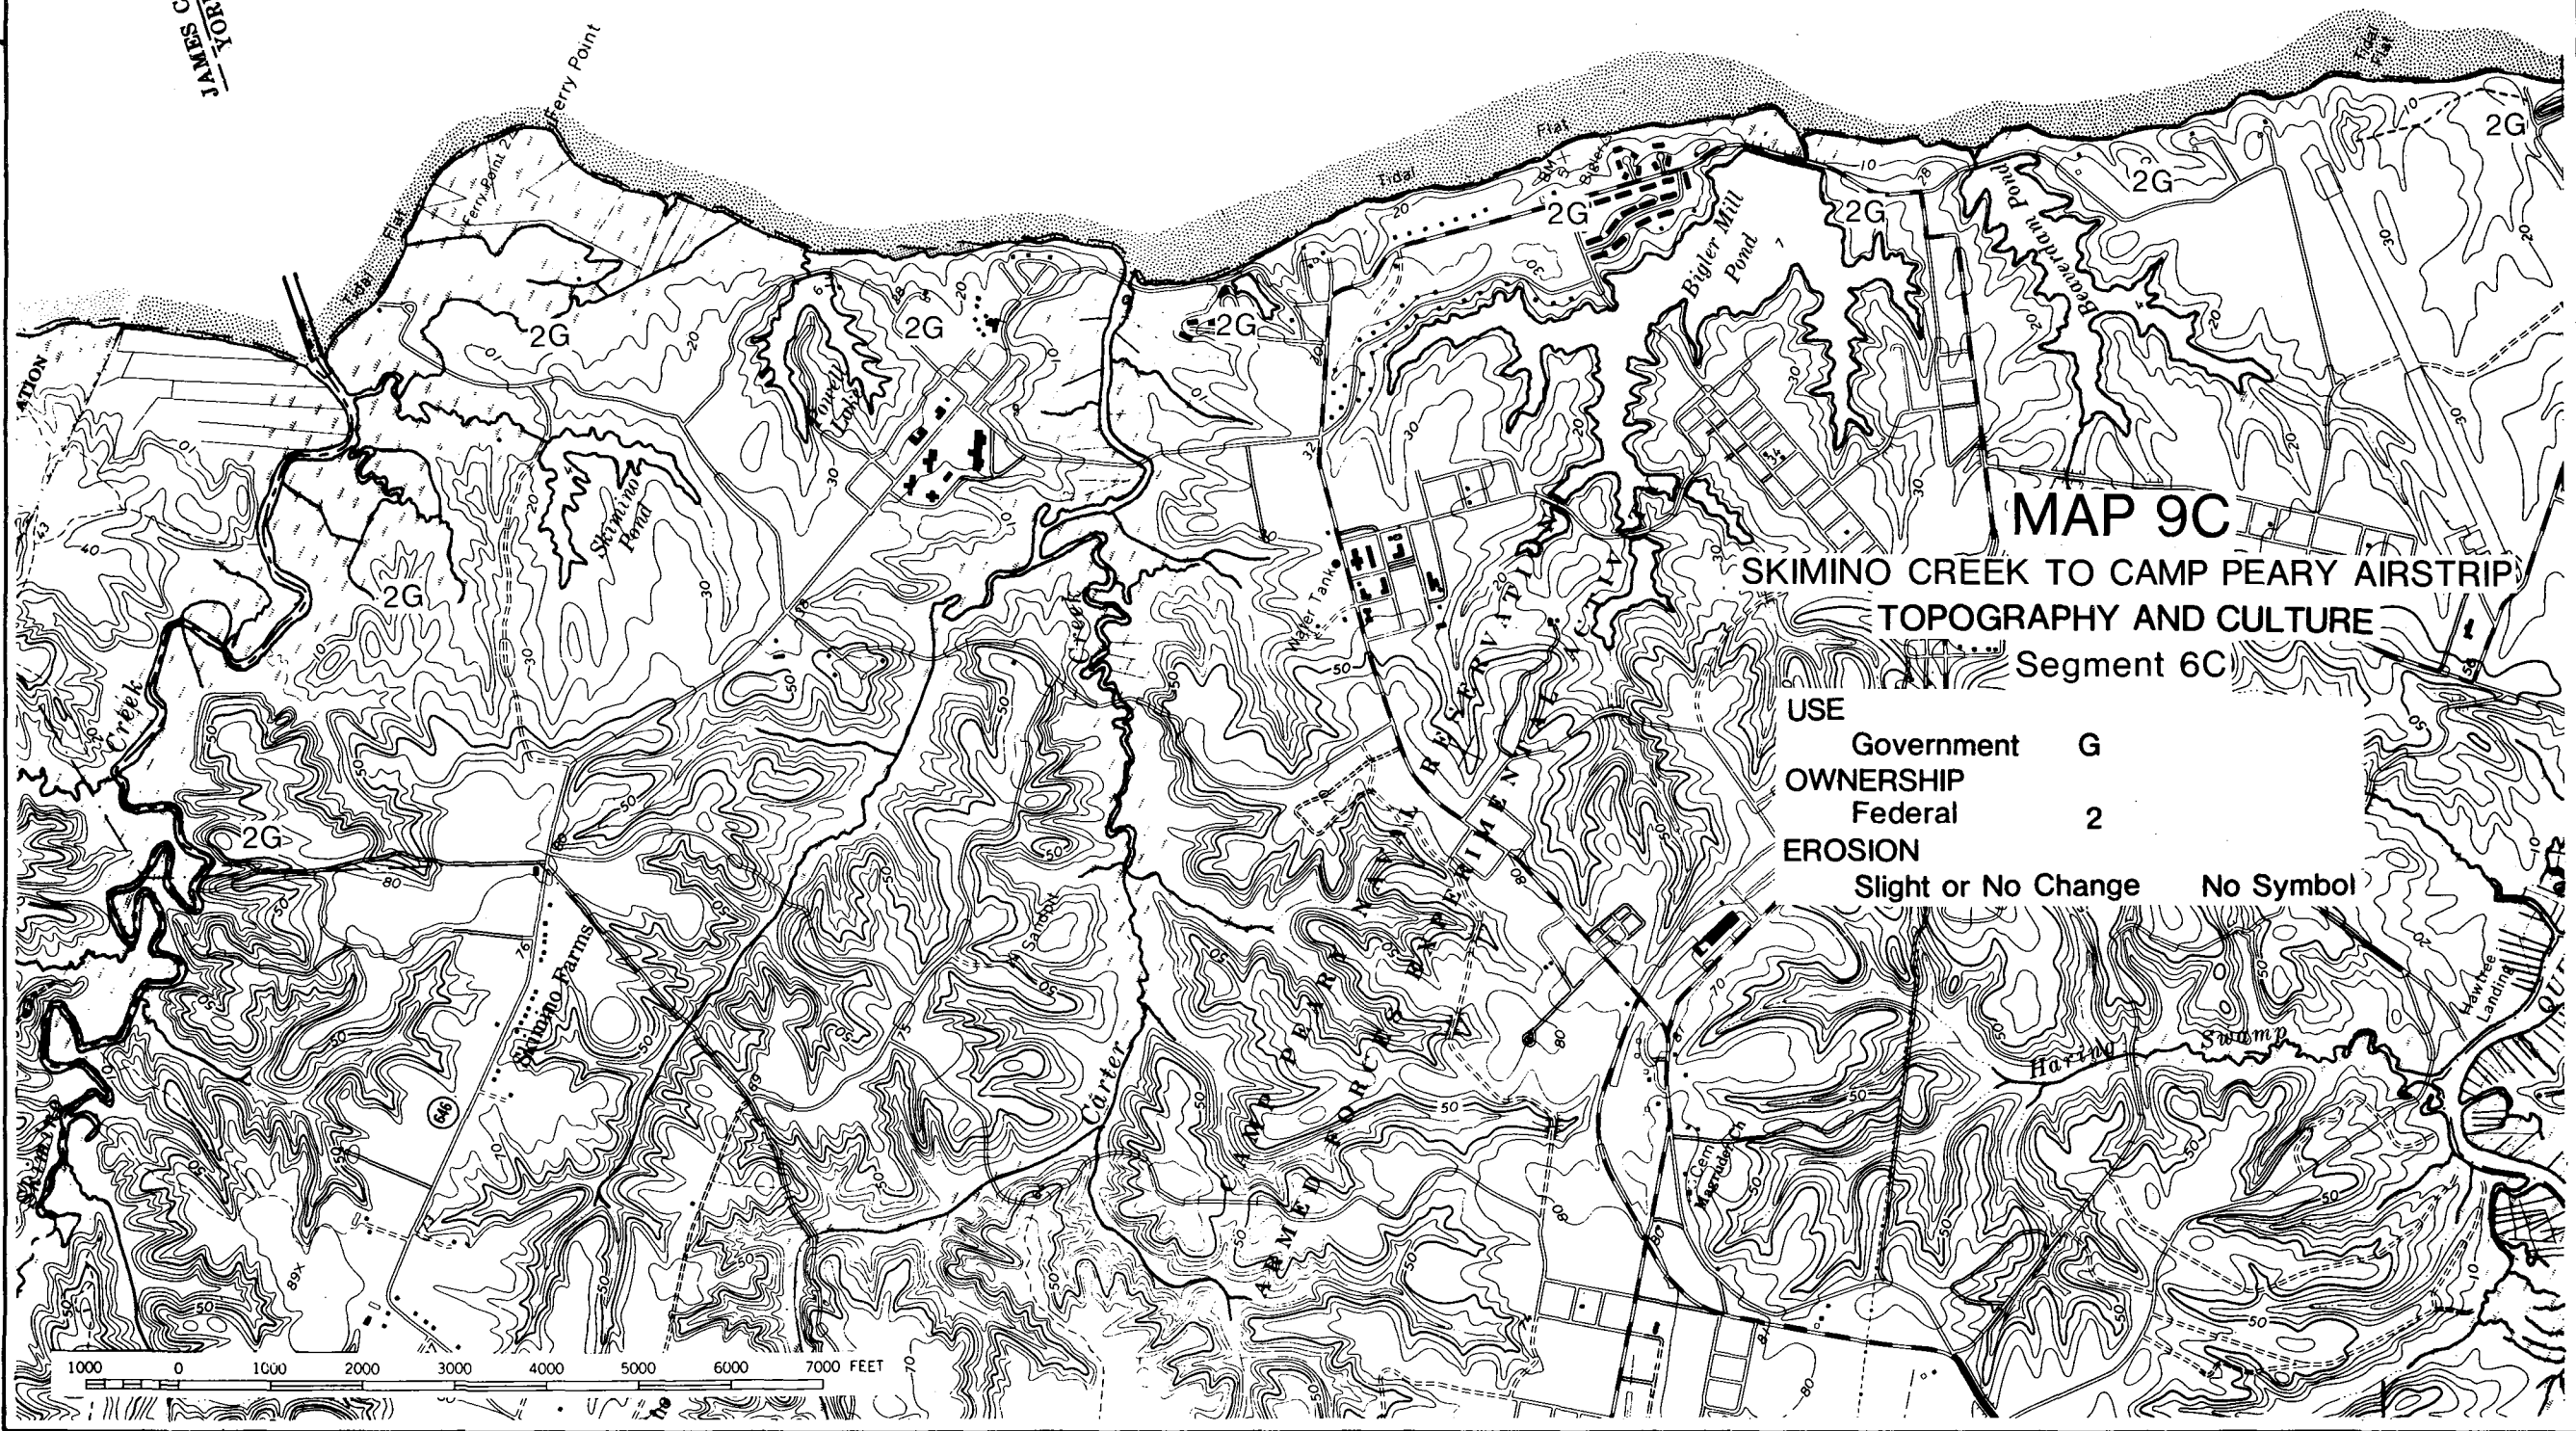
MAP 9C

SKIMINO CREEK TO CAMP PEARY AIRSTRIP
 TOPOGRAPHY AND CULTURE
 Segment 6C
