Shoreline Situation Report Lancaster County

Shoreline Situation Report LANCASTER COUNTY

Special Report In Applied Marine Science and Ocean Engineering Number 160 of the

VIRGINIA INSTITUTE OF MARINE SCIENCE
Gloucester Point, Virginia 23062

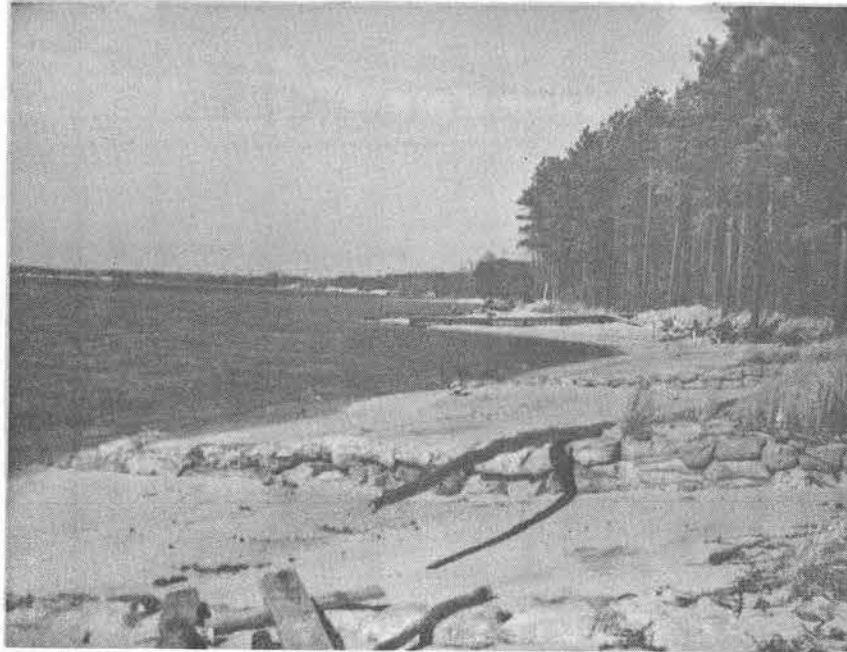
FIGURE 8

FIGURE 8. Concrete bag groins north of Rogue Point, Subsegment 5B. These structures have been effective in trapping good buffer beaches.

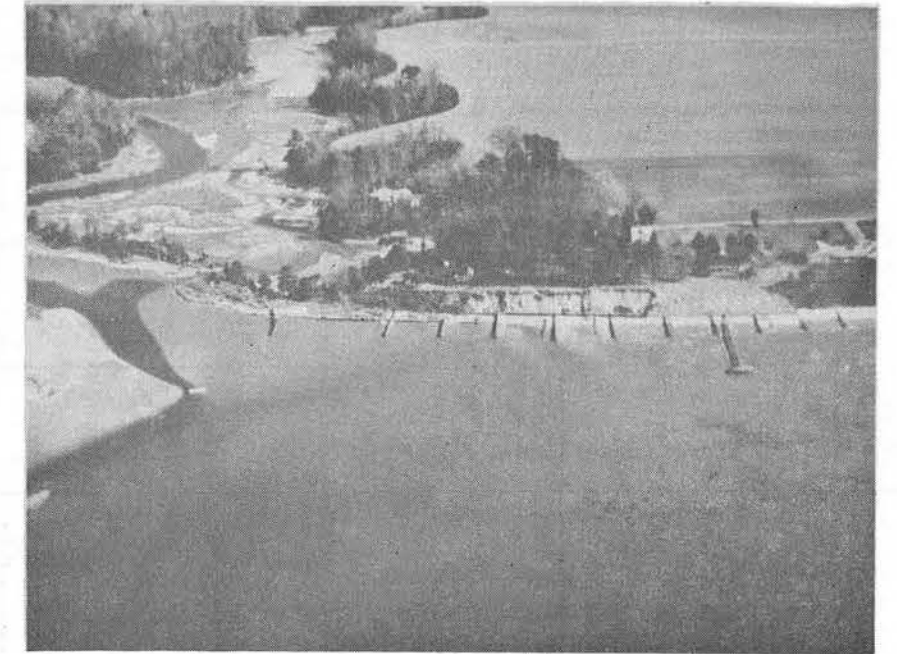
FIGURE 9

FIGURE 9. Belmont Creek, Subsegment 6A. The area is protected by bulkhead and a groin system. Erosion due to downhill rain runoff is continuing along the bluffed portion.

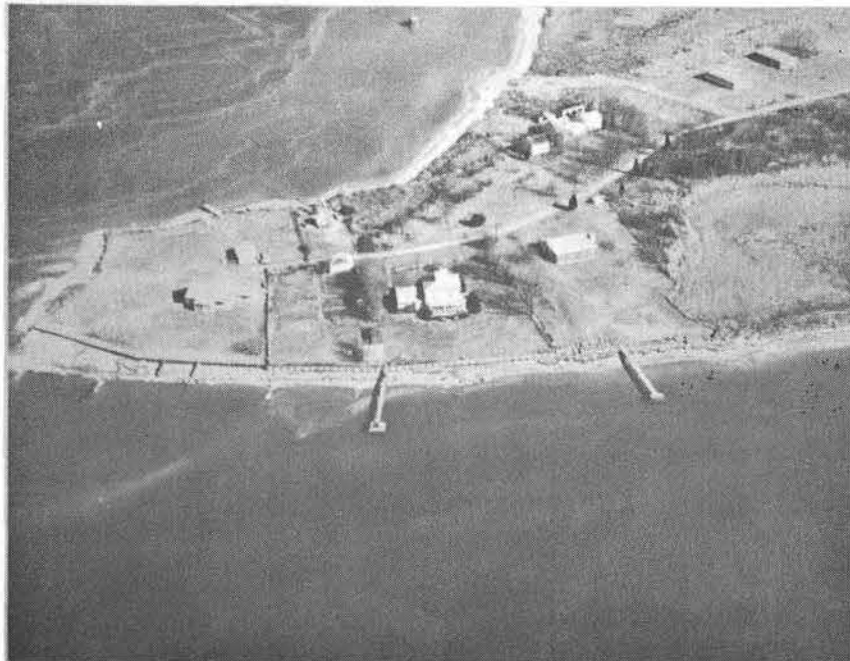
FIGURE 10

FIGURE 10. Morattico - Curletts Point, Subsegment 7B. The river-fronting shoreline is bulkhead, with several effective groins.

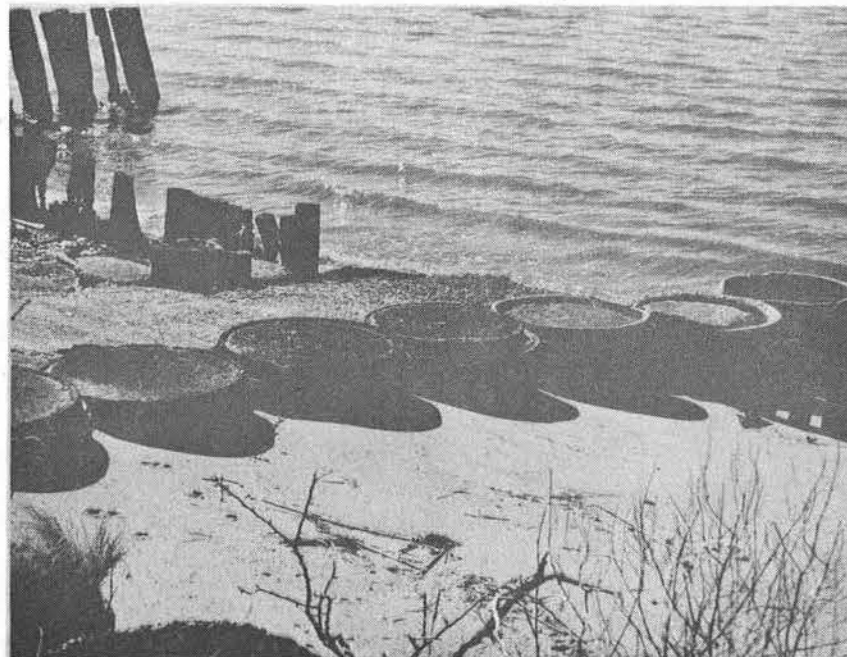
FIGURE 11

FIGURE 11. Curletts Point area, Subsegment 7B. A closeup of concrete-filled culverts, placed to act like a groin. Notice the nice sand beach which has been captured by the structure.

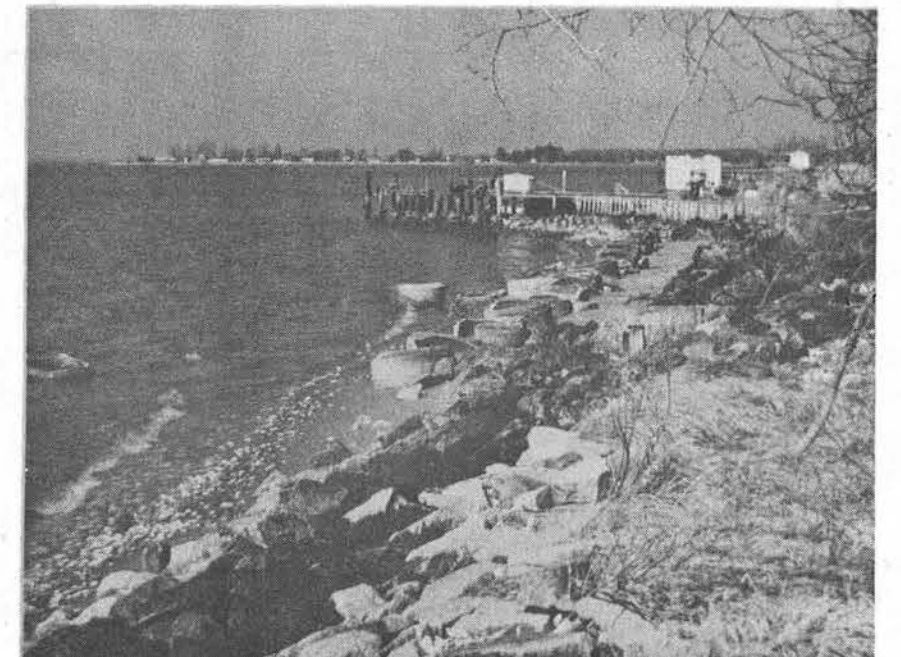
FIGURE 12

FIGURE 12. Morattico - Curletts Point, Subsegment 7B. The riprap appears to be effective. The concrete culverts have been placed parallel to the shoreline, like a bulkhead. The structure's distance from the fast-land indicates that it is not very effective. Riprap has been placed underneath the pier to act like a groin.
