Shoreline Situation Report Northumberland County

Shoreline Situation Report NORTHUMBERLAND COUNTY, VIRGINIA

Special Report In Applied Marine Science and Ocean Engineering Number 161 of the

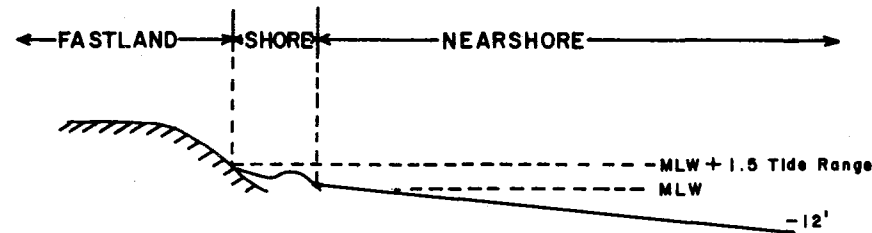
Figure 1

A profile of the three shorelands types.

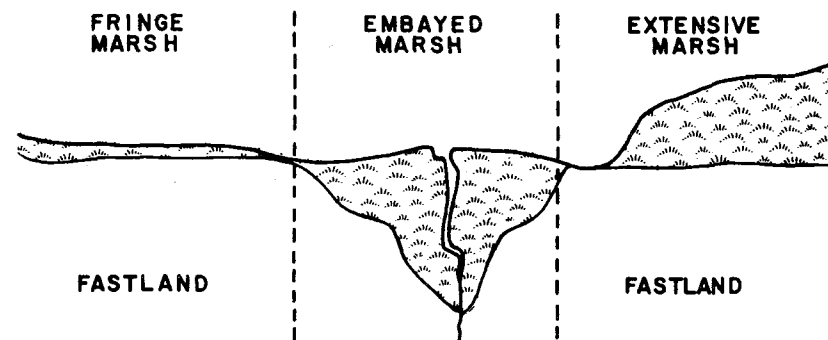
Figure 2

A plan view of the three marsh types.

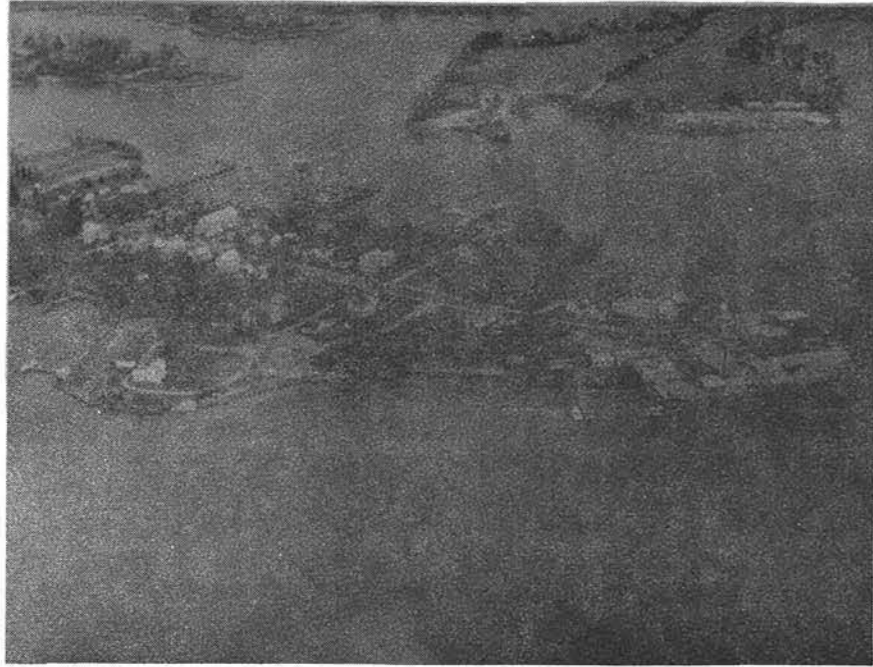
Figure 3

FIGURE 3: Reedville, Subsegment 7F. The tip of the peninsula would be flooded during times of abnormally high water, damaging or destroying the structures. Cockrell Creek has high bacteriological counts due to septic tank leachate around Reedville.

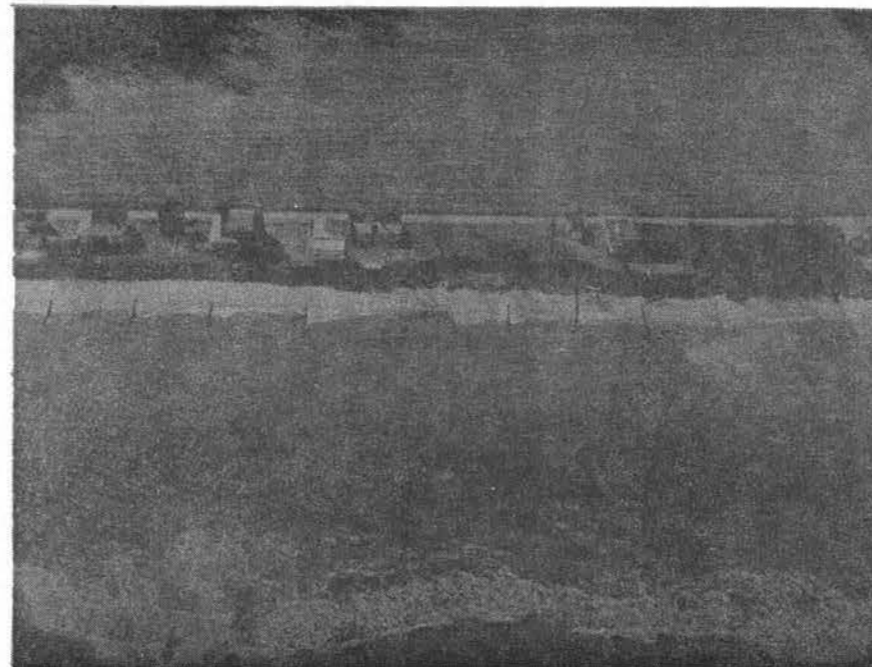
Figure 6

FIGURE 6: Vir-Mar Beach, Segment 10. The groins have been effective in trapping buffer beaches. However, erosion is continuing along many bluff areas of the shoreline.

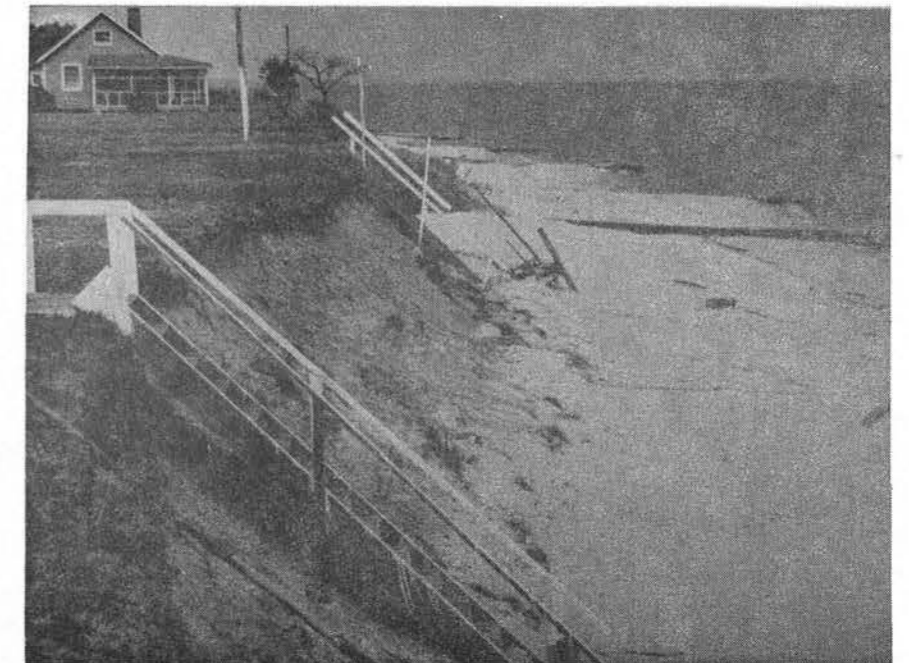
Figure 7

FIGURE 7: Marshalls Beach, Segment 11, ground view. The groins have been very successful in trapping sand. Beach material is coming from the eroding bluffs along this section of shoreline.

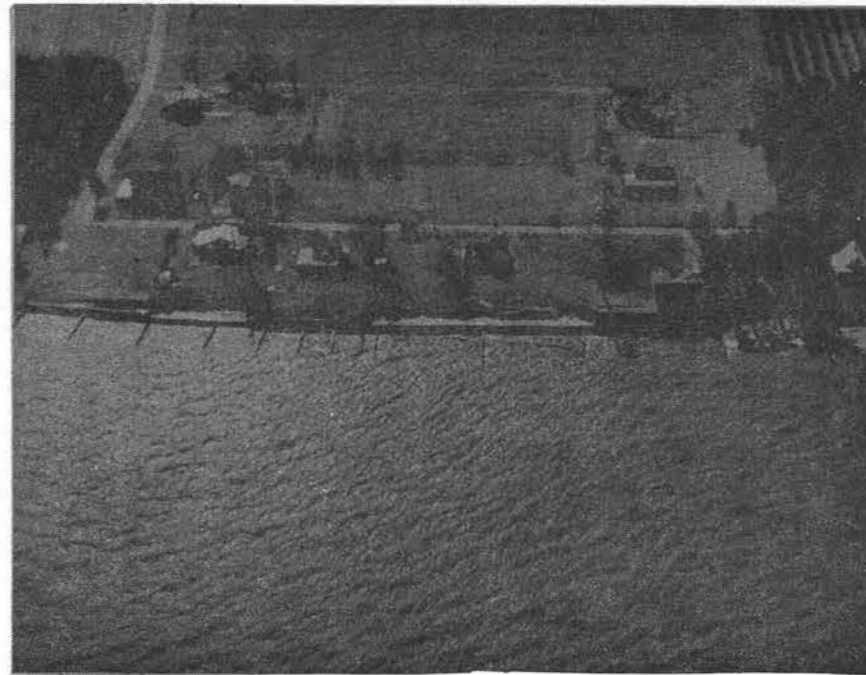
Figure 8

FIGURE 8: Cordreys Beach, Segment 11. The two new sections of bulkhead and groins need to be backfilled. Notice the evidence of past erosion.

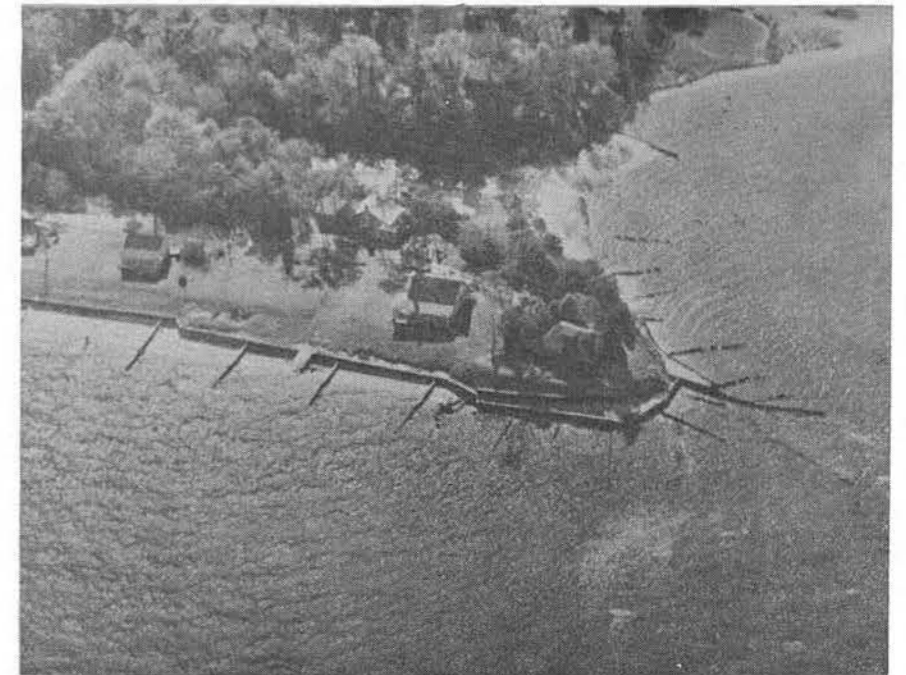
Figure 9

FIGURE 9: Mouth of Rogers Creek, Segment 11. The variety of structures here tends to be self-defeating. Note the different angles which the groins approach the shoreline. A simplified, but well-engineered, plan of shoreline protection would probably be more effective.

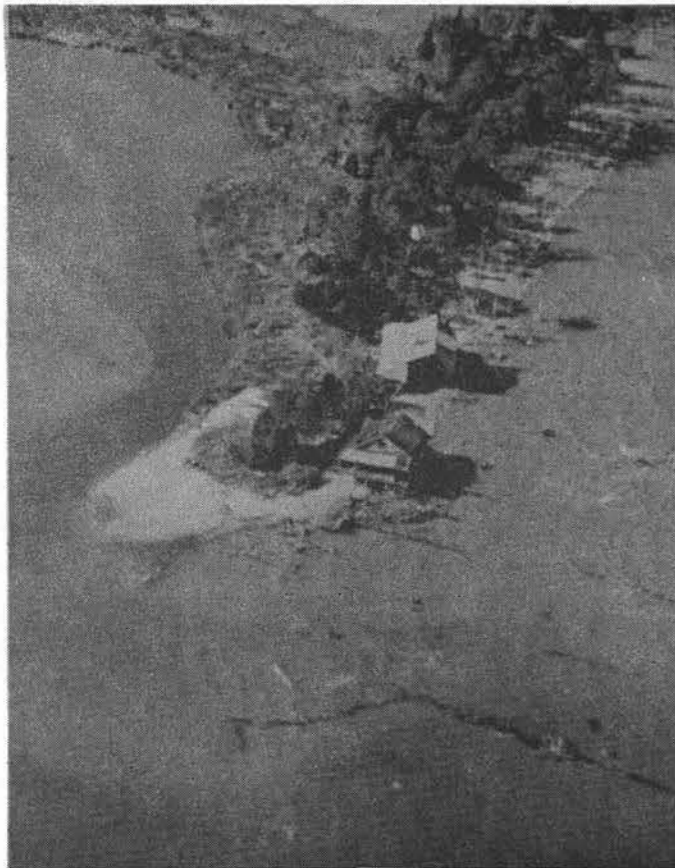
Figure 10

Most shoreline structures have been located a sufficient distance inland not to be endangered by erosion. However, two houses at the mouth of Hull Creek have been severely damaged by erosion and by flood forces (Figure 10). Several other houses along the shoreline of Northumberland County, though not imminently endangered, will be affected by erosion in the next ten to fifteen years if the shoreline is not stabilized.

FIGURE 10: Mouth of Hull Creek, Segment 11. These two houses, damaged by continued erosion, have been abandoned.

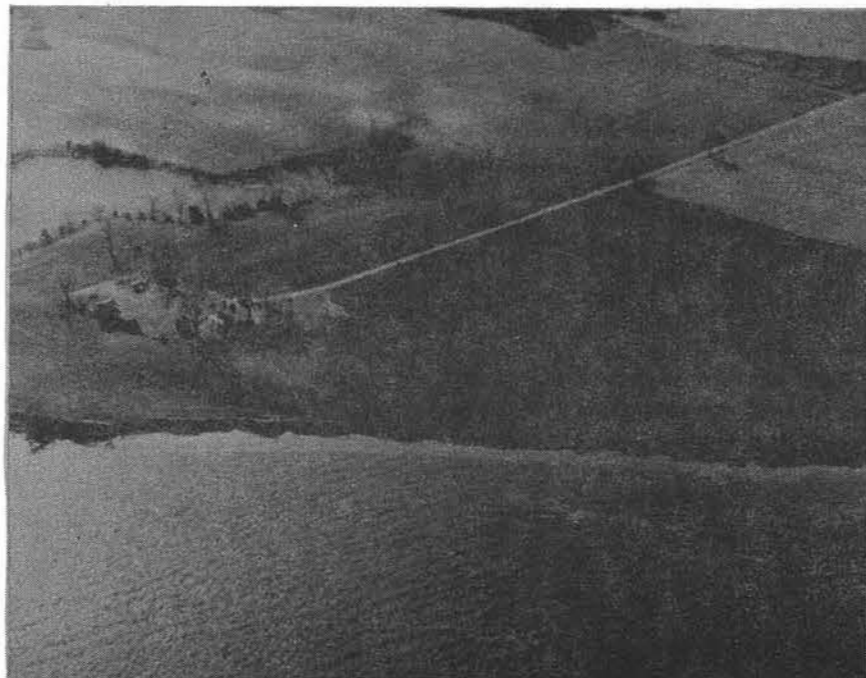
Figure 11

FIGURE 11: Toward Corbin Pond, Segment 11. Continued erosion of the agricultural lands also causes pollution of the water, as fertilizers and insecticides are washed into the river.

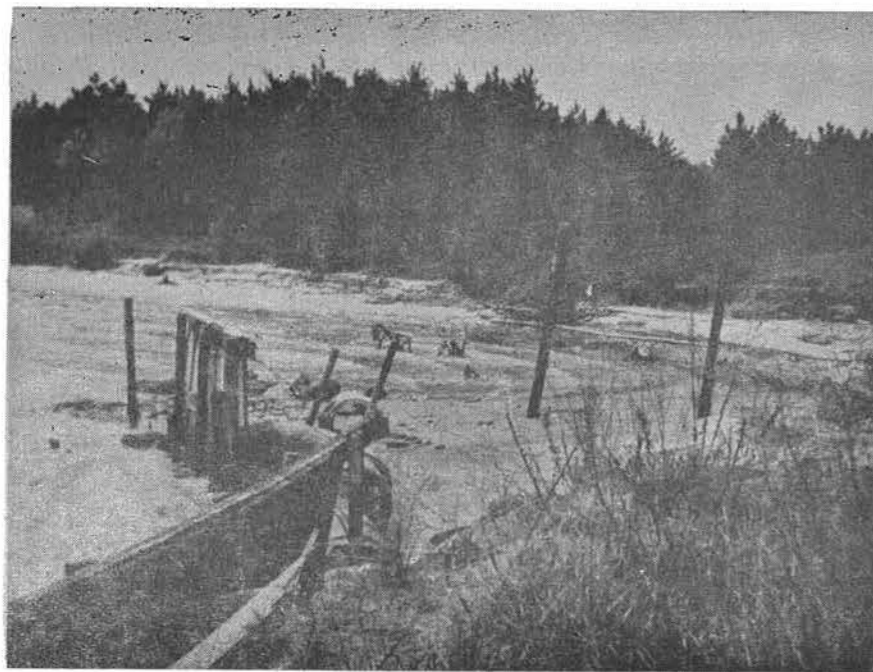
Figure 12

Creek (Segment 11) has an historical average erosion rate of 5.7 feet per year. However, this section is being developed for residential purposes and the shoreline has been mostly artificially stabilized. Several areas between stabilized sections are continuing to erode. One section of bulkhead is failing and scouring is occurring (Figures 12 and 13).

FIGURE 12: Bay Quarter Neck, Segment 11, ground view. The bulkhead has failed and the area behind is eroding.

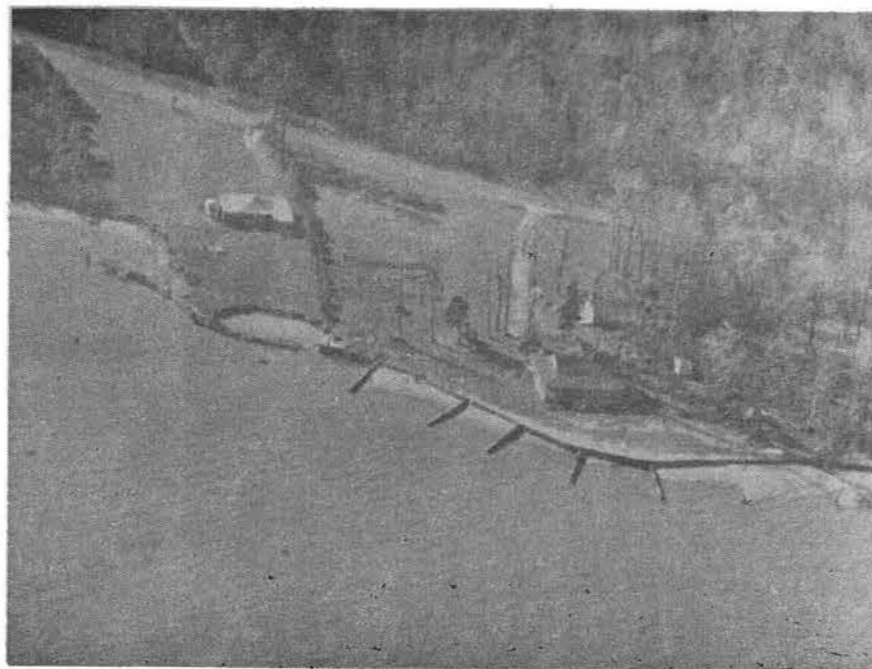
Figure 13

FIGURE 13: Bay Quarter Neck, Segment 11. Aerial view of Figure 12. Notice the erosion behind the failed bulkhead.

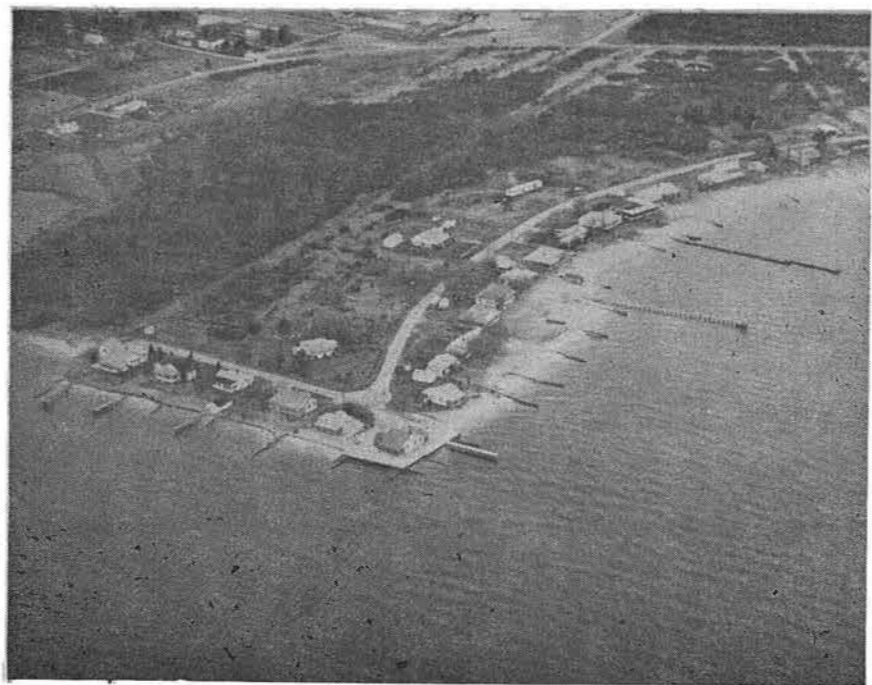
FIGURE 15

FIGURE 15: Mouth of Judith Sound, Segment 13. This area has been artificially stabilized using bulkhead and groins. Both have been effective. Notice the strip development along the shoreline.

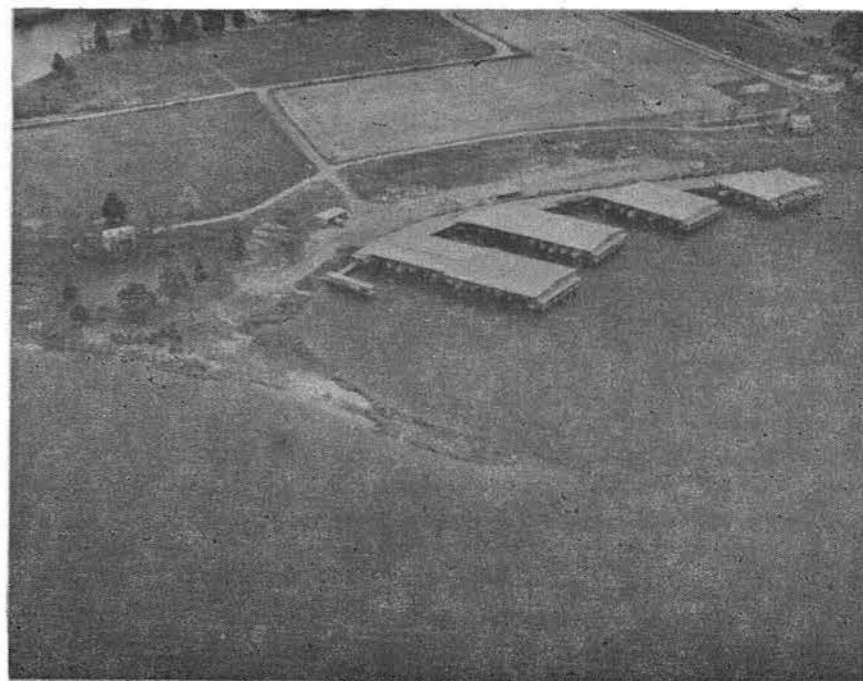
FIGURE 16

FIGURE 16: East bank of Lodge Creek, Segment 15. This is a large marina facility for such a rural area.
