Shoreline Situation Report City of Virginia Beach

Shoreline Situation Report CITY OF VIRGINIA BEACH

Special Report In Applied Marine Science and Ocean Engineering Number 163 of the

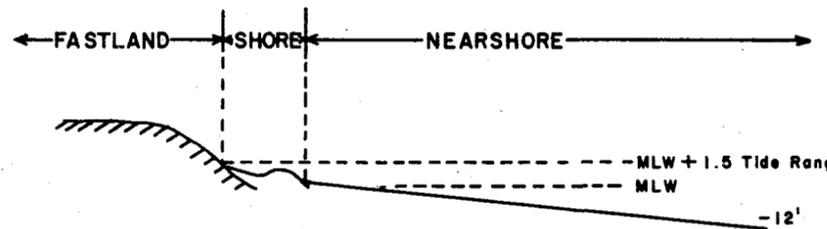
Figure 1

A profile of the three shorelands types.

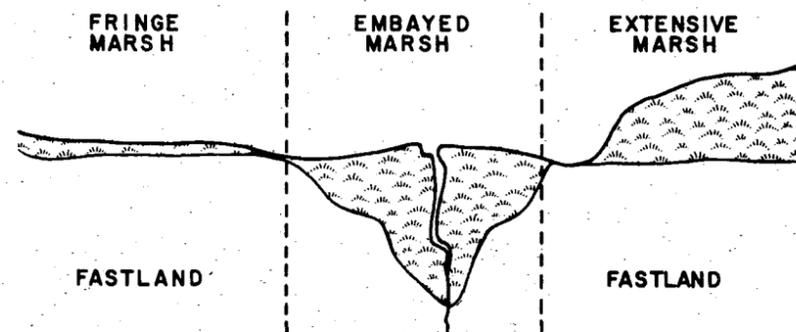
Figure 2

A plan view of the three marsh types.

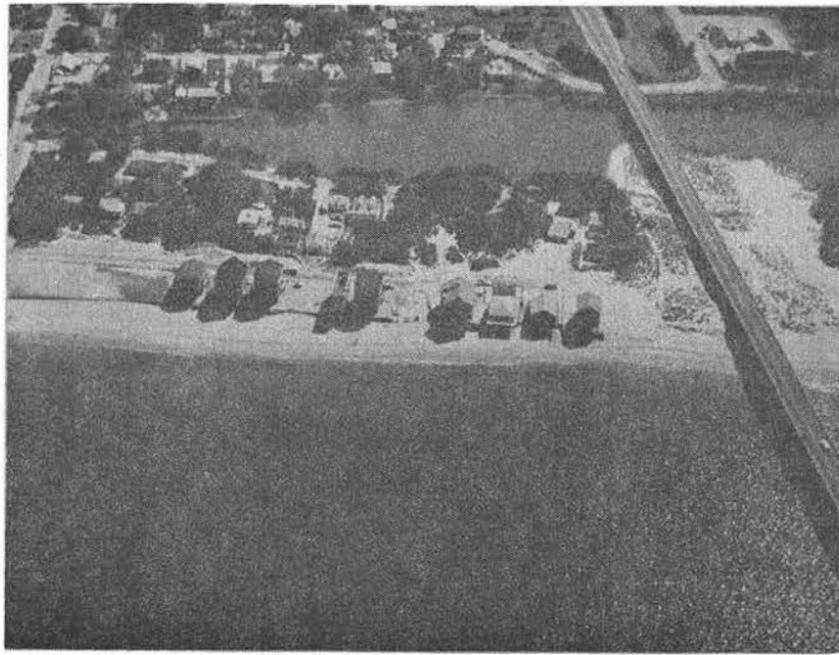
FIGURE 3

FIGURE 3: Chesapeake Bay Bridge Tunnel, Segment 2. These houses have been built very near the tidal zone. Abnormally high water would damage or destroy these structures.

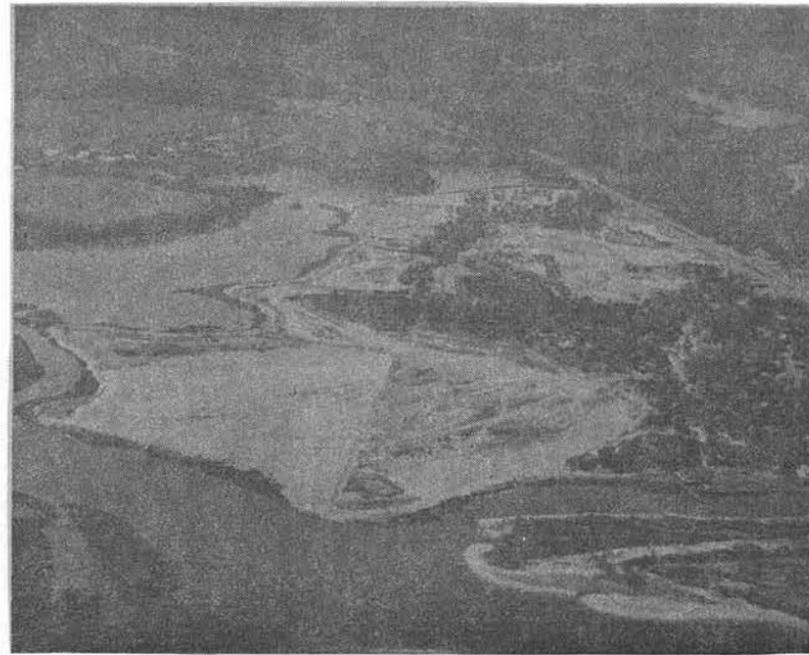
FIGURE 4

FIGURE 4: Pleasure House Point, Subsegment 3A. This area, once marsh, has recently been filled and is to be used for residential purposes.

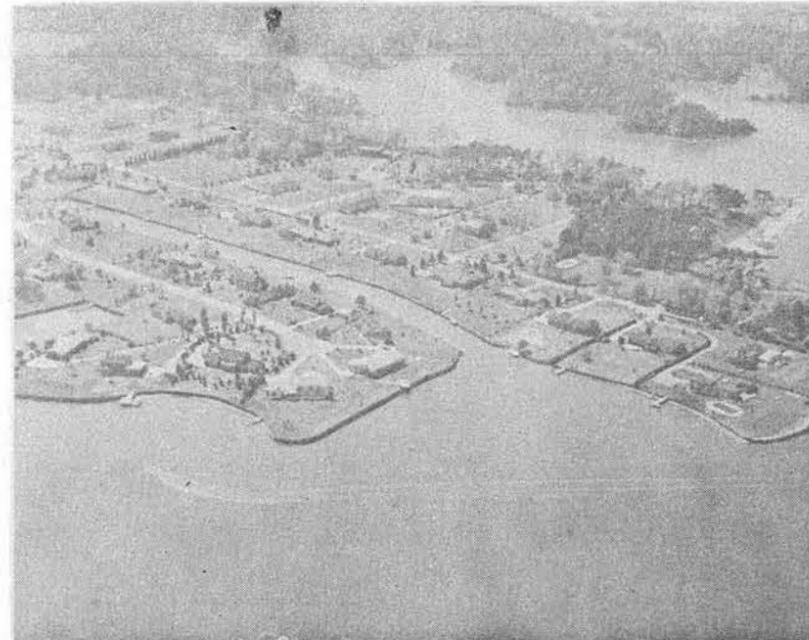
FIGURE 5

FIGURE 5: Witch Duck Point, Subsegment 3B. This is a typical residential development in the Lynnhaven River.

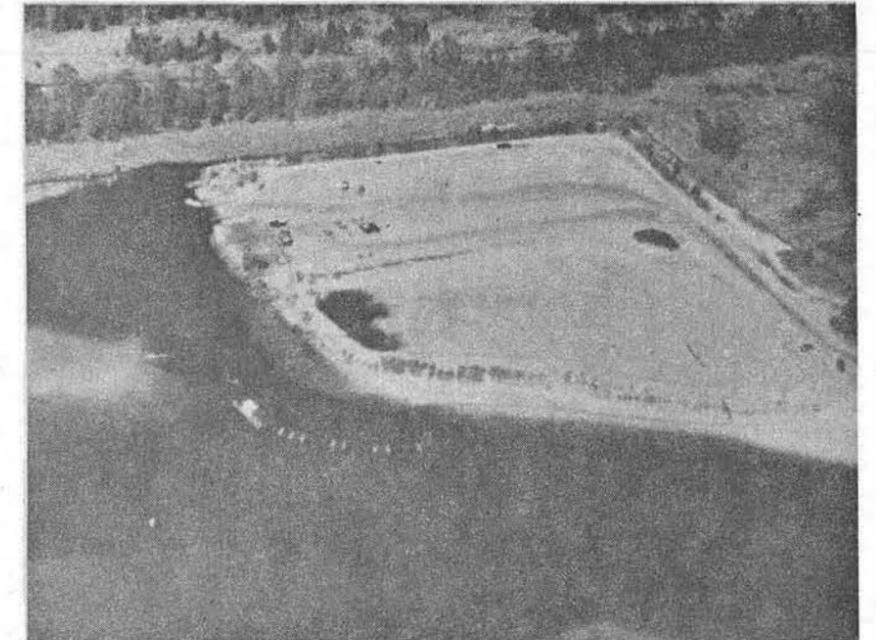
FIGURE 6

FIGURE 6: Filled area, Seashore State Park, Subsegment 3H. Sand from a nearby spit has been used to fill this area to make a public recreational spot.

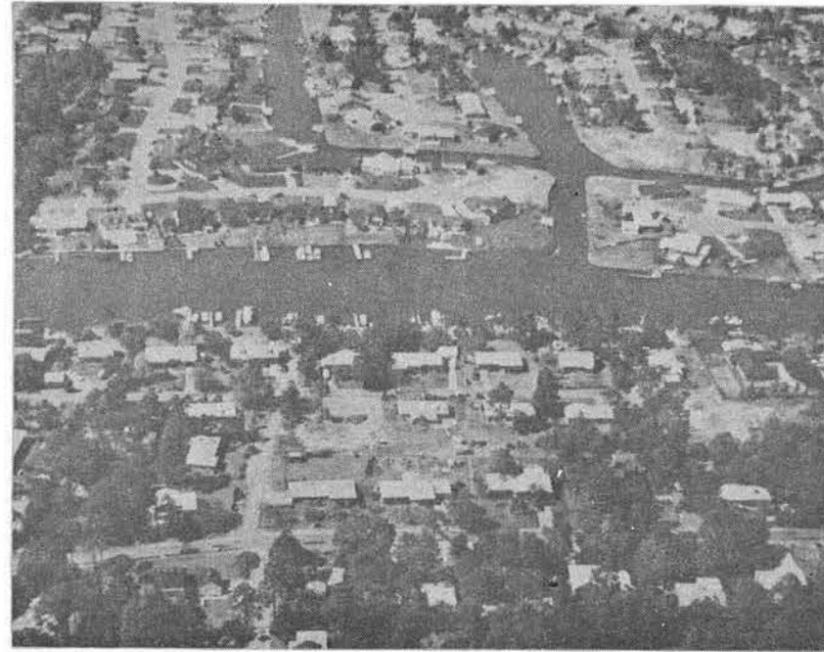
FIGURE 7

FIGURE 7: Cape Story by the Sea, Subsegment 3H. Canals have been dredged here to create waterfront property in this new residential area. This practice has been fairly common in Virginia Beach.

SHORE PROTECTIVE STRUCTURES: All but 200 feet of the 46,700 feet of artificially stabilized shoreline is bulkhead. These structures are for retaining fill along the many dredged canals found in the subsegment. All seem to be effective.

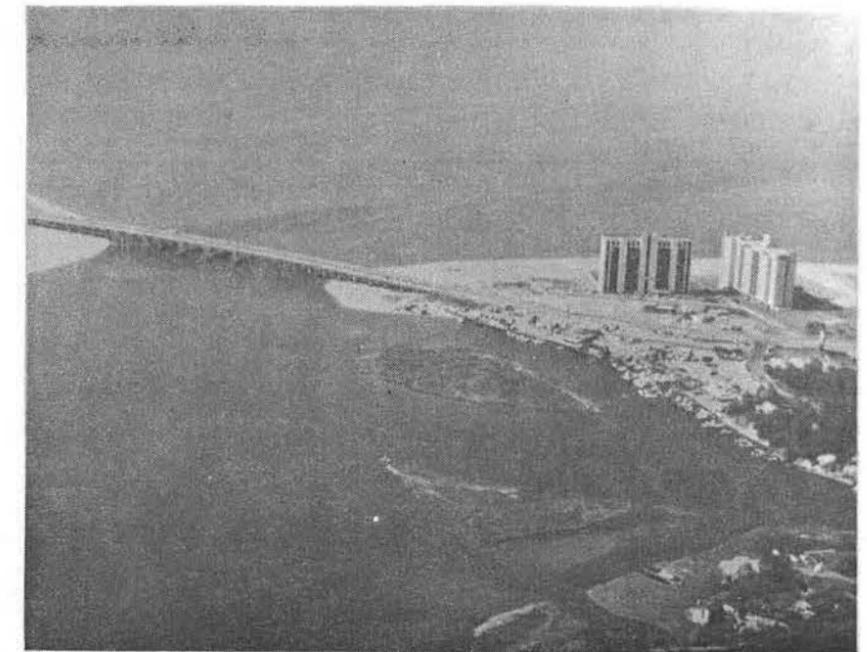
FIGURE 8

FIGURE 8: Mouth of Lynnhaven River, Subsegment 3H. A view from inside the mouth. Notice the large amount of boating activity at the marinas.

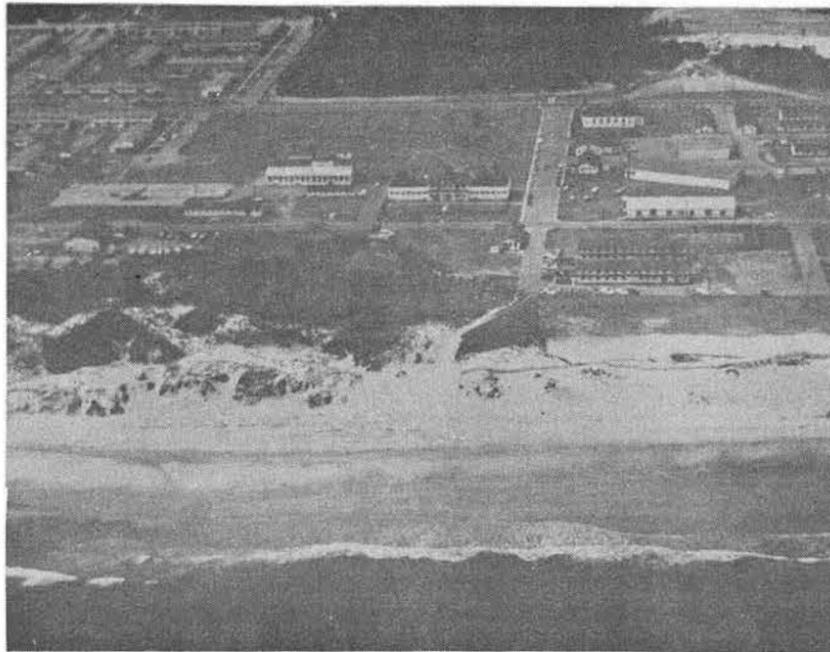
FIGURE 9

FIGURE 9: Fort Story, Segment 5. Note the dunes along the shore. Only minor flooding occurs in this area due to the protection given by the dunes.

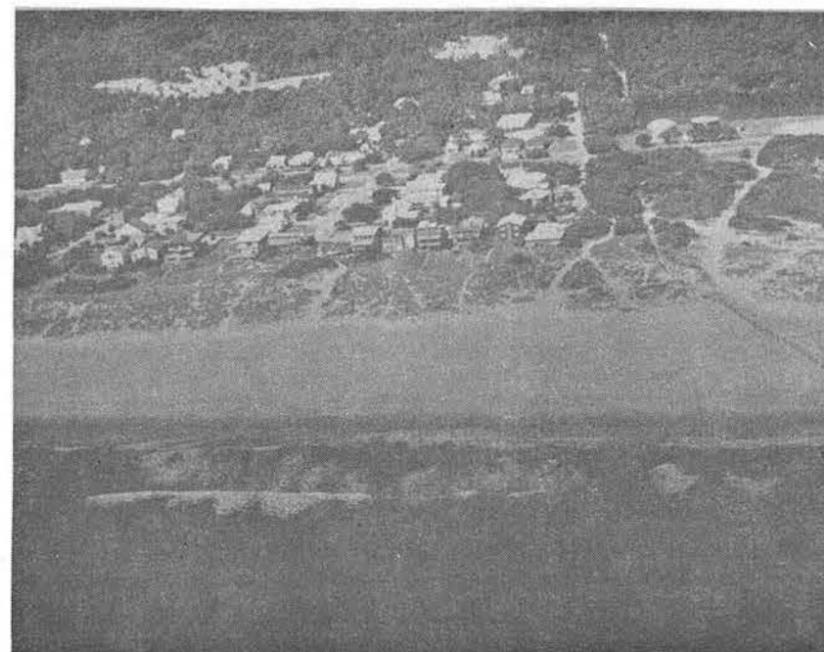
FIGURE 10

FIGURE 10: North Virginia Beach, Segment 6. The wide beach is backed by an area of low vegetated dunes, which serves to protect the residential area.

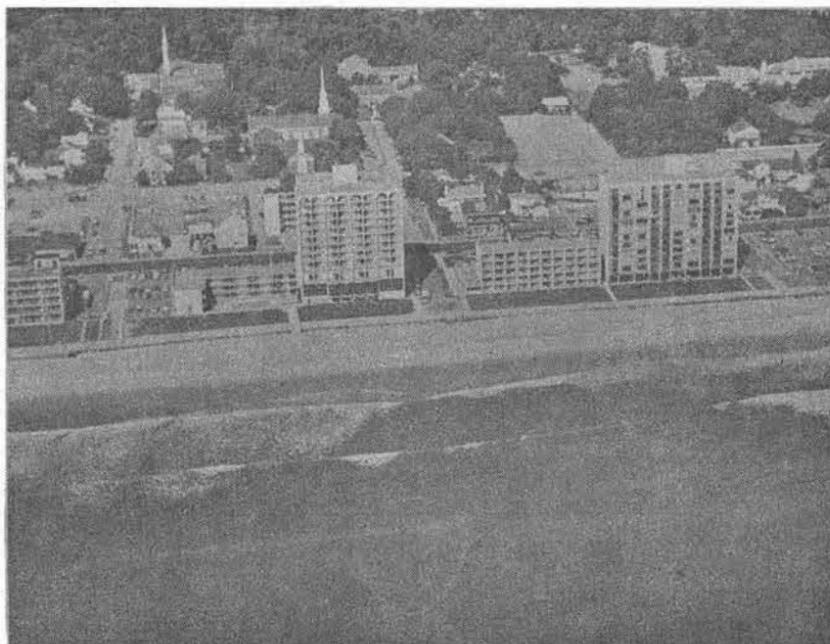
FIGURE 11

FIGURE 11: Virginia Beach resort area, Segment 7. The concrete seawall which protects this section has been defeated in past storms. Though repaired, a severe storm could endanger these structures.

SHORE PROTECTIVE STRUCTURES: 16,400 feet of the segment is protected by a concrete seawall behind the beach zone. The seawall has been damaged during past storms and then repaired or replaced. While the structure is effective, it again could fail during severe storms or hurricanes.

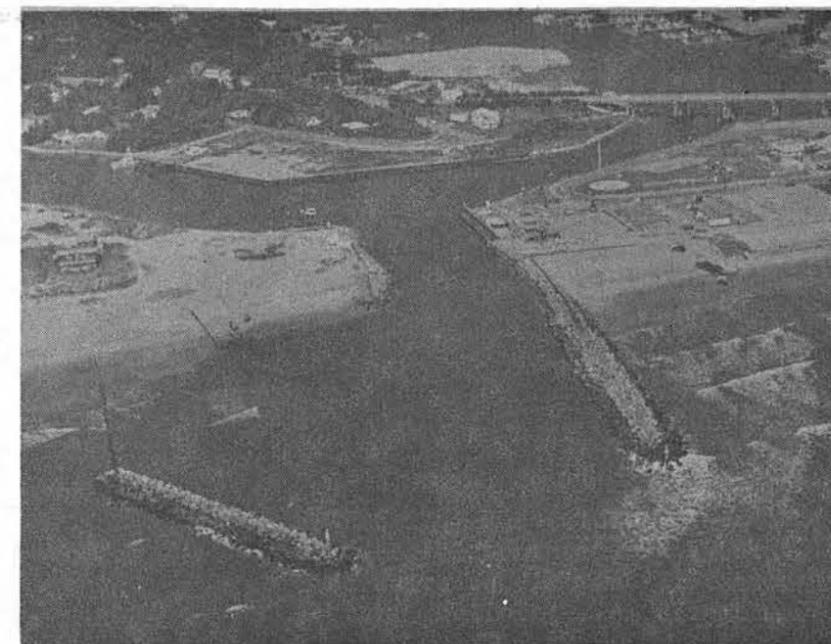
FIGURE 12

FIGURE 12: Rudee Inlet, Segment 8. There are several marinas in the interior of the inlet. The riprap jetties serve to diminish siltation of the inlet and to protect the inlet from direct wave attack.

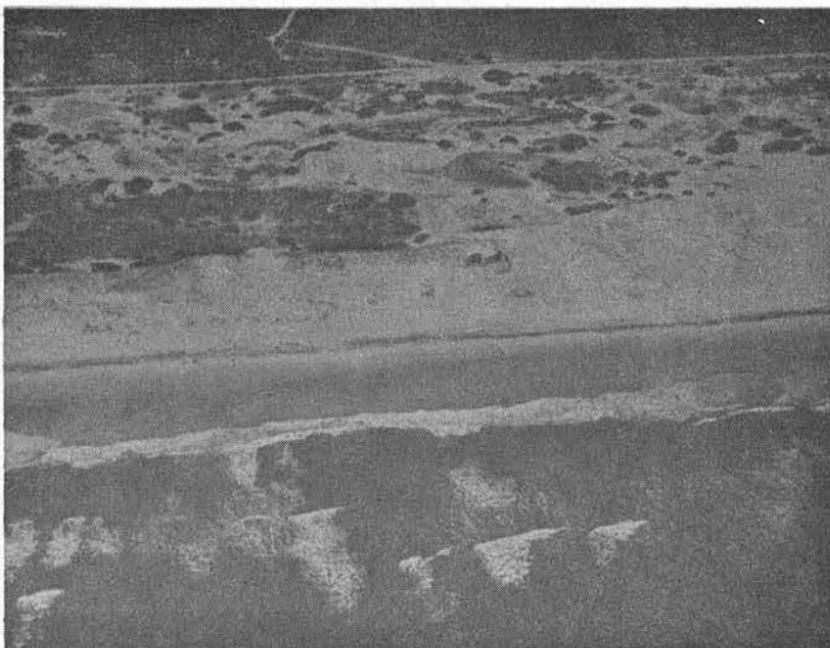
FIGURE 13

FIGURE 13: Back Bay National Wildlife Refuge, Ocean-side, Subsegment 10A. The many dunes here retard flooding of backshore areas.

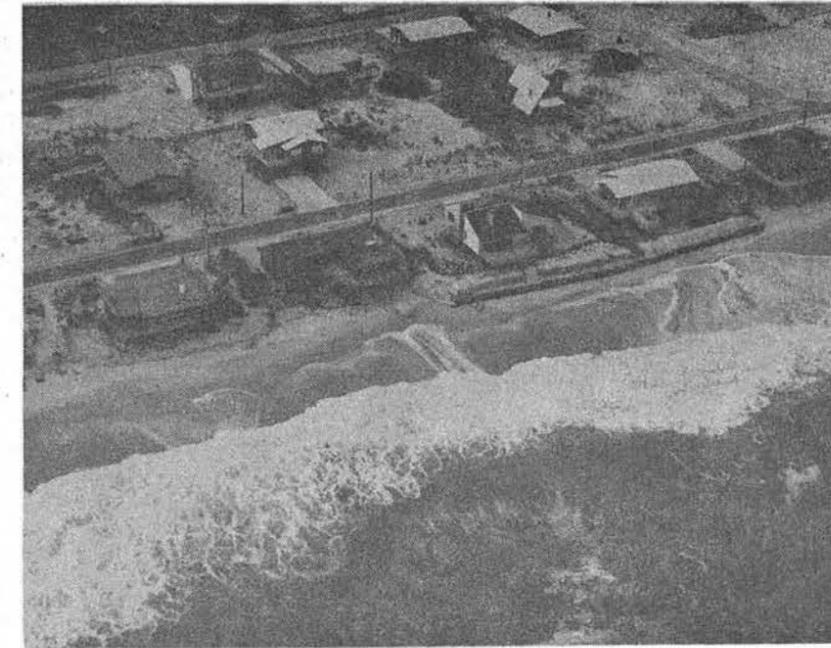
FIGURE 14

FIGURE 14: Sandbridge, Subsegment 9A. Taken after a northeast storm on November 4, 1977. Note high tide line, in places underneath house pilings. The block to the left of the bulkhead is an exposed septic tank.

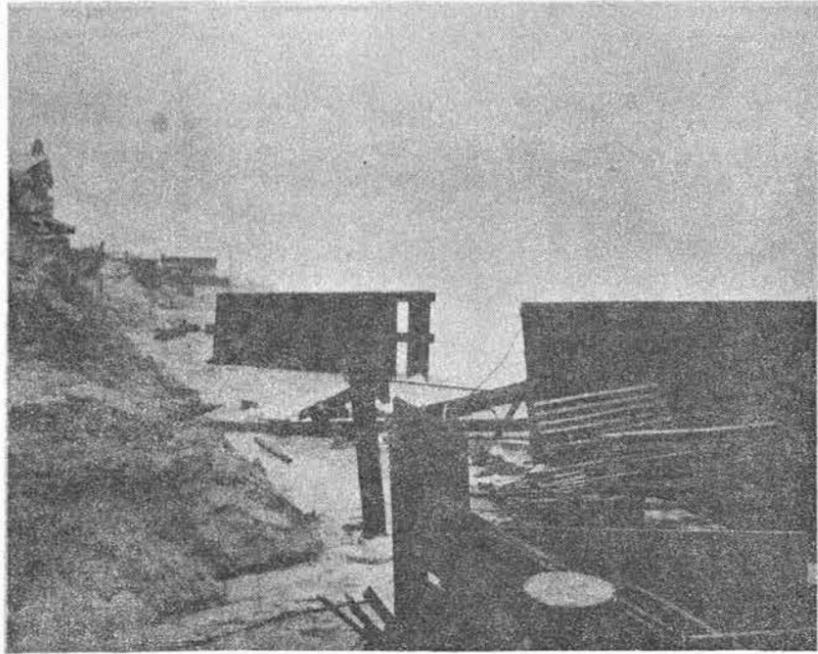
FIGURE 15

FIGURE 15: Failed bulkhead at Sandbridge, Subsegment 9A. Taken November 3, 1977 during a northeast storm, waves were cutting into the sand dunes behind the failed structure.

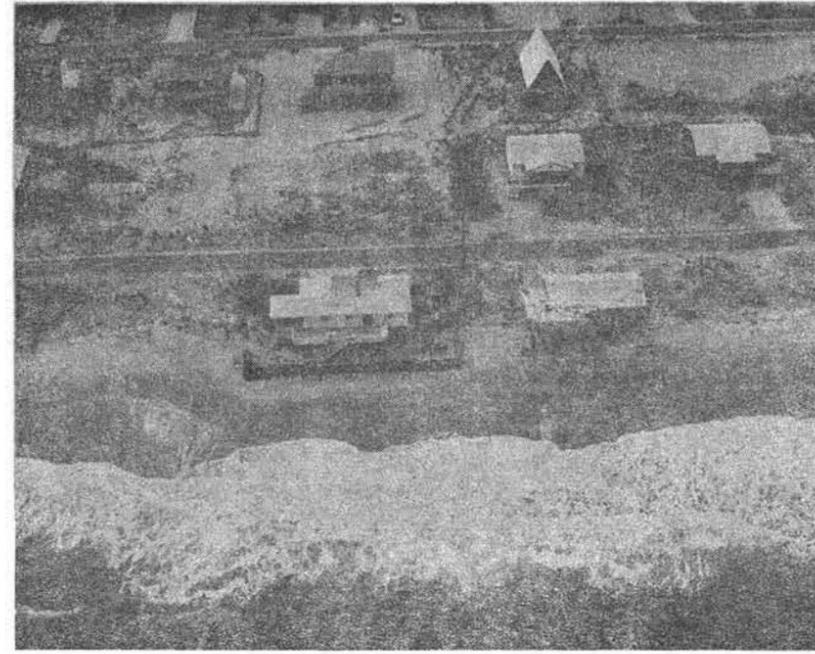
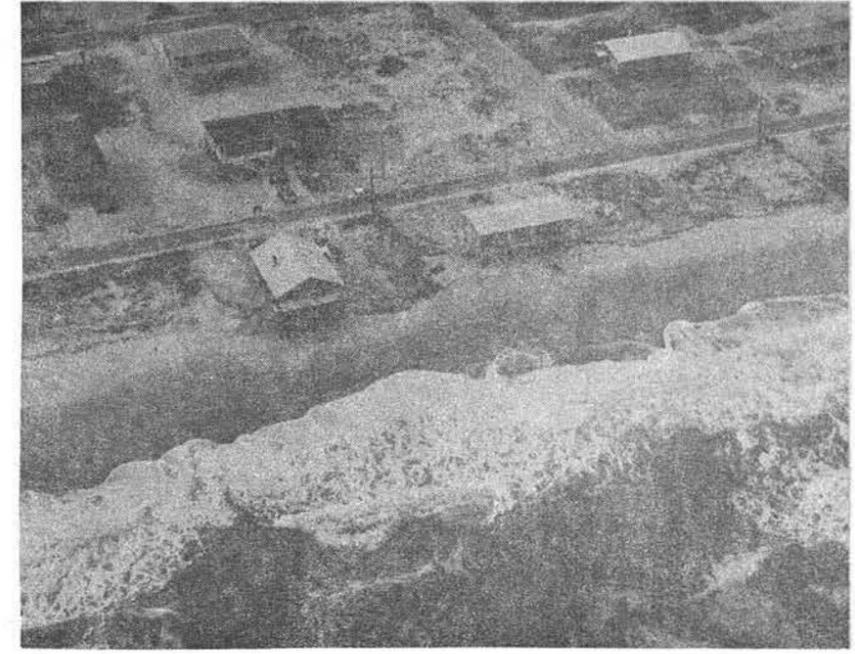
FIGURES 16 and 17: Sandbridge, Subsegment 9A. Also taken during the northeaster November 4, 1977, note the failed section of bulkhead in Figure 16 and the upper limit of wave runup in both figures. The black block in front of the house in Figure 17 is an exposed septic tank.

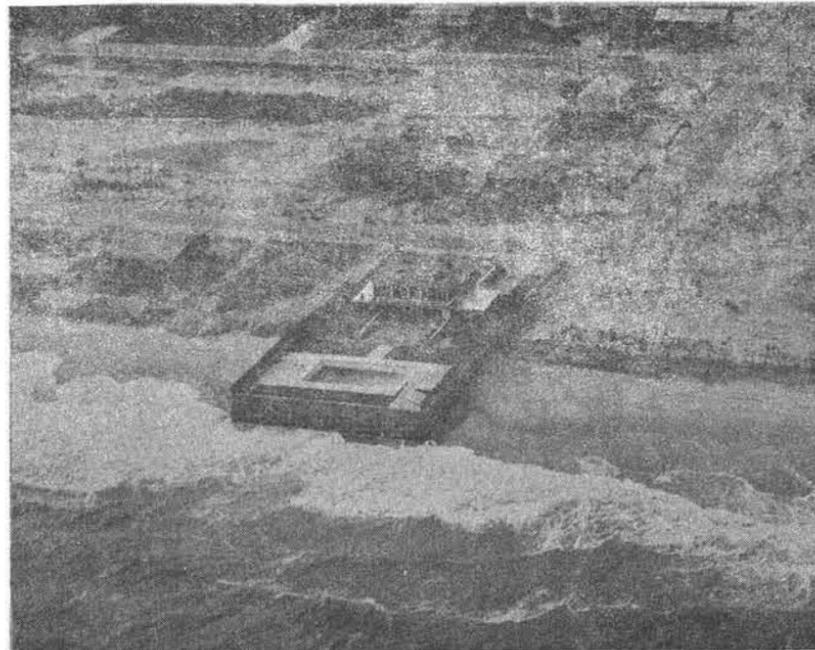
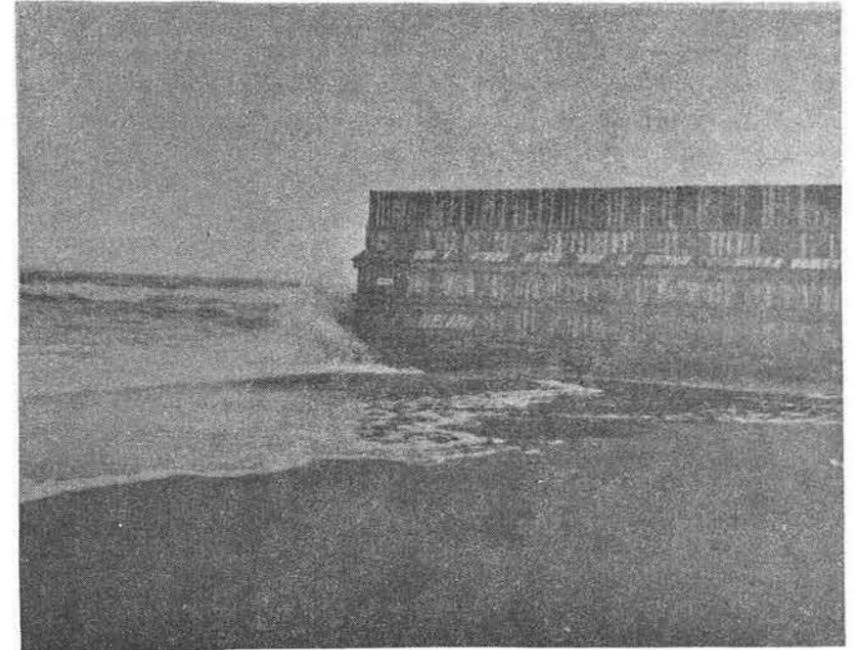
FIGURES 18 and 19: Swimming pool in the tidal zone, Sandbridge, Subsegment 9A. Taken during the November northeaster, the storm has undermined the pool (Figure 18) and has caused two concrete slabs to fall. Waves are attacking the northern corner of the bulkhead (Figure 19). Note the slope of the beach near this corner.
