Shoreline Evolution: Fairfax County, Virginia Potomac River Shoreline

December 2014

Data Summary Report

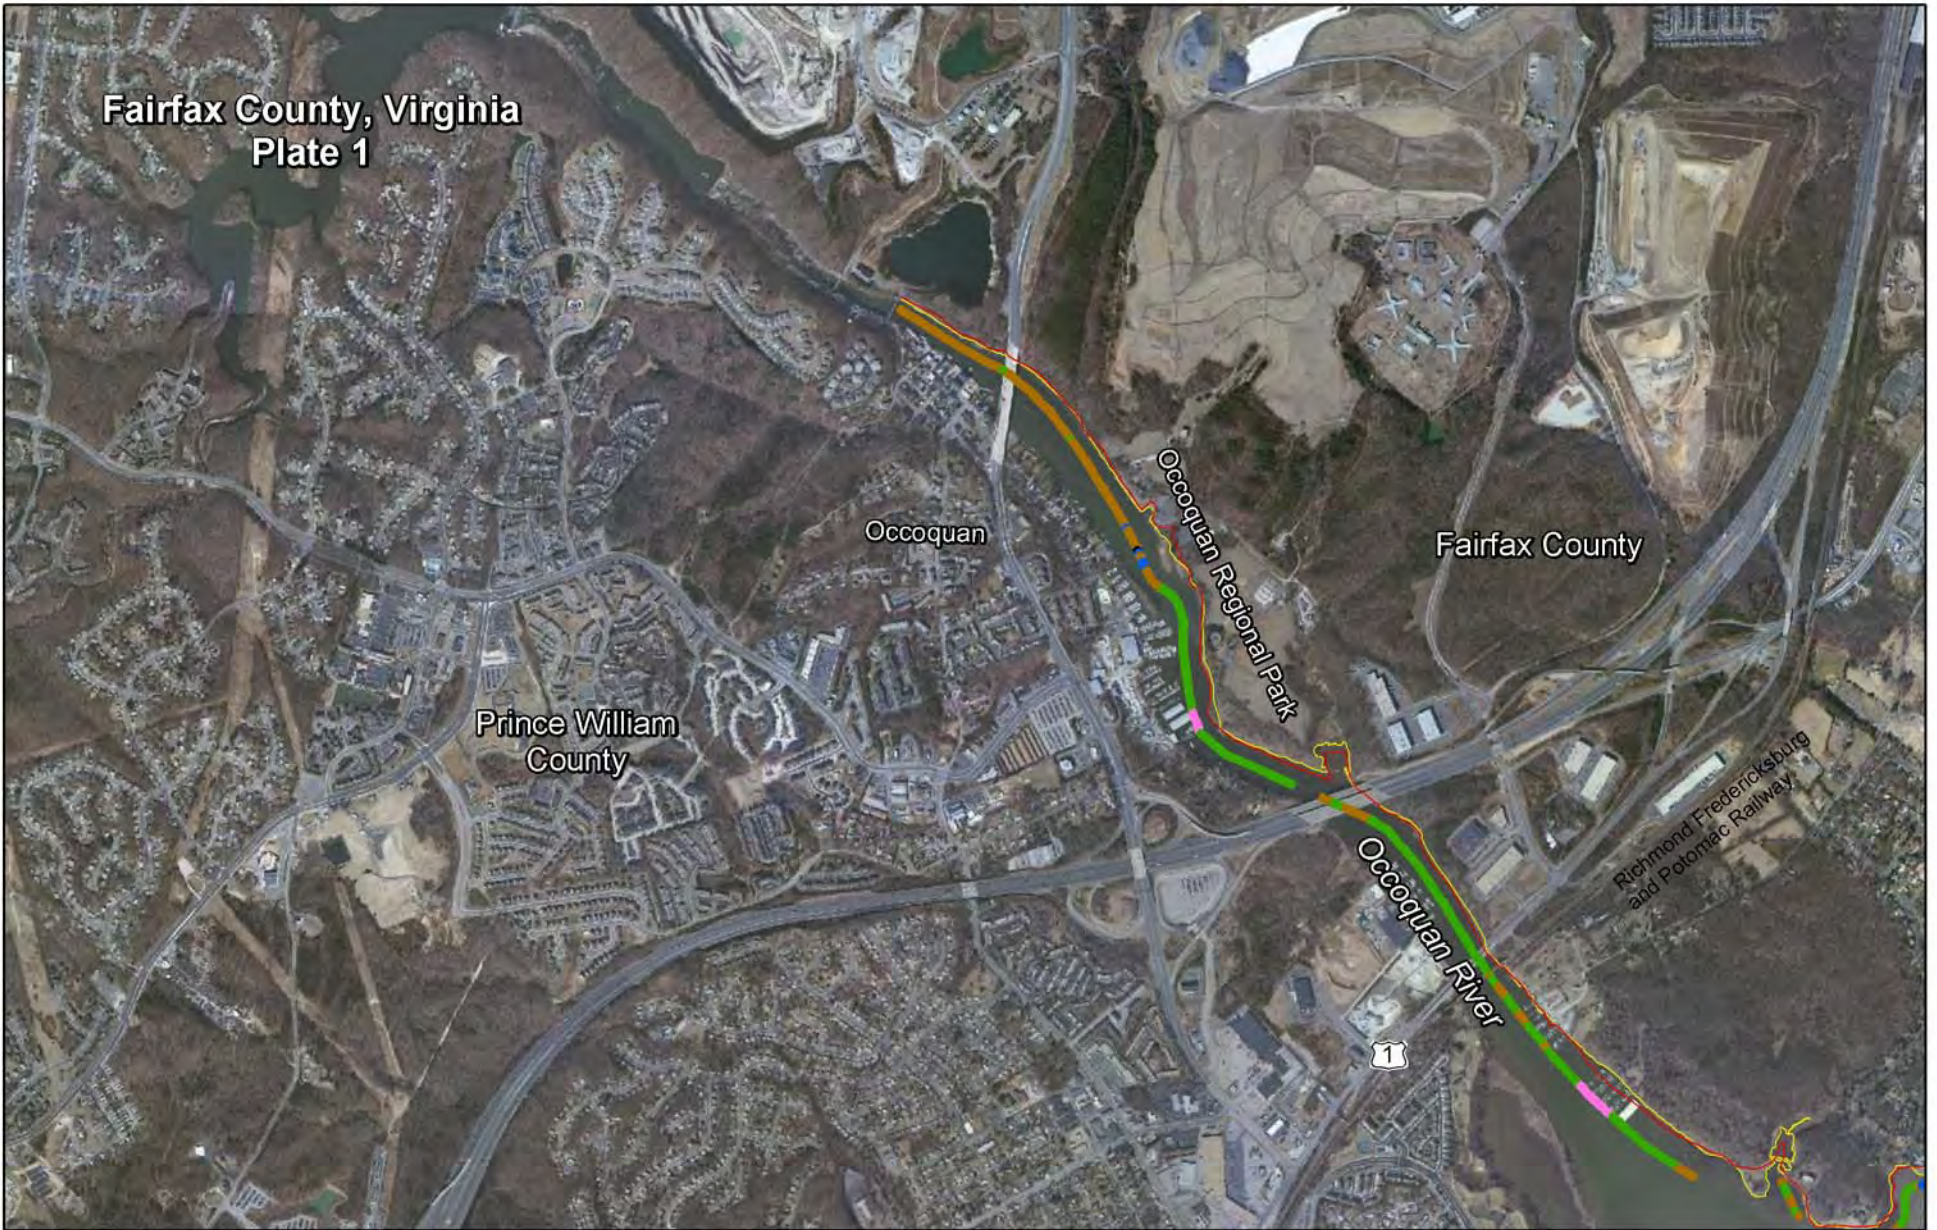
Fairfax County, Virginia
Plate 1

Shoreline change rates calculated between 1937 and 2009 are shown on a 2009 VBMP aerial photo. The calculated rates of change were averaged to determine an average rate of change for sections of shoreline as shown in Table 1 of the report.
