Encroachment of Sills onto State-Owned Bottom: Design Guidelines for Chesapeake Bay

C. Scott Hardaway Jr.
Virginia Institute of Marine Science

March 2009

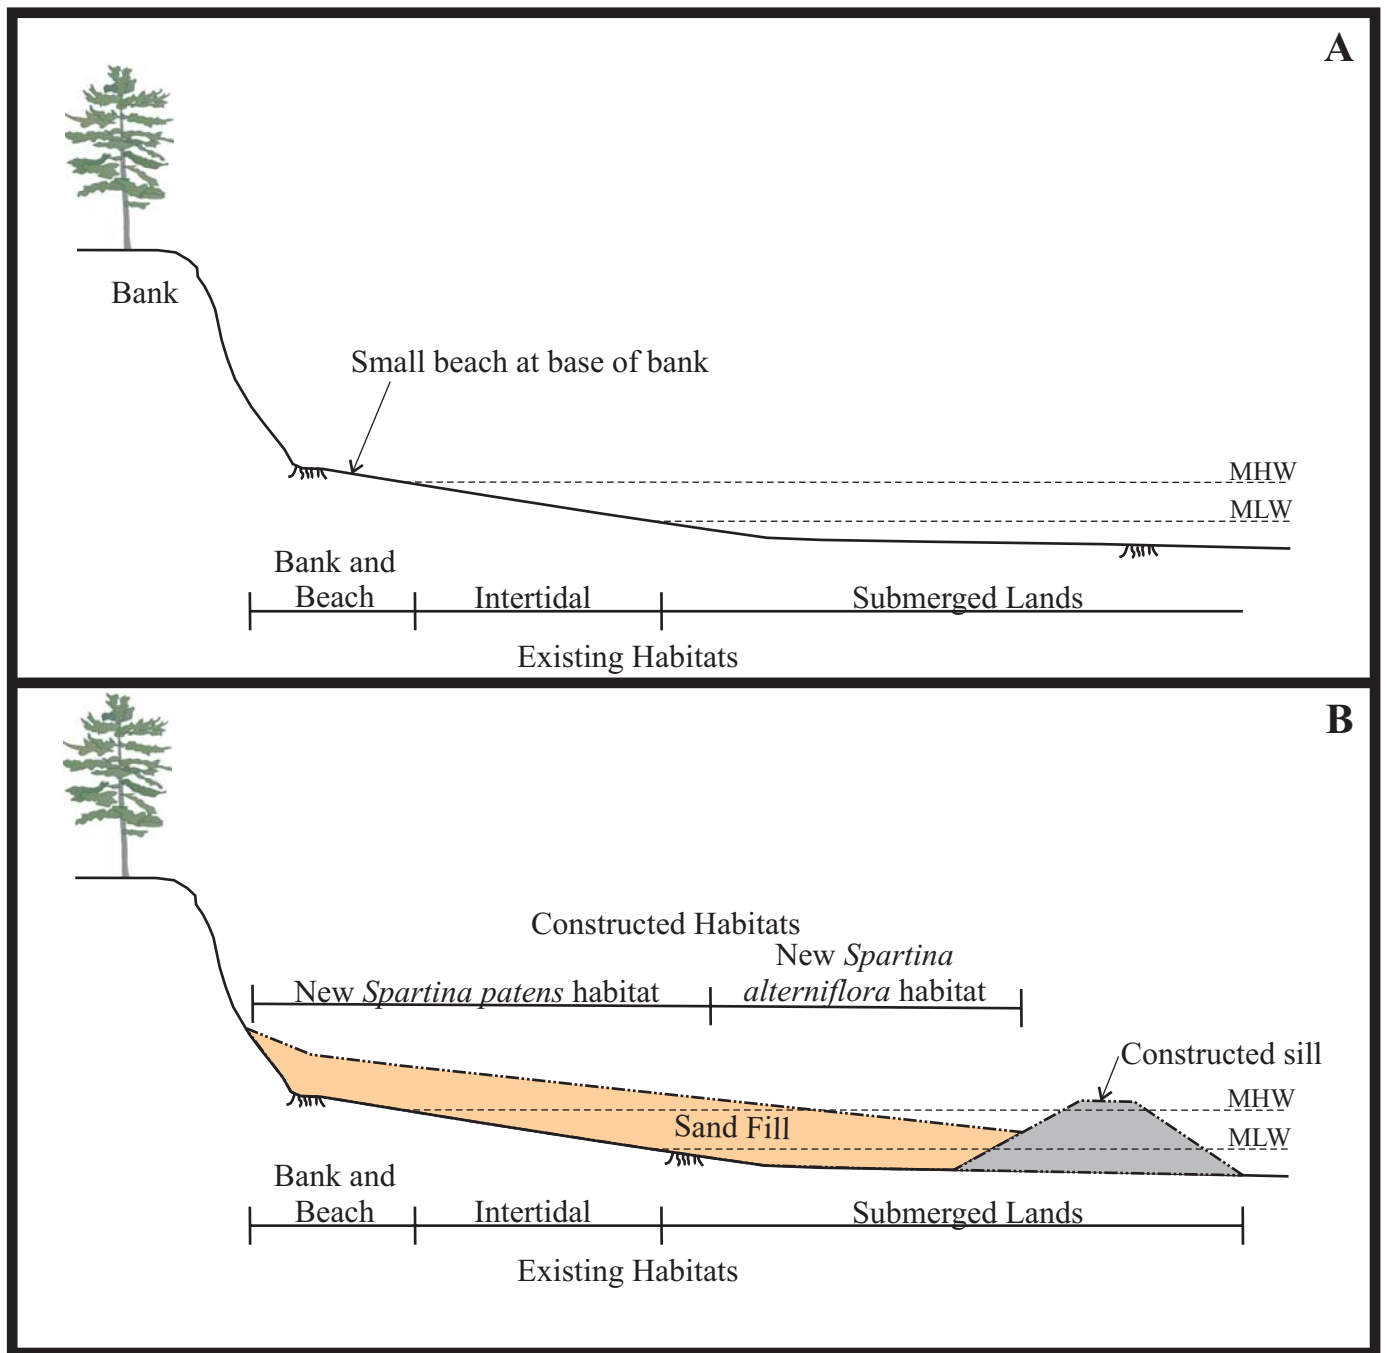
Figure 1. Sketches depicting the cross sections of a typical coastal setting before (A) and after (B) construction of a sill and sand fill project in a low to medium energy environment. The shaded areas show the extent of the encroachment of the project over existing habitats and into the regulated areas beneath MHW(Maryland) and MLW (Virginia).

The following example illustrates encroachment. A site on a large tidal creek is eroding at the base of bank and on the bank face. The site has an average fetch of 2 miles (3.2 km) with a bank height of 20 feet (6 m) and a narrow sand beach. The level of shore protection for a 25 year storm is +5 feet (1.5 m) mean low water (MLW), and the mean tidal range is 2.0 feet (0.6 m). With a proposed sill project, the intersection of the sand fill and the base of the bank is a key point (Figure 1). The sand is placed on a slope of 10:1* ^{see note} (Luscher and Hollingsworth, 2006) and intersects the landside of the sill at about +1.0 foot (0.3 m) MLW or mean tide level (MTL). The amount of encroachment beyond mean high water (MHW) and MLW depends on the pre-existing profile. If the bank is graded, the encroachment landward is a function of bank height where grading begins at +5 feet (1.5 m) MLW and goes 30 feet (9 m) landward on 2:1 grade. The resulting graded bank will be vegetated and might represent an improved upland buffer compared to the previously eroding bank.

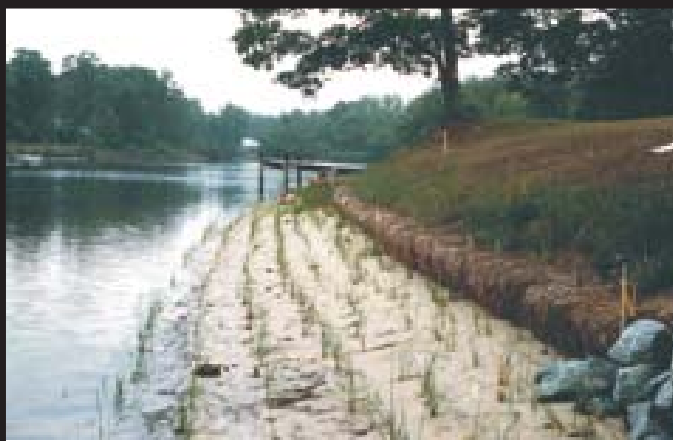
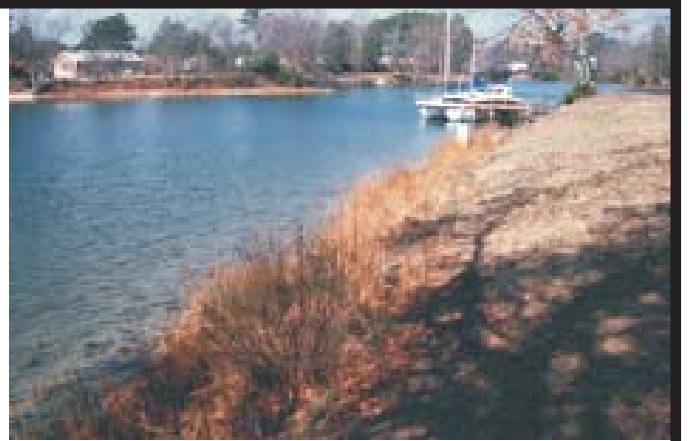
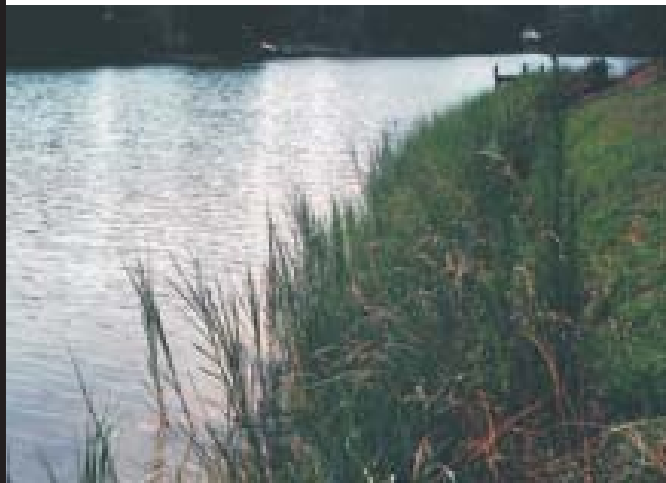
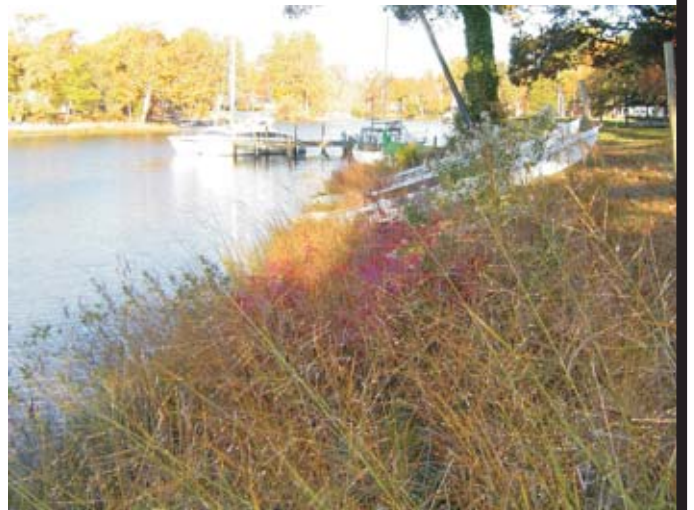
Minor bank grading and temporary toe protection utilizing straw bales was used first then *Spartina alterniflora* was planted to establish a marsh fringe.

At this site, high water impinged upon the base of the bank. Therefore, only the intertidal species (*Spartina alterniflora*) was utilized. This photo shows the site one year after planting.

The established marsh fringe and vegetative upland slope are shown here after six years.

The established marsh fringe and vegetative upland slope are shown here after 24 years.

Figure 2. Example of a marsh planted on existing substrate through time along Tabbs Creek in Lancaster County, Virginia.

- marsh planting on existing substrate (Figure 2)
- sand fill with groins and marsh plantings (Figure 3)
- sand fill with stone sills and marsh plantings (Figure 4)
- sand fill with breakwaters and marsh and dune plantings (Figure 5)

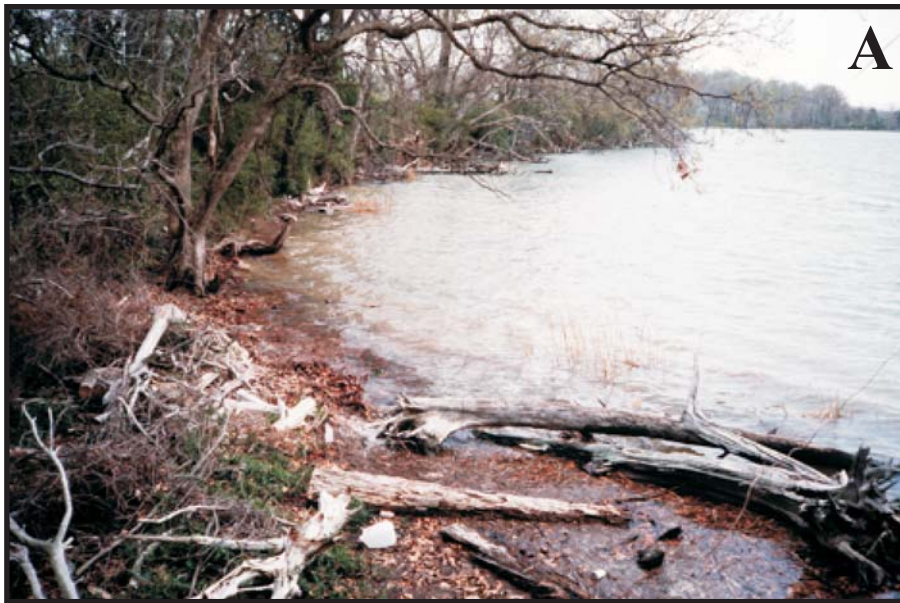
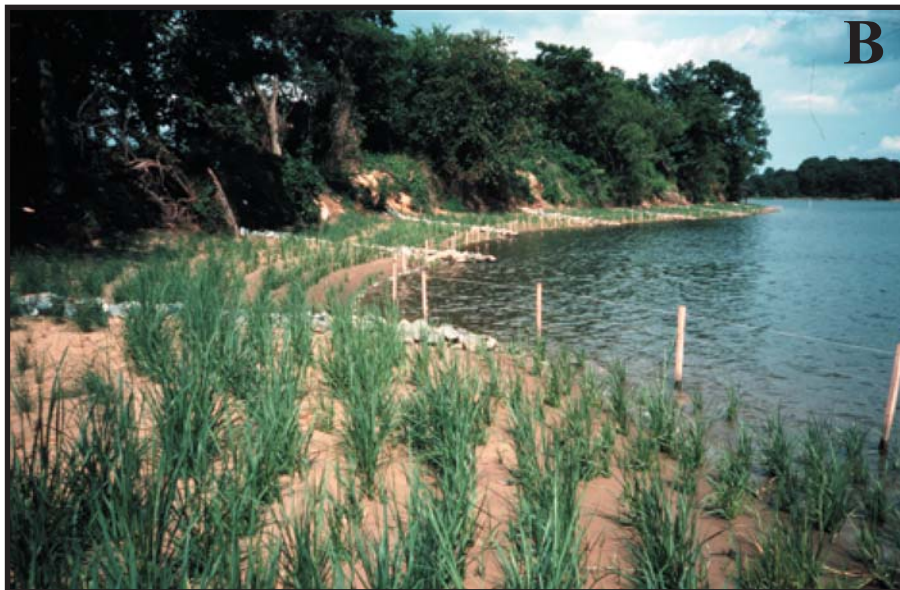
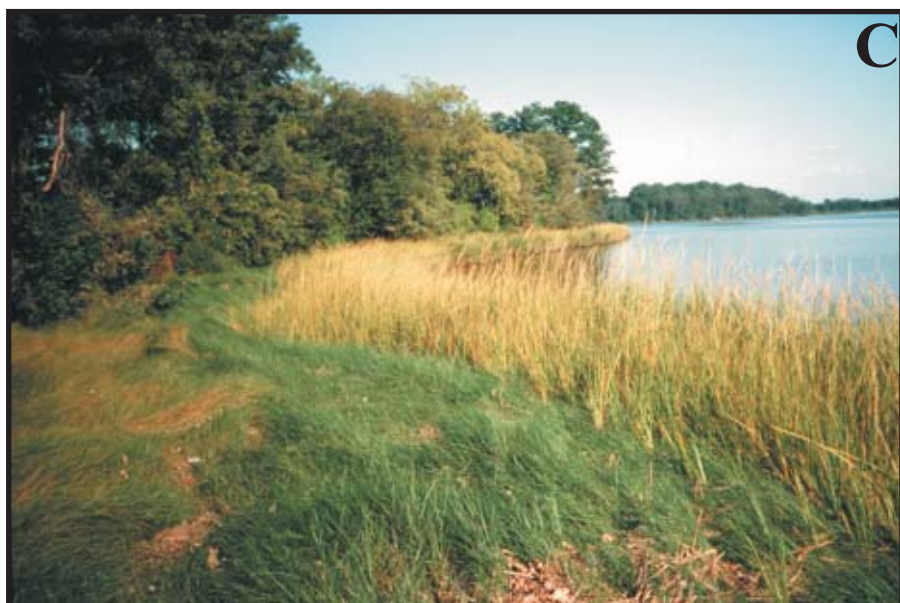
Figure 3. Photos showing a project consisting of short stone groins, sand fill, and marsh plantings at Wye Island, Kent County, Maryland A) before installation, B) three months after installation, and C) after four years.

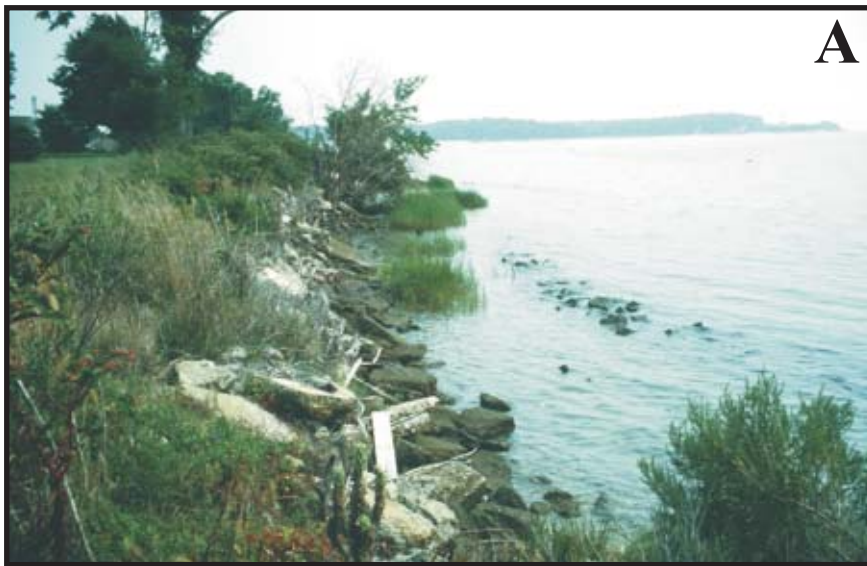
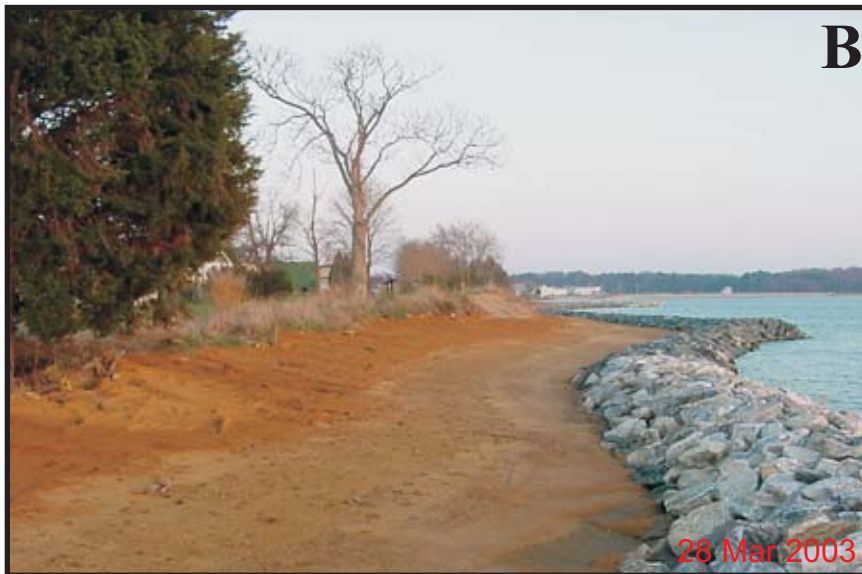
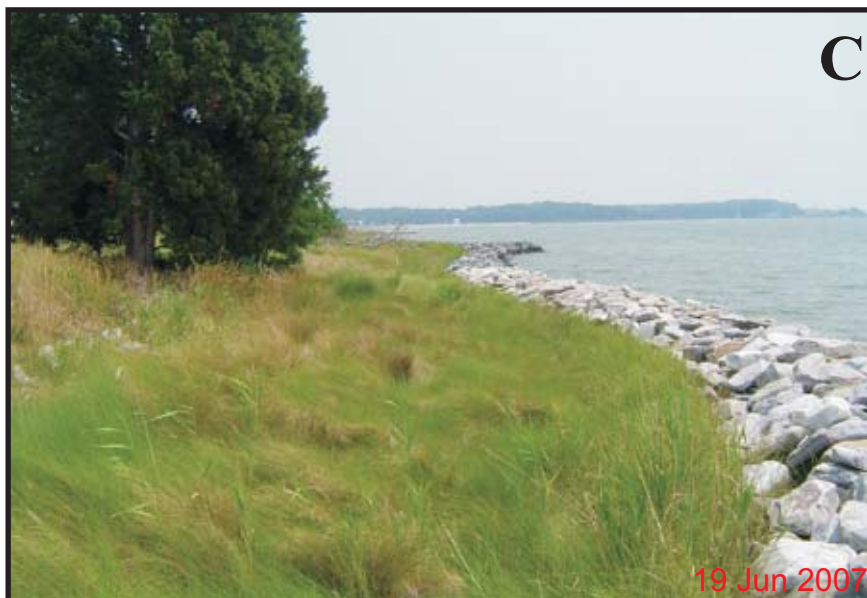
Figure 4. Sand fill with stone sills and marsh plantings at Webster Field Annex, St. Mary's County, Maryland A) before installation, B) after installation but before planting, and C) after four years.

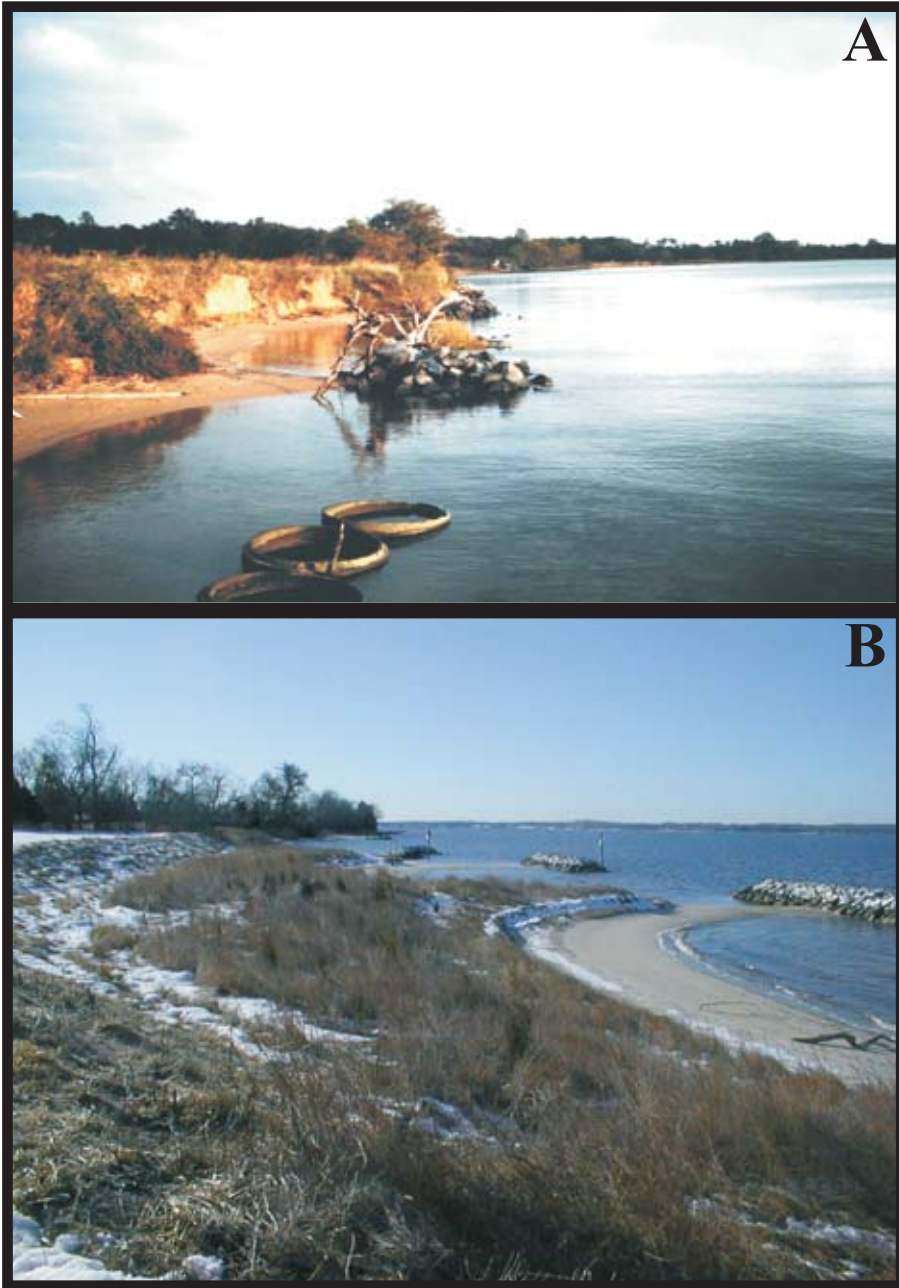
Figure 5. Jefferson Patterson Park and Museum A) before the upriver breakwater project (October 11, 1986) and B) in February 2003.

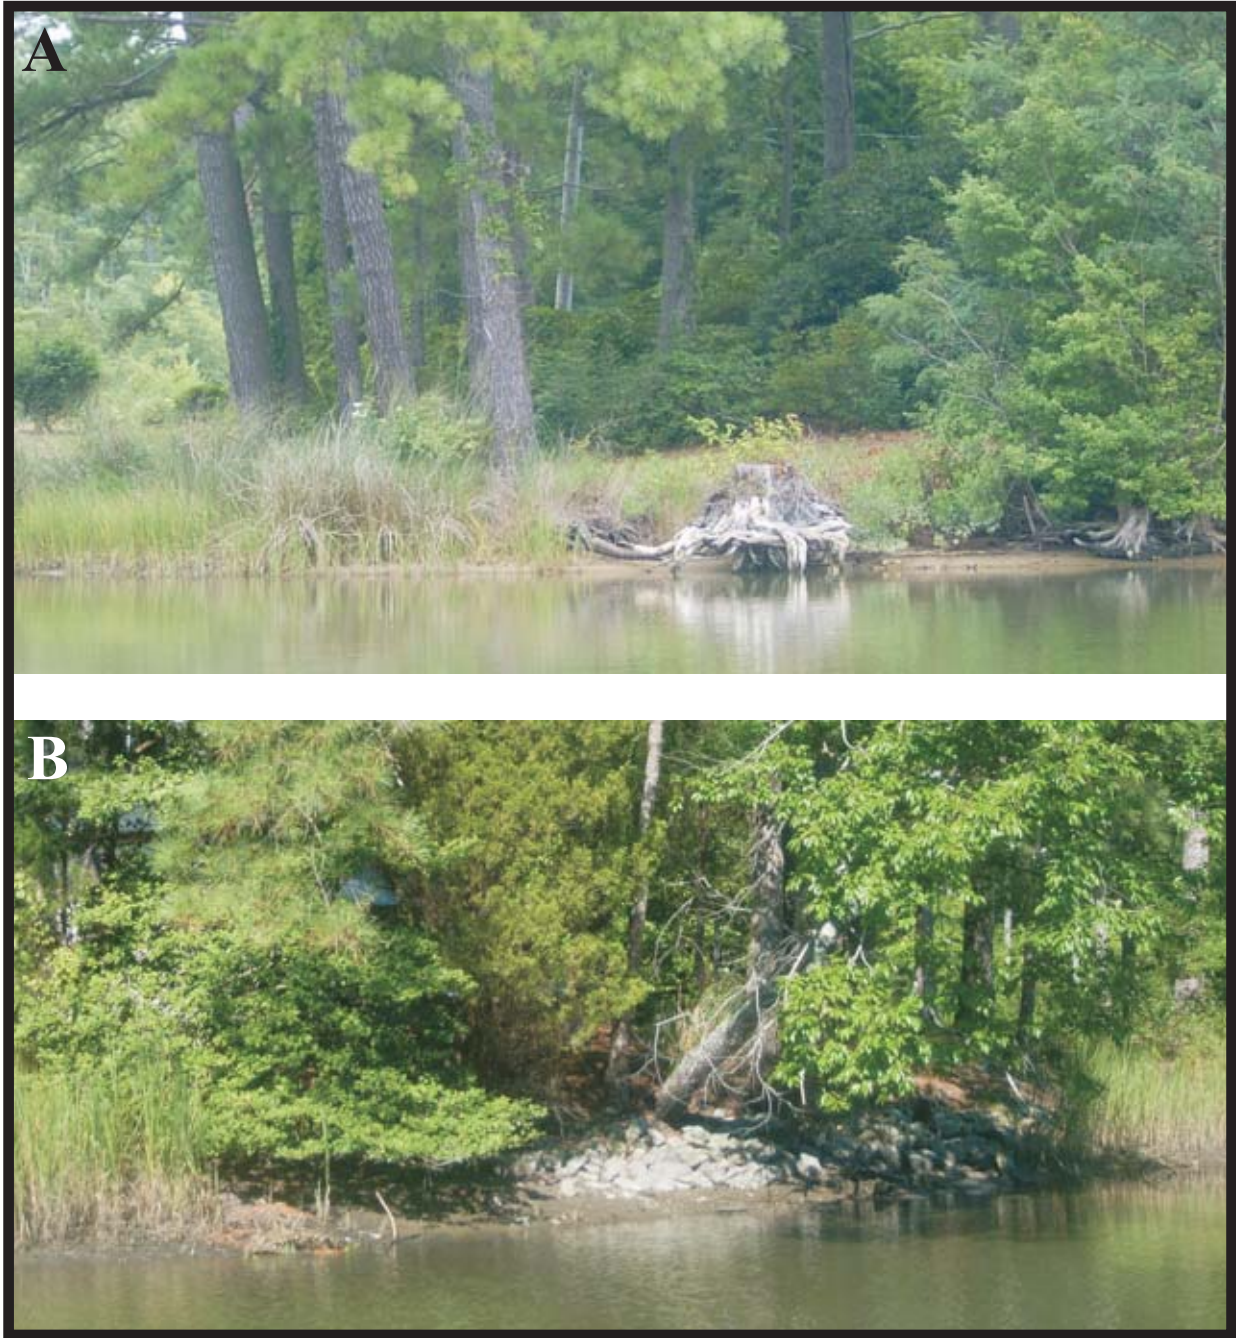
Figure 6. Example of A) a living shoreline that is being shaded by tree cover and dying off, and B) the typical homeowner's response to a perceived erosion.

An erosion problem can be perceived as being more severe than it is, particularly up very fetch-limited tidal creeks where shade from trees prevents the marsh fringe from growing (Figure 6). Nevertheless, landowners often view any loss of land as undesirable and wish to fix it, usually with a revetment or bulkhead. Once the marsh dies or a bulkhead or revetment is installed, the buffer between the upland and the adjacent water body is lost. In contrast to bulkheads and revetments, living shorelines offer a vegetated coastal buffer zone and an equally effective means of controlling shore erosion.

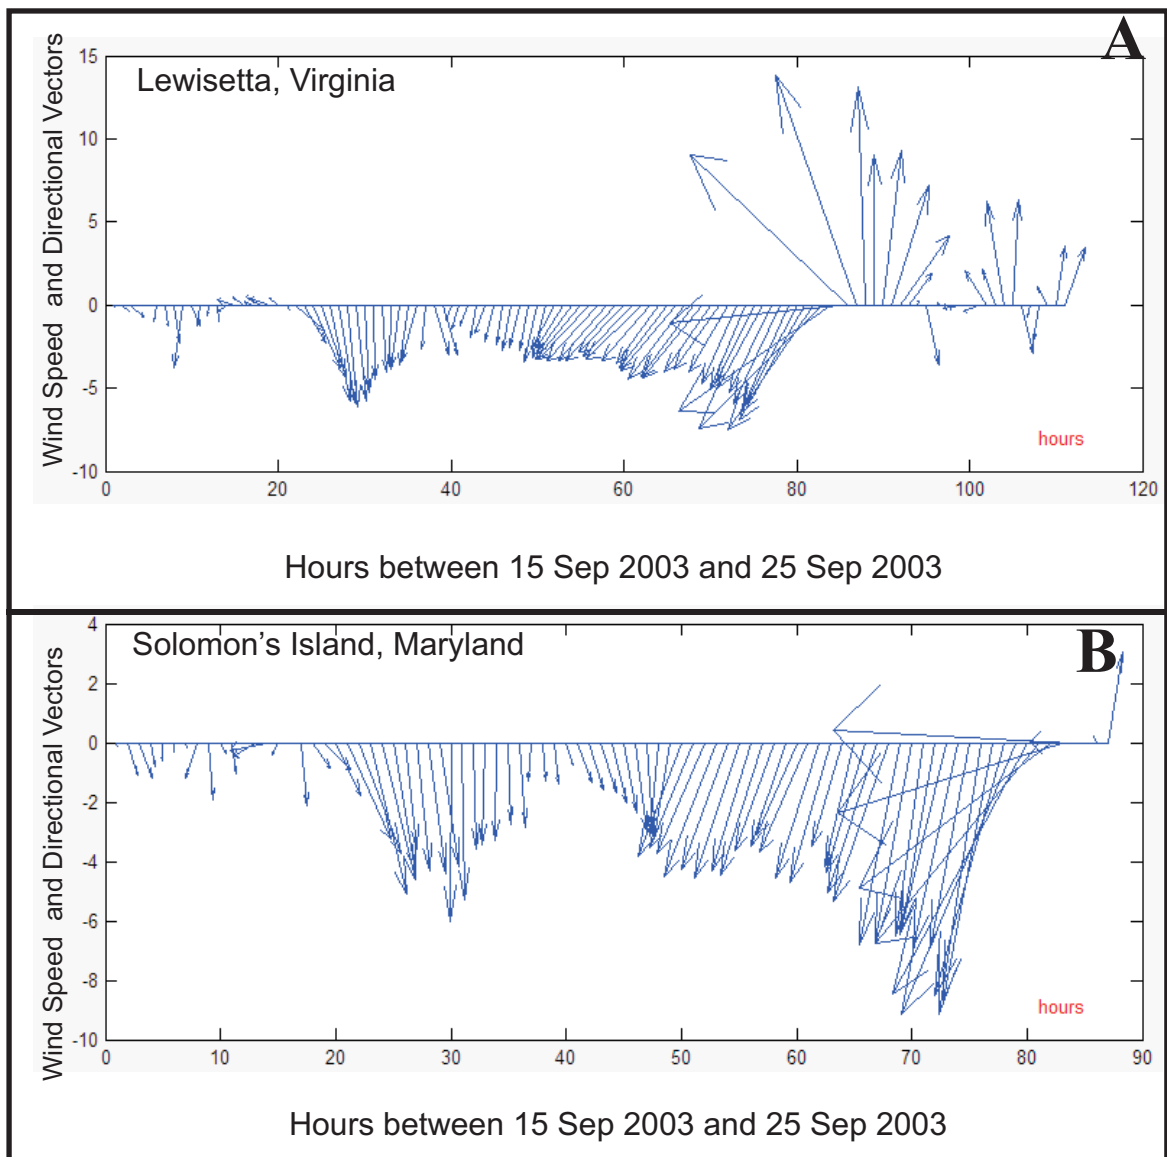
Figure 8. Plots of wind speeds and directions at the NOAA stations at A) Lewisetta, Virginia and B) Solomons's Island, Maryland during Hurricane Isabel. A complete data set may not exist at each site, but all hours available are shown.

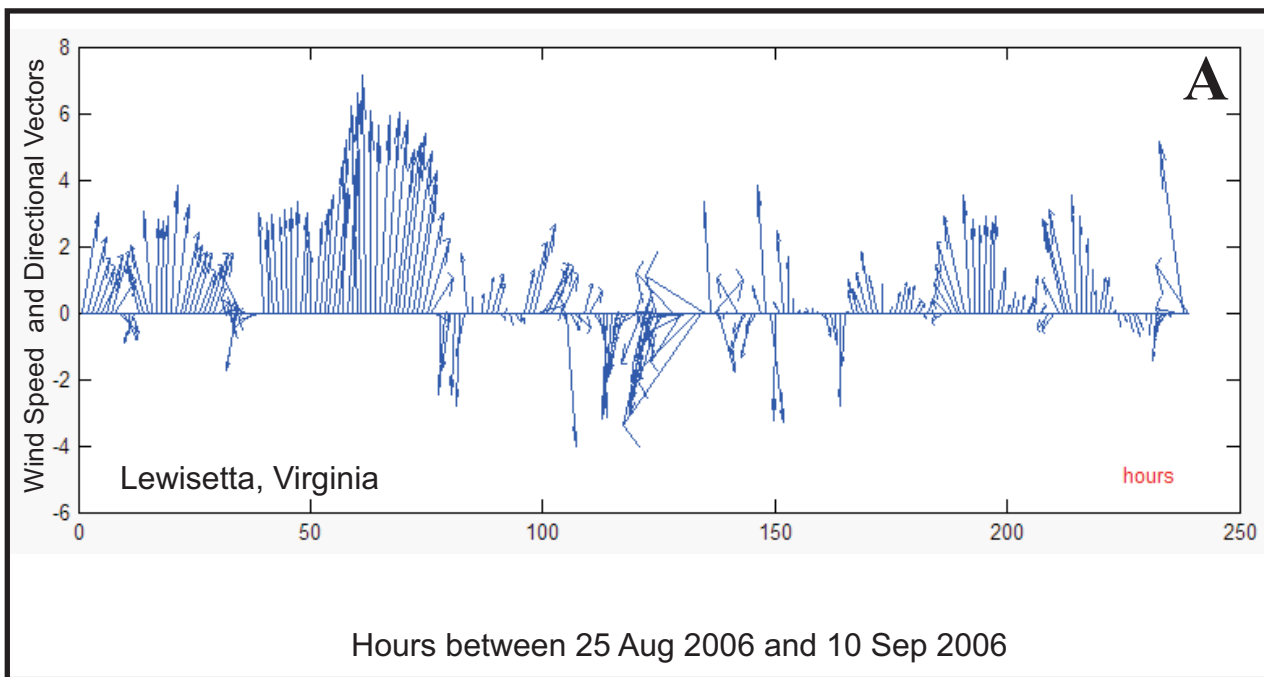
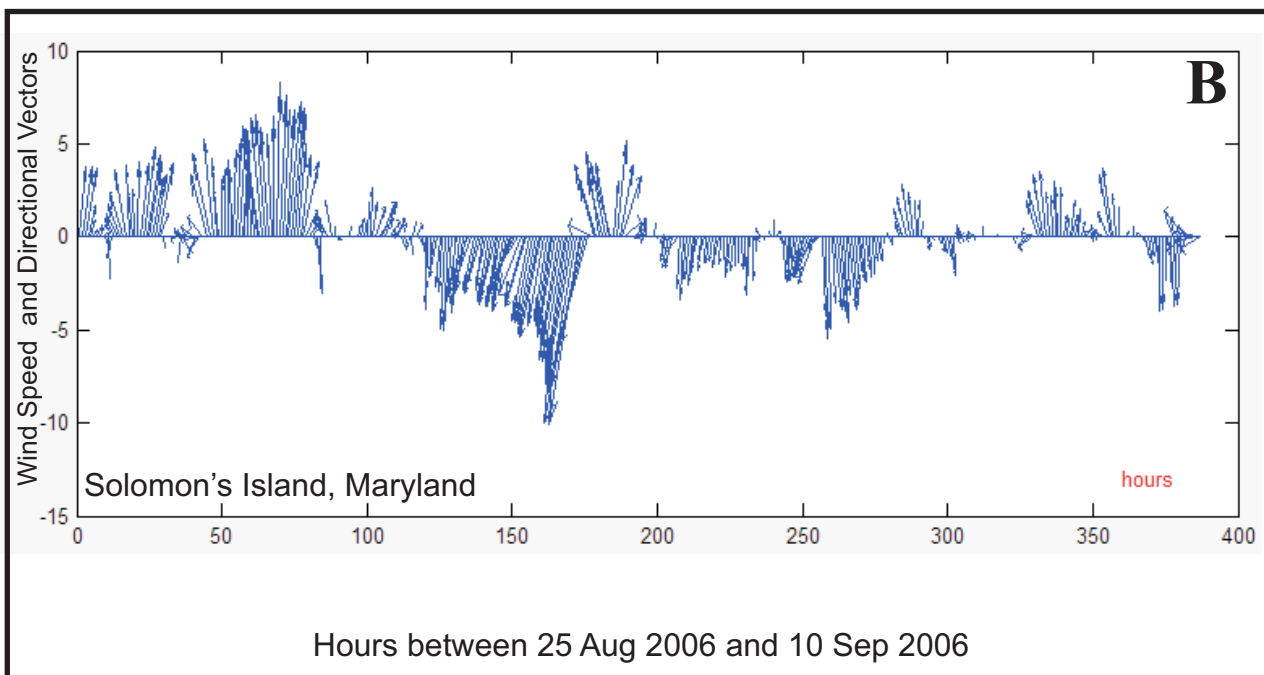
Figure 9. Plots of wind speeds and directions at the NOAA stations at A) Lewisetta, Virginia and B) Solomons's Island, Maryland during Tropical Storm Ernesto. A complete data set may not exist at each site, but all hours available are shown.

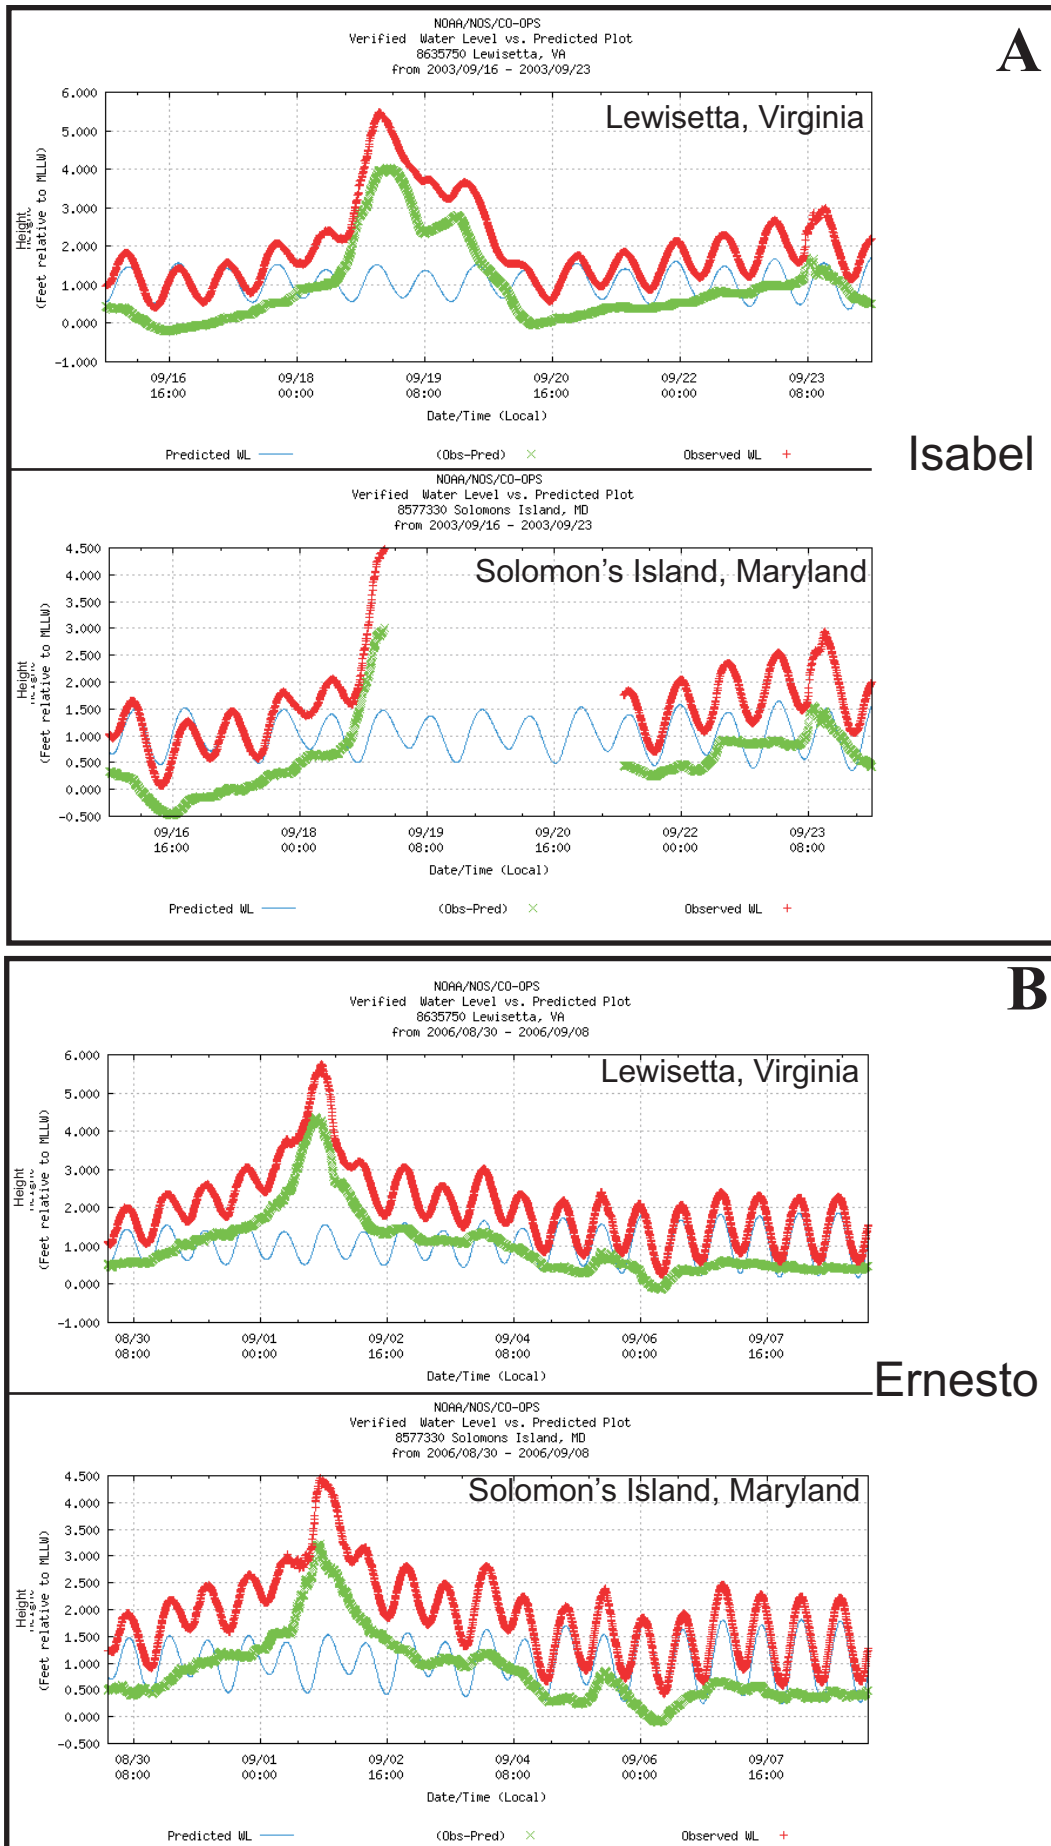
Figure 10. Water levels recorded during A) Hurricane Isabel and B) Tropical Storm Ernesto on the NOAA tide gauges at Lewisetta, Virginia and Solomon's Island, Maryland. The gauge at Solomon's Island did not operate from late on day 3 through early day 6 of Hurricane Isabel. Vertical datum is MLLW.

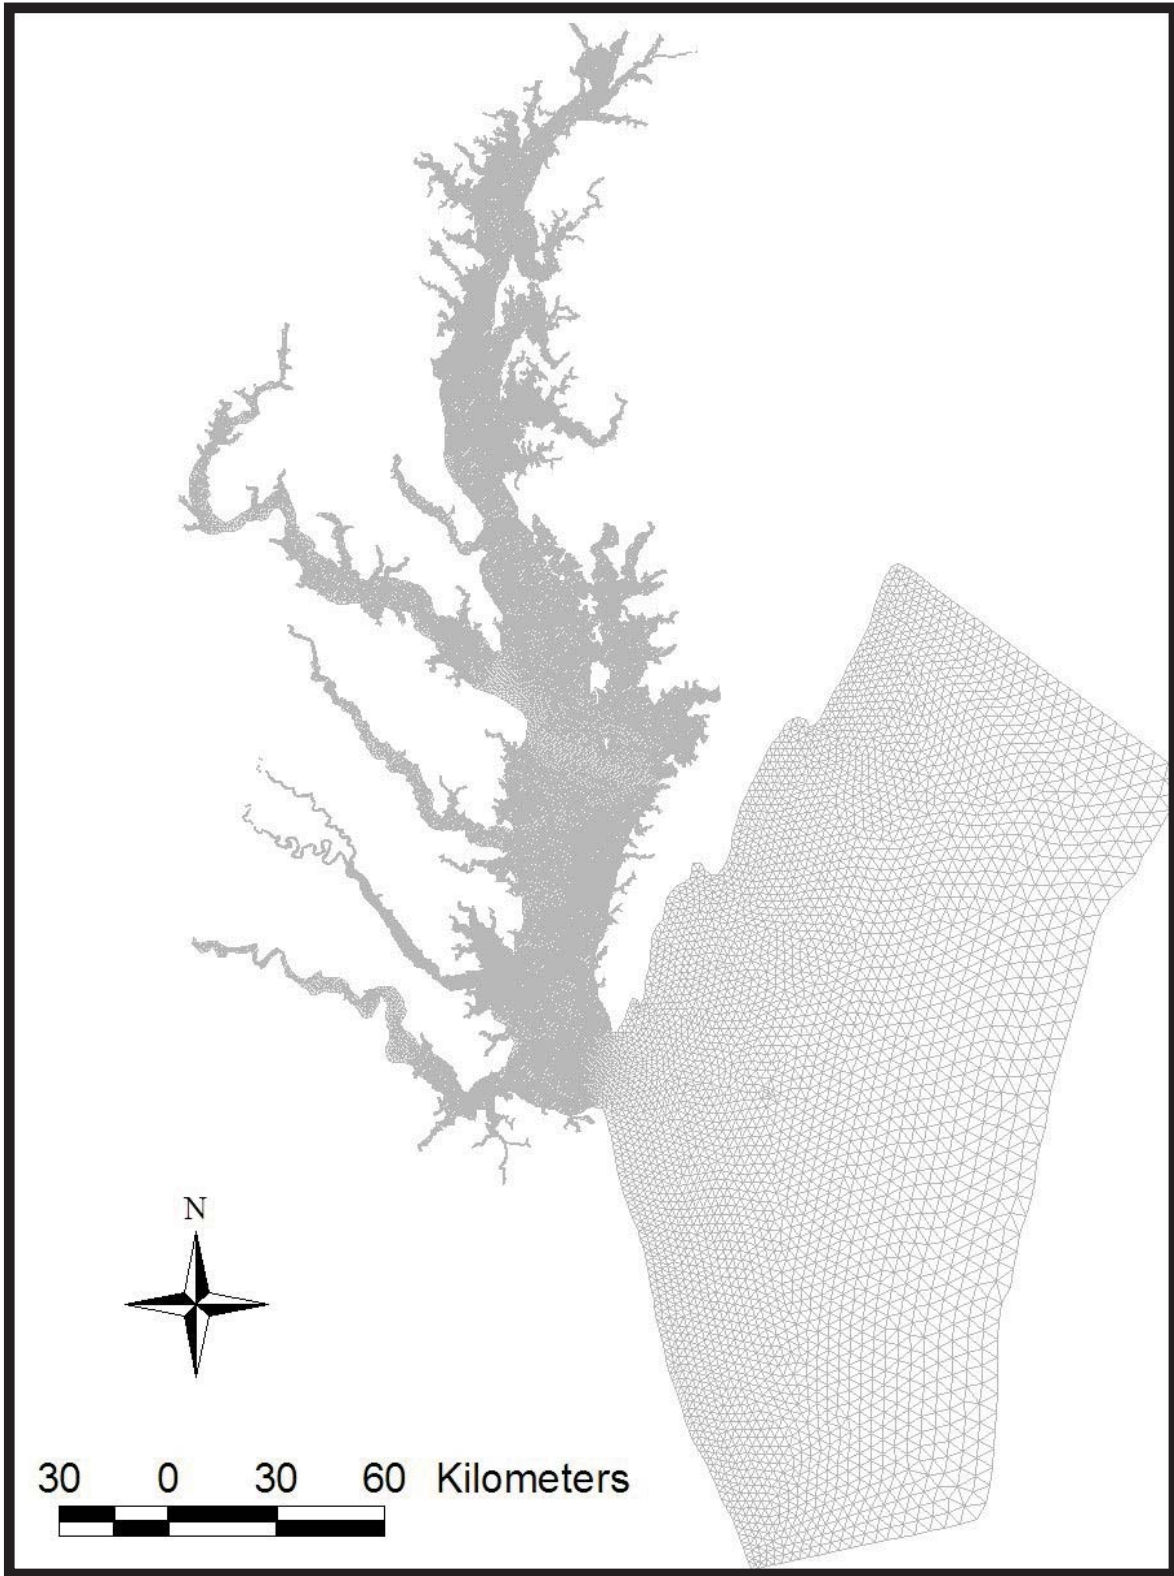
Figure 11. Model grid used for storm tide simulation.

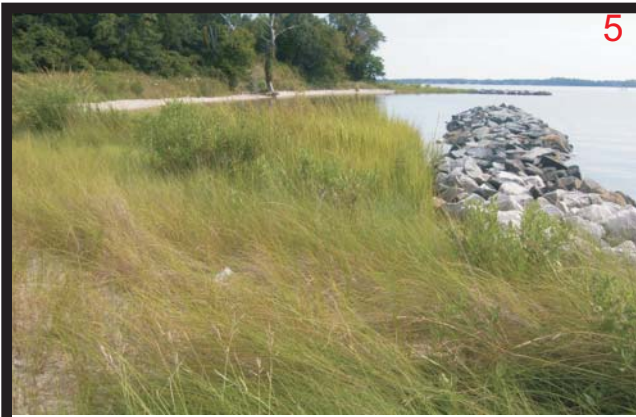
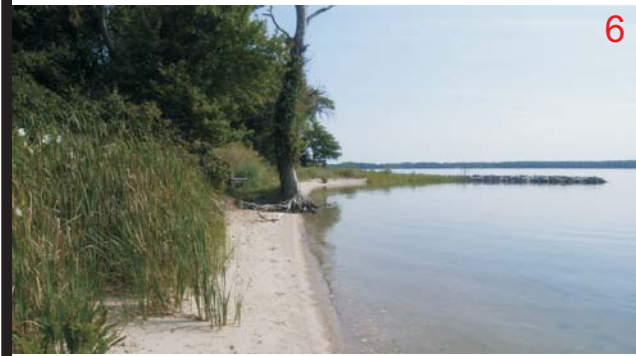
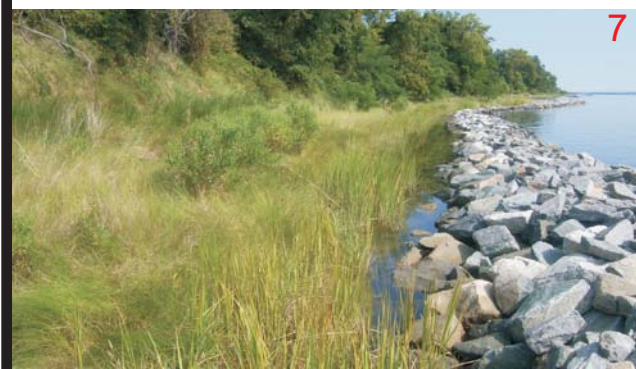
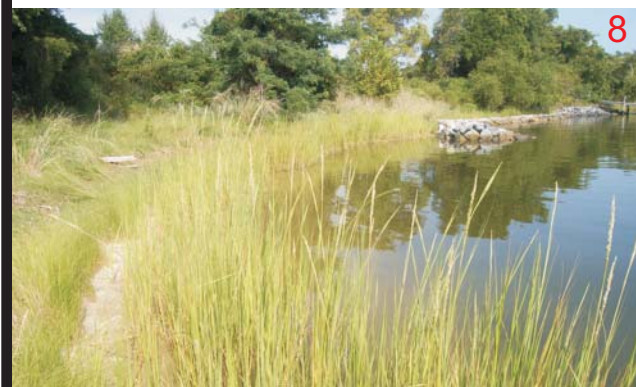
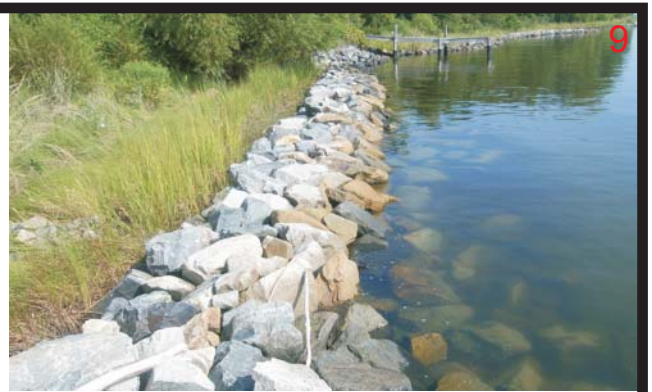
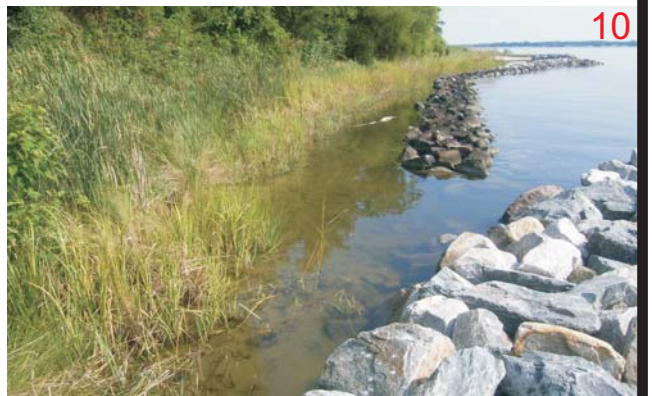
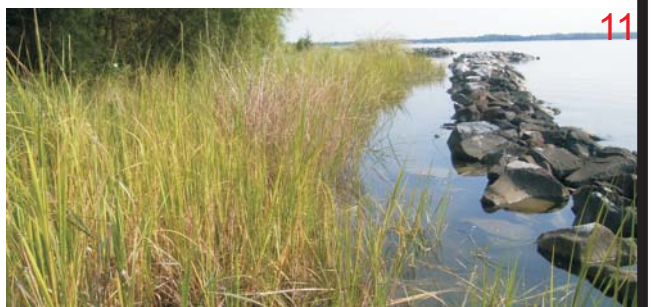
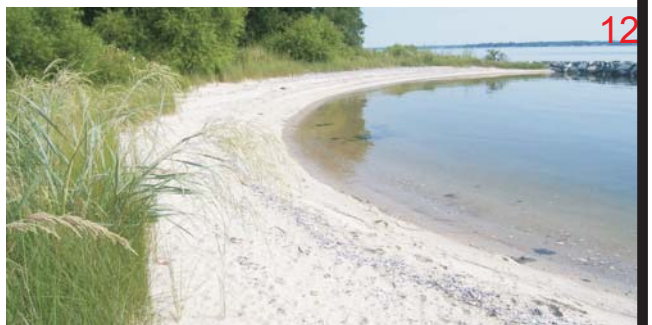
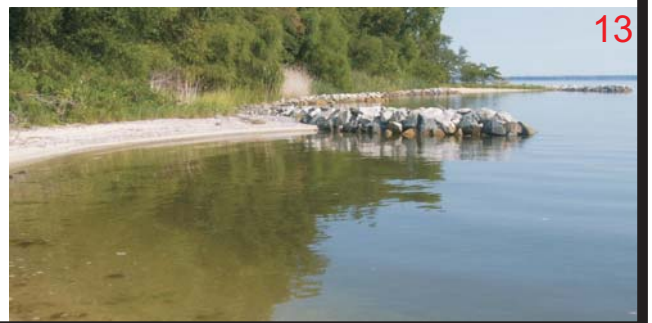
Figure 14. Ground photos taken along the Jefferson Patterson Park & Museum on 20 Aug 2008. Locations are shown on Figure 13.

JPPM is located on the north shore of the Patuxent River beginning at Petersons Point and extending over 2 miles (3 km) upriver ([Figure 7](#)). Their shoreline is protected by several projects built in phases since 1986. Because of availability of pre-, and post construction surveys, this study concentrates on Phase 4 which was built in 1999 ([Figure 13 and Figure 14](#)).

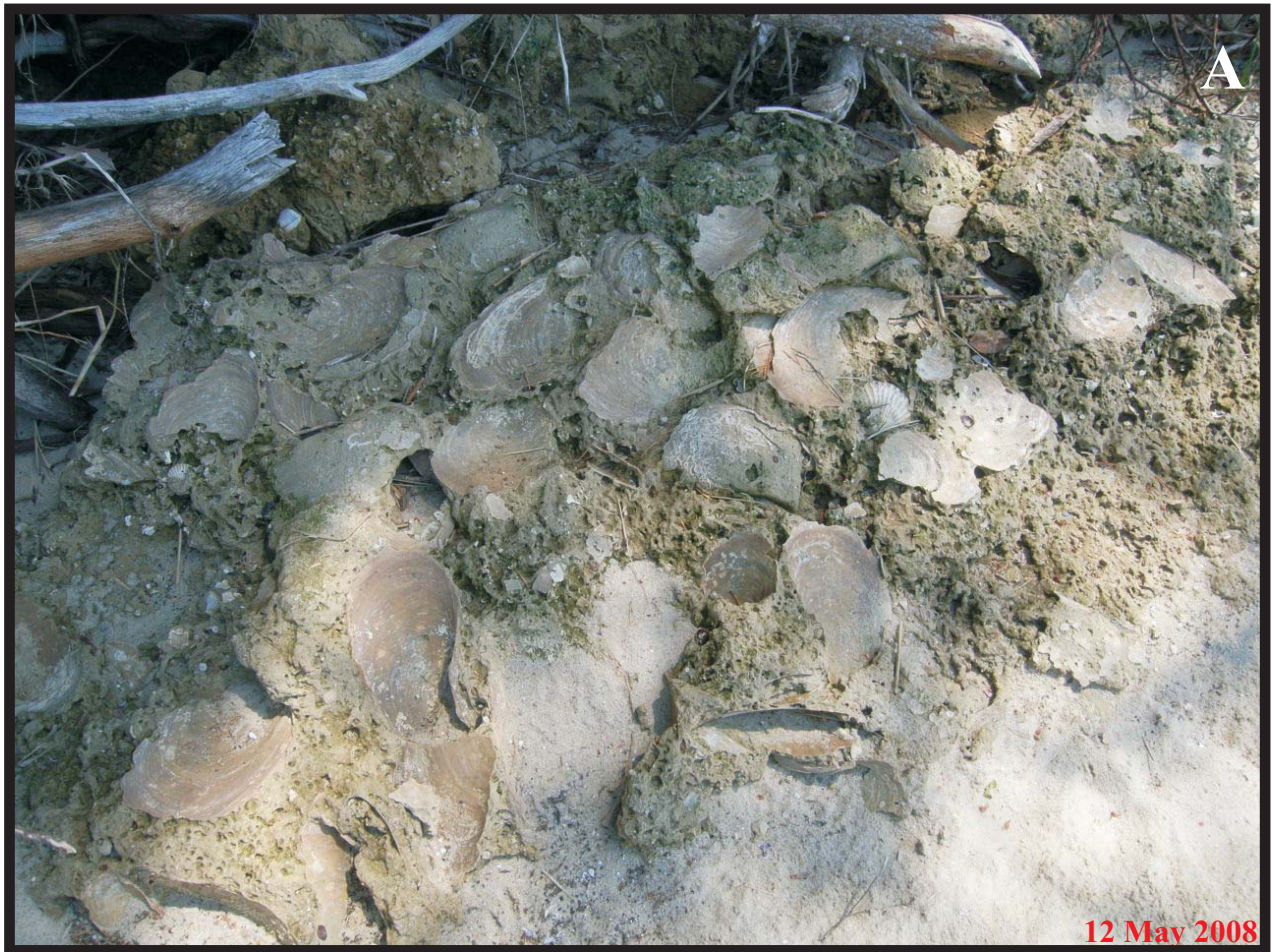
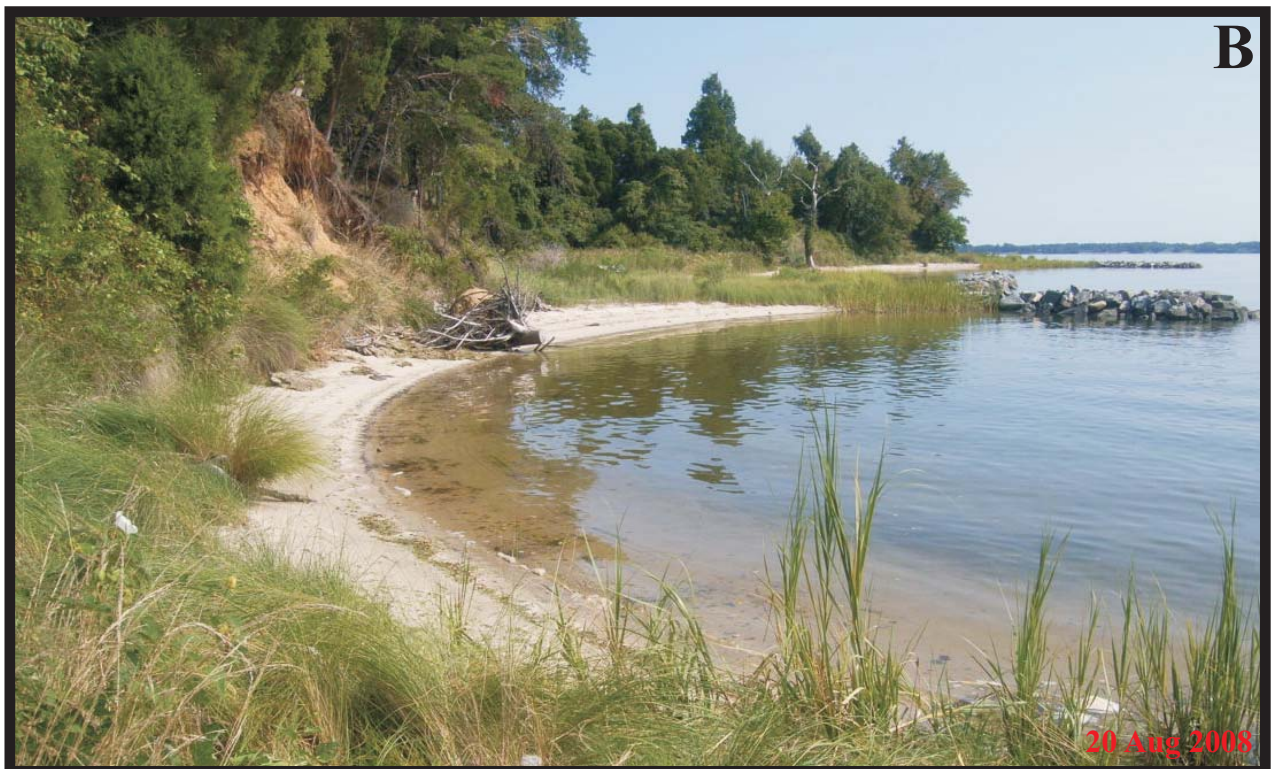
Figure 15. Photographs of the banks a Jefferson Patterson Park & Museum showing A) the indurated, fossiliferous bed along a portion of the base of the bluff and B) the general setting.

drainage occurs within the Phase 4's limits. A small line of stone which acted as a very low sill existed at the site, but it did not offer long-term shore protection for the failing upland banks. One of the main reasons for the project was to protect valuable archaeological resources contained in the banks. Another feature was the paleontological resources along the base of the bank, an indurated highly fossiliferous marl (Figure 15).
