Encroachment of Sills onto State-Owned Bottom: Design Guidelines for Chesapeake Bay

C. Scott Hardaway Jr.
Virginia Institute of Marine Science

March 2009

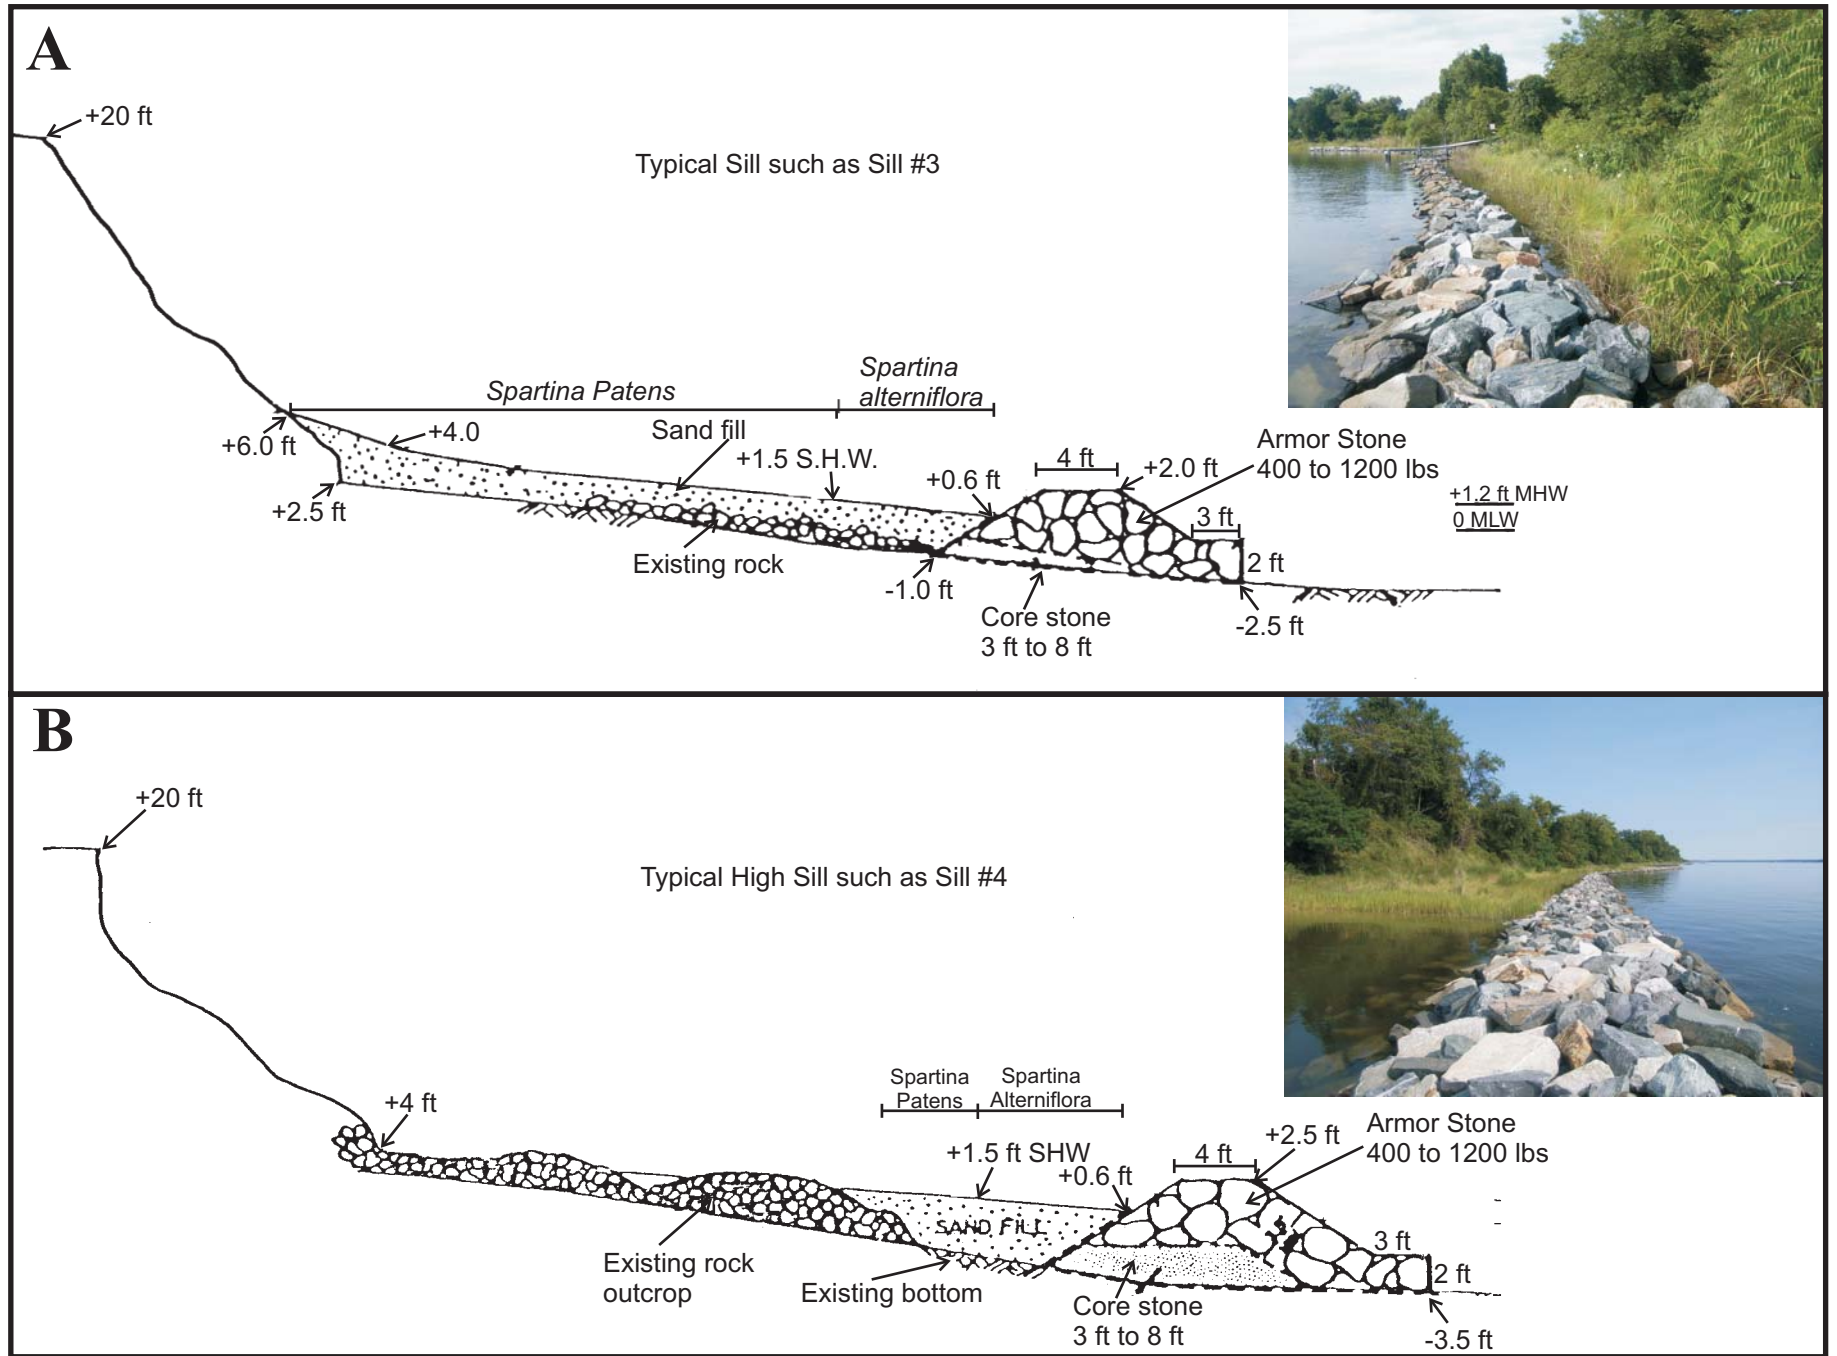
Figure 16. Design cross-sections of structures built at Jefferson Patterson Park & Museum in Phase 4 showing A) a typical sill such as Sill #3 (shown in the photo) and B) a typical high sill such as Sill #4 (shown in photo).

Breakwater #3 was placed in front of a subtle headland with a pocket beach that transitions both up and down river into gapped sills including sill #3 (Figure 16A). A larger and broader headland was addressed with sill #4, a high, continuous sill bounded by spurs (Figure 16B). This headland was the result of a basal, indurated fossil layer that was more erosion resistant than adjacent conditions. Beyond the middle watershed the remaining shore was addressed with breakwater #4 and sill #5.

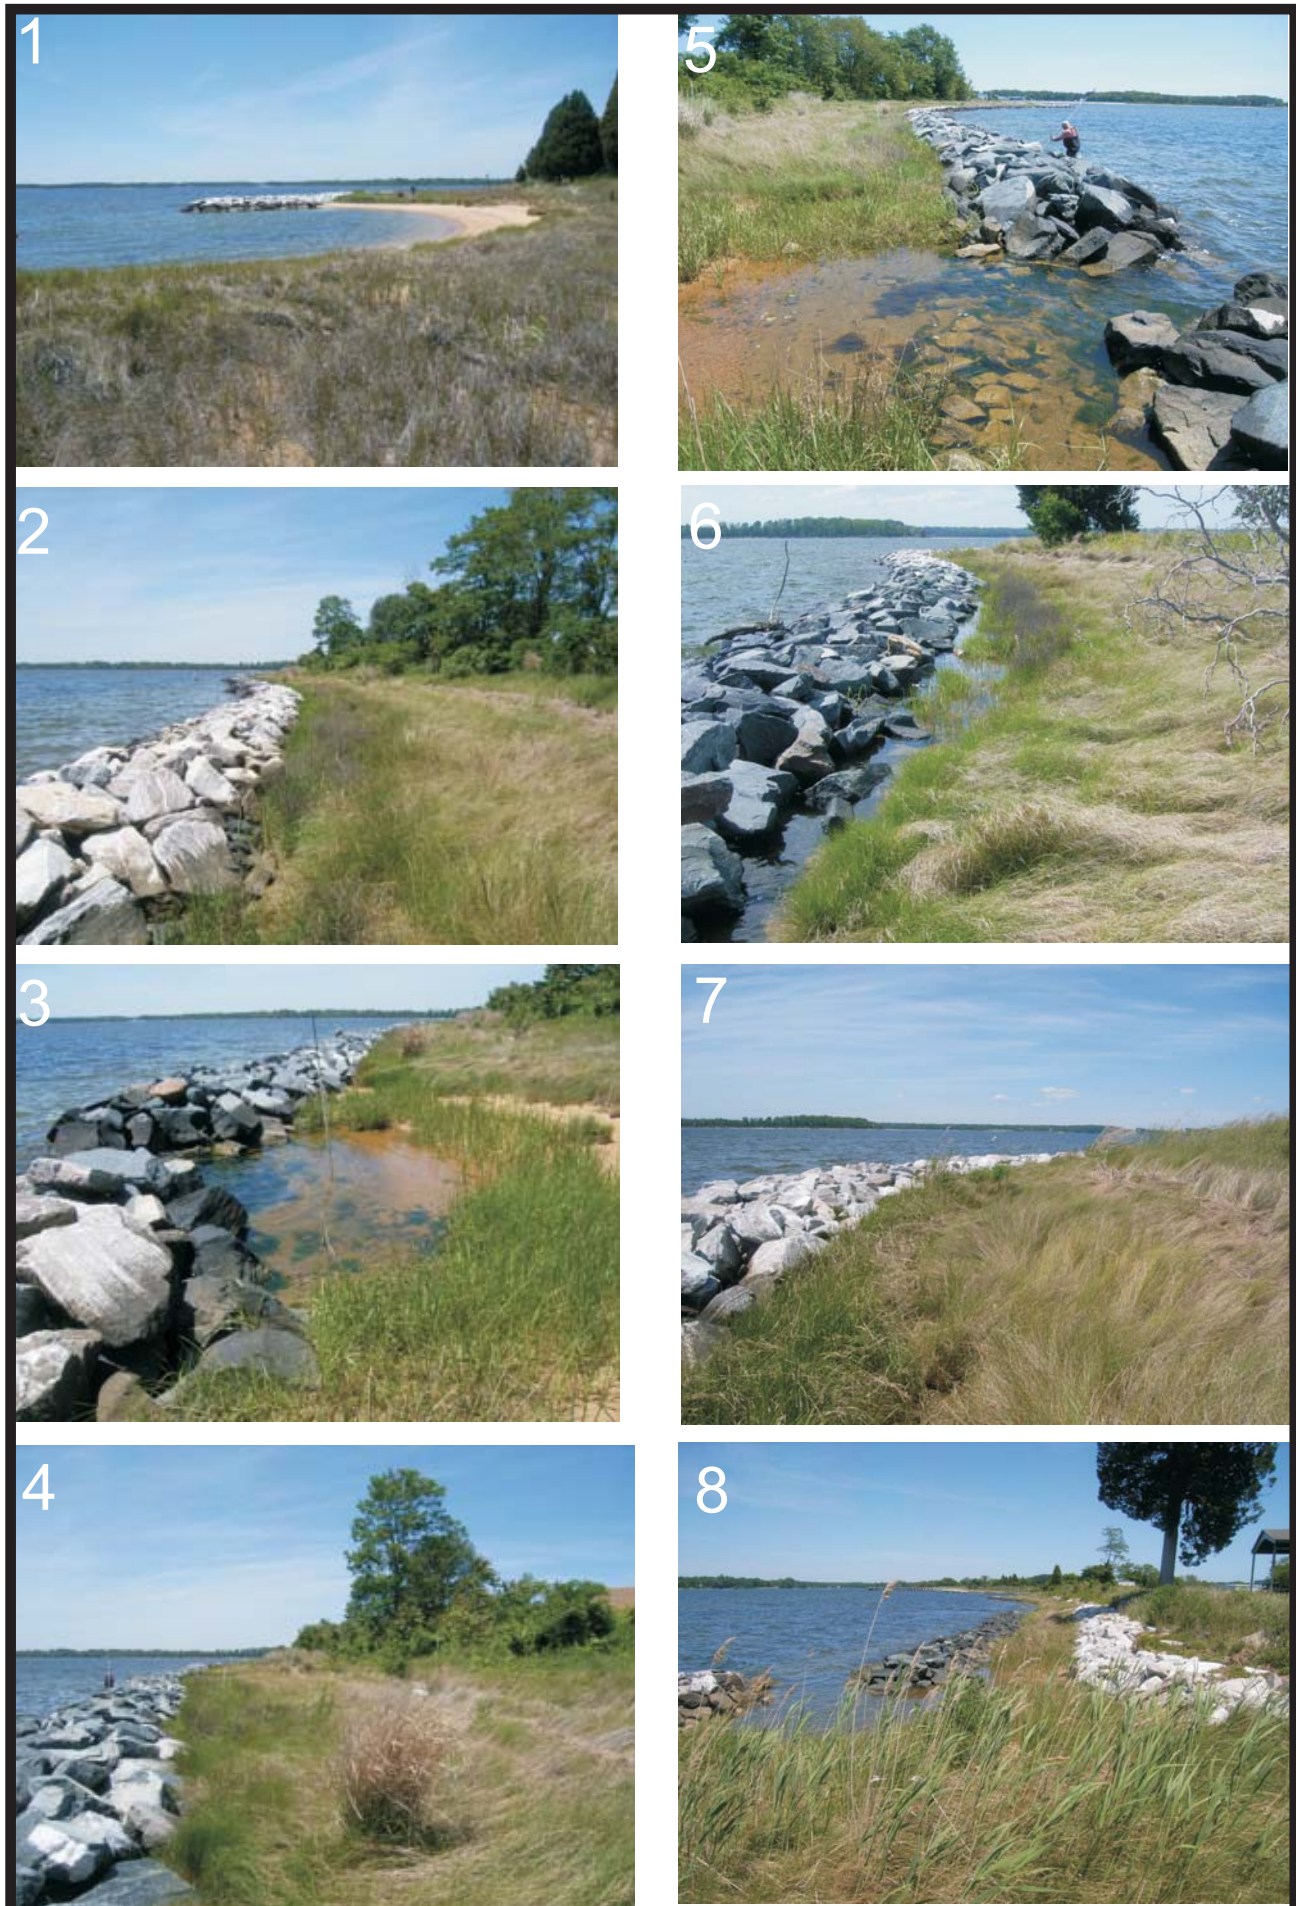
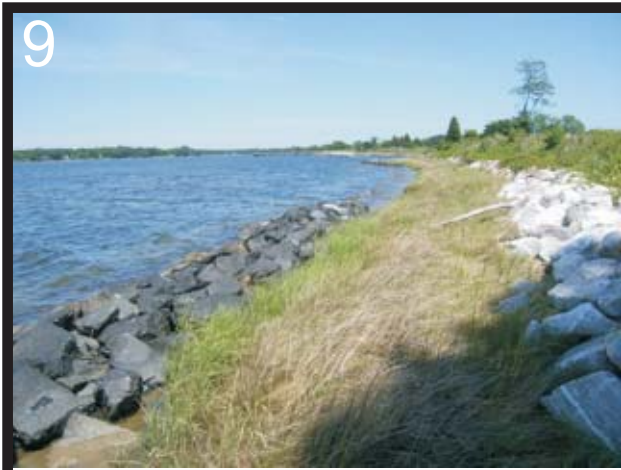
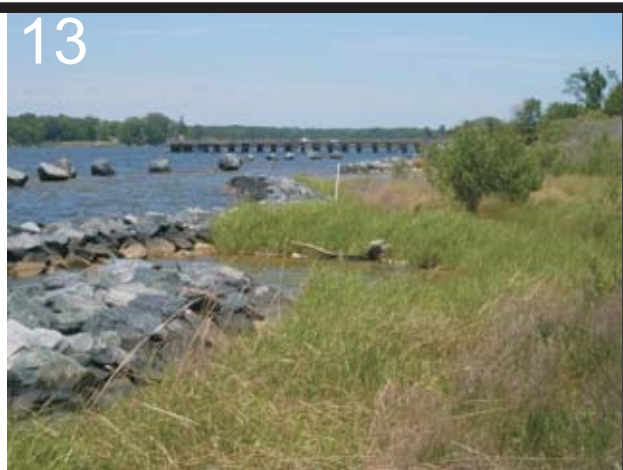
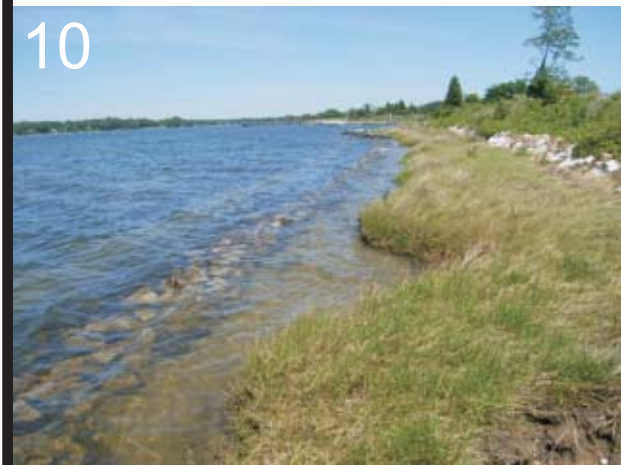
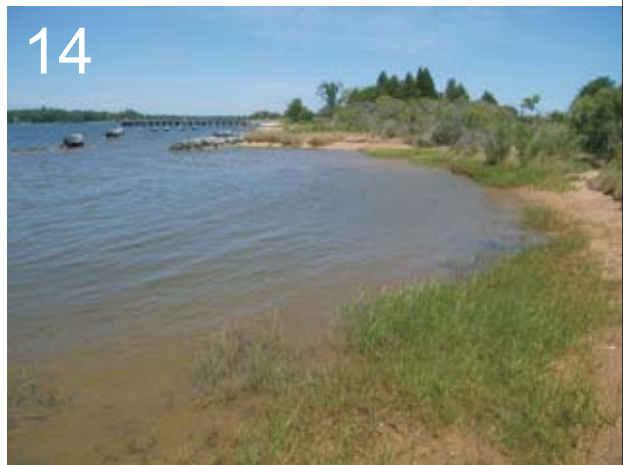
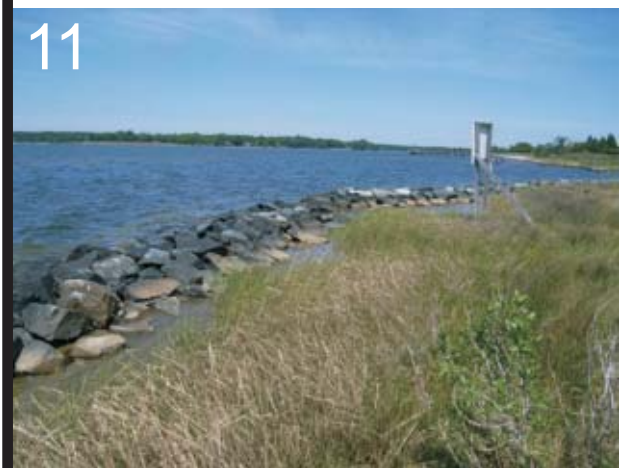
Figure 18A. Ground photos 1-8 taken along the Webster Field Annex on 22 May 2008. See Figure 17 for photo locations.

Figure 18B. Ground photos 9-16 taken along the Webster Field Annex on 22 May 2008. See Figure 17 for photo locations.

Up the St. Mary's River from Priest's Point, the shoreline is an upland bank rising to about +7.5 feet (2.3 m) MLW with a narrow marsh fringe (Figure 18). Broken concrete also had been dumped along the base of this upland bank. The upland then drops down about +3 feet (0.9 m) as the shoreline becomes a narrow, sandy barrier fronting a broad drainage with a small pond that drains to the river. This low sandy bank and marsh fringe abuts the next upland which rises up to about +8 feet (2.4 m) MLW. This upland continues for about 800 feet (245 m) and had a large amount of broken concrete dumped across it over the years. A long pier that is shown in the distance on photos 13 and 14 (Figure 18) also occurs along his reach.

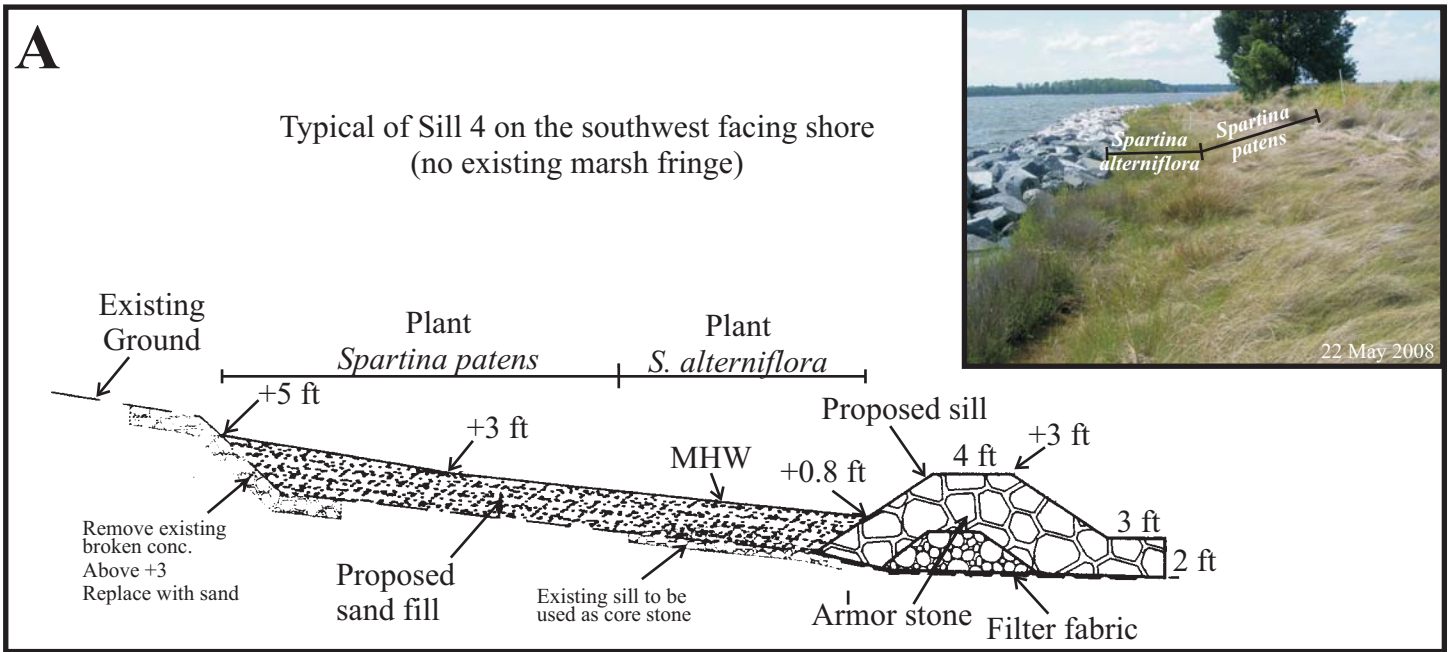
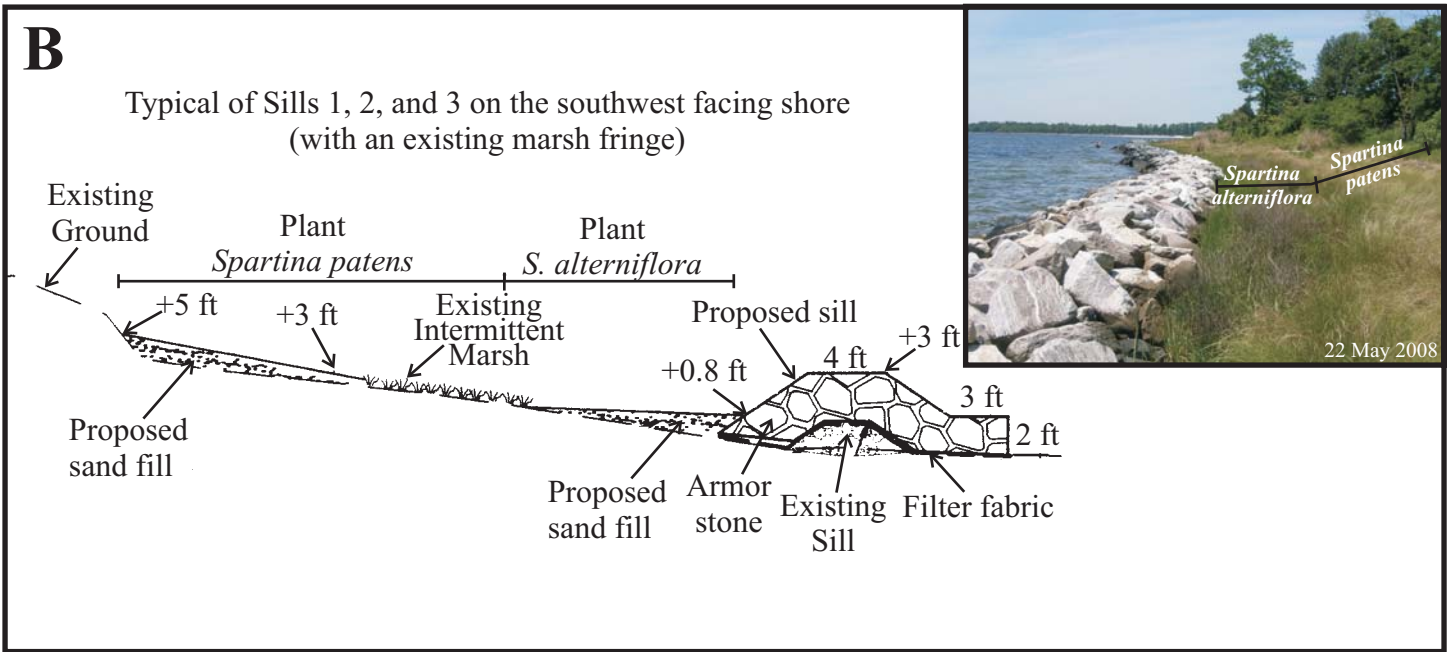
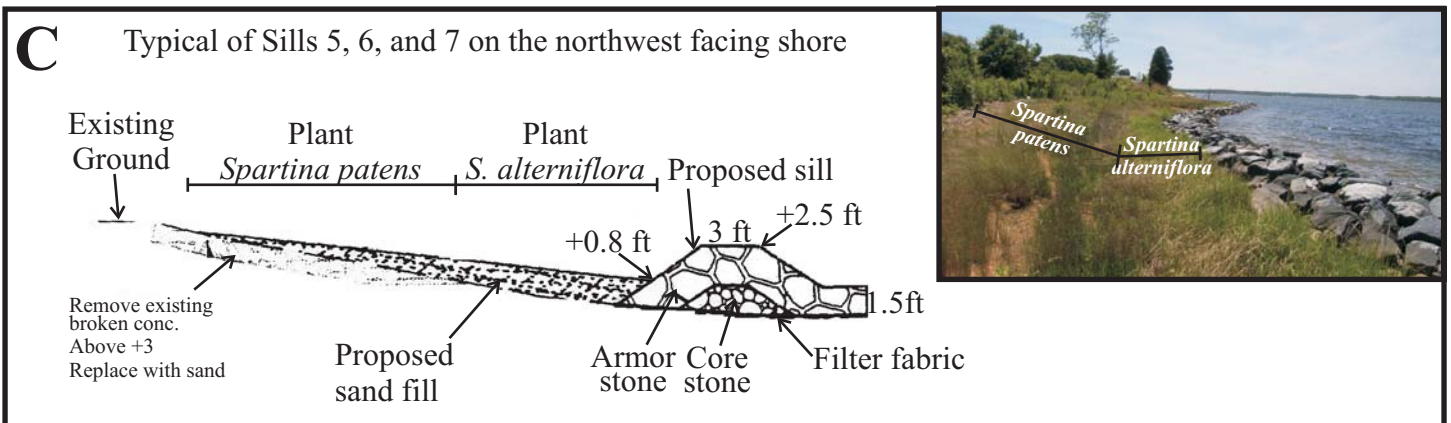
Figure 19. Cross sections of several of the shoreline protection projects at the Webseter Field Annex. A) shows typical conditions at Sill 4. B) shows typical conditions at Sills 1, 2, and 3. C. shows typical conditions at Sills 5, 6, and 7. See Figure 17 for locations of the sills.

The typical cross-sections of the designed structures (Figure 19) show that existing structures, including broken concrete and a nearshore sill, existed prior to installation of the system and had to be incorporated into the project (Figure 20). In addition, the existing intermittent marsh on the southwest facing shore was not covered but included in the design. The level of protection for this project was +5 feet (1.5 m) MLW.

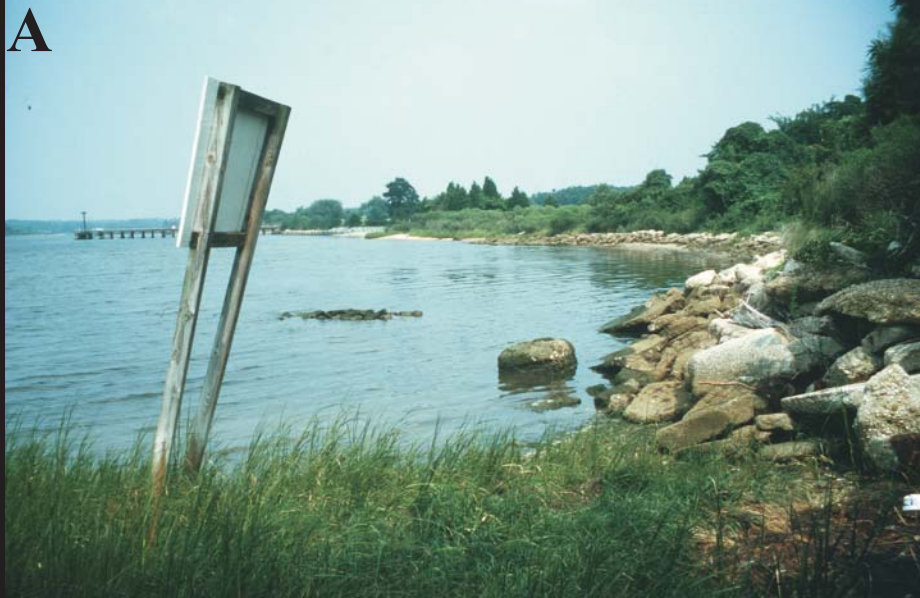
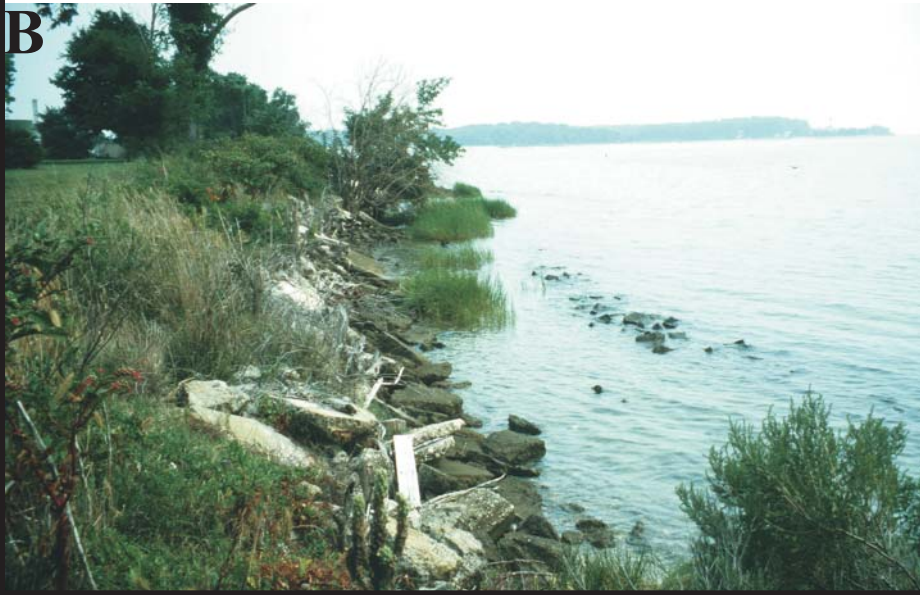
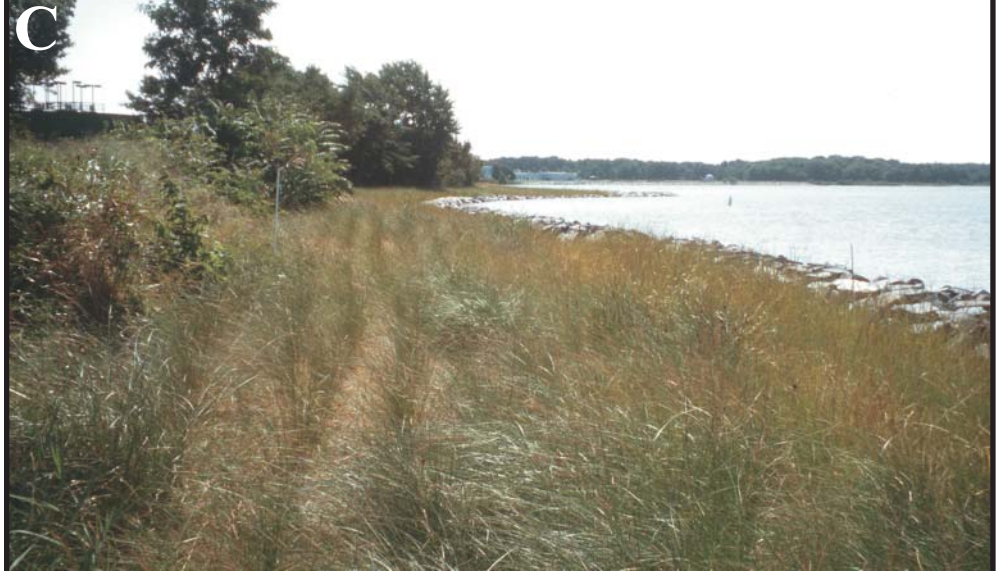
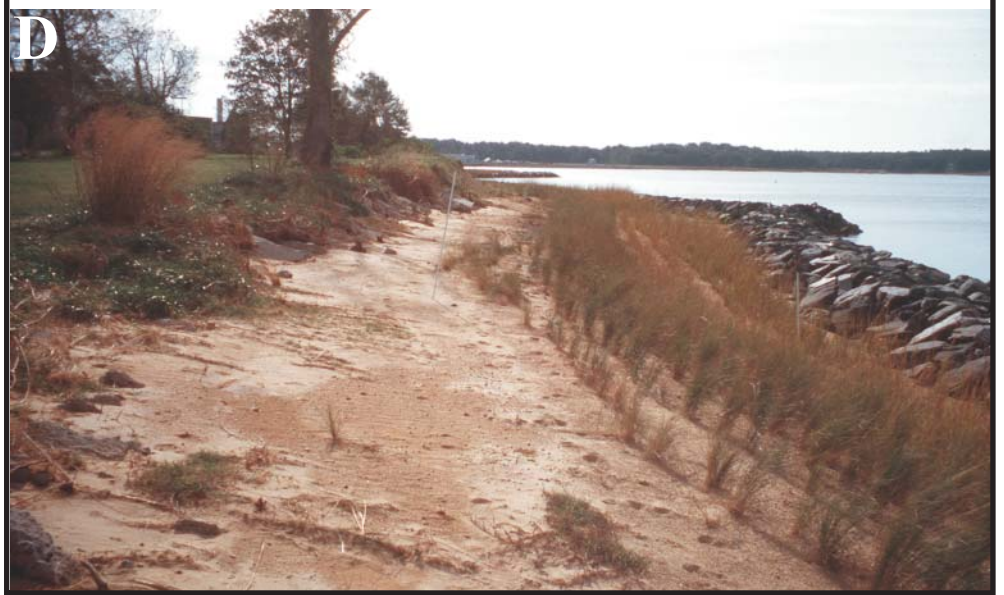
Figure 20. Photographs of the Webster Field Annex site. A and B are before construction. C is after construction, and D is after Hurricane Isabel.

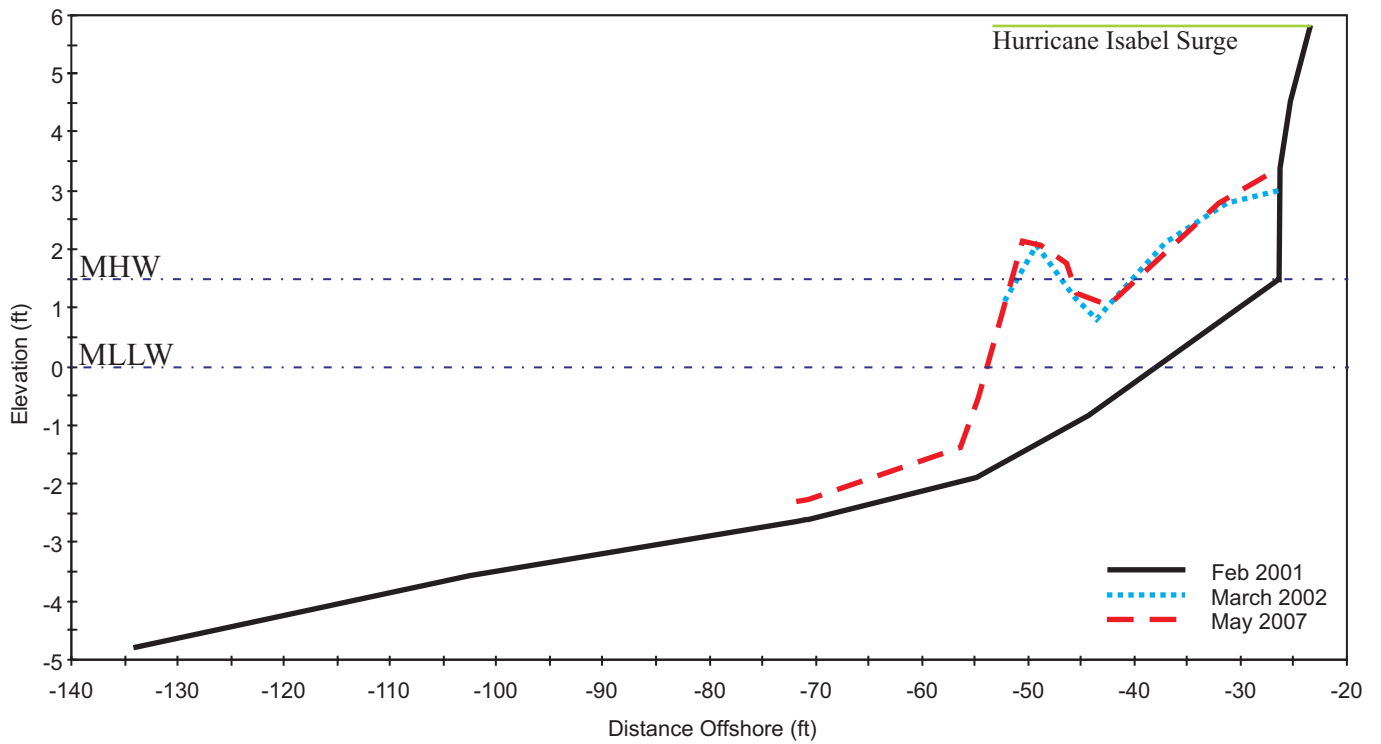
Figure 21. Example cross-sections at St. Mary's from profile data. The surge level is the result of hydrodynamic modeling.

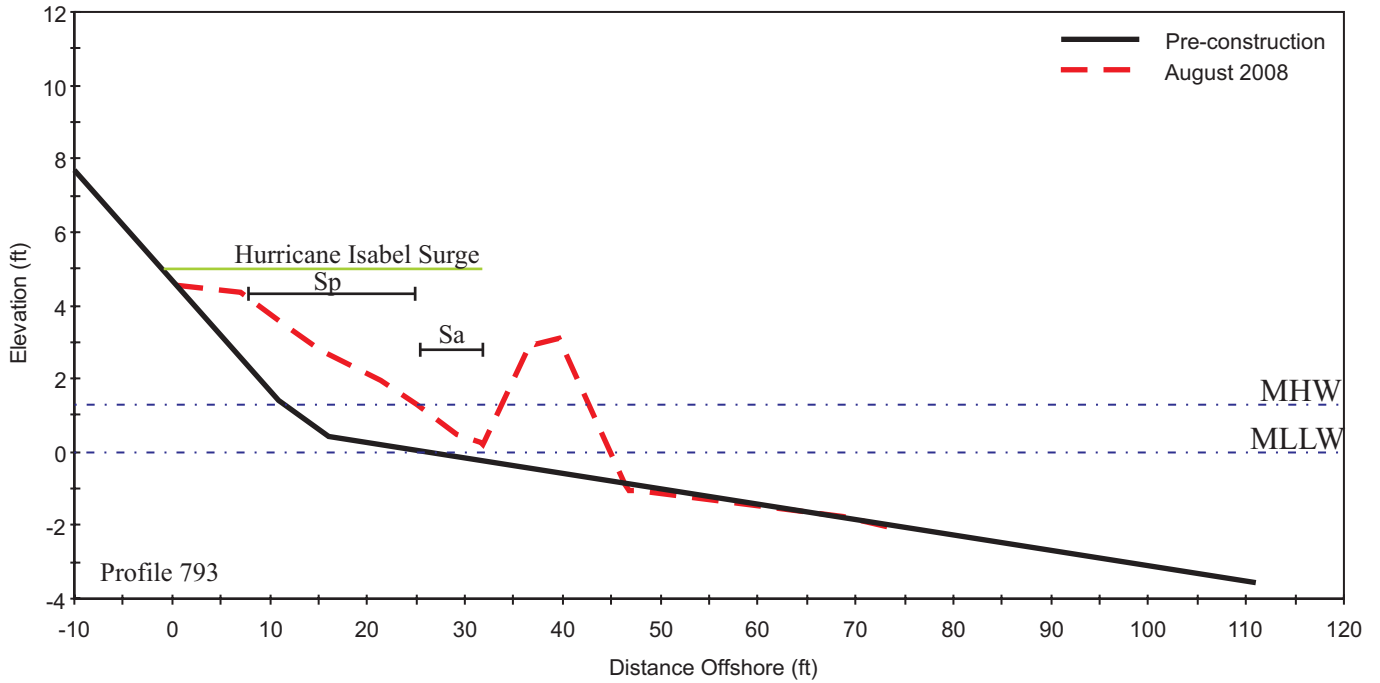
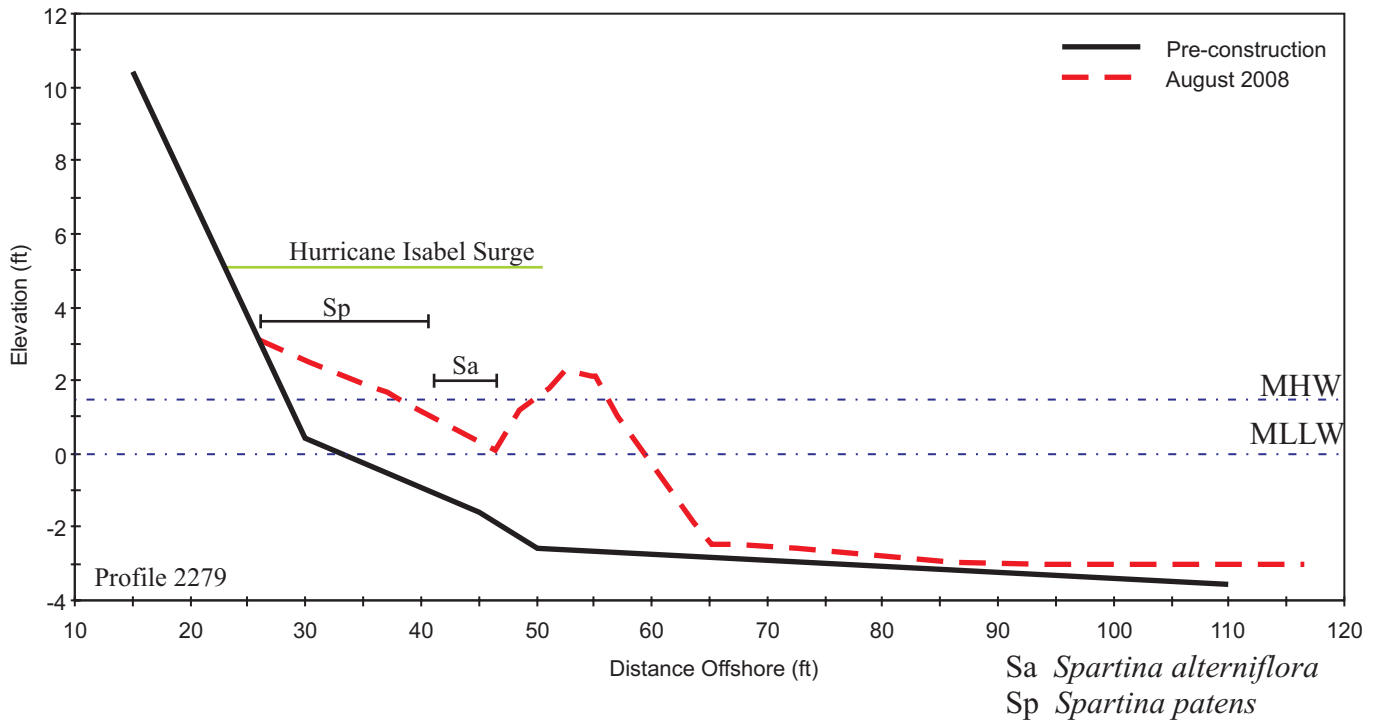
Figure 22. Two example cross-sections at Jefferson Patterson Park & Museum from profile data. The surge level is the result of hydrodynamic modeling. The widths of *Spartina* are averages from profile data and don't necessarily represent these profiles' vegetation.

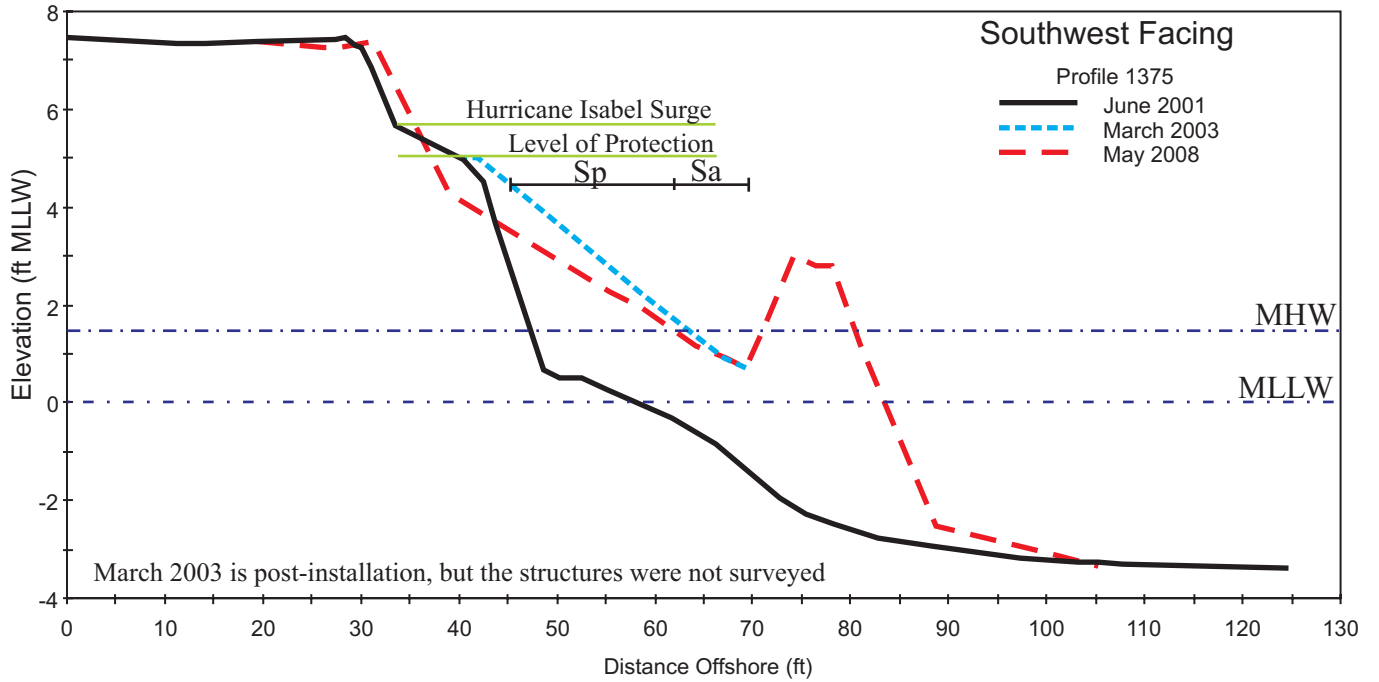
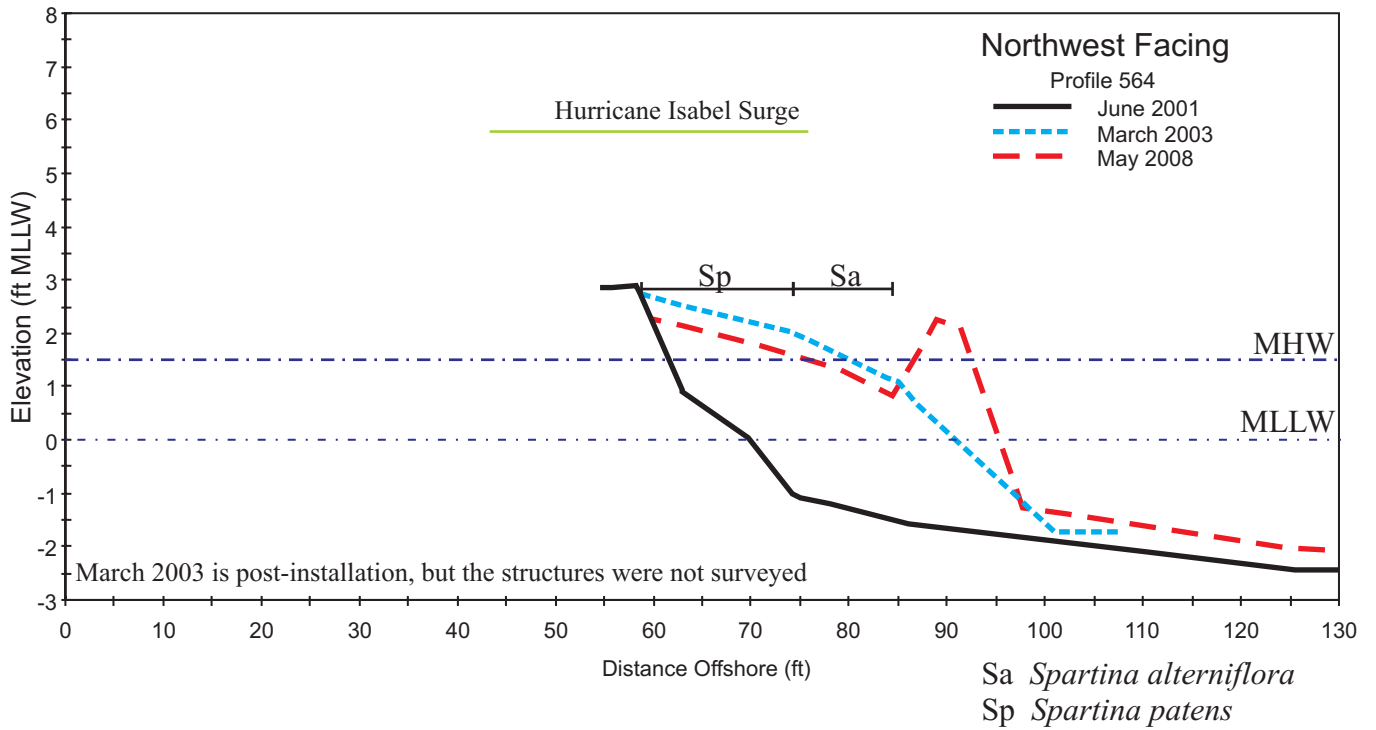
Figure 23. Two example cross-sections at Webster Field from profile data. The surge level is the result of hydrodynamic modeling. The widths of Spartina are averages from profile data and don't necessarily represent these profiles' vegetation.

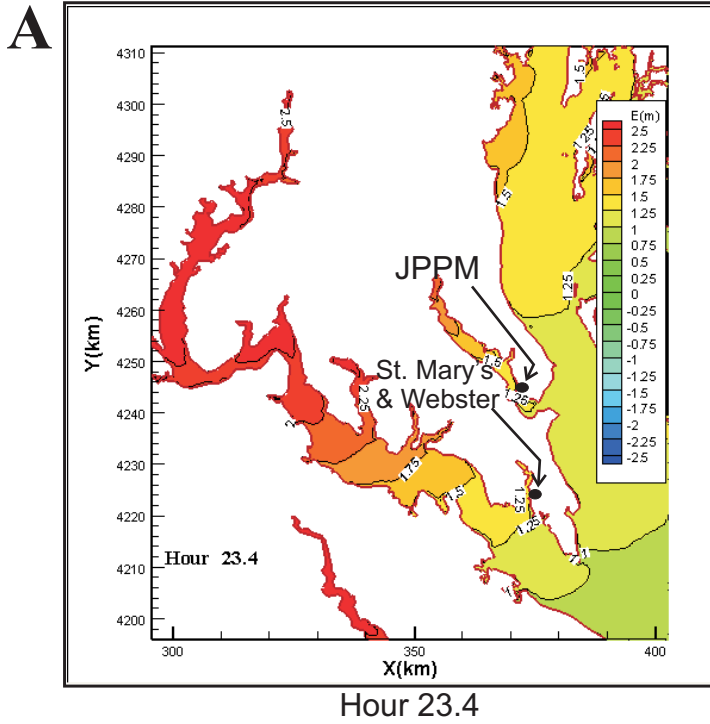
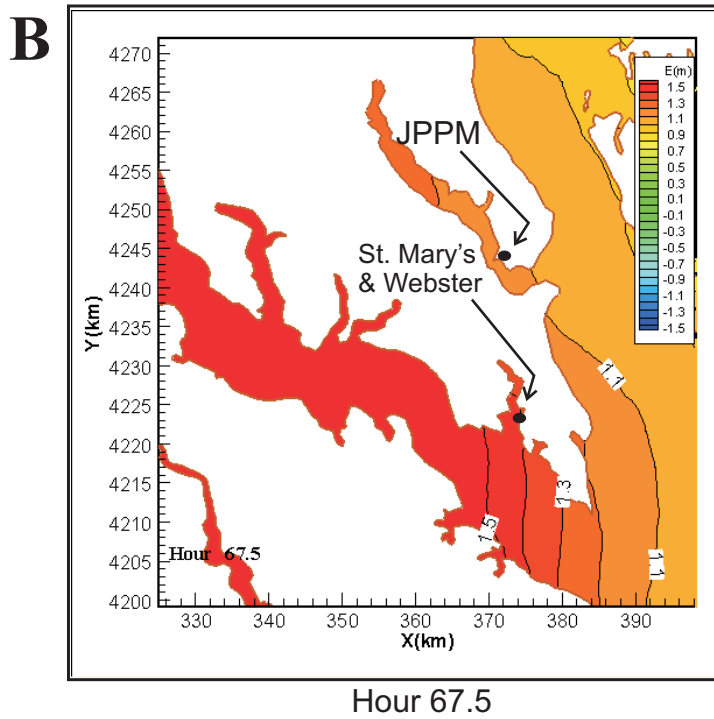
Figure 24. Model results showing the maximum elevation of the storm tide during A) Hurricane Isabel and B) Tropical Storm Ernesto. Site locations are approximate. Elevations are meters above mean tide level. At both locations, mean tide level is 0.2 m (0.7 ft) above mean lower low water.

During Hurricane Isabel and Tropical Storm Ernesto, the dominant winds were from northeast, southeast and south. These directions were modeled to determine storm surge and wave characteristics. The model simulation of storm tide distribution near the mouth of Potomac River and Patuxent River during hurricanes Isabel and Ernesto are shown in [Figure 24](#). The model indicates that the storm surges at study sites are similar during both storms. At JPPM on the Patuxent River, the maximum observed water level was 5.7 feet (1.7 m) MLLW during Isabel and 4.7 feet (1.4 m) MLLW during Ernesto. The maximum water level elevation reported at Solomon's tide gauge, also on the Patuxent, was about 4.5 feet (1.4 m) MLLW during both Isabel and Ernesto ([Figure 10](#)). In the St. Mary's River where St. Mary's City and Webster Field Annex are located, the model predicts a maximum surge of 5.7 feet (1.7 m) MLLW and 5.3 feet (1.6 m) MLLW during Isabel and Ernesto, respectively. The Lewisetta tide gauge recorded maximum water elevation during Isabel (5.5 feet (1.7 m) MLLW) and Ernesto (5.8 feet (1.5 m) MLLW).

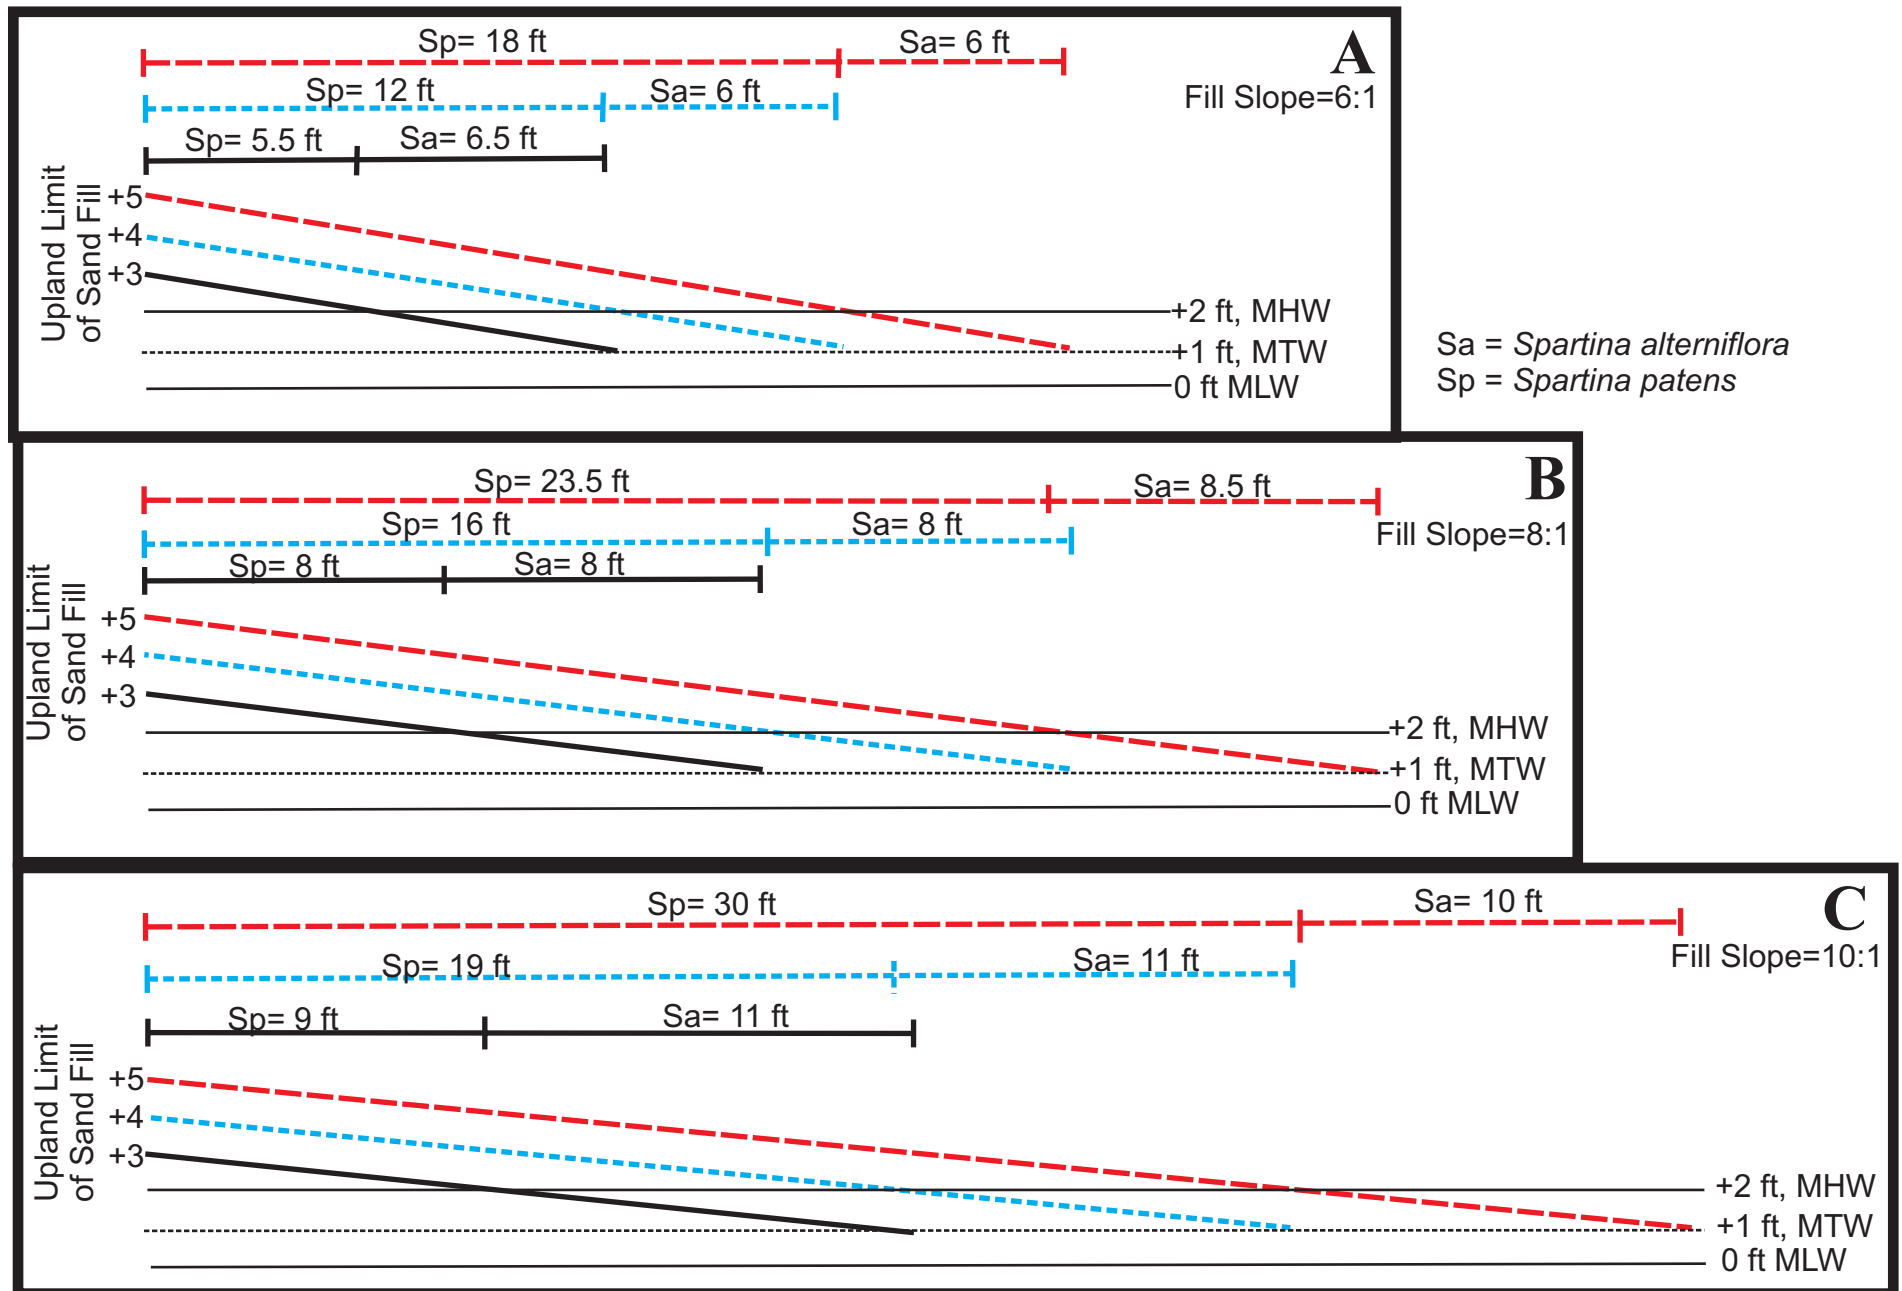
Figure 25. The sand fill model for A) a slope of 6:1, B) a slope of 8:1, and C) a slope of 10:1. The approximate width of the vegetated area (Sa is *S. alterniflora*, Sp is *S. patens*) on each slope is indicated. Sand fill model for various slopes. The total width of Sp and Sa is the total encroachment if no structure is included. Stone sill structure design is site specific.

In less energetic conditions, a narrower system on a 6:1 slope can be used. If the lower level of protection (+3 feet (0.9 m)) is used, the total encroachment would be 12 feet (3.7 m) from the bank to MTL. Encroachment increases with greater fill elevation and shallower slope. The upper limit of protection at +5 feet (1.5 m) would yield a 24 feet (8.3 m) encroachment. As wave energy increases, so too should the fill slope. At the minimum level of protection (+3 feet (0.9 m)) at a fill slope of 8:1, the encroachment would be 16 feet (4.9 m) whereas at the upper level of protection, it would be 32 feet (10 m). At 10:1, the encroachment ranges between 20 and 40 feet (6 and 12 m). Generally, the flatter the fill slope and the higher the level of protection, the more encroachment will occur. While more riverward encroachment, in theory, provides a greater level of storm protection, the amount of *S. alterniflora* does not increase greatly. This means that most of the marsh created would be high marsh. If a structure also is included in the design, the fill slope at MTL should hit the back of the sill. Depending on the width of the sill, encroachment increases by that amount.
