Encroachment of Sills onto State-Owned Bottom: Design Guidelines for Chesapeake Bay

C. Scott Hardaway Jr.
Virginia Institute of Marine Science

March 2009

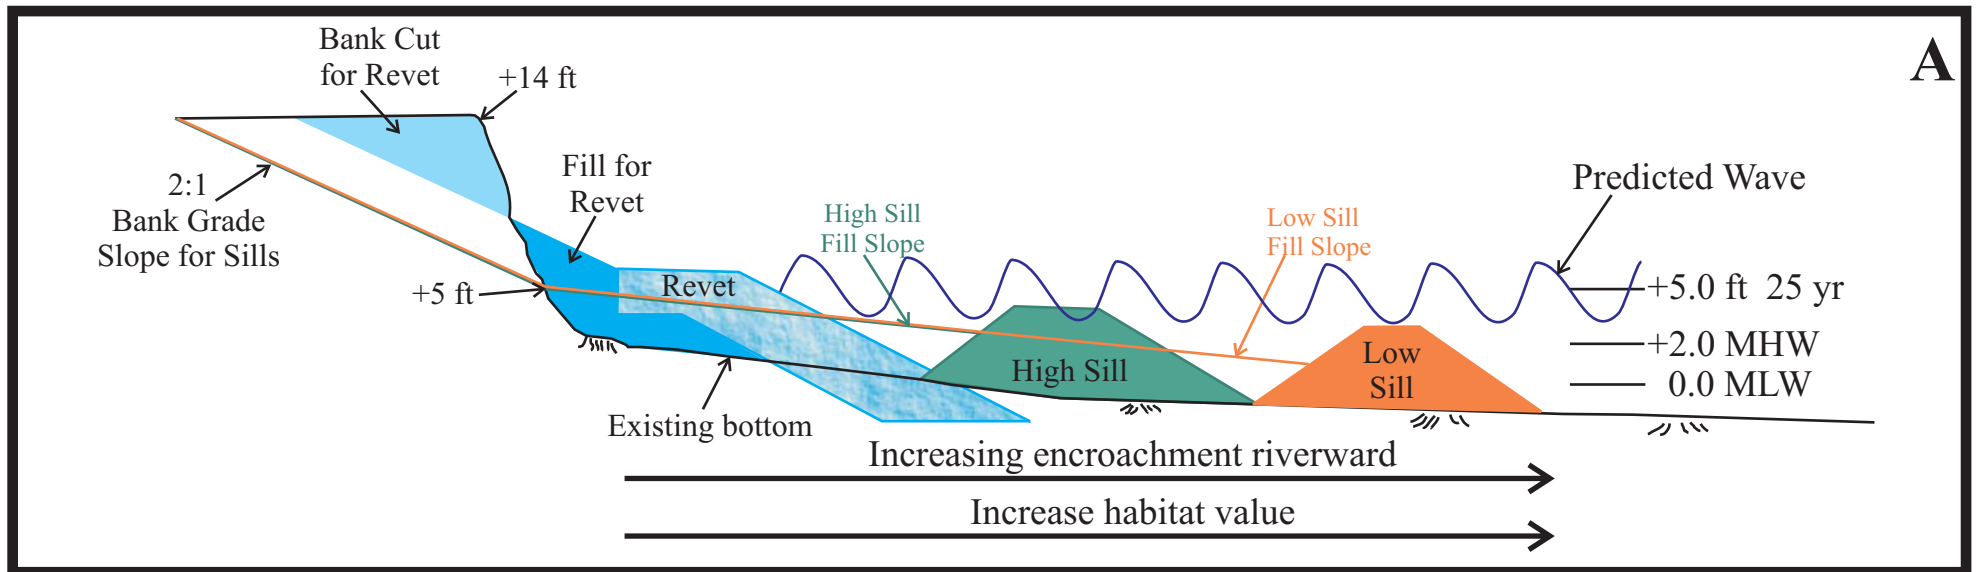
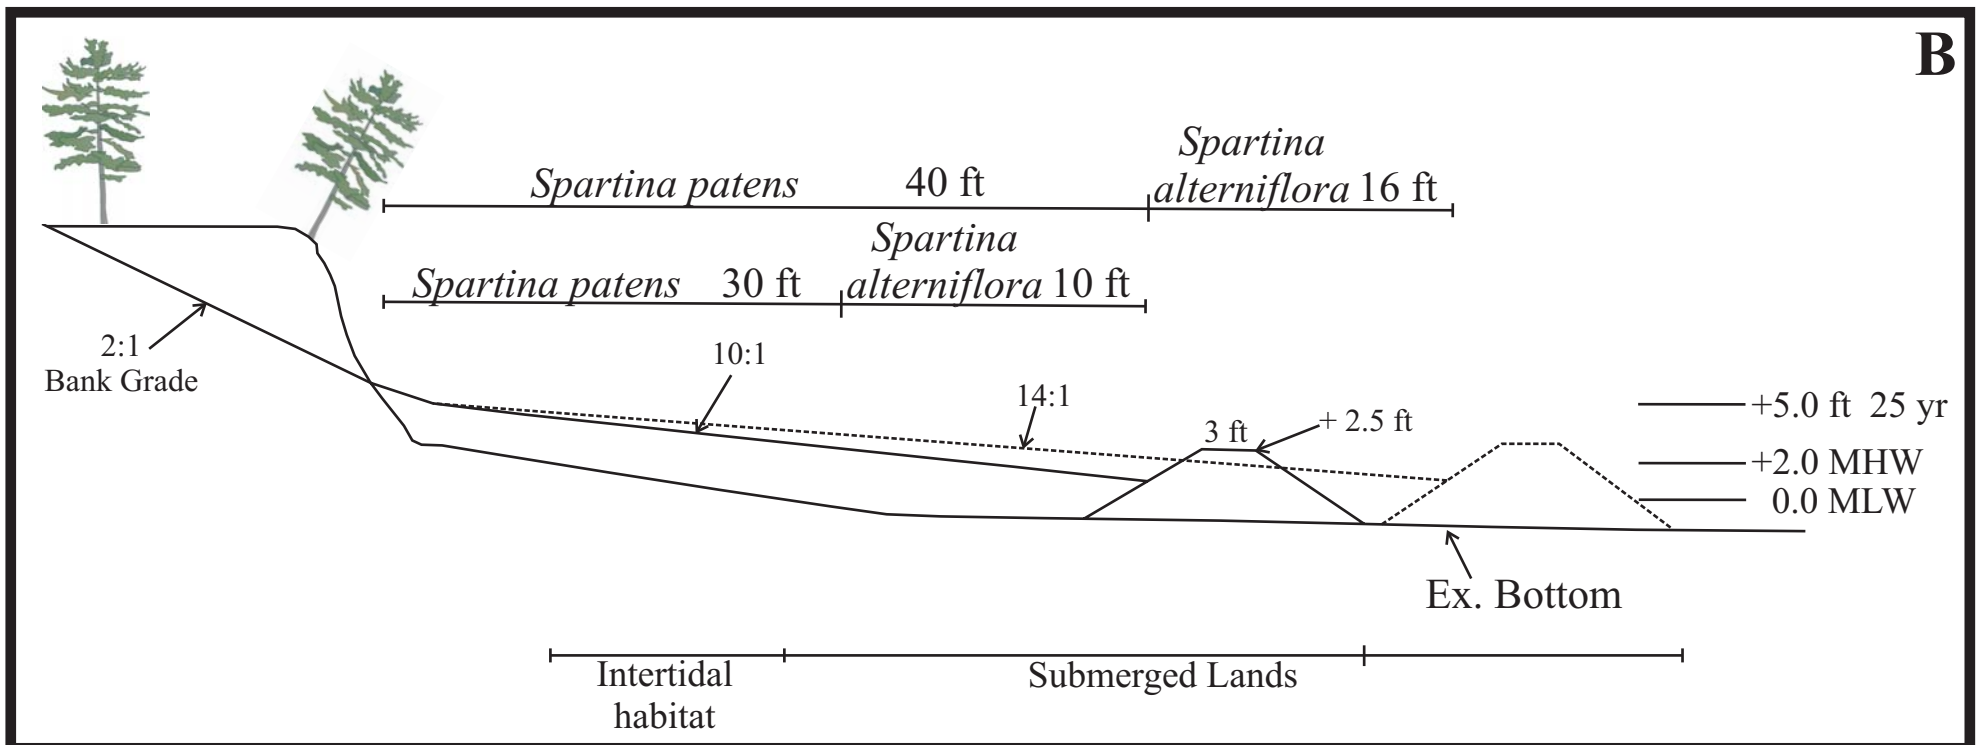
Figure 26. A) Shore protection options with encroachment, level of protection, and habitat value. B) Two sill options showing the amount of encroachment and the amount of habitat gained.

Existing conditions, fetch, and elevation of protection desired are considerations in determining the method of shore protection appropriate at a location. [Figure 26A](#) depicts the encroachment and habitat types of three different methods. The most common shore-protection structure used in Chesapeake Bay today is the stone revetment which usually requires balanced bank cut and fill for construction. Therefore, the bayward encroachment may be dependent on bank height. A low bank may only require the stone to come up to or near the top of the bank whereas higher banks will require more landward grading and filling of the backshore. In [Figure 26A](#), shore protection is afforded by the stone revetment with minimal encroachment bayward but with minimal habitat created.
