Performance of Sills: St. Mary's City, St. Mary's River, Maryland

December 2007

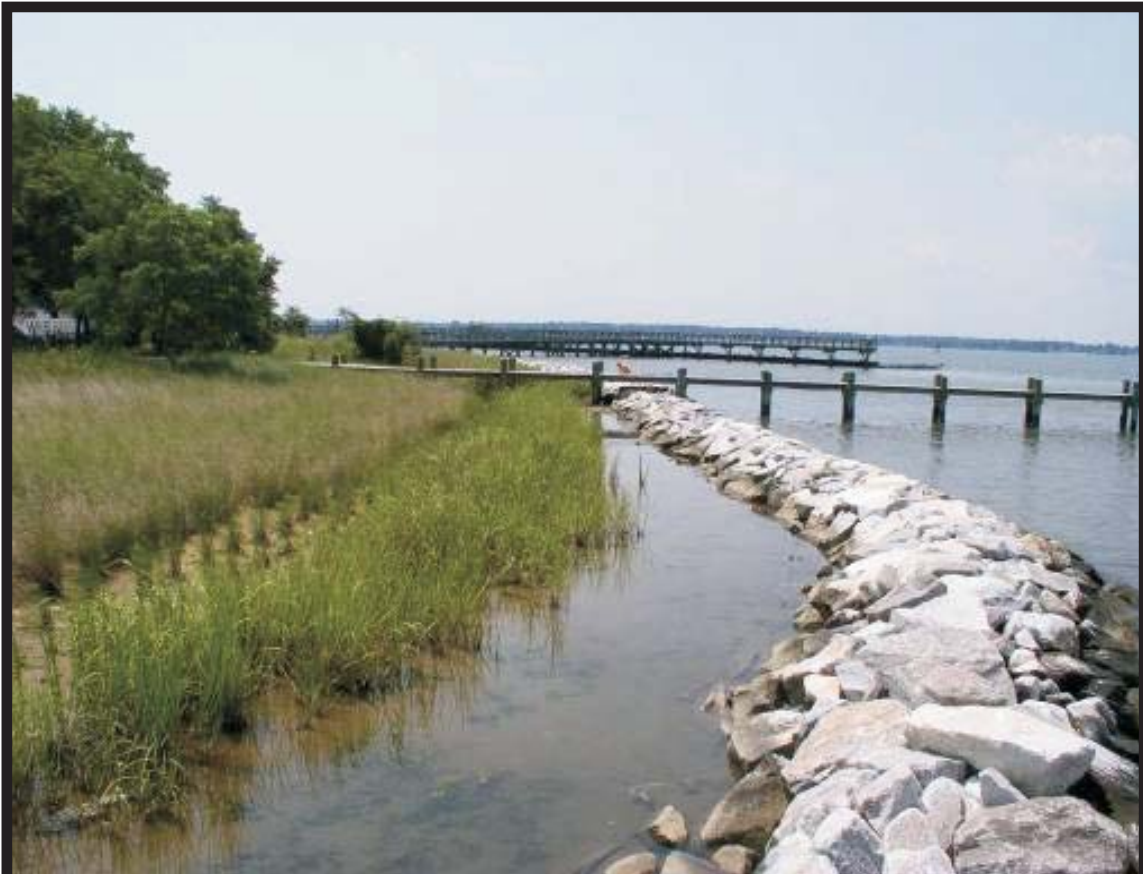
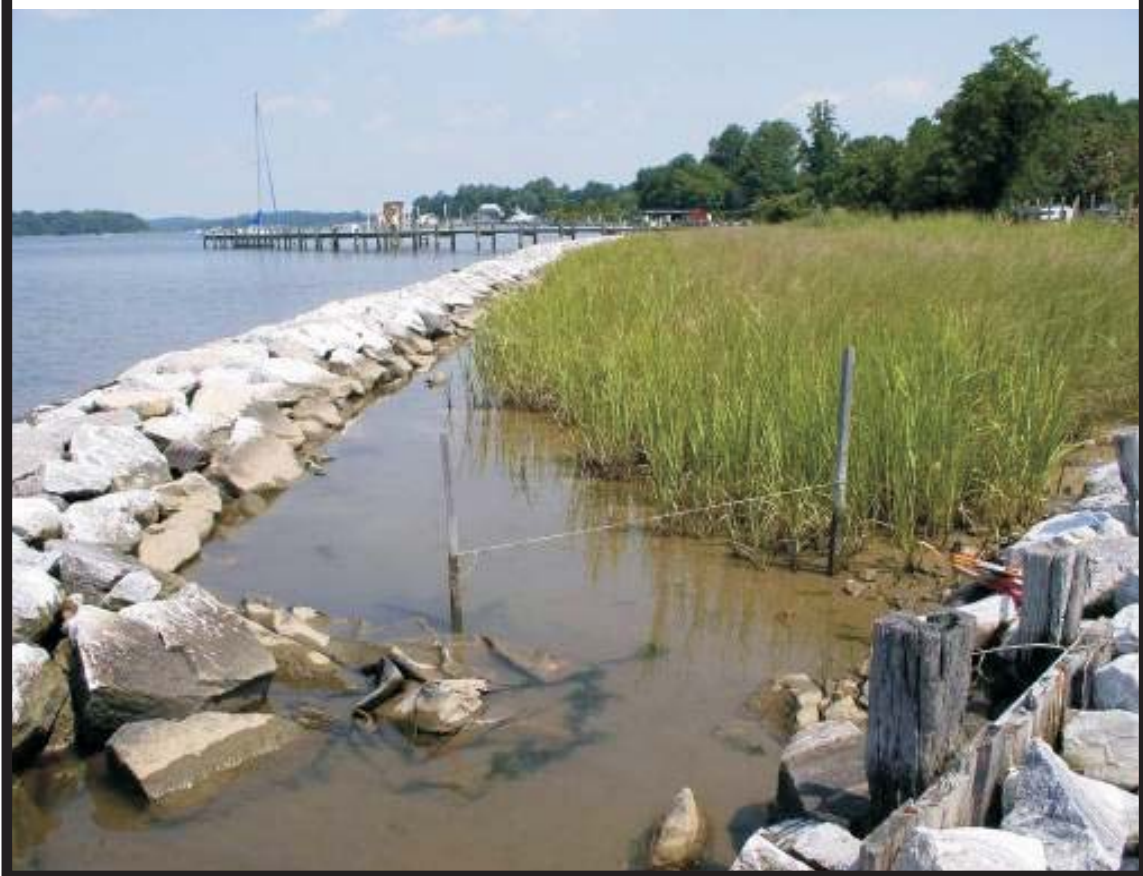
Figure 1-3. The Poster Child for Successful Marsh Projects. Photos taken at a community marsh in Anne Arundel County. This site received the highest overall marsh ranking and embodies many of the factors deemed essential to a successful project (from Bosch *et al.*, 2006).

In order to evaluate the effectiveness of these installations, a recent study by Bosch *et al.* (2006) surveyed and assessed 80 man-made wetlands in the State of Maryland. Of these, 43 sites had sills and 15 of these had gaps or vents of some type. The sites were ranked according to four elements including 1) vegetation 2) wildlife 3) erosion and 4) was the overall marsh ranking. Elements of a successful marsh with sill are embodied in Figure 1-3; this site had most of the eight factors deemed essential to a successful project according to Bosch *et al.* (2006):

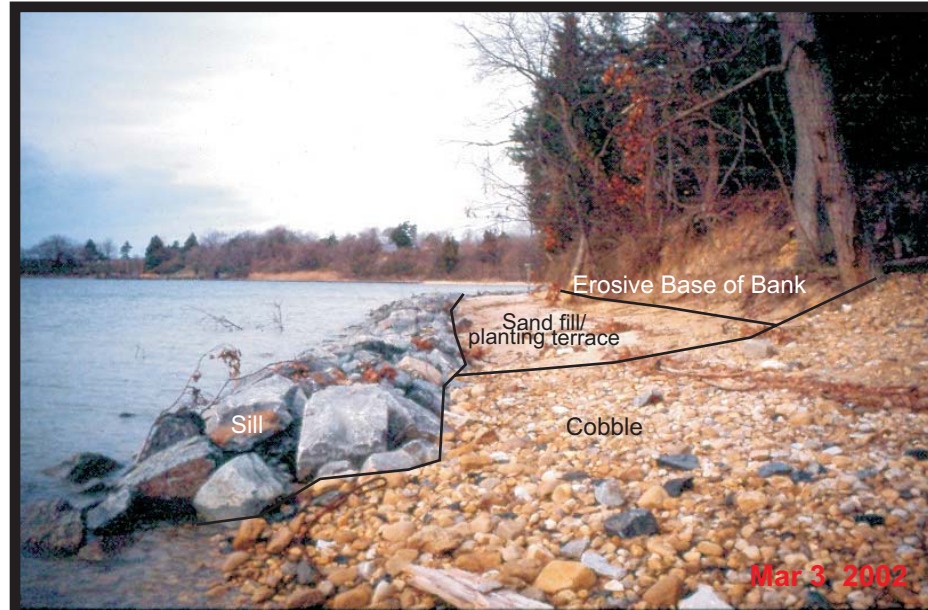
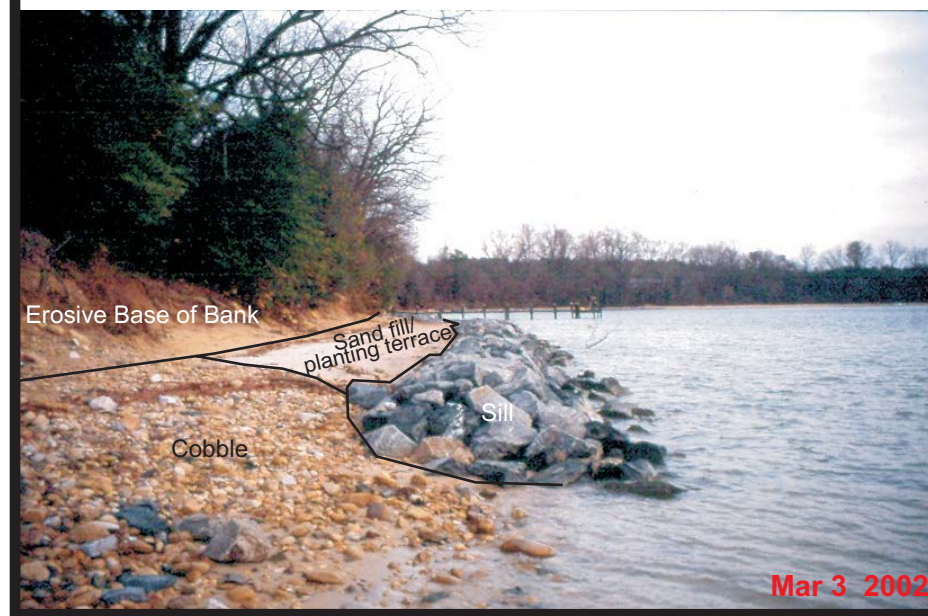
Figure 1-6 . Photos of Window 8 showing the elements of the sill project. These photos were taken before the marsh grass was planted.

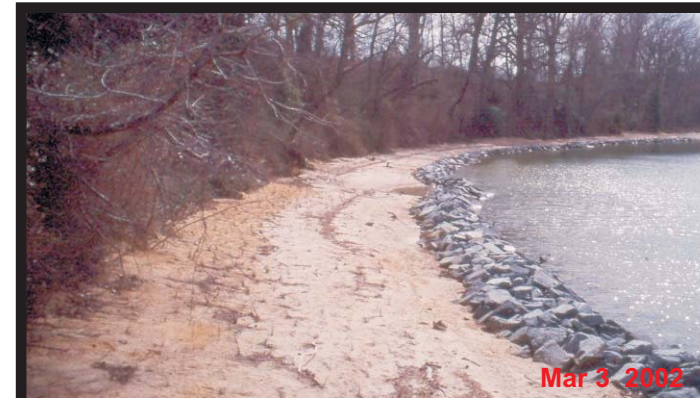
Looking south from the pier at Window 3. Post Installation.

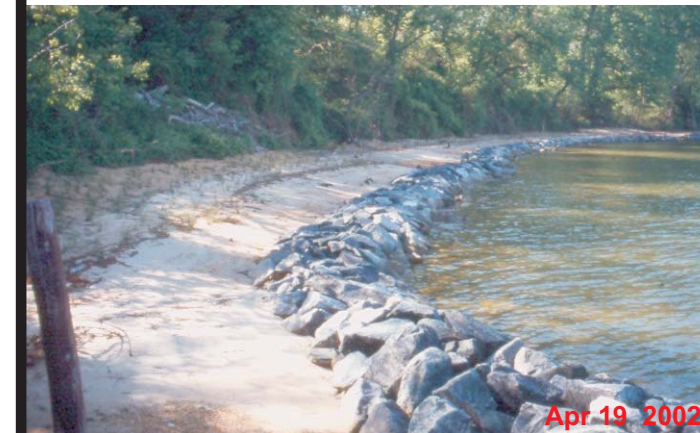
Looking south from the pier at Window 3. *Spartina patens* have been planted along the sand fill/terrace.

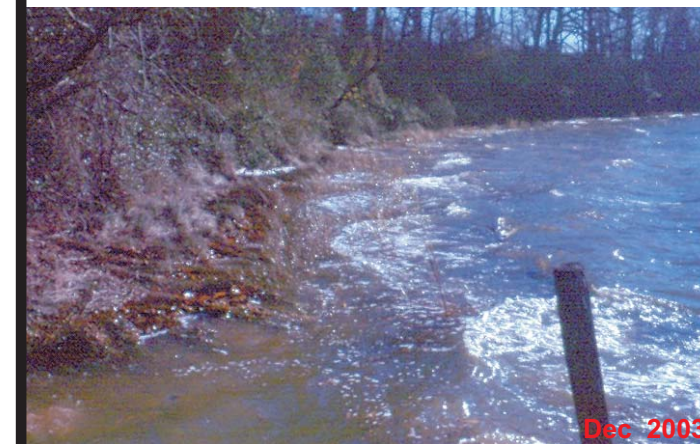
Looking south from the pier at Window 3. During a high water event with northwest winds. The water covers the sill, and the waves are attenuated by the grasses.

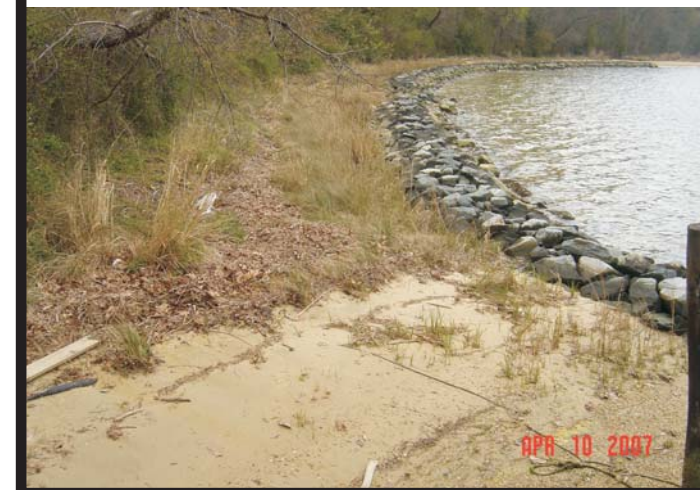
Looking south from the pier at Window 3. Five years after installation.

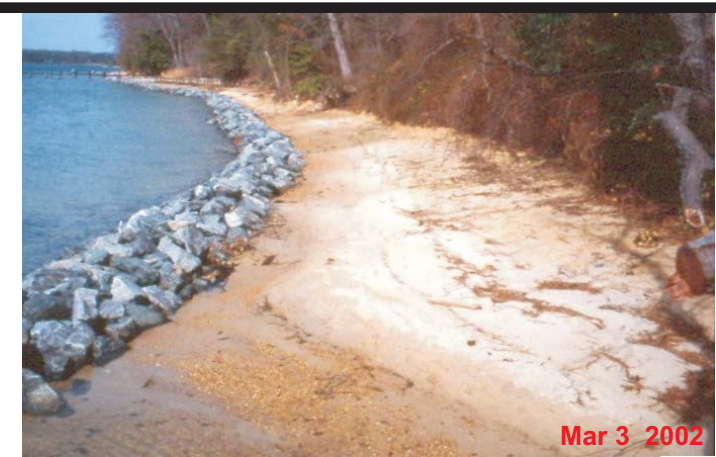
Looking north from the pier at Window 3. Post Installation.

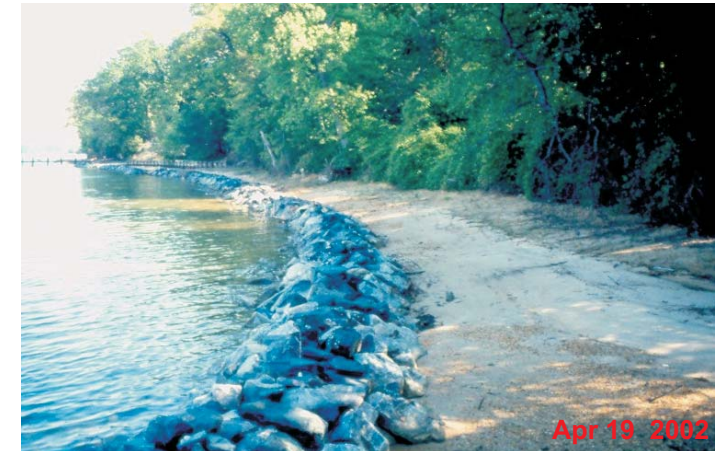
Looking north from the pier at Window 3. *Spartina patens* have been planted along the sand fill/terrace.

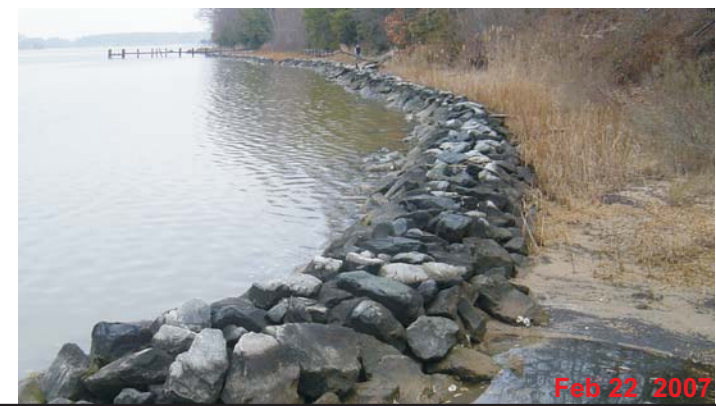
Looking north from the pier at Window 3. Five years after installation.

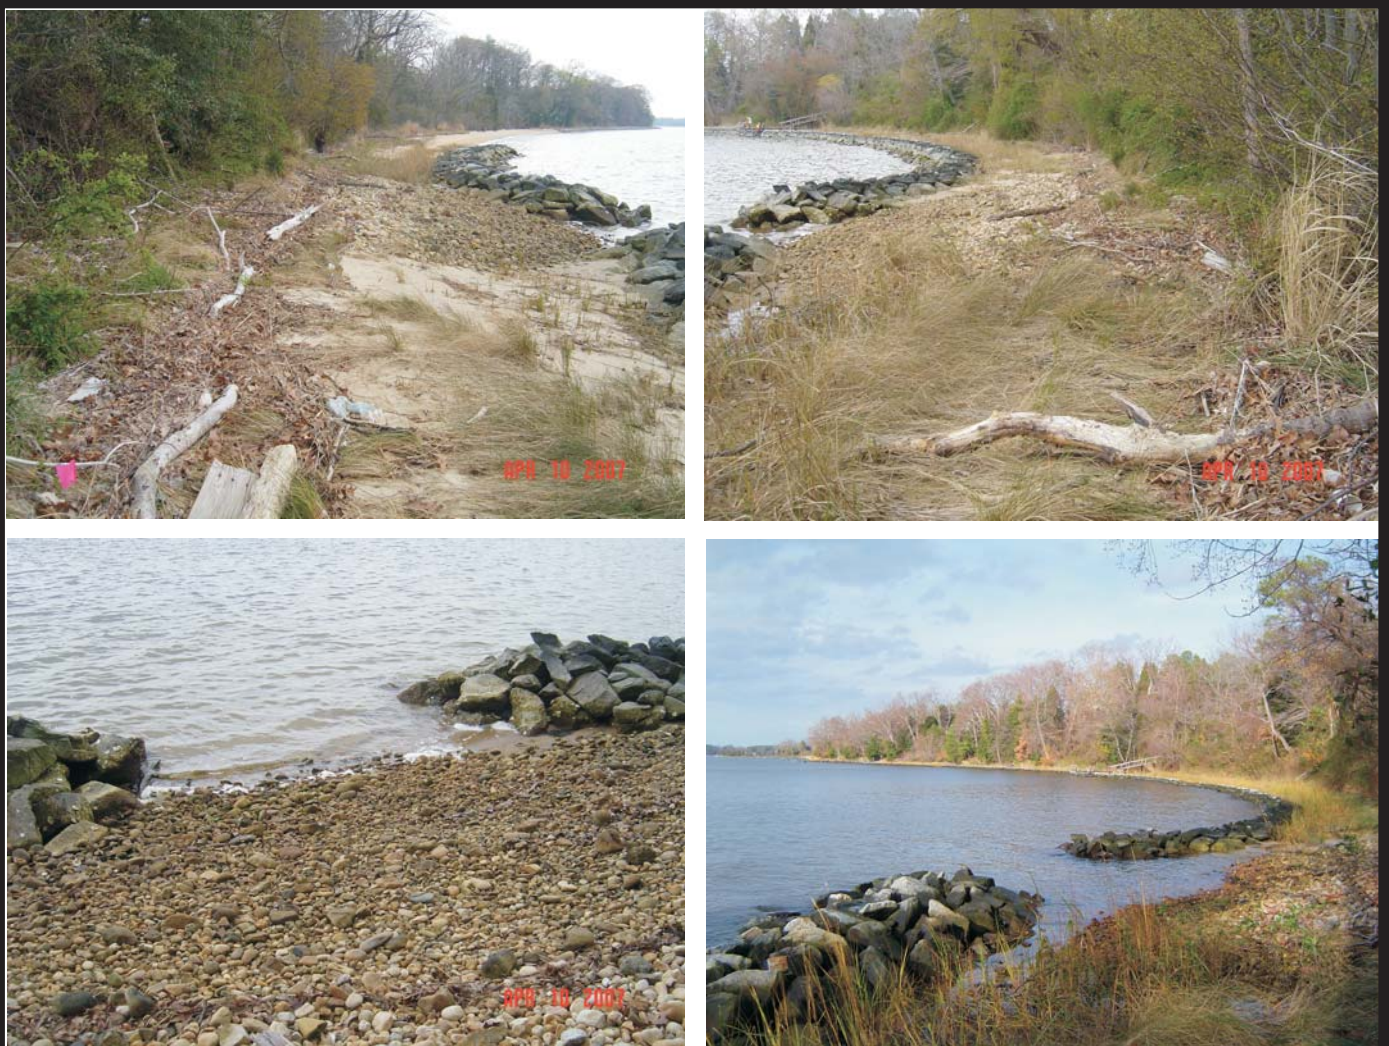
Figure 2-3. Photos showing Window 1 in 2007. Window 1 is a Type IIB window or vent along Site 1 that has a cobble and gravel backshore as shown in the planform and cross-sectional design.

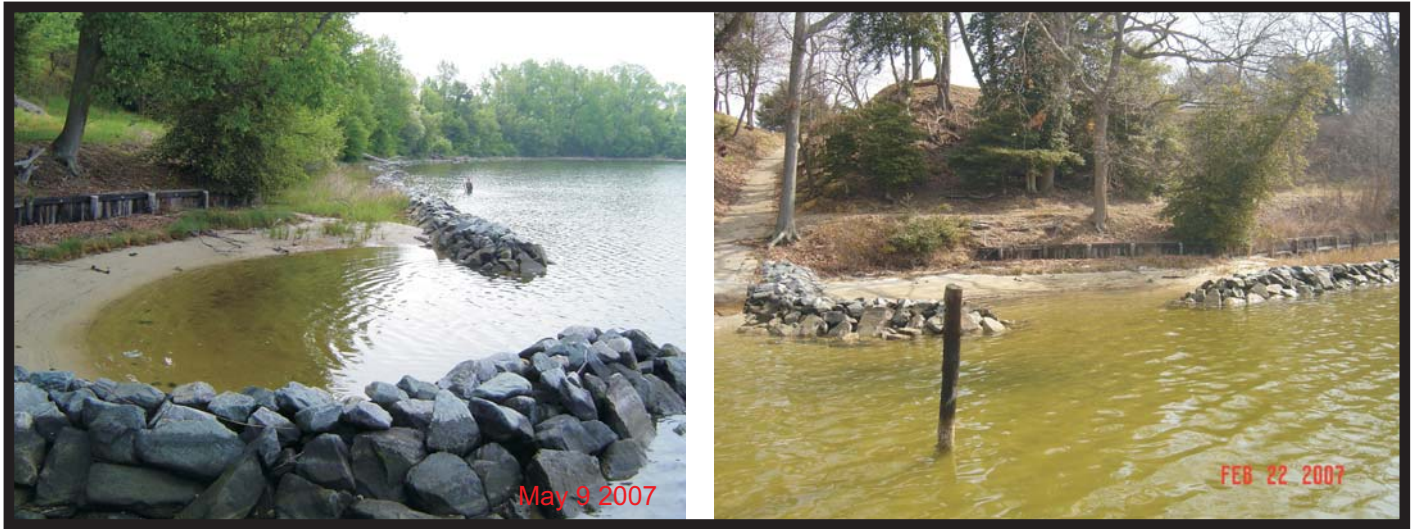
Window 5: This window was created so that an adjacent boat ramp would continue to have access to the river. A berm on the downriver side of the embayment has mostly *Spartina alterniflora* across it. A beach exists around the perimeter with no grasses in the intertidal zone, but *S. patens* occupies the backshore in front of the existing bulkhead. A slight base of bank scarp is visible on the other half of the bay but no bank failure.

Figure 2-7. Photos showing Window 5 in 2007. Window 5 was created to have access an existing boat ramp. No design planform exists for this window.

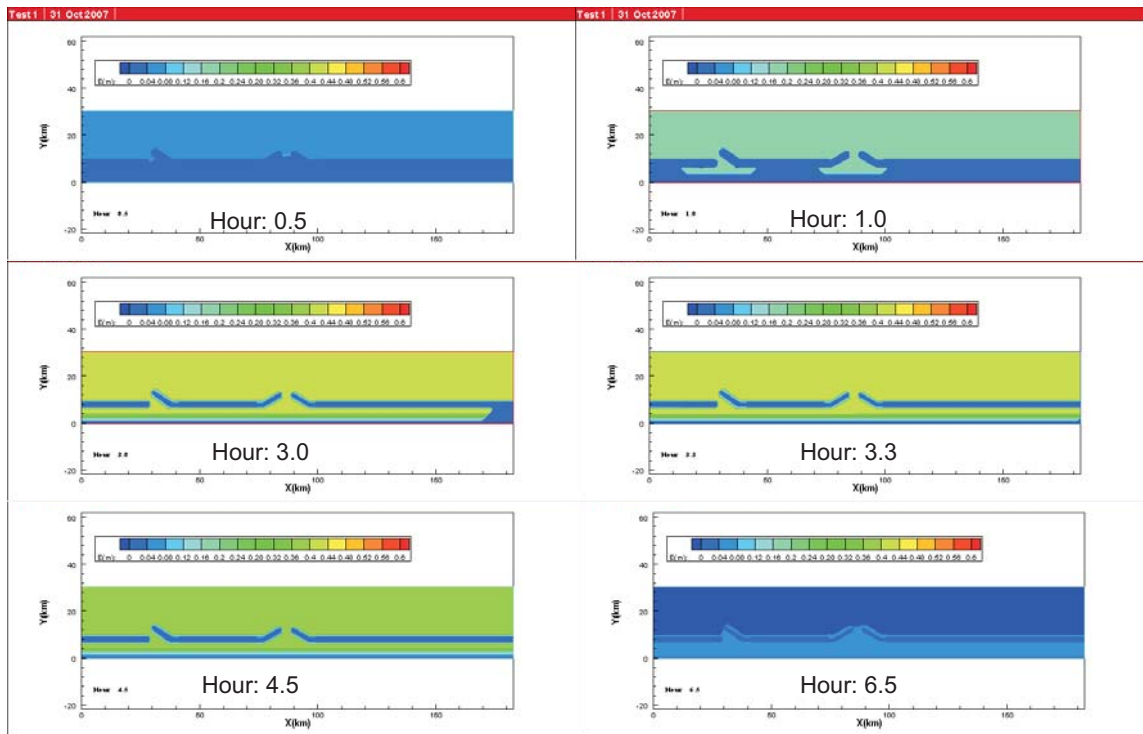
Figure 3-6. Sequence of submerging processes (2 windows).

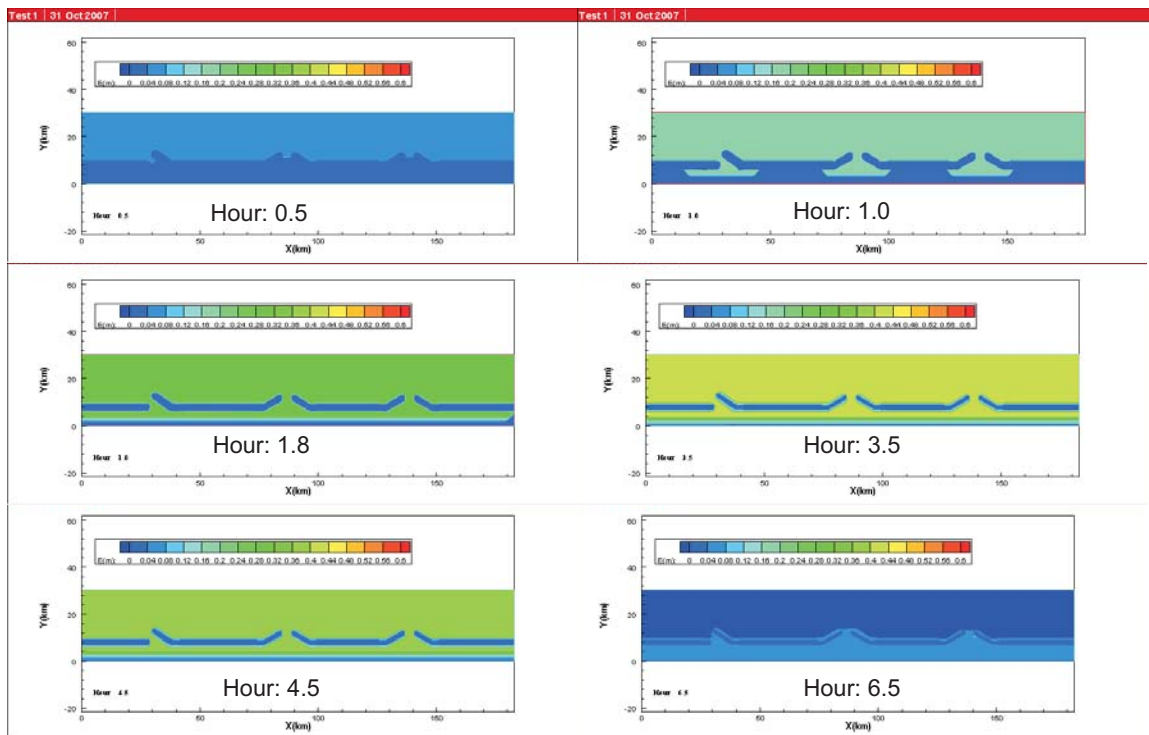
Figure 3-7. Sequence of submerging processes (3 windows).

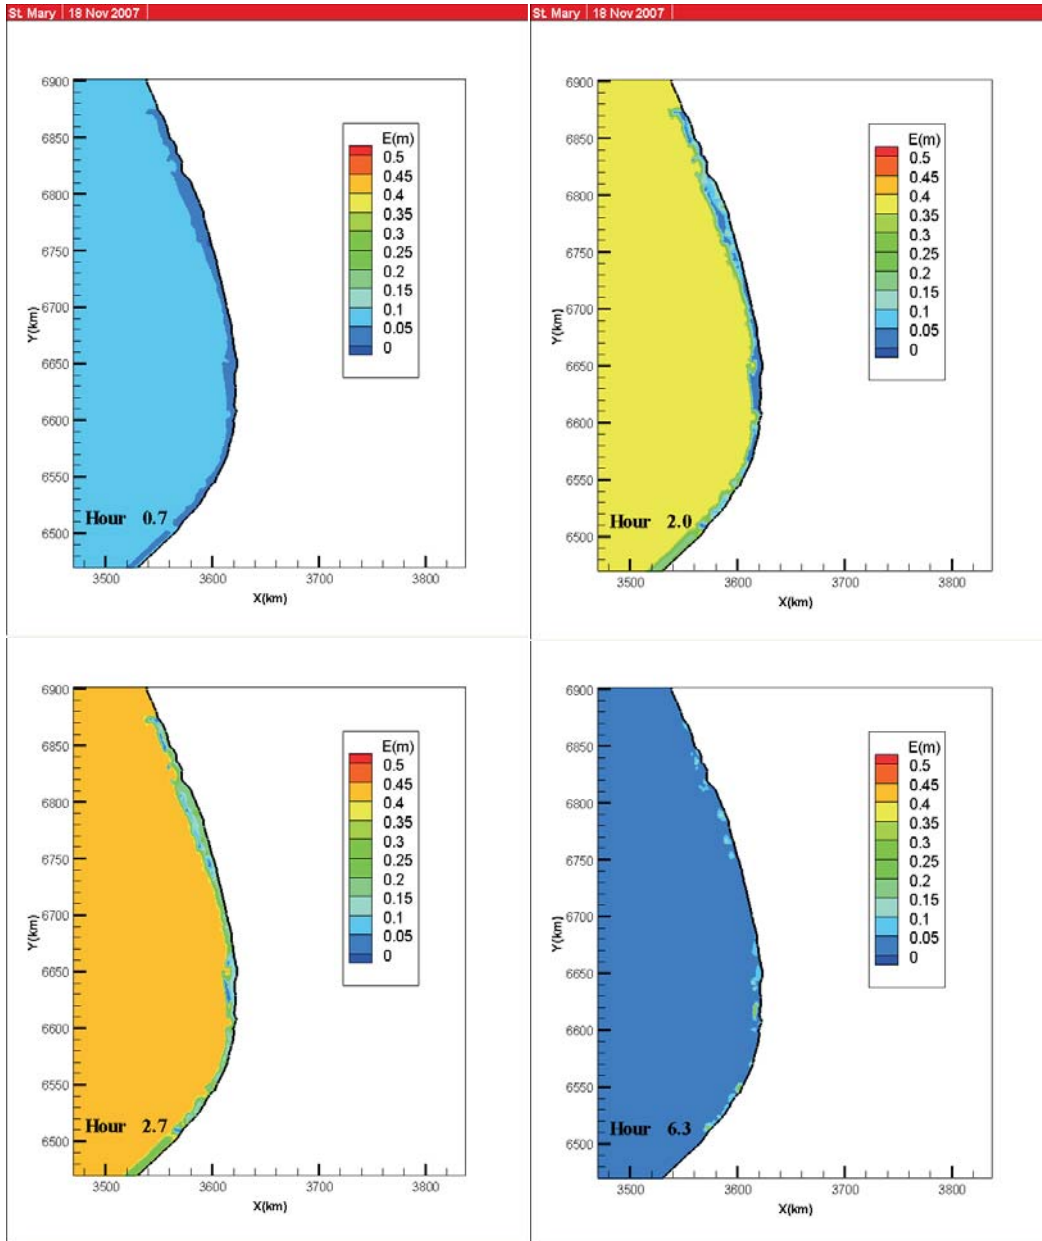
Figure 3-10. Sequence of submerging processes of St. Mary's River.

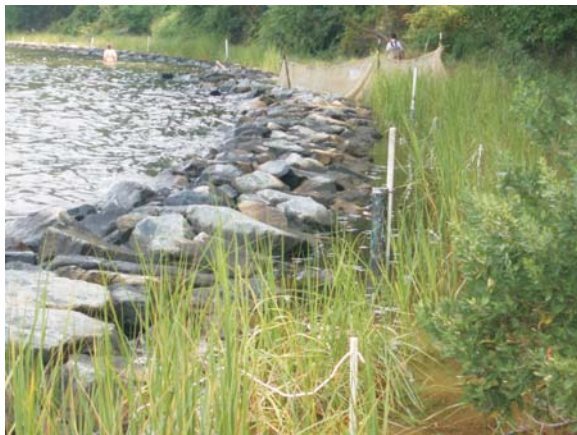
Figure 4-3. Basic sill structure with fish traps and water quality sonde in the foreground and blocking net in the background.

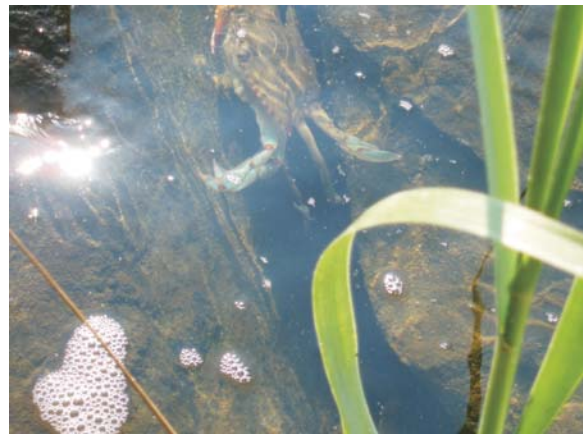
Figure 4-4. Example of pore space between individual rocks. Note scale by presence of adult blue crab.

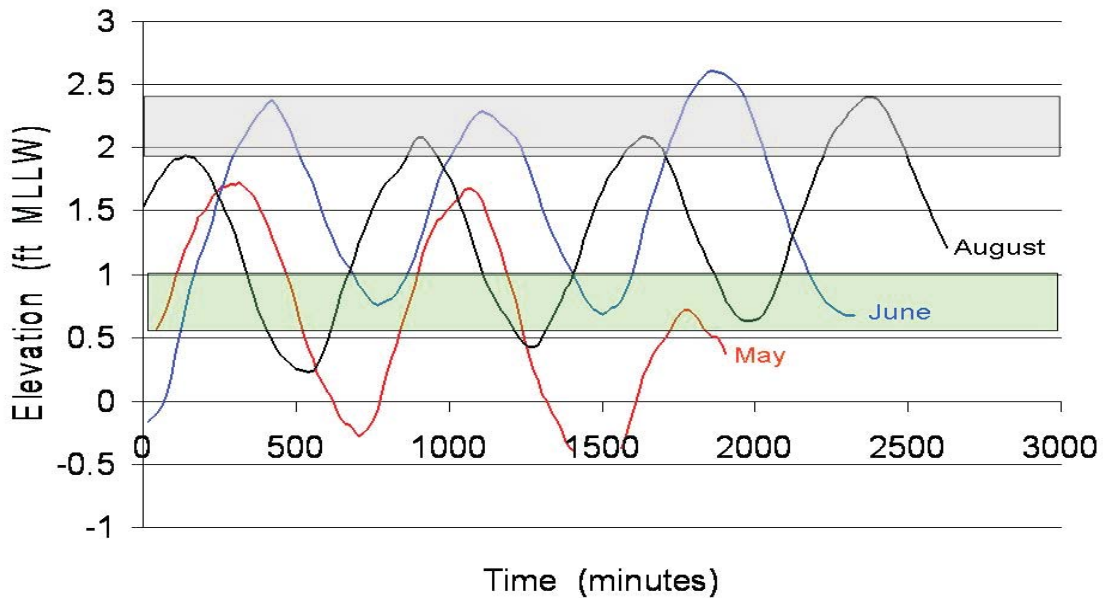
Figure 4-6. Tidal elevations referenced to MLLW for May, June, and August 2007 sampling. Shaded green region represents surface elevation range where the low marsh begins to inundate with flooding waters and the shaded gray region represents elevation range where the sill structure begins to be overtopped with flooding waters.
