COLONIAL NATIONAL HISTORICAL PARK

**Shoreline Management Plan: Phase II
York River Shoreline and Swanns Point, James River Shoreline**

Final Report

Shoreline Studies Program
Department of Physical Sciences
Virginia Institute of Marine Science
College of William & Mary

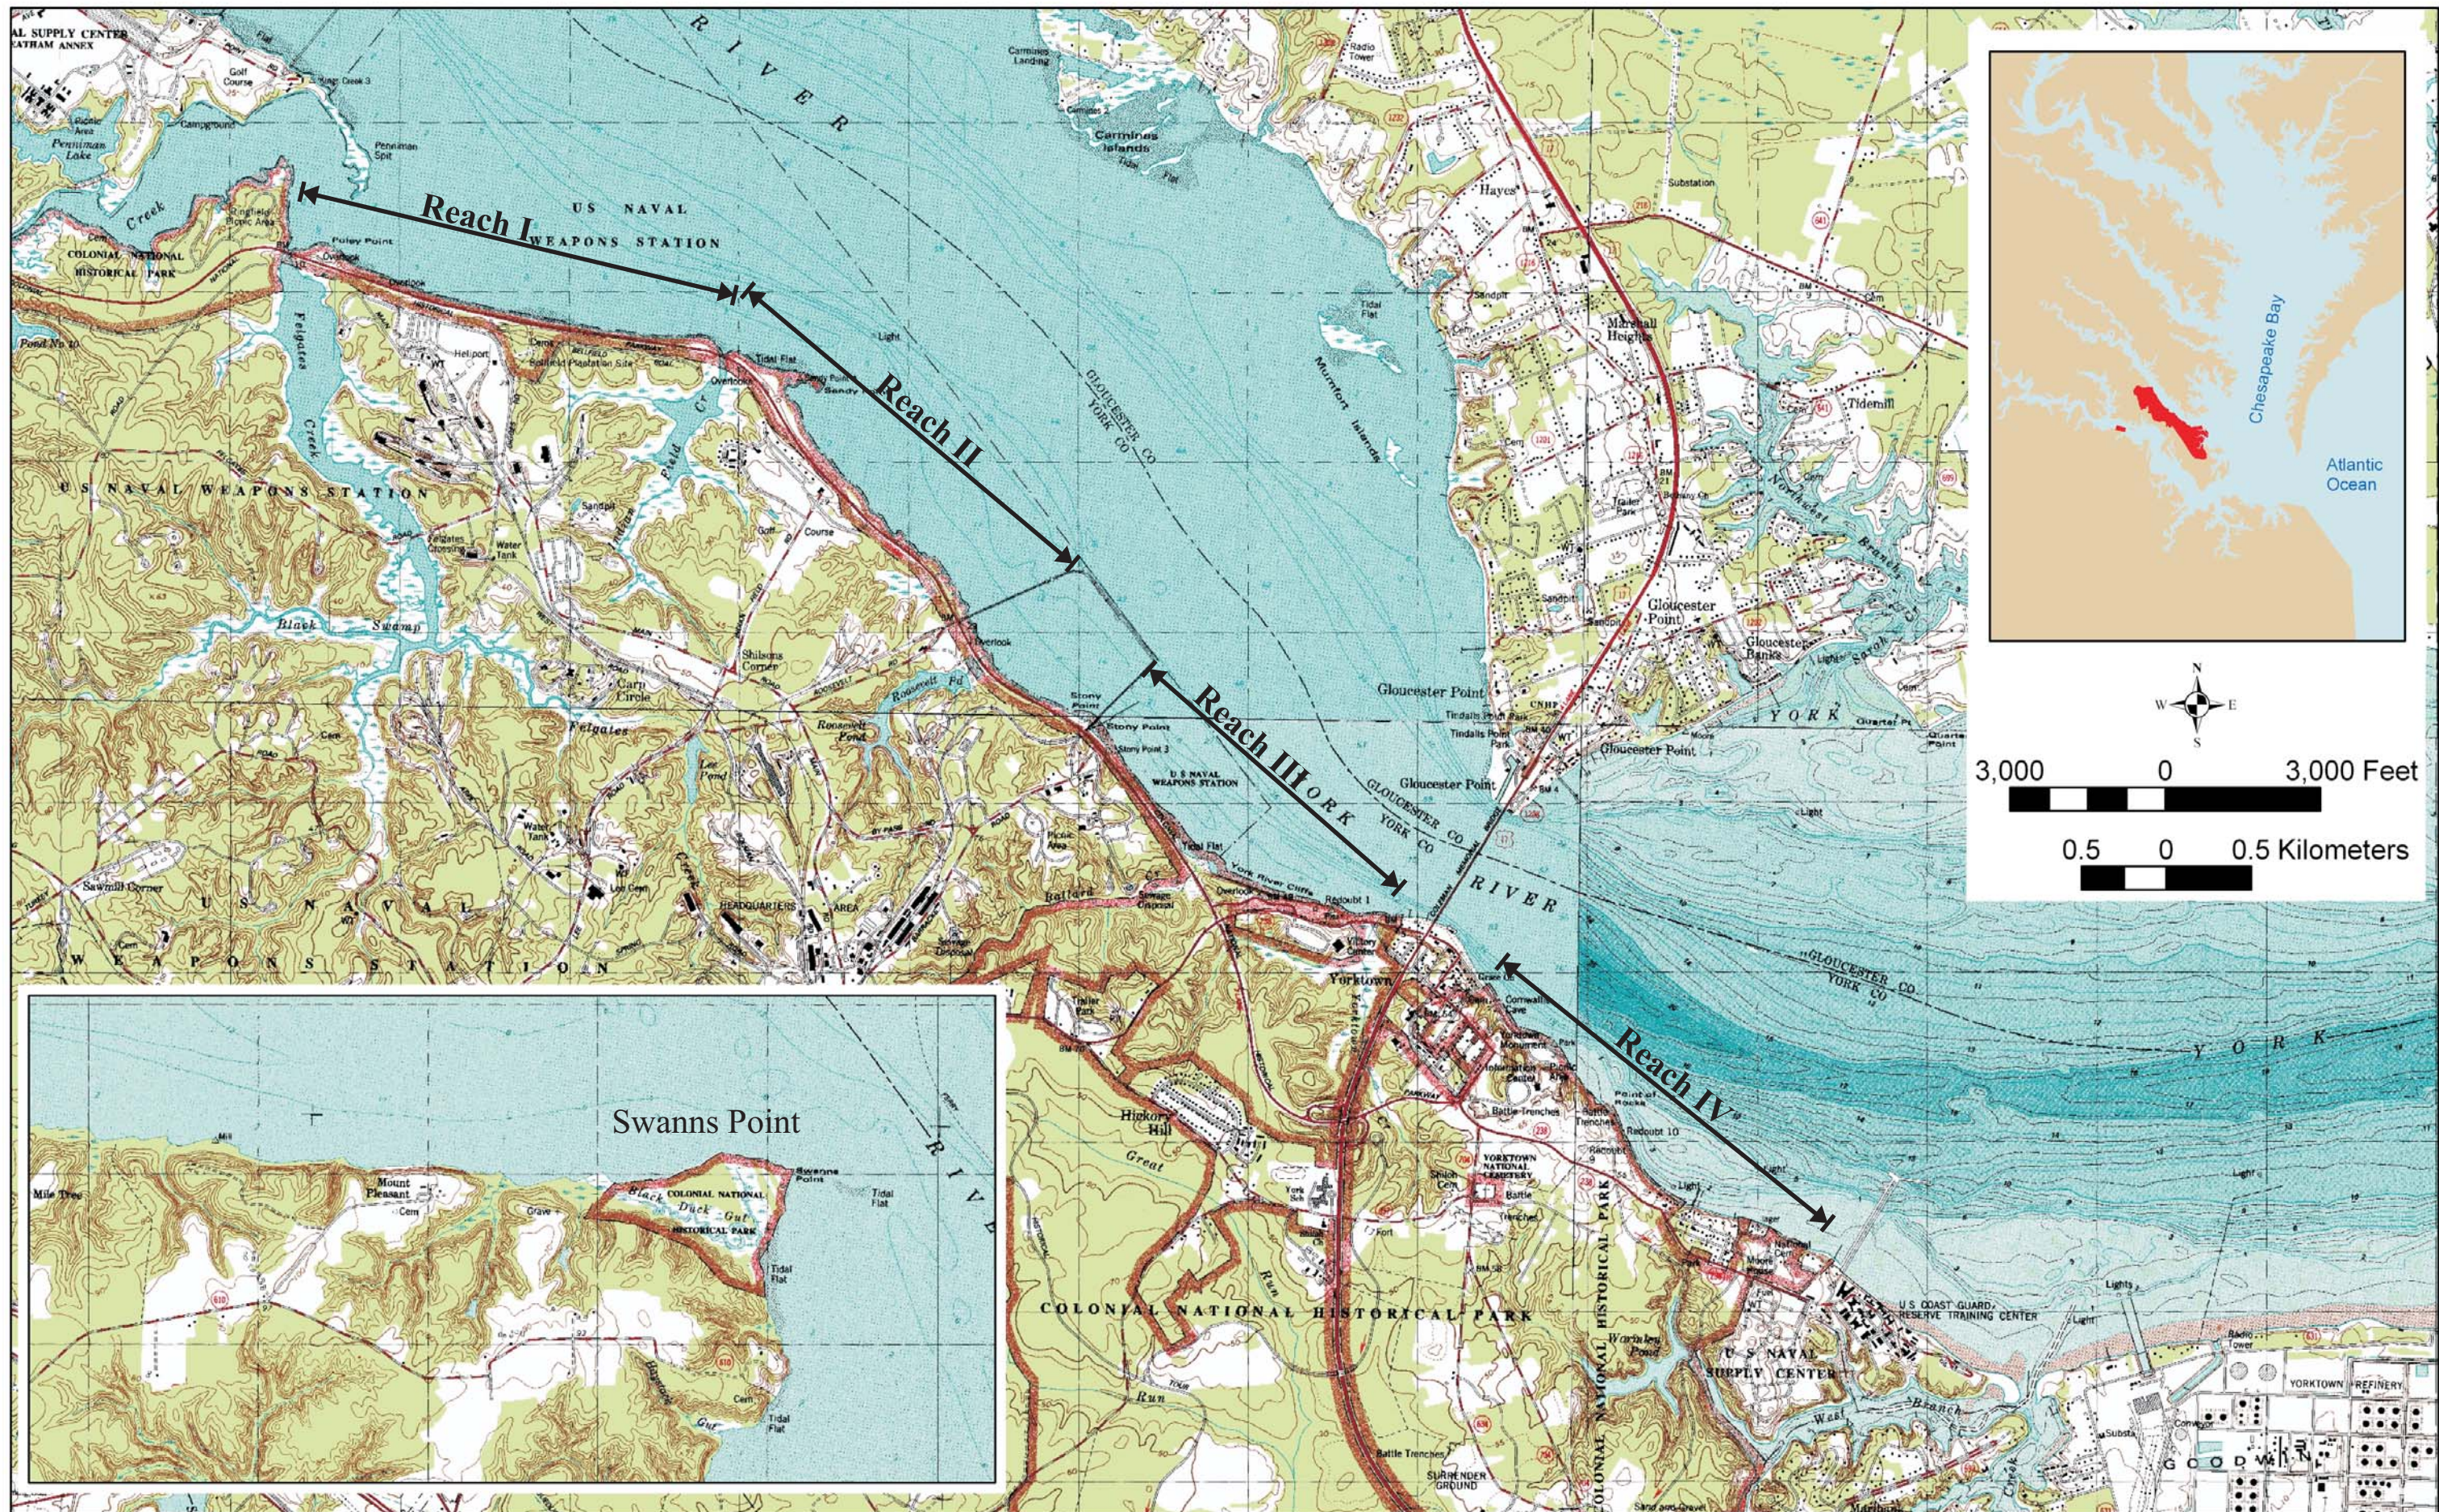
Figure 3-1 Location of reaches and bathymetry along COLO's York River shoreline and Swanns Point on the James River.

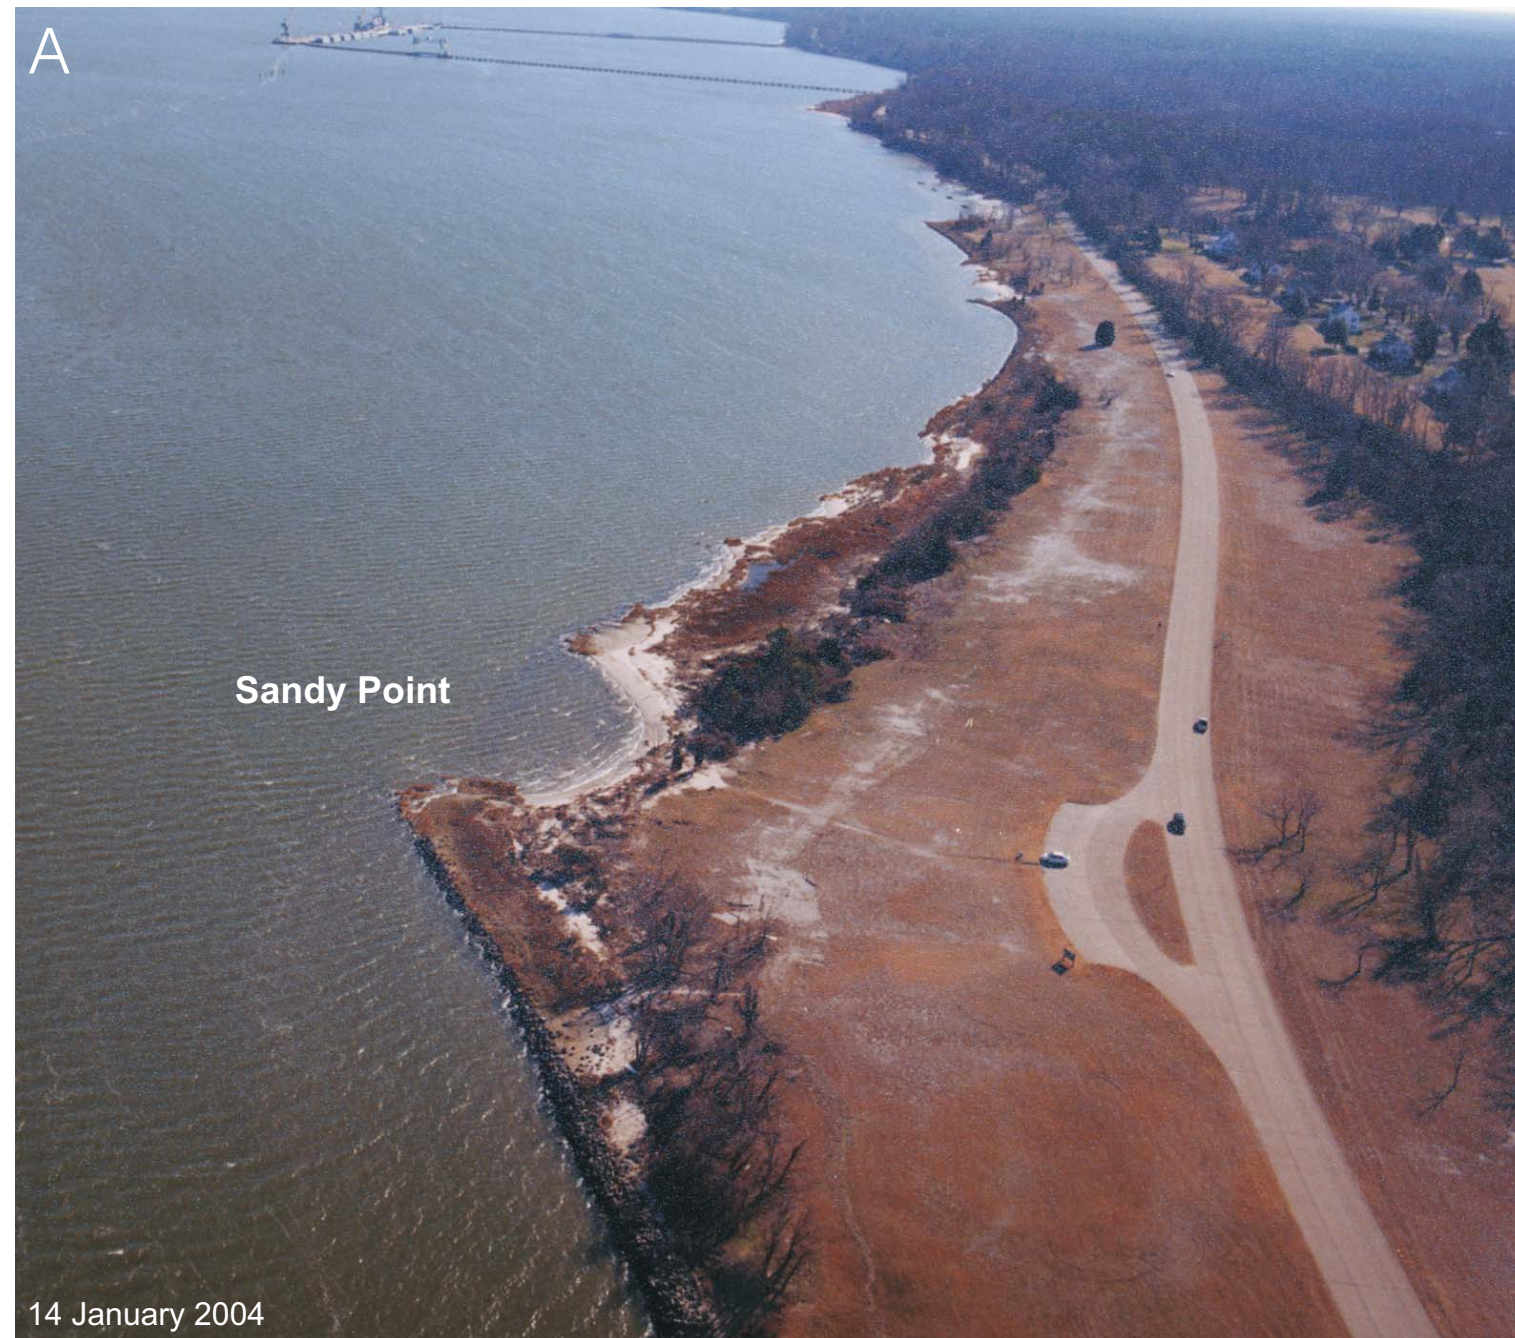
Figure 7-1. Aerial photos along Reach II of the COLO shoreline looking downriver A) toward the Naval Weapons Station Pier and B) showing the existing Parkway breakwaters.

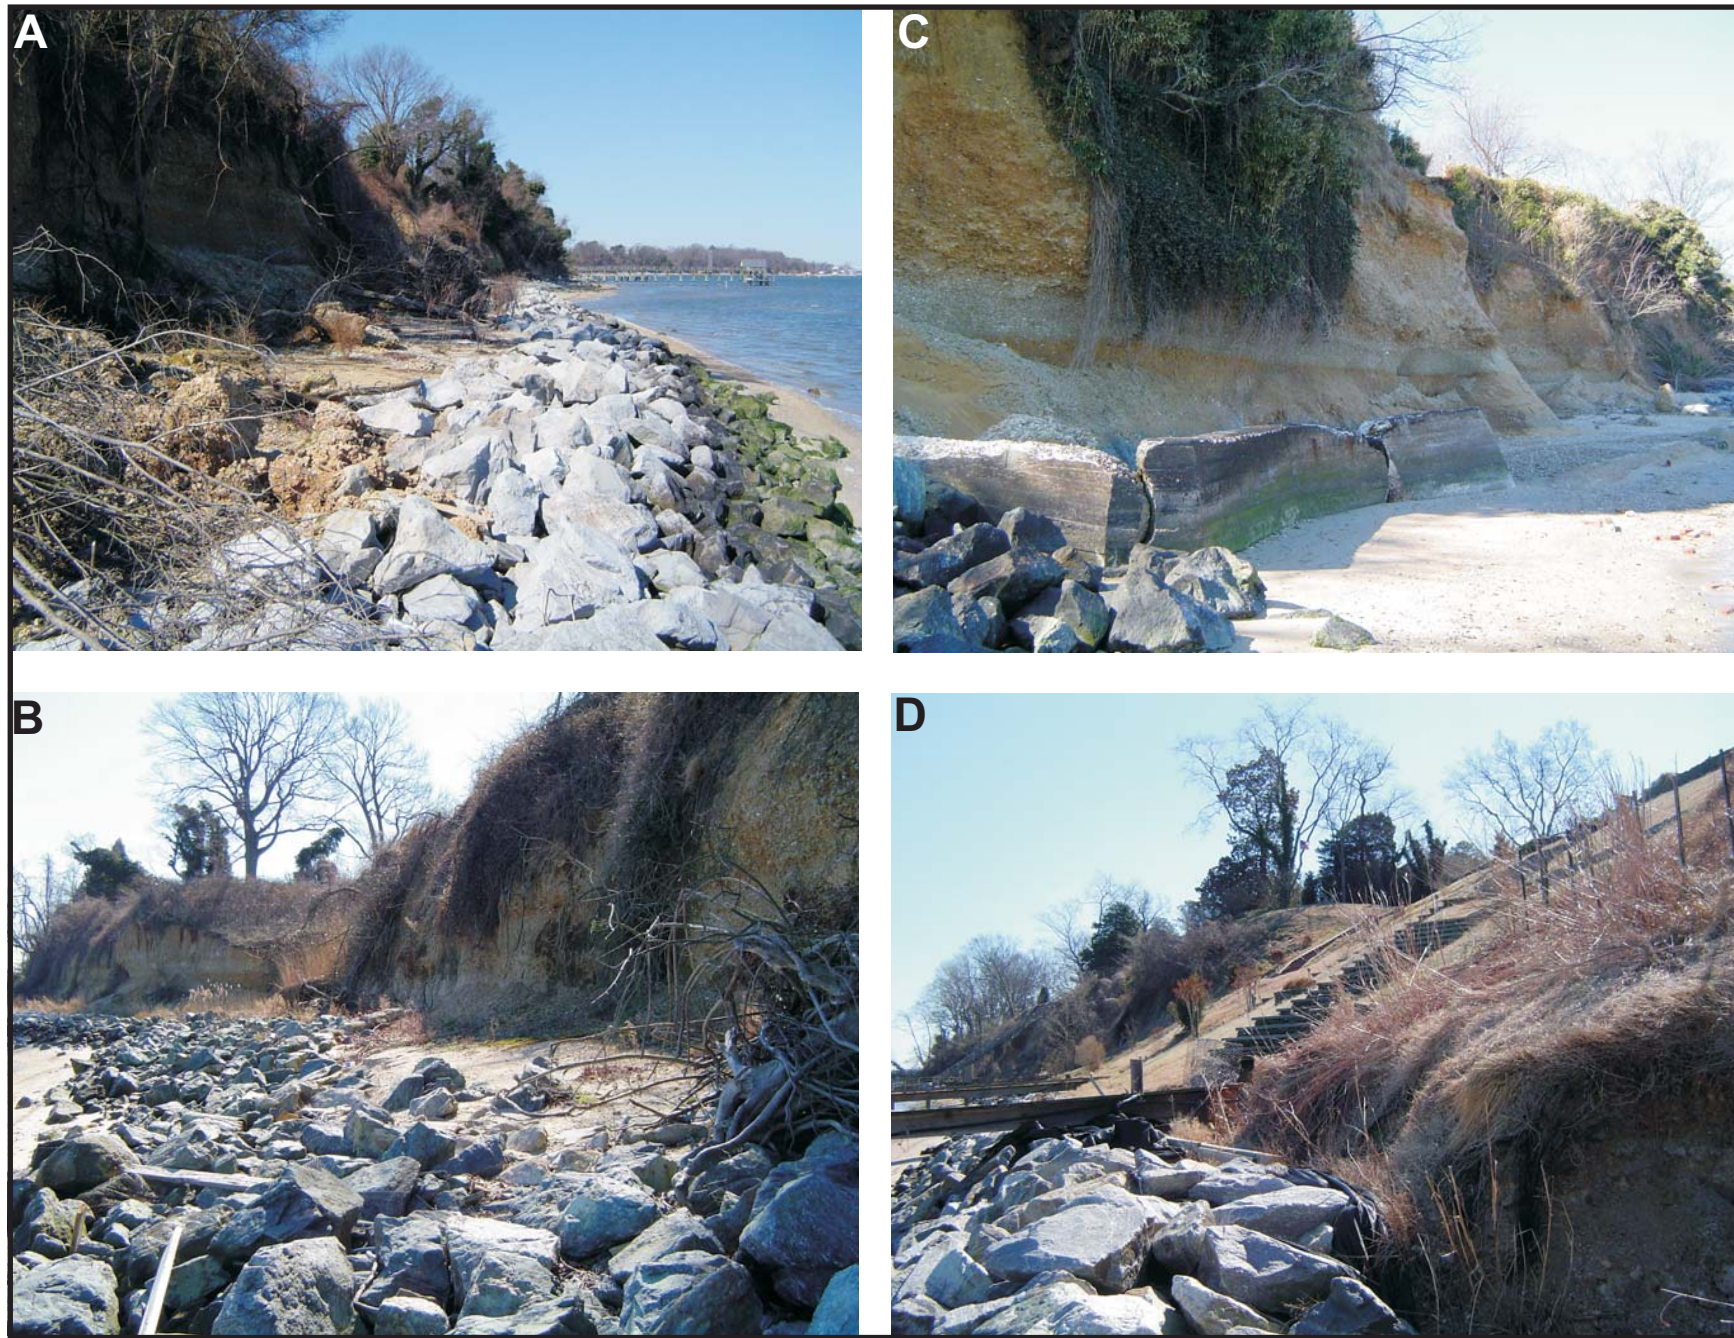
Figure 9-2. Ground photos showing the York River shoreline in the vicinity of the Moore House. Photos A and B show the rubble revetment and eroding shoreline; photo C shows the concrete structure; and D shows the grading of the shoreline on the private property near Moore House. Photos taken 3 March 2005.
