The Value of Created Dunes to address Coastal Hazards in Chesapeake Bay: Hurricane Isabel Impacts

Data Report

Shoreline Studies Program
Department of Physical Studies
College of William & Mary
Gloucester Point, Virginia

November 2004

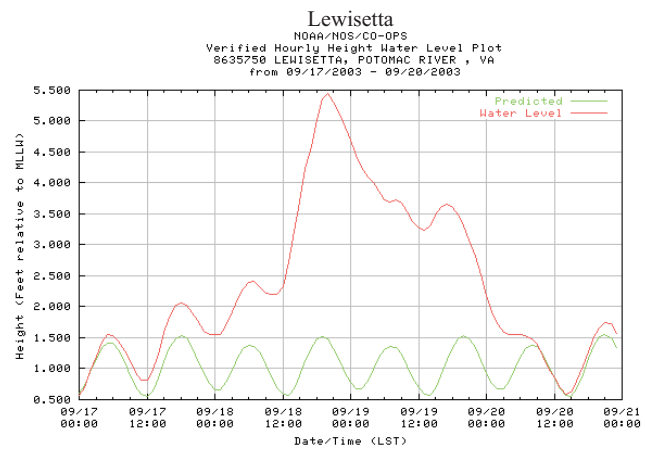
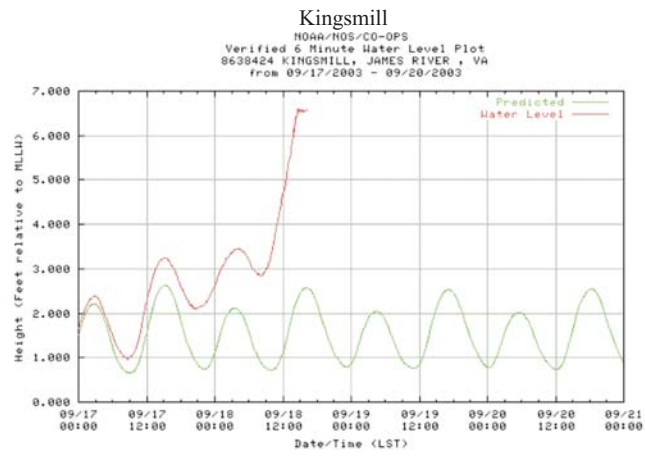
Figure 2. Verified water levels at wave gages around Chesapeake Bay during the storm and approximate gage location. From the NOAA website (<http://www.co-ops.nos.noaa.gov/>).

Around the Bay, similar impacts were recorded by wave gages ([Figure 2](#)). The location and records of five wave gages indicate the widespread flooding that occurred due to the storm. In the lower Bay, the Sewells Point and Chesapeake Bay Bridge Tunnel gages survived the storm and indicated a total water level of 8 ft and 7.5 ft above MLLW at the peak of the storm. This is about 5 ft above normal. Also of note was that tide was running higher than normal for the day before the storm and the two days after at both locations. In fact, on the day after the storm at Sewells Point, the lowest tide was higher than predicted high tide of 2.5 ft.

Two of the the other three wave gages were destroyed during the storm before the peak water level. At Gloucester Point on the York River, the tide gage stopped recording at 8.5 ft MLLW during the storm. Maximum measured stillwater level across the river at Yorktown was 8.6 ft MLLW with the trash line indicating the water plus waves was at 12.5 ft MLLW. That is a surge above the mean range (2.4 ft) of 6 ft with additional 4 ft waves. Kingsmill on the James River stopped recording at 6.5 ft MLLW. Measured trash lines indicate that the maximum surge and wave level was about 12 ft MLLW or about 8 ft above the mean tide range. Lewisetta, on the Potomac River, remained intact probably owing to its slightly more sheltered location. It measured a maximum storm surge of 5.5 ft MLLW.

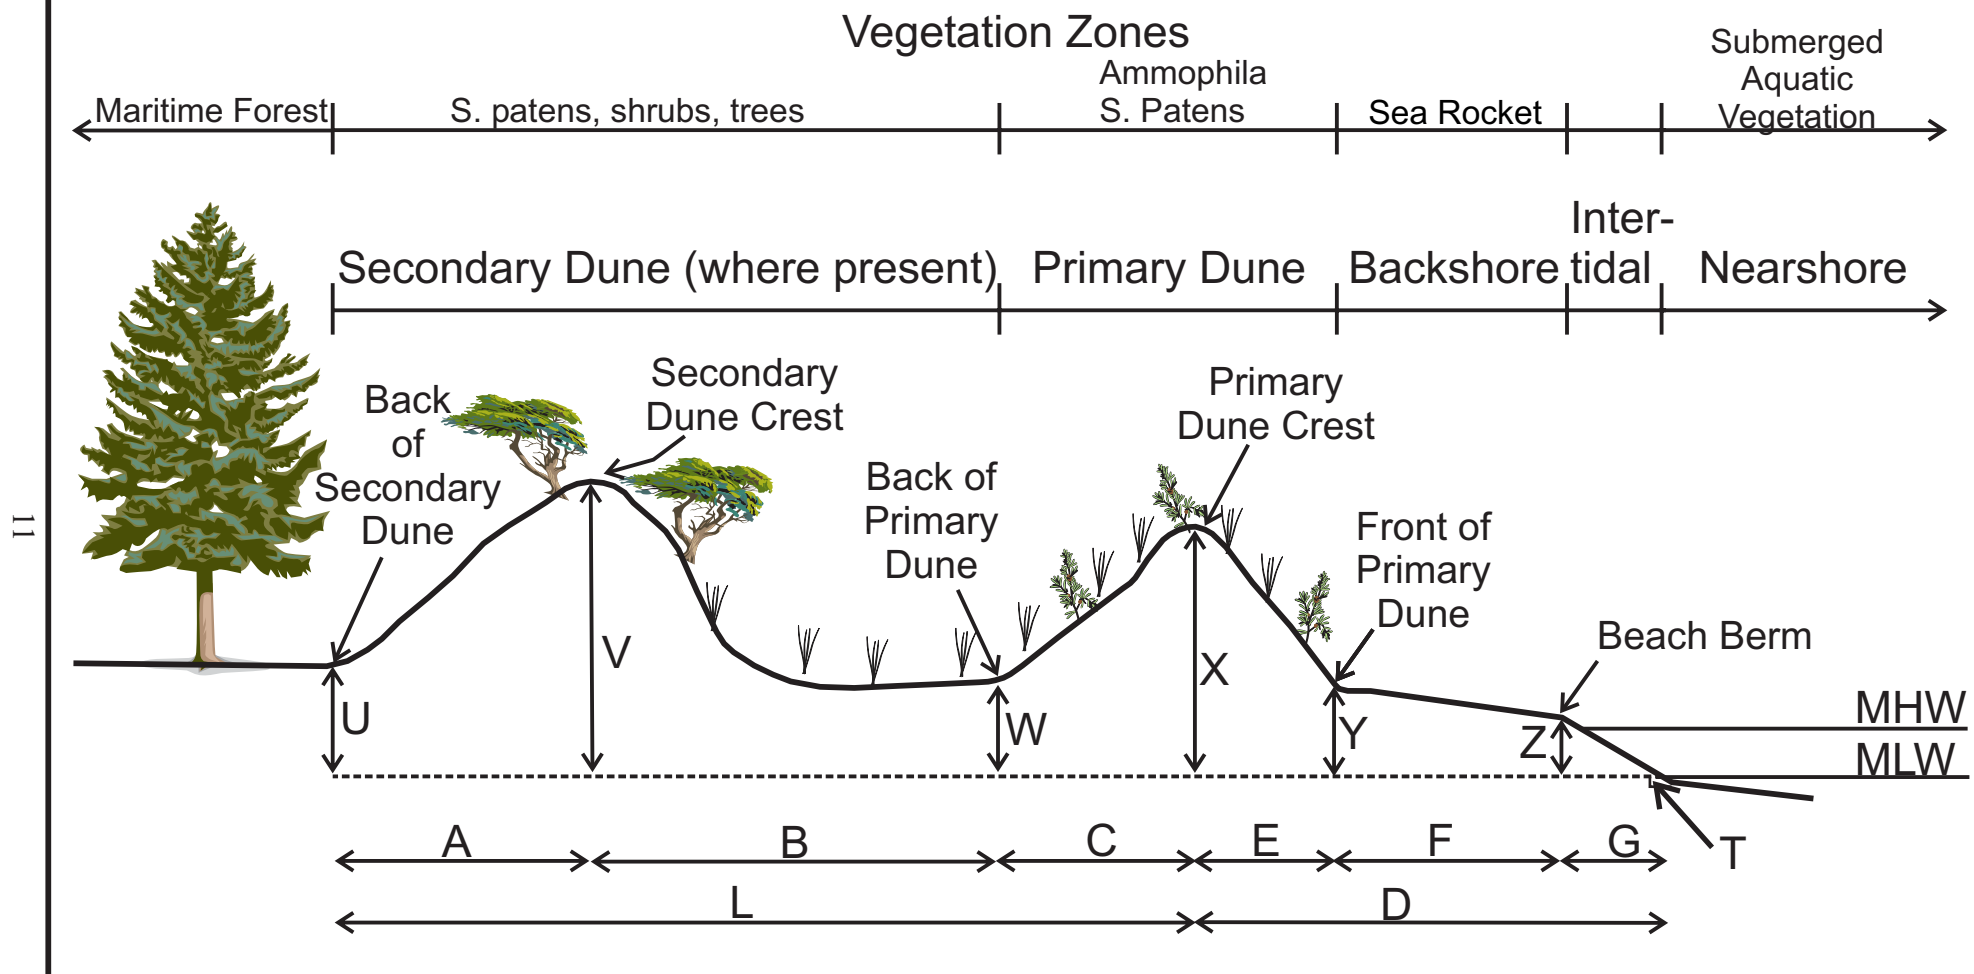
Chesapeake Bay Dune Profile

Figure 6 . Typical profile of a Chesapeake Bay dune system with measured parameters indicated.

The primary dune profile has several components (Figure 6). A continuous sand feature generally exists from the offshore landward consisting of a 1) nearshore region, bayward of MLW, 2) an intertidal beach, berm and backshore region, sometimes vegetated, between MLW and base of primary dune, 3) a primary dune from bayside to landside including the crest and where present 4) a secondary dune region. All profiles extended beyond MLW bayward and to the back of the primary dune landward. The back or landward extent of the secondary dune was not always reached but the crest was. The dimensions, including lateral position and elevation of various profile components were measured.

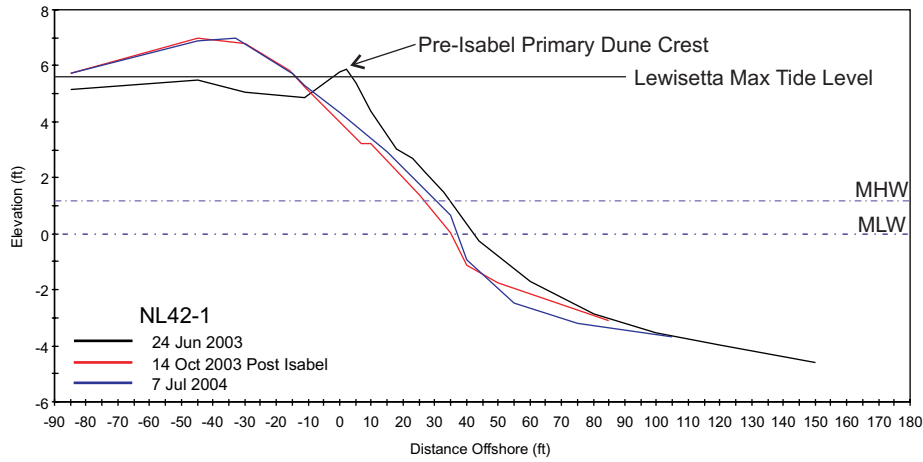
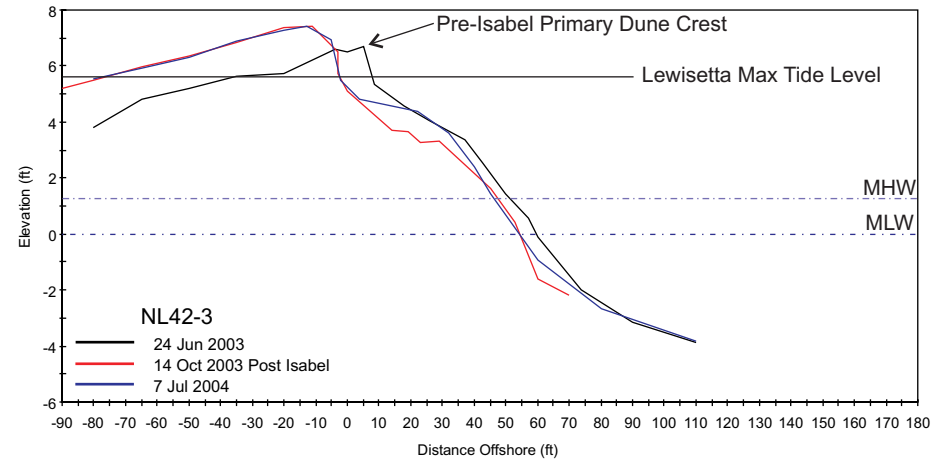
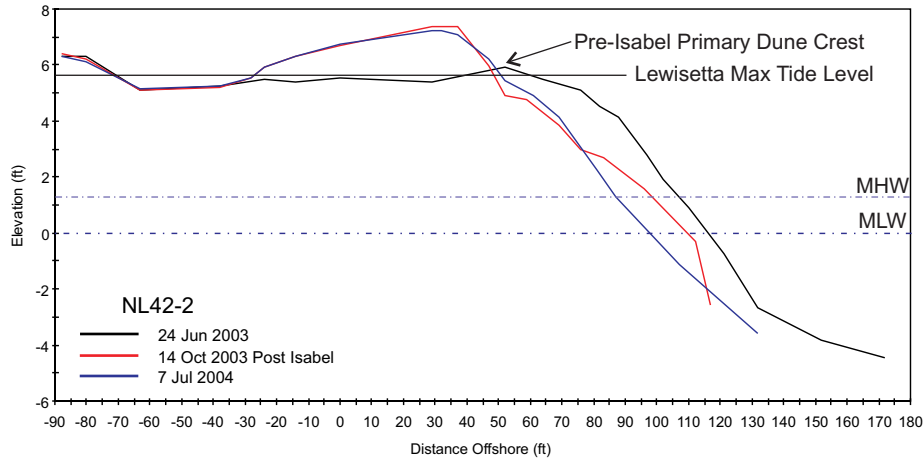
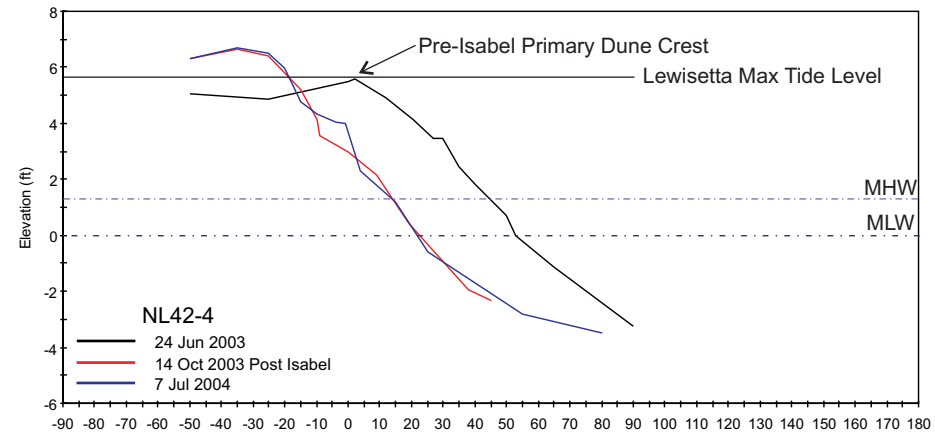
Figure 7. Beach profiles taken before Hurricane Isabel, after Isabel and 10 months after the storm at NI42.

Survey data along the site shows that Isabel over-topped the primary dune and moved the beach face landward. The position of the primary dune shifted landward on all profiles along the dune field coast where it has remained through the recovery period (Figure 7). Landward shifts were about 50 ft, 35 ft, 10 ft, and 40 ft for NL42-1, NL42-2, NL42-3, and NL42-4, respectively. MHW shifted landward as well. Shore change on NL42-4 is interesting in that all the updrift groins were detached from the shoreline during the storm, and the large pre-storm sand fillet against the adjacent groins were eroded and carried landward (Figure 8).

The dune field at NL 42 is relatively low in elevation so that the combination of storm surge and wave action completely overwashed the entire site. The whole beach and dune system shifted landward during Isabel. During the recovery period the upper beach and backshore have stabilized or moved slightly bayward but not to the pre-storm profile position. The groin field to the south was stranded during Isabel allowing the position of MHW to move significantly landward. These groins have since been repaired.

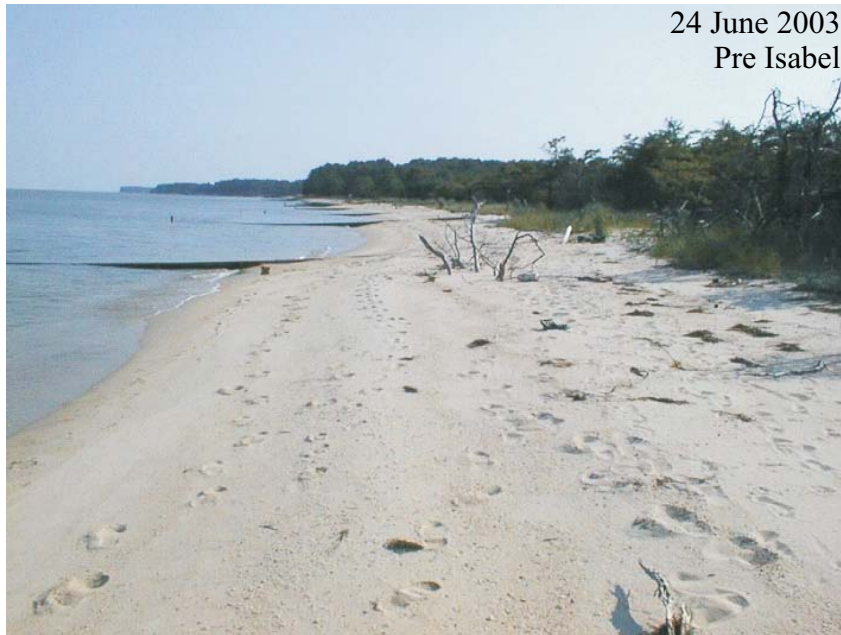
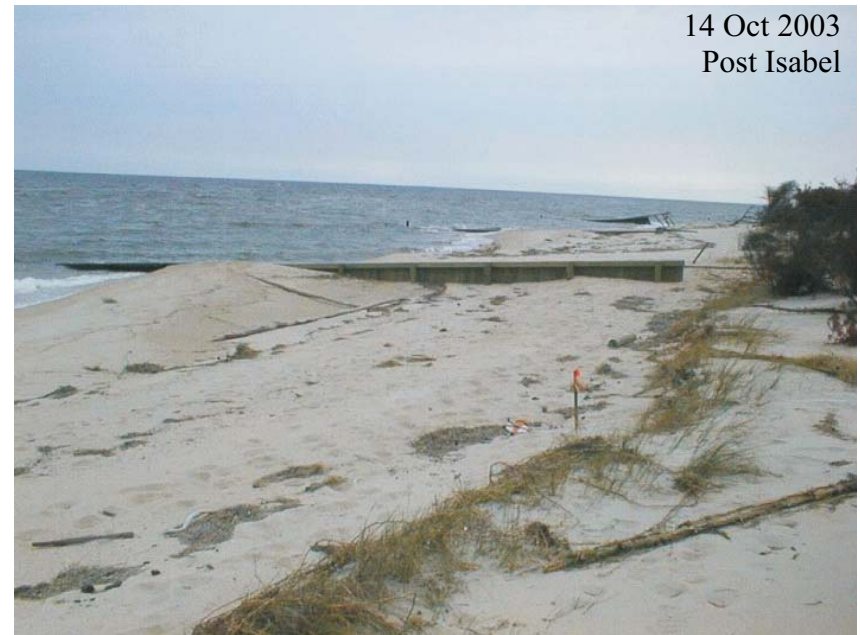
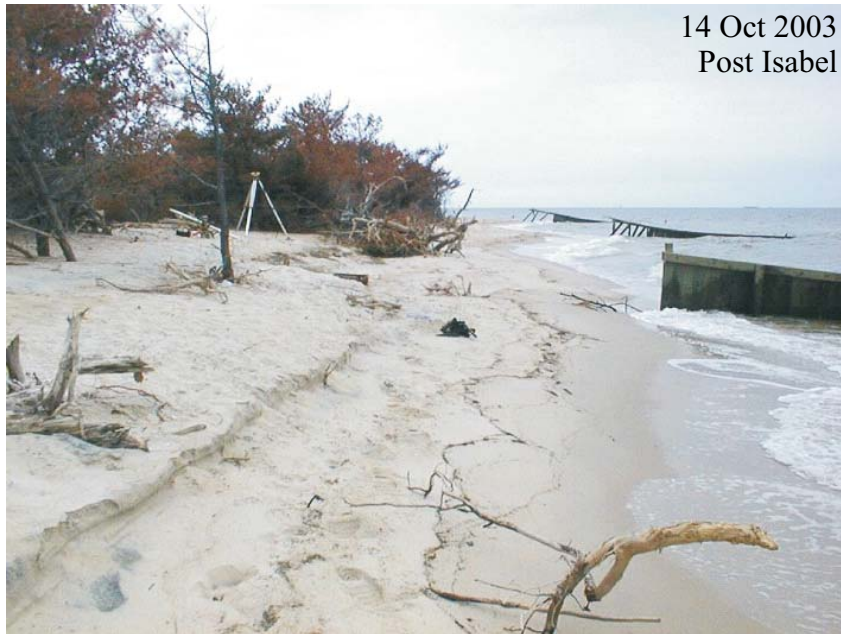
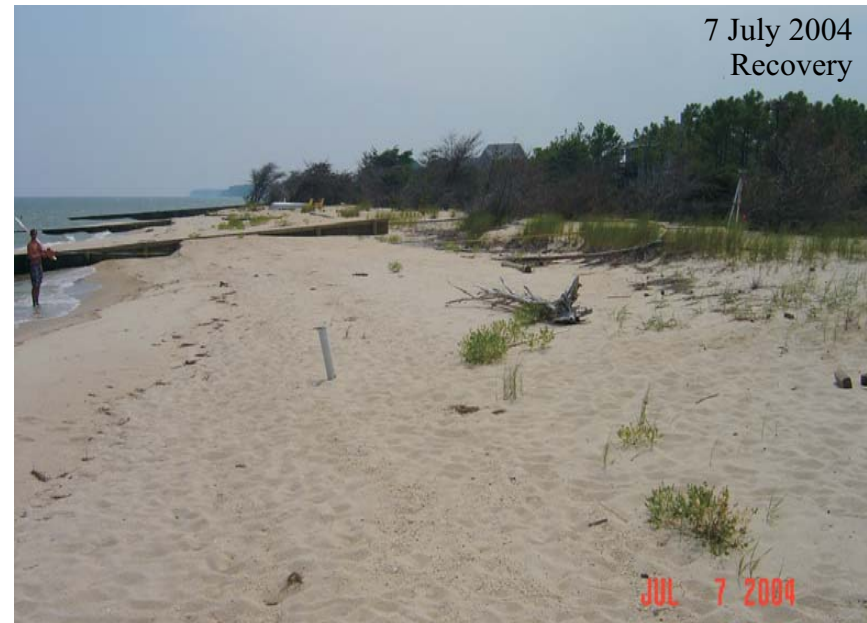
Smith Point NL 42

Figure 8. Ground shots taken before Hurricane Isabel, after Isabel and 10 months after the storm at NL42.

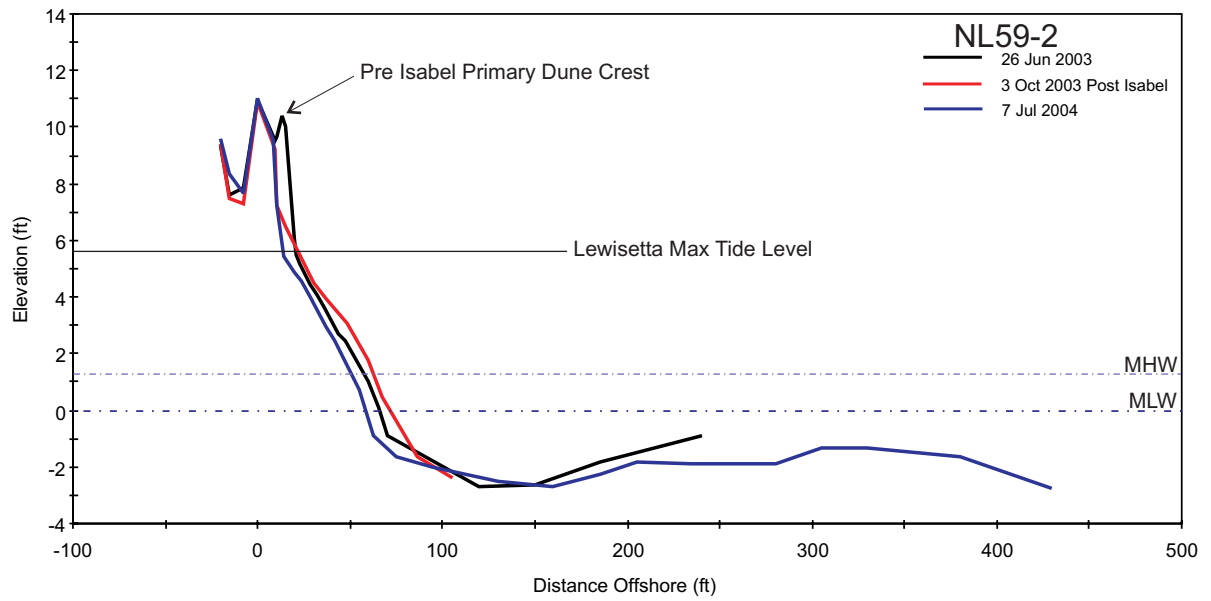
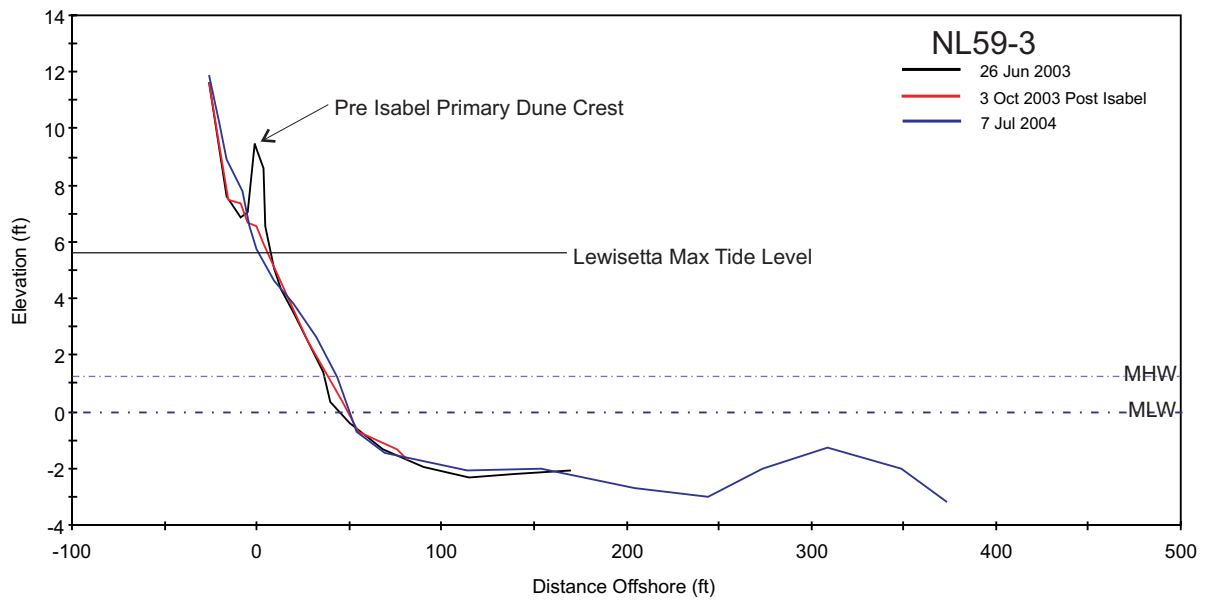
Figure 9. Beach profiles taken before Hurricane Isabel, after Isabel and 10 months after the storm at NL59.

Survey data show the loss of the bayward half of the primary dune face dune on NL59-1 and NL59-2 and the loss of the entire primary dune on NL59-3 due to Isabel (Figure 9). Much of this sand shifted to the beach and backshore. The following recovery period has been slow to develop a pre-Isabel profile on any transect. The pre- post and recovery is seen in the ground imagery (Figure 10)

The groins along this reach have worked well to capture littoral sands, encapsulate a beach, and allow a significant primary dune to develop and grow. A sufficient supply of sand exists in the system for this approach to be successful over time. The distance that the beach can progress bayward is limited by the length of the groins. In addition, no area exists for the system to move landward because of the high bank “backstop”. The dune survives quite well in this restricted setting and serves as good shore protection. However, over time, if the supply of sand diminishes or becomes more restricted alongshore, then the material needed for the recovery may not be available for the next primary dune generation after each severe storm event.

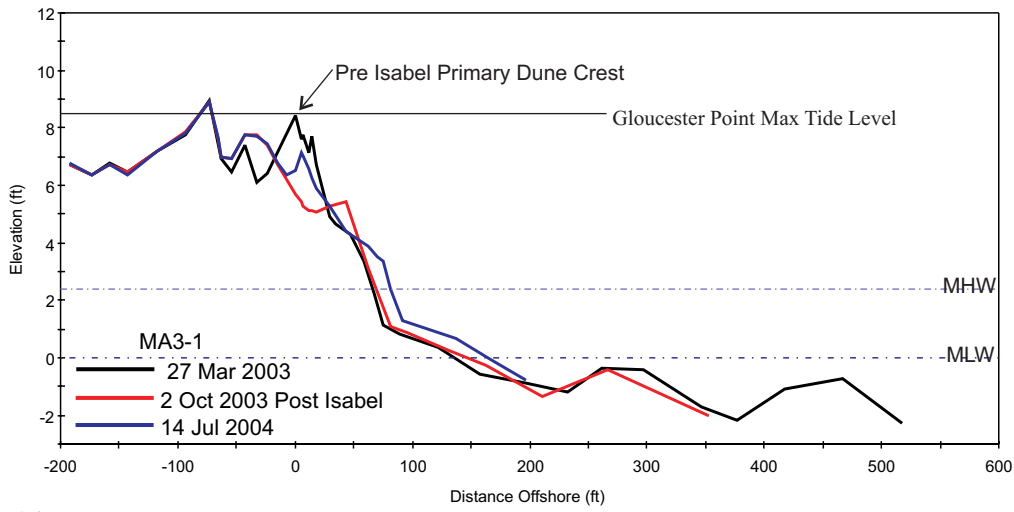
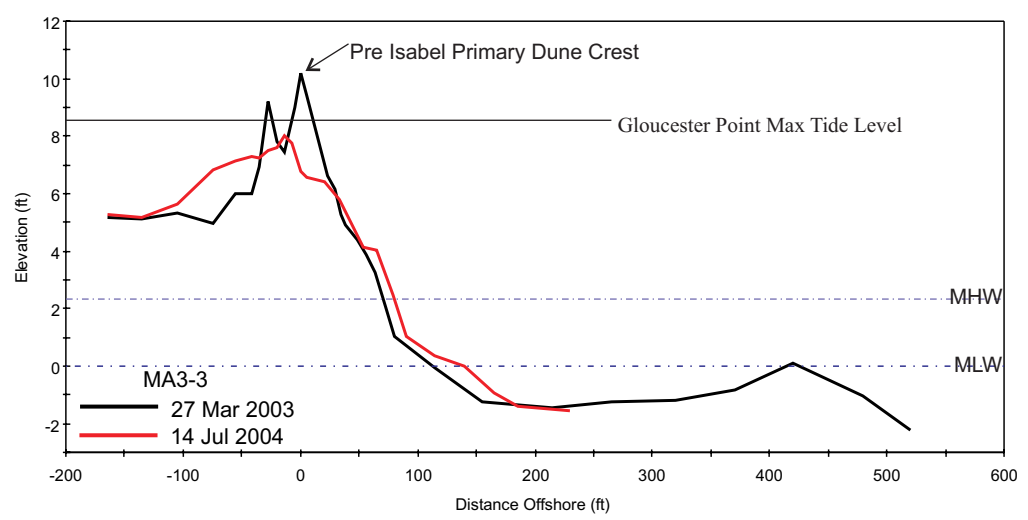
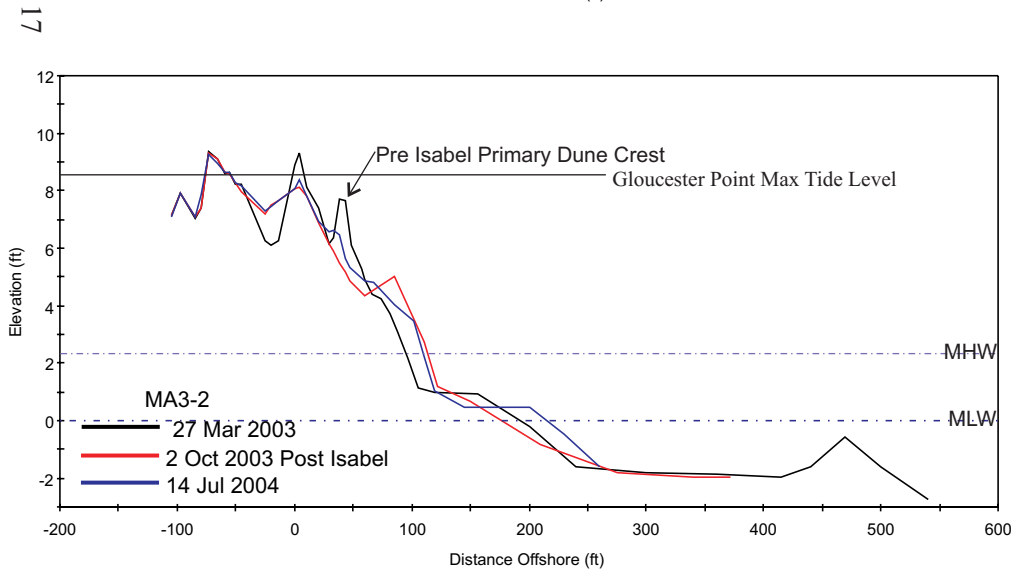
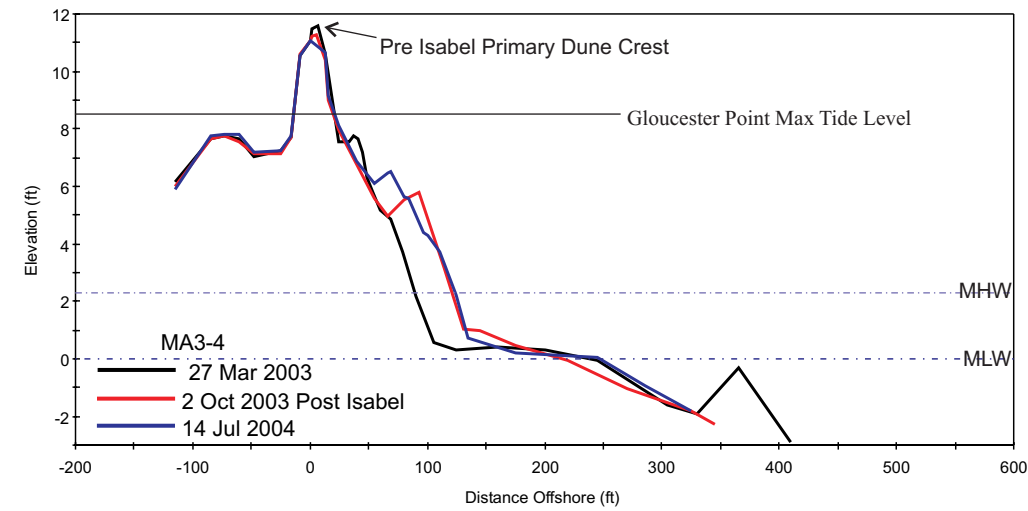
Figure 11. Beach profiles taken before Hurricane Isabel, after Isabel and 10 months after the storm at MA3, profiles 1-4.

Five profiles have all three periods of pre- post- and recovery: MA3-1, MA3-2, MA3-4, MA3-5 and MA3-8. Impacts of Isabel varied along the length of the project site. The northern section, MA3-1 and MA3-2, had the primary dune material carried landward to fill the trough and bayward to widen the upper beach (Figure 11). Recovery has the primary dune redeveloping at about the same location as the pre- storm dunes with a wider beach/backshore and fore dune development. The sequence of events are seen clearly in ground photos. The residents had installed new fence and did some intermittent dune grass plantings after the storm.

The middle section, MA3-4 and MA3-5 had different impacts (Figure 11 and Figure 12). The primary dune at MA3-4 was impacted to the extent that the dune face was scarped and the foredune eroded. A wide beach was left after the storm. The “hot spot” of the site is typified by MA3-5 where the primary dune was flattened to fill the adjacent trough and widen the beach. Recovery shows the beach/berm positions to have remained fairly constant since the post-storm shift. A new primary dune appears to be developing very near the pre-storm position at MA3-5. A widened backshore has provided the opportunity for foredune development on both profiles. The sequence of pre- post and recovery are illustrated in (Figure 13 and Figure 14)

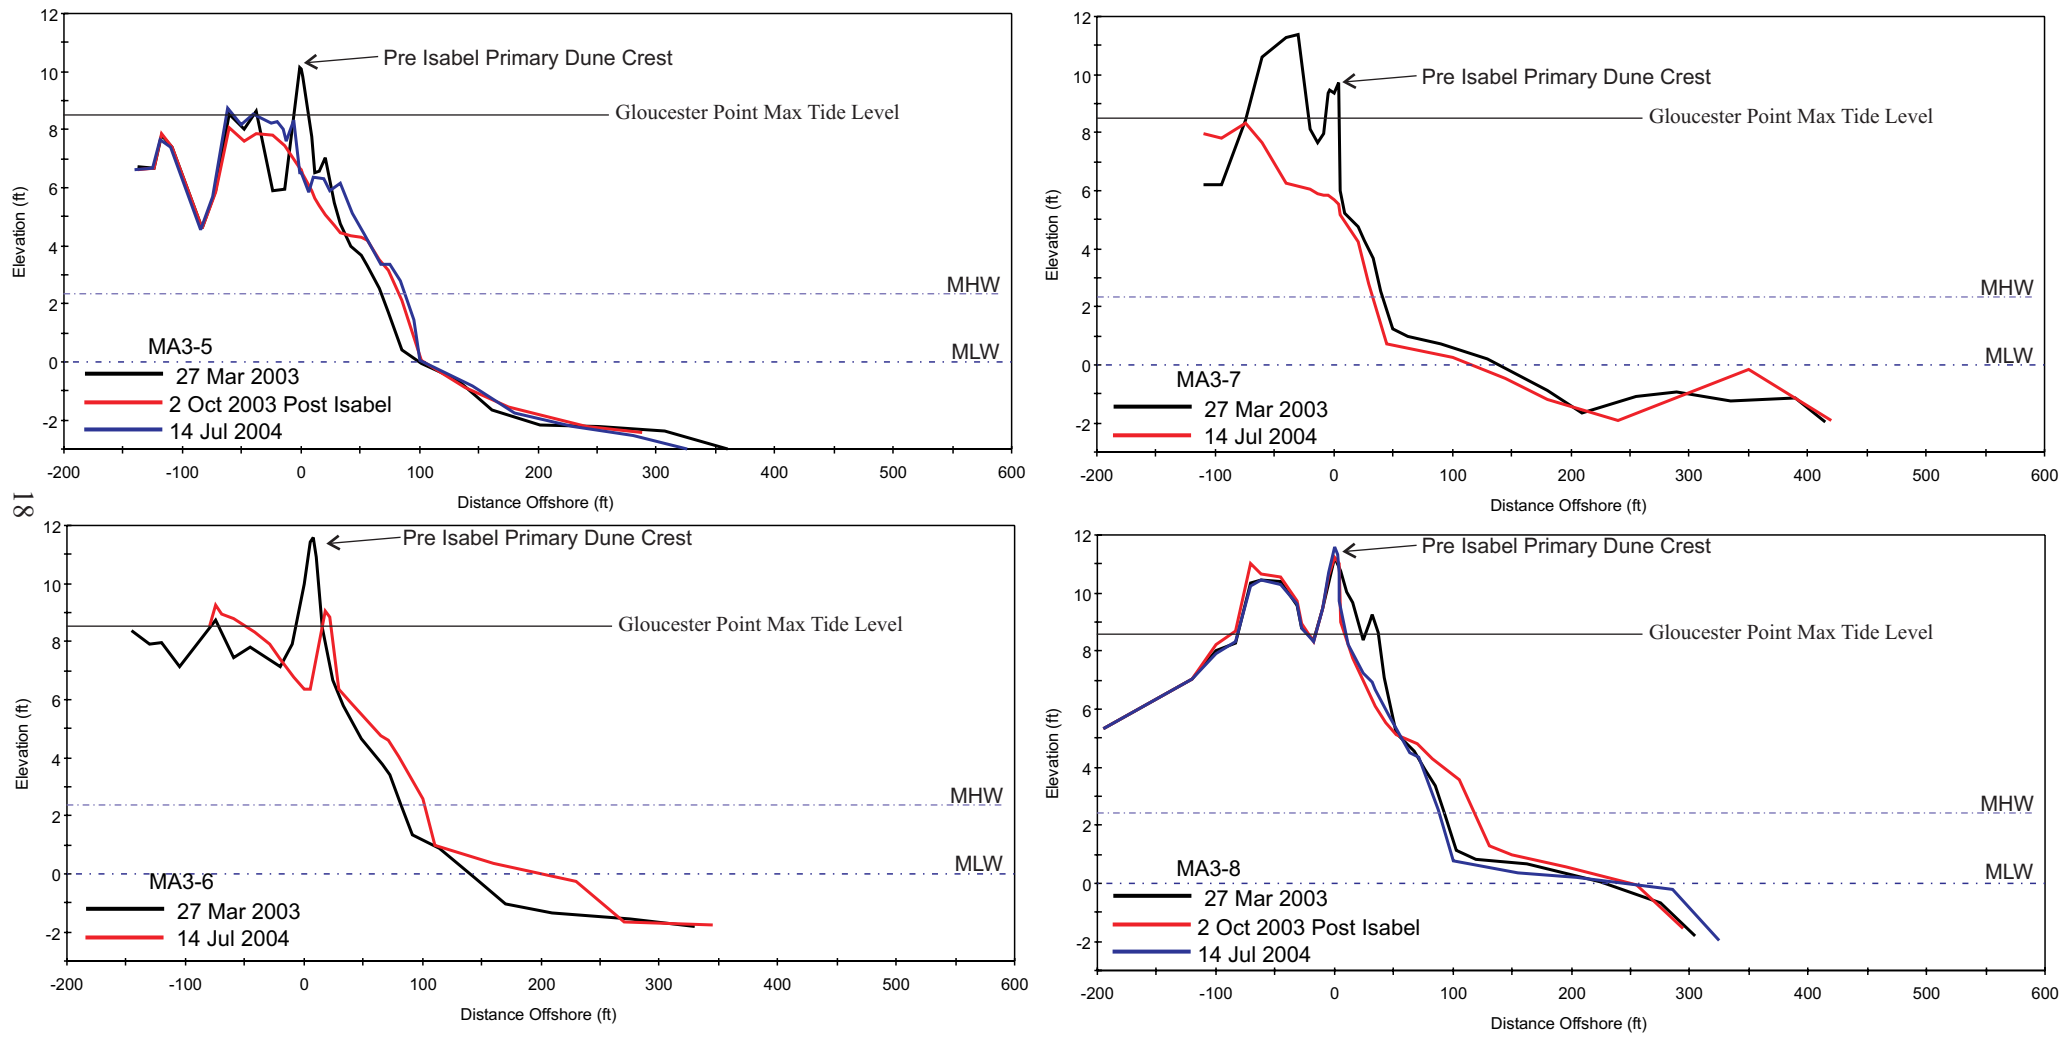
Figure 12. Beach profiles taken before Hurricane Isabel, after Isabel and 10 months after the storm at Ma3, profiles 5-8.

The southern part of the project shore is MA3-8. It had a large foredune pre-Isabel which was eroded out with a consequent increase in beach width (Figure 12). The recovery period shows a significant foredune re-vegetation (Figure 15).

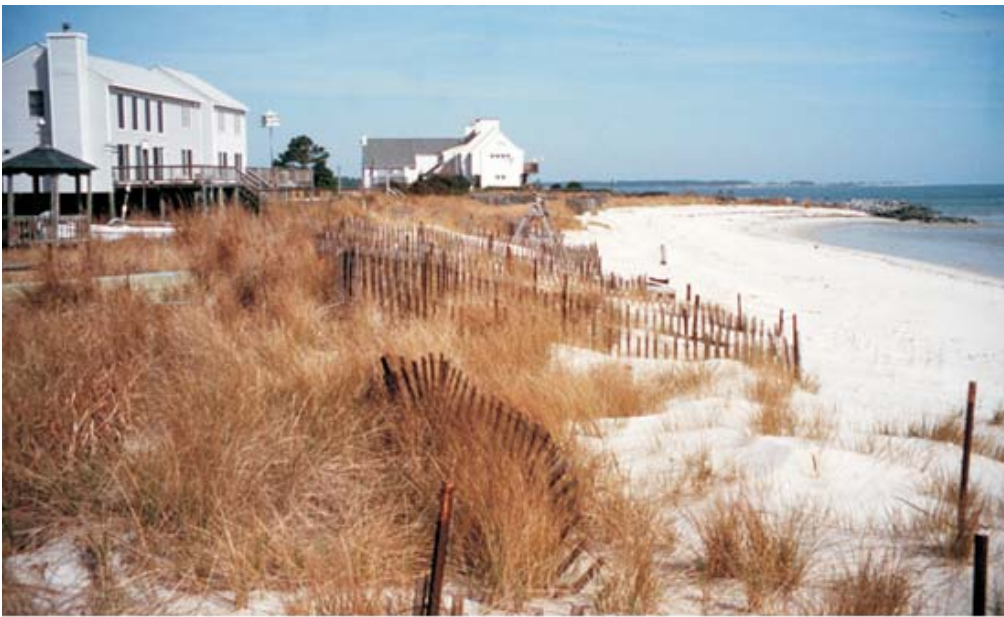
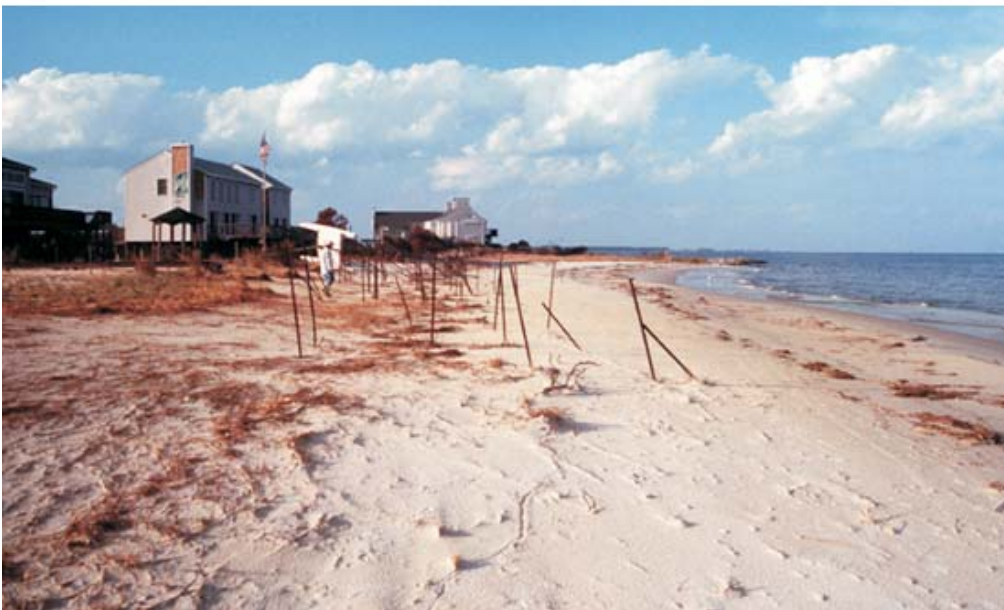
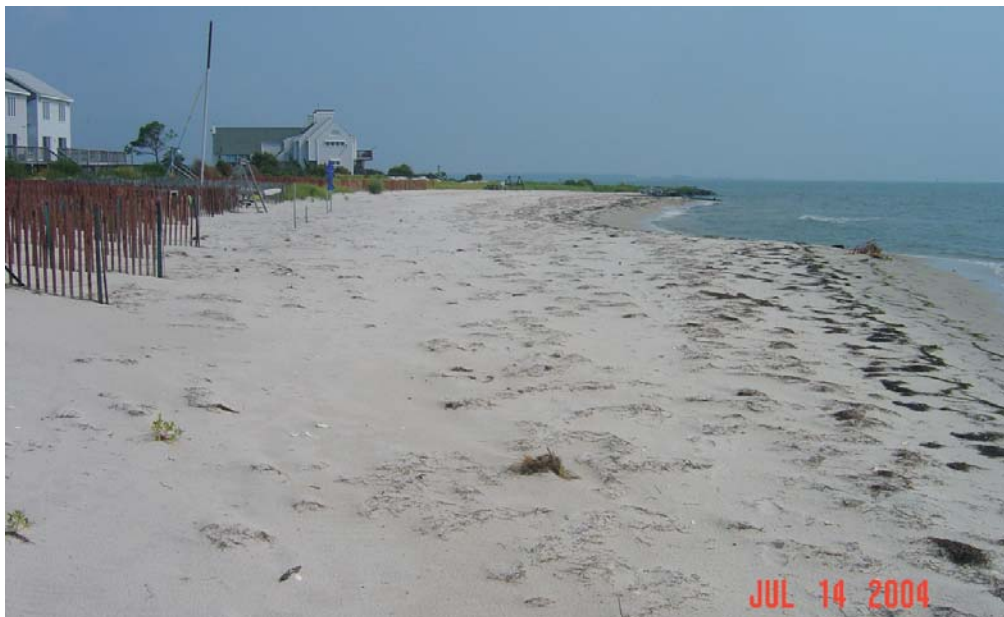
Figure 13. Ground shots taken before Hurricane Isabel, after Isabel and 10 months after the storm at Ma3-1.

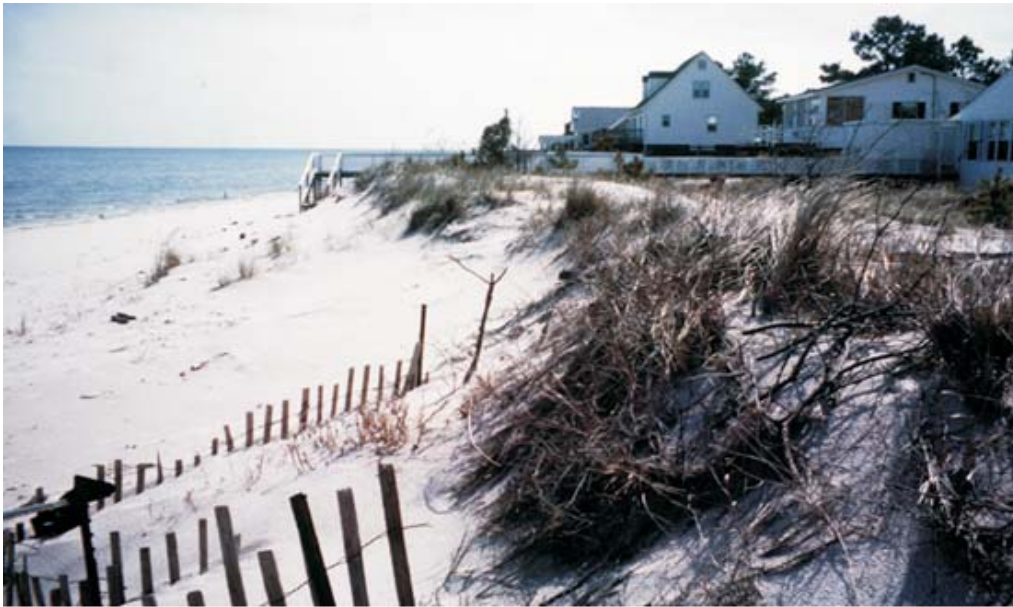
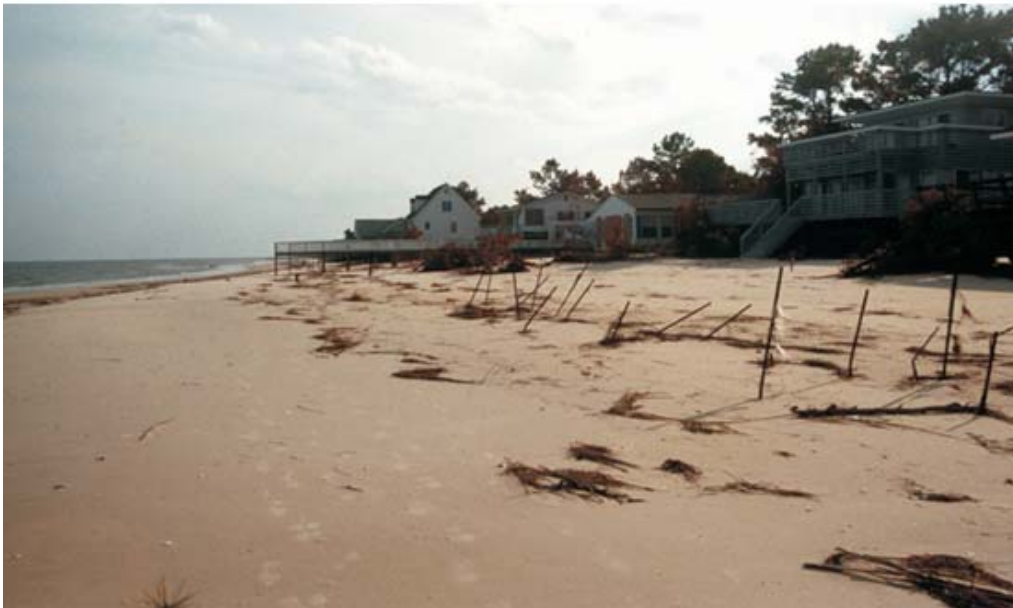
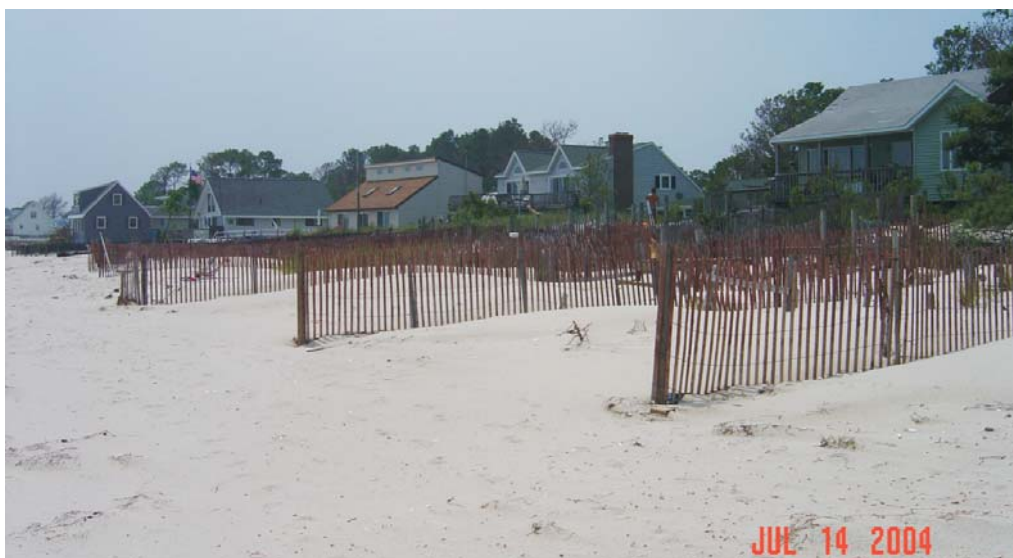
Figure 14. Ground shots taken before Hurricane Isabel, after Isabel and 10 months after the storm at Ma3-4.

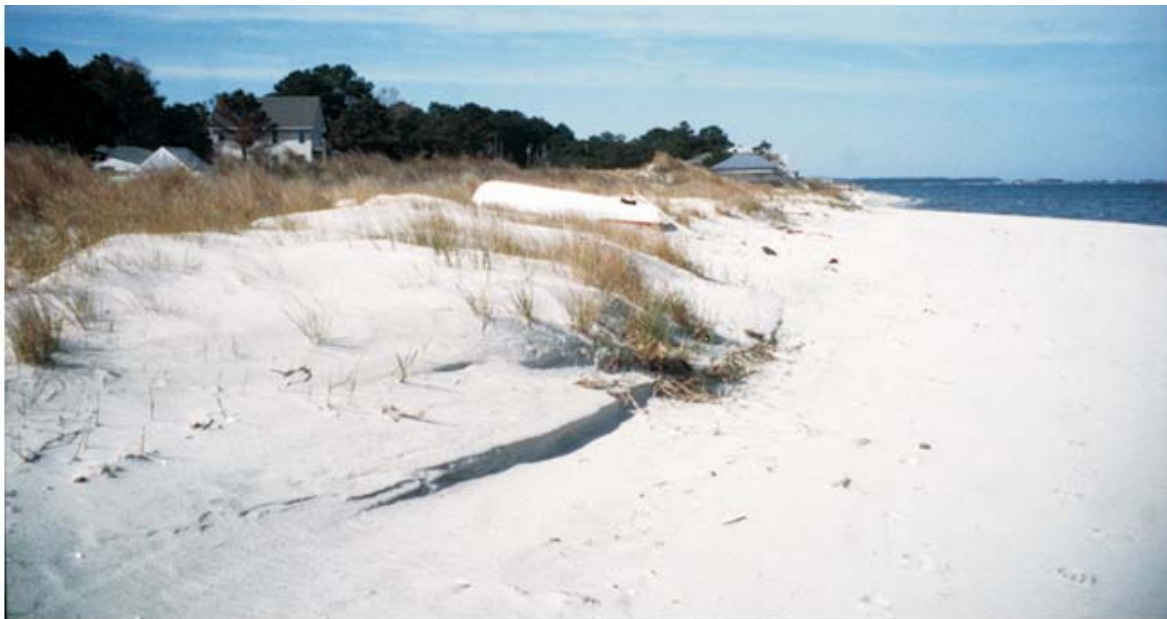
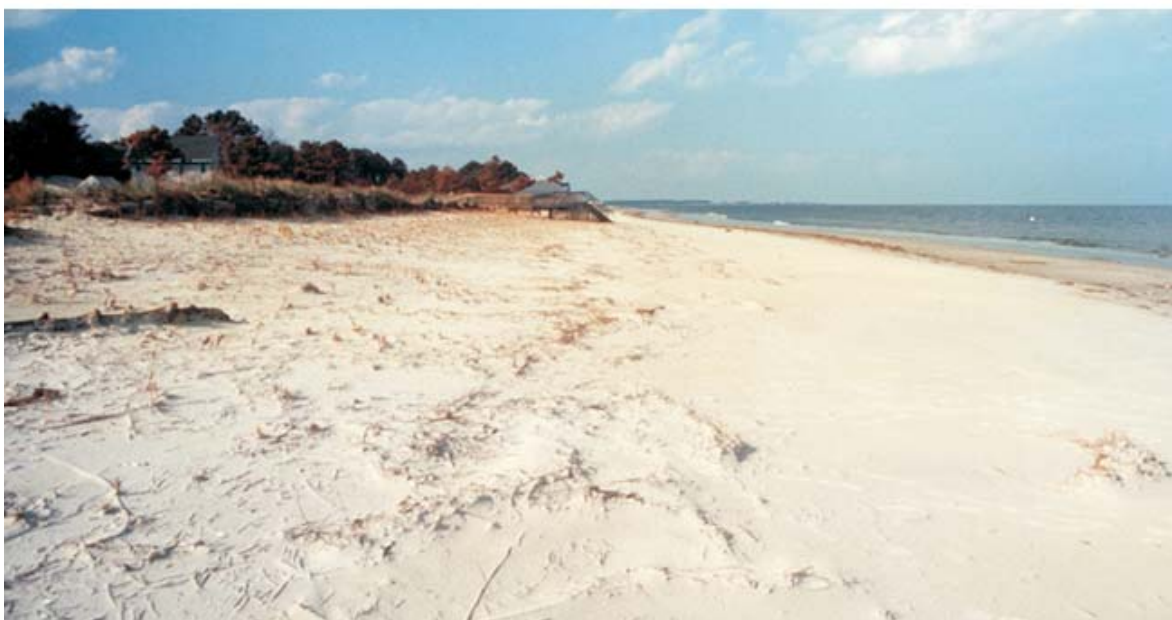
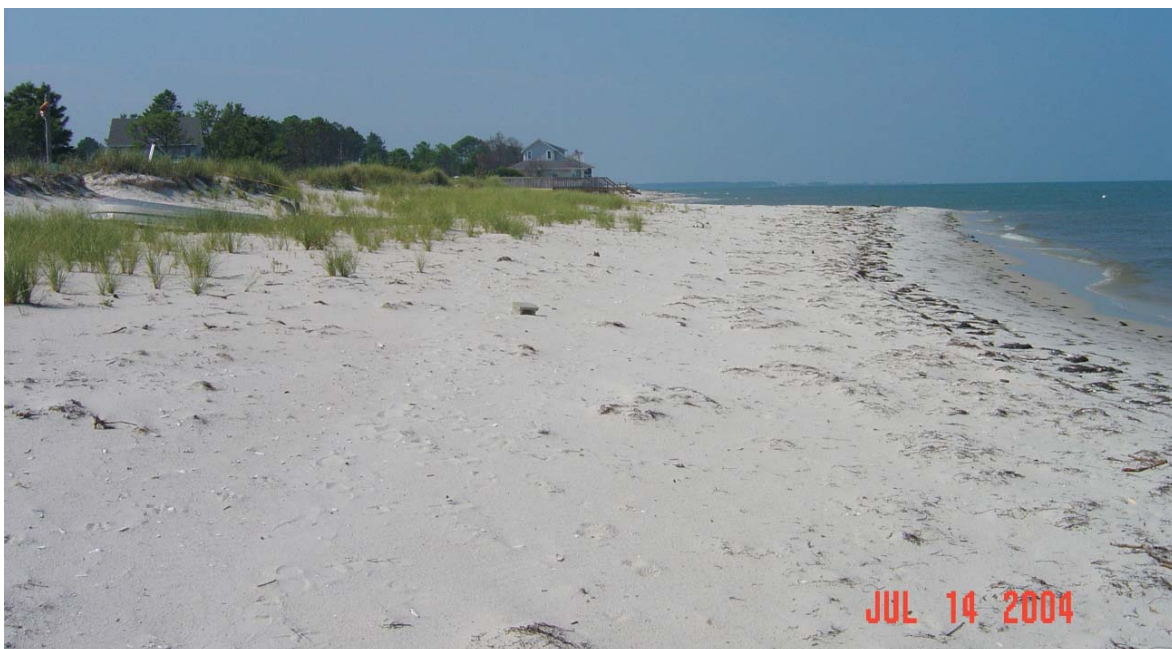
Figure 15. Ground shots taken before Hurricane Isabel, after Isabel and 10 months after the storm at Ma3-8.
