Chesapeake Bay Shoreline Study: Headland Breakwaters and Pocket Beaches for Shoreline Erosion Control Final Report

A Final Report Obtained Under Contract With
The United States Army Corps of Engineers, Norfolk District
With The Virginia Department of Conservation and Recreation

Special Report in Applied Marine Science and Ocean Engineering
No. 313

March 1991

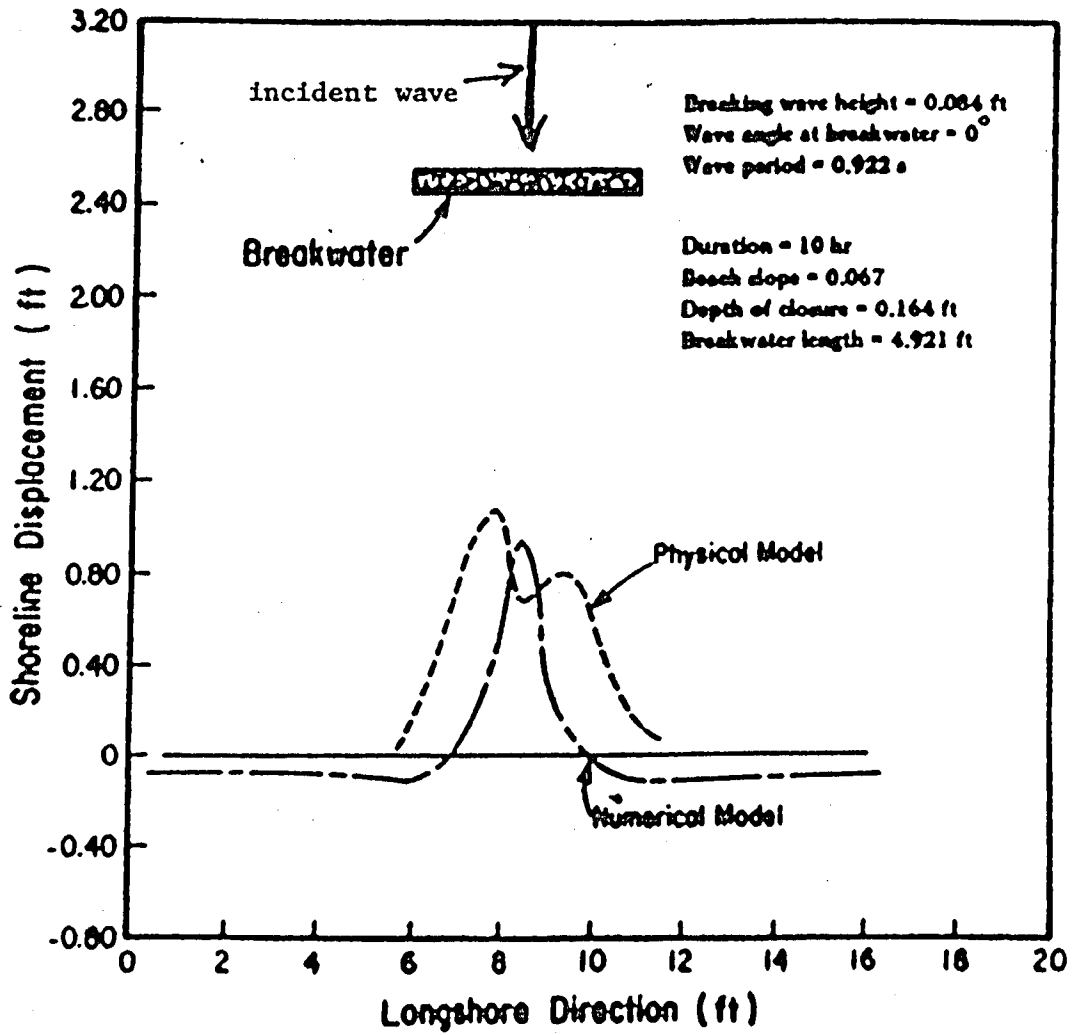
Figure 1. Simulation of the physical breakwater model by Shinohara and Tsubaki (after Perlin, 1979).

Shinohara and Tsubaki (1966) performed physical model tests propagating shore normal waves onto single breakwaters. They concluded that the main cause of shore change and sand movement on a beach is the diffraction of the incoming wave around the breakwater. The diffraction in turn depends on the ratio of offshore position of the breakwater to its length. The amount of sand deposition per unit area in the sheltered region behind the breakwater rapidly decreases with the increase of distance offshore.

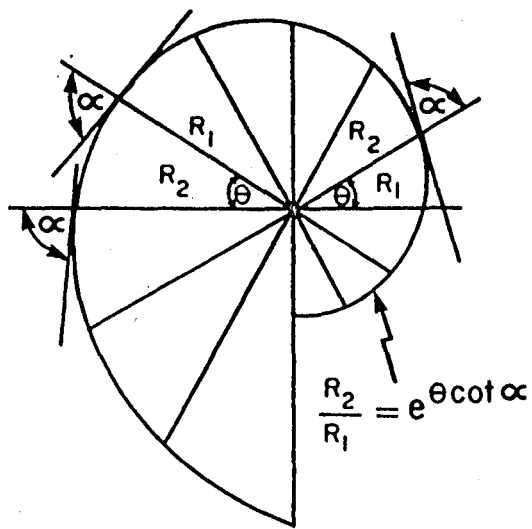
Figure 2. Definition sketch of logarithmic spiral (after Yasso, 1965).

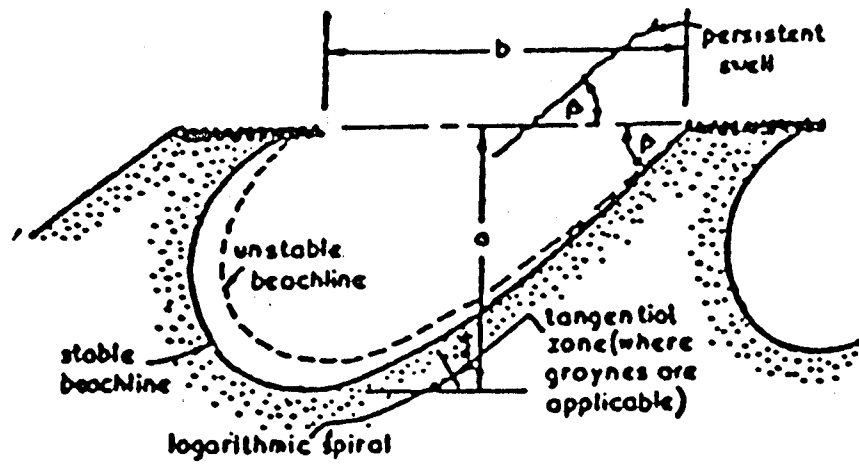
Figure 3. Crenulate shaped bay in stable and unstable conditions (after Silvester, 1976).

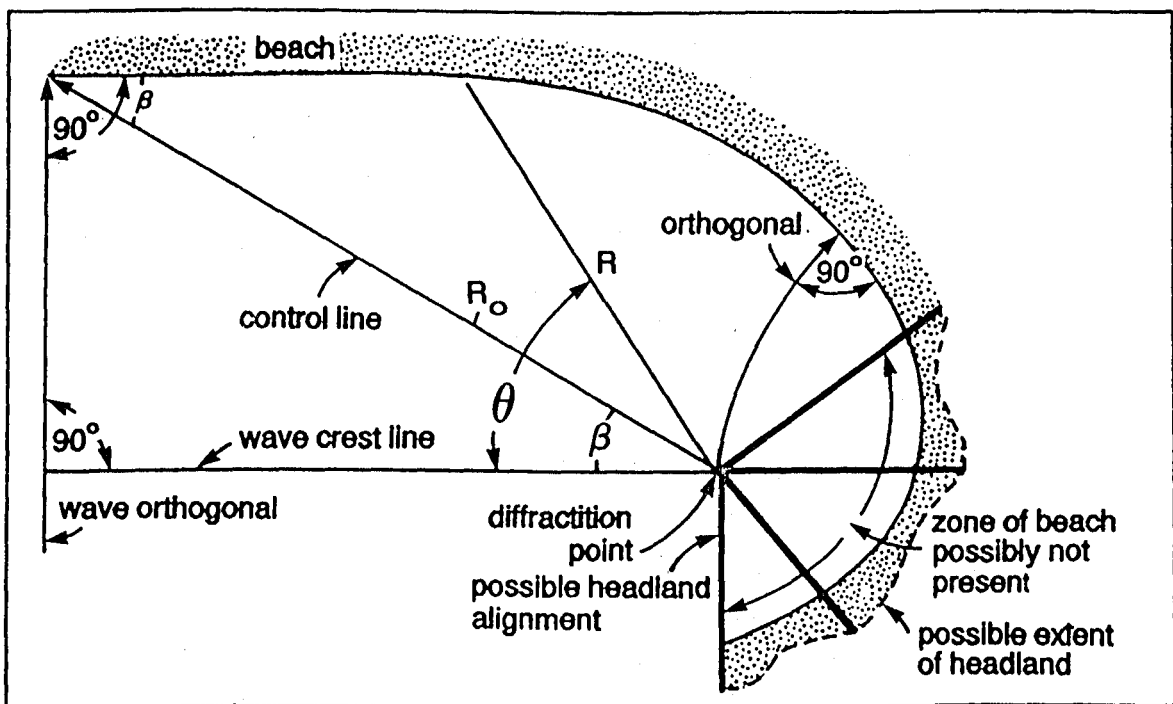
Figure 4. Parameters of the static equilibrium bay (after Hsu et al., 1989).

Hsu et al. (1989a) determined that defining bay curvature through the log-spiral method was not precise and should be replaced by some new relationships. These new relationships revolve around what they call a static equilibrium bay (Figure 4). The line joining the point of diffraction to the downcoast limit of the bay (R_0) is termed the "control line" and its angle to the incident wave crests is the obliquity of the waves (θ), which is the only input variable that determines the bay shape. This angle is the same as that between R_0 and the downcoast tangent to the beach when the bay is in static equilibrium. From the definition sketch in Figure 4, it is seen that the variables (R and θ) involved in this new presentation are an arc of length R angled θ to the wave crest line, which is assumed parallel to the tangent at the downcoast limit of the beach (Hsu et al., 1989b). Hsu et al. (1989a) admitted that the log-spiral formulation of Silvester (1974) is still useful as a secondary check.

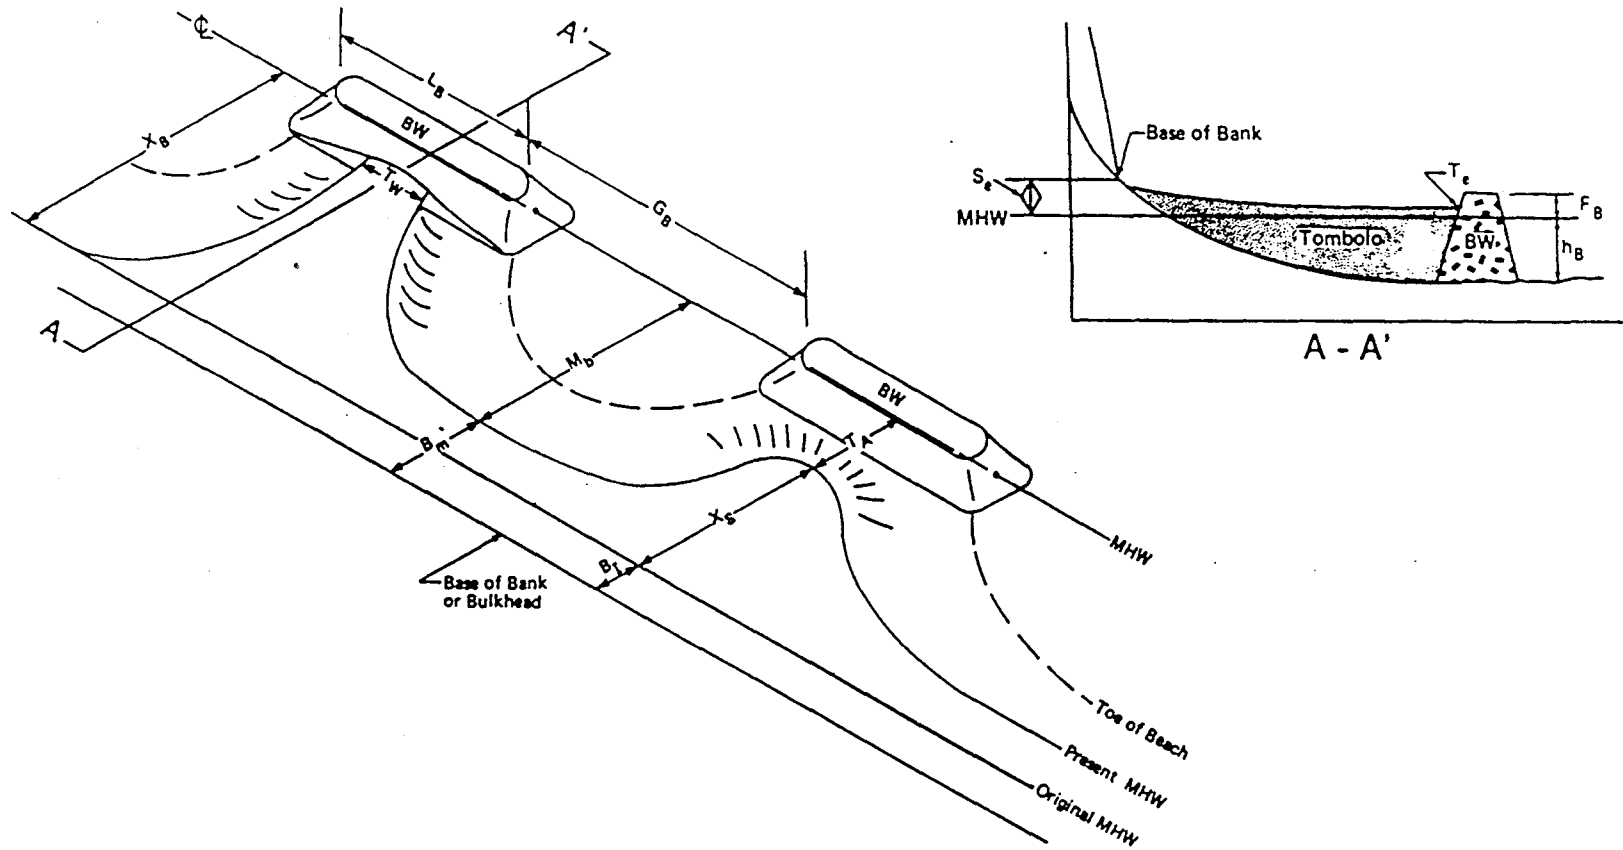
L_B - Breakwater crest length

G_B - Breakwater gap

The parameters that will be discussed are depicted in Figure 6. Some parameters were obtained from Suh and Dalrymple (1987) and are L_B , G_B , h_B , X_B and X_s . The other parameters were developed by this study and include M_b , B_m , B_I , T_w , T_A , F_B , S_e , and T_e .

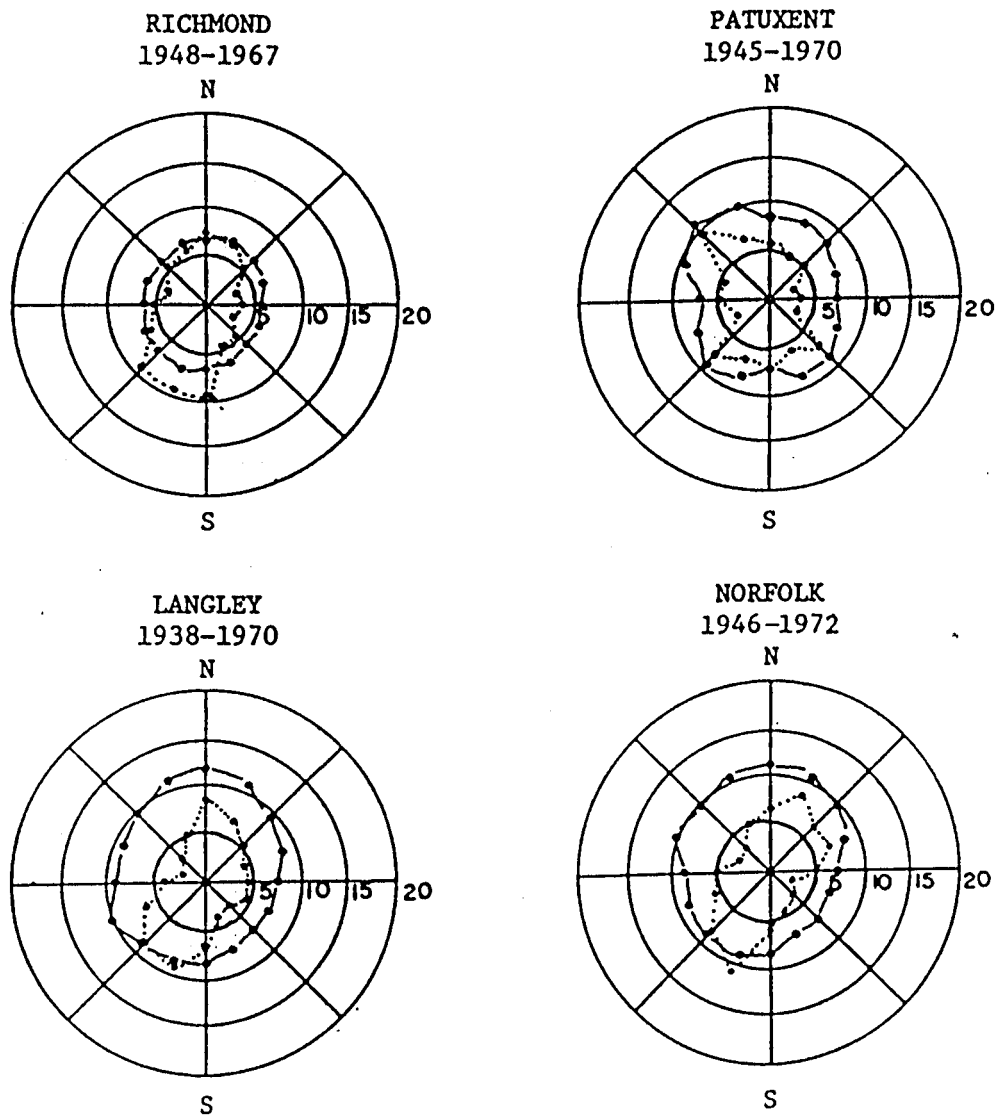
Figure 7. Long term wind roses for Richmond, Patuxent, Langley, and Norfolk.
 ••••• Frequency of occurrence(%)
 —•— Average velocity(kts)
 (Hardaway et al., 1984)

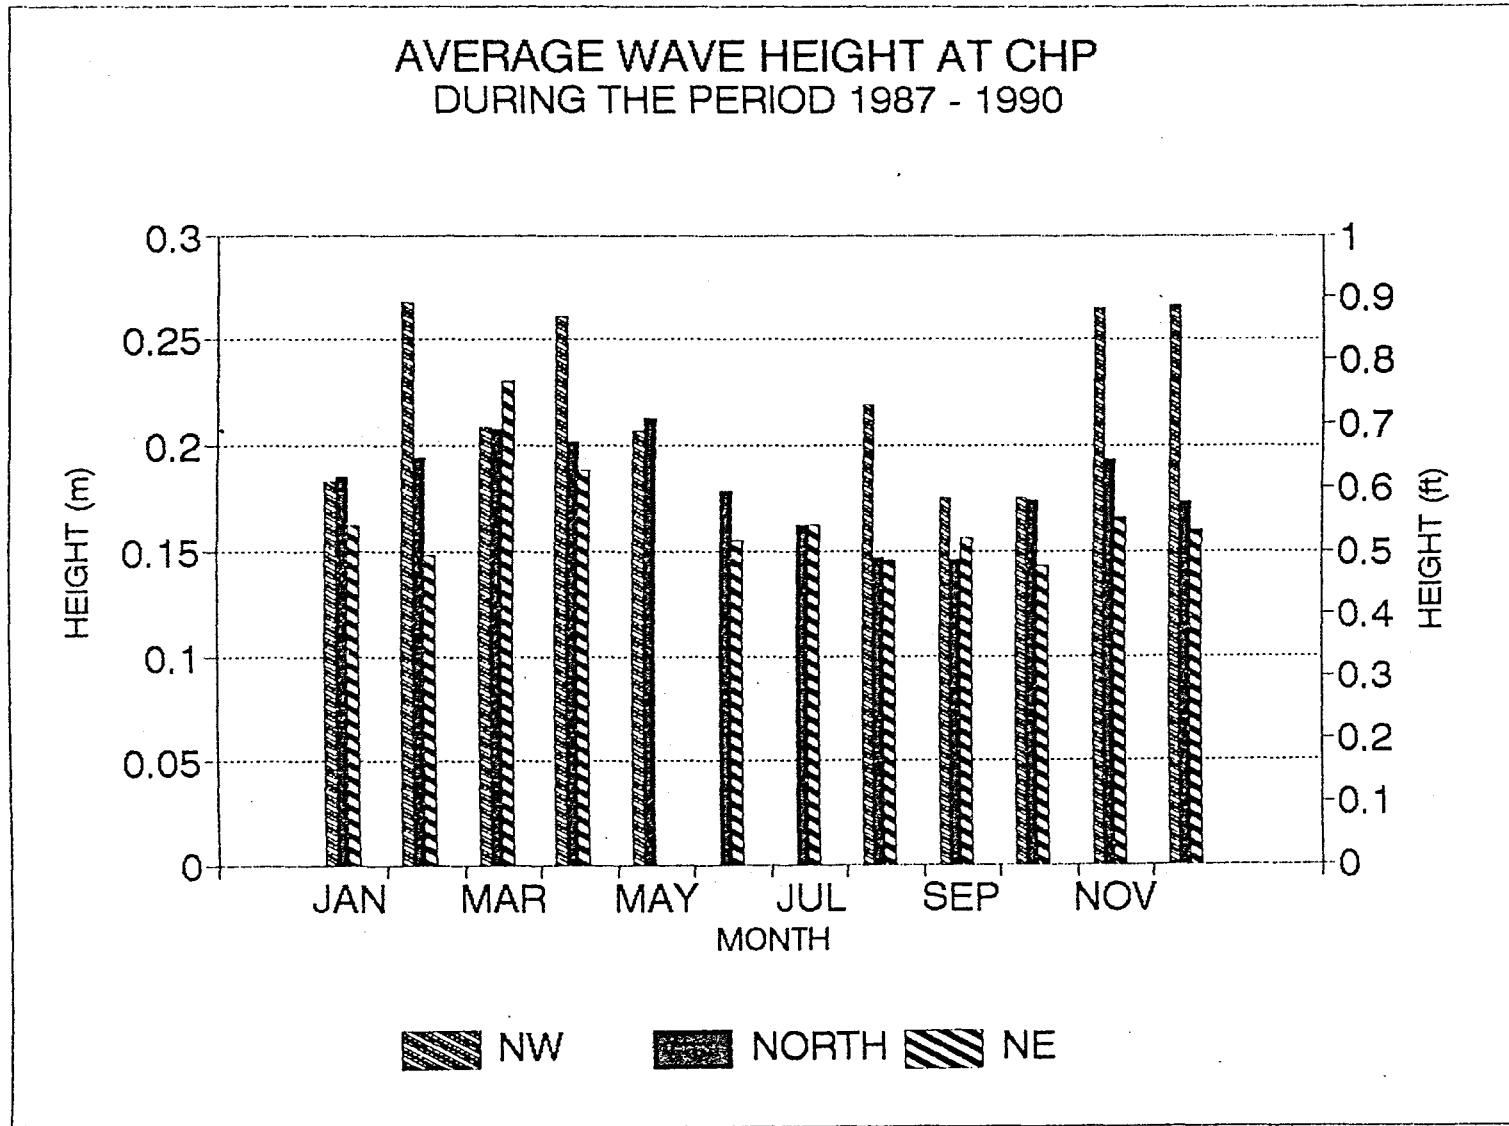
Figure 9. Chippokes State Park wave heights.

The Chippokes breakwater system faces almost due north with an average fetch of 2.4 nautical miles. Long fetches of 5.0 and 8.0 nautical miles occur to the north northeast and northwest, respectively. Strong seasonal winds from the north and northwest tend to force beach sediments to the east. During northeast storm events (i.e. April 1988), waves approach from the north to north northeast with breaking wave heights of 1.4 to 1.8 feet. Wave conditions at the breakwaters are seen in Figure 9 for the period January 1987 to August 1990. The mean wave height for this

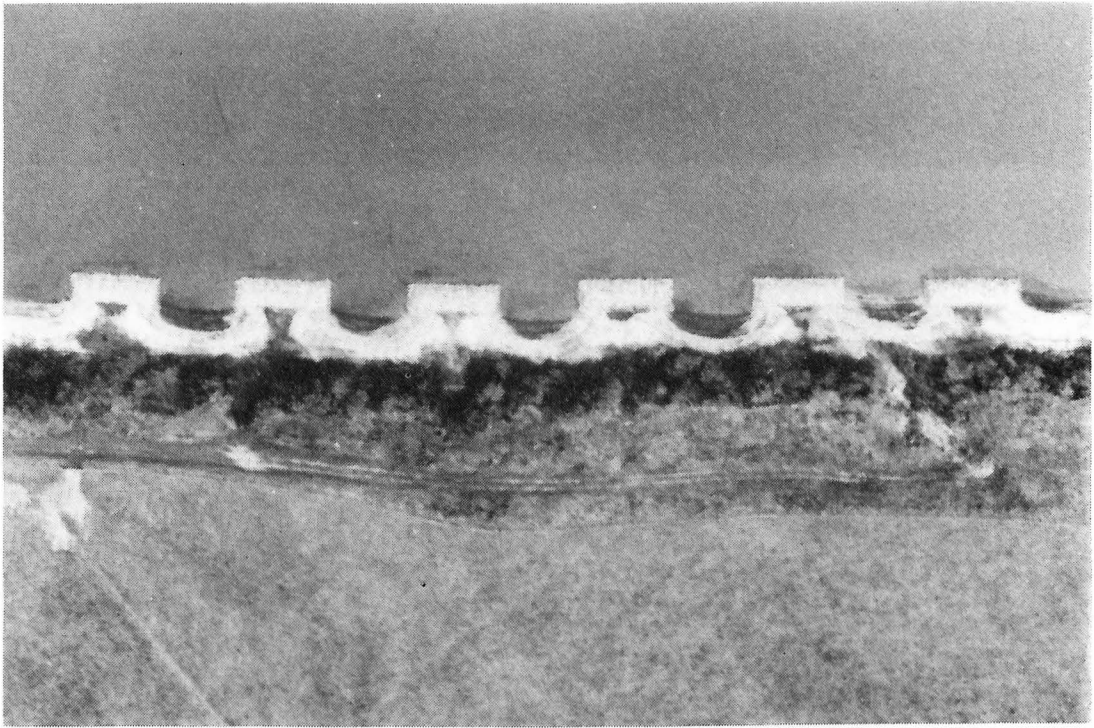
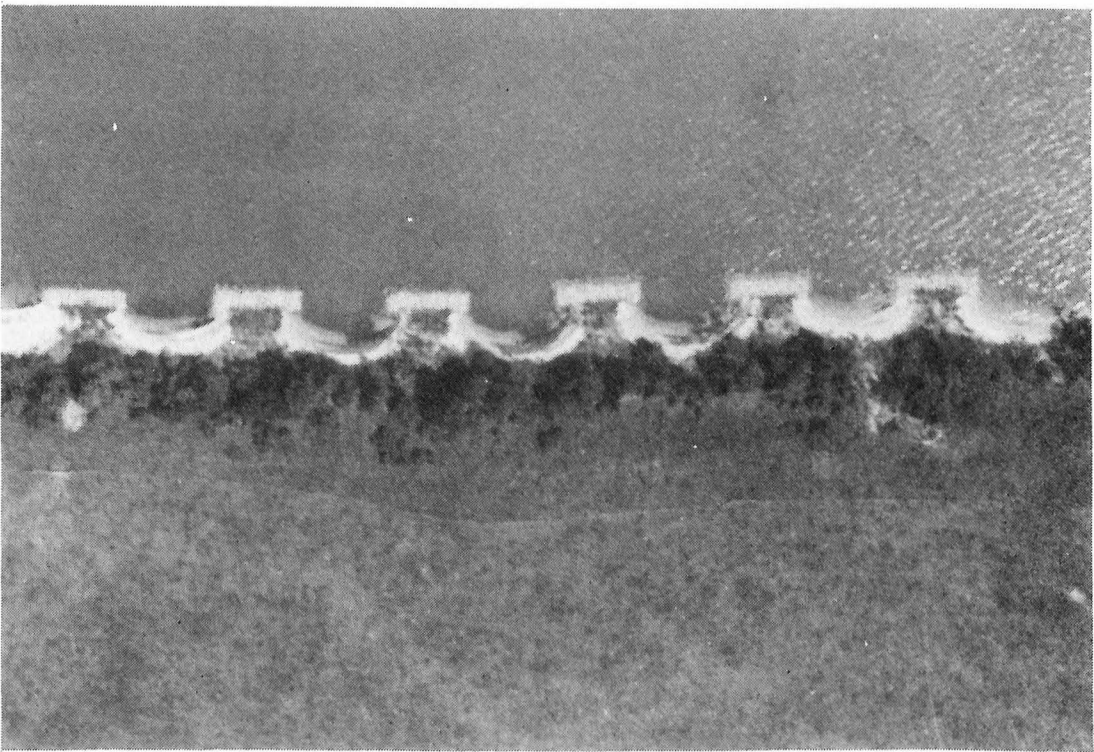
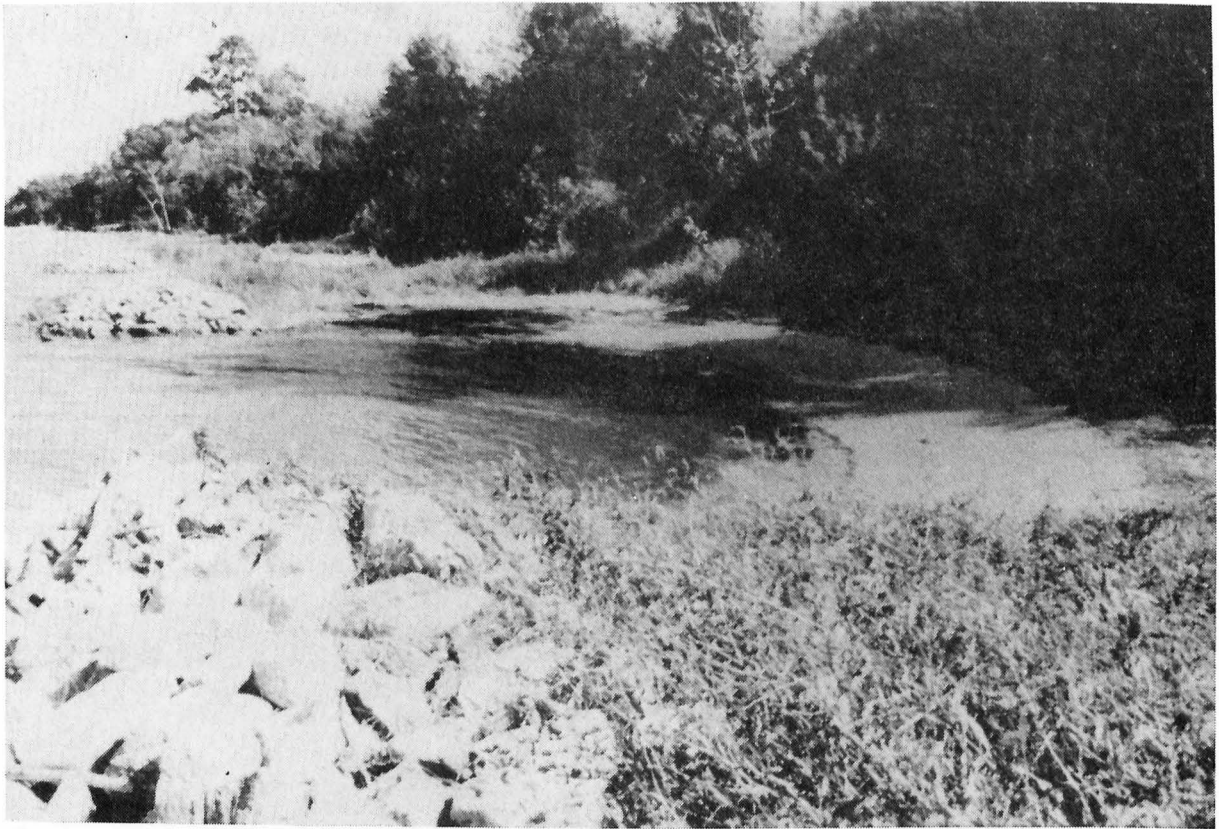
Figure 10A. Chippokes State Park - vertical aerial, 25 September 1987.

Figure 10B. Chippokes State Park - vertical aerial, 25 May 1990.

Figure 10C. Chippokes State Park - ground view looking east from
breakwater number 1.

The overall shape of each embayment has remained constant. Slight shifts are observed in beach position in response to more oblique northwest winds but a general symmetrically curvilinear planform persists.

Sand accretion on the updrift end and behind breakwater 1 is observed as well as sand bypassing into bay A and behind breakwater 2. Breakwater 3, in the center of the system has accumulated less material than the other structures. Bays B, C, and D have lost sand while Bay E has gained a significant amount. This increase is mostly from the continued washout of the construction access road at that point. For the most part the base of the bank continues to erode. Most of the losses occurred during the April 1988 storm (Hardaway et al., 1989). Shore profile changes for the project period are found in Appendix A.

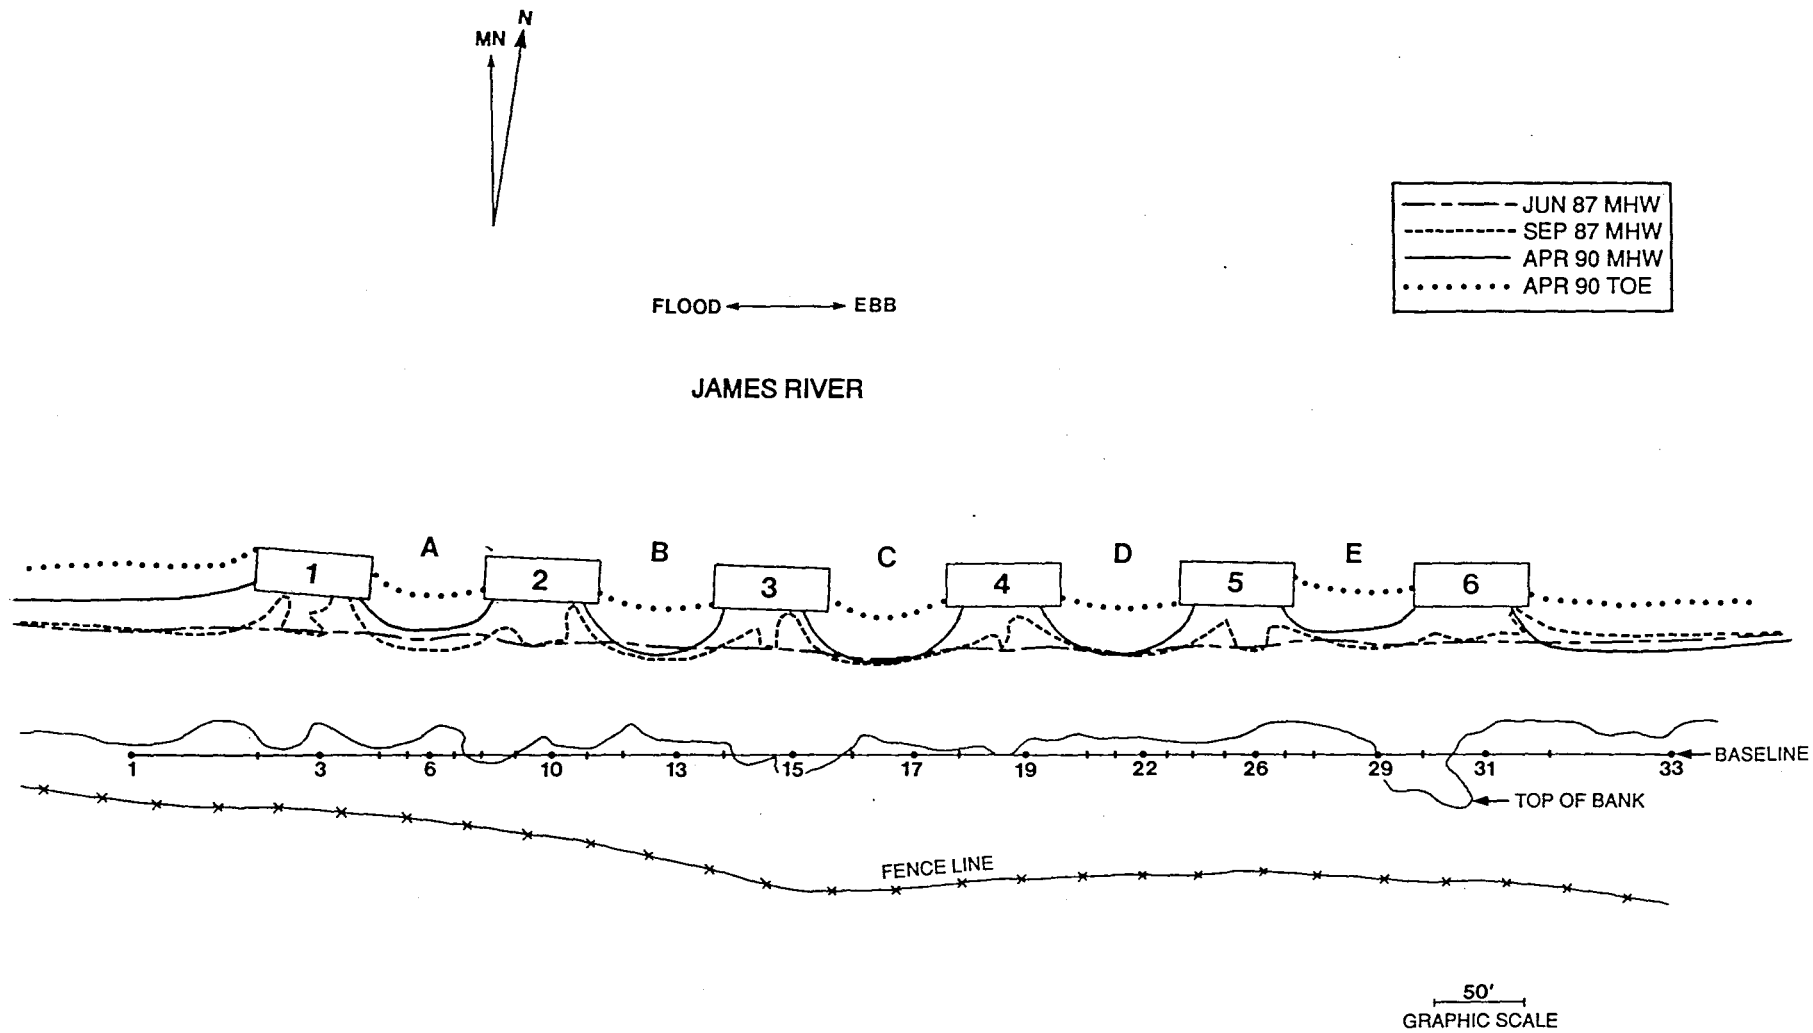
Figure 11. Chippokes State Park base map.

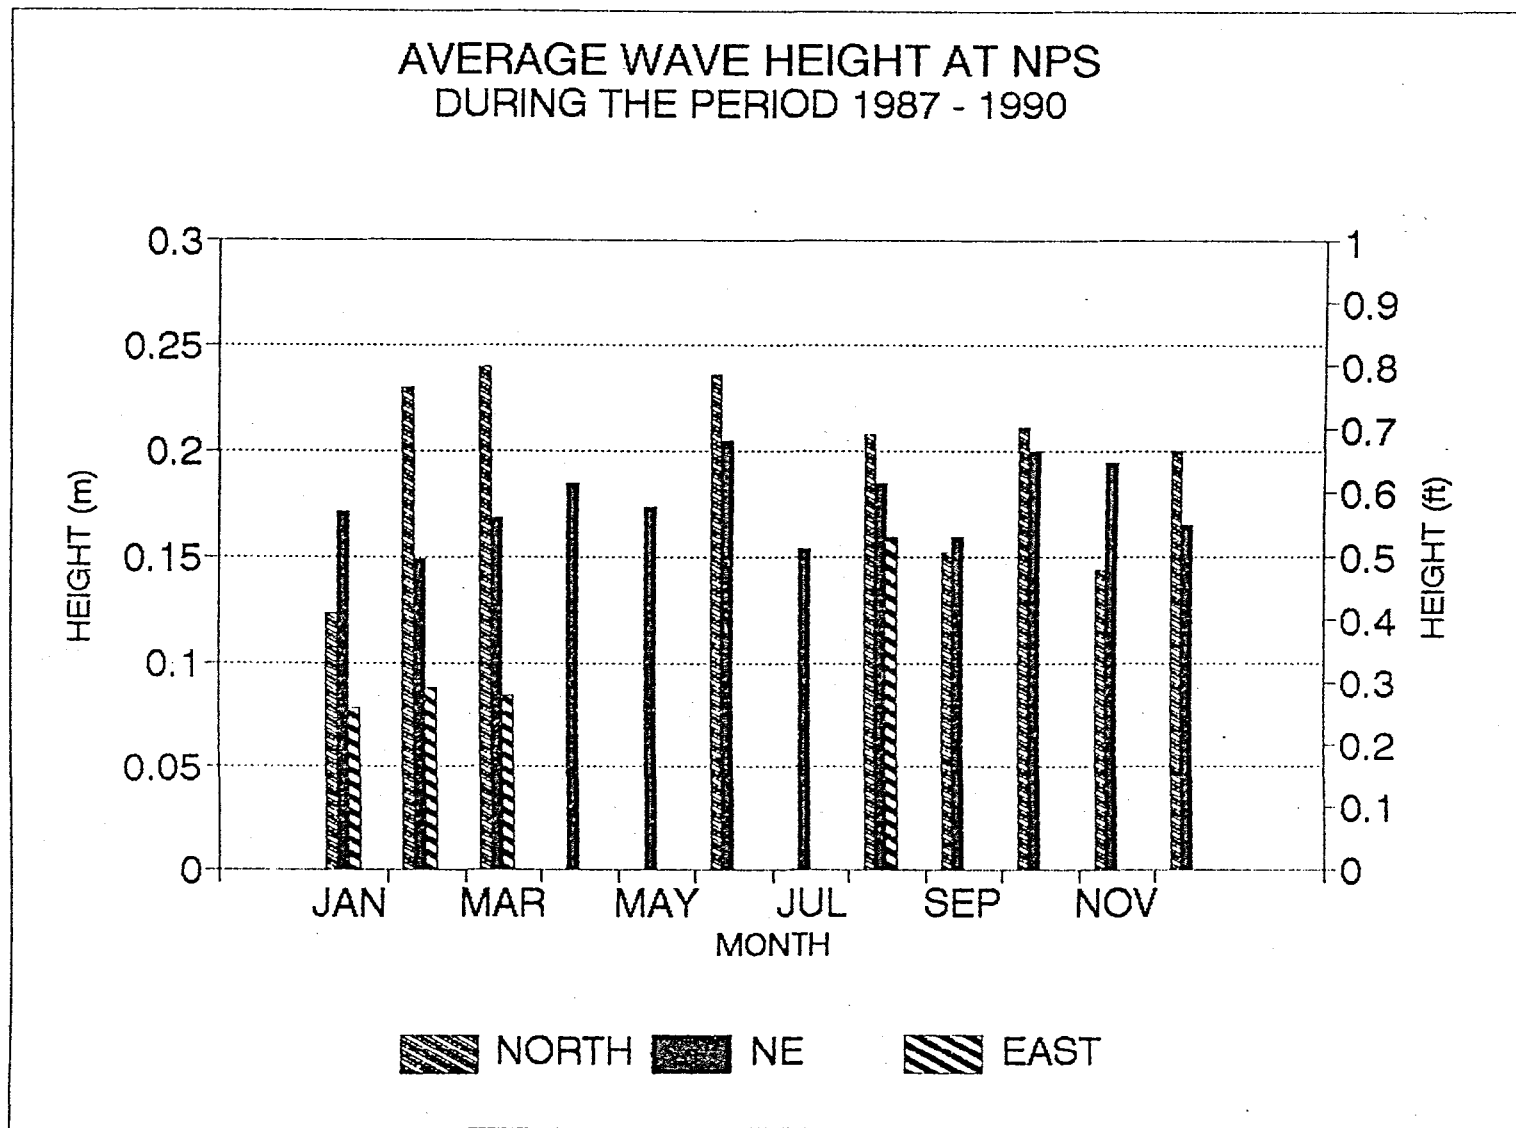
Figure 14. Parkway Breakwaters wave heights.

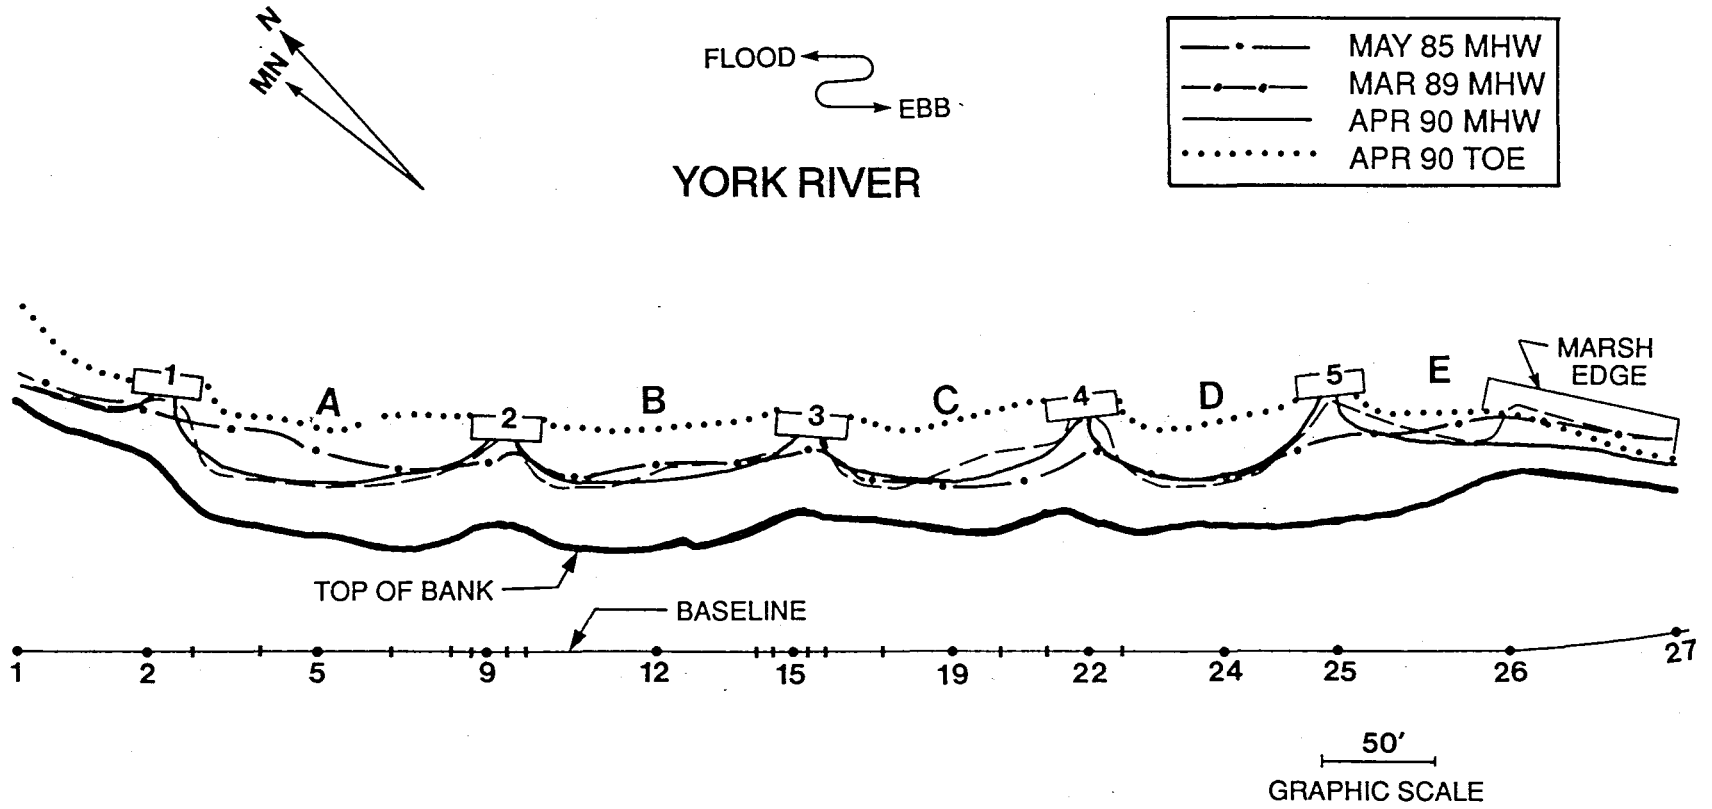
Figure 15. Parkway Breakwaters base map.

Beach volume changes show net losses in Bays A and B (Table 5). This material most likely was shifted behind adjacent breakwaters as well as downriver. Bank erosion has supplied additional sediments and accounts for the increase in beach volume behind breakwaters 3, 4 and 5.

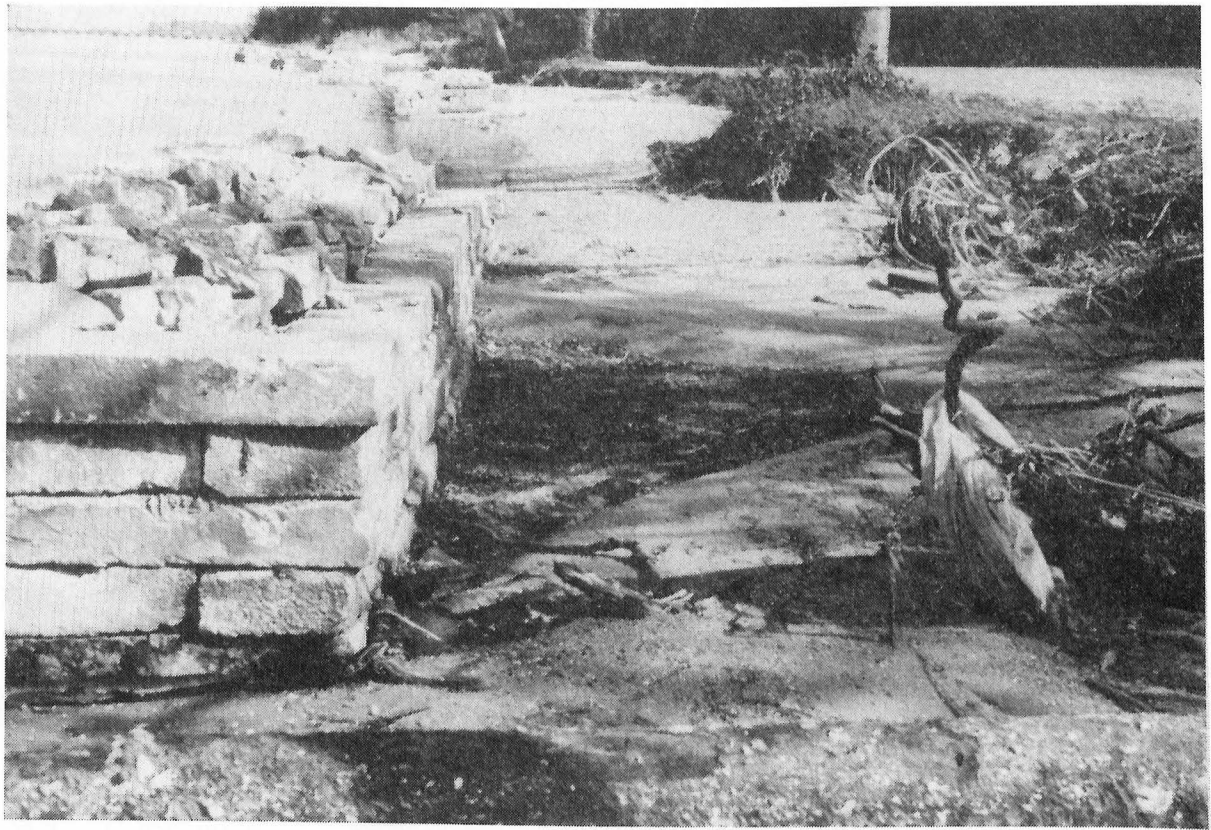
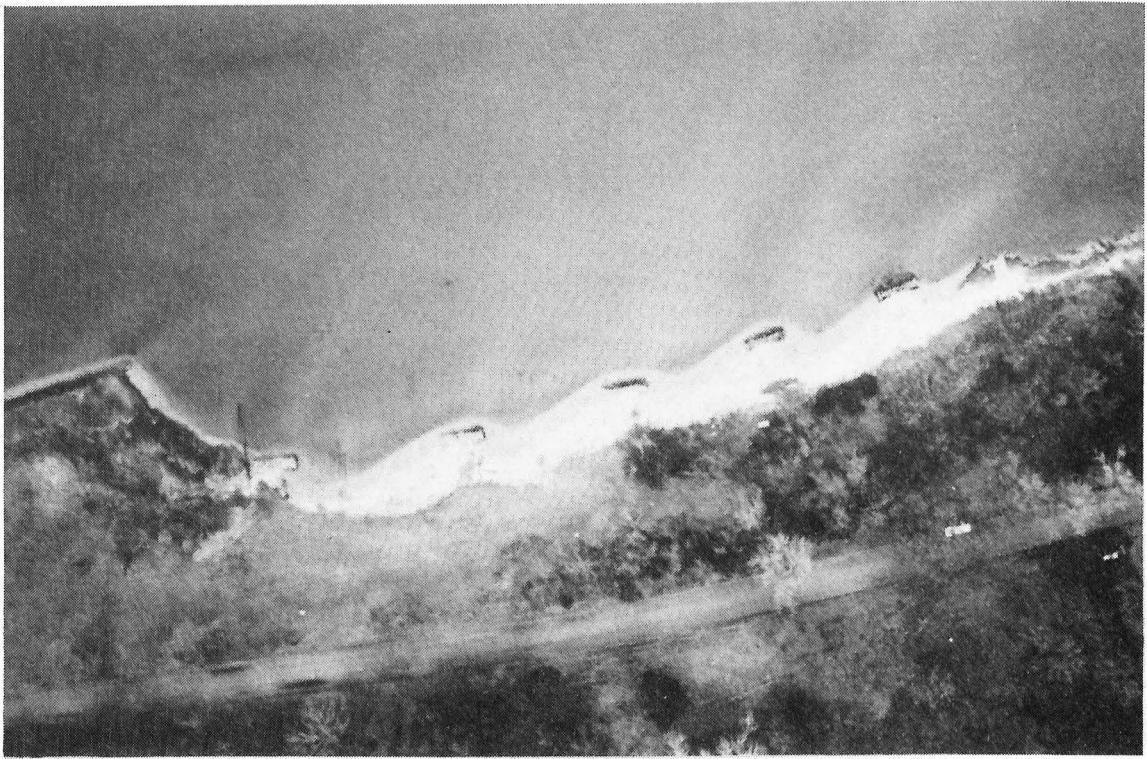
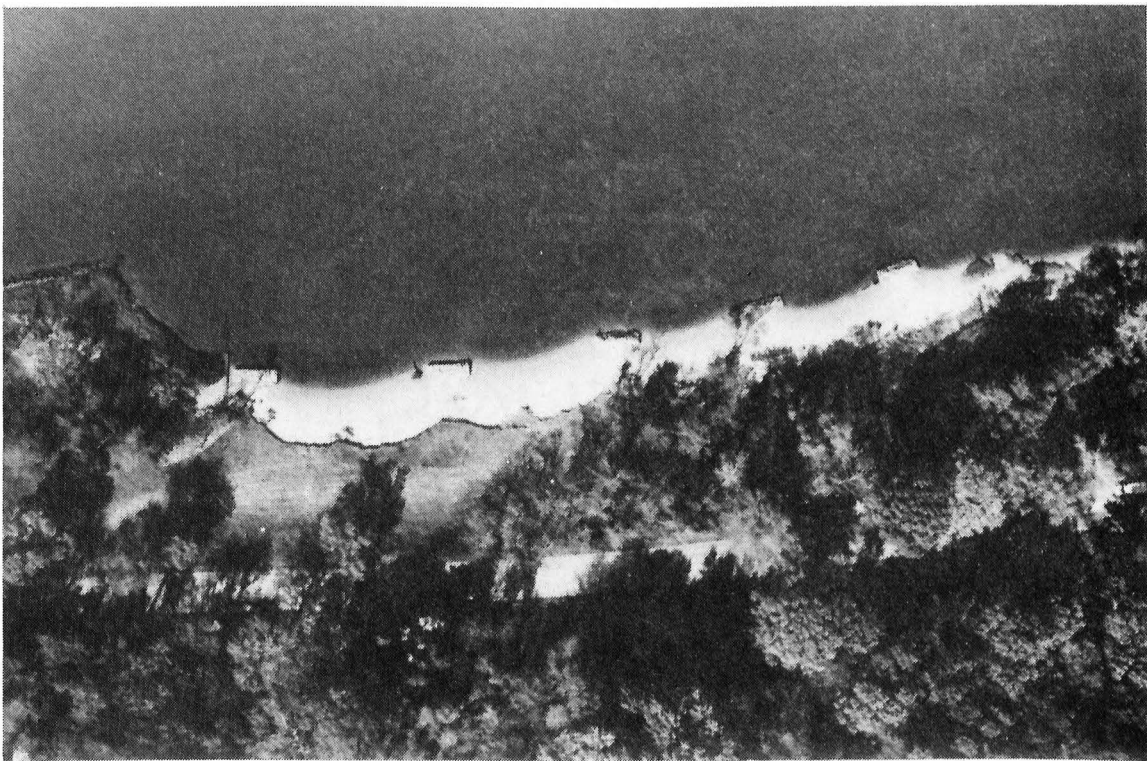
Figure 16A. Parkway Breakwaters - ground view looking east. Breakwater number 1 is in the foreground.

Figure 16B. Parkway Breakwaters - vertical aerial, 9 March 1988.

Figure 16C. Parkway Breakwaters - vertical aerial, 20 April 1988.

The April 1988 northeaster caused additional bank erosion at Parkway breakwaters which also widened the backshore along most of the site (Figure 16C). Storm waves approached the site during high tide from between 35 and 40 degrees (TN). This caused a shift in the beach planform to a more symmetrical shape with flattened embayments. This general symmetrical planform persisted until the late fall of 1988 when the return of northwesterly winds reshaped the beaches into a log-spiral configuration. The late winter storms of 1989 once again shifted the

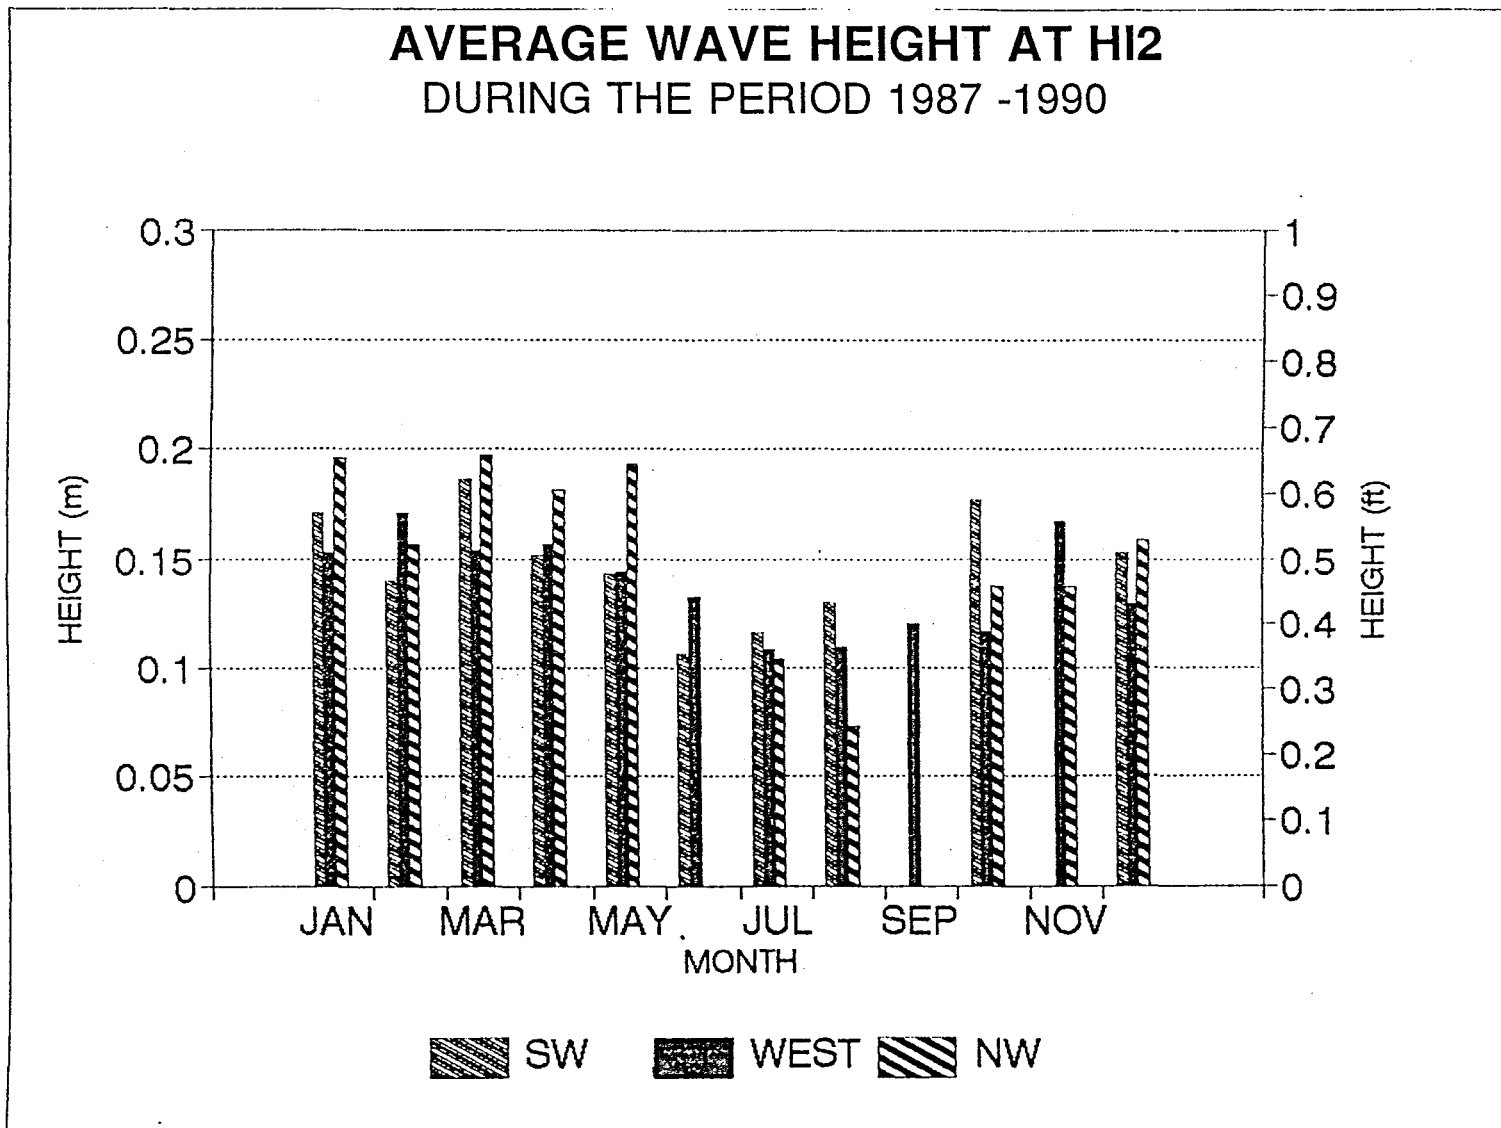
Figure 19. Hog Island Breakwaters wave heights.

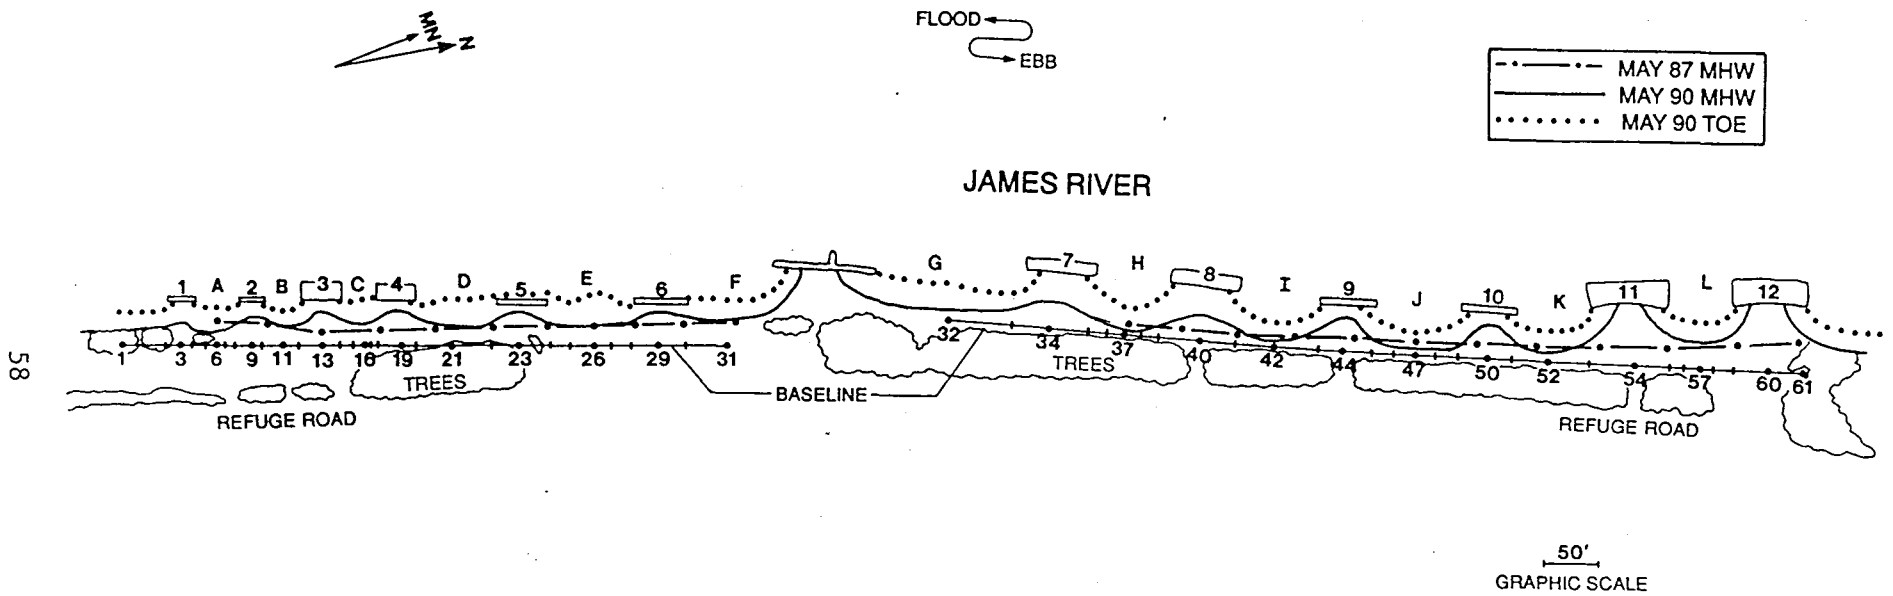
Figure 20. Hog Island Breakwaters base map.

Beach widths (B_m) are restricted in the most bay types due to the initial close proximity to the upland bank. There has been a general sand loss from the entire system but locally net gains in beach sand are noted at breakwaters 3, 4, 5, 7, 11 and 12 (Table 7). The value V_f indicates the net gain or loss after the initial beach fill. There is a general gain behind each breakwater unit and a corresponding loss from the embayments. Beach profiles for the duration of the project are found in Appendix A.
