Chesapeake Bay Shoreline Study: Headland Breakwaters and Pocket Beaches for Shoreline Erosion Control Final Report

A Final Report Obtained Under Contract With
The United States Army Corps of Engineers, Norfolk District
With The Virginia Department of Conservation and Recreation

Special Report in Applied Marine Science and Ocean Engineering
No. 313

March 1991

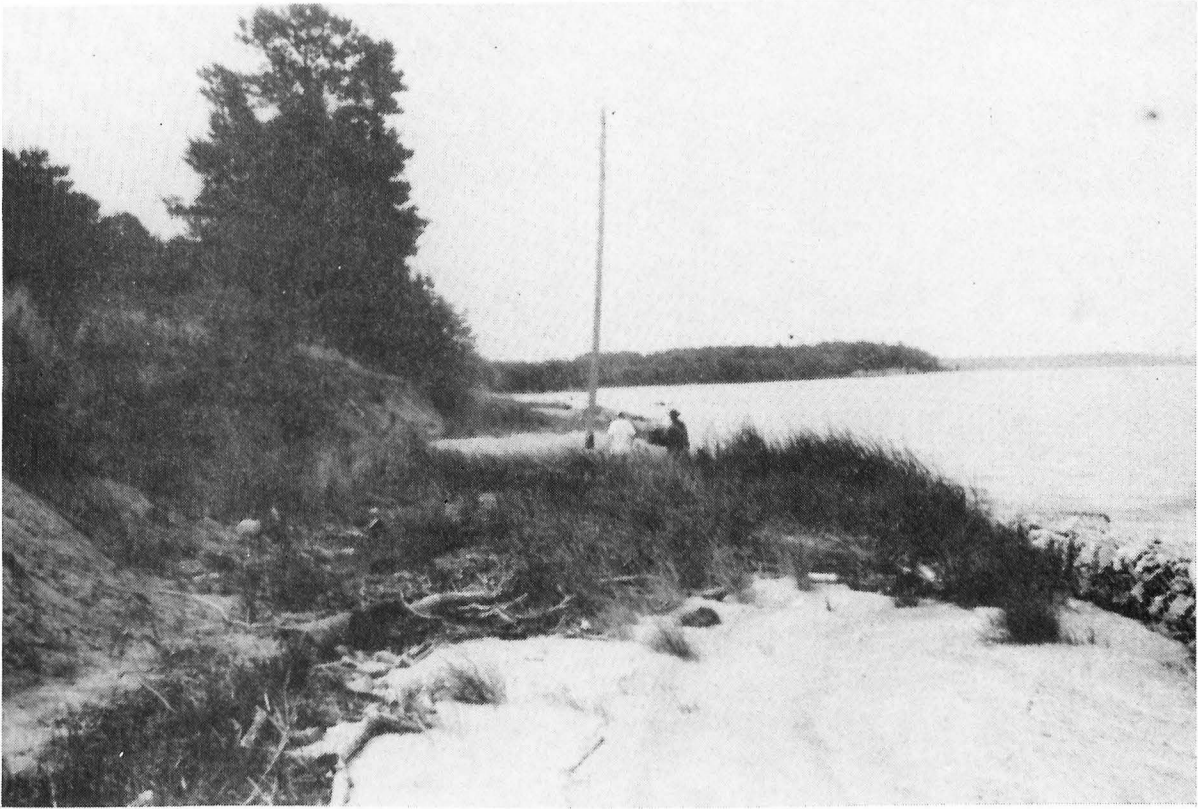
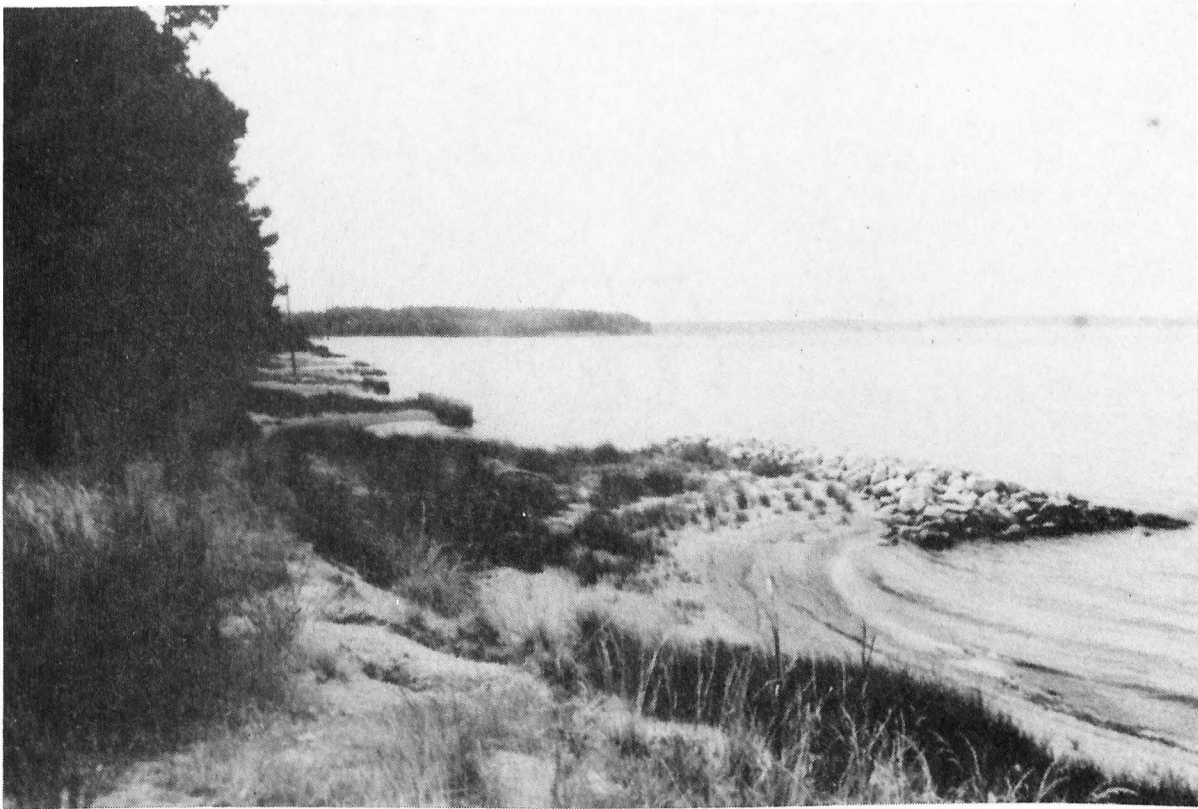
Figure 21A. Hog Island Breakwaters - vertical aerial, 10 September 1987.

Figure 21B. Hog Island Breakwaters - vertical aerial, 25 May 1990.

Figure 21C. Hog Island Breakwaters - ground view looking west from breakwater number 5.

Figure 21D. Hog Island Breakwaters - ground view looking west from breakwater number 12.

(Spartina alterniflora and Spartina patens) have taken hold behind each breakwater and appear to be thriving (Figure 21 C and D). The breakwater system has stabilized the beach and allowed the marsh grasses time to establish in an environment that proved to hostile before. Installing wave damping devices was a recommendation from the previous project (Hardaway et al. 1984).

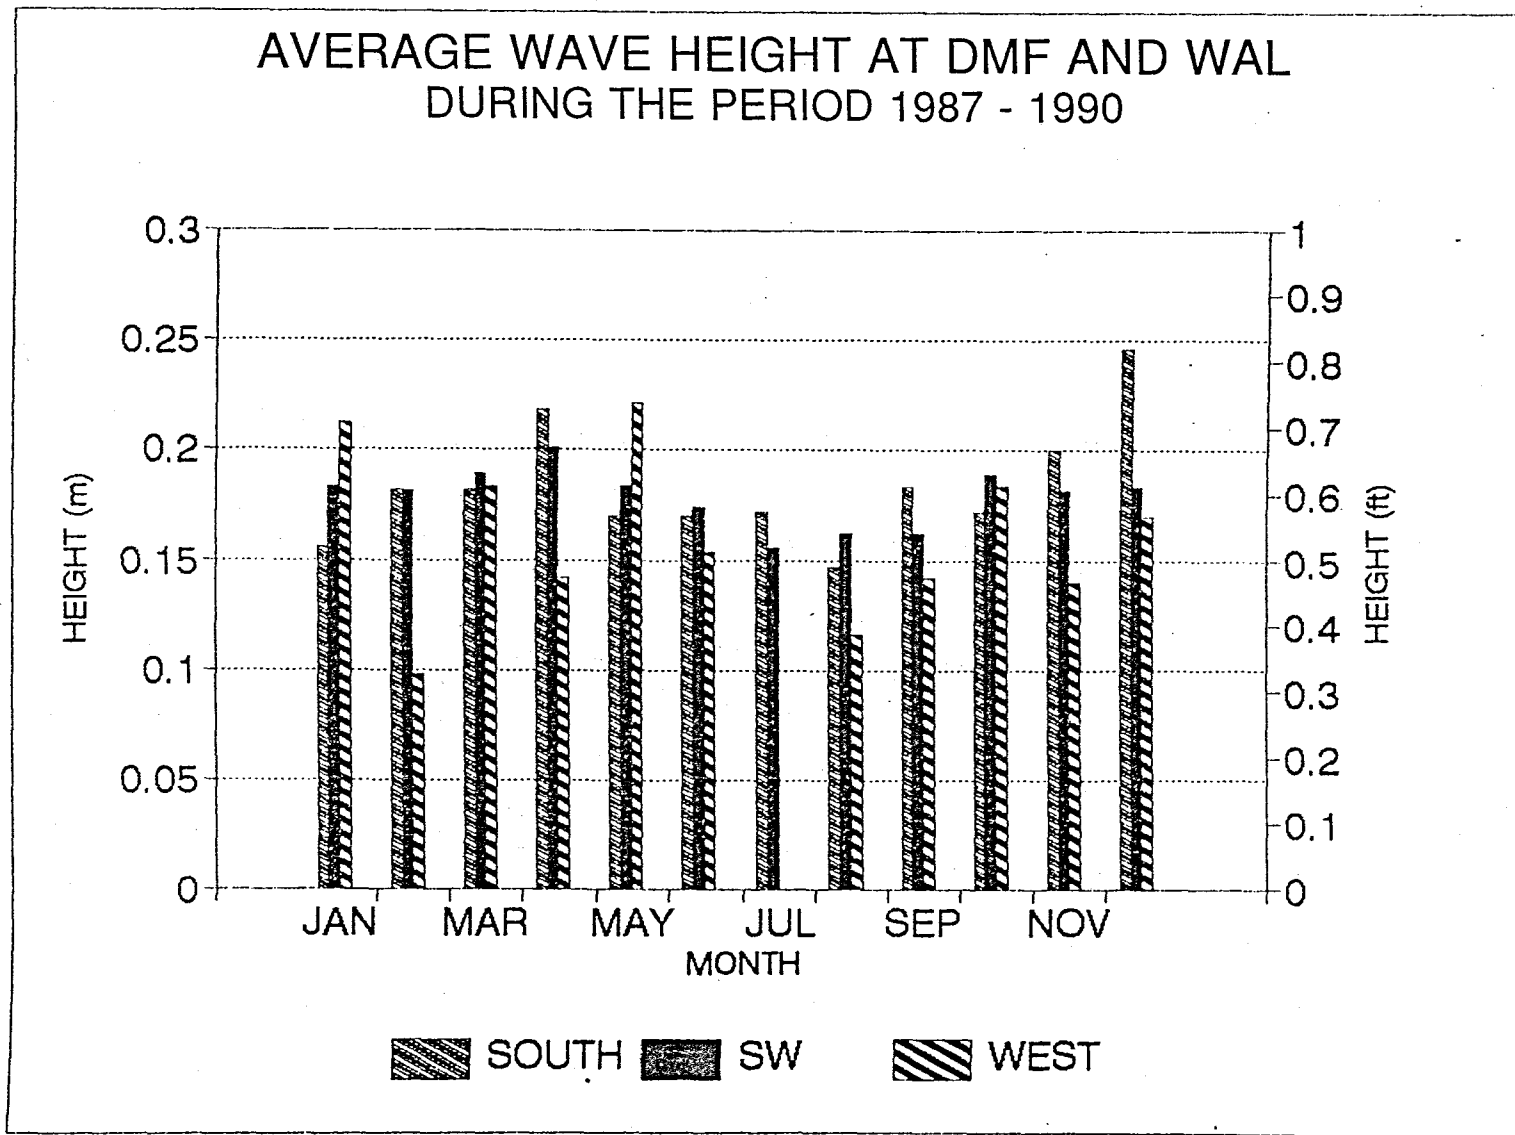
Figure 24. Drummonds Field and Waltrip wave heights.

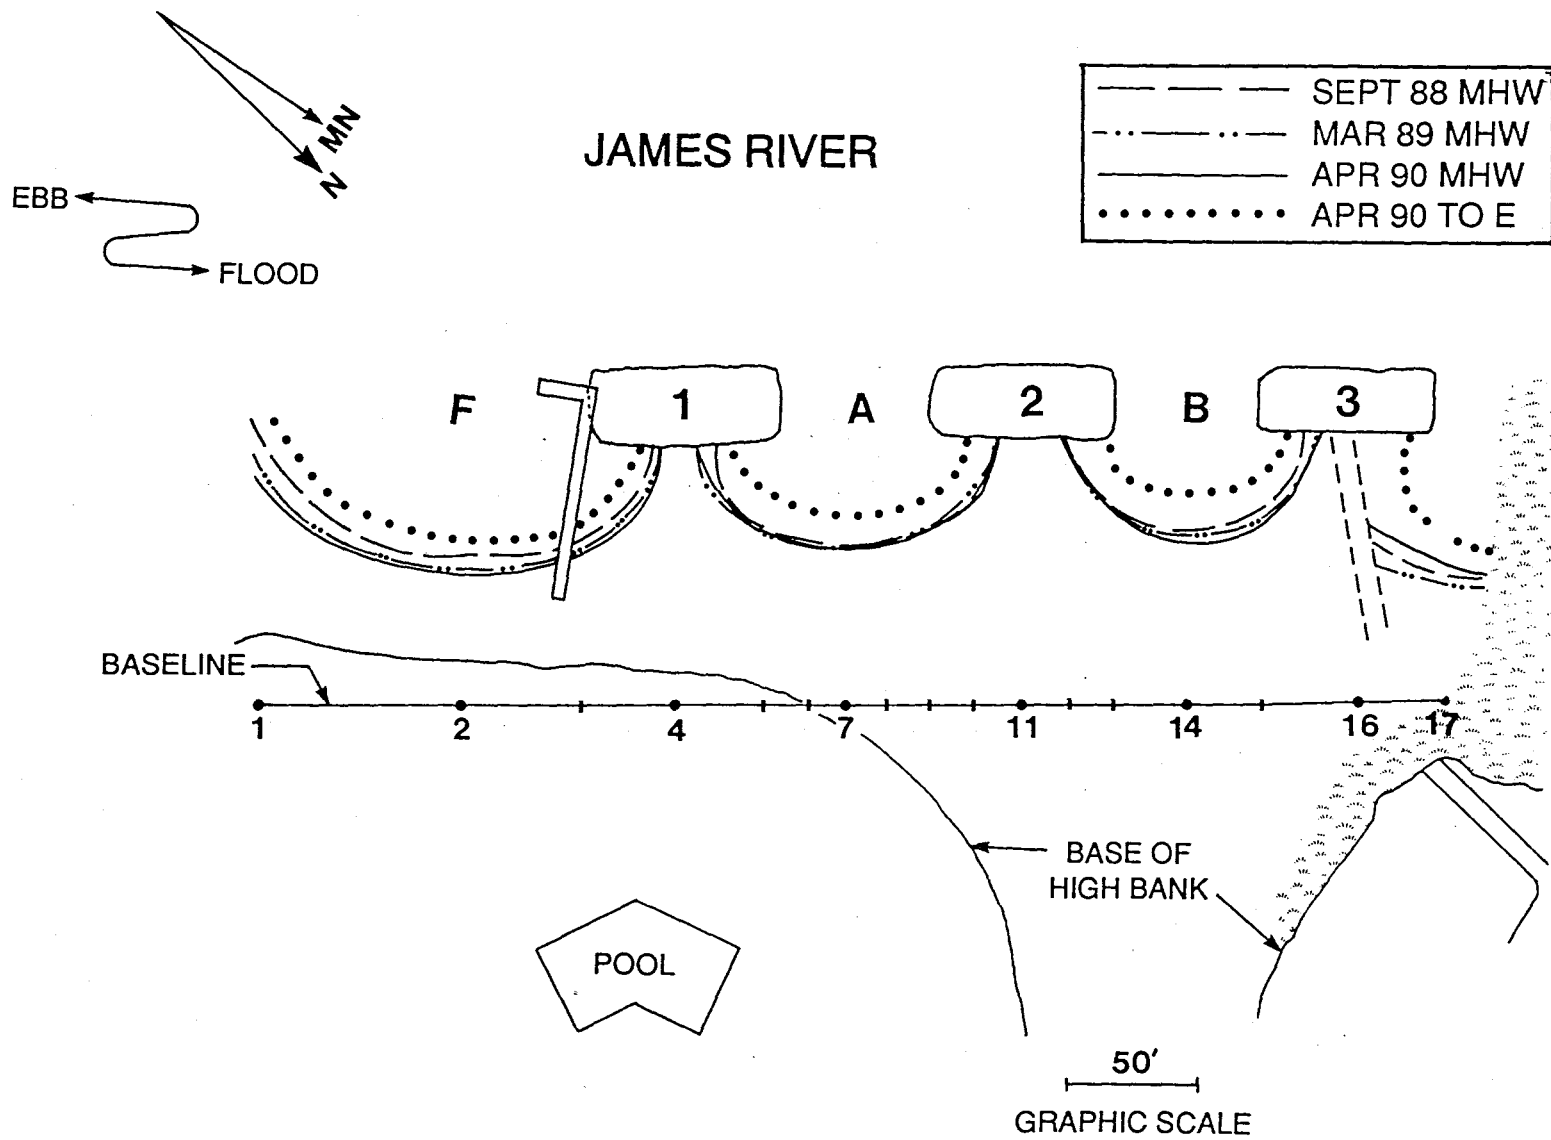
Figure 28. Waltrip base map.

There were no pre-construction profiles established at Waltrip. The site was included in this project in August 1988 and monitoring began in September 1988. After one year, a decrease in tomoblo elevation was noted behind breakwater 2. This corresponds to a net sand volume loss in the lee of the same structure. A slight narrowing of the tomobolos behind each breakwater unit was noted, as well as a landward shift of MHW in Bay B and Bay F (in the adjacent Drummonds Field breakwater system) (Figure 28).

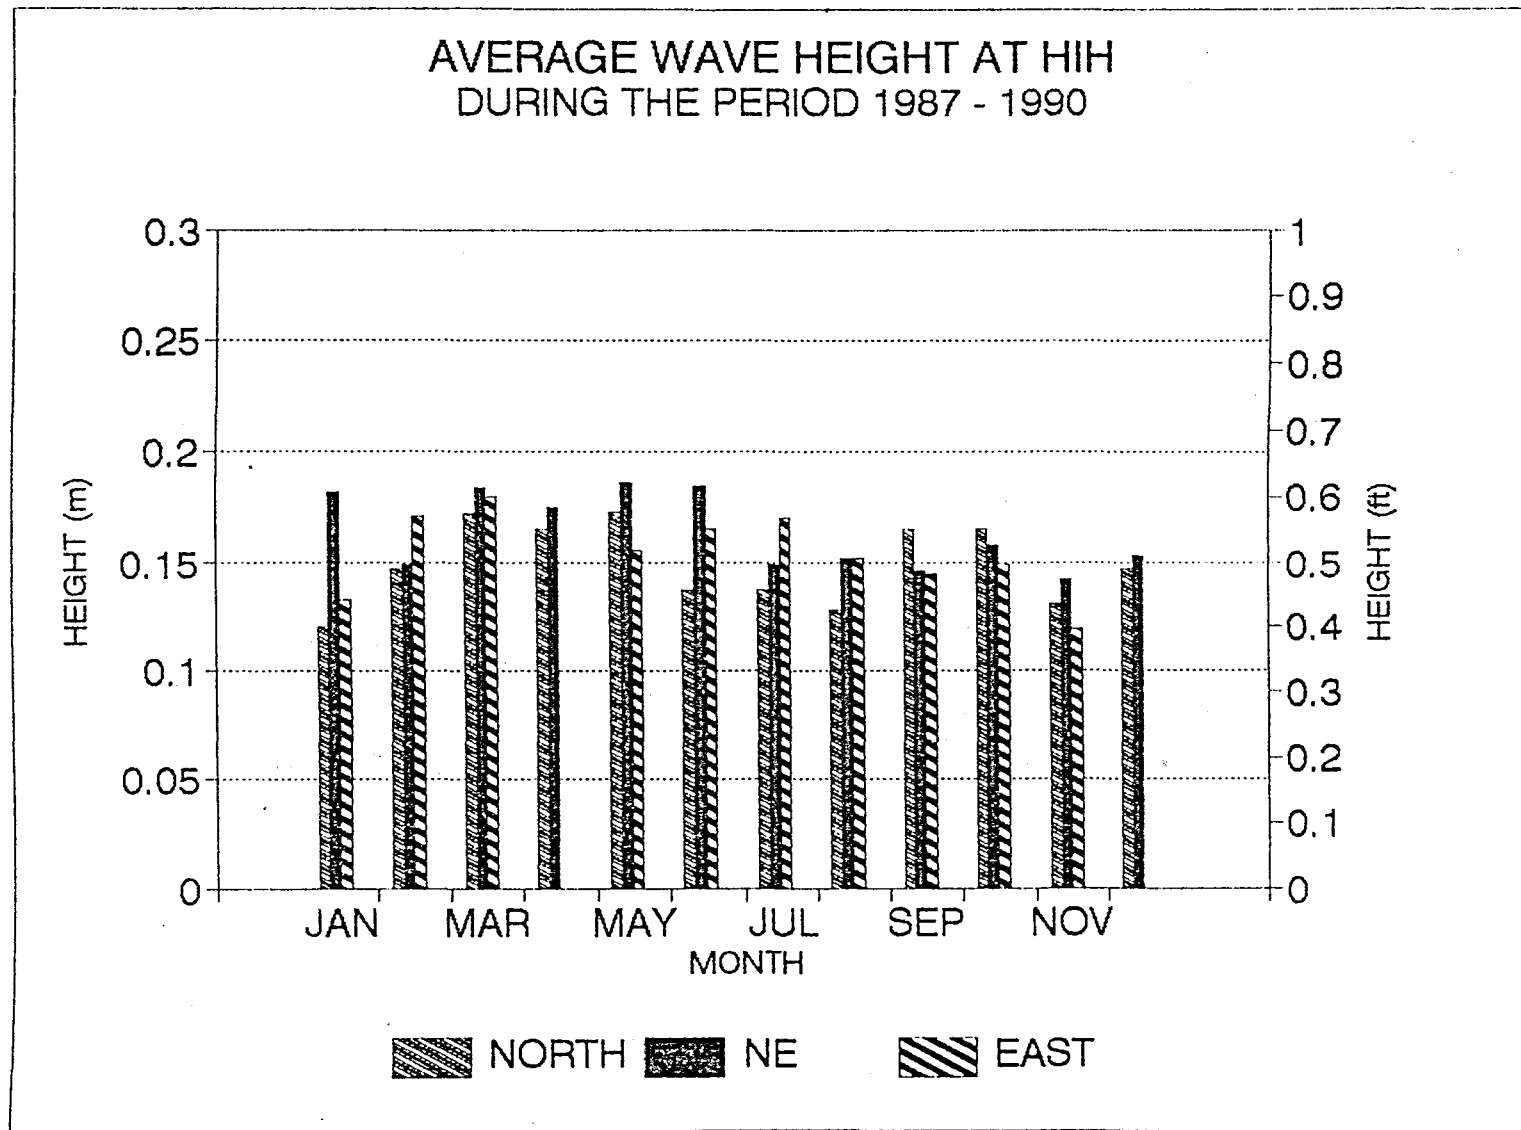
Figure 32. Hog Island Headlands wave heights.

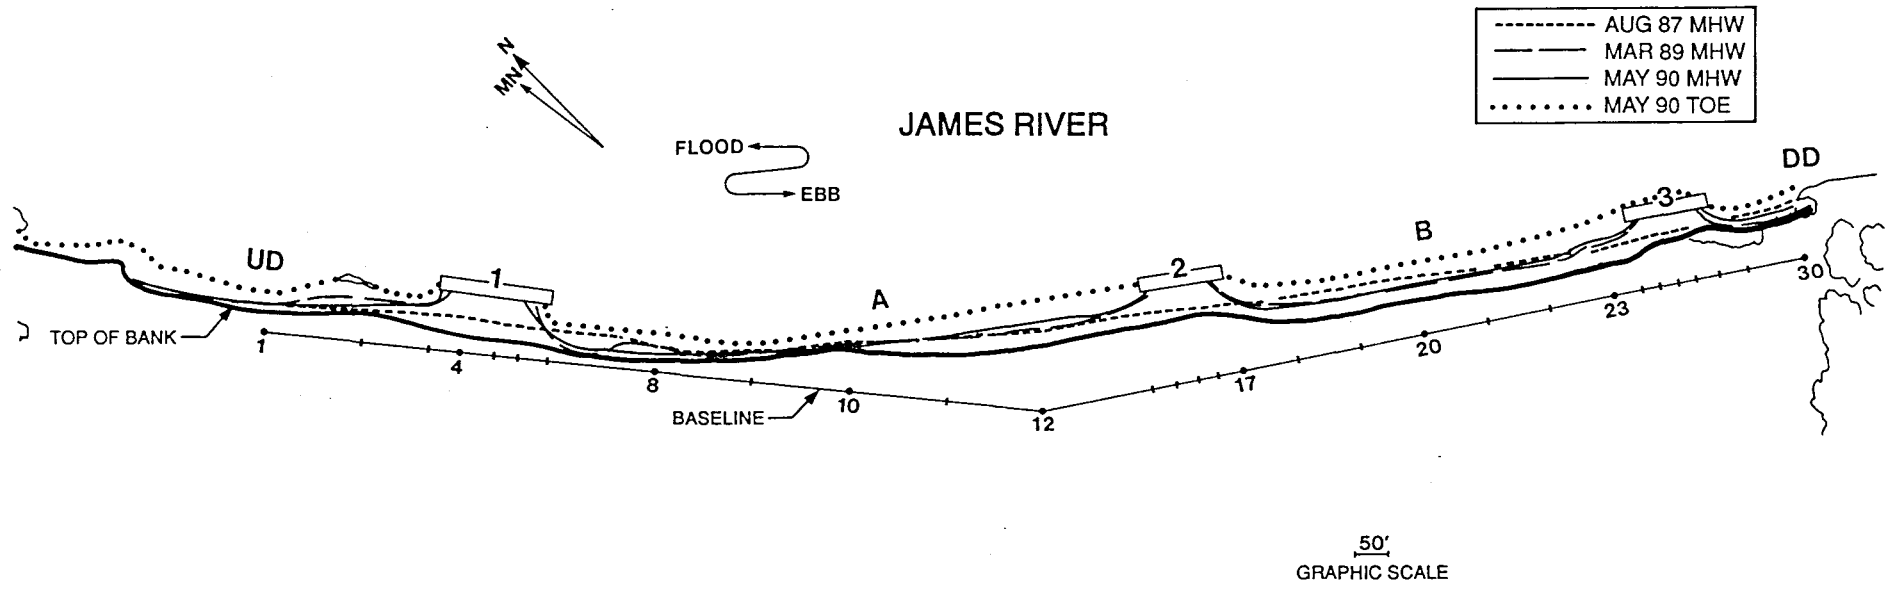
Figure 33. Hog Island Headlands base map.

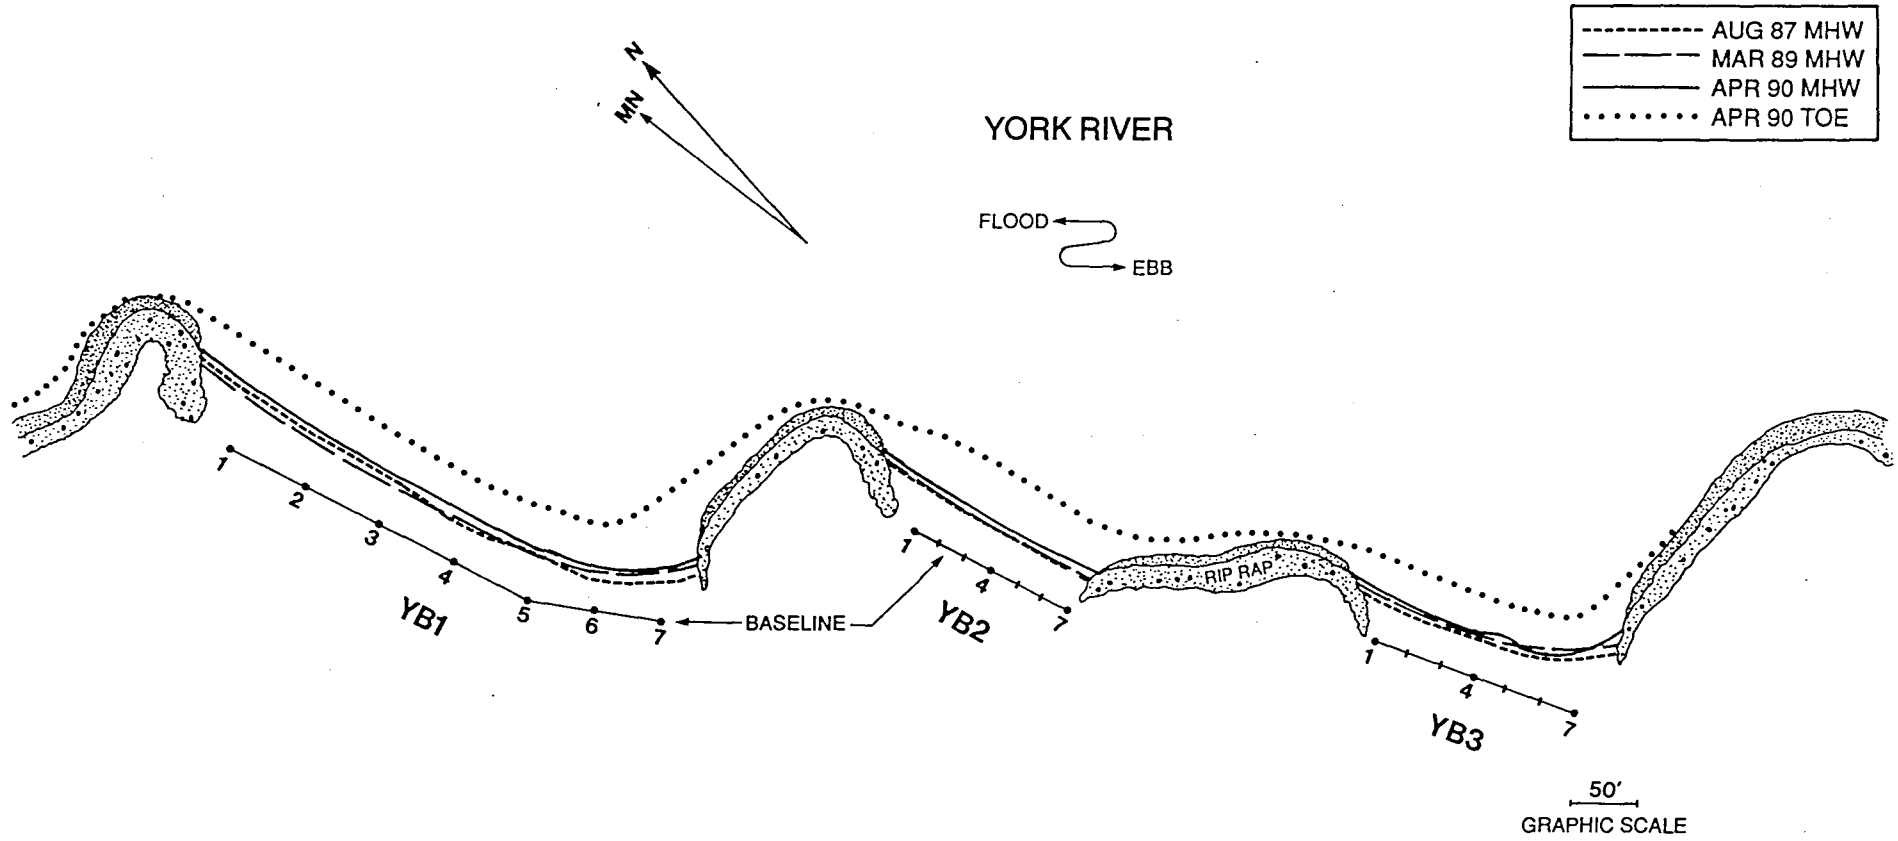
Figure 37. Yorktown Bays base map.

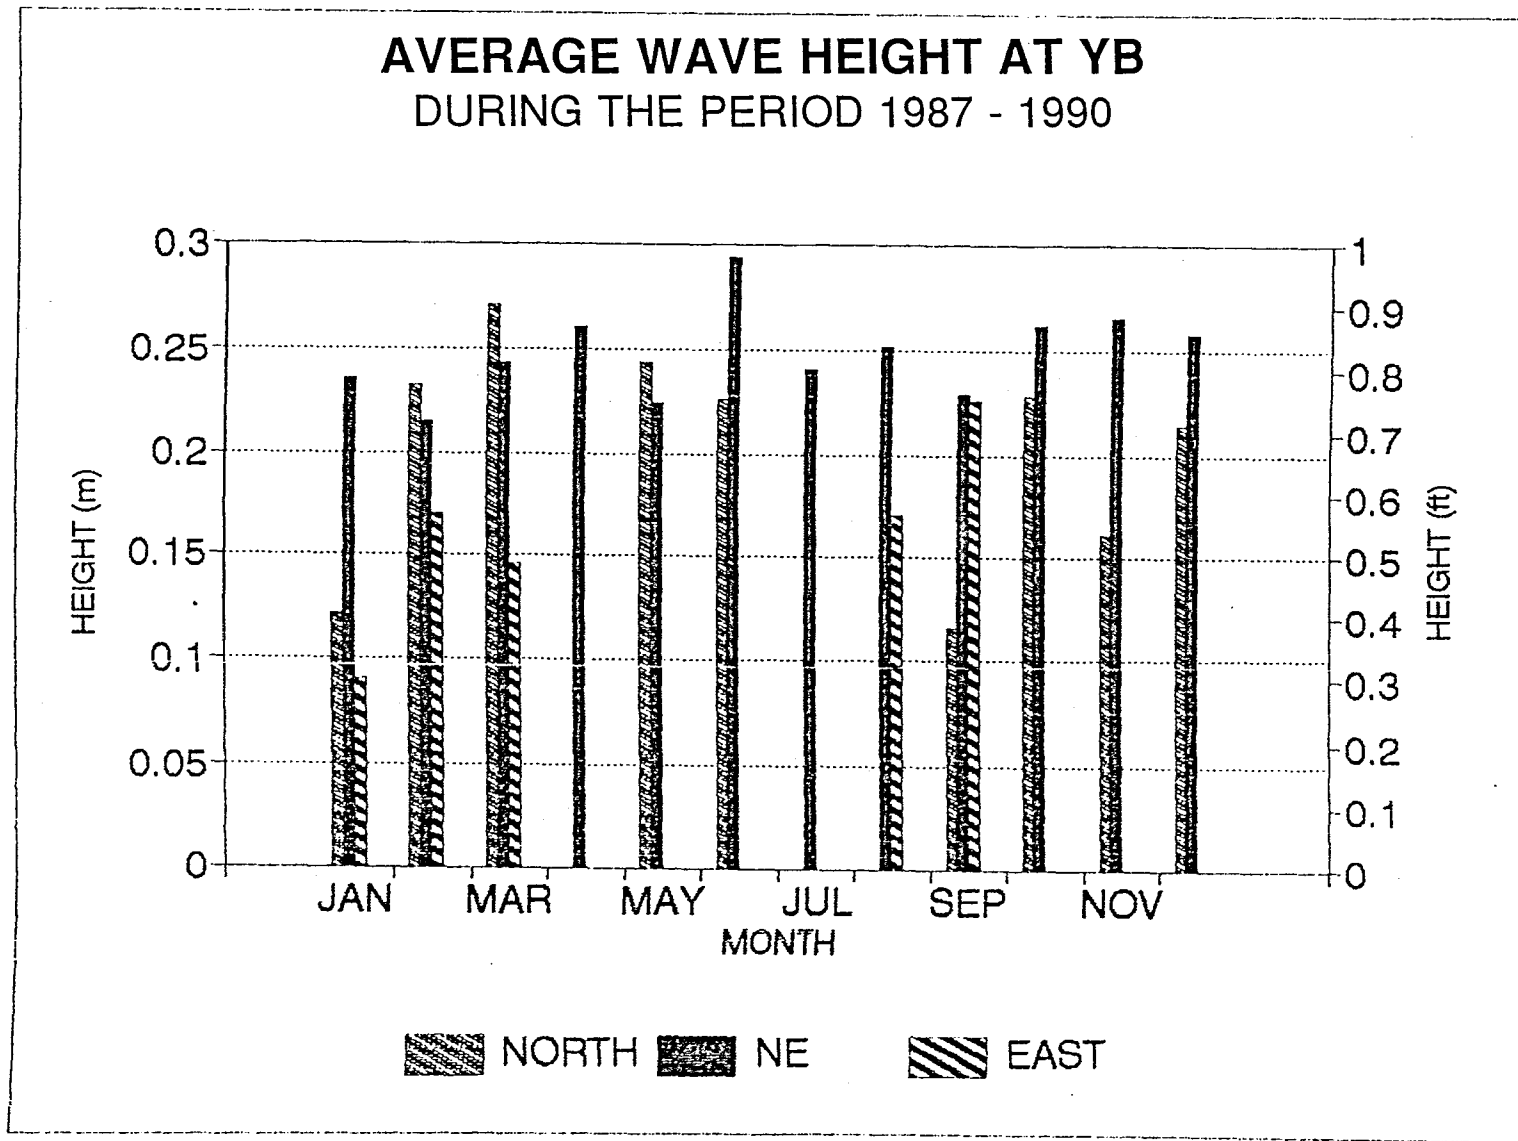
Figure 38. Yorktown Bays wave heights.

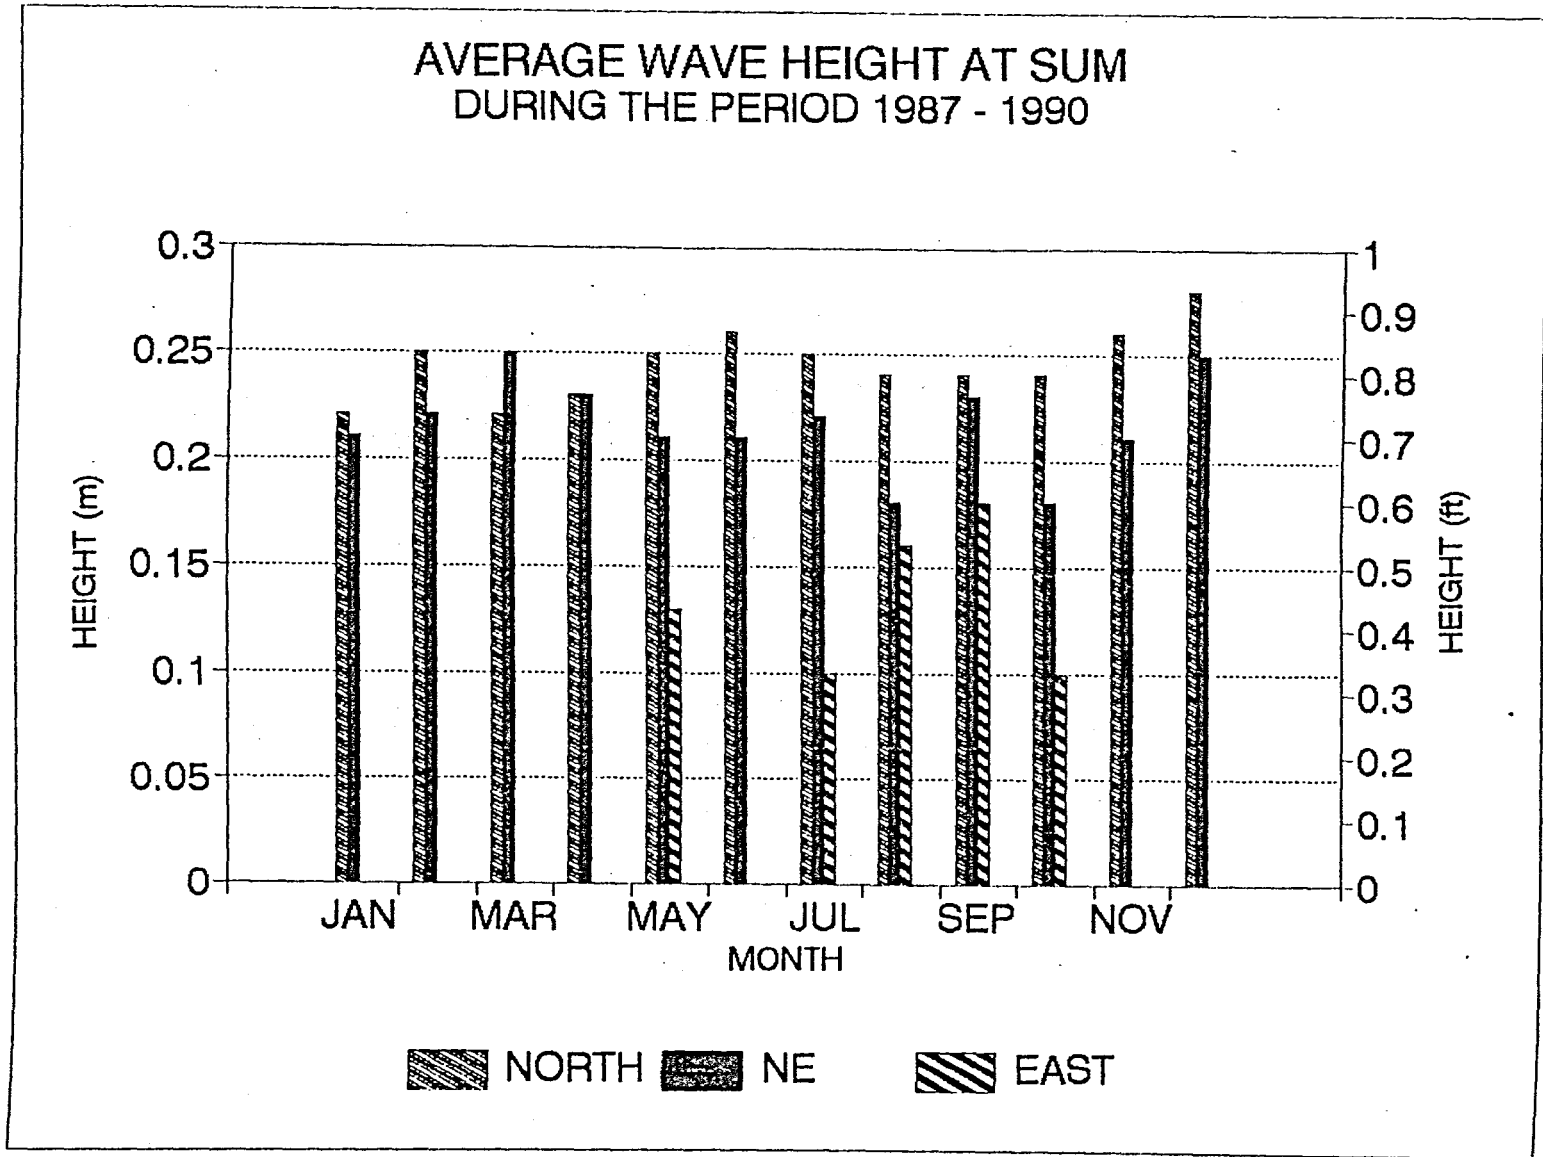
Figure 42. Summerille wave heights.

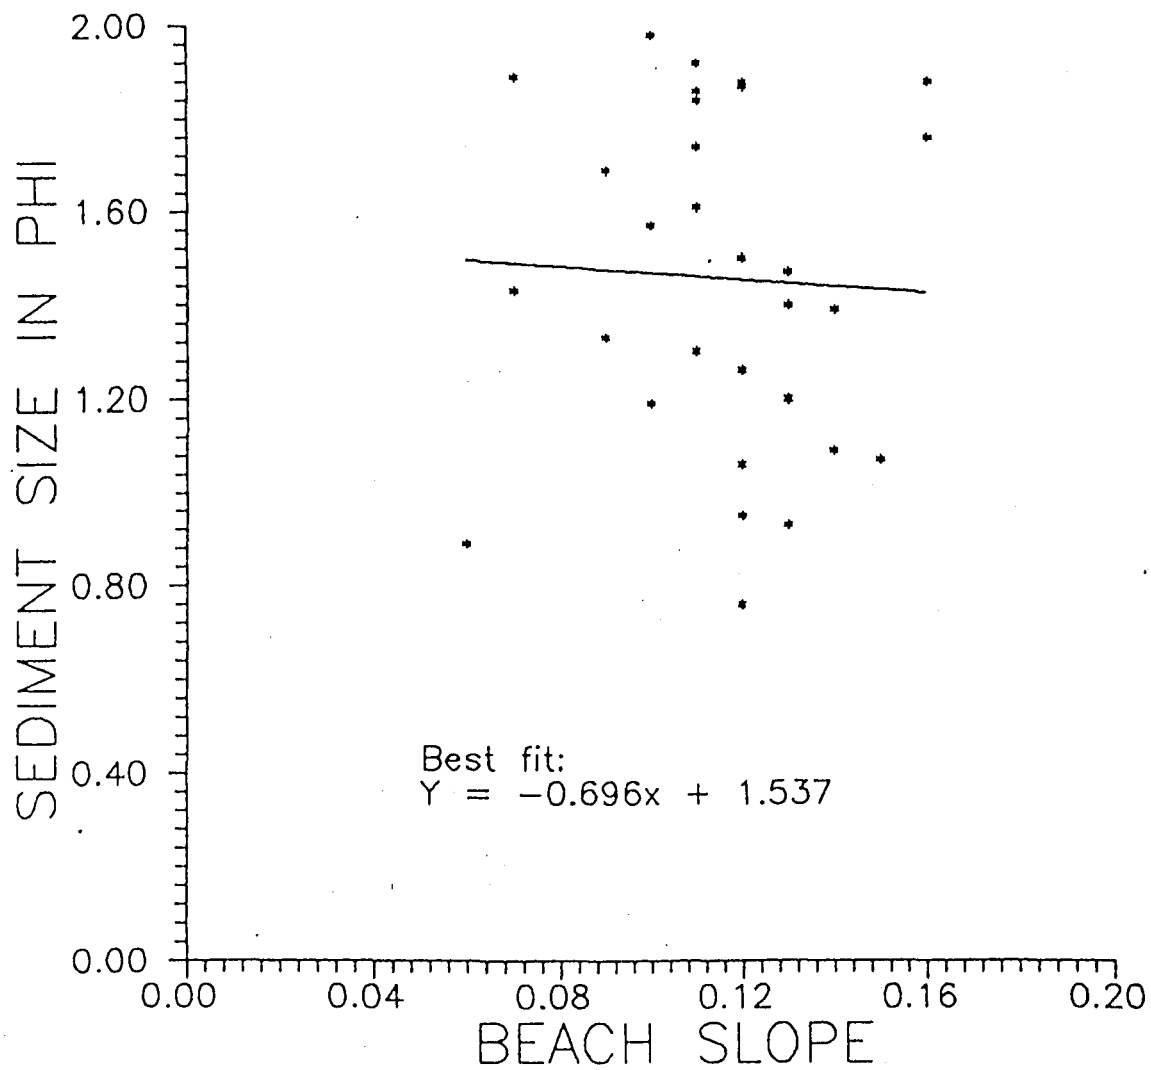
Figure 46. A linear regression analysis for beach slope and sediment size. The beach slope increases slightly with sediment size.

Beaches along the Chesapeake Bay shorelines have planar beach faces and would be considered highly reflective. There is generally a measurable sharp break at or just below MLW where the offshore portion of the profile flattens out. This has been called the beach step or toe. There has been very little research done on the dynamics of these fetch-limited beaches. However, Skrabel (1987) found that beach profiles along a nourished beach on the York River tended to follow an equilibrium state as defined by Dean (1977) where coarser sands are associated with steeper beach profiles and lesser beach profiles are relative to finer sands.

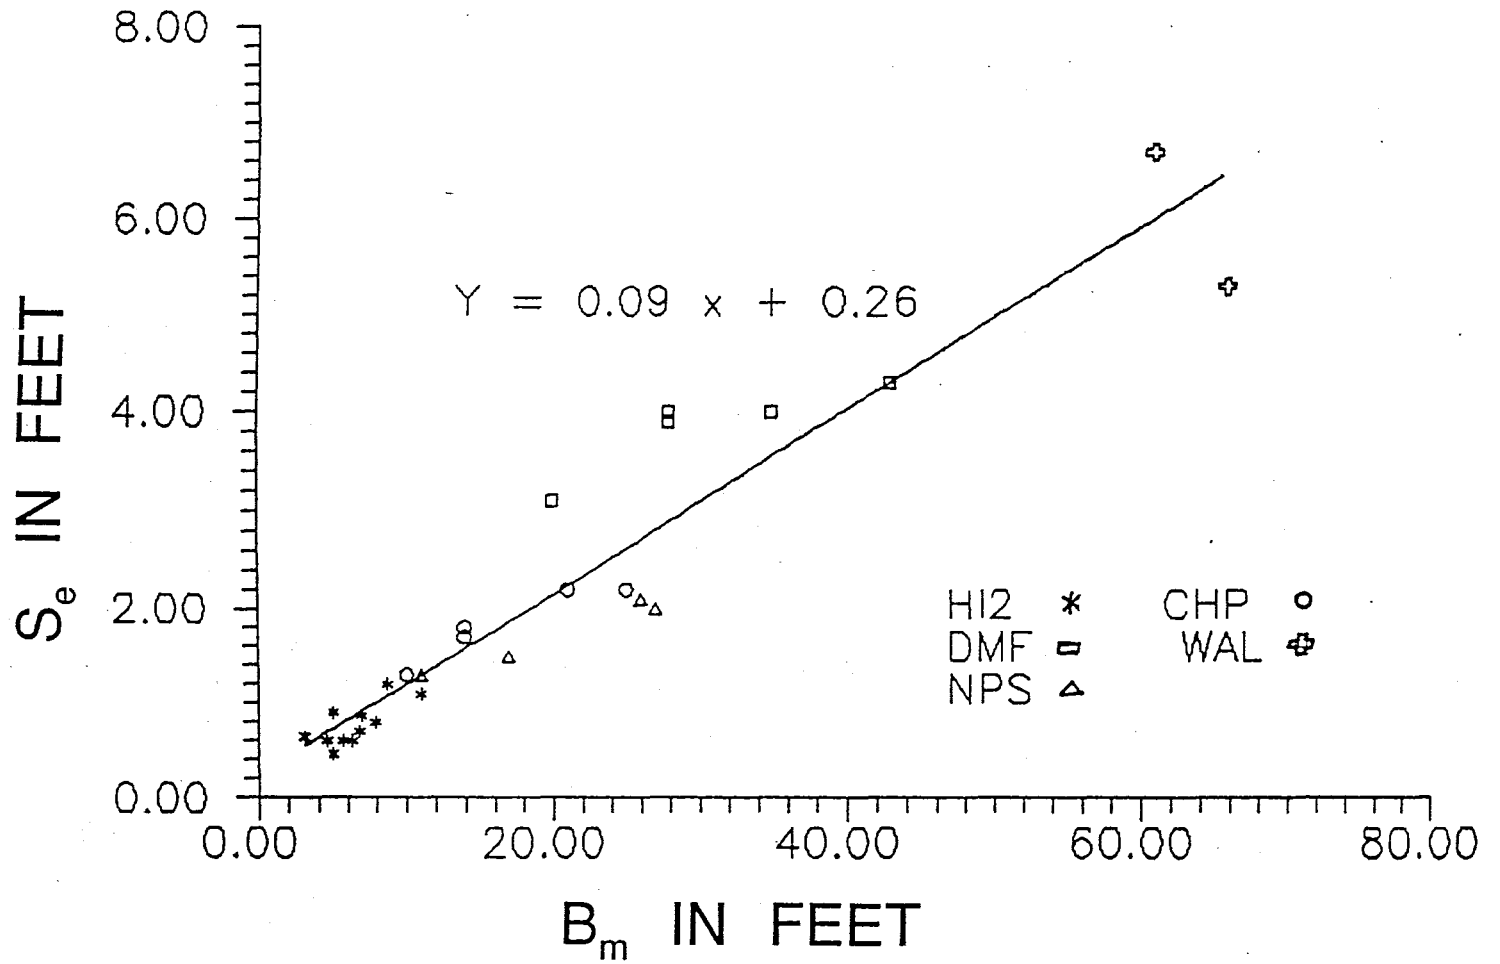
Figure 47. The relationship of B_m to S_e for breakwater/bays at HI2, CHP, DMF, WAL and NPS.

Unstable and eroding BOB occurs at CHP, NPS, and HI2. The breakwater units at these sites were placed at or just beyond MLW. Presently, they do not allow enough offshore distance for the development of stable backshore beach width, even at HI2 where beach fill was placed. Further bank erosion may create the necessary distance. This is especially true of NPS where erosion of the low bank continues to increase the backshore beach width and erosion rates have decreased over the past two years.

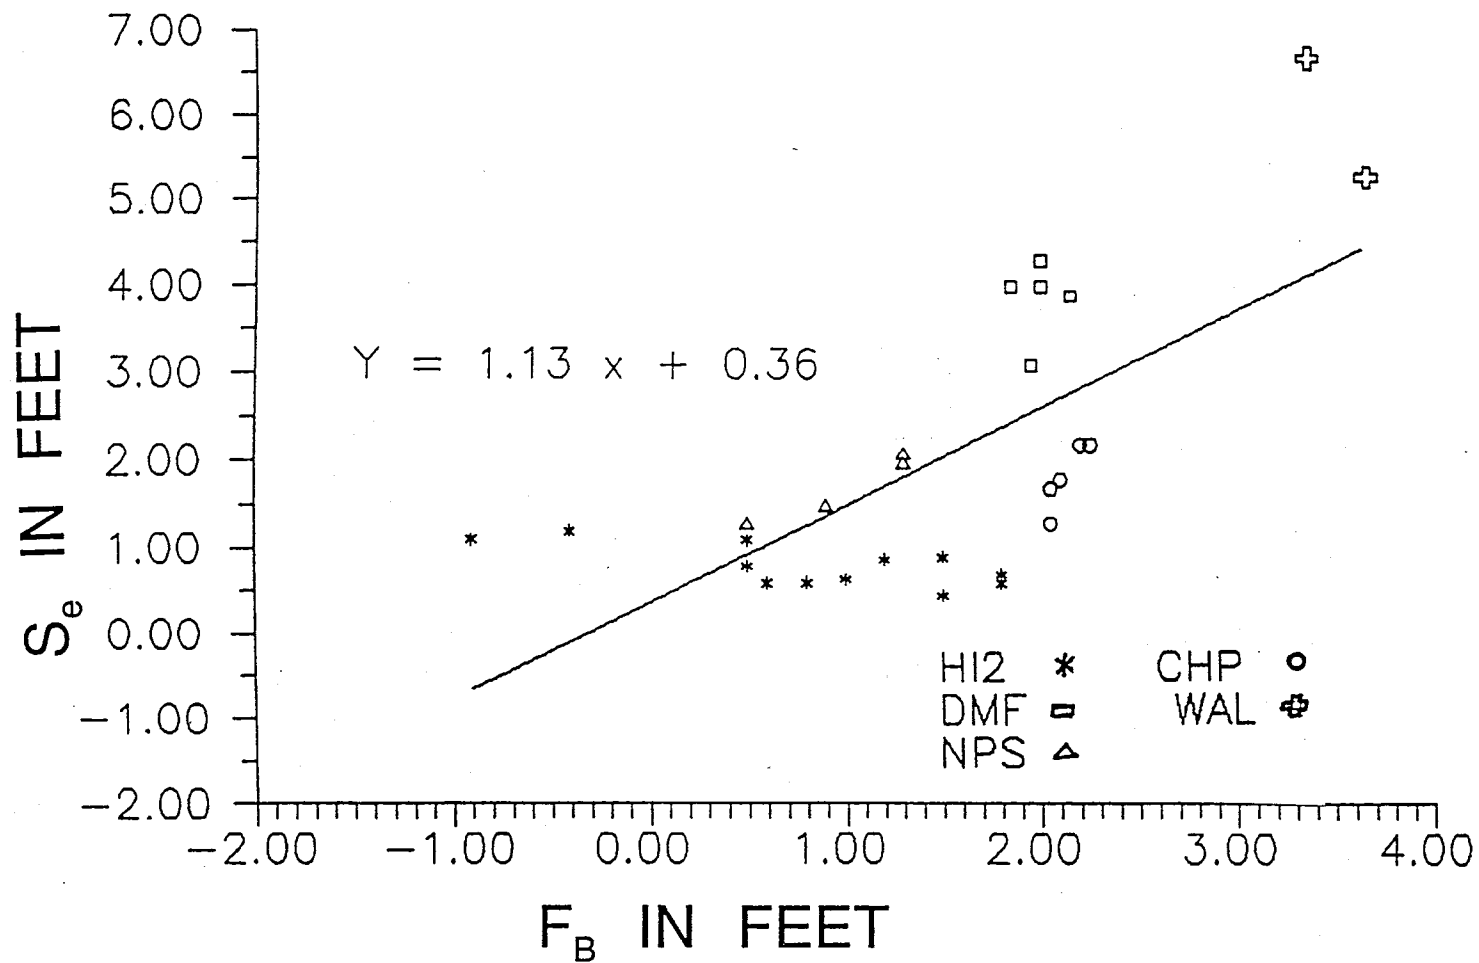
Figure 48. The relationship between F_B and S_e for breakwater/bays at HI2, CHP, DMF, WAL and NPS.

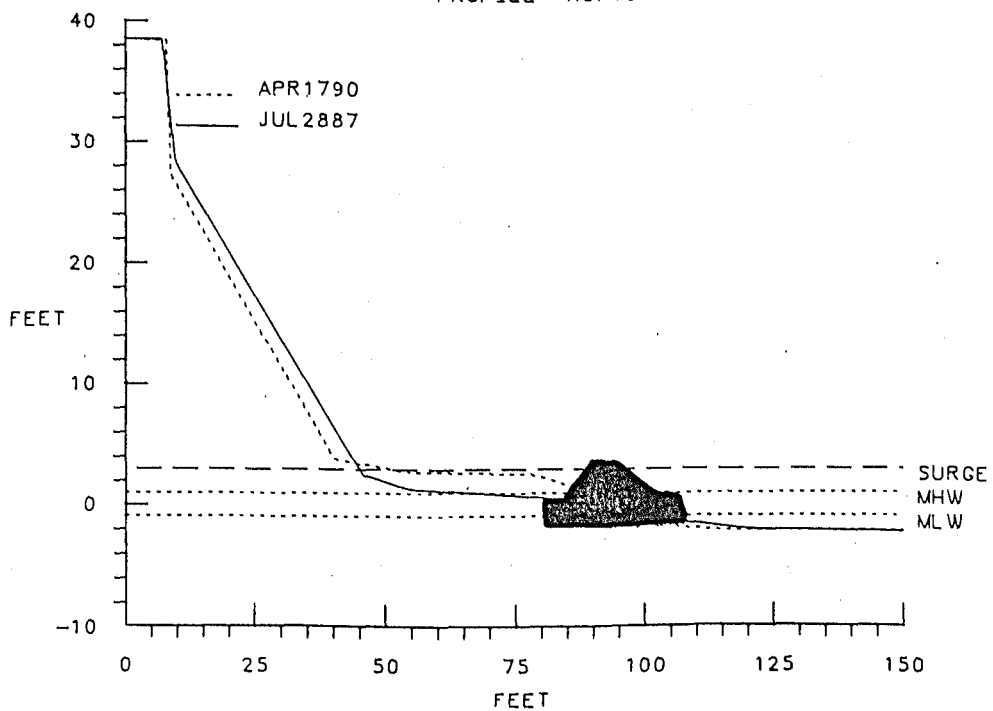
CHIPPOKES STATE PARK
PROFILE NO. 10

Figure 49. Chippokes State Park representative profiles.

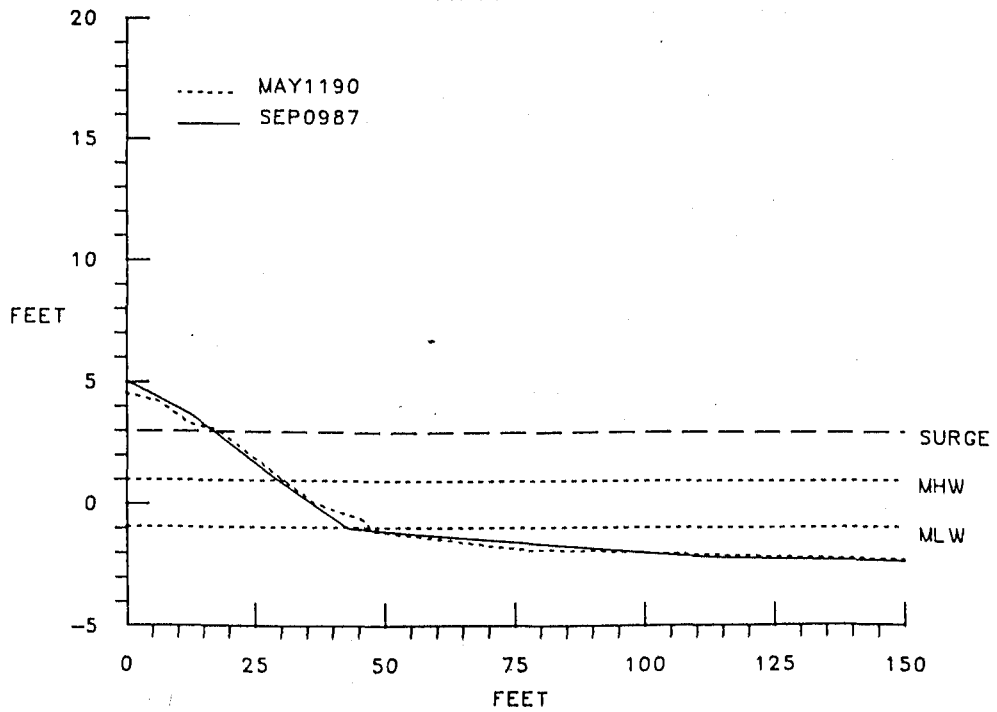
DRUMMONDS FIELD
PROFILE NO. 08

Figure 52. Drummonds Field representative profiles.

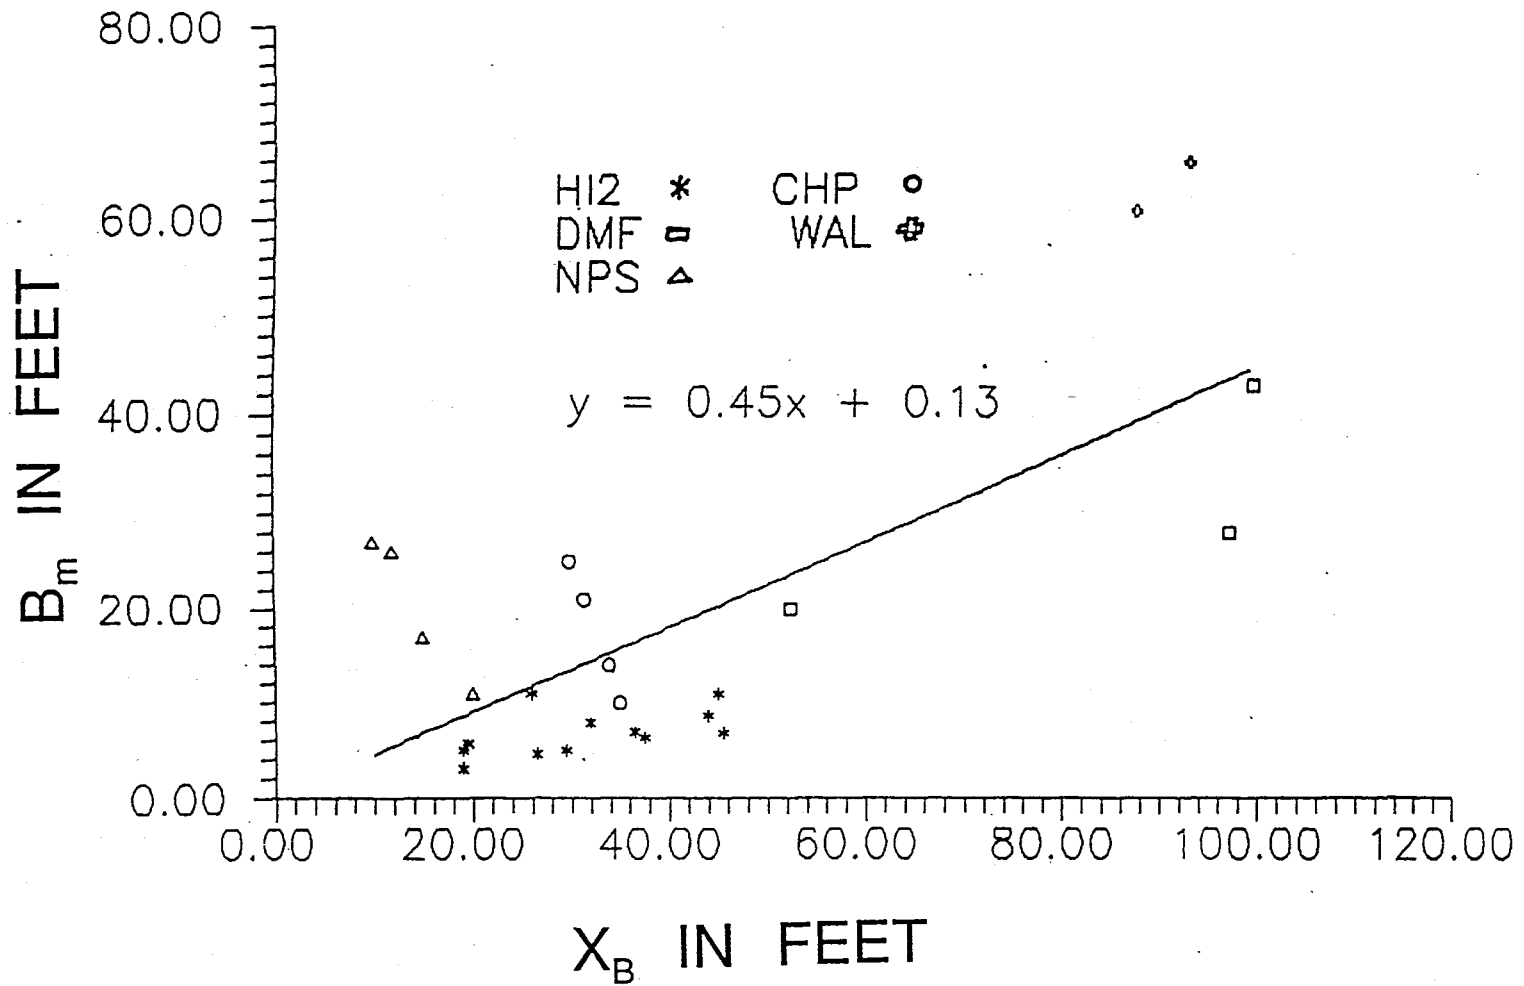
Figure 54. The relationship between X_B and B_m for breakwater/bays at HI2, CHP, DMF, NPS and WAL.

A series of comparisons among parameters was done using linear regression (Figures 58, 59 and 60). The breakwater offshore position (X_B) correlates fairly well ($r^2 = 0.764$) with the bay indentation (M_b) (Figure 58). Figure 59 shows the best relationship, M_b and G_B , with a correlation coefficient of 0.892. A similar "good fit" for M_b and G_B was obtained by

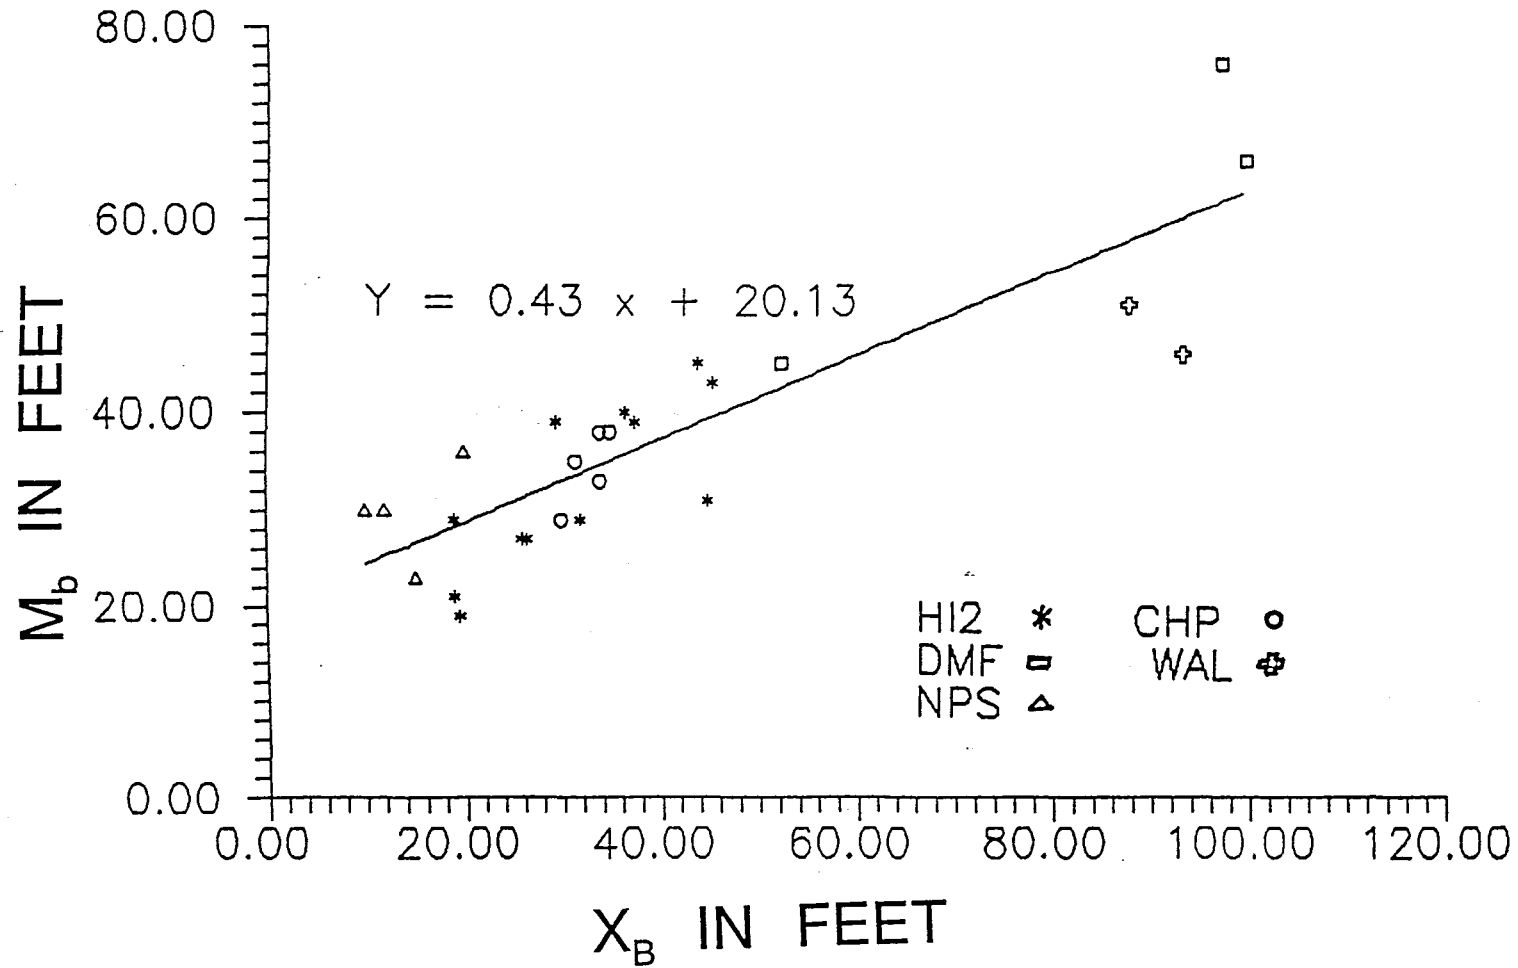
Figure 55. The relationship between X_B and M_b for breakwater/bays at HI2, CHP, DMF, WAL and NPS.
