Chesapeake Bay Shoreline Study: Headland Breakwaters and Pocket Beaches for Shoreline Erosion Control Final Report

A Final Report Obtained Under Contract With
The United States Army Corps of Engineers, Norfolk District
With The Virginia Department of Conservation and Recreation

Special Report in Applied Marine Science and Ocean Engineering
No. 313

March 1991

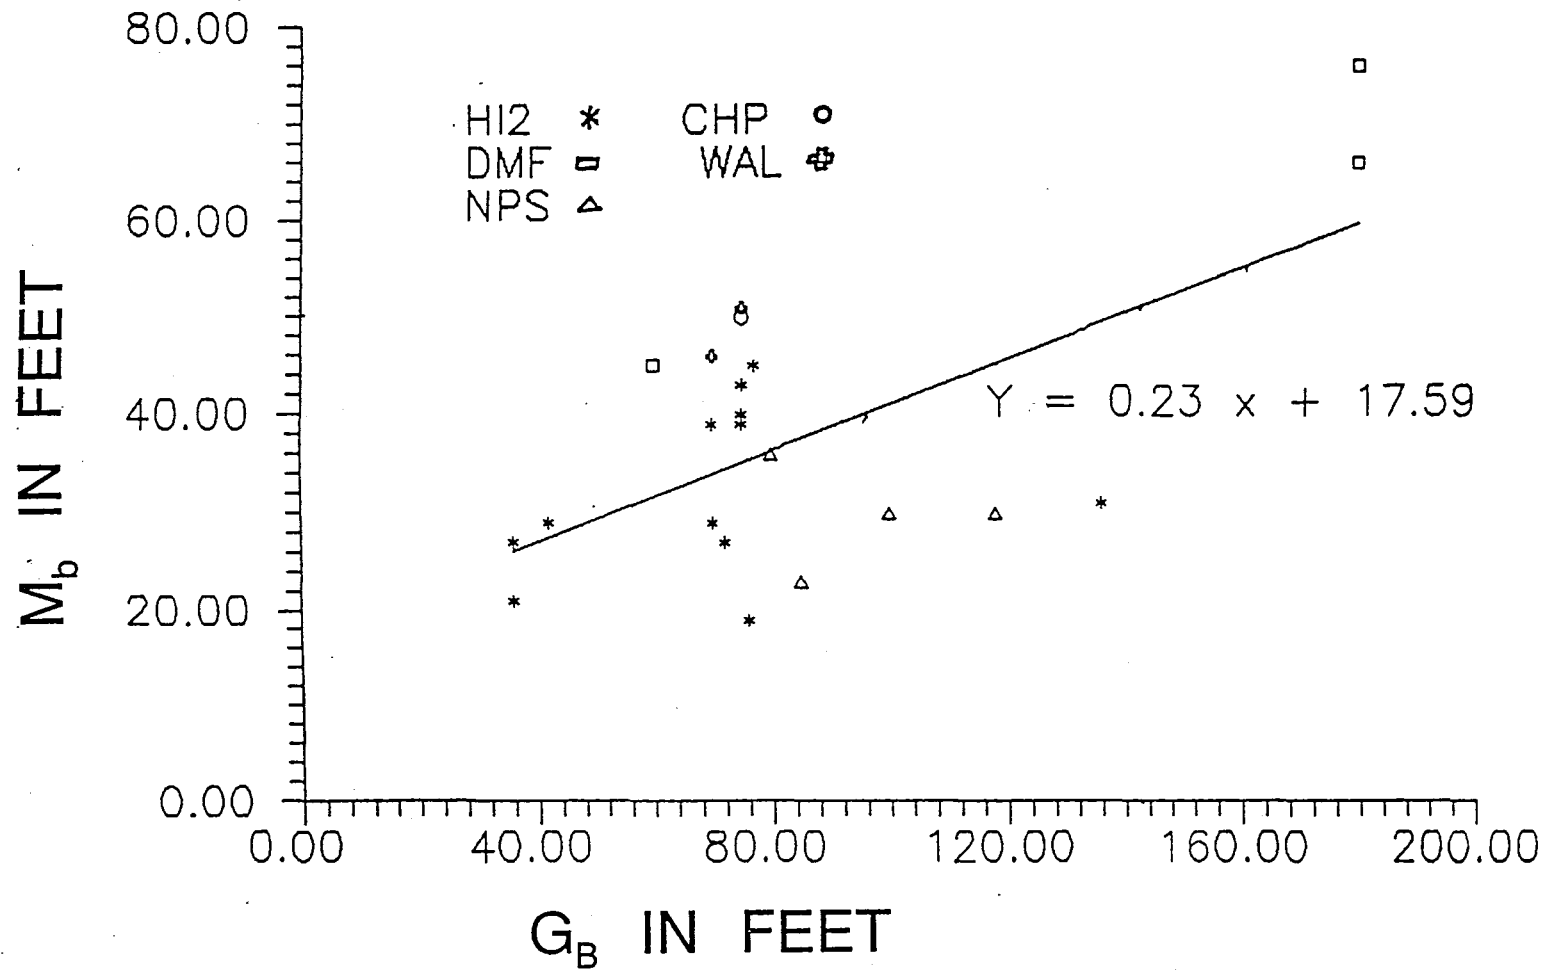
Figure 56. The relationship between G_B and M_b for breakwater/bays at HI2, CHP, DMF, WAL and NPS.

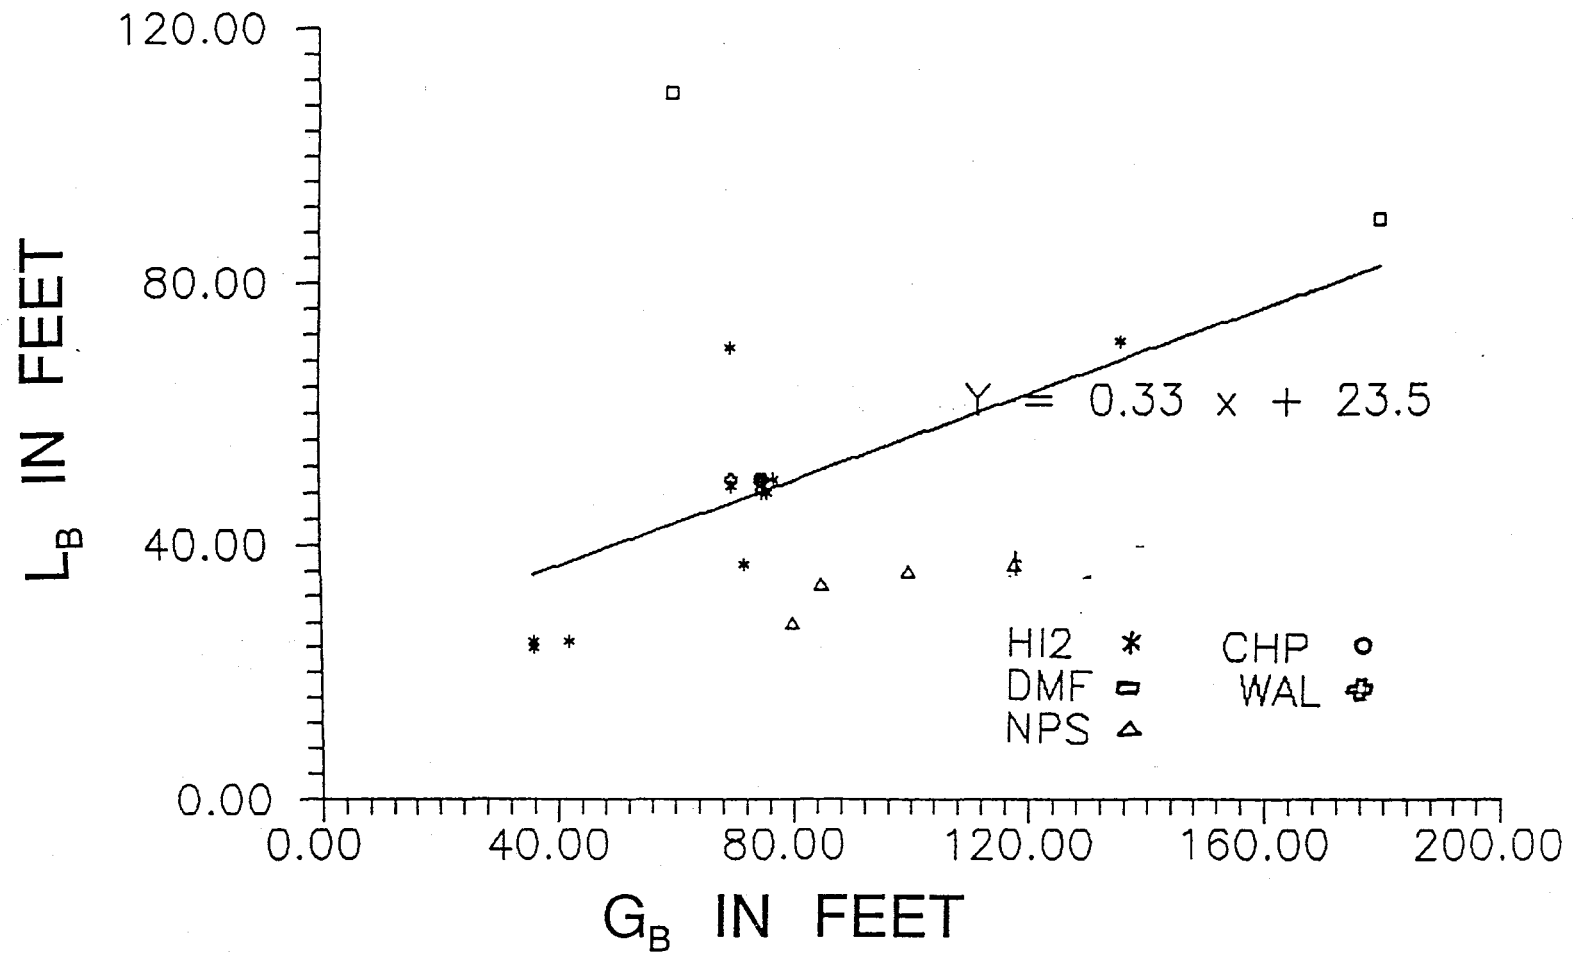
Figure 57. The relationship between G_B and L_B for breakwater/bays at HI2, CHP, DMF, WAL and NPS.

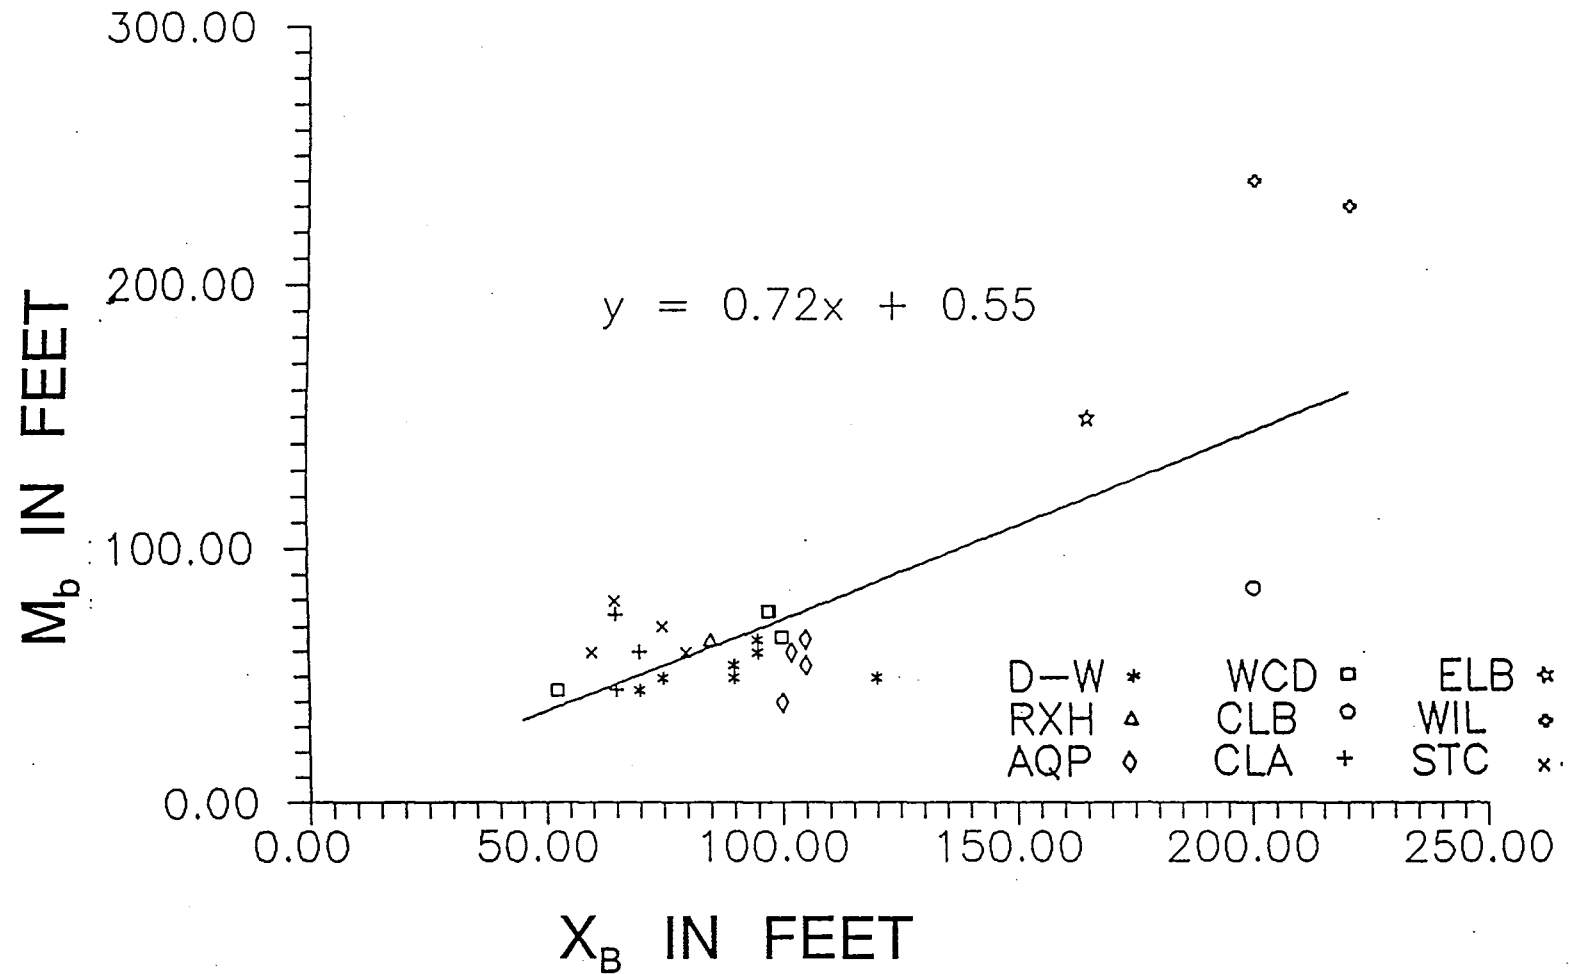
Figure 58. The relationship between X_B and M_b for breakwater/bays at D-W (DMF and WAL), ELB, WCD (WAR, CHR and DRK), AQP, STC, CLA, RXH, CLB and WIL.

A series of comparisons among parameters was done using linear regression (Figures 58, 59 and 60). The breakwater offshore position (X_B) correlates fairly well ($r^2 = 0.764$) with the bay indentation (M_b) (Figure 58). Figure 59 shows the best relationship, M_b and G_B , with a correlation coefficient of 0.892. A similar "good fit" for M_b and G_B was obtained by

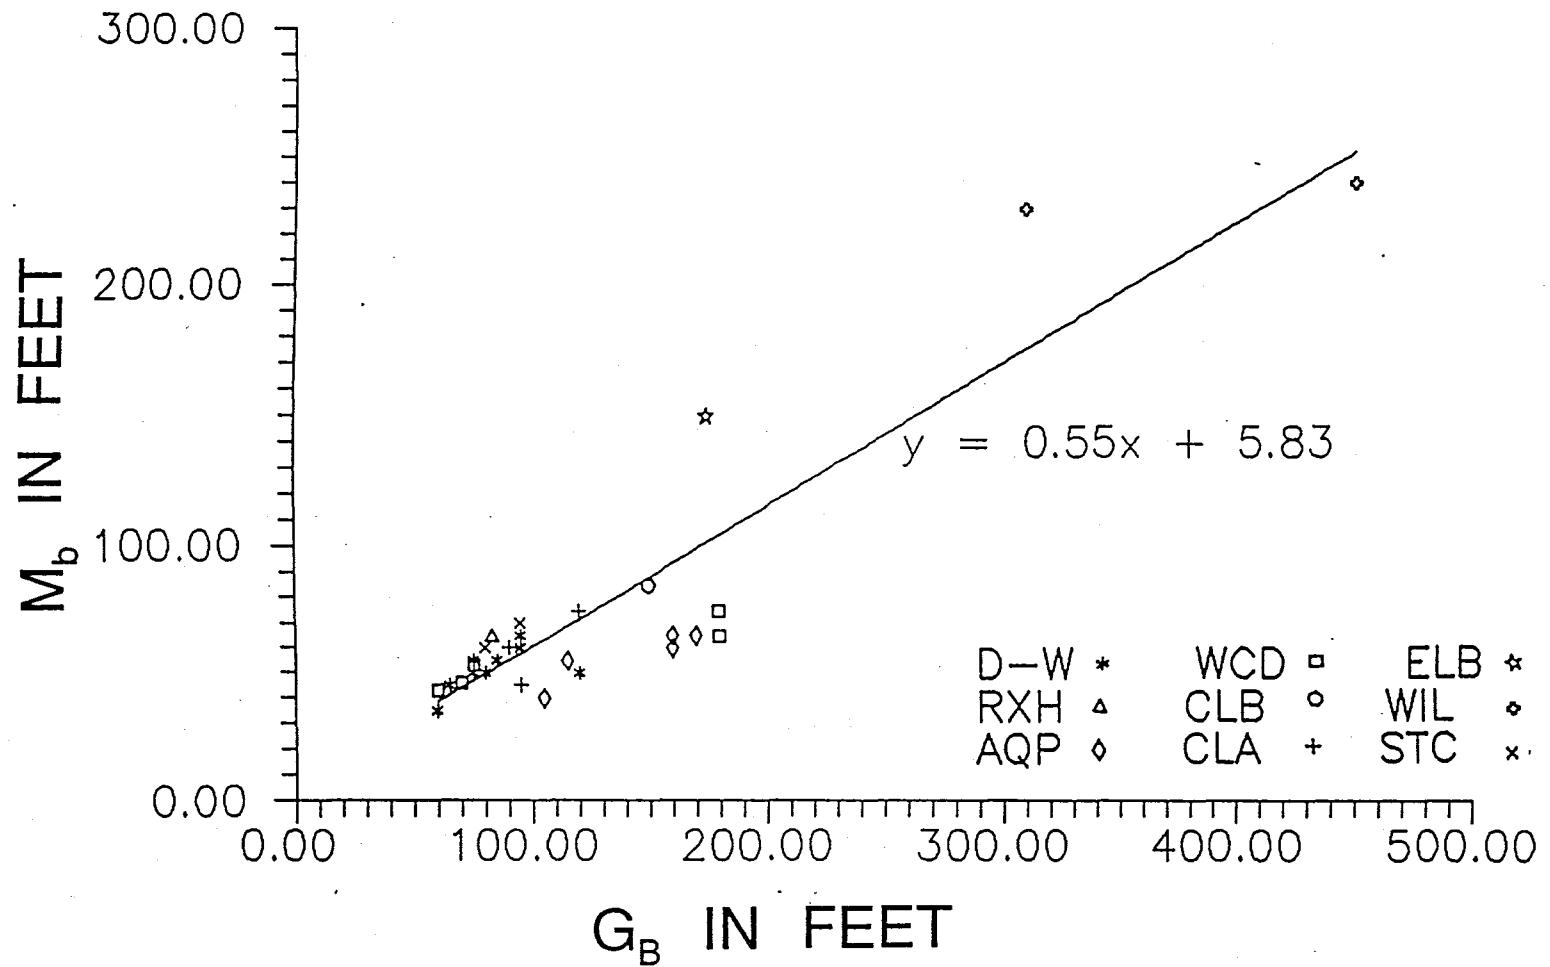
Figure 59. The relationship between G_B and M_b for breakwater/bays at D-W (DMF and WAL), WCD (WAR, CHR and DRK), AQP, CLA, STC, RXH, CLB, WIL and ELB.

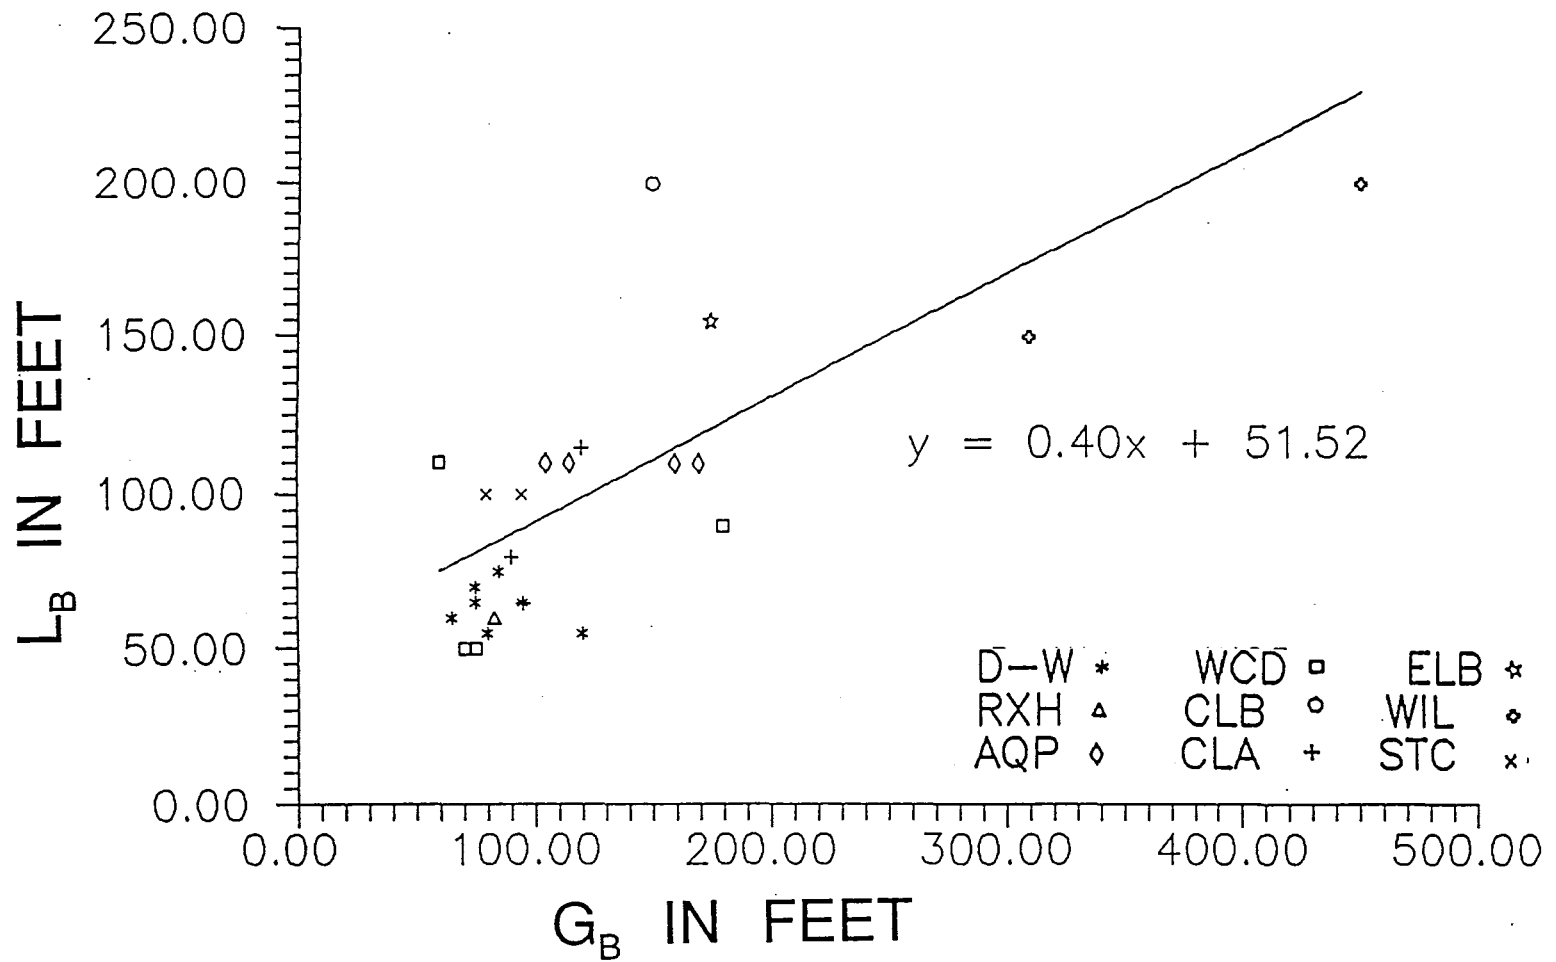
Figure 60. The relationship between G_B and L_B for breakwater/bays at D-W (DMF and WAL), WCD (WAR, CHR and DRK), AQP, CLA, STC, RXH, CLB, WIL and ELB.

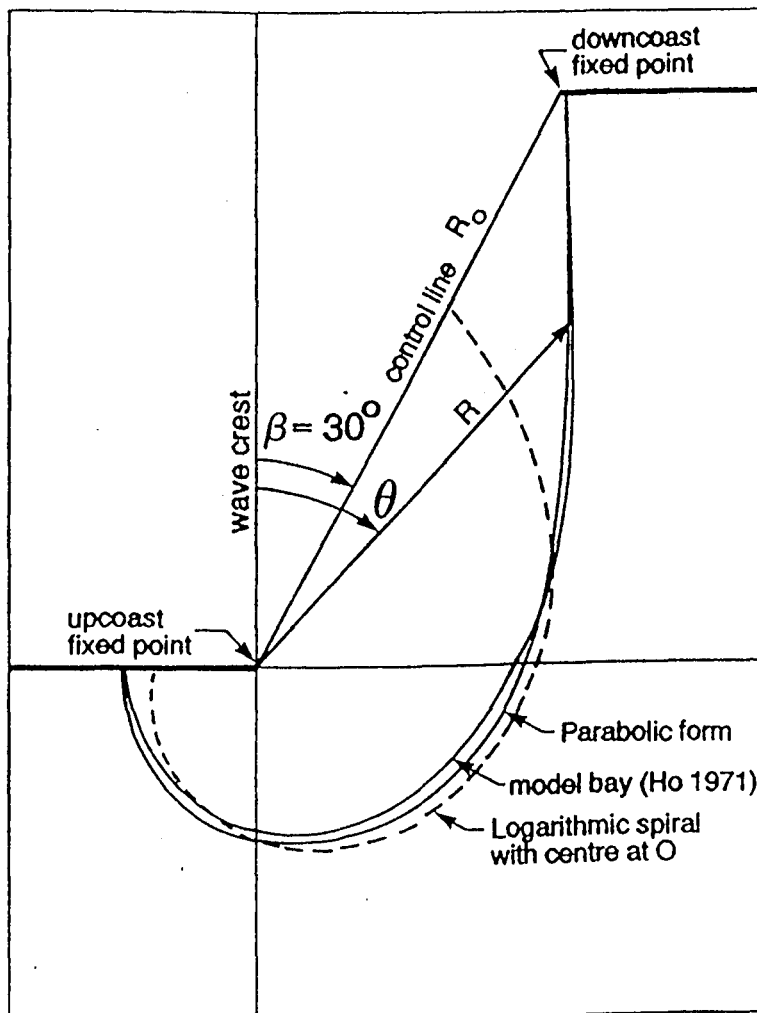
Figure 62. Hsu's static equilibrium bay (SEB) model. (Hsu et al., 1989a).

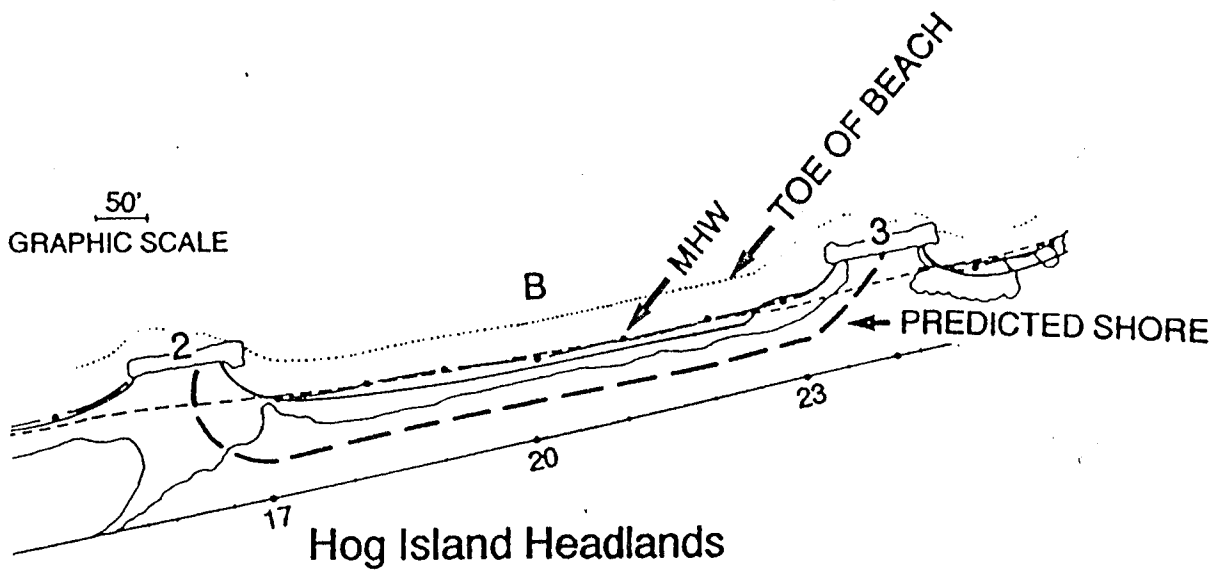
Figure 65. SEB model applied headland sites.

The SEB model was applied to the headland sites on the bay at Summerille, Bay B at the Hog Island Headlands and Bay 1 at the Yorktown Bays (Figure 65). The direction of wave approach was determined from the orientation of the tangential section of each embayment. The predicted planform for each bay appears to correspond to the top of the bank at Summerille and Hog Island Headlands Bay B and to about 3.0 feet above MHW at Yorktown Bay 1. The SEB model shows that Yorktown Bay 1 is in near equilibrium. At Summerille further bank erosion is predicted from profile
