# Lancaster County, Virginia Shoreline Inventory Report Methods and Guidelines

**Comprehensive Coastal Inventory Program  
Center for Coastal Resources Management  
Virginia Institute of Marine Science, College of William and Mary  
Gloucester Point, Virginia  
December 2015**

Special report in Applied Marine Science and Ocean Engineering No. 448 of the Virginia Institute of Marine Science

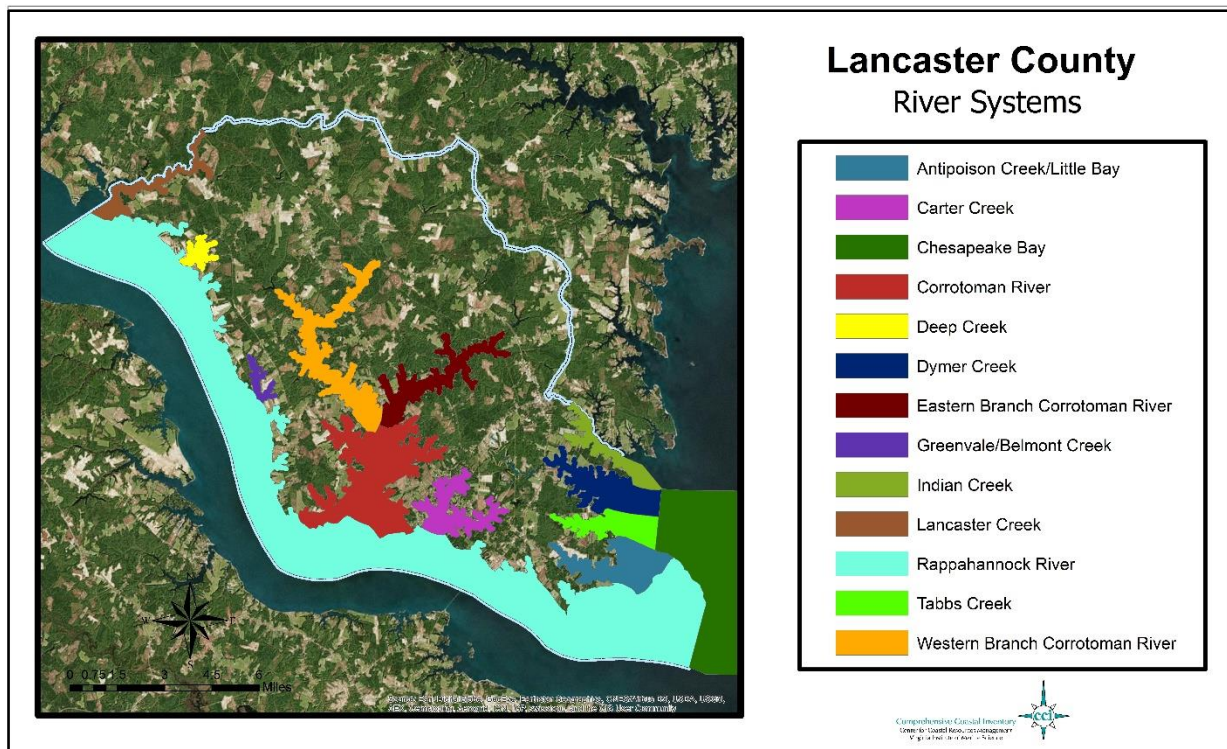
Figure 2. River Systems in the Lancaster County

Summary tables (Tables 4-7) quantify conditions observed on the basis of river systems (Figure 2). Refer to Figure 2 for the location of these river systems. Note, river systems do not correspond to watershed boundaries. They were developed for convenience in reporting data.

The top toolbar also includes tabs to access some important status information for the locality. By clicking on the “River System Pie Charts” button, users can obtain a statistical summary distribution of the riparian land use and amount of hardened shoreline for a specific water body selected from the drop down menu in the upper left (Figure 7). More detailed results in table format can be found by clicking the Lancaster County Summary PDF button also in the window. The summary statistics are reported by river systems (Figure 2).

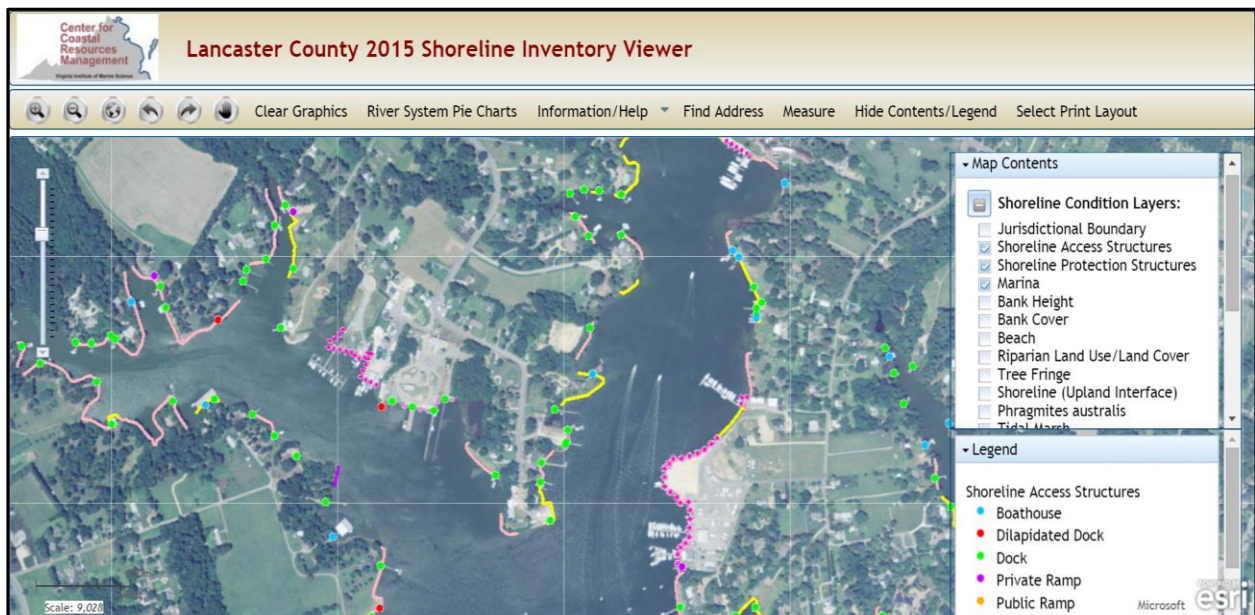
Figure 4. Map Viewer illustrates Shoreline Access and Protection Structures for a section of the County

In Figure 4 Shoreline Access Structures, and Shoreline Protection structures are selected. Shoreline Access structures are point features that includes piers and boat ramps. The actual footprint of these structures is not measured; only their location. Shoreline Protection Structures are line features and are mapped and illustrated in the viewer to show where they occur along the shoreline. Figure 5 illustrates riparian land use in the riparian zone for the same section of the County.
