## Henrico County, Virginia - Shoreline Inventory Report: Methods and Guidelines

# Henrico County, Virginia Shoreline Inventory Report Methods and Guidelines

Special report in Applied Marine Science and Ocean Engineering No. 460 of the Virginia Institute of Marine Science

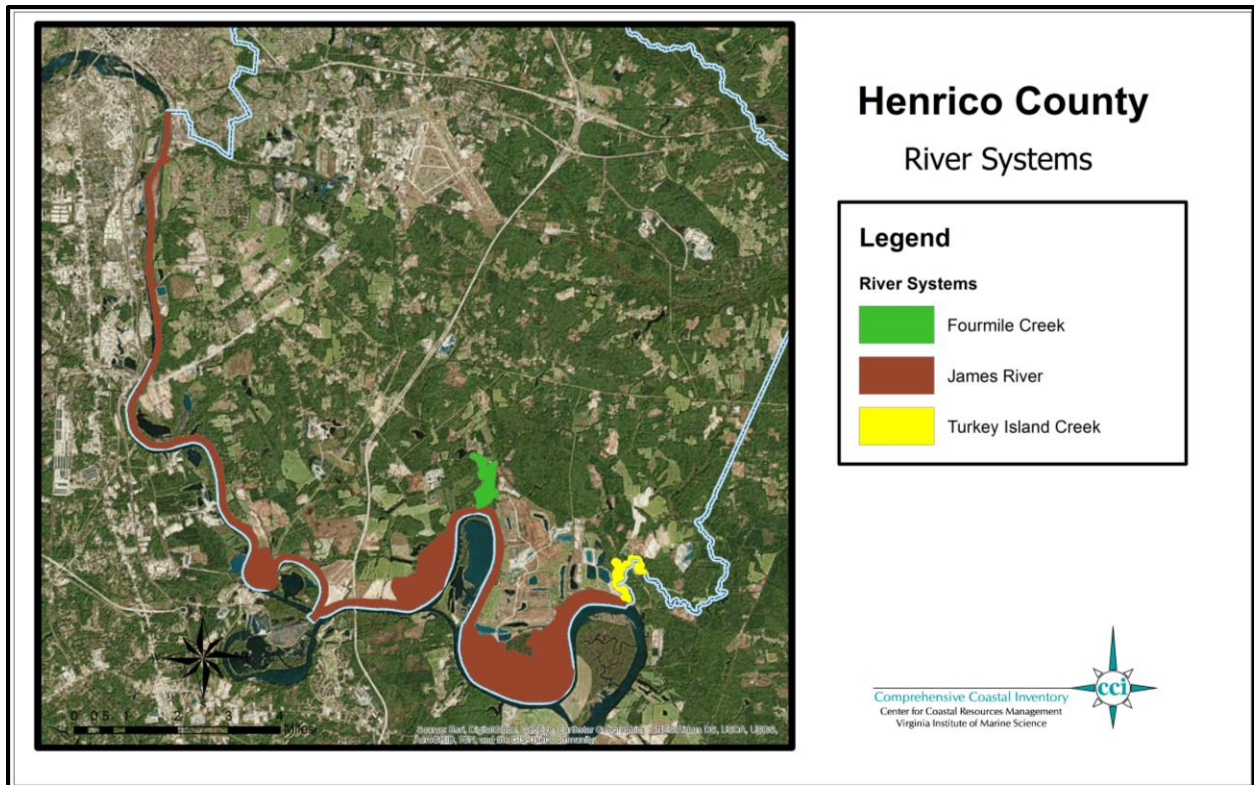
Figure 2. River Systems in Henrico County

Summary tables (Tables 4-7) quantify conditions observed on the basis of river systems (Figure 2). Refer to Figure 2 for the location of these rivers systems. Note, river systems do not correspond to watershed boundaries. They were developed for convenience in reporting data.

The top toolbar also includes tabs to access some important status information for the locality. By clicking on the “River System Pie Charts” button, users can obtain a statistical summary distribution of the riparian land use and amount of hardened shoreline for a specific water body selected from the drop down menu in the upper left (Figure 7). More detailed results in table format can be found by clicking the Henrico County Summary PDF button also in the window. The summary statistics are reported by river systems (Figure 2).

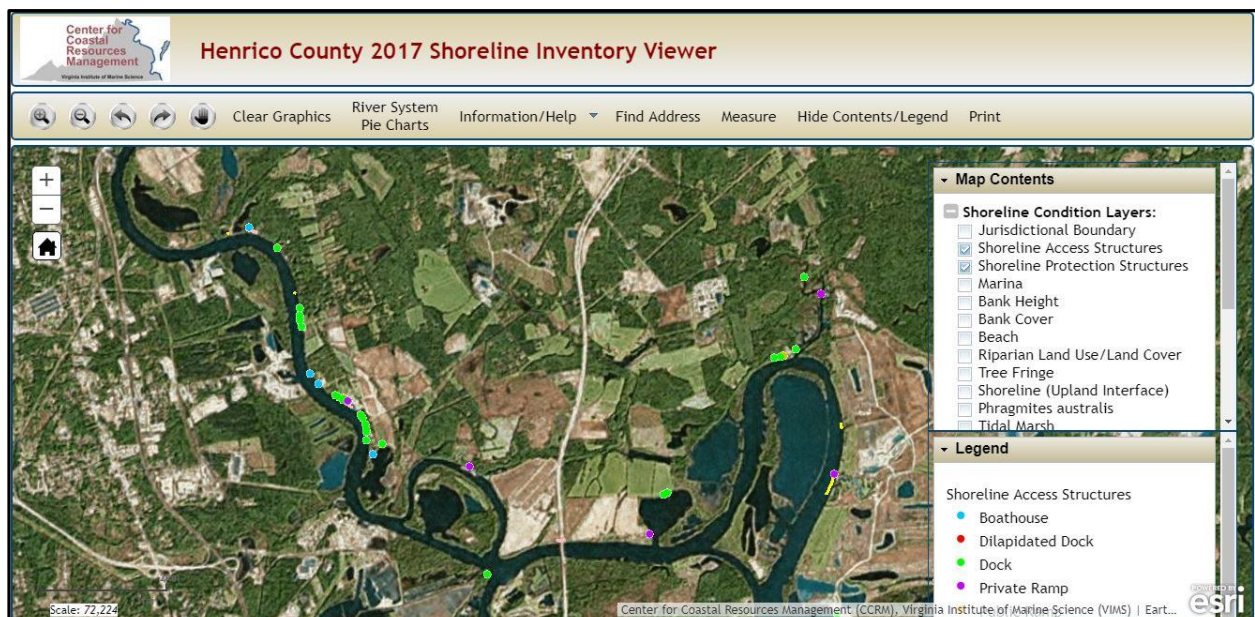
Figure 4. Map Viewer illustrates Shoreline Access and Protection Structures for a section of Henrico County.

In Figure 4 Shoreline Access Structures, and Shoreline Protection structures are selected. Shoreline Access structures are point features that includes piers and boat ramps. The actual footprint of these structures is not measured; only their location. Shoreline Protection Structures are line features and are mapped and illustrated in the viewer to show where they occur along the shoreline. Figure 5 illustrates riparian land use in the riparian zone for the same section of the County.

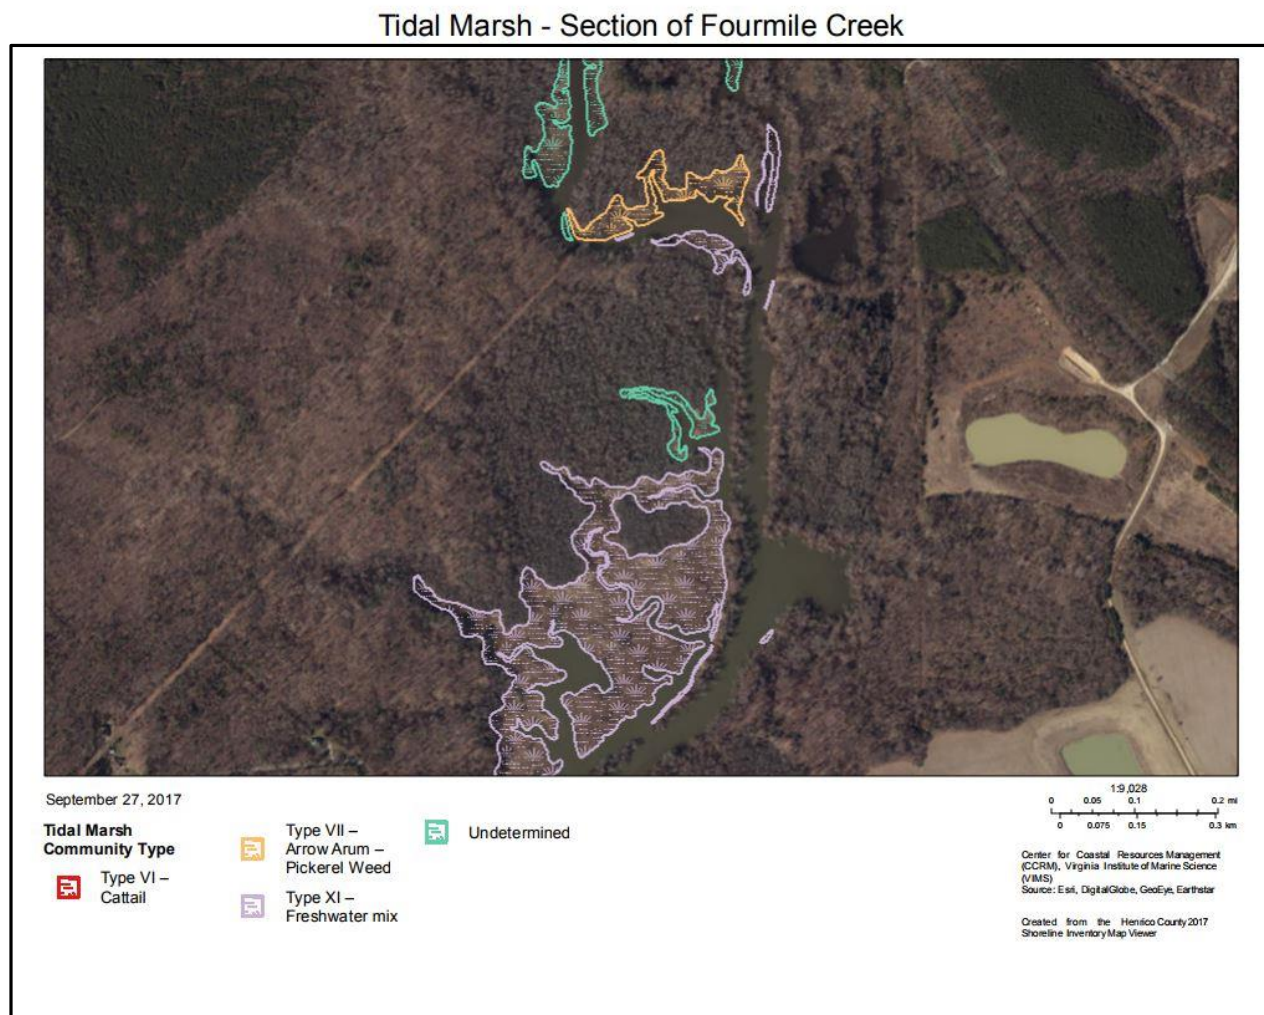
Figure 8. Customized print window for a section of Fourmile Creek

Finally, users have the option to personalize their own maps (i.e. map extent, data displayed, map title, etc.) and save them as a pdf file by clicking “Select Print Layout” button. The page can be set up for printing to 8.5 x 11 portrait or landscape style. Figure 8 is an example of a customized map generated for a section of Fourmile Creek. Here the tidal marsh communities are displayed, and the community type is reported in the legend beside the illustration.
