City of Suffolk, Virginia Shoreline Inventory Report Methods and Guidelines

**Comprehensive Coastal Inventory Program
Center for Coastal Resources Management
Virginia Institute of Marine Science, College of William and Mary
Gloucester Point, Virginia
October, 2013**

Special report in Applied Marine Science and Ocean Engineering No. 437 of the Virginia Institute of Marine Science

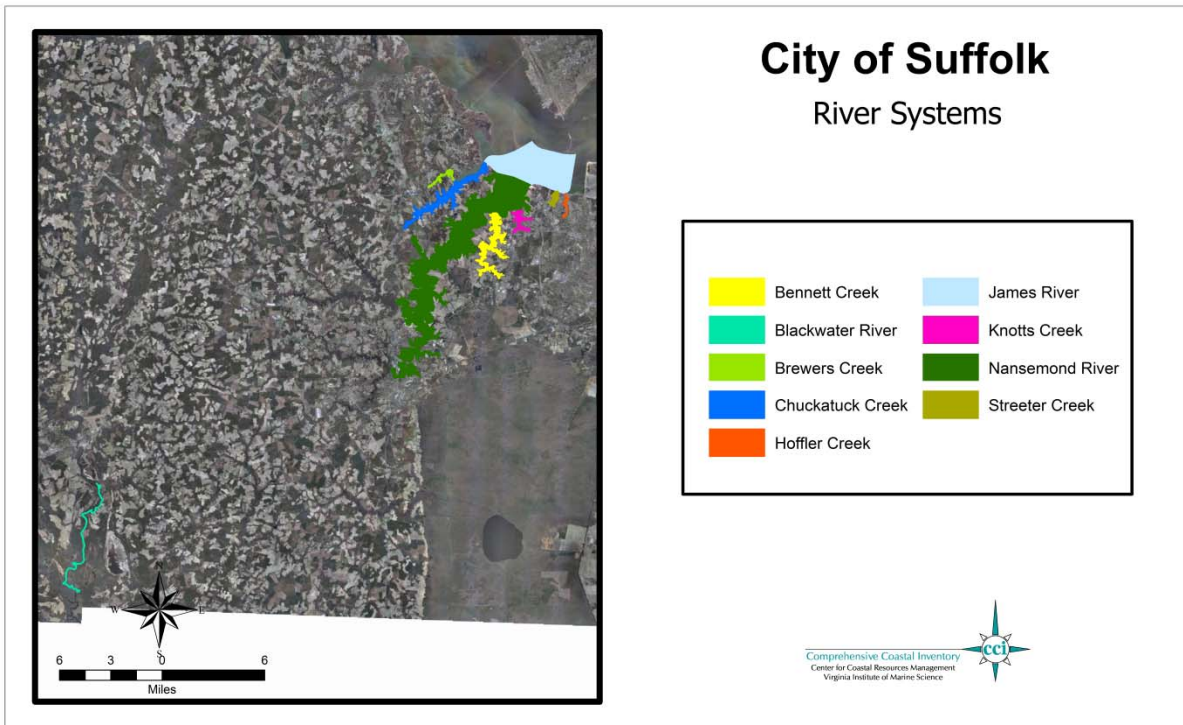
Figure 2. River Systems in the City of Suffolk

Summary tables quantify conditions observed on the basis of river systems (Figure 2). The total miles surveyed in the field and using remote sensing techniques is reported in Table 4.

The top toolbar also includes tabs to access some important status information for the locality. By clicking on the “River System Pie Charts” button, users can obtain a statistical summary distribution of the riparian land use and amount of hardened shoreline for a specific water body which is selected from the drop down menu in the upper left (Figure 8). More detailed results in table format can be found by clicking the City of Suffolk Summary PDF button also in the window. The summary statistics are reported by river systems (Figure 2).

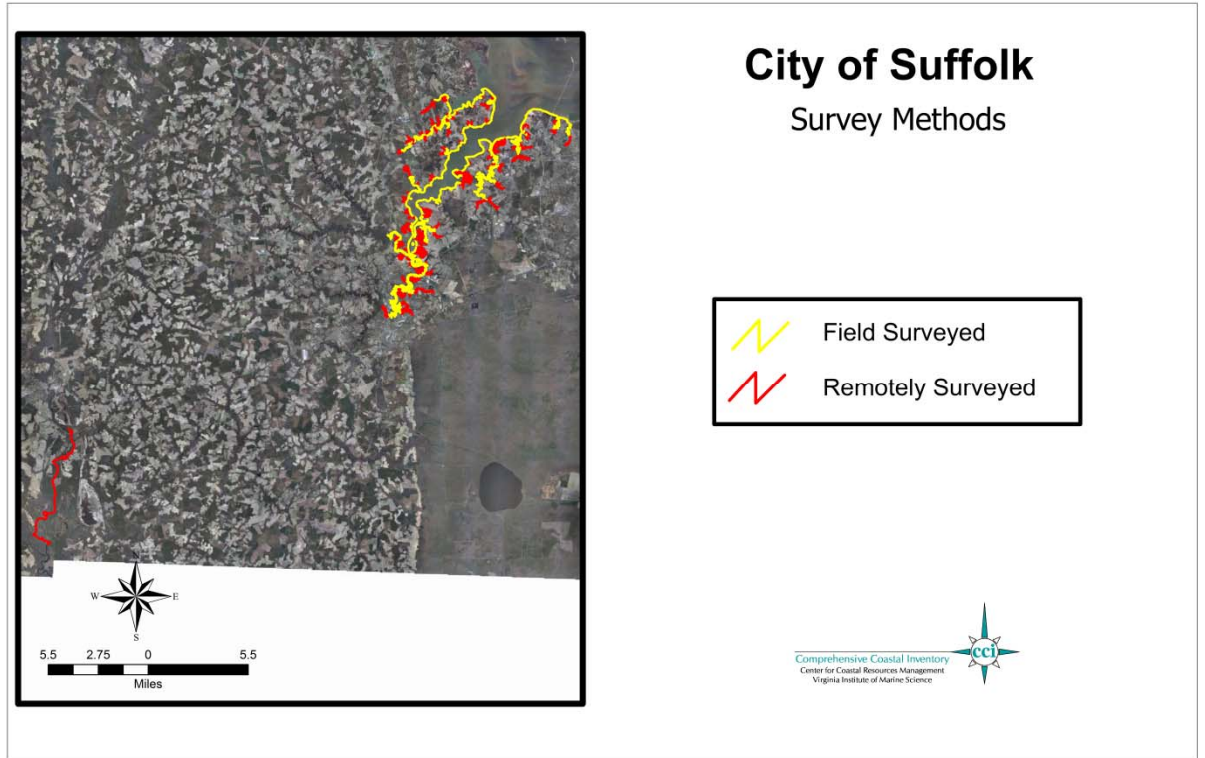
Figure 3. Survey Methodology in City of Suffolk

In the City of Suffolk, nearly 123.6 miles of shoreline were surveyed in the field. Just over 135 miles of shoreline were surveyed remotely. Remotely sensed areas comprised the Blackwater River and some upper reaches of the other tributaries (Figure 3). All these areas are noted in Table 4 along with either survey dates and/or the image year class used for remote coding.

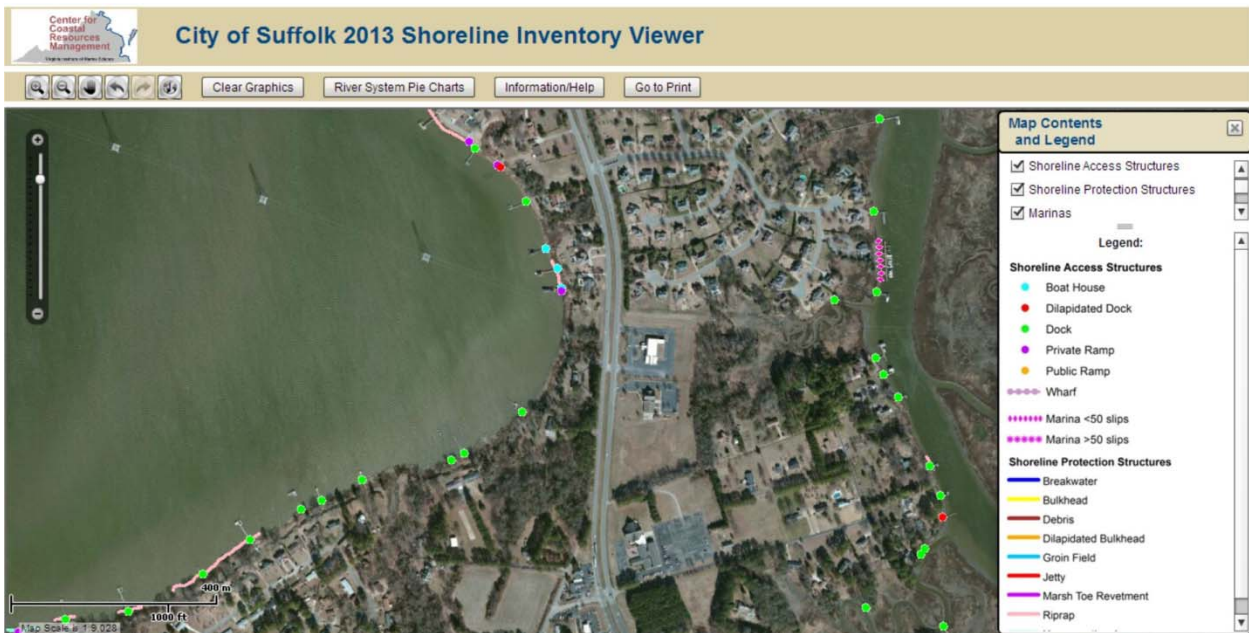
Figure 5. Map Viewer illustrates Shoreline Access and Protection Structures.

In Figure 5 Shoreline Access Structures, and Shoreline Protection structures have been selected along with the boundary. Shoreline Access structures are point features that includes piers and boat ramps. The actual footprint of these structures is not measured; only their location. Shoreline Protection Structures are line features and are mapped and illustrated in the viewer to show where they occur along the shoreline. Figure 6 illustrates riparian land use.

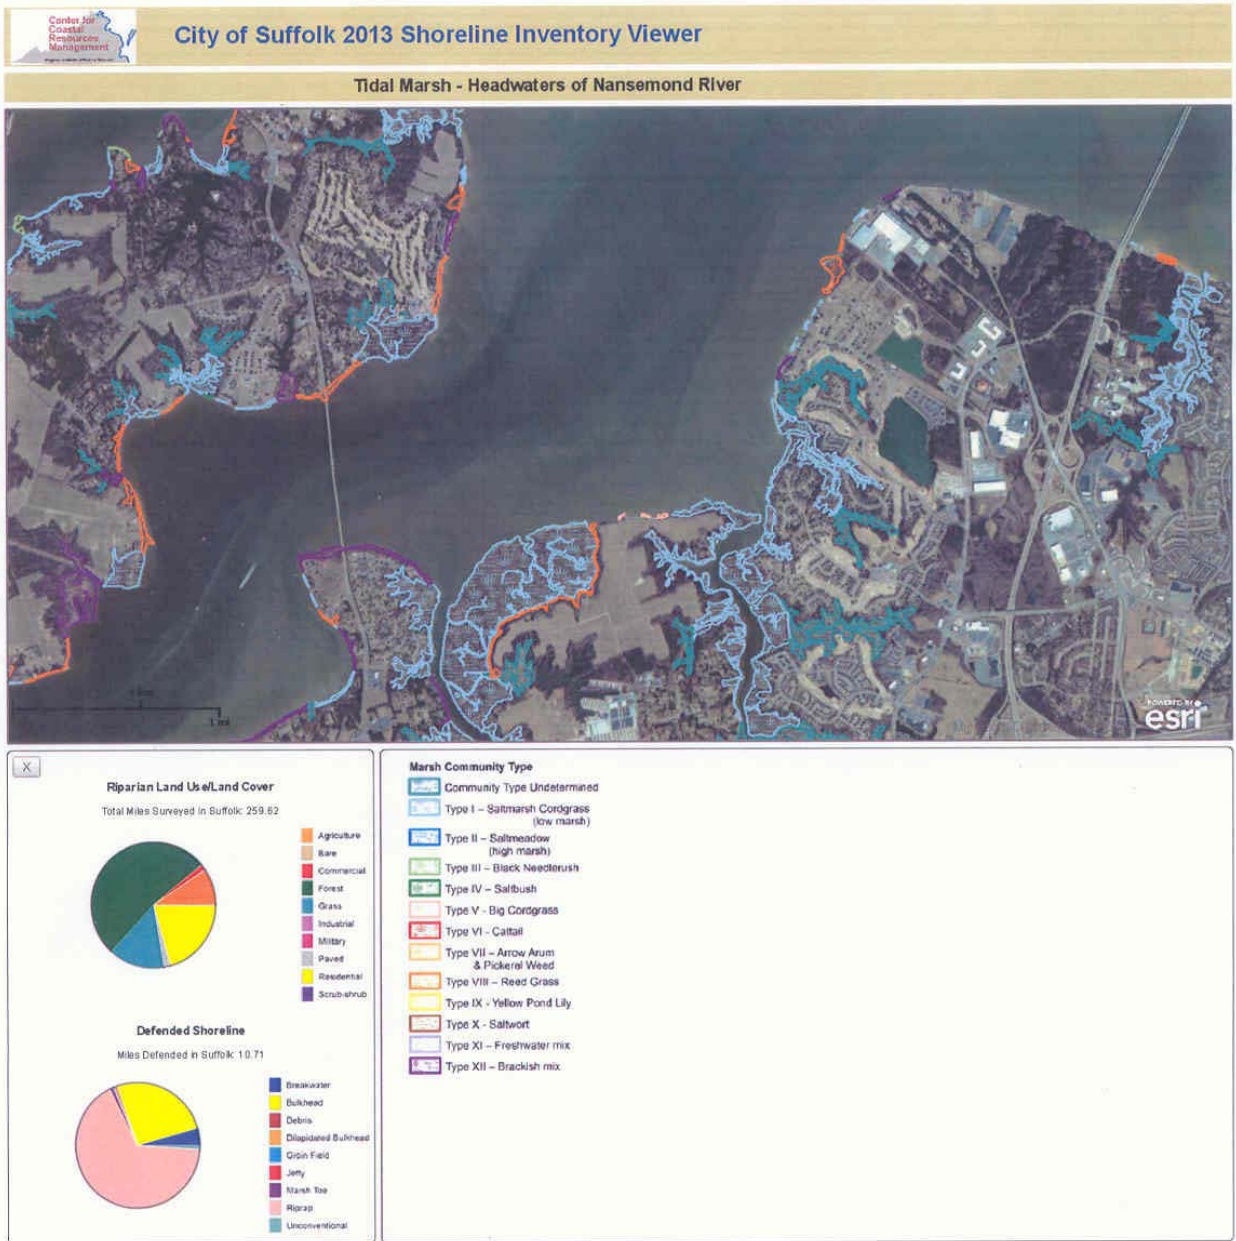
Figure 9. Customized print window for the mouth of Nansemond River.

Finally, users have the option to personalize their own maps (i.e. map extent, data displayed, map title, etc) and print them by clicking “Go to Print” button. The map legend and the charts display below the map. The page is set up for printing to 8.5 x 11 portrait style. Figure 9 is an example of a customized map generated for the mouth of Nansemond River. Here the tidal marsh communities are displayed, and the community type is reported in the legend below the illustration. Also illustrated are the summary pie charts showing land use and shoreline hardening along the entire tributary.
