# Fairfax County and the City of Alexandria, Virginia Shoreline Inventory Report Methods and Guidelines

Special report in Applied Marine Science and Ocean Engineering No. 419 of the Virginia Institute of Marine Science

September, 2010

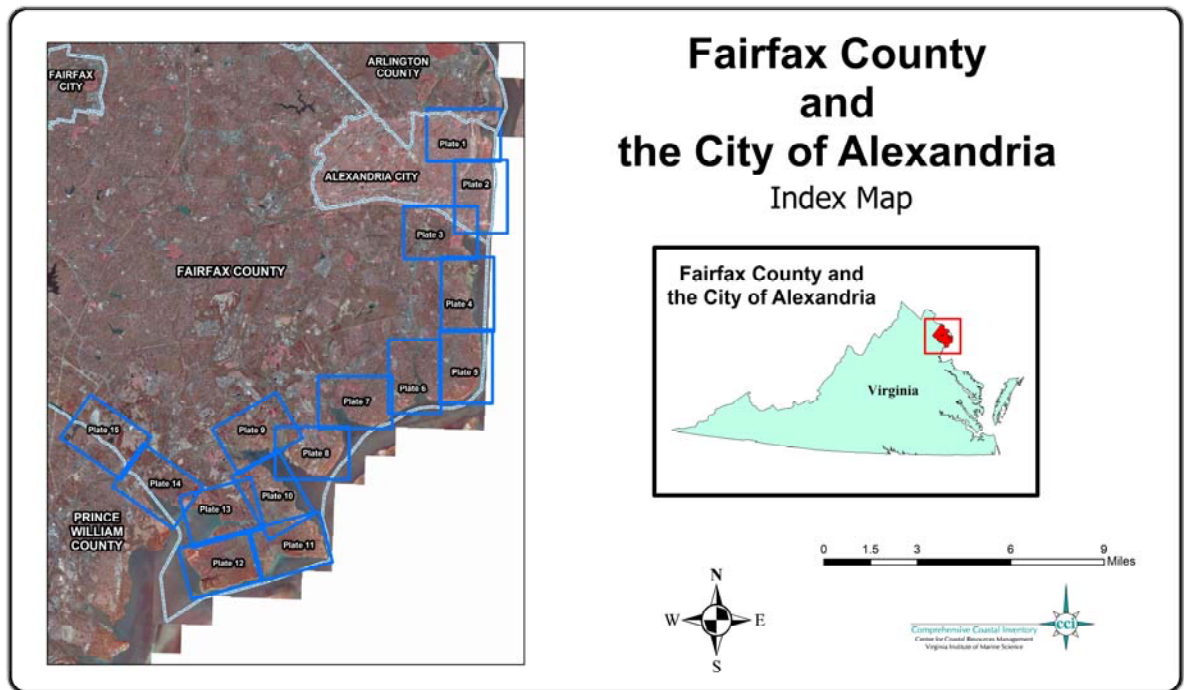
Figure 2. Map index for Fairfax County and the City of Alexandria

For publication purposes Fairfax County and the City of Alexandria are divided into a series of maps. Maps are scaled at 1:12,000 for publication at 11x17. Scale will vary if printed at a different size. There are total of 15 maps that cover Fairfax County and the City of Alexandria. The maps are determined by the geographic size and shape of the region. For each map there are four plates (plate 1a, 1b, 1c, 1d, etc.), for a total of 60 map compositions. On the website (Figure 1), an index is provided to help users locate the area of interest and view the orientation of the maps to each other (Figure 2). Each plate can be individually selected and viewed from the plate list along the left hand column of the index page.

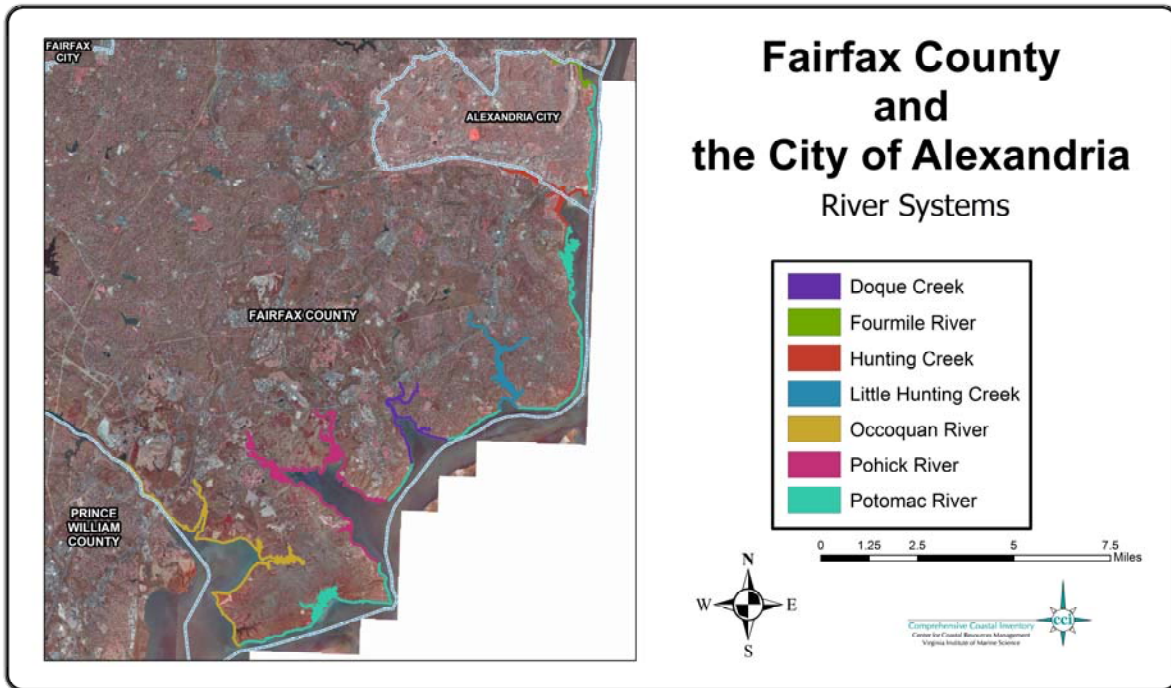
Figure 3. Delineation of river systems used for data reporting

Tables 4, 5, 6 and 7 quantify features and conditions mapped along the rivers using frequency analysis techniques in ArcInfo. The values quantify features by river systems (Figure 3). For linear features, values are reported in actual miles surveyed. Point features are enumerated. The total miles of shoreline surveyed for each tributary is reported. For Fairfax County and the City of Alexandria, a total of 98.87 miles were surveyed in the field. Approximately 28.39 miles of shoreline were surveyed using remote sensing techniques. Figure 4 illustrates where field surveys were conducted and where remote sensing techniques were applied. Remote sensing occurred in places where navigation was restricted. Table 6 reports the survey dates, miles surveyed, and miles surveyed remotely.

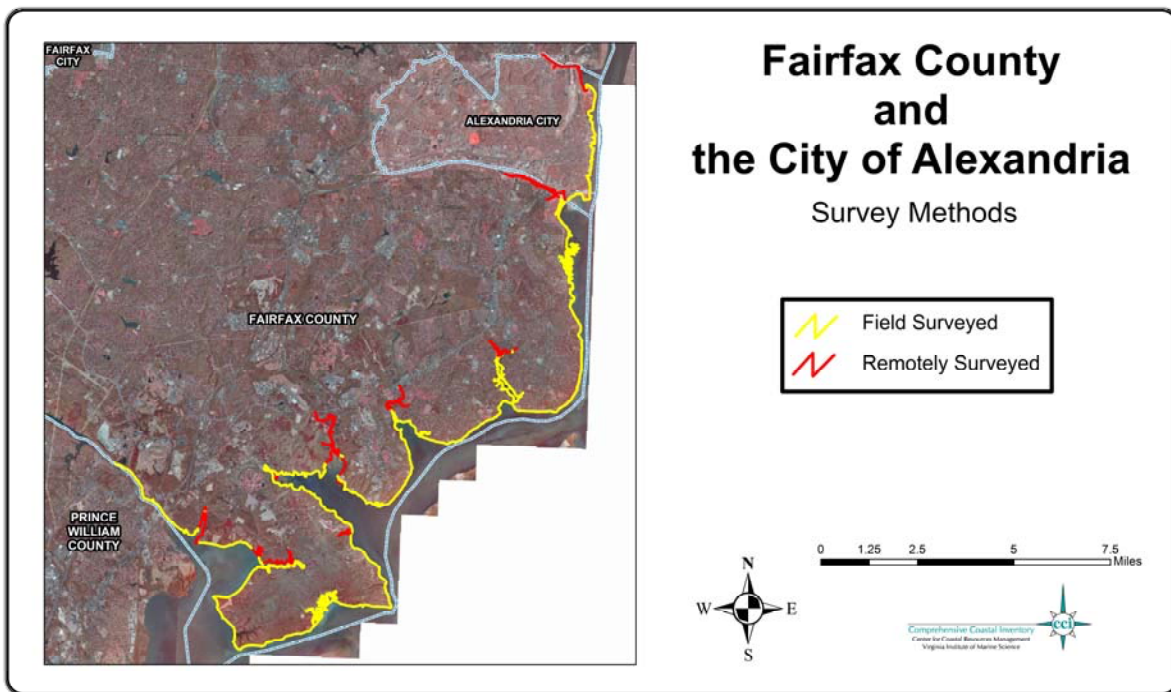
Figure 4. Location of field surveys and remotely sensed data collection.

Shoreline condition is described for Fairfax County and the City of Alexandria and along primary and secondary shoreline. Characteristics are described for all navigable tidal waterways contiguous to these shorelines. A total of 98.87 miles of the total 120.38 miles of shoreline are described. Less than 30 miles (28.39 miles) were coded remotely

shoreline that could not be accessed by boat occurs in well protected, low fetch environments, the remote coding assumes that upland banks are well protected by vegetation, and erosion is low. It is possible, however, for these banks to experience undercutting from tidal currents. This cannot be verified since field visits were not performed. Bank height conditions along reaches characterized using remote sensing techniques were estimated from USGS 1:24,000 topographic maps.

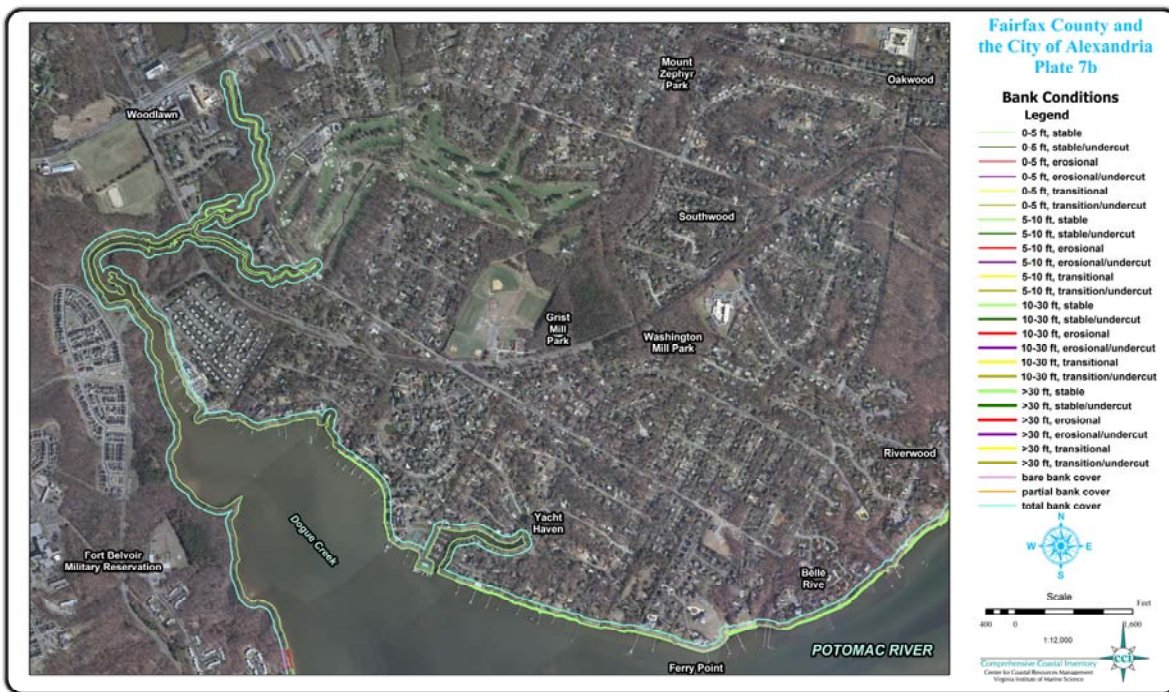
Figure 7. Map illustrating bank conditions for plate 7

Plate B depicts the condition of the bank; specifically bank stability and bank height. The colors light green, red and yellow are used to report if the bank is stable, erosional, or transitional, respectively. If each of these conditions occurs with undercutting at the base of the bank, the colors become, dark green, fuchsia, olive green, respectively. The thickness of the line reflects the bank height; where the thickest lines designate the highest banks (> 30 feet). Plate B uses natural color VBMP imagery for the backdrop.

Once you determine which plate you want, the scroll down menu on the left has links to the four part series for each plate (Figure 5). At the top of the scroll bar Riparian Land Use (plate a) is first. You can scroll down to see links to maps illustrating Bank Conditions (plate b), Shoreline Features (plate c), and Natural Buffers (plate d). The content and details of the four part plate series was described in detail in Chapter 2. The actual map will come up when you click on the plate number. For example, Figure 6 is the riparian land use map for plate 7. Figure 7 is the map illustrating bank conditions for the same area. Figure 8 shows all the shoreline features for plate 7, and Figure 9 the natural buffers associated with that section.

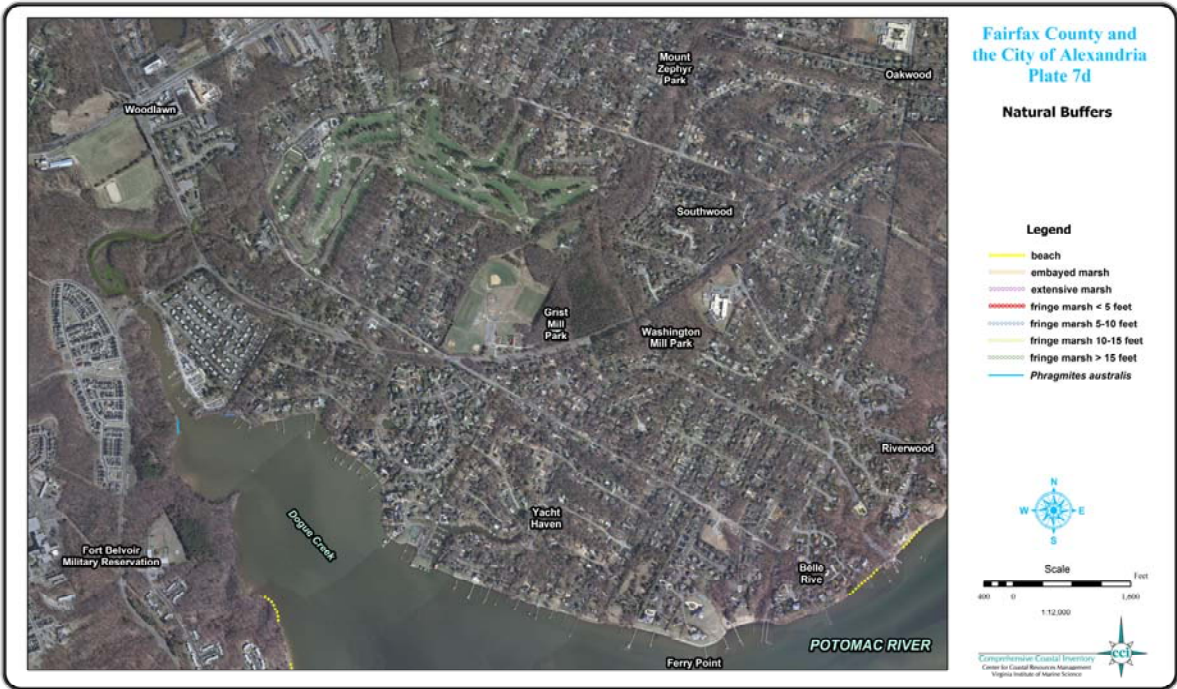
Figure 9. Map illustrating natural buffers for plate 7

On Plate D a pattern of small colored circles along the shoreline describes any natural buffers present. These are limited to marshes and beaches. Orange open circles represent embayed marshes. Purple open circles are extensive marshes. Red open circles indicate the presence of fringe marshes that are less than 5 feet in width. Dark blue open circles represent fringe marshes that are 5-10 feet in width. Fringe marshes 10-15 wide are depicted with light green open circles. If the fringe marsh is greater than 15 feet the open circles will be dark green. The invasive species *Phragmites australis* is designated with blue line shown behind the shoreline. Beaches, if present are delineated with solid yellow balls.
