Prince George County and the City of Hopewell, Virginia Shoreline Inventory Report Methods and Guidelines

**Comprehensive Coastal Inventory Program
Center for Coastal Resources Management
Virginia Institute of Marine Science, College of William and Mary
Gloucester Point, Virginia
September 2016**

Special report in Applied Marine Science and Ocean Engineering No. 449 of the Virginia Institute of Marine Science

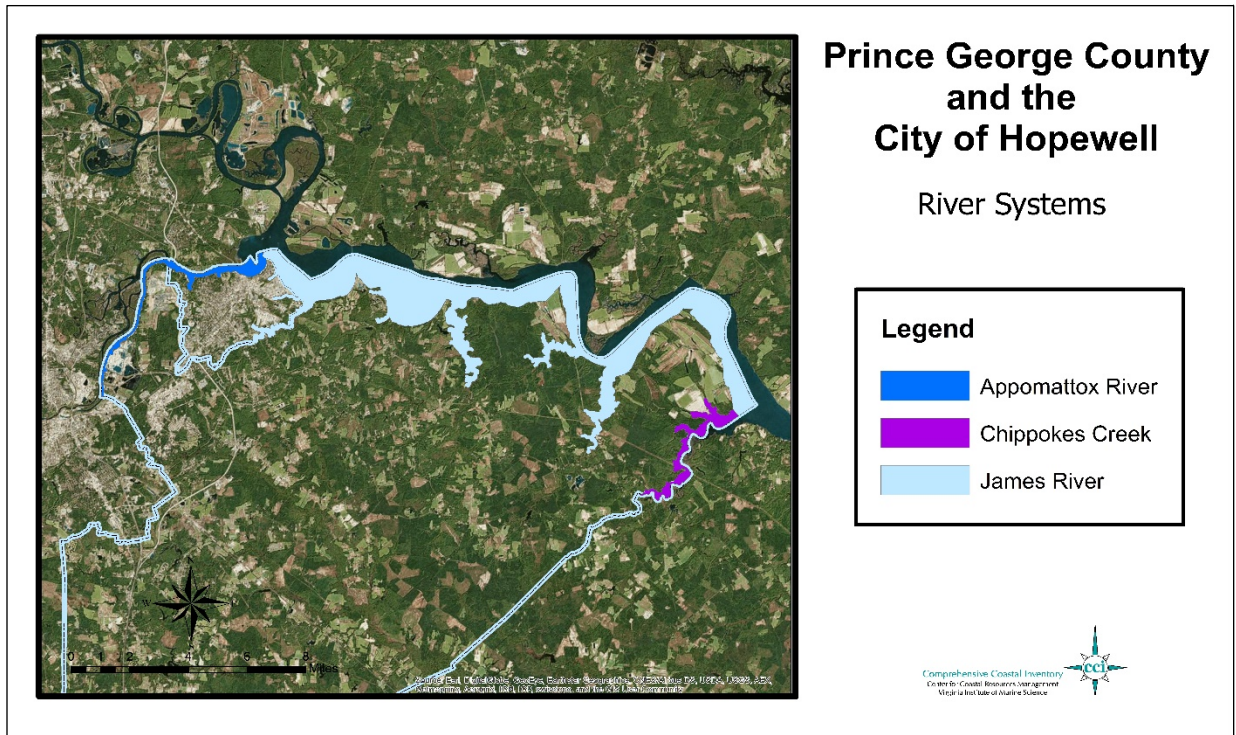
Figure 2. River Systems in Prince George County and the City of Hopewell

Summary tables (Tables 4-7) quantify conditions observed on the basis of river systems (Figure 2). Refer to Figure 2 for the location of these river systems. Note, river systems do not correspond to watershed boundaries. They were developed for convenience in reporting data.

The top toolbar also includes tabs to access some important status information for the locality. By clicking on the “River System Pie Charts” button, users can obtain a statistical summary distribution of the riparian land use and amount of hardened shoreline for a specific water body selected from the drop down menu in the upper left (Figure 7). More detailed results in table format can be found by clicking the Prince George County and the City of Hopewell Summary PDF button also in the window. The summary statistics are reported by river systems (Figure 2).

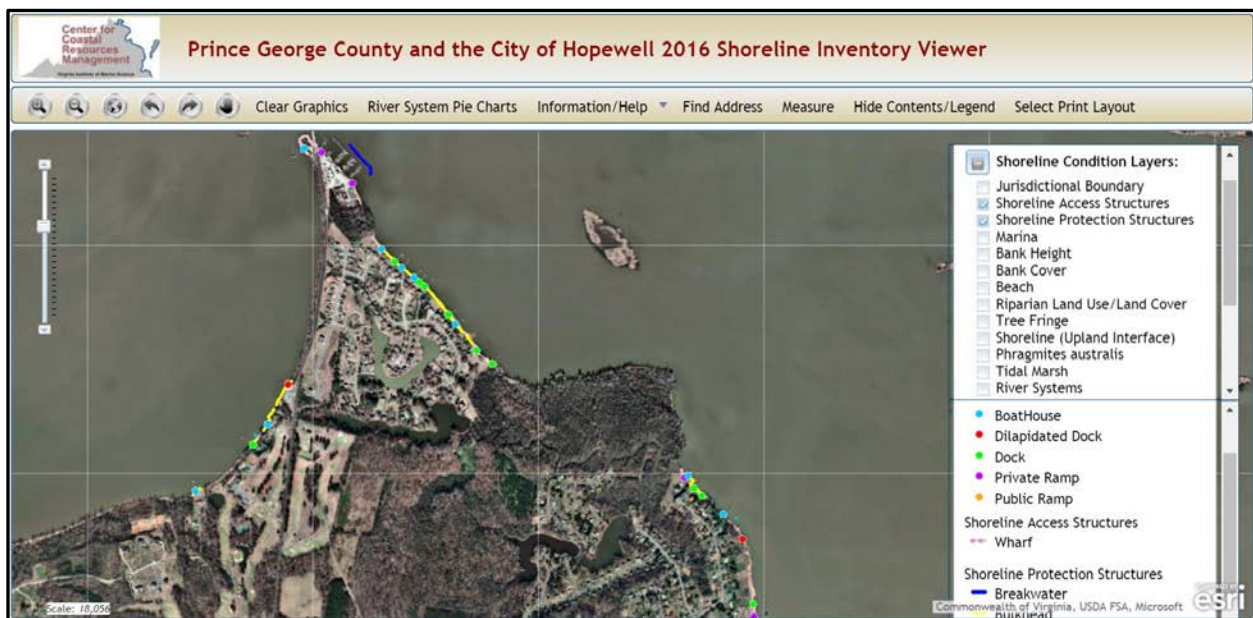
Figure 4. Map Viewer illustrates Shoreline Access and Protection Structures for a section of Prince George County.

In Figure 4 Shoreline Access Structures, and Shoreline Protection structures are selected. Shoreline Access structures are point features that includes piers and boat ramps. The actual footprint of these structures is not measured; only their location. Shoreline Protection Structures are line features and are mapped and illustrated in the viewer to show where they occur along the shoreline. Figure 5 illustrates riparian land use in the riparian zone for the same section of the County.

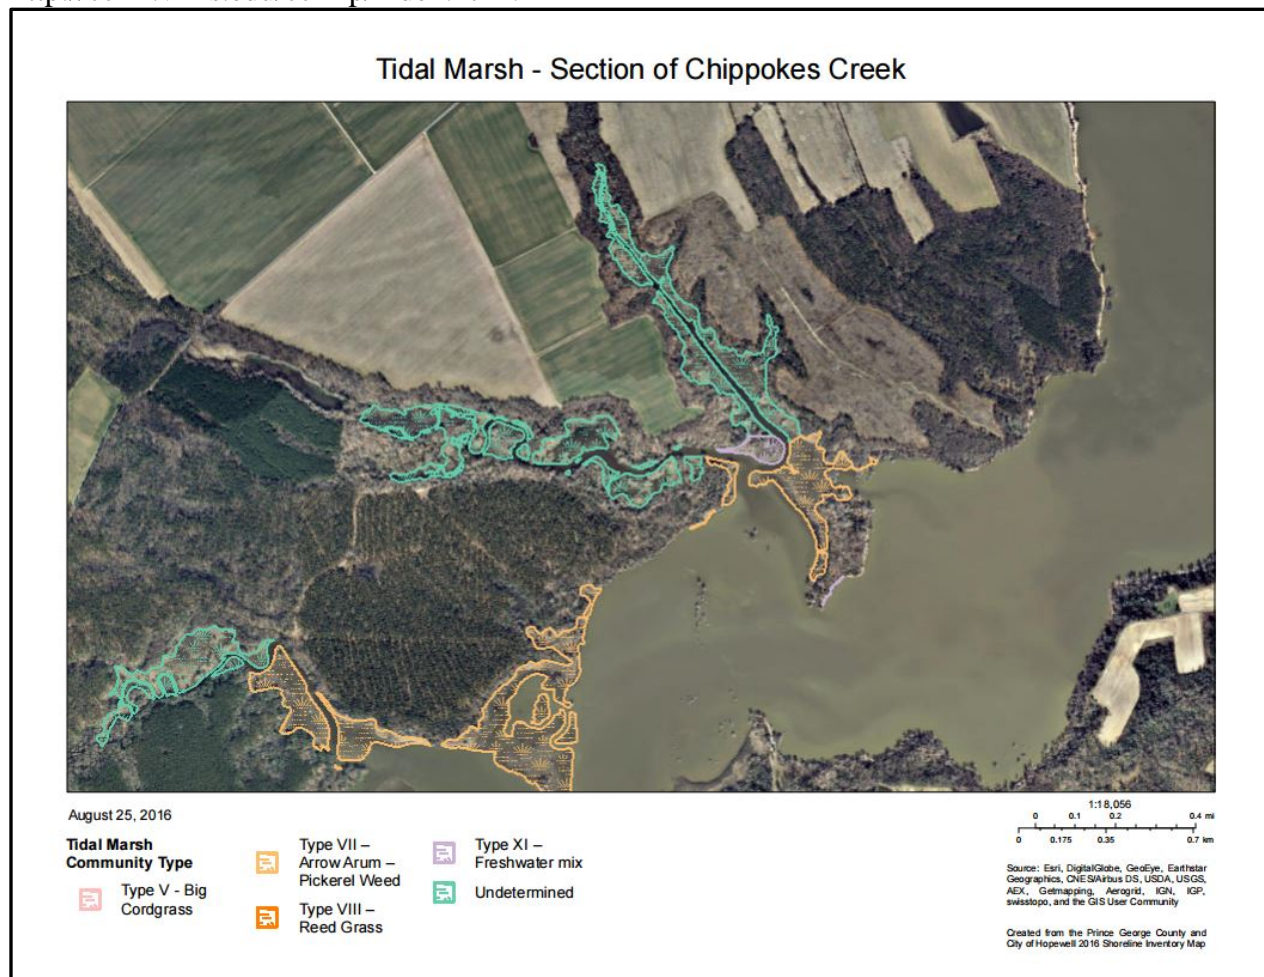
Figure 8. Customized print window for a section of Upper Chippokes Creek

Finally, users have the option to personalize their own maps (i.e. map extent, data displayed, map title, etc.) and save them as a pdf file by clicking “Select Print Layout” button. The page can be set up for printing to 8.5 x 11 portrait or landscape style. Figure 8 is an example of a customized map generated for a section of Upper Chippokes Creek. Here the tidal marsh communities are displayed, and the community type is reported in the legend beside the illustration.
