Accomack County, Virginia Shoreline Inventory Report Methods and Guidelines

**Comprehensive Coastal Inventory Program
Center for Coastal Resources Management
Virginia Institute of Marine Science, College of William and Mary
Gloucester Point, Virginia
September 2016**

Special report in Applied Marine Science and Ocean Engineering No. 450 of the Virginia Institute of Marine Science

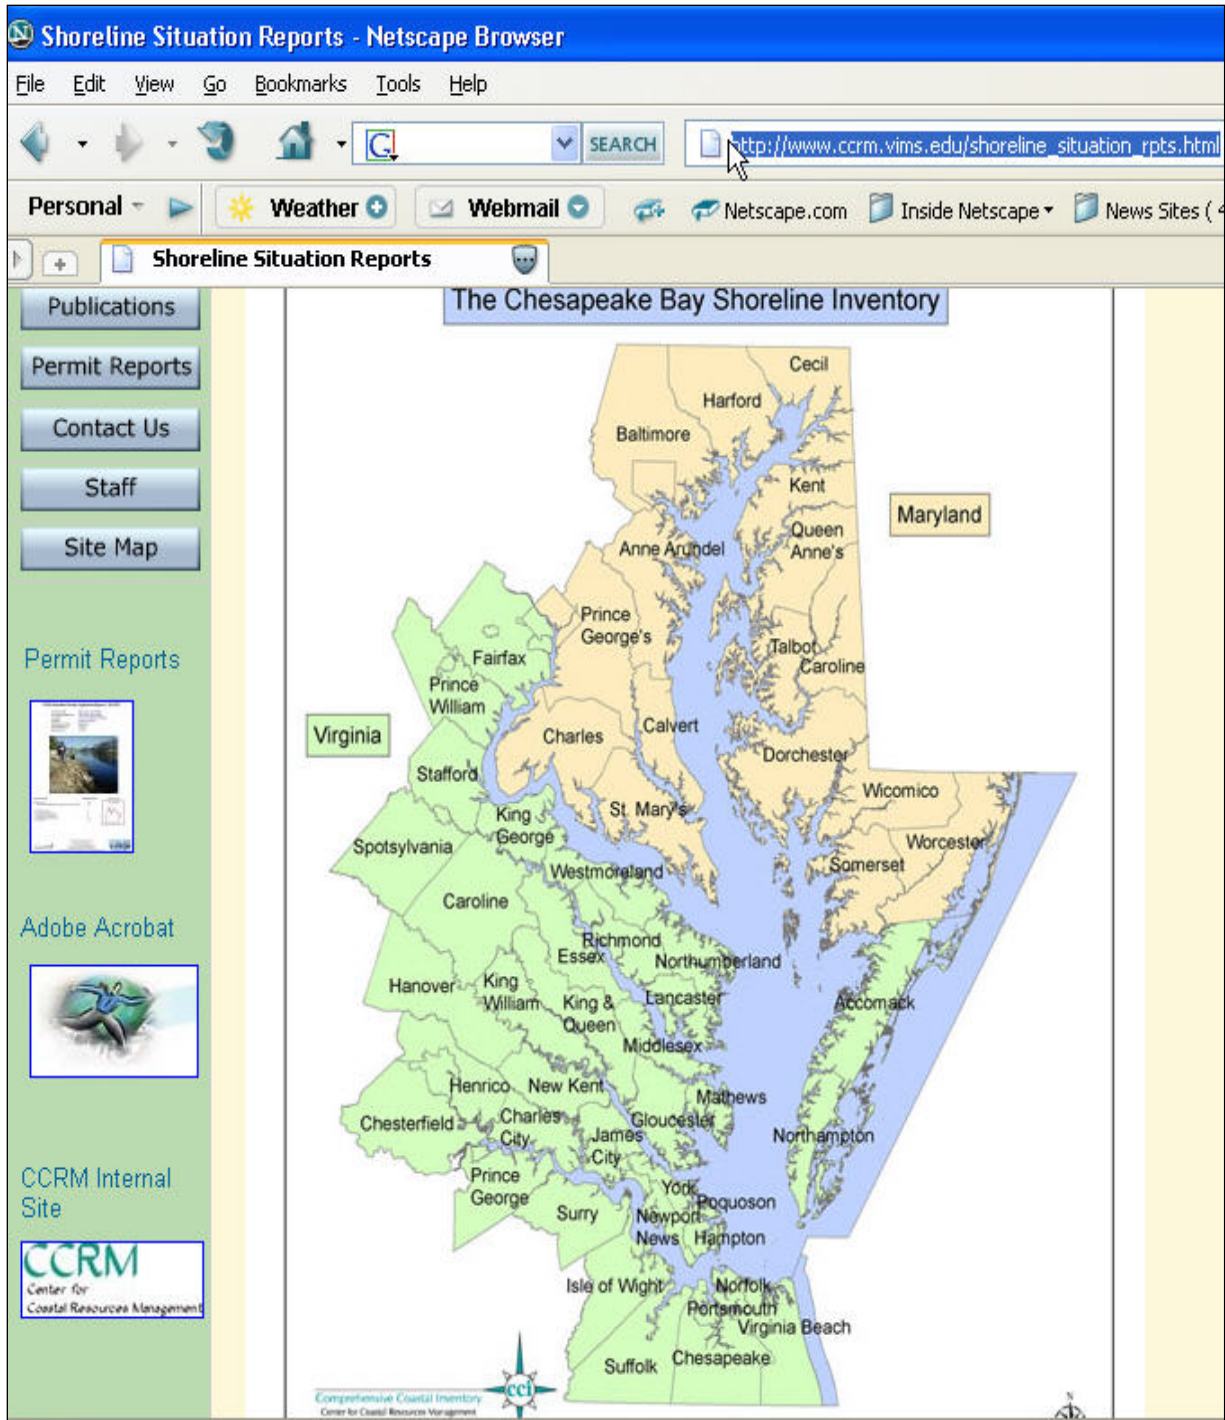
Figure 1. Shoreline Inventory Website

2.4c.) Map Viewer and Summary Tables: The Accomack County Shoreline Inventory is delivered to the end user through a website; http://ccrm.vims.edu/gis_data_maps/shoreline_inventories/index.html (Figure 1.), by clicking on Accomack County in the map or list of localities. The new format for Shoreline Inventories includes a map viewing tool rather than maps in pdf format. The map viewer allows users to interact with the datasets within a familiar “google” type map service that was developed with Javascript. Here they can view data of their choice and customize map products for printing themselves. Access to the GIS data, summary tables and methods report is also available through this website.

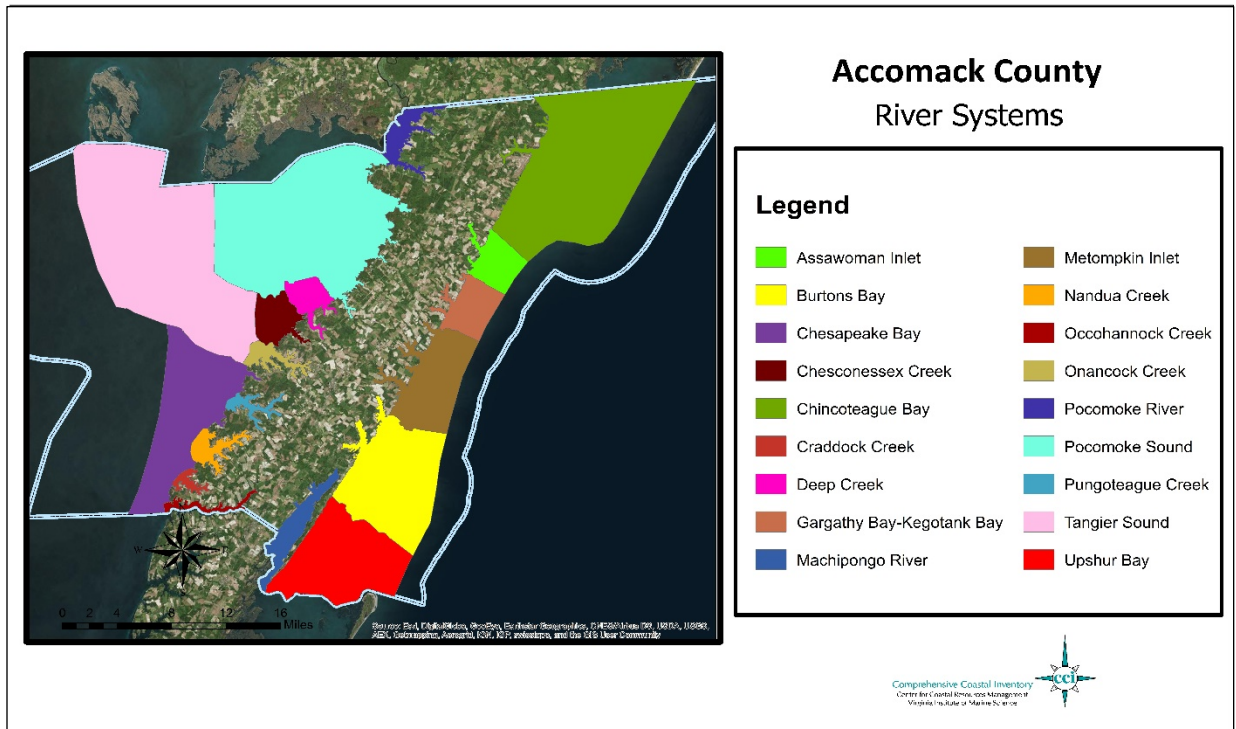
Figure 2. River Systems in Accomack County

Summary tables (Tables 4-7) quantify conditions observed on the basis of river systems (Figure 2). Refer to Figure 2 for the location of these river systems. Note, river systems do not correspond to watershed boundaries. They were developed for convenience in reporting data.

The top toolbar also includes tabs to access some important status information for the locality. By clicking on the “River System Pie Charts” button, users can obtain a statistical summary distribution of the riparian land use and amount of hardened shoreline for a specific water body selected from the drop down menu in the upper left (Figure 7). More detailed results in table format can be found by clicking the Accomack County Summary PDF button also in the window. The summary statistics are reported by river systems (Figure 2).

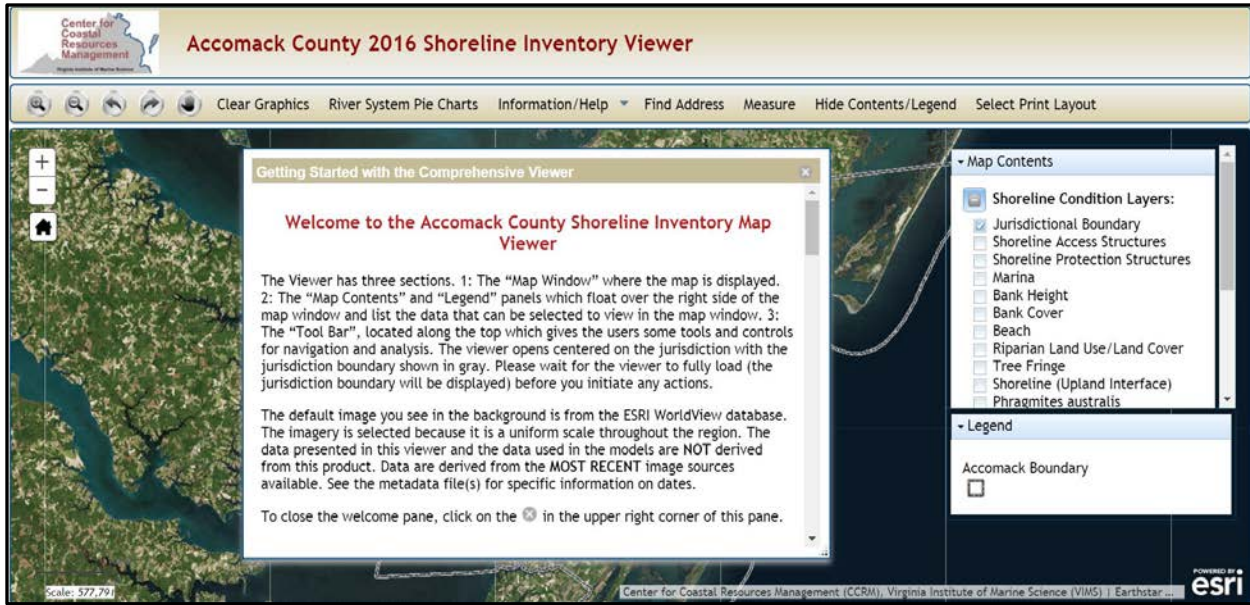
Figure 3. Opening page for the Accomack County Shoreline Inventory Viewer

The Viewer has two panels: “Map Window”, where the map is displayed and “Map Contents and Legend”, where data that can be selected and viewed in the map window are listed. A tool bar is located along the top of the “Map Window” which gives users some controls for navigation and analysis (Figure 3.).

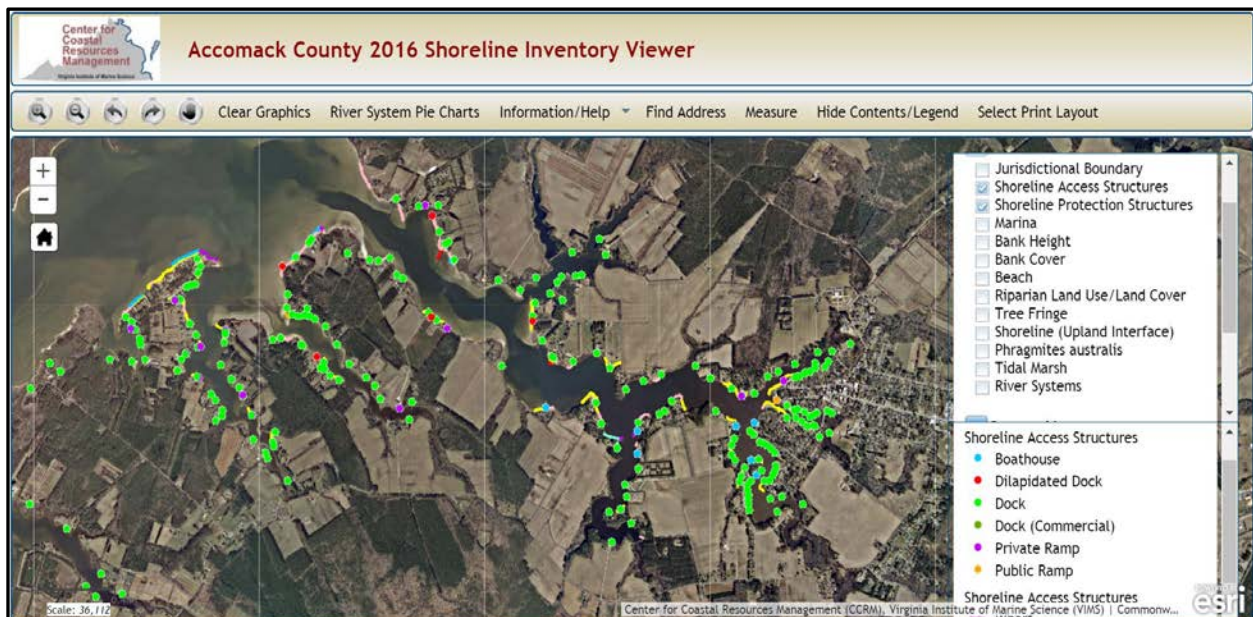
Figure 4. Map Viewer illustrates Shoreline Access and Protection Structures for a section of Accomack County.

In Figure 4 Shoreline Access Structures, and Shoreline Protection structures are selected. Shoreline Access structures are point features that includes piers and boat ramps. The actual footprint of these structures is not measured; only their location. Shoreline Protection Structures are line features and are mapped and illustrated in the viewer to show where they occur along the shoreline. Figure 5 illustrates riparian land use in the riparian zone for the same section of the County.

From the “Map Contents” the user may check various attribute layers on or off. The user must use the scroll bar on the far right to see the complete list of layers available. When layers are turned on, the corresponding legend appears in the “Legend” panel, and the data are displayed in the “Map Window” (Figure 4).

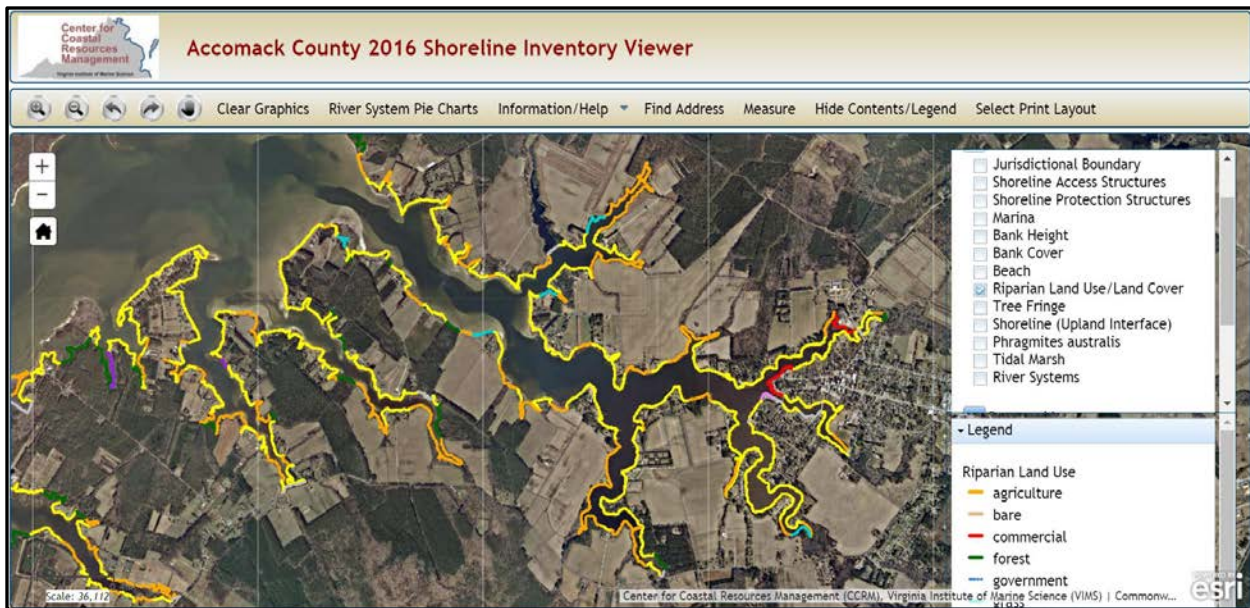
Figure 5. Distribution of land use in the riparian zone is displayed for this region of Accomack County.

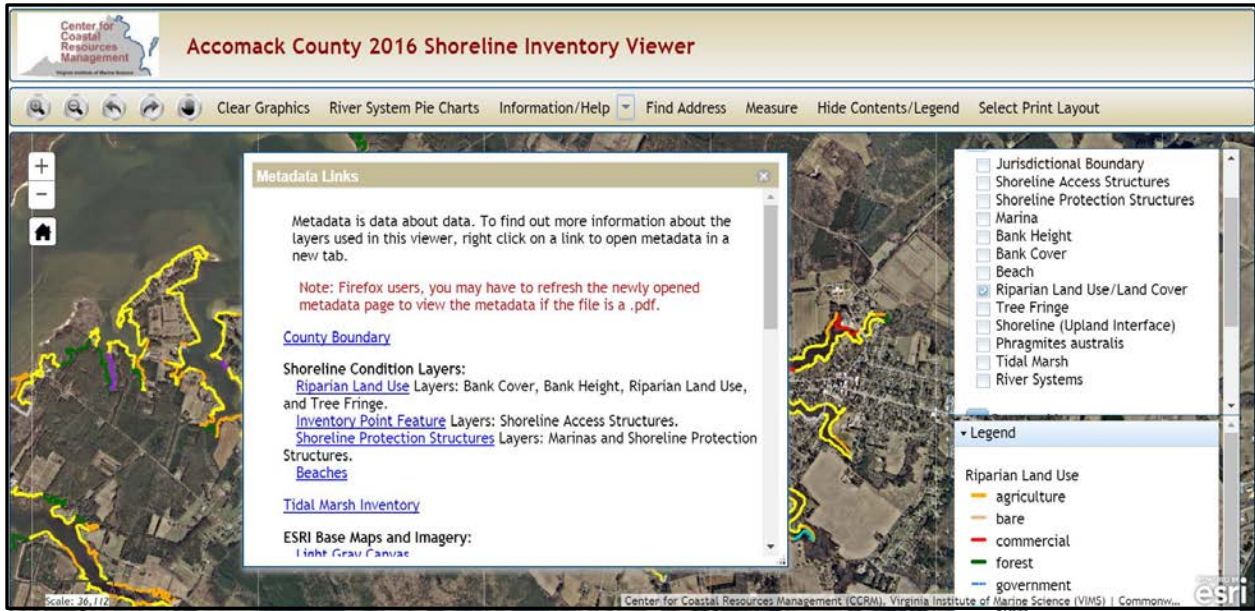
Figure 6. Link to Metadata records has been selected from the top Information tab in the toolbar.

The user can use the zoom and pan tools from the top toolbar or the slide bar on the left side of the map window to change their map extent. If the map resolution is exceeded the window will become illegible. Detailed information can be obtained about the data by selecting the “Information/Help” tab at the top of the map viewer. From here the inventory glossary and metadata records can be easily accessed. In Figure 6 the selection for metadata has been made and 5 possible records can be retrieved.

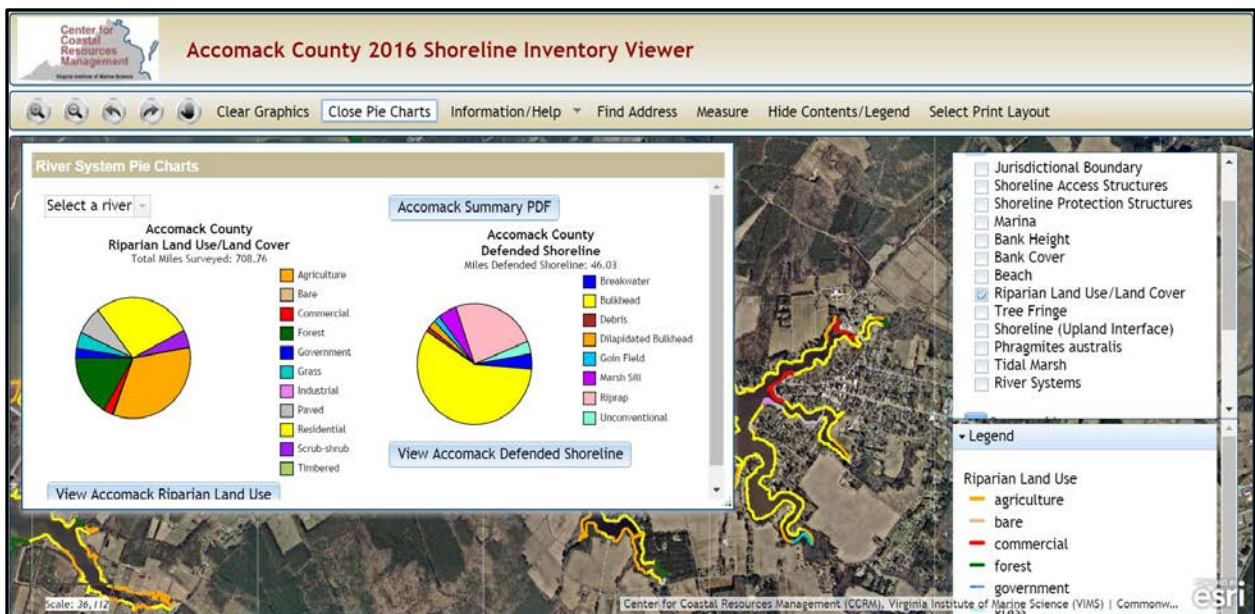
Figure 7. Pie charts display land use and shoreline hardening statistics for each tributary.

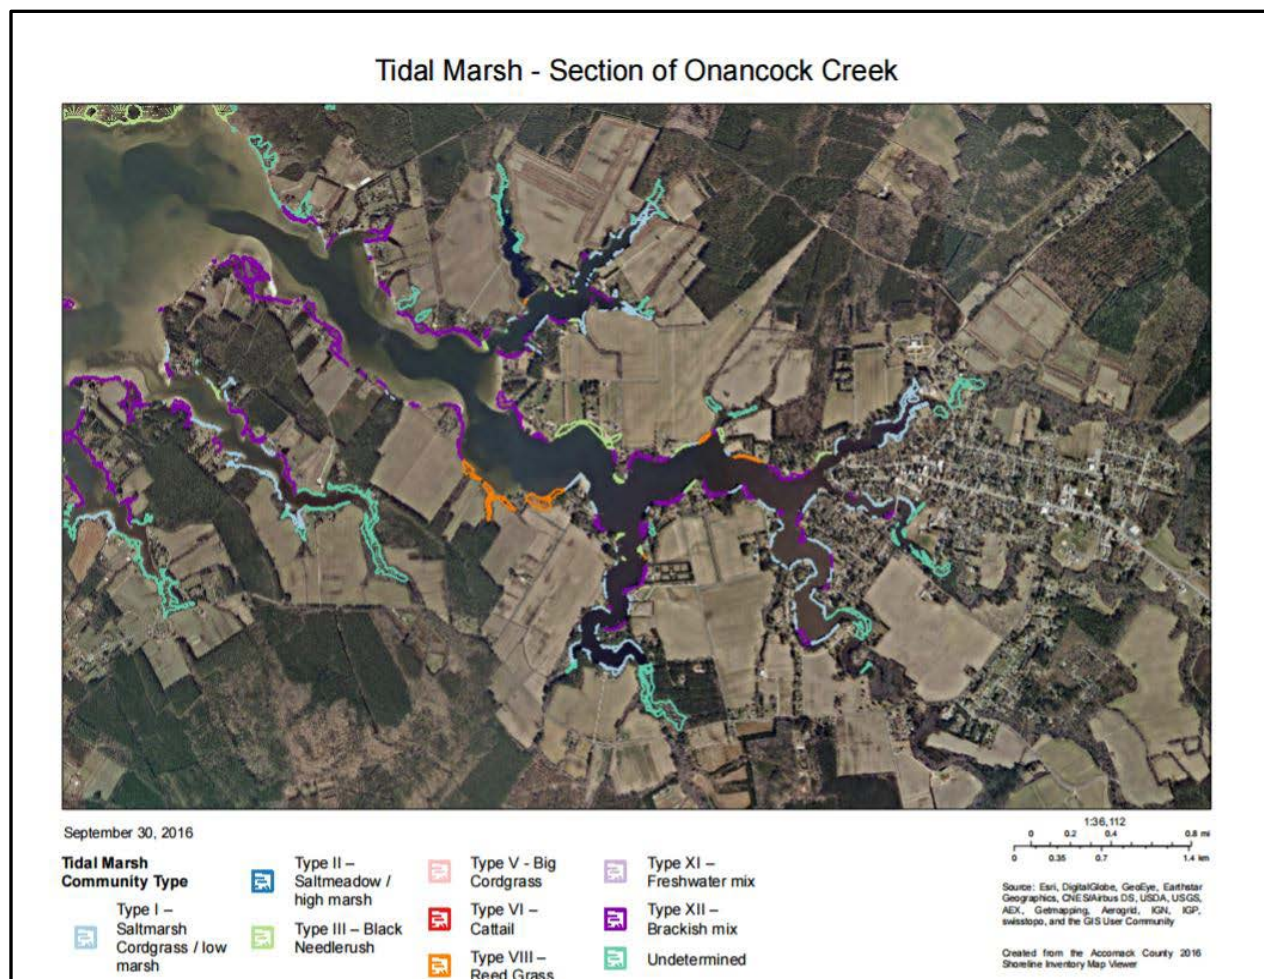
Figure 8. Customized print window for a section of Onancock Creek

Finally, users have the option to personalize their own maps (i.e. map extent, data displayed, map title, etc.) and save them as a pdf file by clicking “Select Print Layout” button. The page can be set up for printing to 8.5 x 11 portrait or landscape style. Figure 8 is an example of a customized map generated for a section of Onancock Creek. Here the tidal marsh communities are displayed, and the community type is reported in the legend beside the illustration.
