Shoreline Situation Report Surry County, Virginia

Shoreline Situation Report
SURRY COUNTY, VIRGINIA

Chesapeake Research Consortium Report Number 50
Special Report In Applied Marine Science and Ocean Engineering Number 112 of the

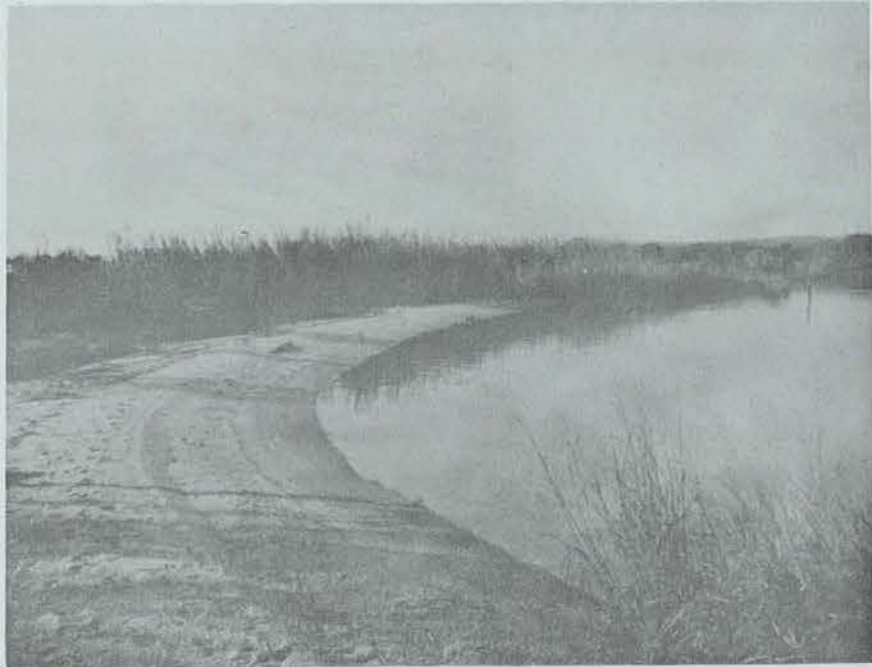
FIGURE 3

FIGURE 3: Beach and marsh at Hog Island State Waterfowl Refuge. The entire area is preserved.

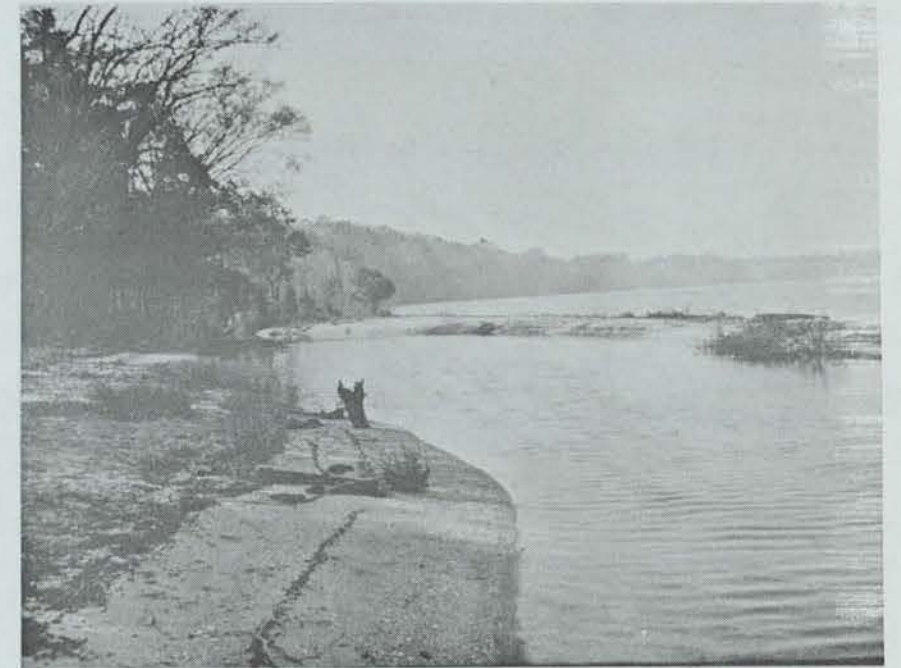
FIGURE 4

FIGURE 4: Beach at Chippokes State Park. A sand bar has formed at the mouth of the creek.

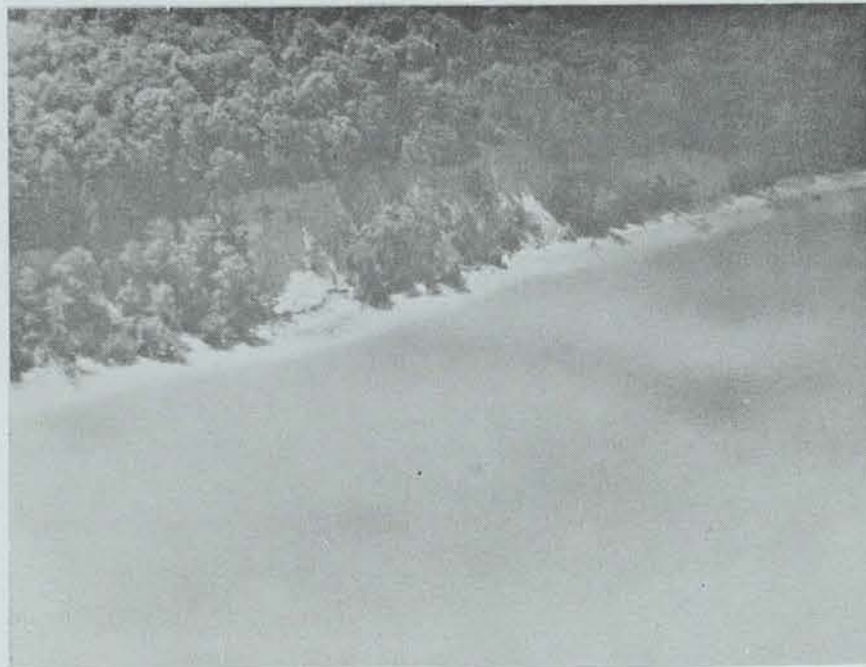
FIGURE 5

FIGURE 5: Bluffs between Broad Swamp and Wakefield. The bluffs here, as in most of Surry, are continually eroding. Rain runoff, wind and wave actions all contribute to this problem.

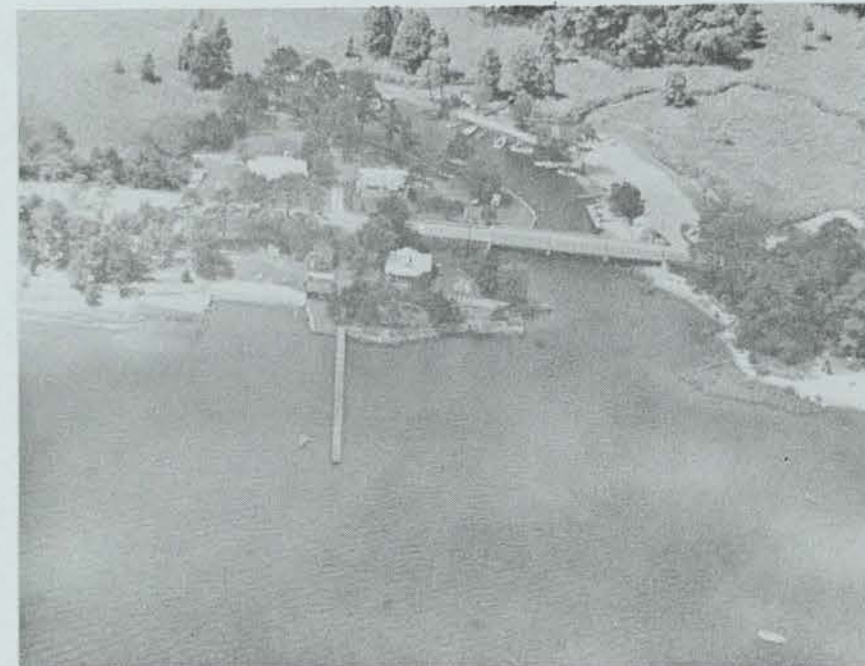
FIGURE 6

FIGURE 6: A marina and several private residences are located at Pleasant Point at the mouth of Crouch Creek.

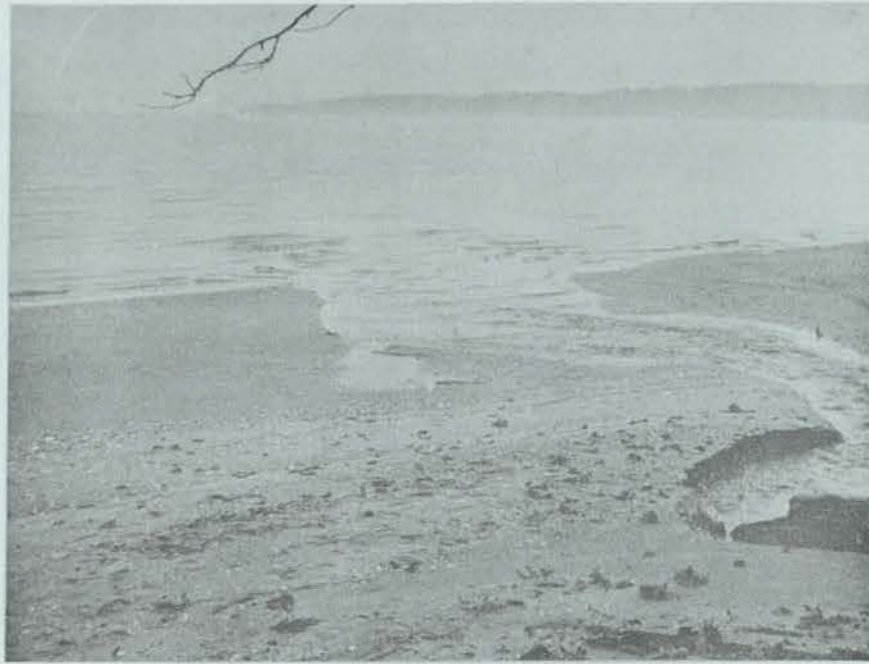
FIGURE 7

FIGURE 7: Creek on beach at Guildford Heights. The beaches here are nourished by the erosion of the bluffs behind.

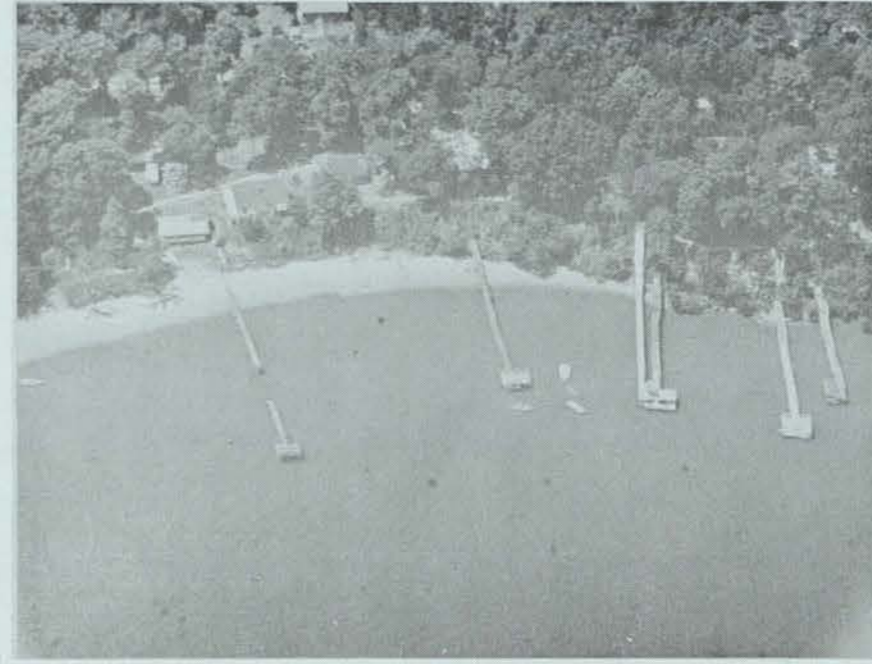
FIGURE 8

FIGURE 8: The piers at Scotland reflect the heavy summer vacation residential usage of this area. Most houses are built on the bluffs along the shoreline.

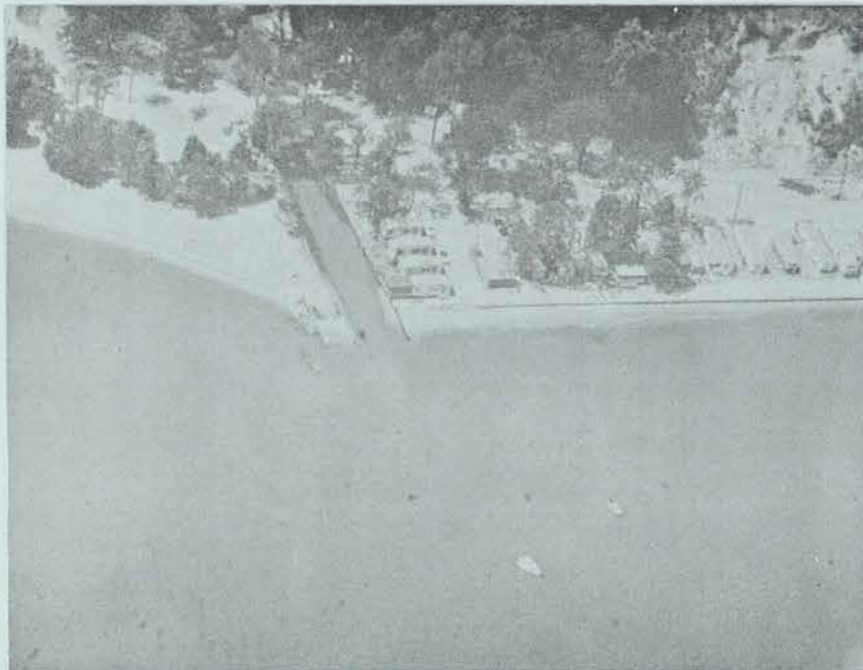
FIGURE 9

FIGURE 9: Beach and stream at Sunken Meadow. The trailers are placed on artificial fill behind a wooden bulkhead. Flooding from storm induced waves poses a serious problem here.

all below the 10-foot contour and is susceptible to flooding. No structures are endangered here. Further west at Sunken Meadow, the flood hazard is moderate, critical. Structures and numerous trailers have been placed along the beach behind bulkheading with fill. This stabilized area averages only 2 feet in height, with the normal tide range extending to the bulkhead. Flood waters here would overtop this structure and possibly cause severe damage to the trailers and other buildings behind. To the northwest, at Sloop Point, many structures are on a beach zone below the 10 foot contour. The flood hazard for this area ranges from low to moderate, critical. Several structures here are within 5 feet of the water, with normal high tide levels extending even closer. Since the flood levels for the James River this far from the mouth are not very high, the flood hazard here would be moderate, critical. Even limited flooding could cause damage to some buildings.

SHORE PROTECTIVE STRUCTURES: All protective structures in the segment are found at Sunken Meadow. Two areas of artificial fill are bulkheaded. About 1,600 feet of wooden bulkhead has been erected to retain the fill here. Both installations seem to be effective. The stream to Sunken Meadow Pond has wooden bulkheading along its banks, extending as jetties into the river. Several areas of the structure along the creek are failing, and the jetties seem partially ineffective, as the channel is silting in.

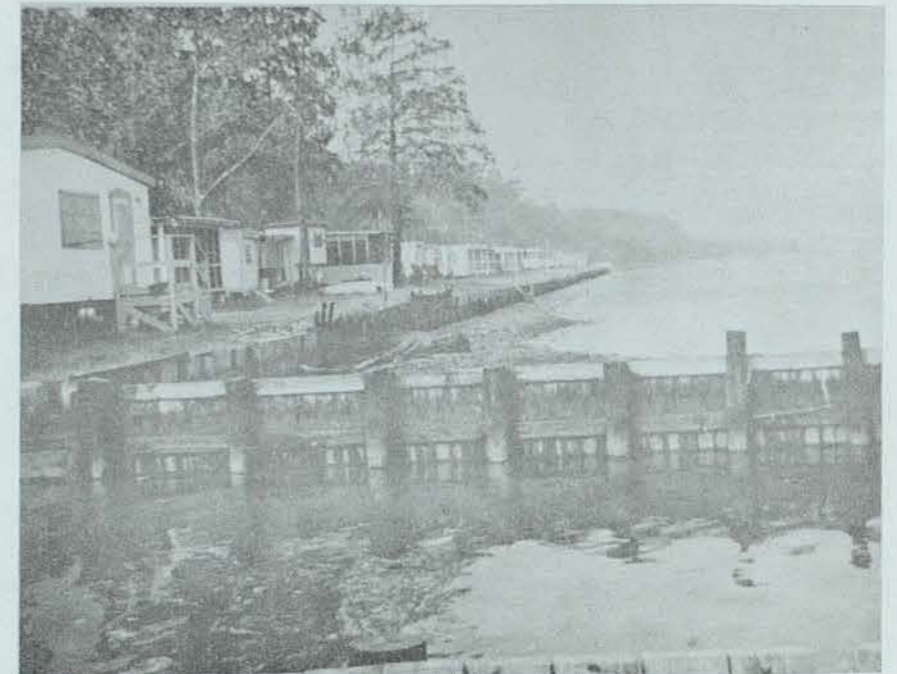
FIGURE 10

FIGURE 10: Ground view of trailers at Sunken Meadow. The bulkhead has been repaired in several places.
