Shoreline Situation Report Isle of Wight County, Virginia

Shoreline Situation Report ISLE OF WIGHT COUNTY, VIRGINIA

Chesapeake Research Consortium Report Number 46

Special Report In Applied Marine Science and Ocean Engineering Number 97 of the

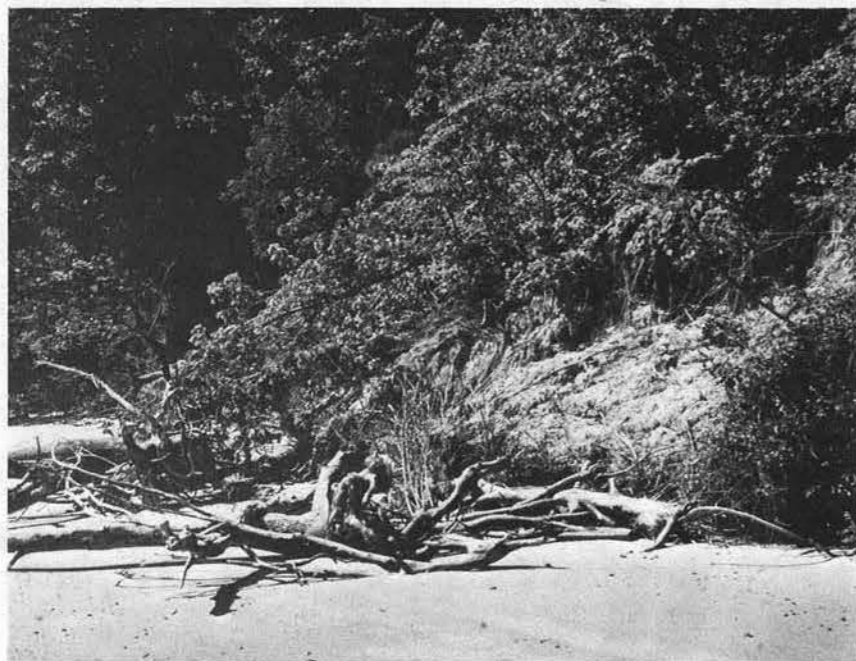
FIGURE 3

Figure 3: Eroding bluffs at Lawnes Neck. The falling trees uproot large amounts of soil, further adding to the erosion problem.

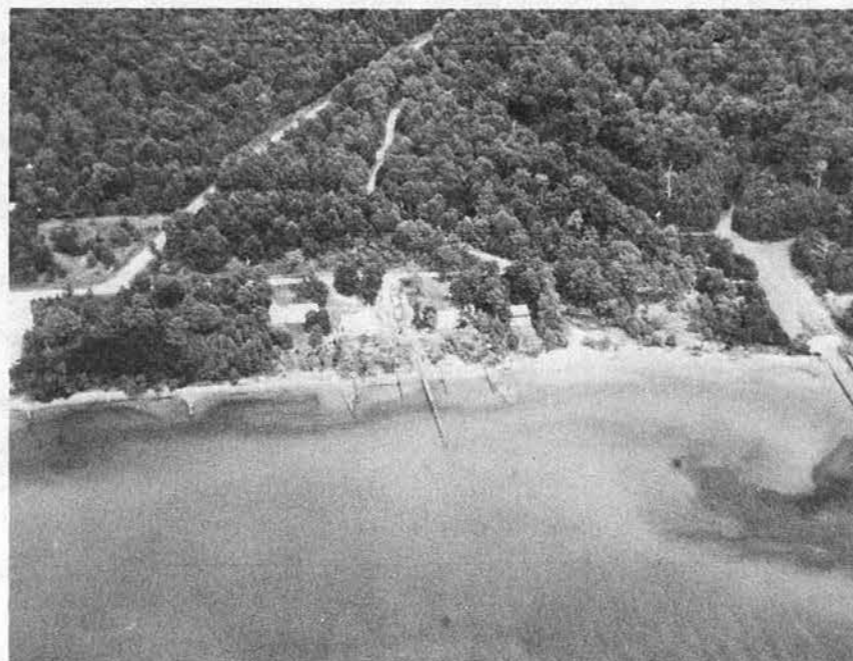
FIGURE 4

Figure 4: Aerial view north of Baileys Beach. This picture, taken in July, 1974, shows a creek behind the two jetties on the right in the photo. Groins seem only moderately effective in trapping sand. Several appear to have been flanked.

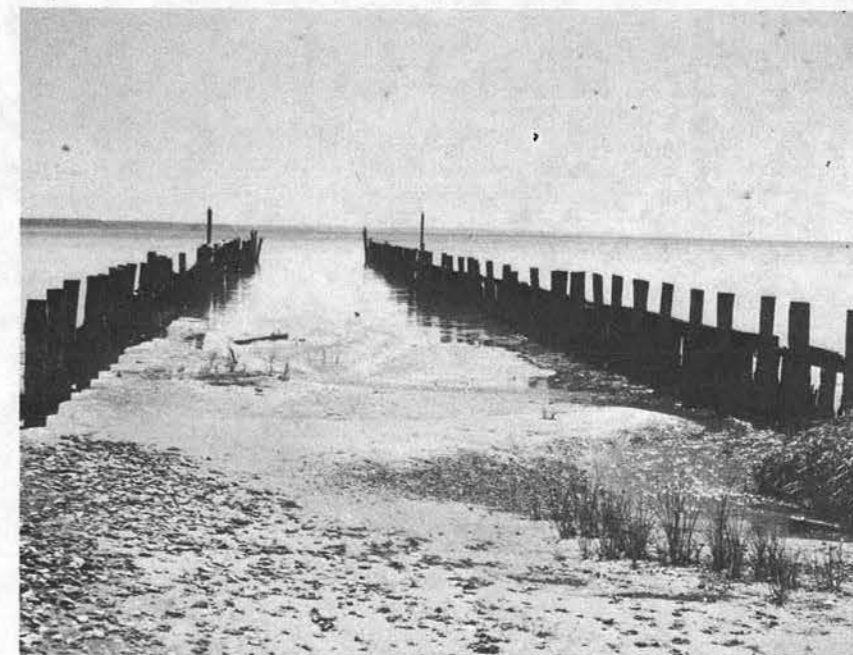
FIGURE 5

Figure 5: Ground view, taken in July, 1975, of the area in the previous photo. The jetties have served to close off the creek, which is now dry and filled with marsh grasses and sand.

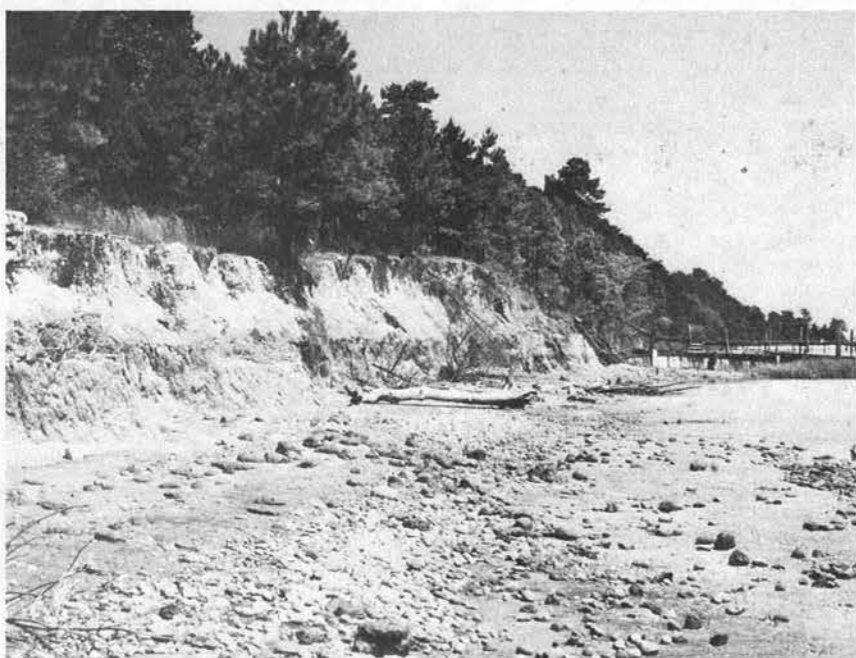
FIGURE 6

Figure 6: Eroding bluffs just north of previous photo. The beach and lower half of the bluffs are mostly clay and are not suitable for most recreational activities. When the Reserve Fleet extended south this far, the area was mostly stable. Without that offshore protection, erosion is again a problem.

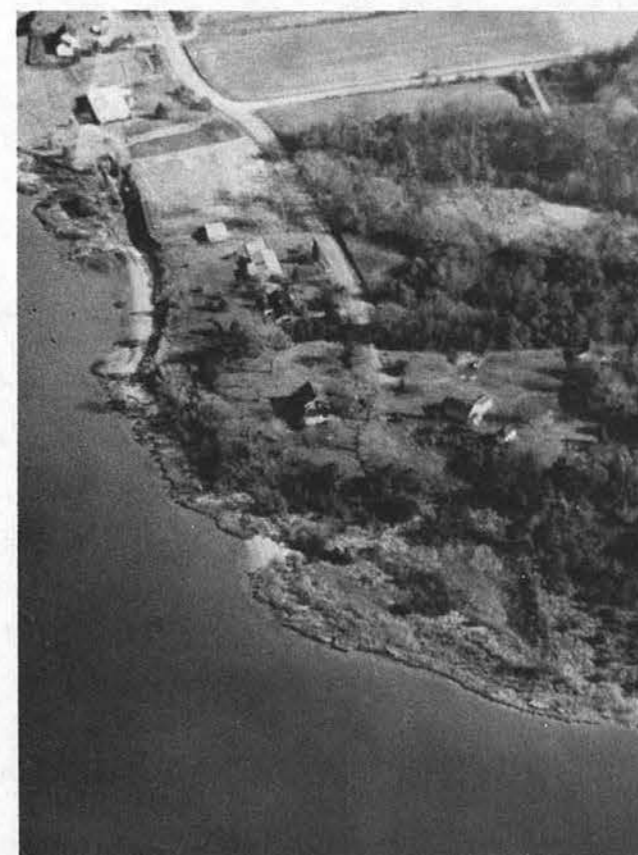
FIGURE 7

Figure 7: An aerial view of Goodwin Point. Parts of the shoreline have been bulkheaded, but unprotected stretches are very vulnerable to wind and wave attacks.

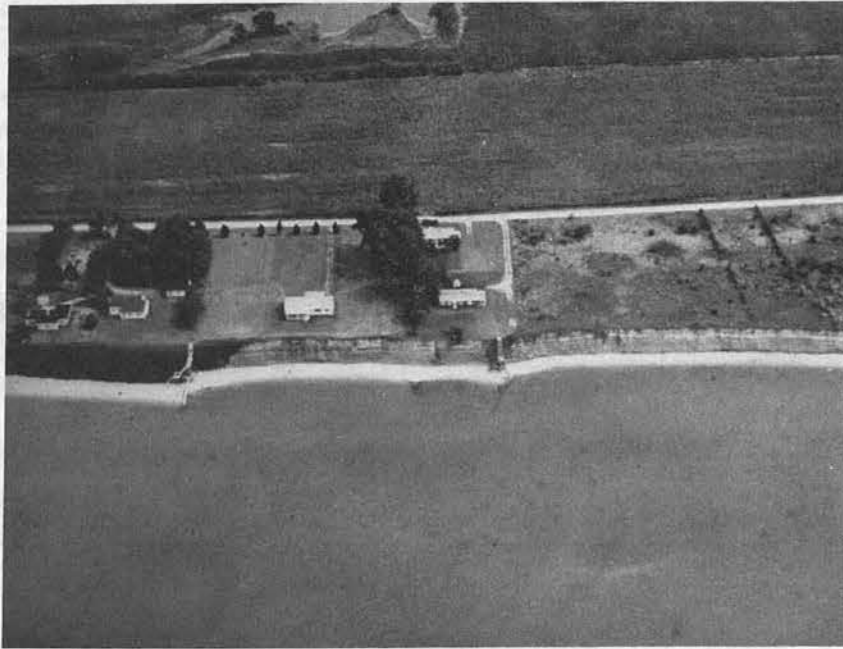
FIGURE 8

Figure 8: Aerial view of Mogarts Beach. This area had an erosion rate of 3.8 feet per year until the Reserve Fleet was anchored to the north. Although erosion is still a problem in some areas, it is not as severe.

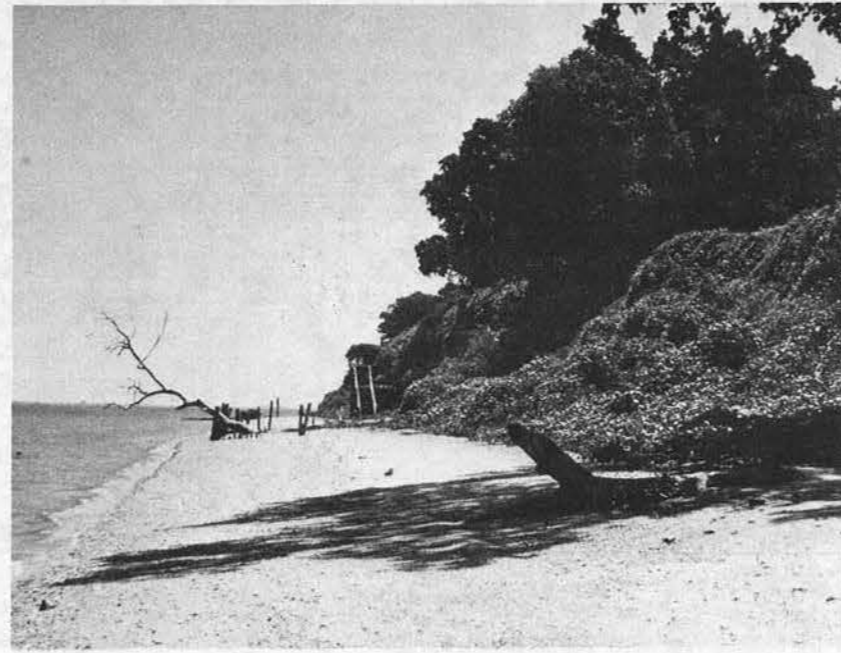
FIGURE 9

effectively cut off the long fetch to the north-northwest, protecting the shoreline from severe storm effects. Along Mogarts Beach, the once eroding 30-foot high bluffs are now covered with vegetation (Figure 9). However, this condition of stability probably will be short lived, for the Reserve Fleet is being constantly diminished in numbers. This was the case at Rushmere Shores. When the Fleet was offshore, the area stabilized and a beach developed. Since the Fleet has been moved from offshore, the area has again been suffering from erosion (Figure 6). When the Reserve Fleet is no longer interrupting the long north-west fetch to Mogarts Beach, the area will once again suffer from the effects of the severe north-western storms.

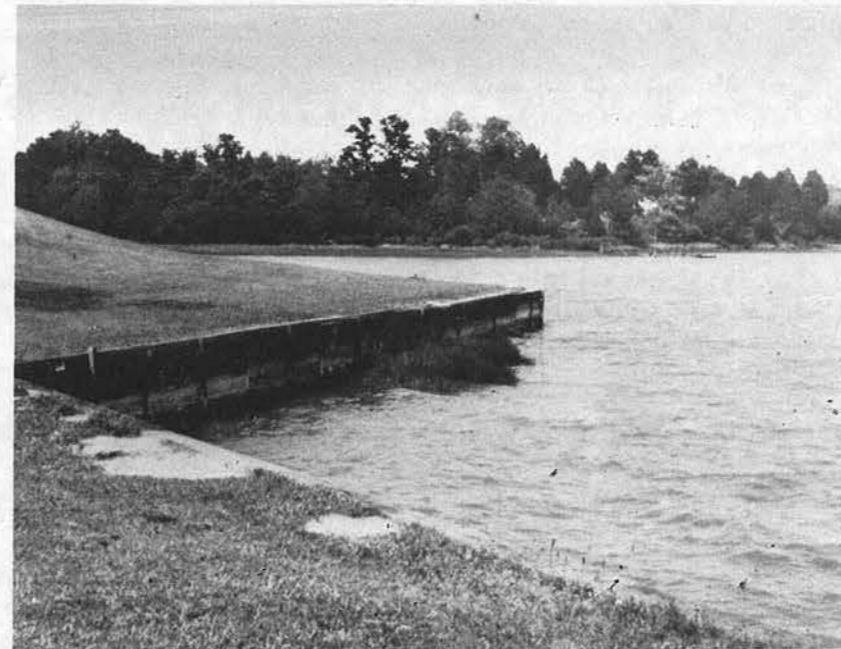
FIGURE 11

Figure 11: Wooden bulkhead near the mouth of Brewers Creek. The structure is in very good shape and is retaining fill in front of several residences.
