Gloucester County Shoreline And Tidal Marsh Inventory

Special Report in Applied Marine Science and Ocean Engineering
Number 351 of the Virginia Institute of Marine Science

RMAP.99.003.1
February, 1999

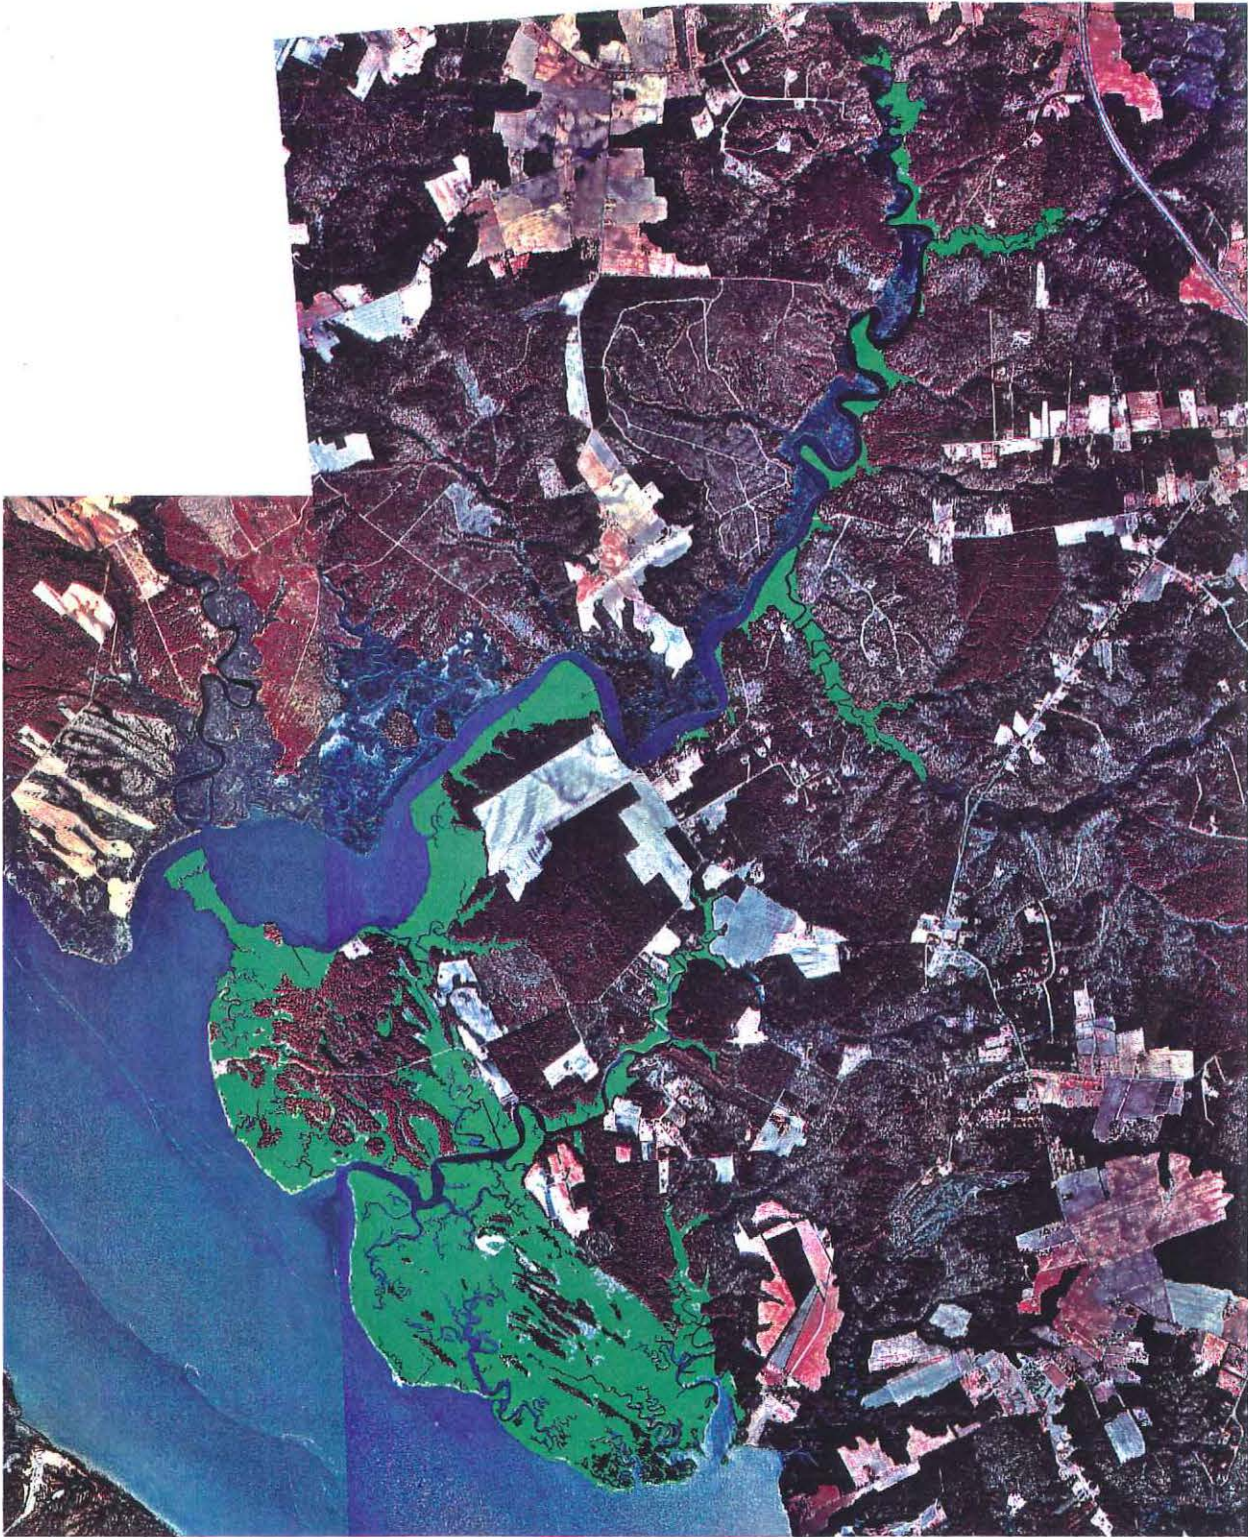
POROPOTANK R. - PURTAN IS.

This region of Gloucester County is relatively rural. The landscape is dominated by forest cover interspersed with agricultural uses and low density residential districts. Purtan Island is one of the more prominent features within the river segment, accounting for much of the 1300 acres of tidal marsh delineated.

Approximately 127 km (78.9 miles) of shoreline was surveyed from the air. Nearly 117 km (72.7 miles) of this has been measured as stable marsh habitat along the fringes of the shore and the larger Purtan Island. The outer edge of Purtan Island flanking the York River accounts for much of the unstable marsh habitat surveyed. The well protected reaches, along with the limited shorefront development, has left the shoreline of the Poropotank relatively untouched. Less than 270 meters (885.6 ft) of this segment have installed shoreline protection structures to counteract erosion problems. Tables 1a-1c reports the values for the shoreline attributes surveyed within each plate boundary.

Compiled from NAPP photos
 Index No: 7683-174 7683-175 7683-179
 Dated: 3/94

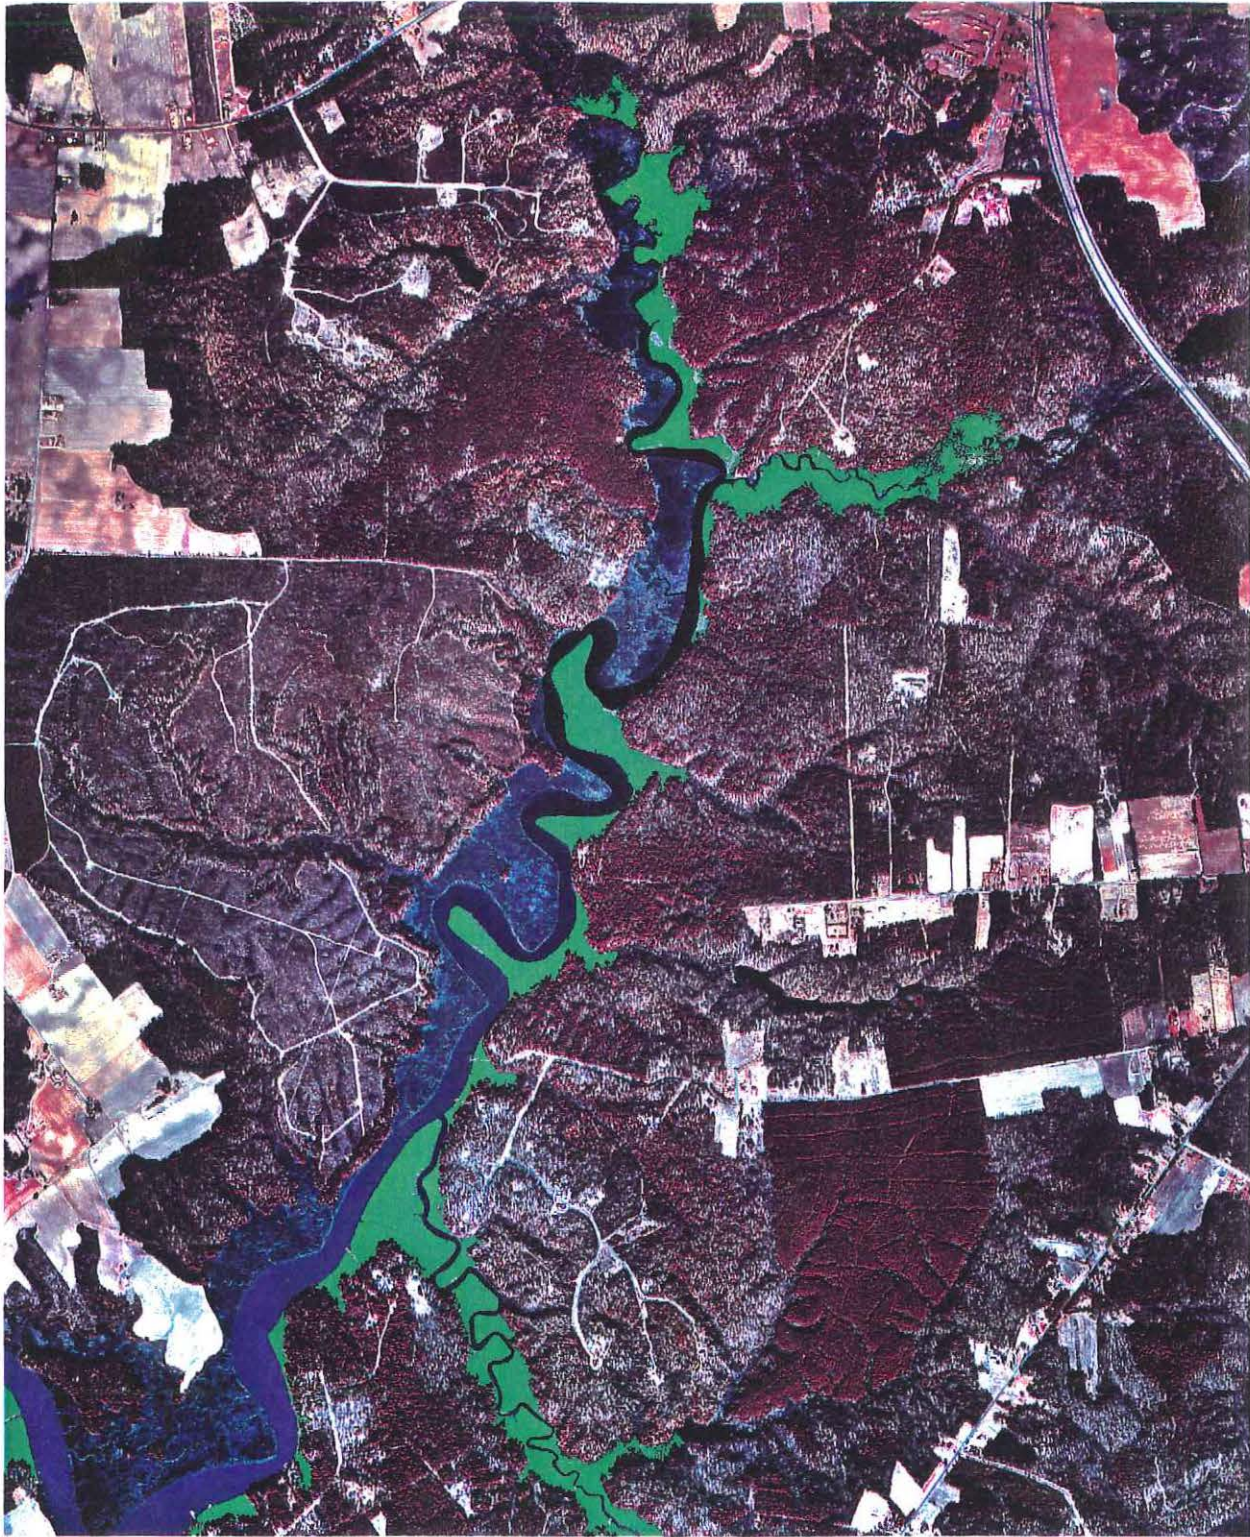
POROPOTANK R. - PURTAN IS. (A)

The headwater marshes of the Poropotank River, near Wood Mill Swamp, are dominated by freshwater plant species (type XI marsh). Prior surveys of vegetation show that the marsh community contains mainly wild rice and beggar ticks, with smaller amounts of pickerelweed, saltmarsh cordgrass, water-hemp, smartweeds, jewel weed, water dock and trace amounts of cattails, saltmarsh aster, royal fern, and spikerush.

As we move down river the marshes change to large stands of predominately saltmarsh cordgrass mixed with freshwater species (type I marsh) consisting of pickerelweed, wild rice, and trace amounts of softstem bulrush, beggar ticks, cattails, and water-hemp.

The marshes furthest downstream this segment of the river, toward Red Bank Landing, are cordgrass (type I marsh) dominated with saltmarsh cordgrass and big cordgrass being almost exclusive of other species. Small amounts of cattails and pickerelweed can also be found.
